Building and Timber Pest Inspection Report

Inspection Date: Wed, 8 Apr 2026

Property Address: 4 Penola Dr, South Morang VIC 3752, Australia

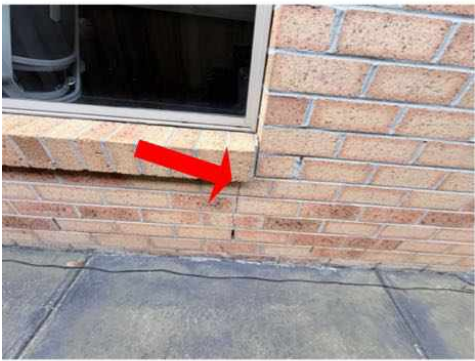
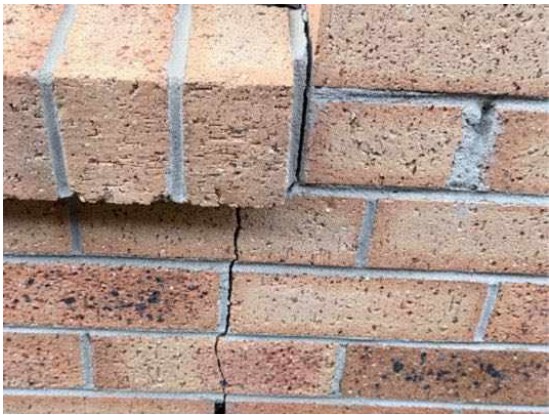
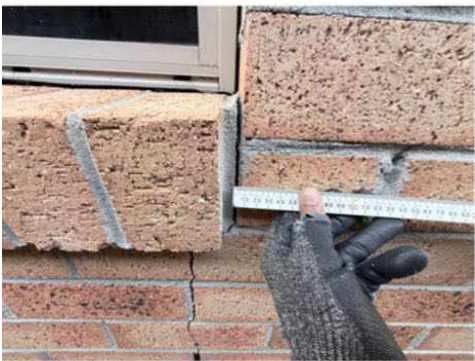
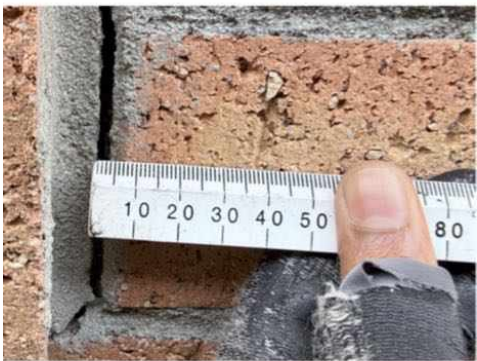
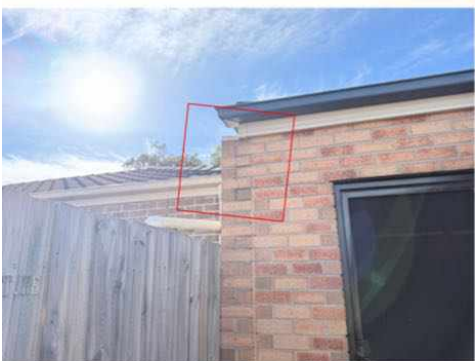
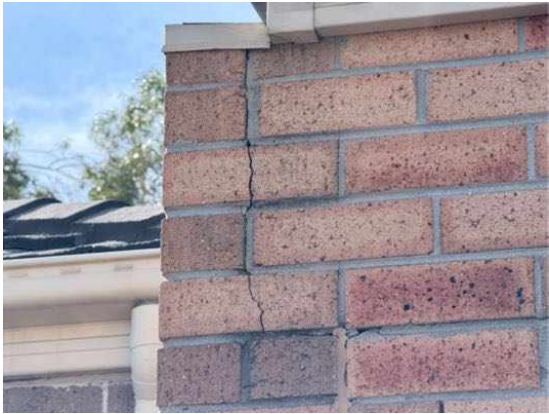
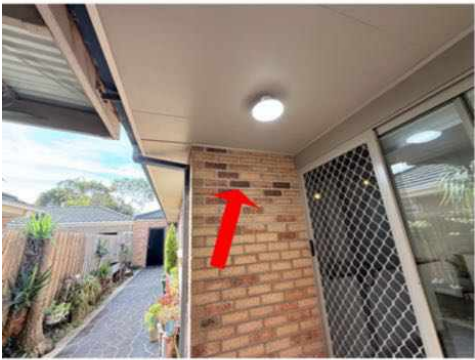
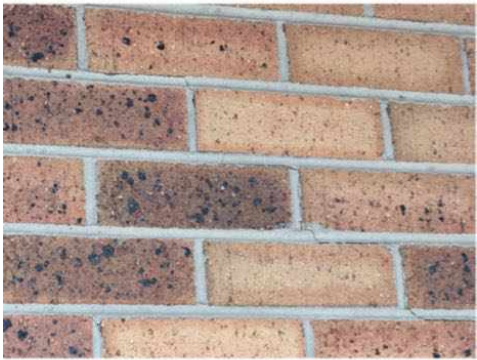
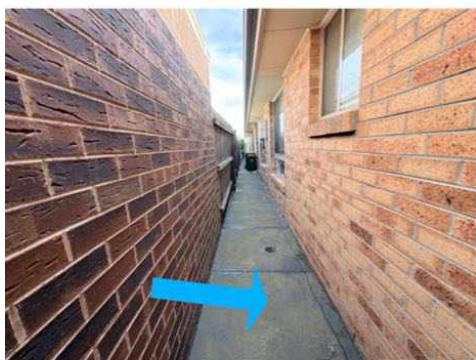
Building: Main Building
Location: Some External Areas
Finding: Step Cracking (Indicative of Localised Movement/Subsidence)- Moderate to Major
Information: Two significant step cracks were observed to the external brickwork, one located along the left-hand side wall and the other to the rear garage wall. The cracks follow a typical stepped pattern through mortar joints and brick units, with measured widths of approximately 4 mm in sections, which is indicative of moderate to major movement in accordance with common masonry assessment criteria.

The cracking pattern suggests differential or localised foundation movement. While internal observations indicate only minor signs of subsidence at this stage, the external manifestation is more pronounced, implying that movement may be concentrated along specific zones rather than uniform across the structure.

Contributing factors may include general ground movement and ageing of the structure. Additionally, site conditions appear to be influencing the issue. The paving along the left-hand side is noted to fall towards the dwelling, which can promote surface water migration toward the footing system. Although drainage points are present, they may be insufficient during heavy rainfall events. Minor gaps adjacent to the slab/edge beam further allow water ingress, which can soften supporting soils and accelerate localised subsidence over time.

If left unaddressed, continued movement may lead to further widening of cracks, potential distortion of openings, and secondary defects internally.

It is recommended that a structural engineer be engaged to assess the extent and cause of movement. Remedial works may include addressing site drainage (regrading paving, improving stormwater management), sealing gaps to limit water ingress, and undertaking masonry repairs once movement is stabilised. Continued monitoring of crack progression is also advised.

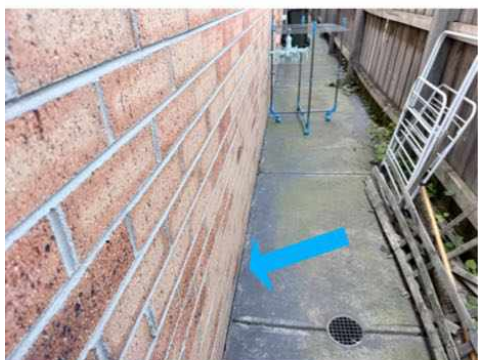
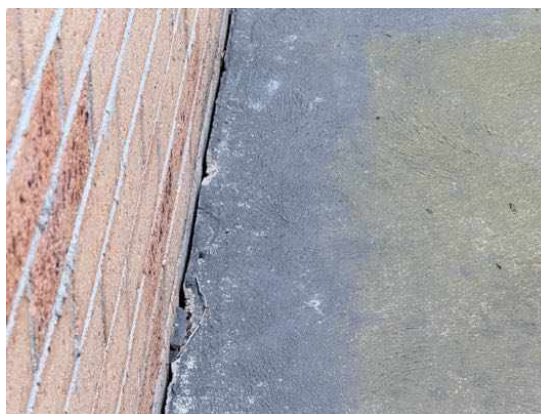
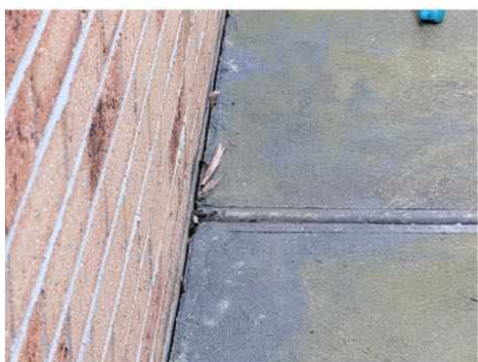
Finding 3.01

| Information: | Gaps were observed in the external concrete paving during the inspection. While not currently presenting as a major defect, these gaps may lead to minor secondary issues over time, such as potential water ingress if not addressed. |

This movement could be attributed to several factors including natural soil reactivity, general wear over time, or possible stormwater drainage issues.

In areas with reactive clay soils, it is advisable to ensure that stormwater from both roof and ground surfaces is effectively directed and regularly maintained, as consistent moisture can contribute to soil movement and may attract termites.

Engaging a licensed plumber to check the condition and adequacy of stormwater drainage is recommended. Additionally, sealing any visible gaps in the paving with the help of a licensed builder or handyman can assist in reducing moisture entry. If certain sections are significantly compromised, a licensed concreter may be consulted for potential repair or replacement.

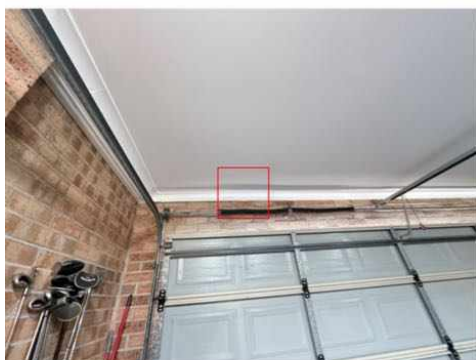
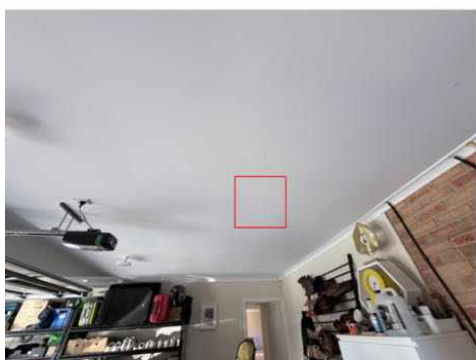
Finding 3.02

| Information: | A few popped nails were identified in the internal ceiling at the time of inspection. Nails and screws hold simply by the friction between them and the surface they are applied to. Over time, the nails and screws can back out, which is often a result of general ageing and deterioration of the building structure. |

If left unmanaged, the ceiling sheets may become loose and unstable, increasing the rate of deterioration of the internal ceiling and creating potential for the development of secondary defects.

Re-fastening of popped nails will help to maintain the stability of the internal ceiling and associated building elements. Such minor works will also help to improve the appearance of the affected area and secure the ceiling sheets, so as to prevent the onset of ceiling sagging. These works should be performed by a qualified carpenter or plasterer at client discretion.

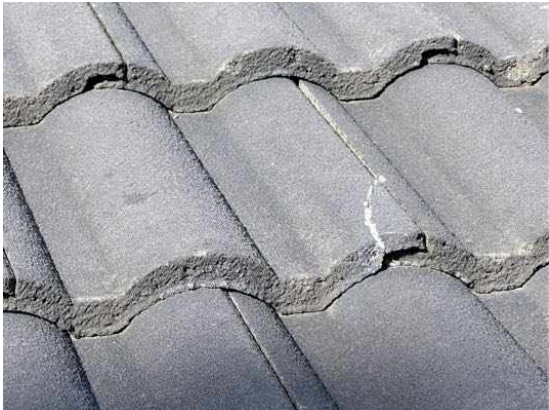
Finding 3.03

| Information: | Minor chipping and edge deterioration were observed to some roof tiles. This is typically consistent with general ageing, weathering, or minor impact damage. At the time of inspection, no evidence of active water ingress was noted; however, continued deterioration of tile edges can reduce weatherproofing effectiveness over time and may allow moisture ingress if left unaddressed. |

It is recommended that periodic roof maintenance be undertaken, including replacement of significantly chipped tiles and general inspection by a qualified roof plumber as required, to maintain the integrity and serviceability of the roof covering.

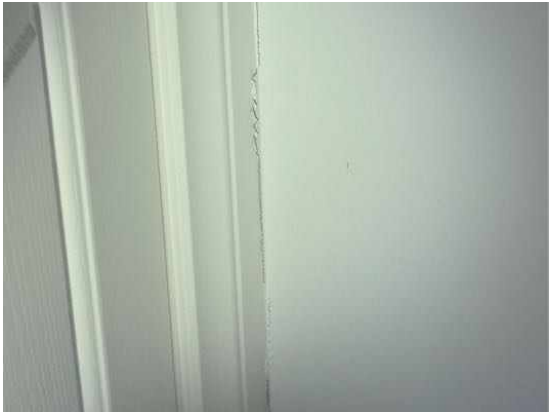
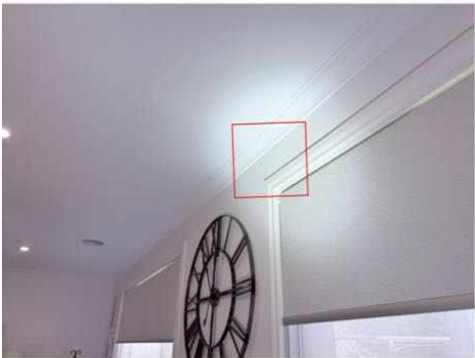
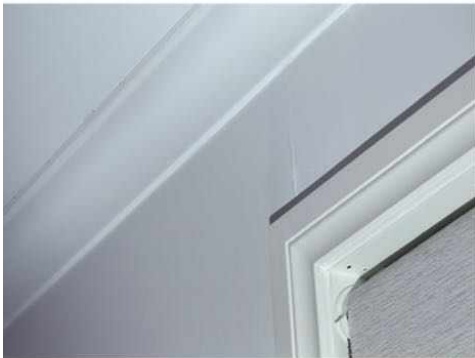
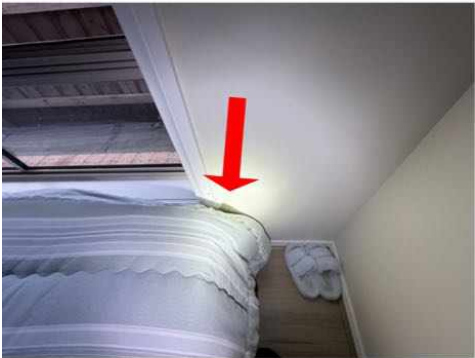
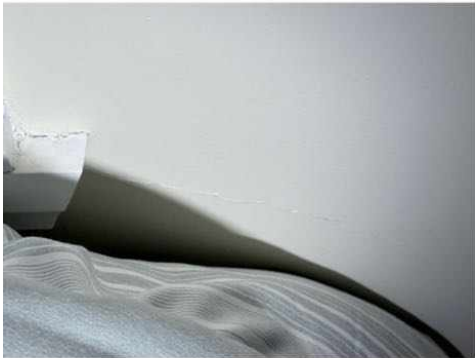
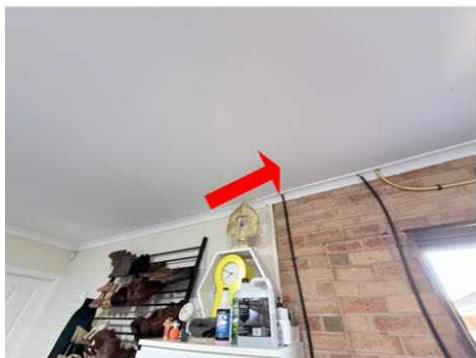
Finding 3.04

Building: Main Building
Location: Some Internal Areas
Finding: Cracking - Damage Category 1 - Fine (up to 1mm)
Information: Although fine cracks are quite noticeable, they are often only considered to be an appearance defect, and usually do not indicate any structural damage. Generally, the cause of a fine crack is indicative of a separation between building materials and finishes (e.g. paint, plaster, etc.) along joins.

Cracking of this nature can generally be repaired with minor sanding, filling and/or repainting. Such works should be performed by a qualified painter or a general handyman.

Monitoring of all cracking should be conducted frequently. Always contact a building inspector should cracks widen, lengthen, or become more numerous.

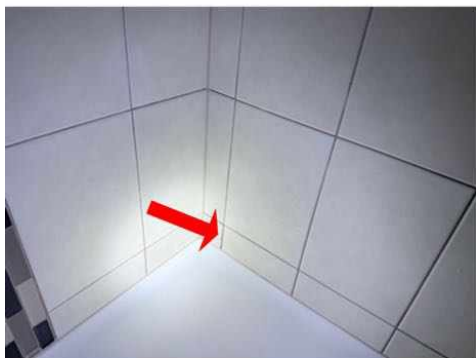
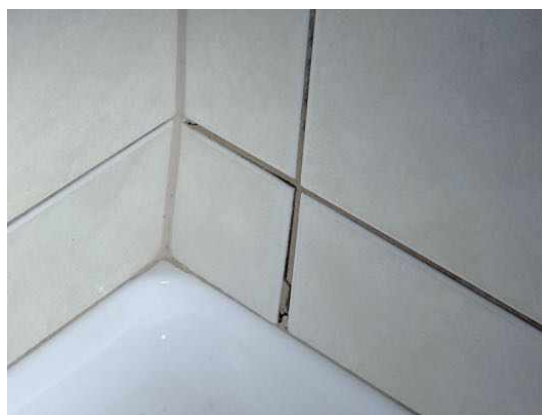
Finding 3.05

| Finding: | Grout - Missing/ cracked |
| Information: | Grout is missing/ cracked in this area. Grout is used to protect gaps and crevices in building materials to ensure that they are water-tight and prevent water penetration to the associated structures. |

Where grout is missing, a tiling contractor should be appointed immediately to apply grout and re-apply any silicone where necessary. Failure to do so is likely to lead to water damage to the surrounding area.

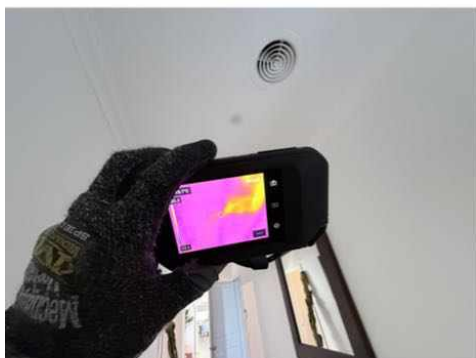
Finding 3.06

| Information: | Upon inspection of the roof void it was noted that there was uneven coverage of insulation. Insufficient or uneven insulation will result in a comparatively higher cost to heat and cool a property, which works as a barrier to heat transfer. This helps to keep out unwanted heat in summer and preserves warmth inside your home in winter. It can also help soundproof your home from unwanted airborne noise transfer. Example |

- Where there is a gap in coverage totaling 5% there is a potential for up to 50% of the energy efficiency to escape.

Installation of adequate insulation is recommended as soon as possible. Caution should be exercised when accessing the roof void. Do not attempt to stand on the framework to the underside of the trusses and be aware there is a potential for electric shock if contact is made with exposed or faulty electrical wiring.

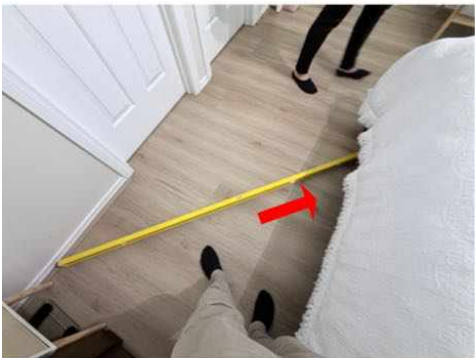
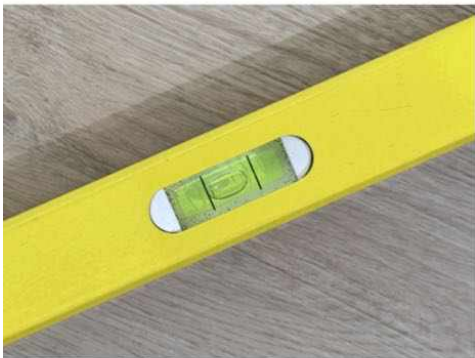
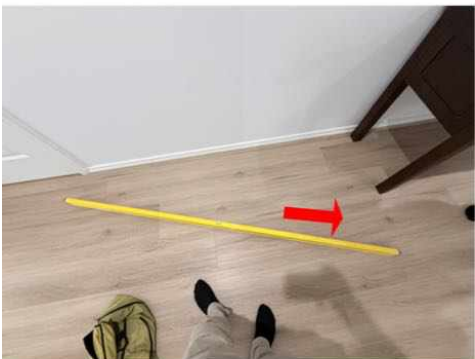
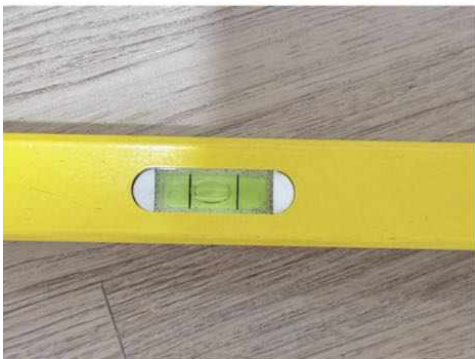
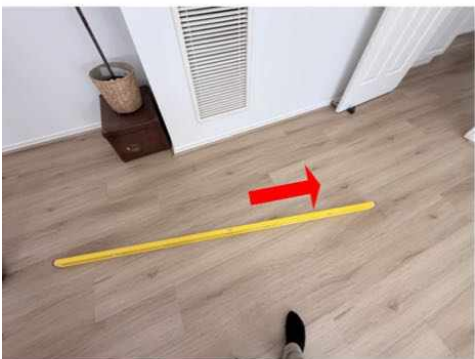
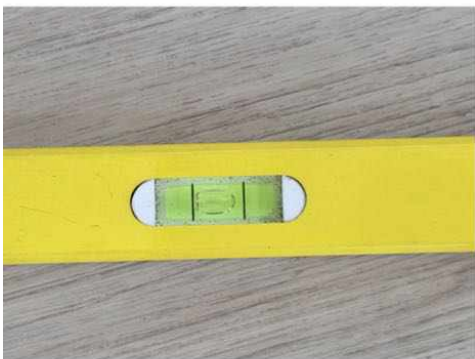
Finding 3.07

| Information: | It is suspected that the subfloor structure might have been affected by movement of the foundations, often referred to as sinking or subsidence. |

General subsidence is usually initiated by changes in soil moisture content. The most critical factor is identifying the specific causes, and identifying if this is a recurring or ongoing problem, or one that has been resolved by previous works in the past.

Subsidence can have complex and varying causes, which will influence the required remedial works. If secondary defects like door binding, cracks around the cornices, or gaps between walls & flooring are evident. It will be advised to begin by consulting a structural engineer to determine the required scope of works. This generally includes some form of underpinning, as well as addressing the underlying cause.

A Registered Builder specialising in underpinning would then generally carry out works as advised by an Engineer.

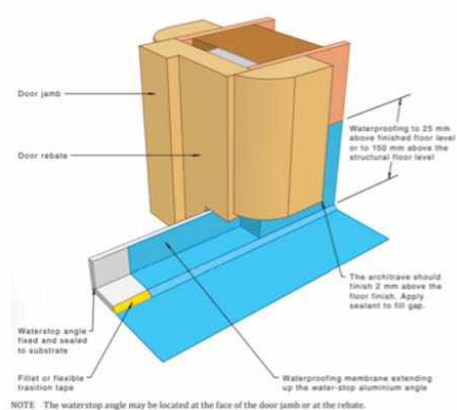
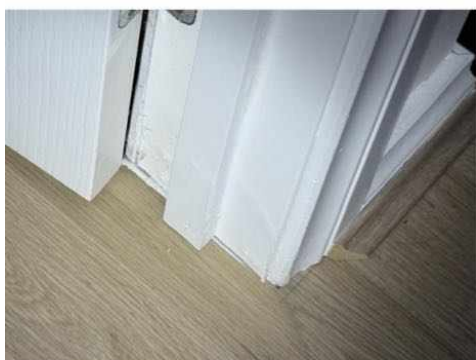
Finding 3.08

| Finding: | Water stop- Missing/ Incomplete (pre-build) |
| Information: | It was identified that the water stop is missing or incomplete at these door opening of wet areas at time of inspection. Without a properly installed waterproofed water stop as required by the BCA and relevant Australian Standard AS 3740, which could allow water to leak into non-waterproofed areas and causing possible future damage. |

(b) For other than whole wet area floor waterproofing A water stop that has a vertical leg finishing flush with the top of the finished floor level shall be installed at floor level openings. The water stop shall be waterproofed to the perimeter flashing.

In the event where the house is more than 20 years old, missing water stop is normal. However, in newer or renovated bathrooms/ homes. Installation which complies with the relevant Australian standards is necessary. As a faulty/ missing water stop also dictates that the quality of overall waterproofing could be substandard.

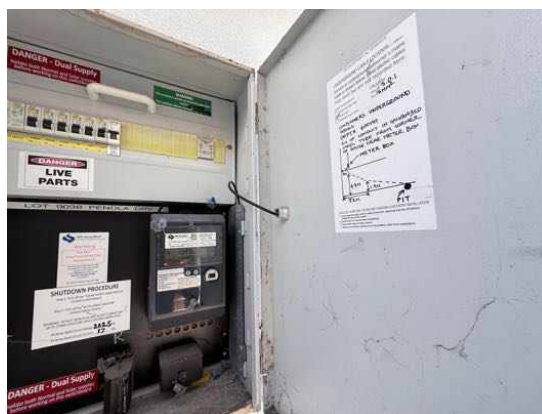
Building: Main Building
 Location: Meter Box
 Finding: Termite Management System - no evidence of a chemical installation
 Information: The application of a post-construction chemical termite barrier is highly recommended for all properties, particularly if live termite activity has been found on the site previously. Such barriers are highly effective in preventing termite attack on any timber building elements throughout the property.

system has been installed, with no evidence to suggest preventative works taking place.

The client may consider gaining further advice from a pest controller as to the costs and procedures involved with this application. It is recommended that obtaining such advice be a short-term priority.

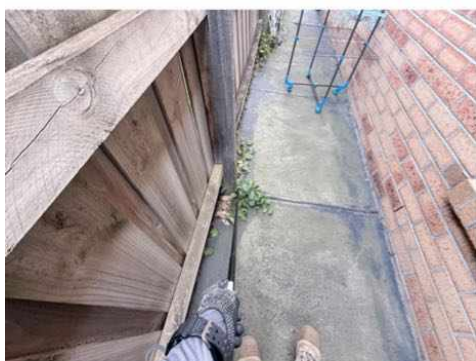
Finding 6.02

| Information: | Any timbers in direct ground contact provide opportunity for concealed termite entry and are likely to be subject to premature rot and decay as the soil retains moisture or damp conditions against the timbers. |

Remove untreated timber that is in direct contact with external grounds. Consider replacement with more durable materials i.e. treated timber or non timber elements. Frequent pest inspections are advised to readily identify any termite activity in these areas.

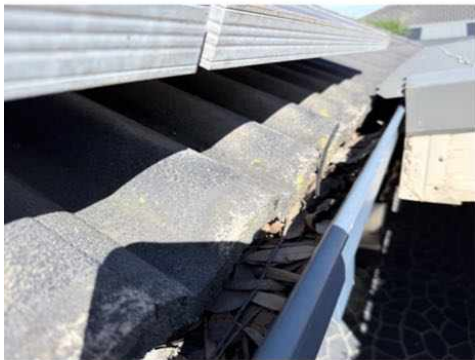
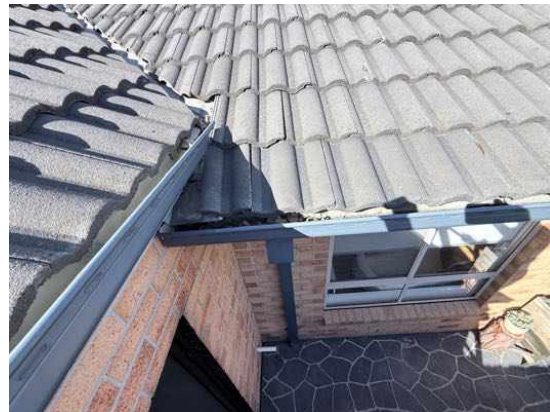
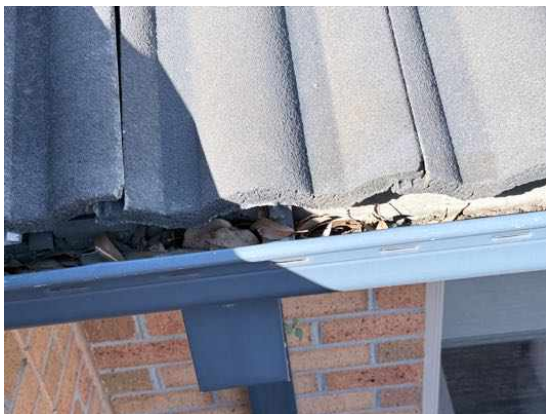
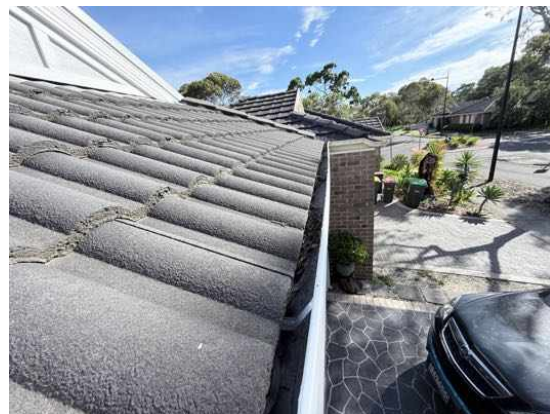
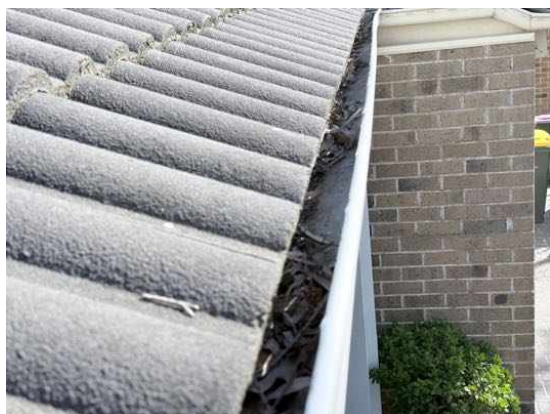
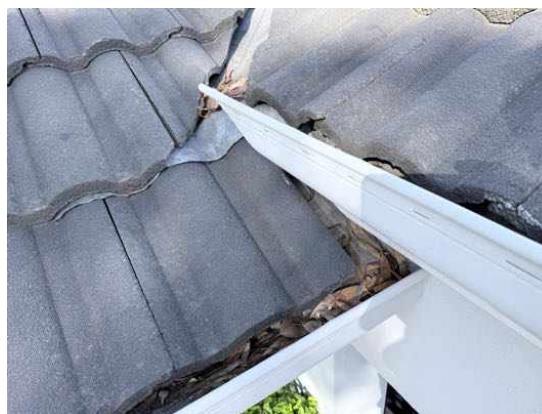
Finding 6.03

Building: Main Building
Location: Roof Exterior
Finding: Gutters - Needs maintenance
Information: Roof plumbing structures, such as guttering and downpipes, should be free of all debris to prevent blockages. Accumulation of debris in gutters and downpipes will lead to pooling and accumulated water overflows, which is likely to subsequently flood eaves and exterior walls.

Blocked or partially blocked gutters can lead to high levels of moisture in the affected areas (eg: entry porch). Such moisture will not only cause rust and decay of the associated building materials, but can also provide conditions that are conducive to termite and timber pest activity. Blocked part of the gutters should therefore be cleaned immediately to ensure dry conditions are maintained.

It is advised that gutters should be maintained regularly by the homeowner & a general handyman should be appointed as a matter of urgency to clean the gutters.

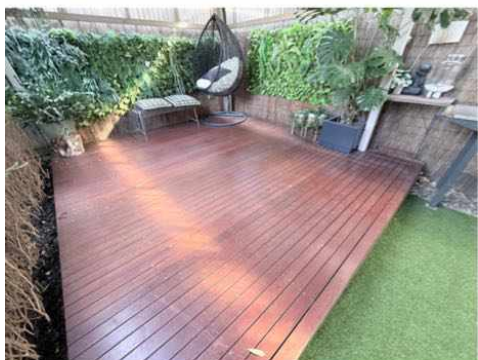
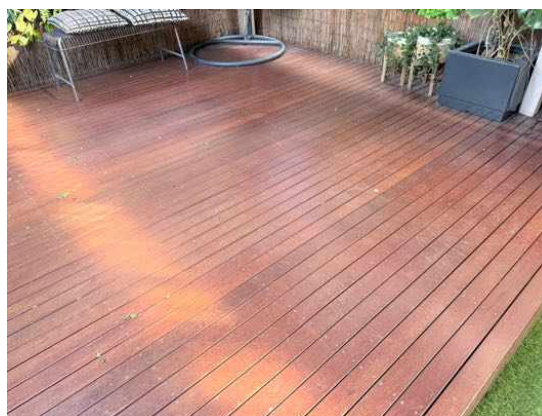
Finding 6.04

Building: Main Building
 Location: Yard - Back
 Finding: Timber deck- High conducive condition.
 Information: We are unable to inspect under the timber deck if its in close proximity to the ground.

Where we are unable to inspect timber structures, decks and subfloor areas the risk of undetected termite activity is rated as extremely High.

We strongly recommend the purchaser prioritise a termite treatment by a Licensed Pest Controller to protect and maintain the asset as it is a timber structure.
