Building and Timber Pest Inspection Report

Inspection Date: Thu, 05 Mar 2026

Property Address: 1/11 Erskine Ave, Reservoir VIC 3073,
Australia

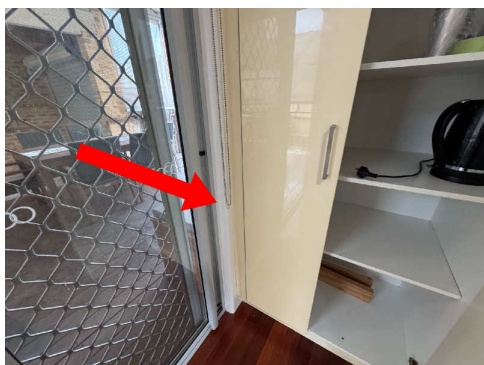
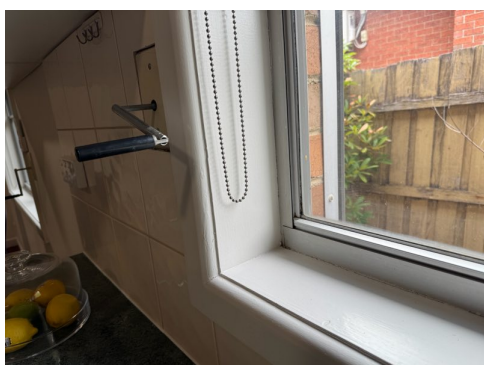
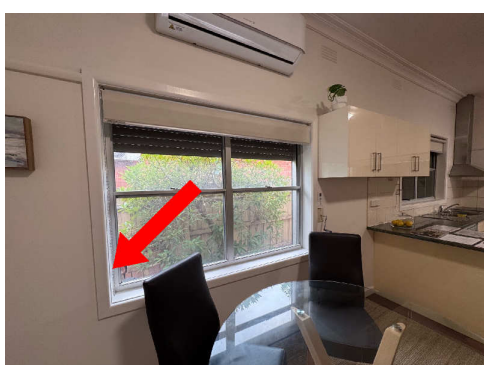
Information: Looped curtains and blind cords pose a significant strangulation hazard for children as they can place the loop over their heads and/or get tangled in the loose cords. The mandatory standard for blinds, curtains and window fittings (in place from 30th December 2010) requires all new window furnishings to come with warning labels and to be installed with tensioning devices. However, as this standard is not retrospective, curtains and blinds installed before 2010 still need to be made safe. Check all the rooms in your house for any blinds or curtains with long, loose or looped cords. This includes any cords within children's reach at floor level or near furniture they can climb on. Secure any loose or looped cords with cleats or tension devices - these can be purchased from your local curtain and blind retailer or hardware store. Do not put furniture such as cots, beds, highchairs, playpens, couches, chairs, tables or bookshelves near a window where children can reach the blind or curtain cord. When installing new blinds and curtains, ensure you or the installer secures loose or looped cords immediately. Depending on the types of curtains/blinds in your home, various kits and devices can help you make them safe. These can be purchased from your local hardware store, curtain, or blind retailer. It is recommended that this defect be resolved immediately to avoid harm to occupants.

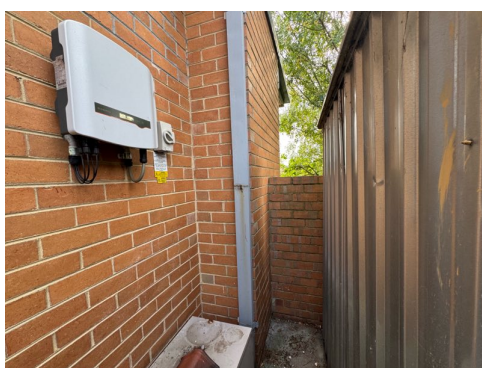
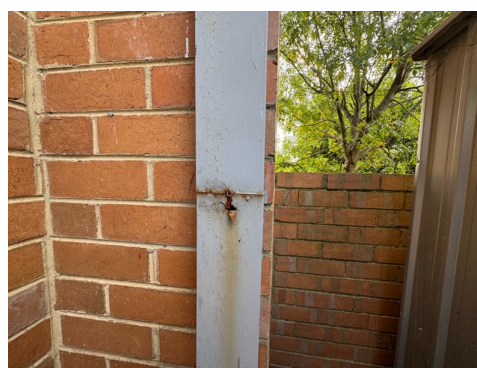
Blocked gutters and drains are likely to lead to high levels of moisture in the affected areas. Such moisture will not only cause rust and decay of the associated building materials, but can also provide conditions that are conducive to termite and timber pest activity. Blockages in gutters and drains should therefore be removed immediately to ensure dry conditions are maintained.

A qualified plumber should be appointed to further inspect the property and perform any necessary remedial works. It is also recommended that a CCTV inspection of the stormwater drainage system be carried out to identify any blockages, damage, or defects that may be contributing to poor site drainage. Water damage and secondary defects are likely to occur if the issue remains unmanaged.

It is highly advised that gutters and drains be checked and cleaned regularly for the long-term care of your property.

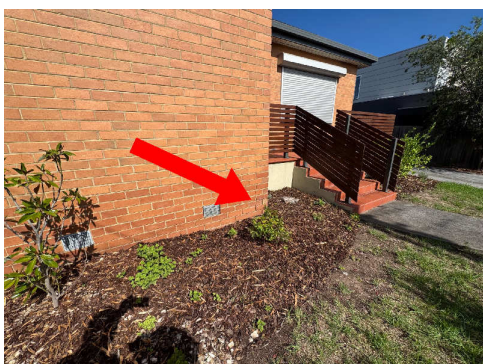
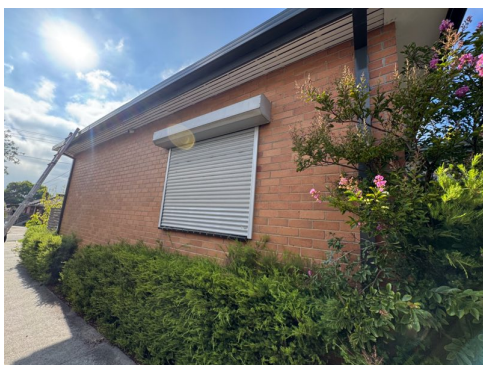
Finding 3.02

Finding: Brickwork - Cracking [Fine]

Information: Although fine cracks are quite noticeable, they are often only considered to be an appearance defect and usually do not indicate any structural damage. Generally, the cause of a fine crack is indicative of a separation between brickwork and mortar throughout the structure, but single bricks may also show cracks of this nature.

Cracking of this nature can generally be repaired with minor filling and should be conducted by a qualified bricklayer.

Always contact a building inspector should cracks widen lengthen or become more numerous.

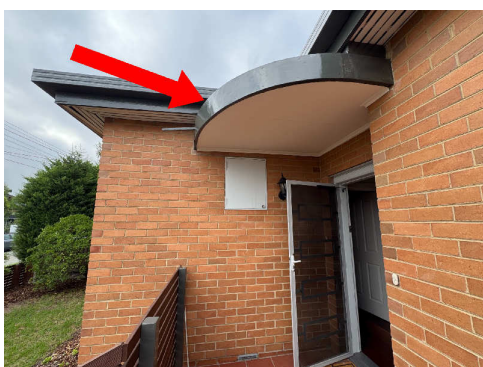
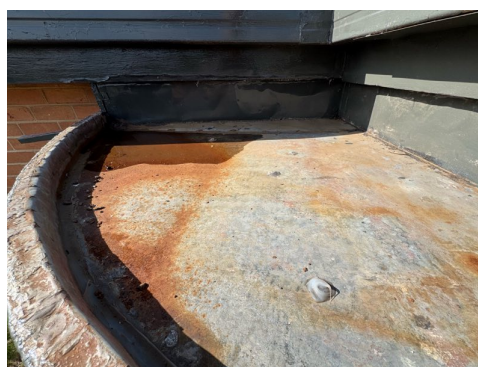
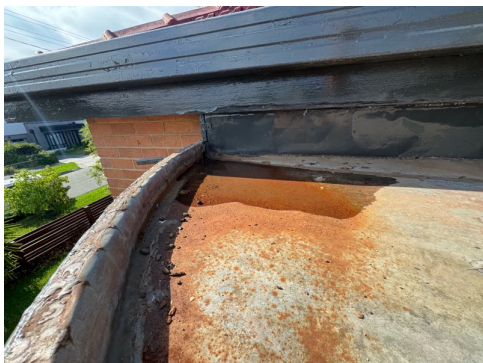
Finding 3.03

Finding: Building element - Rusted or corroded

Information: This building element shows evidence of rusting and corrosion. As surface rust provides no protection to the underlying iron, the deteriorating condition is likely to worsen if not addressed in the short-term. Rust formation can be controlled with coatings, such as paint, that isolate the iron from the environment. as does regular general maintenance. A painting contractor or general handy person should be appointed as soon as possible to perform necessary works to ensure the area is protected against further deterioration.

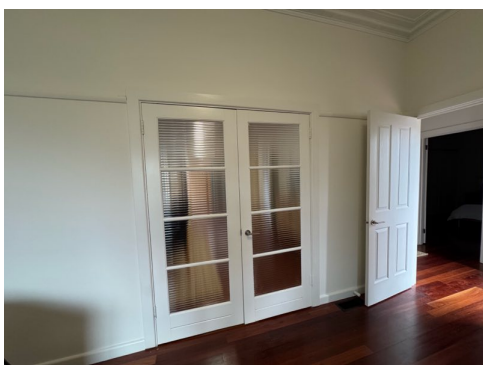
Finding 3.04

Finding: Door - Rubbing

Information: The door was found to be rubbing during standard operation. This defect inhibits the functionality of the affected door as well as creating potential for secondary defects to associated building elements. A qualified carpenter or general handyperson should be appointed to perform minor rectification works to improve the operational state of the associated door at the clients discretion.

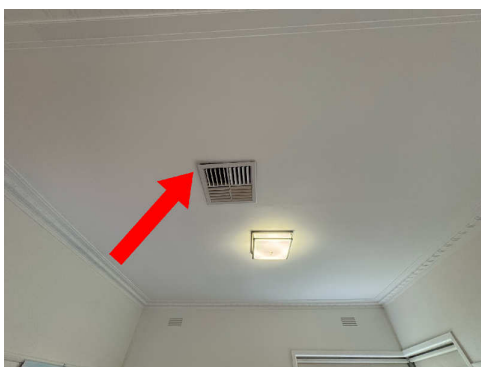
Finding 3.05

Finding: Air vent or grille loose.

Information: At the time of inspection, the air vent was observed to be loose and not securely fixed in position.
Breakage occurs generally when the building materials have either aged and decayed, or as a result of damage (accidental or deliberate).

Repair and/or replacement of broken elements is advised to ensure that additional secondary defects do not arise as a consequence. Such works are necessary, as all building elements play a key role in the operation and function of the overall structure and its performance.

A relevant tradesperson should be appointed to repair or replace the affected building element prior to any subsequent damage being caused.

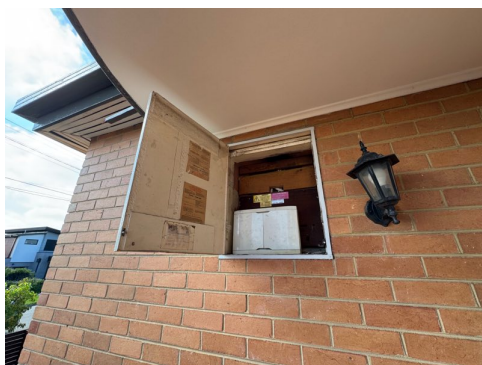
Finding 6.01

Building:	Main Building
Location:	Meter Box
Finding:	Termite Management System - no evidence of a chemical installation
Information:	<p>The application of a post-construction chemical termite barrier is highly recommended for all properties, particularly if live termite activity has been found on the site previously. Such barriers are highly effective in preventing termite attack on any timber building elements throughout the property.</p> <p>A durable notice should be placed in the switchboard unit to indicate current termite barriers. At the time of inspection, it appeared as though no termite management system has been installed, with no evidence to suggest preventative works taking place.</p> <p>The client may consider gaining further advice from a pest controller as to the costs and procedures involved with this application. It is recommended that obtaining such advice be a short-term priority.</p>

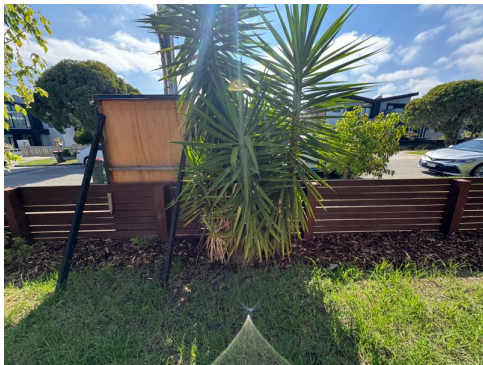
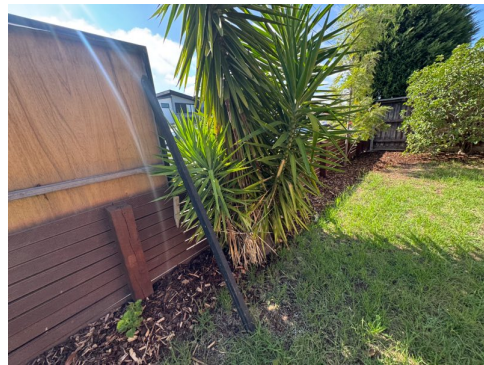
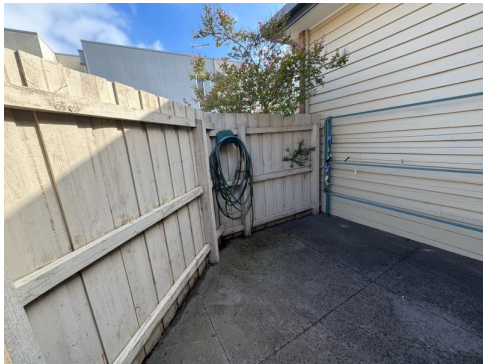
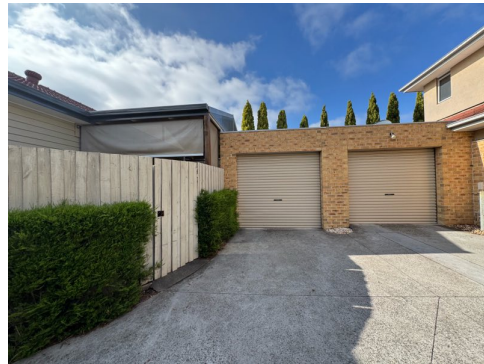
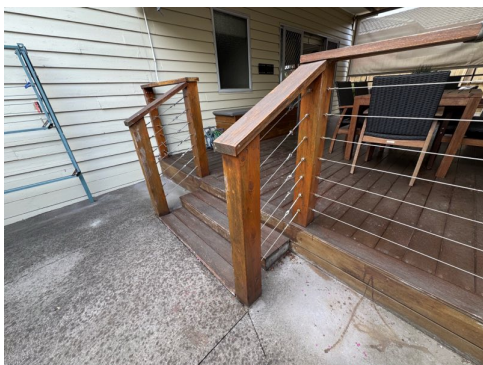
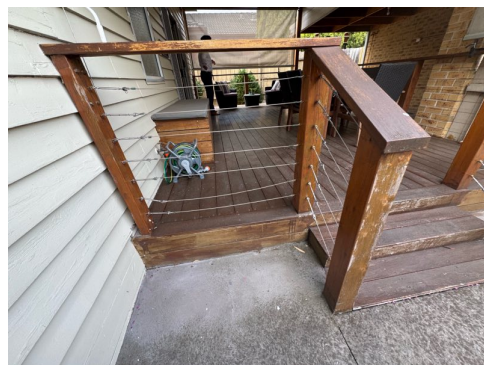
Finding 6.02

Information: Where timber elements are in direct contact with the ground and consequently moisture or dampness they become conducive to termite activity. Whether timber is used as a building element part of a fencing structure or stored as an unused item they can provide an environment that is attractive to termite infestation.

When met with excessive moisture timber begins to decay and develop wood rot. Any timbers that are in direct contact with external grounds especially if left untreated or non-durable also provide ingress for subterranean termites into that particular element. Consider replacement with more durable materials i.e. treated timber or non timber elements.

The removal of any such materials that may be conducive to termite activity should be removed as soon as possible to minimise the risk of termite attack. Where it is not possible frequent inspections of these areas shall be undertaken to provide early detection of infestation

It is highly recommended that termite or timber pest inspections be carried out every 6-12 months to aid protection of the property against infestation.

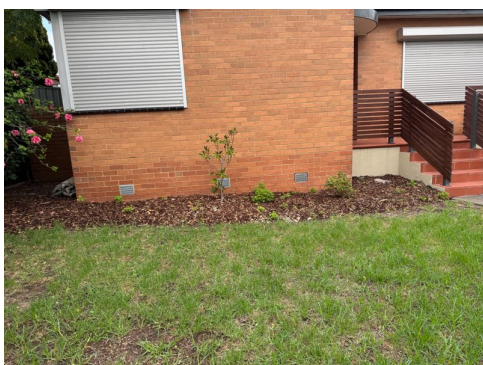
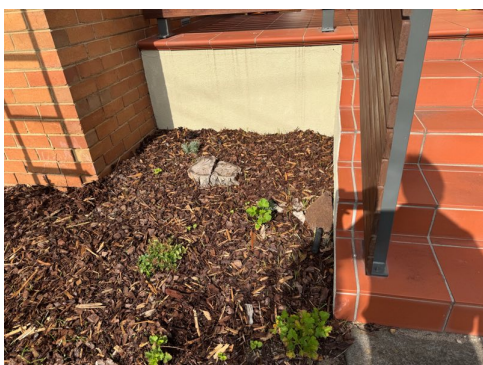
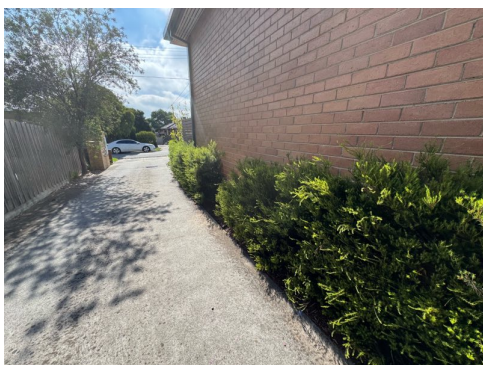
Finding 6.03

Finding: Garden Beds - Conditions Conducive to Termites

Information: Garden beds were found at the time of inspection. These garden beds can include untreated timber, and with a combination of moisture from watering hosing can make conditions conducive to termite activity and termite ingress.

The building of gardens or planting of shrubs close to the perimeter of the building may promote termite activity. It is highly recommended that termite or timber pest inspections be carried out every 6-12 months to aid protection of the property against infestation.

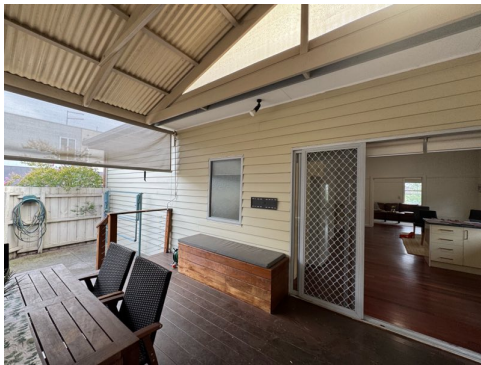
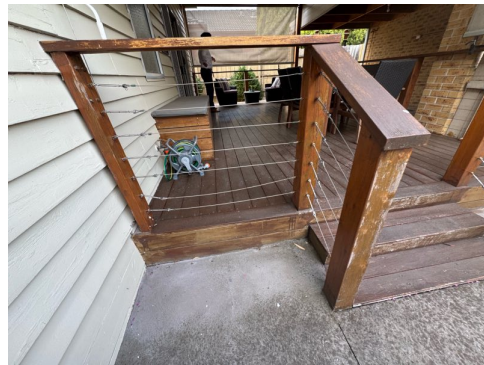
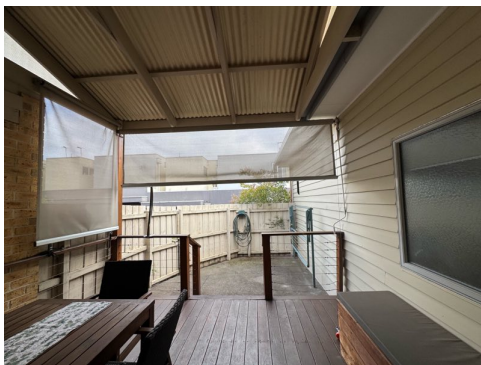
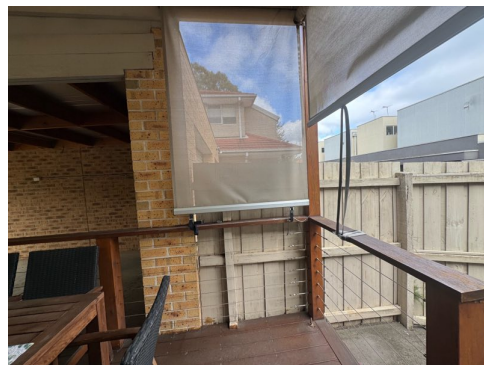
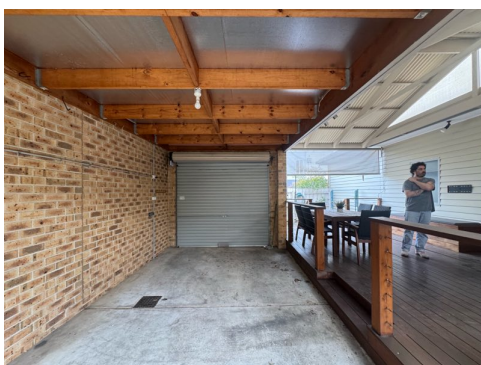
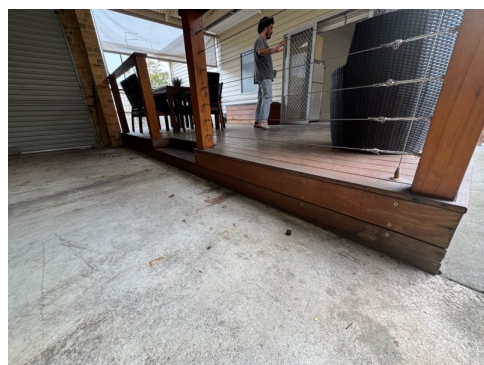
Information: Attachments to buildings shall have a nominal gap to allow clear and uninterrupted visual inspection across the inspection zone. Attachments and items adjacent to buildings, such as fencing, steps, verandas, porches, access ramps, carports, trellises, decks, hot-water systems, air conditioners, downpipes, service pipes, or similar attachments, shall be separated from the building by a gap of at least 25 mm, to allow clear and uninterrupted visual inspection. Where it is not possible to separate existing attachments from the building, frequent inspections of these areas shall be undertaken to provide early detection of infestation.

When bridging has occurred, full inspection is prevented, and termites may enter a property in a concealed or undetectable manner. It is highly recommended that termite or timber pest inspections be carried out every 6-12 months to aid protection of the property against infestation.

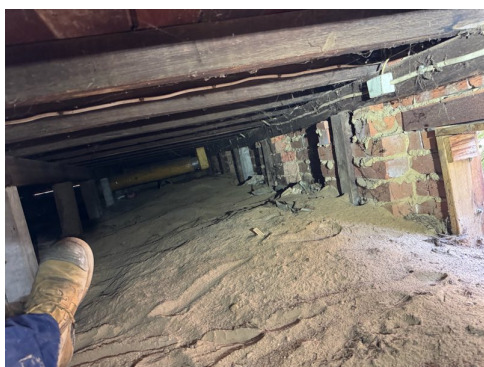
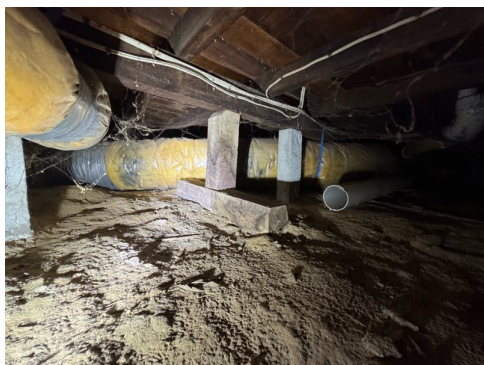
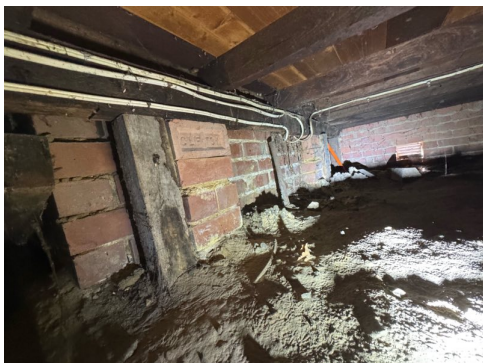
Finding 6.06

Information: The storing of timbers in the subfloor space or around the external property increases the risk of termite activity being present. As they are likely to come into contact with weather conditions or excessive moisture wood rot is likely to develop on timbers that are not treated.

It is highly recommended that any stored timbers be immediately removed from areas in which they may attract any termite / timber pest attack. Minimisation of risk / prevention of termite attack is far more adequate than dealing with the presence of termite activity.

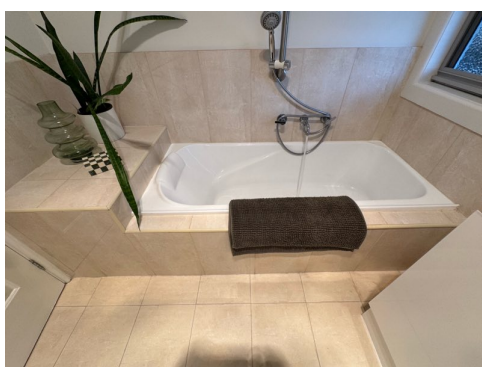
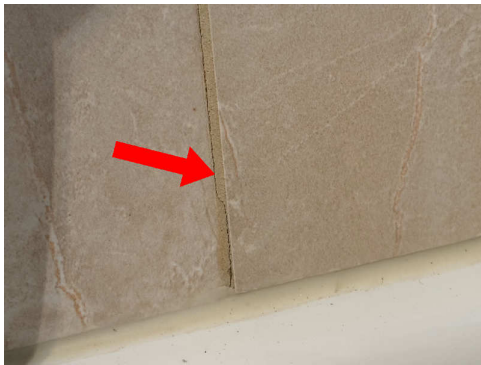
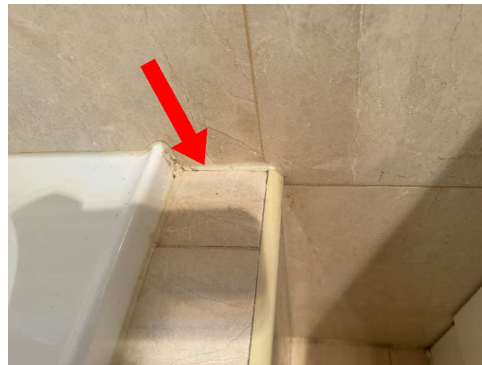
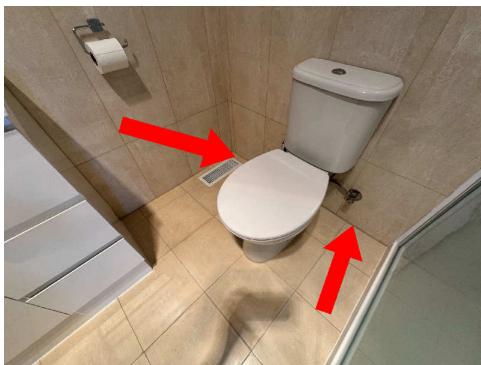
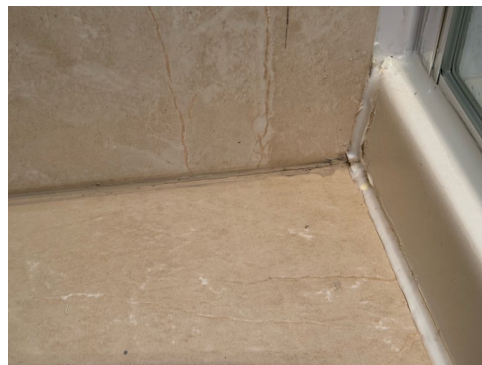
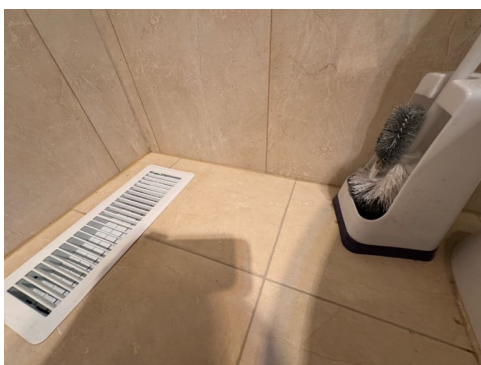
Finding: Sealant and grouting - Missing or damaged

Information: It was noted on inspection that sealant or grout is degraded to the tiled shower alcove and or other areas of the bathroom.

Different materials and floor areas move at different rates, generally causing cracking to grout or sealant at this point. A flexible sealant is required to allow for expected expansion and contraction, while keeping the joint water tight and protective of all associated building materials.

Flexible and mould resistant materials should be applied to affected areas to prevent any subsequent water damage that is likely to occur. Regular maintenance and replacement of damage or missing or damaged sealant and grout is highly recommended to the wet areas, as this is a regular wear and tear defect. Sealant and grouting in areas that come into regular contact with water should be maintained for the long term care of your property.

A sealant specialist or tiling contractor should be appointed to complete these works in the short to medium term.

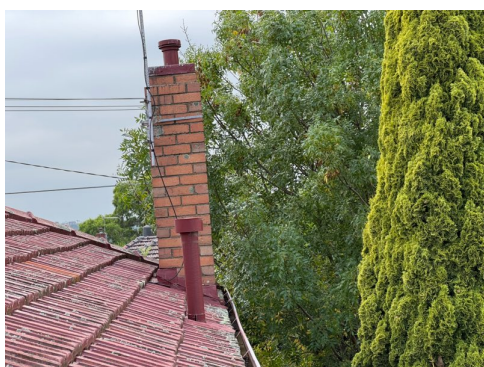
Gutters are a critical part of the building's management of storm water and rain. It is therefore important that they be kept clear to prevent secondary damage to associated building elements, including exterior and interior walls, ceiling linings and any adjoining building elements. Where gutters are blocked, pooling of rainwater is likely to occur, fast-tracking rust and corrosion of the roof plumbing elements.

It is highly advised that all overhanging tree branches be removed as soon as possible to prevent any further damage. Repair and/or replacement of sections of damaged guttering may also be required where the extent of the damage necessitates.

Such works should be performed by the homeowner; however, appointment of a landscape contractor or an arborist may be required. Consultation with a licensed roof plumber is required where guttering has been damaged.

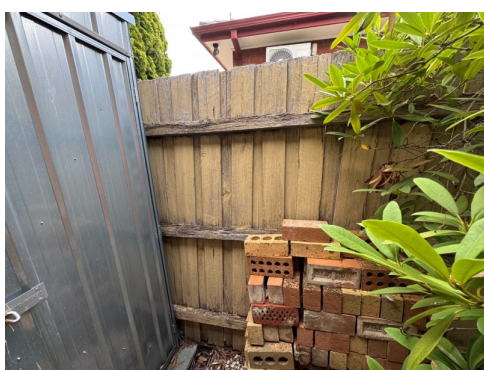
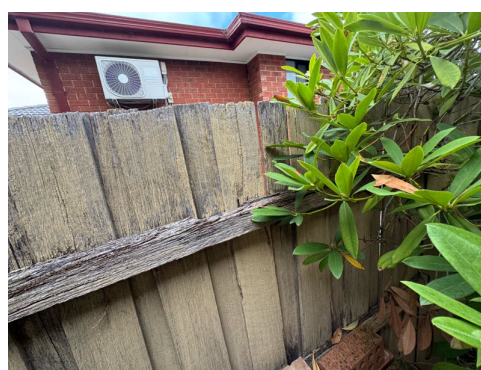
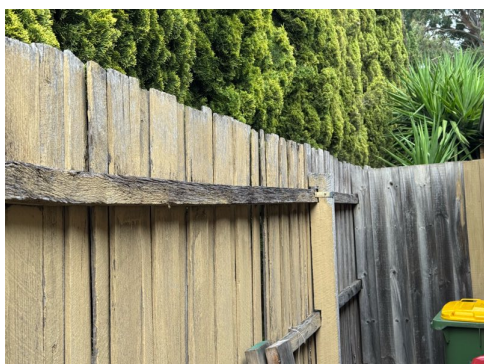
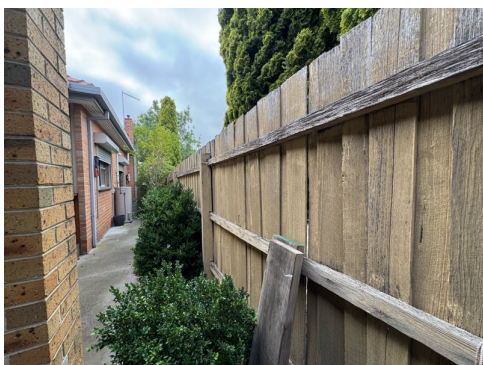
Building: Main Building
 Location: Fencing
 Finding: Fencing - Deteriorated

It was noted at the time of inspection that sections of the fencing throughout the property have deteriorated. Typically fencing deteriorates due to age and or wear, rot and or rust which is generally expected for a structure of this age, due to prolonged exposure to weather conditions. Sometimes inadequate installation or maintenance can be to blame.

If left unattended, it is likely that further damage will occur. It is suspected that repair of several elements of the fencing may be required however replacement may be a consideration of the client also.

A licensed fencing contractor should be appointed to provide further advice and perform rectification works as necessary.

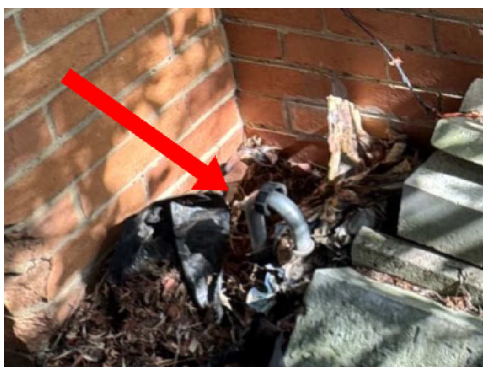
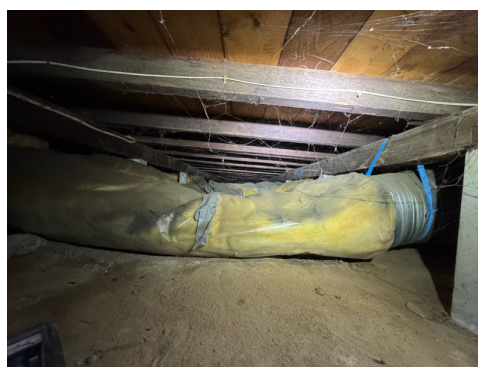
Information: At the time of inspection, the ducted heating system was suspected to be non-operational. Sections of the ductwork were also observed to be damaged in the subfloor and no gas meter was located at the time of inspection.

This item is provided for information purposes only. Further information regarding the operation of the system should be obtained from the vendor or the vendor's agent. A licensed HVAC contractor should inspect the system and carry out any necessary repairs as required.

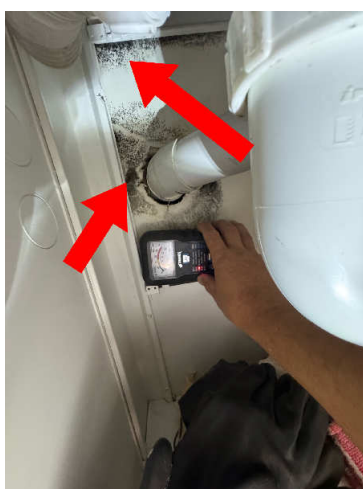
Information: Where evidence of mould growth was noted, there may be environmental, biological or health issues associated with the report. A specialist inspection by a suitably qualified environmental health inspector is warranted, where mould is extensive or where any queries regarding air quality spores or other related issues apply.

Generally, the client is advised to ensure that the general environment is free of moisture and humidity to aid in the prevention of mould formation and development. Any mould found during the inspection should be cleaned immediately by a cleaning contractor or the homeowner as applicable.

Please note that severely affected building elements may require replacement by a registered builder or qualified carpenter.
