Building and Timber Pest Inspection Report

Inspection Date: Wed, 14 Jan 2026

Property Address: 6 Goddard St, Turrella NSW 2205, Australia

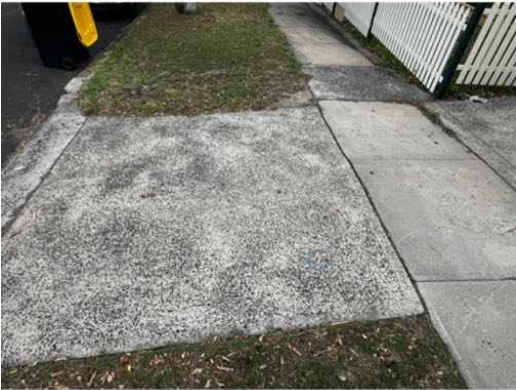
Building: Main Building
 Location: Driveway
 Finding: Crack in concrete slab - Category 2
 Information: A crack coded as Category 2 was identified in the slab. A Category 2 crack is described as a distinct crack, with the slab being noticeably curved or changed in level.

To be considered Category 2, the approximate width of the crack is less than 2.0mm, or a change in offset of less than 15mm when a 3m straight edge is placed over the defect.

Category 2 cracks to slabs should be monitored for a period of 12 months. At the end of the monitoring period, cracks rated greater than Category 2 are considered defects that require rectification.

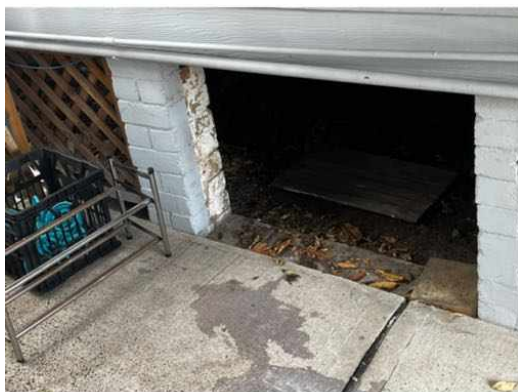
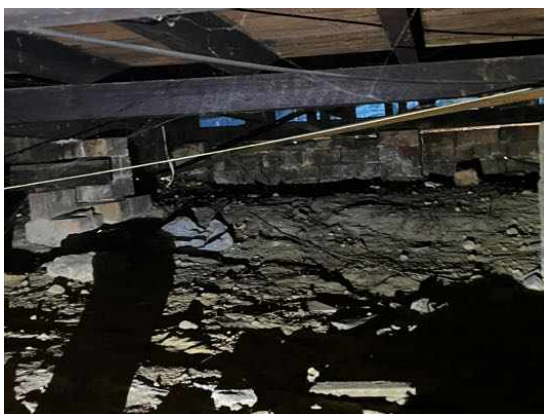
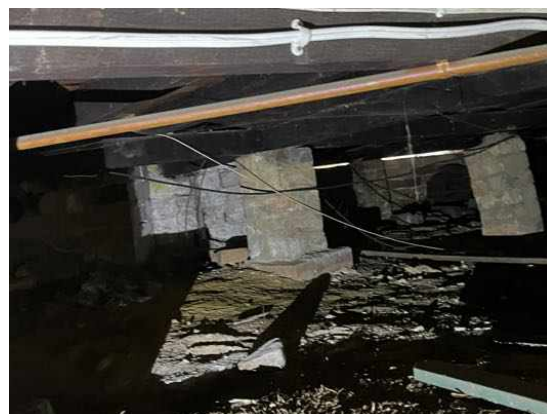
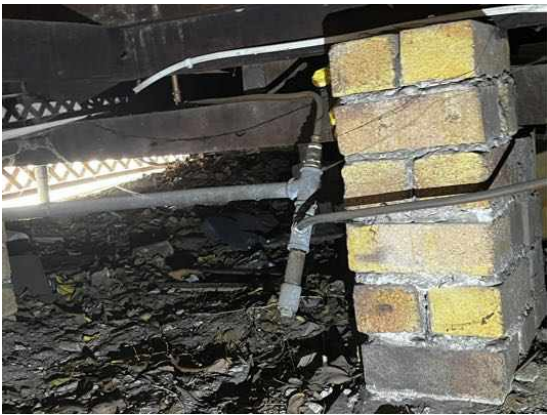
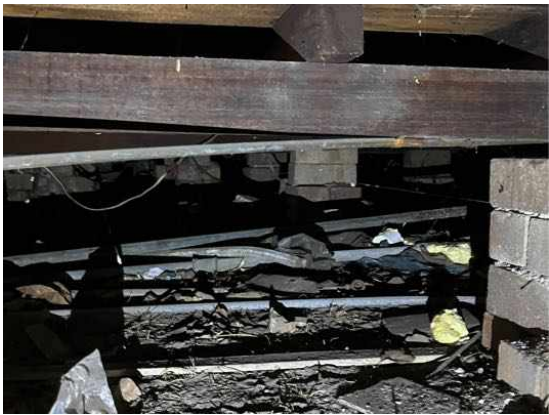
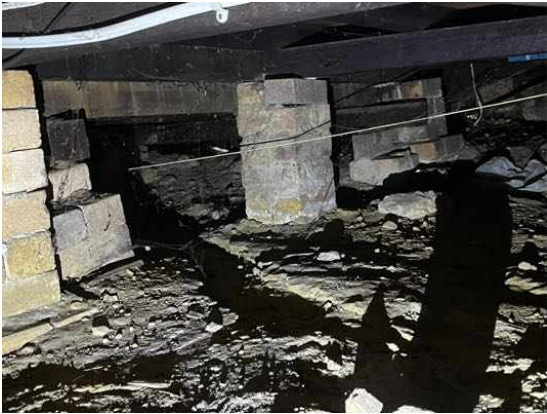
Antcaps missing on top of Brick stumps.

The storing of timbers/ Other items/ Ducting/ Pipes/ Services/ Electrical Wiring in the subfloor space or around the external property increases the risk of termite activity being present. As they are likely to come into contact with weather conditions or excessive moisture wood rot is likely to develop on timbers that are not treated.

It is highly recommended that any stored timbers be immediately removed from areas in which they may attract any termite / timber pest attack. Minimisation of risk / prevention of termite attack is far more adequate than dealing with the presence of termite activity.

These obstructions can hide an array of defects and should be removed to allow full inspection to be carried out. A re-inspection is recommended once the areas are made accessible.

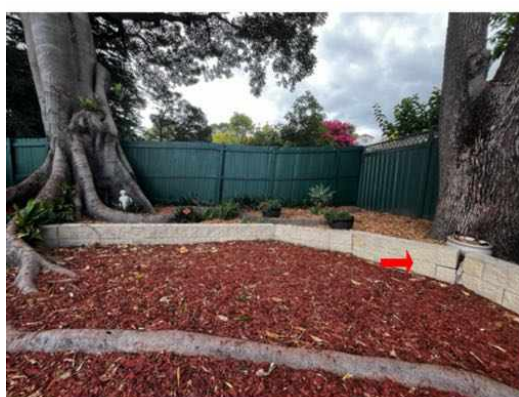
Building:	Main Building
Location:	Studio- Back
Finding:	Water pooling - against property
Information:	Water appears to be pooling against the house. It is suspected that this is a result of poor site drainage but may also be due to excessive moisture from an unidentified source.

Where water is pooling against the house water damage to the external wall cladding is imminent.

Such water pooling also increases the risk of termite activity and the development of fungal decay in the area.

Consult a Licensed Plumber regarding the cost of potential site drainage rectification works.

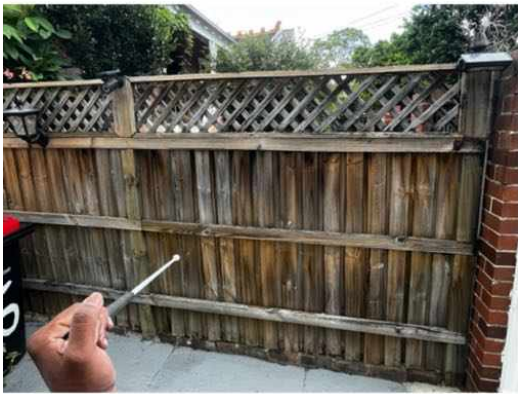
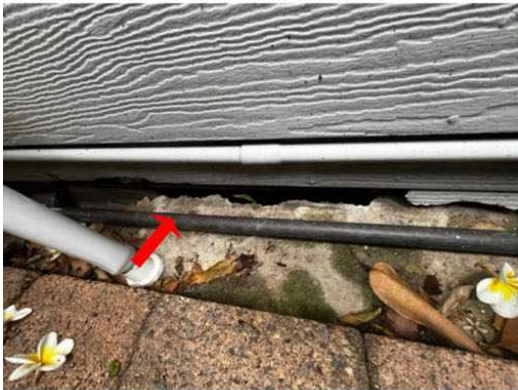
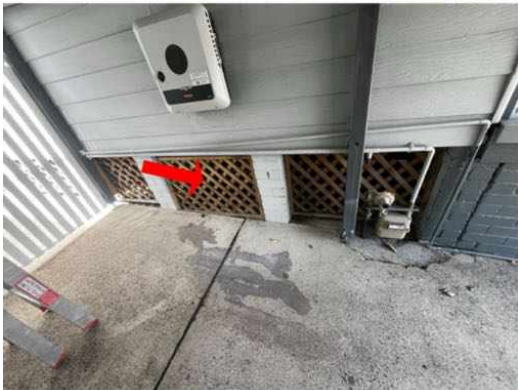
Finding 6.07

Building:	Main Building
Location:	All Areas
Finding:	Building materials in direct ground contact - conducive to termites
Information:	Where timber elements are in direct contact with the ground and consequently moisture or dampness they become conducive to termite activity. Whether timber is used as a building element part of a fencing structure or stored as an unused item they can provide an environment that is attractive to termite infestation.

When met with excessive moisture timber begins to decay and develop wood rot. Any timbers that are in direct contact with external grounds especially if left untreated or non-durable also provide ingress for subterranean termites into that particular element.

The removal of any such materials and timbers stored that may be conducive to termite activity should be removed as soon as possible to minimise the risk of termite attack.

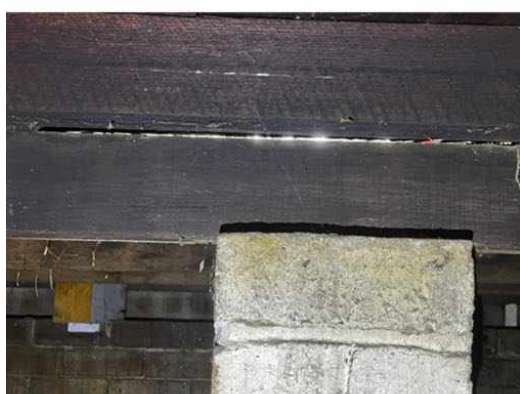
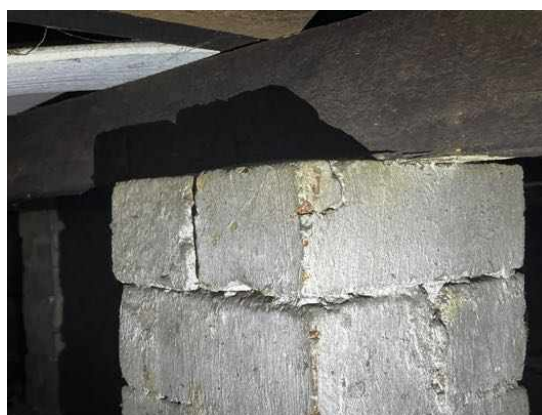
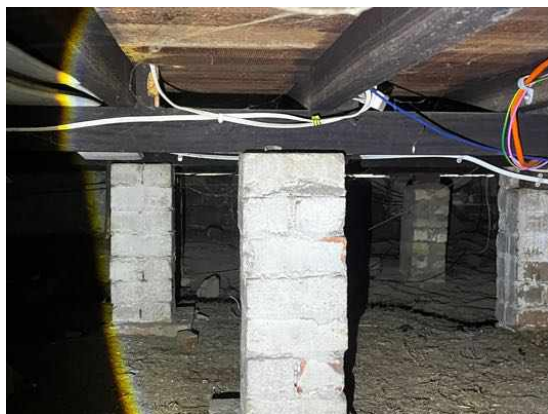
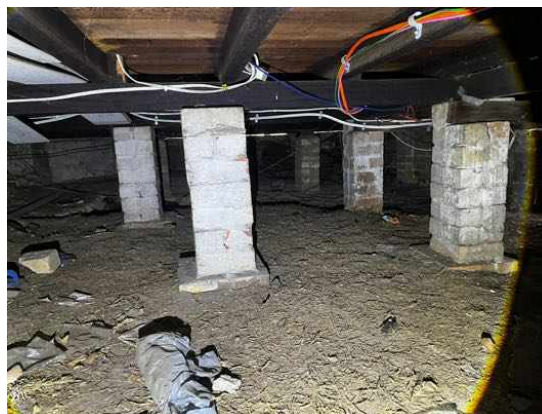
Finding 6.08

Building: Main Building
 Location: Subfloor
 Finding: Ant caps - Not installed
 Information: Ant caps have not been installed to the subfloor structure at the time of inspection. Generally, ant caps are installed to the intersection between the top of the stumps (or piers) and the subfloor structures.

Generally Installed during the construction process, ant caps are designed to easily identify termite or pest ingress from stumps to the adjoining bearers.

Where ant caps have not been installed, frequent monitoring of these areas should be carried out in order to identify any signs of termite or timber pest workings.

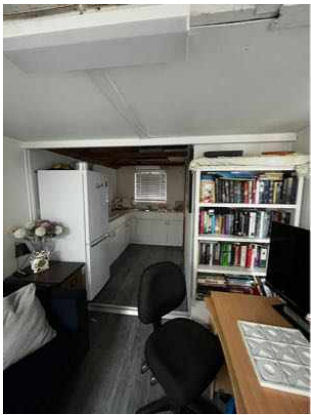
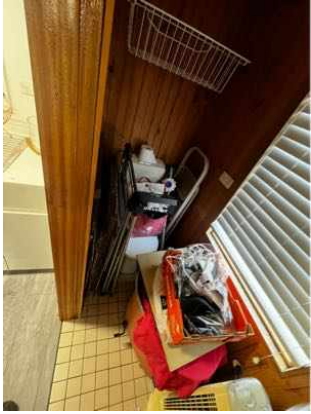
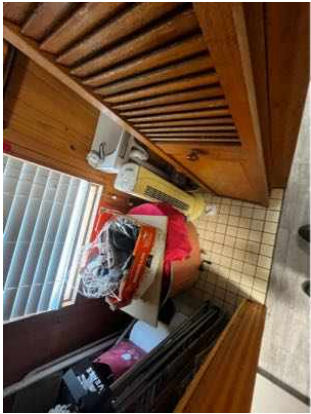
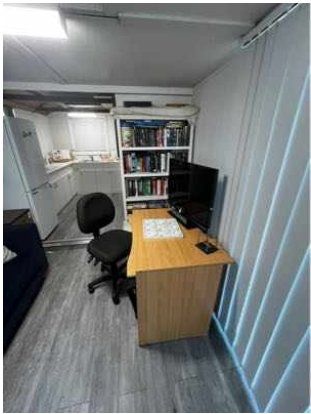
Building: Main Building
 Location: All Areas
 Finding: Additional Photos - Obstructions and Limitations
 Information: These photographs are an indication of the obstructions and limitations which impeded full inspection of the property at the time of inspection. These obstructions can hide an array of defects and should be removed to allow full inspection to be carried out. A re-inspection is recommended once the areas are made accessible.

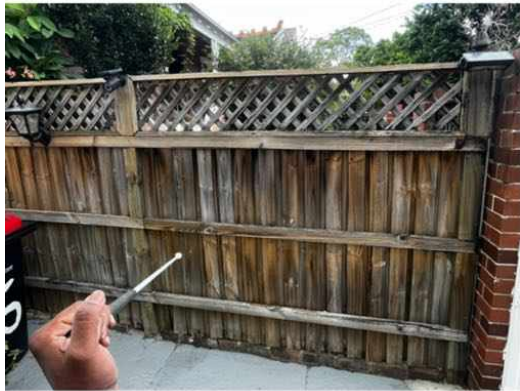
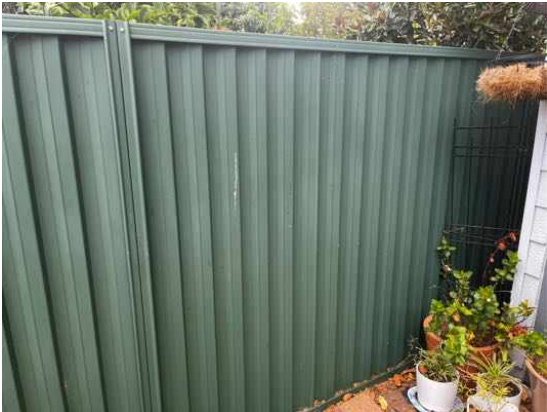
Building: Main Building
 Location: Yard
 Finding: Perimeter Fencing - Timber fence/ Colourbond Fence
 Information: For your information photos taken at the time of inspection - During the inspection the Colourbond fence was inspected and found minor defects/ dents, deterioration but the fence at the back of the property Timber fence inspected.

Please appoint a fence installer to inspect and rectify the same at buyers convenience.

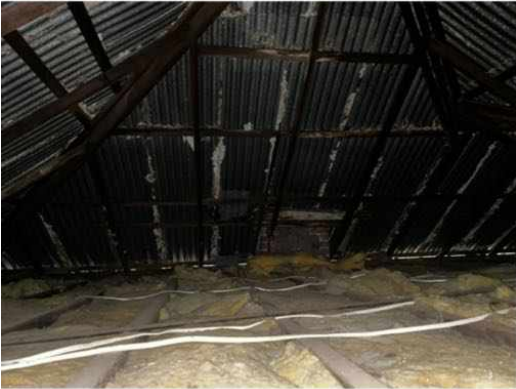
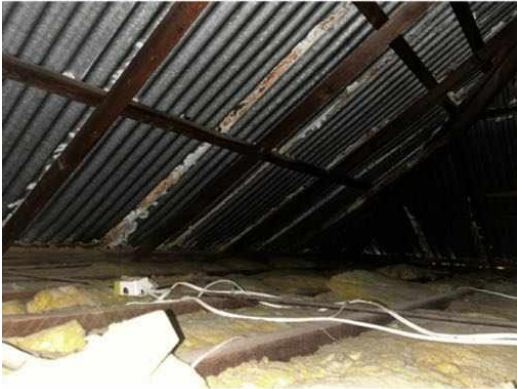
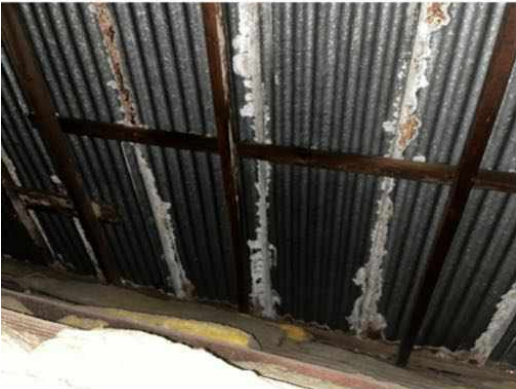
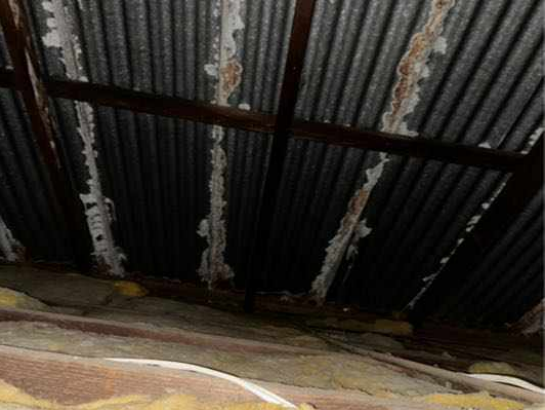
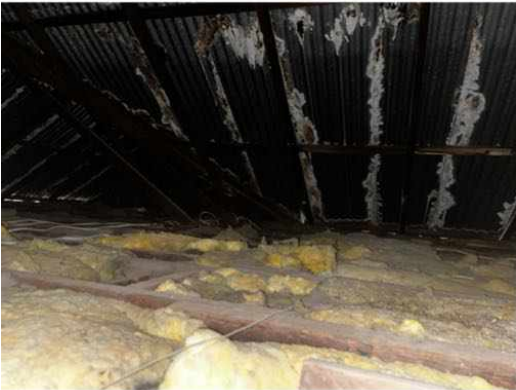
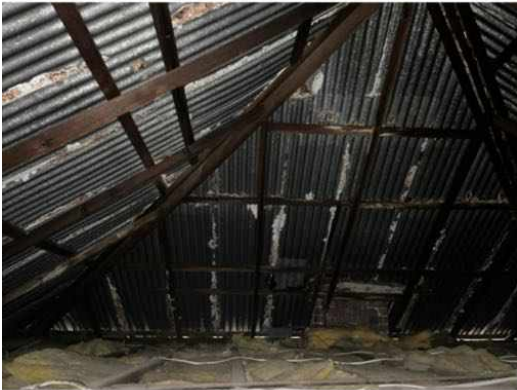
Building: Main Building
 Location: Roof Void
 Finding: Obstructions and Limitations - Roof space
 Information: These photographs are an indication of the obstructions and limitations which impeded full inspection of the Roof Space/Void at the time of inspection such as Stored items, Skylight tubes, Electrical wires , insulation and cross beams, rafters, low clearance as of the pitch in the roof.

Signs or Rust in the roofing sheets are visible during inspection. For a longevity of the structure and the property the buyer can consider replacing the rusted sheets if preferred.

These obstructions can hide an array of defects and should be removed to allow full inspection to be carried out.

A re-inspection is recommended once the areas are made accessible.

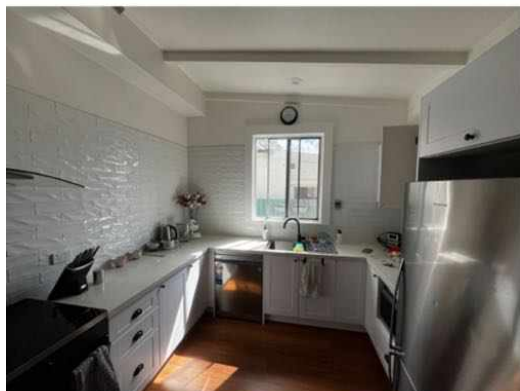
Building: Main Building
Location: All Internal Areas
Finding: Smoke Detector and Alarms
Information: Reporting on Smoke Detectors or Alarms, including hard wired smoke detection systems and their legislative requirements, is outside the Scope of this Report.

Additionally, it is advised that all smoke detectors be tested by the homeowner on a monthly basis.

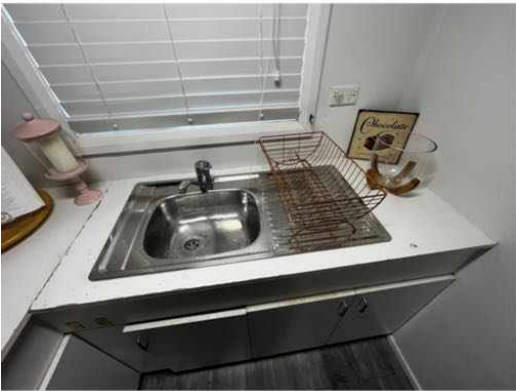
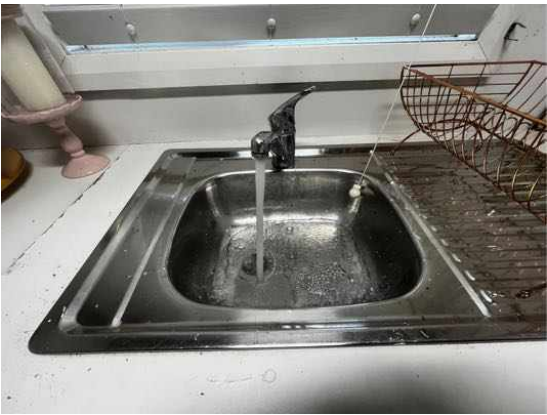
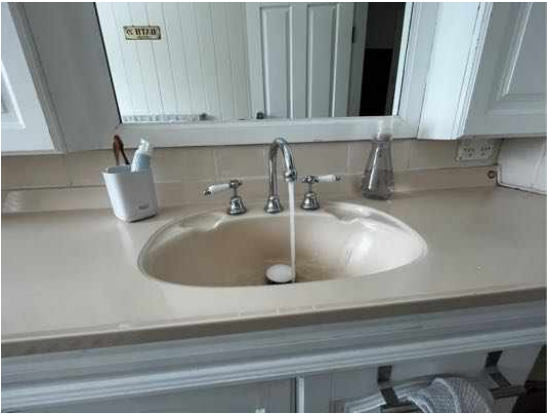
Building: Main Building
Location: Kitchen/ Laundry Bathroom
Finding: Cabinetry Plumbing - Kitchen/ Laundry/Bathroom
Information: All cupboards where sinks and basins with drainage plumbing were inspected and no evidence of leaks were present at the time of inspection.

For your information only no remedial works are required at the time of inspection.

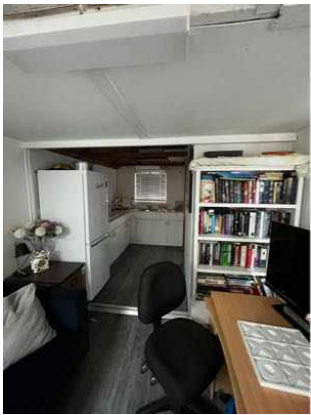
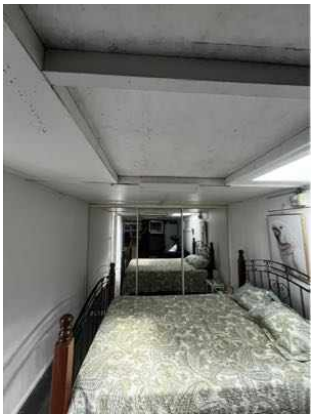
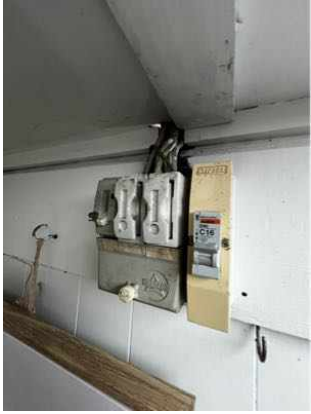
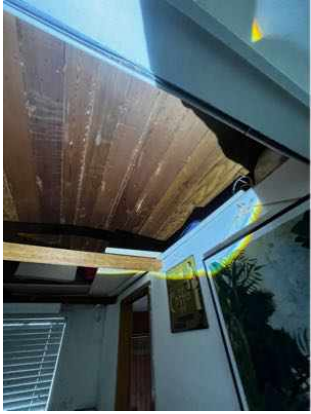
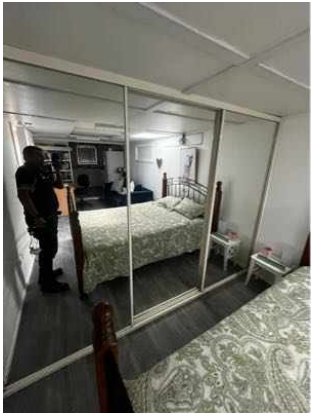
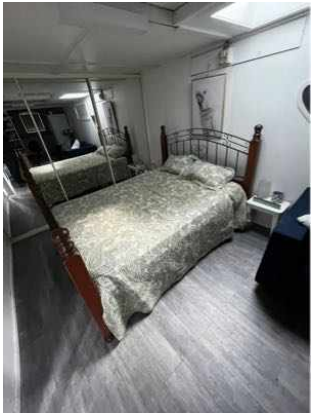
Building: Studio
 Location: Studio
 Finding: Garage converted to Studio Additional structure - Non-compliant - Check
 Information: The additional structure that has been affixed to this area of the dwelling does not appear to comply with contemporary building practices and current Australian Standards. While the structure does not currently appear to be unsafe, compliance with such standards ensures the structural integrity of the main dwelling and abutting addition.

As building standards have not been followed, this area provides a heightened risk of the development of building defects. The structural integrity of the area may have been compromised, which creates potential for the development or presence of major safety issues.

It is highly recommended that any planned repair, remodeling or demolition works be carried out by registered builders. Such works may be necessary in the short-term future to ensure the safety and functionality of the area.
