Building and Timber Pest Inspection Report

Inspection Date: Fri, 30 Jan 2026

Property Address: 7A Malpas St Rostrevor

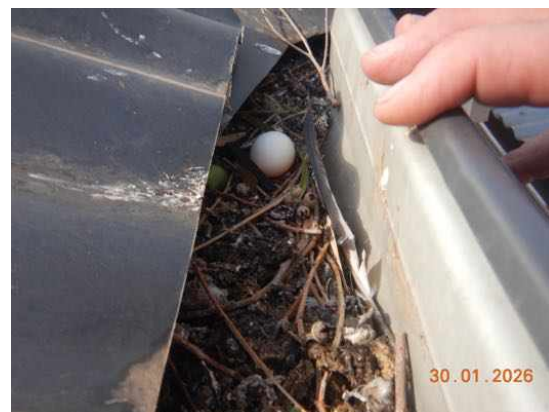
Finding 2.01

Building: Building 1
Location: Roof Exterior
Finding: Gutters - Blocked
Information: Roof plumbing structures, such as guttering and downpipes, should be free of all debris to prevent blockages. Blockages of the guttering and downpipes will lead to pooling and accumulated water overflows, which is likely to subsequently flood eaves and exterior walls.

At the time of inspection there were varying levels of blocked gutters evident mainly above the laundry door with a bird nest under the solar panels.

Blocked gutters are likely to lead to high levels of moisture in the affected areas. Such moisture will not only cause rust and decay of the associated building materials, but can also provide conditions that are conducive to termite and timber pest activity. Blockages in gutters should therefore be removed immediately to ensure dry conditions are maintained.

Consult a Licensed Plumber for further specific advice on remedial works that may be required. In the interim, it is highly advised that blocked gutters be removed by the homeowner or a general handyperson as a matter of urgency. Bird proofing the solar panels should be considered also.

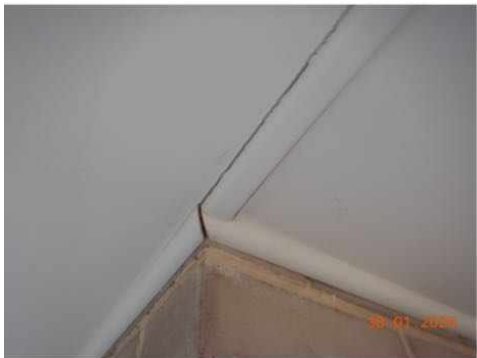
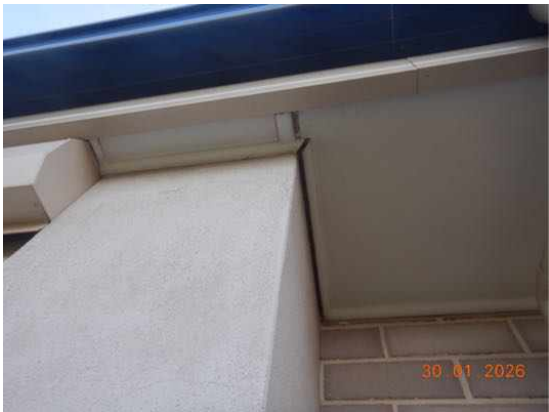
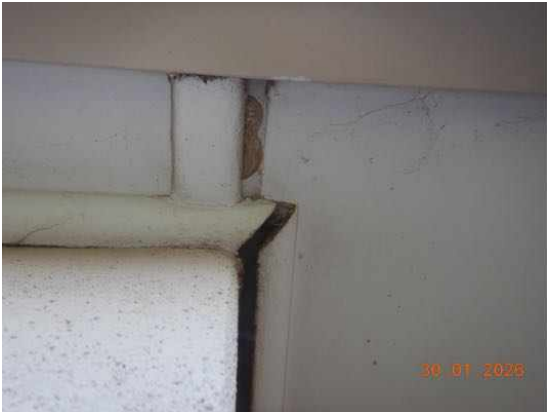
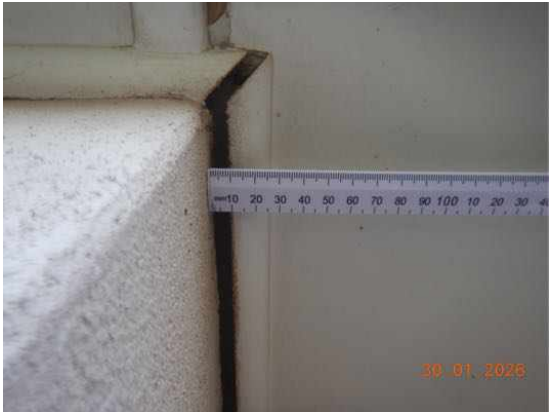
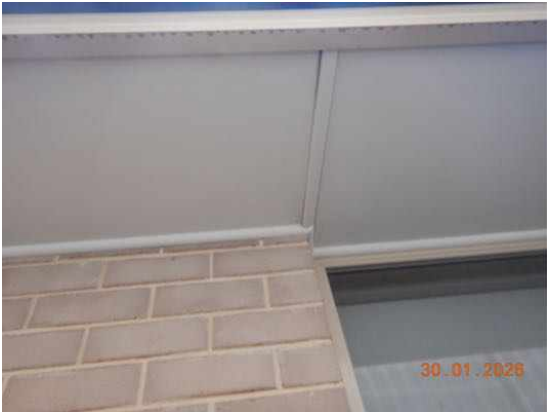
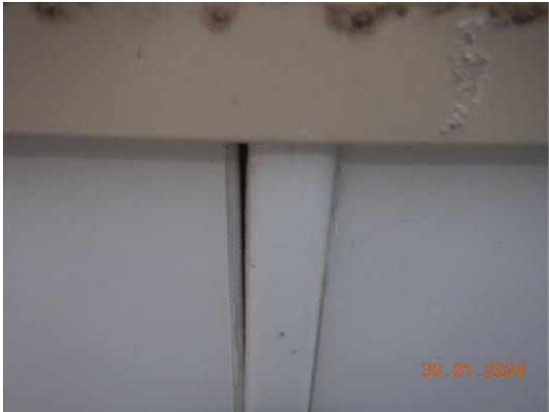
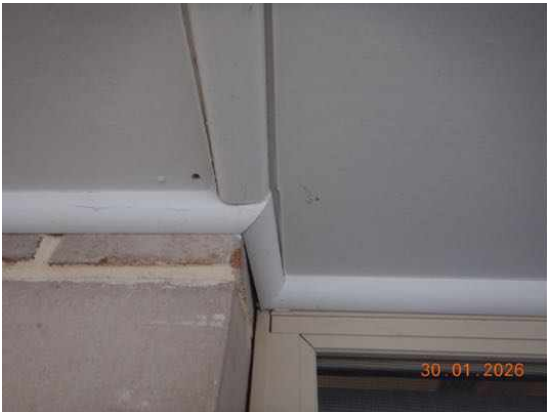
Finding 3.01

| Finding: | Eaves - Minor damage |
| Information: | The eaves around the external property were found to be showing evidence of expansion and contraction and or other minor defects. |

The movement is considered acceptable for the age of the property and no secondary defects are likely to occur.

The damage to the eave sheeting in this area detracts from the appearance of the structure, and could be repaired by the installation of cover strips and or ceiling or gap filling.

Repair repairs could be carried out by licensed carpenters and painters at the discretion of the client

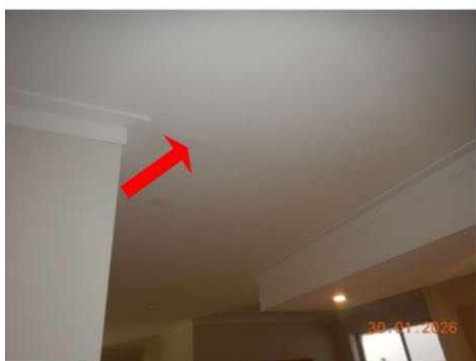
Finding 3.02

Building: Building 1
Location: Kitchen
Finding: Cracking - Damage Category 1 - Fine (up to 1mm)
Information: There were fine cracks evident to the ceiling adjacent to the kitchen at the time of inspection.

Although fine cracks are quite noticeable, they are often only considered to be an appearance defect, and usually do not indicate any structural damage. Generally, the cause of a fine crack is indicative of a separation between building materials and finishes (e.g. paint, plaster, etc.) along joints.

It is likely that the ceiling is cracking in this area due to inadequate control joints installed to the kitchen which should be installed for any Plasterboard lining over 12 m in length

Cracking of this nature can generally be repaired with minor sanding, filling and/or repainting. Such works should be performed by a qualified painter or a general handyman.

A licensed Plasterboard contractor should be appointed to install articulation joints to the ceiling to prevent further movement.

Monitoring of all cracking should be conducted frequently. Always contact a building inspector should cracks widen, lengthen, or become more numerous.

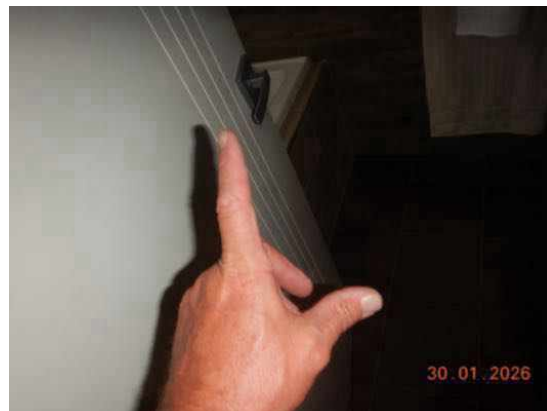
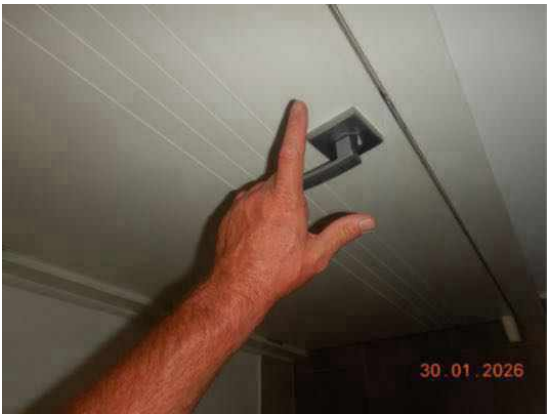
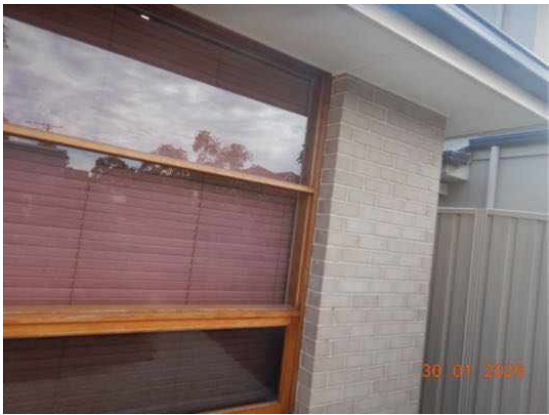
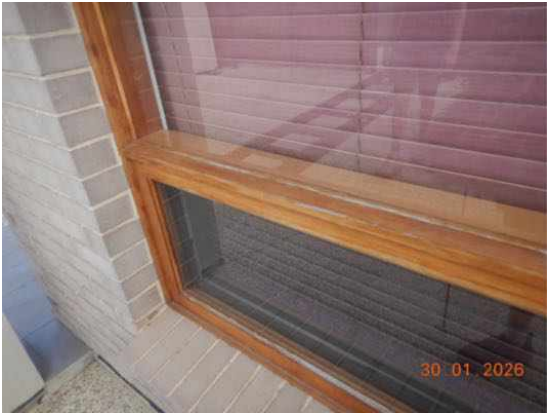
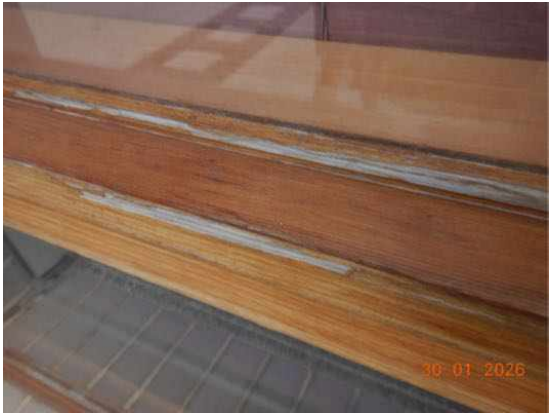
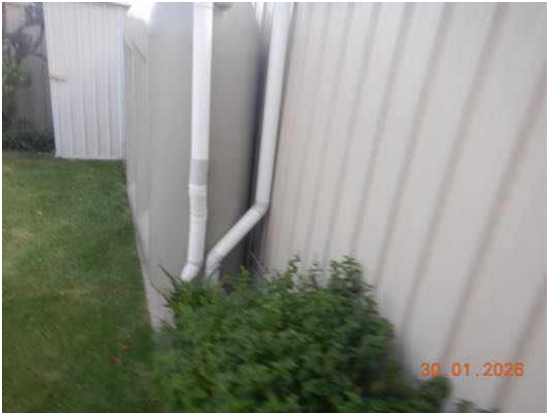
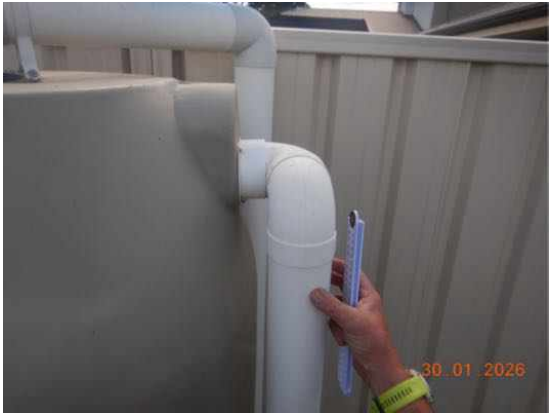
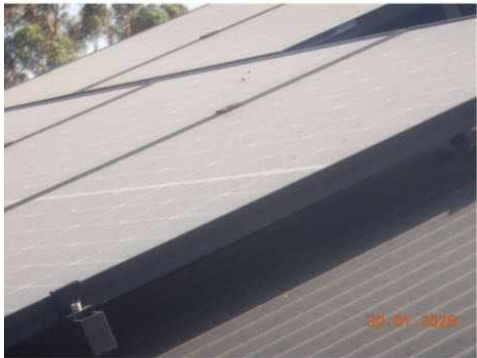
Finding 3.03

Building: Building 1
Location: All Areas
Finding: Minor defects present
Information: There were several age and maintenance related defects evident to the dwelling at the time of inspection. These defects include but are not limited to

- Many Door handles are loose.
- Front window requires paint
- PVC to rain water tank requires paint as it is not UV rated.
- Solar panels require clean

Appropriate licensed trades people could be appointed to make repairs at the discretion of the client.

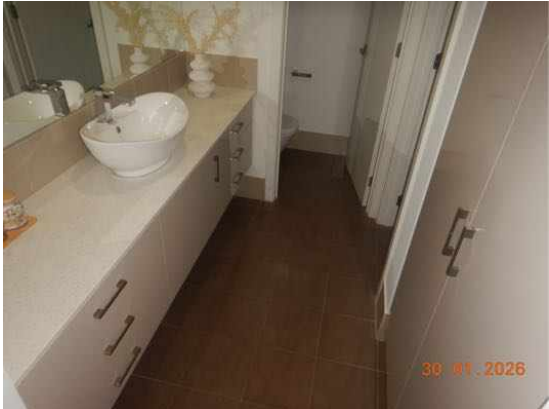
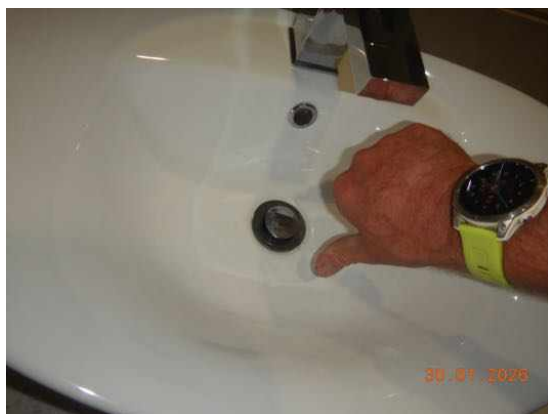
Finding 3.05

Building: Building 1
Location: All Internal Areas
Finding: Plumbing - Drain plug defective
Information: The drain plugs to the bathroom hand basins appeared to be inoperable at the time of inspection requiring maintenance or repair.

Degraded drain plugs can create issues with regard to functionality and should be addressed to bring the basin back to an operational stage.

A licensed plumber should be appointed to repair or replace the drain plugs at the discretion of the client.

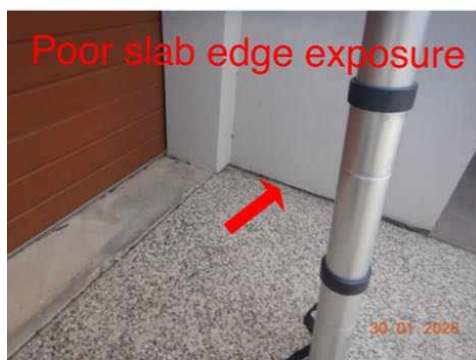
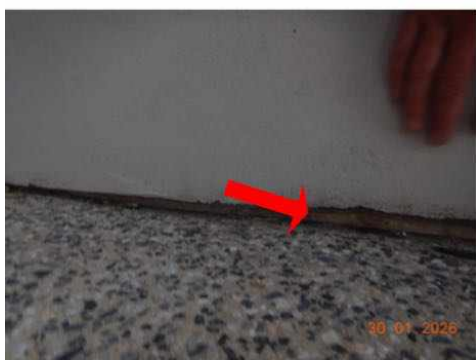
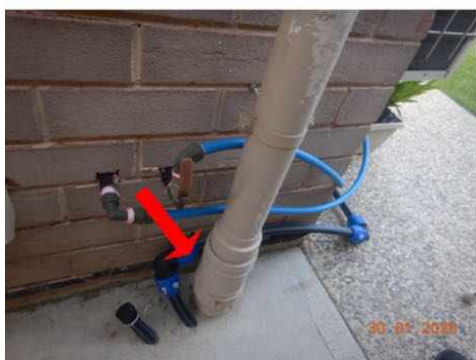
Finding 6.01

| Finding: | Slab Edge - Exposure |
| Information: | An inspection zone of at least 75mm in relation to the exposed slab edge, between the bottom brick and the perimeter pavement, is required. This inspection zone should be maintained in order to force termites into the open where they can be detected more readily during regular inspections. The slab edge should not be concealed by anything that may prevent inspection of the area, including render, landscaping, soil, turf, paving, concrete cladding or other structures. |

If the slab edge is not properly exposed there is a high risk of concealed termite attack which your inspector will likely not be able to see. Sometimes, in order to determine the type of slab, a suitably qualified person such as an architect or builder may be required to consult construction plans.

Where the slab edge cannot be properly inspected, it is highly recommended that termite or timber pest inspections be carried out every 6-12 months to aid protection of the property against infestation and termite treatment advice is followed closely.

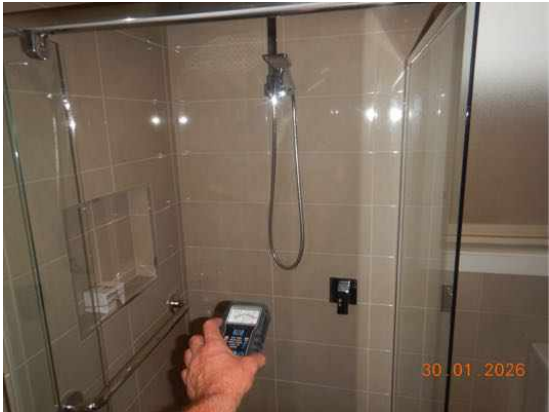
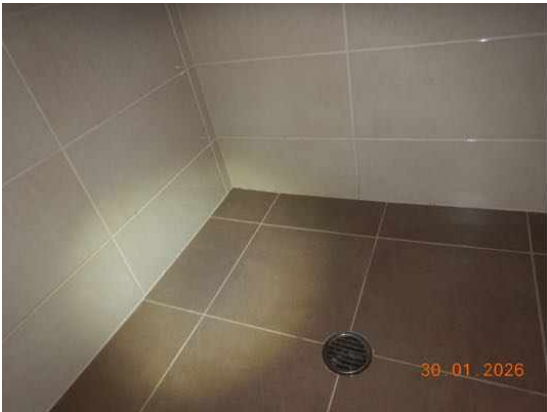
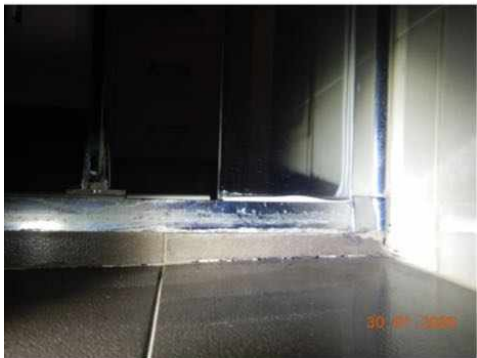
Finding 6.03

| Information: | It was noted on inspection that sealant and grout is showing signs of deterioration to both bathrooms. There were no abnormally high readings for moisture in the area. |

Secondary defects can occur if maintenance is not carried out ranging from moisture in walls to deterioration of adjacent building elements

Flexible and materials should be applied to affected areas to prevent any subsequent water damage that can occur. Regular maintenance and replacement of damaged/deteriorated sealant and grout is highly recommended as this is a regular wear and tear defect.

Repairs are required and should be carried out by a licensed bathroom sealant specialist immediately.

Silicone and grout generally need repair at least every 5 years and as such close monitoring should be carried out in the future after repairs are carried out.
