Building and Timber Pest Inspection Report

Inspection Date: Wed, 18 Feb 2026

Property Address: 5 Riverview Parade, Leonay NSW 2750, Australia

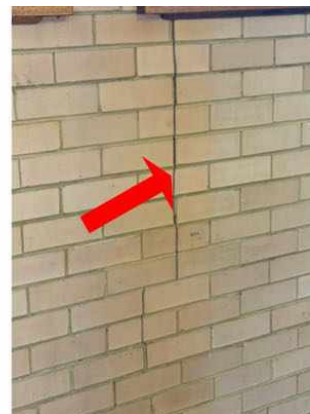
Building: Main Building
Location: Shed
Finding: Brickwork - Cracking [Extensive repairs required]
Information: Major cracking is evident to the brickwork in this area. When managing this degree of cracking, major extensive repair work is generally required. Such work is likely to involve replacement of sections of affected brickwork.

Structural issues are generally the underlying cause of such cracking. It is suspected that this damage has been created due to movement of key structural elements or general subsidence of associated footings.

A structural engineer and bricklayer should be appointed immediately to inspect the structural integrity of the affected brickwork and to assess the safety of the associated structures. The engineer can also nominate a scope of works required for rectification.

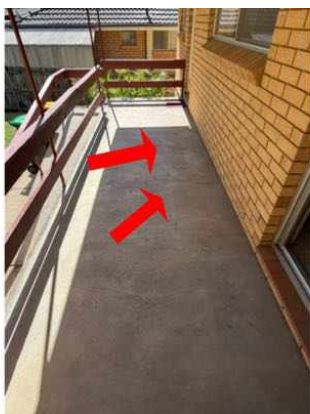
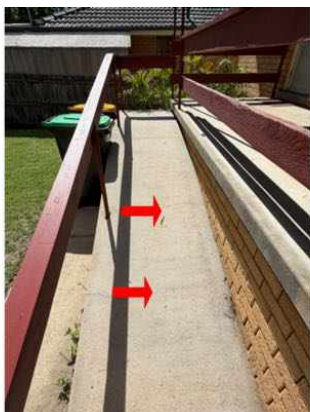
Building:	Main Building
Location:	Rear porch and ramp
Finding:	Cracking - External Concrete Paving Damage Category 0 - Hairline (less than 1mm)
Information:	Hairline cracks were identified in external concrete paving. Hairline cracks are very minor in nature and generally are only ever an appearance defect. To be classified as a Category 0 or hairline crack, the crack width would be less than 0.3mm. While such cracking may be noticeable in some cases, it is common and does not indicate any structural damage.

Generally the cause of a hairline crack in existing concrete paving such as driveways and pathways is indicative of the expansion and contraction of the concrete. Such causes are generally due to environmental factors, such as moisture levels, weather conditions, root systems of nearby trees or the soil types on which they are laid.

Hairline cracks may also be due to poor original installation of the concrete. Factors such as poor compaction of the sub surface and/or inadequate reinforcing of the slab may create cracking and other secondary defects.

Monitoring of all cracking should be conducted frequently. Always contact a building inspector should cracks widen, lengthen, or become more numerous.

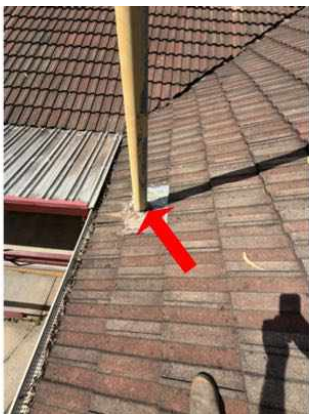
Finding 3.02

Building:	Main Building
Location:	Roof Exterior
Finding:	Flashing-Weathered/repair required
Information:	The lead flashing installed around the roof vent penetration was observed to be deteriorated at the time of inspection. Signs of wear and breakdown were noted, and a visible gap is present between the flashing and the penetration.

This gap may allow water ingress during rainfall, increasing the risk of moisture penetration into the roof space and potential damage to surrounding building elements.

It is recommended that a suitably qualified roofing contractor assess the affected area. The deteriorated lead flashing should be repaired or replaced as required, and all gaps properly sealed to ensure the penetration is watertight and performing as intended.

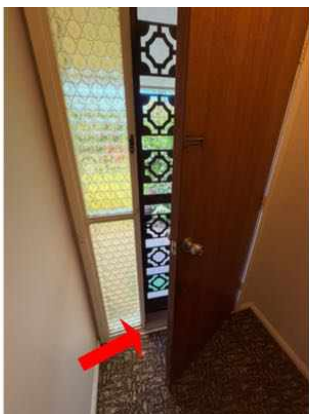
Finding 3.03

Information: Binding and/or jamming of this door is evident during standard operation. This defect inhibits the functionality of the affected door as well as creating potential for secondary defects to associated building elements, such as damage to the door and jamb.

A door that binds to flooring or to the associated door frame may have several causes, ranging from minor defects, such as poor installation of the door or deteriorated hinges, through to minor building movement.

For minor causes, a qualified carpenter or general handyperson should be appointed to perform minor rectification works at client discretion.

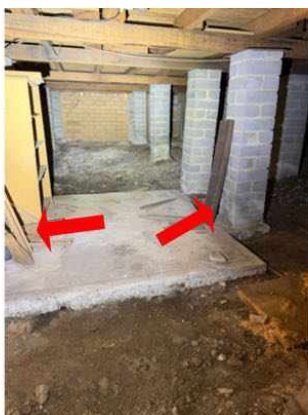
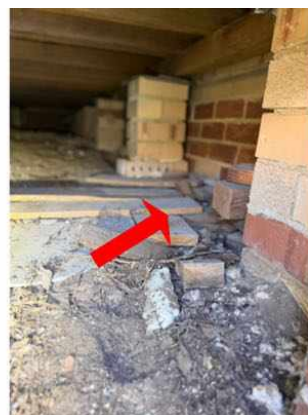
Building:	Main Building
Location:	All Areas
Finding:	Stored timbers - subfloor space or external area
Information:	The storing of timbers in the subfloor space or around the external property (including bark mulch) increases the risk of termite activity being present. As they are likely to come into contact with weather conditions or excessive moisture wood rot is likely to develop on timbers that are not treated.

It is highly recommended that any stored timbers be immediately removed from areas in which they may attract any termite / timber pest attack. Minimisation of risk / prevention of termite attack is far more adequate than dealing with the presence of

termite activity.

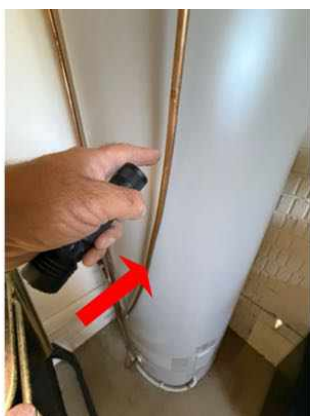
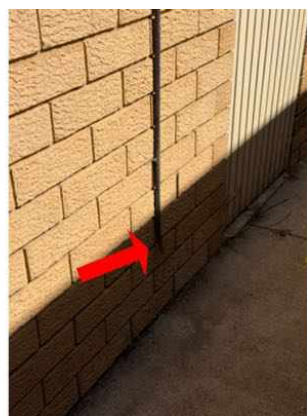
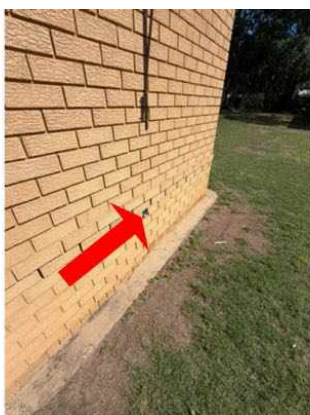
These damp conditions can lead to secondary defects such as rot, rust or corrosion of associated building elements, the formation of fungal decay, or even the creation of potential slip hazards. When coupled with poor site drainage, pooling of water may also attract termite activity to this area.

It is highly recommended that a qualified plumber be appointed to install adequate drainage to the overflow. These works will ensure that the area remains dry and free of any secondary defects.

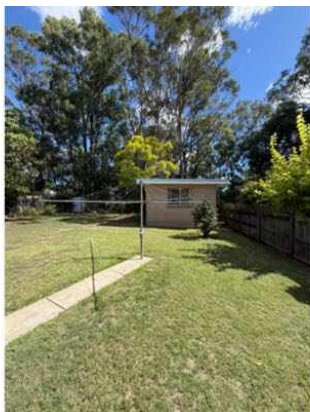
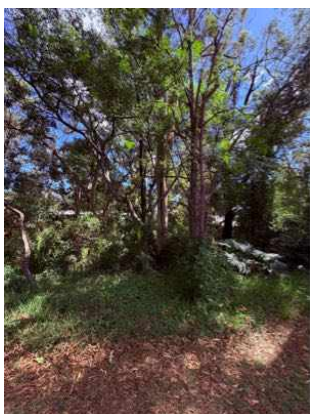
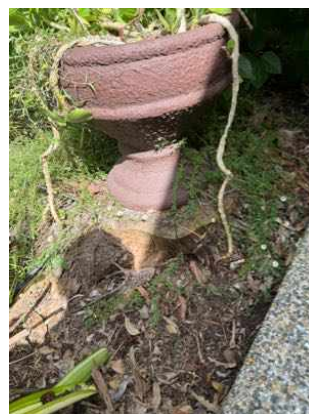
Finding 6.05

Building: Main Building
 Location: Yard
 Finding: Large trees/stumps within 30m of house
 Information: There are a number of large trees/stumps within 30m of the house which may contain natural termite activity. It is important to monitor these areas to ensure no natural activity is allowed to progress into the main house.

Regular inspections are recommended. Consider test drilling any large trees.

A pest controller can be contacted to carry out such testing at the owners discretion.

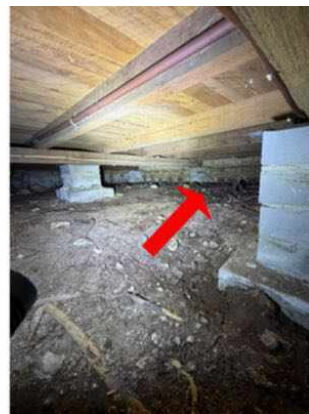
Finding 6.06

Building:	Main Building
Location:	Subfloor
Finding:	Excessive subfloor moisture
Information:	Excessive moisture can attract termites and produce conditions that promote termite attack fungal growth and wood decay.

Excessive moisture is generally caused by inadequate subfloor ventilation and poor site drainage.

There appear to be inadequate vents installed to the perimeter of the building and I would suggest that further solar powered fans or the like be installed to improve cross flow ventilation and aid in keeping the subfloor area relatively dry.

The installation of additional surface drainage to the rear of the property would also be beneficial to keeping the subfloor dry.

It is highly recommended that both subfloor ventilation and site drainage be improved and maintained regularly in order to prevent excessive moisture being present in the external / internal property.

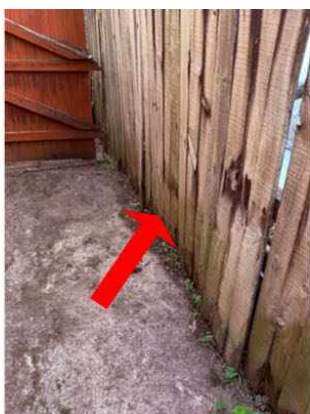
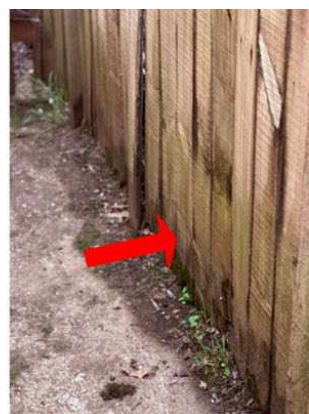
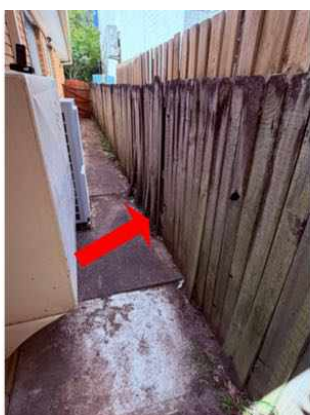
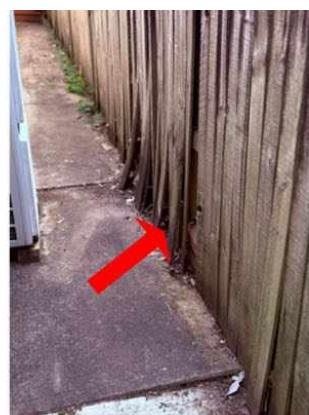
Finding: Fungal decay - present at the time of inspection

Information: Fungal decay also known as wood decay or wood rot occurs when timbers and other cellulose building materials are exposed to damp conditions on an ongoing basis. This could be the result of exposure to weathering in the long term or the pooling of water or absorbed moisture from other abutting building materials or a shower leak. It is advisable to remove these affected timbers to prevent any chance of attack in the future.

Wood decay is more susceptible to termite attack and these timbers should be replaced to limit termite attack.

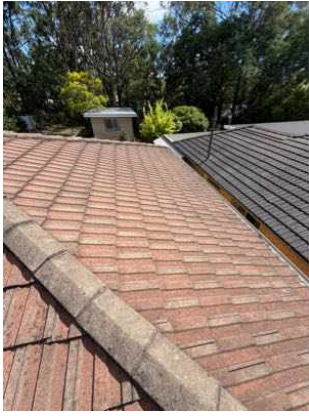
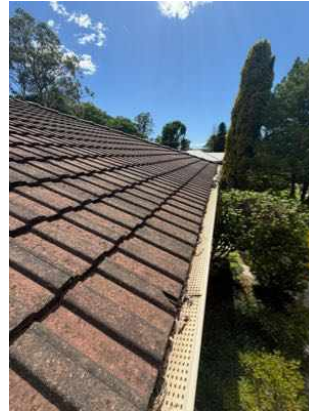
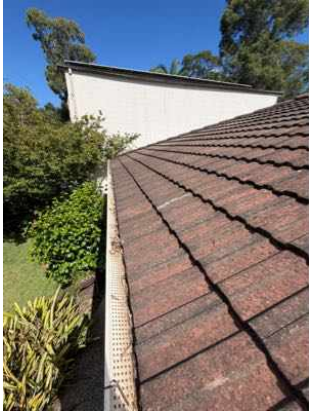
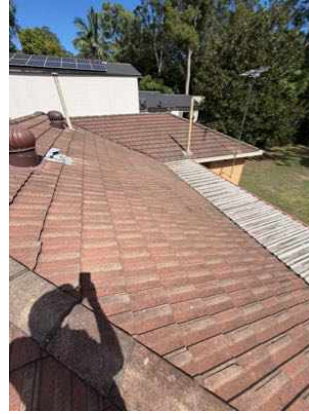
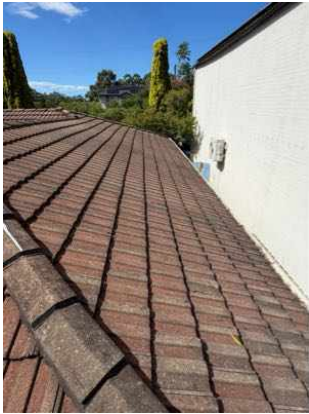
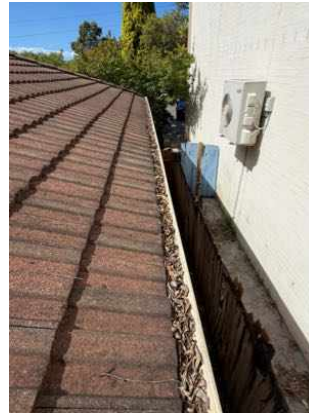
Building: Main Building
Location: Roof Exterior
Finding: Roof tiles - Weathered
Information: Upon inspection of the exterior roofing, the majority of roof tiles were considered to be in a fair condition. While weathering of the tiles is consistent with the age of the property, maintenance works are required.

Consultation with a roofing contractor is highly advised to gain advice on cost of remedial works that may be required in the short to medium term. Remedial works are likely to increase the longevity of the exterior roofing structure.
