# Building and Timber Pest Inspection Report

Inspection Date: Thu, 29 Jan 2026

Property Address: 23 North St, Casino NSW 2470, Australia

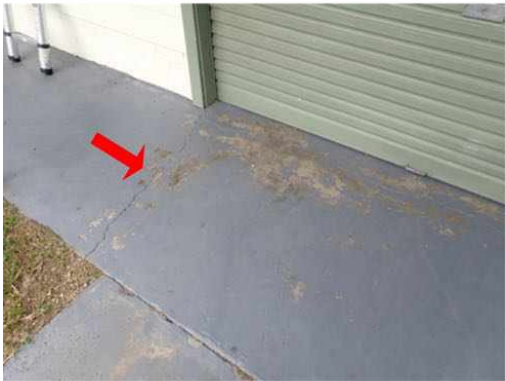
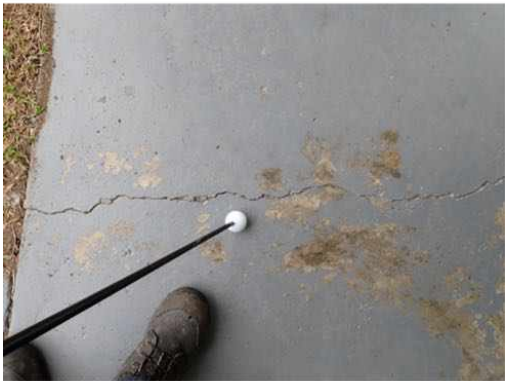
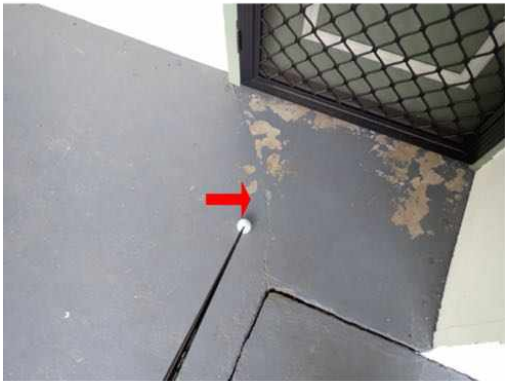
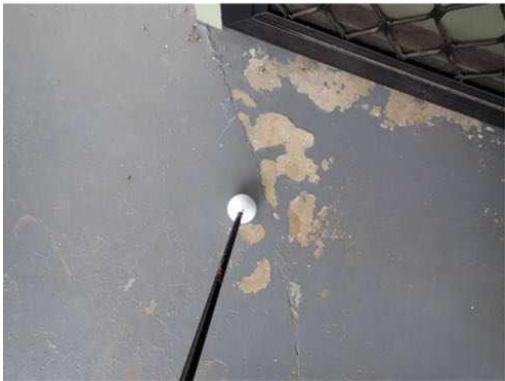
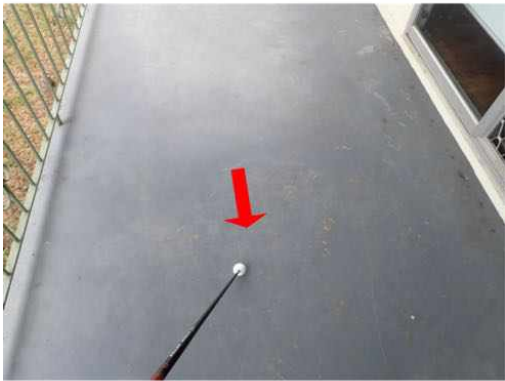
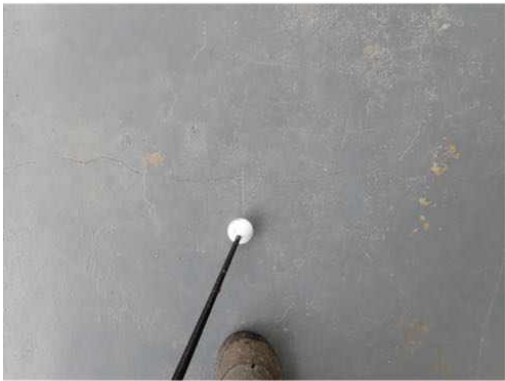
#### Finding 2.01

Building: Main Building

Location: Concreted areas  
Finding: Concrete Areas – Major and Minor Cracking  
Information: Major and minor cracks were identified to the concrete ramps, front patio, and rear concreted areas. This condition may be associated with ground movement, shrinkage, or age-related deterioration. Cracking may worsen over time and allow moisture ingress if left unaddressed. Ongoing monitoring and repair or replacement as required is recommended. Works should be carried out by a licensed concreter or suitably qualified contractor.

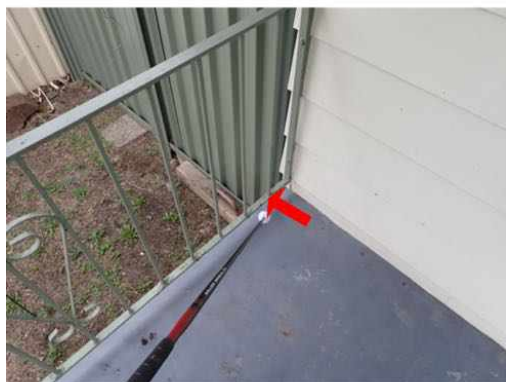
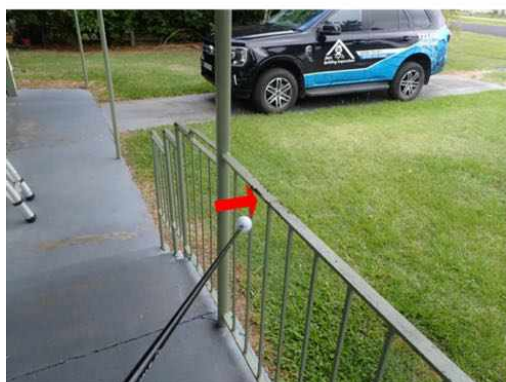
Finding 2.02

Building:	Main Building
Location:	Front patio area
Finding:	Front Patio Balustrade – Rusting
Information:	Rust was identified to the steel balustrade at the front patio. This condition is typically associated with age and weather exposure and may worsen over time if left untreated. Cleaning, rust treatment, and protective coating are recommended to help prevent further corrosion. Works should be carried out by a suitably qualified metal tradesperson or experienced handyman.

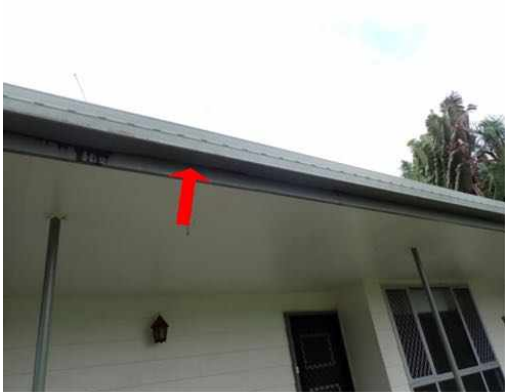
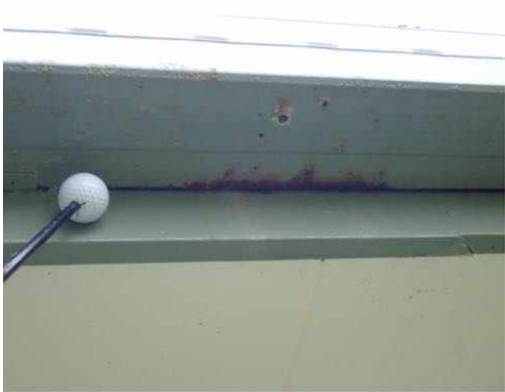
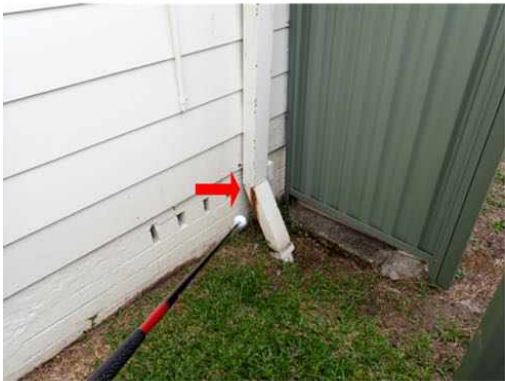
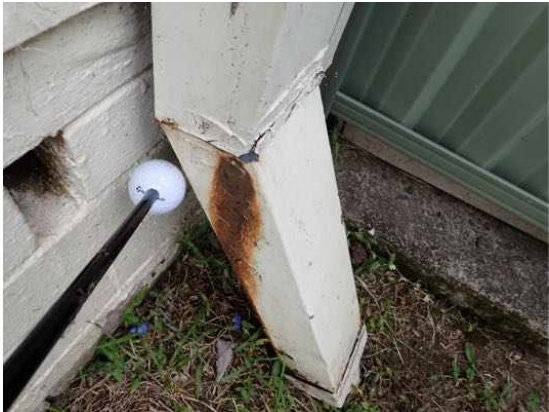
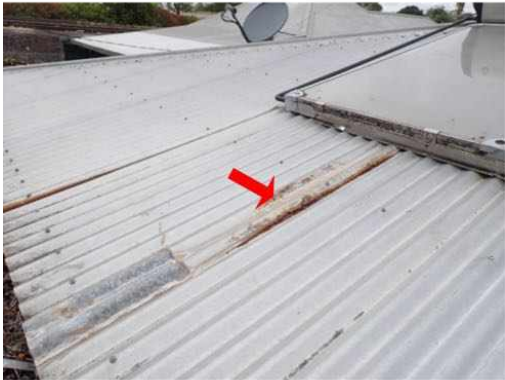
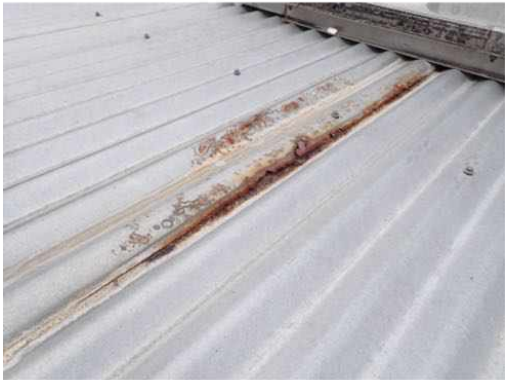
### Finding 2.03

Building:	Main Building
Location:	Roof
Finding:	Roof – Poor Condition
Information:	The roof was observed to be in poor condition, with rust identified to isolated sections of corrugated iron, as well as to downpipes and gutters. Gutters were also found to be blocked. These conditions may lead to reduced roof service life, water overflow, and an increased risk of water ingress if left unaddressed. Cleaning of gutters and repair or replacement of affected roofing and drainage components is recommended. Works should be carried out by a licensed roofing contractor or suitably qualified roof plumber.

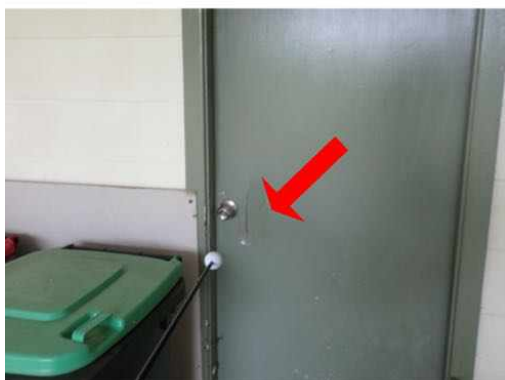
**Finding 2.04**

Building: Main Building  
Location: Garage rear door  
Finding: Rear Garage Door – Impact Damage  
Information: Impact-related damage was identified to the rear garage door. This condition may affect the appearance and operation of the door and could worsen over time if left unaddressed. Repair or replacement of the damaged door is recommended as required. Works should be carried out by a carpenter or suitably qualified tradesperson.

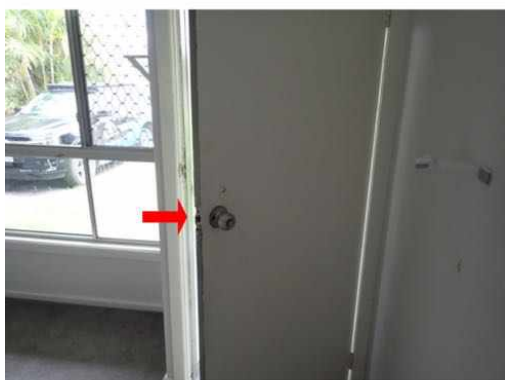
### Finding 2.05

Building:	Main Building
Location:	Entry door
Finding:	Entry Door – Poor Condition
Information:	The entry door was observed to be in poor condition. This may affect its appearance and operation and may worsen over time if left unaddressed. Repair or replacement of the door and associated hardware is recommended as required. Works should be carried out by a carpenter or suitably qualified tradesperson.

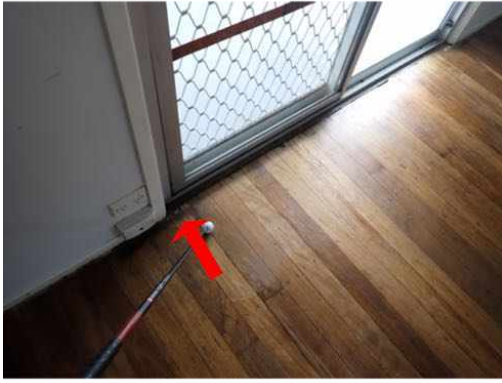
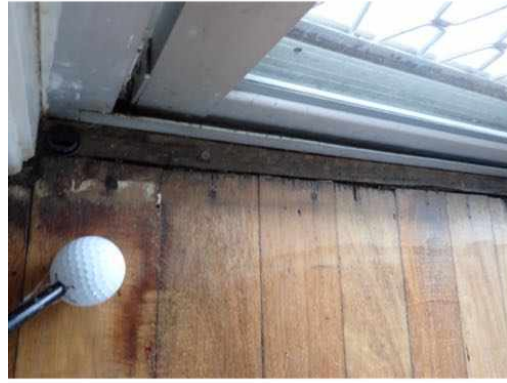
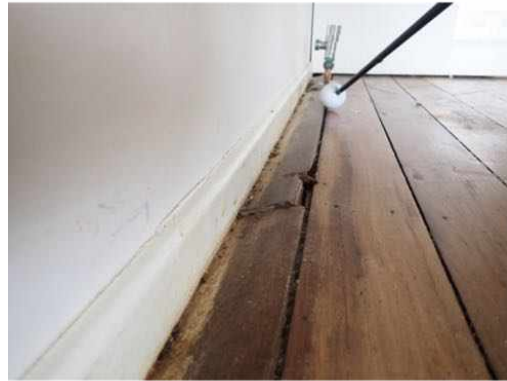
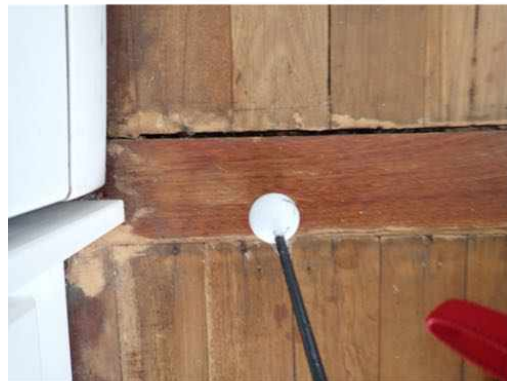
### Finding 2.06

Building:	Main Building
Location:	Timber flooring
Finding:	Timber Flooring – Poor Condition and Termite Damage
Information:	Sections of the timber flooring were found to be in poor condition, with evidence of termite damage identified. This condition may be associated with timber pest activity, age, wear, or moisture exposure and may worsen over time if left unaddressed. Further assessment is recommended to determine the extent of damage. Repair or replacement of affected flooring sections should be carried out as required by a licensed timber pest technician and a suitably qualified carpenter or flooring contractor.

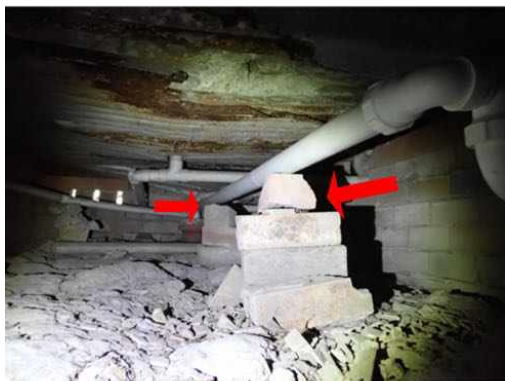
Finding 2.09

Building:	Main Building
Location:	Subfloor
Finding:	Subfloor – Plumbing Pipes Inadequate Support
Information:	Bricks were identified being used as supports for plumbing pipes within the subfloor, and were not securely fastened to the underside of the floor. This is a poor practice and may compromise the adequacy of support and ongoing performance of the plumbing. Further assessment is recommended, with rectification works required to ensure compliant plumbing installation and adequate support. Works should be carried out by a licensed plumber.

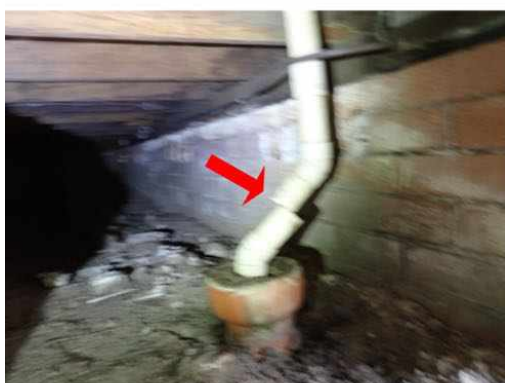
### Finding 2.10

Building:	Main Building
Location:	Subfloor
Finding:	Subfloor – Kitchen Waste Pipe Cut
Information:	The kitchen waste pipe was observed to be cut within the subfloor area. This condition may affect proper waste discharge and could lead to leaks, blockages, or moisture-related damage if left unaddressed. Further investigation and rectification of the pipework is recommended. Works should be carried out by a licensed plumber.

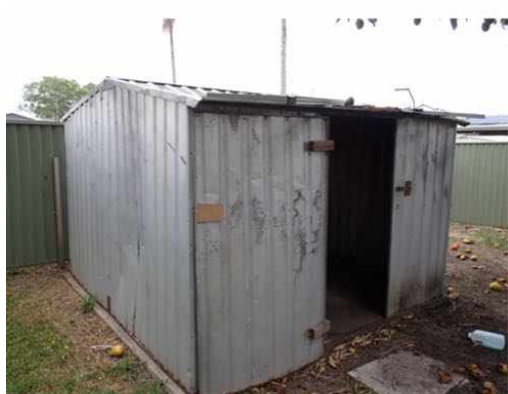
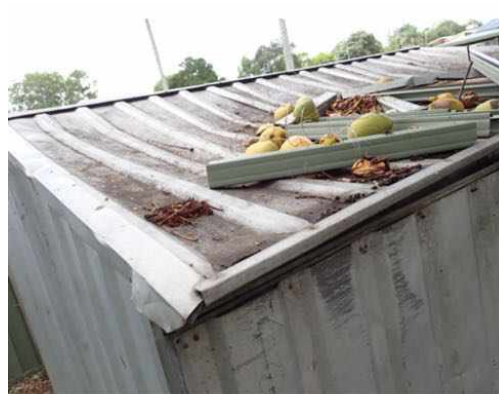
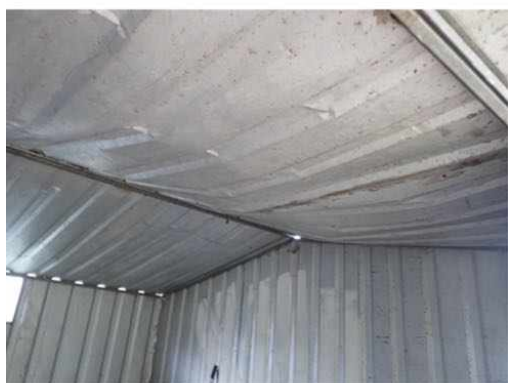
### Finding 2.11

Building:	Shed
Location:	Garden shed
Finding:	Garden Shed – Poor Condition
Information:	The garden shed was observed to be in poor condition. This may be associated with age, weather exposure, and general wear and may worsen over time if left unaddressed. Repair or replacement of the shed is recommended as required. Works should be carried out by a suitably qualified tradesperson or experienced handyman.

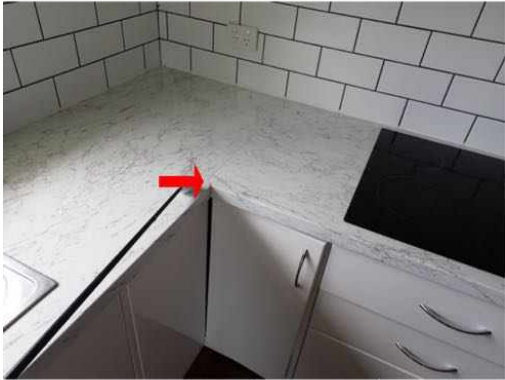
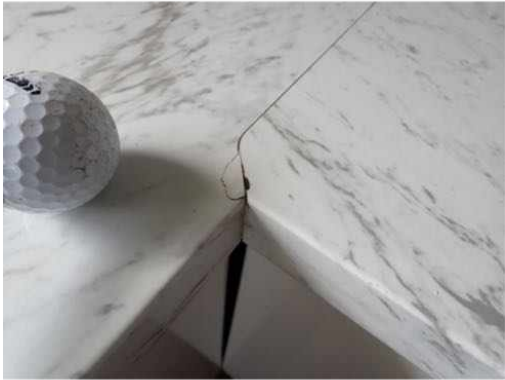
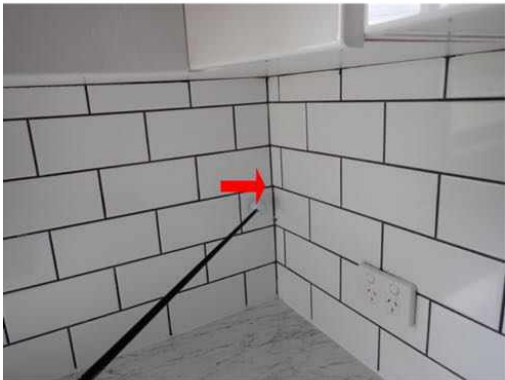
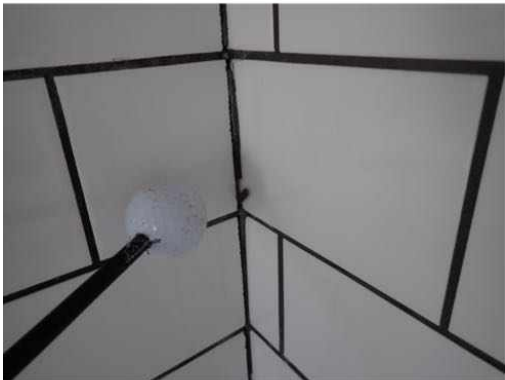
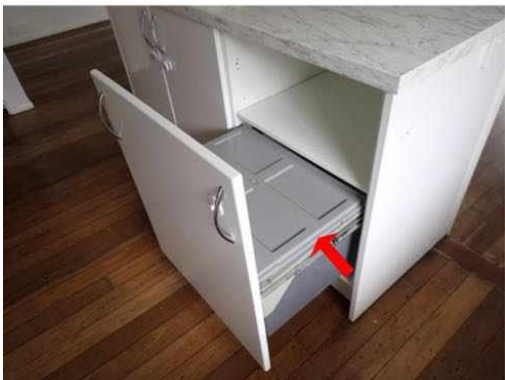
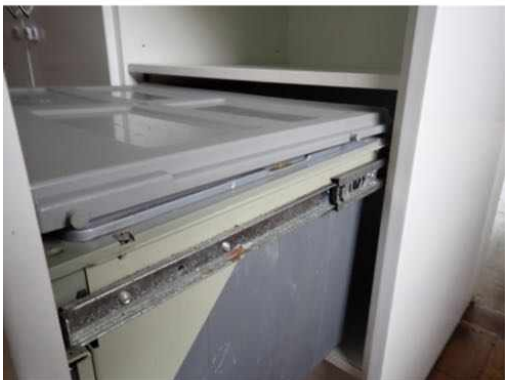
### Finding 3.01

Building:	Main Building
Location:	Kitchen
Finding:	Kitchen – Fair Condition with Defects
Information:	The kitchen was observed to be in fair condition overall; however, several defects were identified, including missing silicone, poor application of grout, broken bin drawer fittings, and a small crack in the laminate benchtop. While these issues are generally minor, they may affect functionality and durability if left unaddressed. Rectification of the identified defects is recommended as required. Works can be carried out by a suitably qualified carpenter, cabinet maker, or handyman.

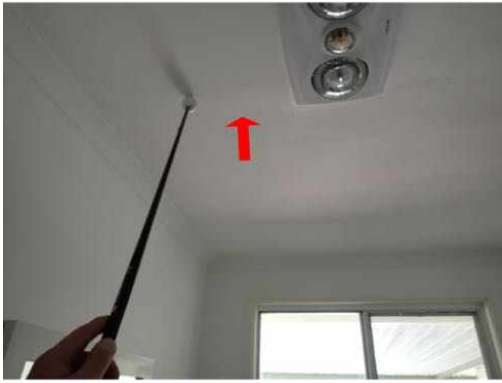
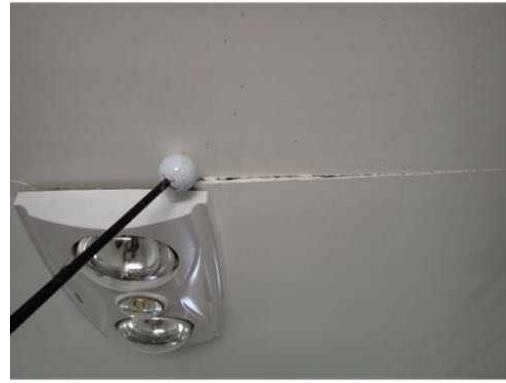
Finding 3.02

Building: Main Building  
Location: All areas  
Finding: Internal Cladding – Cracking  
Information: Minor cracks were identified to internal wall cladding, with a larger crack noted to the bathroom ceiling. This is a common defect for a home of this age and is typically associated with movement, shrinkage, or age-related wear. Cracks may worsen over time if left unaddressed. Monitoring and repair as required is recommended. Works should be carried out by a plasterer or suitably qualified tradesperson.

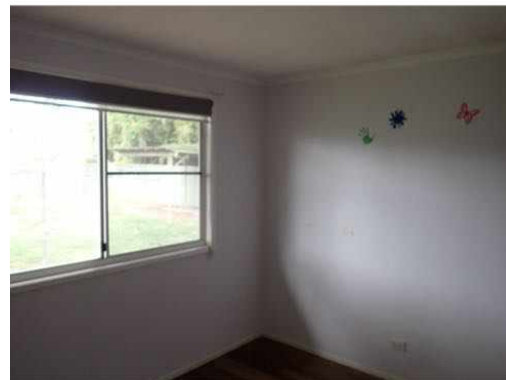
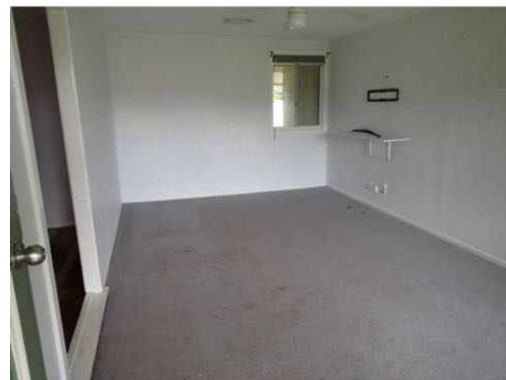
### Finding 3.03

Building:	Main Building
Location:	Internal painted areas
Finding:	Internal Painted Surfaces – Poor Condition
Information:	General internal painted surfaces were observed to be in poor condition. This appears to be consistent with age, wear, and deferred maintenance. Repainting and associated surface preparation is recommended to improve finish and protect underlying materials. Works should be carried out by a painter or suitably qualified tradesperson.

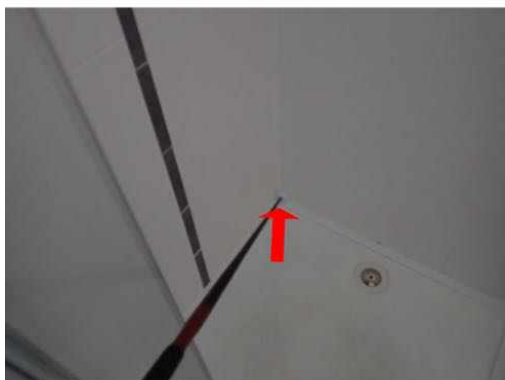
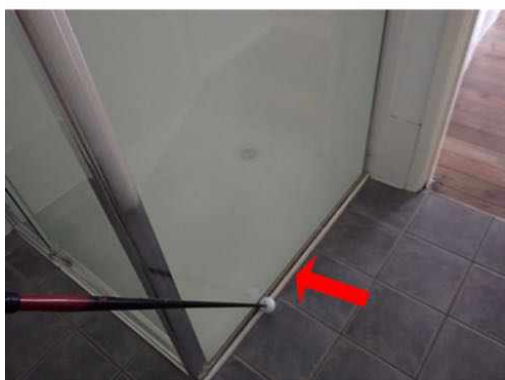
### Finding 3.04

Building:	Main Building
Location:	Bathroom
Finding:	Bathroom – Deteriorated Silicone
Information:	Deteriorated silicone sealant was identified within the bathroom. This condition may allow moisture penetration behind tiled surfaces and contribute to ongoing deterioration if left unaddressed. Removal and replacement of the failed silicone is recommended to maintain adequate water resistance. Works should be carried out by a licensed tiler or suitably qualified tradesperson.

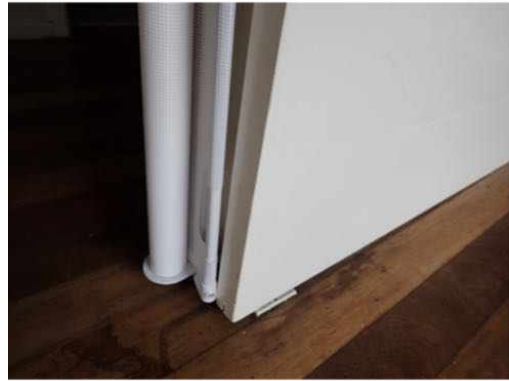
### Finding 3.05

Building:	Main Building
Location:	Bedroom
Finding:	Bedroom Sliding Door – Not Operating
Information:	The sliding door to the bedroom was not operating correctly at the time of inspection. This condition may be due to worn rollers, misalignment, or damaged tracks and may affect usability and security if left unaddressed. Repair or adjustment of the door is recommended as required. Works should be carried out by a carpenter, or suitably qualified tradesperson.

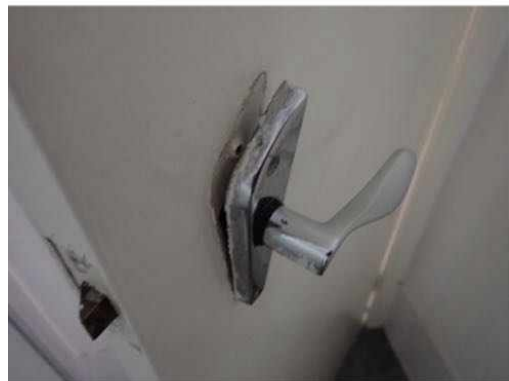
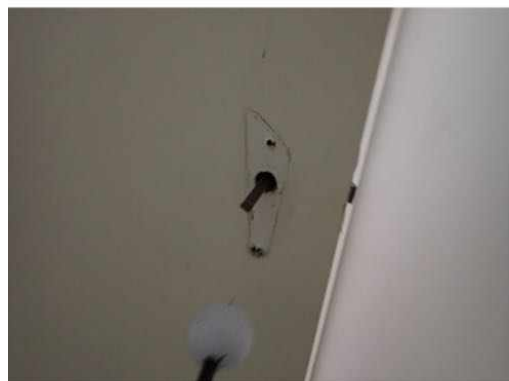
### Finding 3.06

Building: Main Building  
Location: Bathroom and the laundry  
Finding: Bathroom and laundry Door Handles – Damage  
Information: Damage was identified to the bathroom and laundry door handles. This condition may affect the operation and security of the door and could worsen over time if left unaddressed. Repair or replacement of the damaged handle is recommended as required. Works should be carried out by a carpenter or suitably qualified handyman.

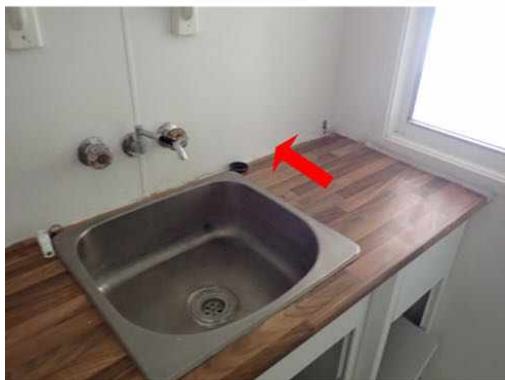
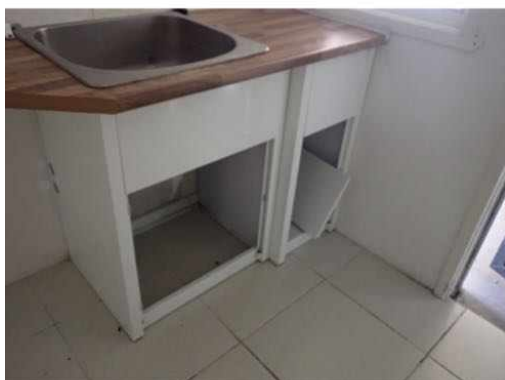
### Finding 3.07

Building:	Main Building
Location:	Laundry
Finding:	Laundry Cabinet – Poor Condition
Information:	The laundry cabinet was observed to be in poor condition, with missing doors and untidy silicone work to the benchtop. These defects affect functionality and appearance and may worsen over time if left unaddressed. Repair or replacement of the cabinet components and rectification of the silicone work is recommended as required. Works should be carried out by a cabinet maker, carpenter, or suitably qualified tradesperson.

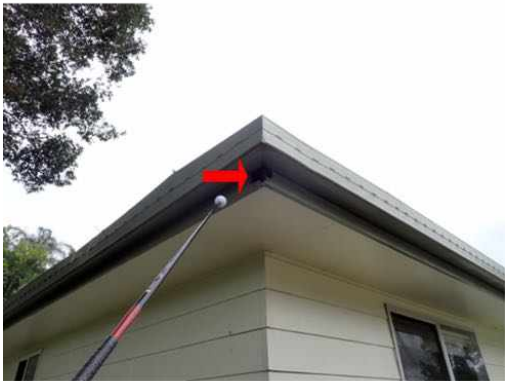
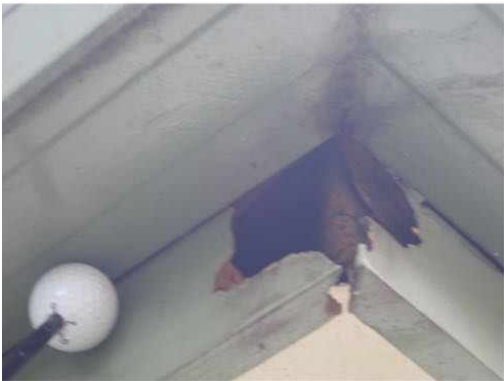
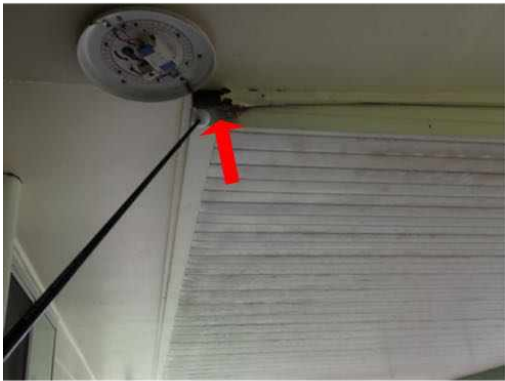
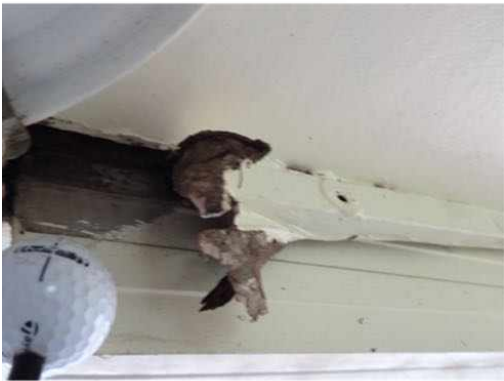
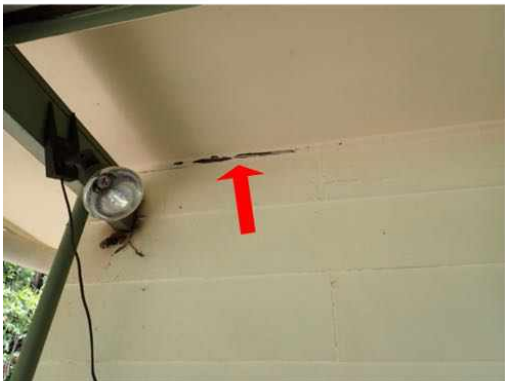
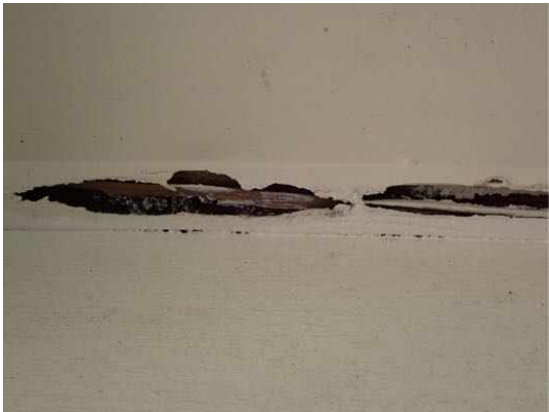
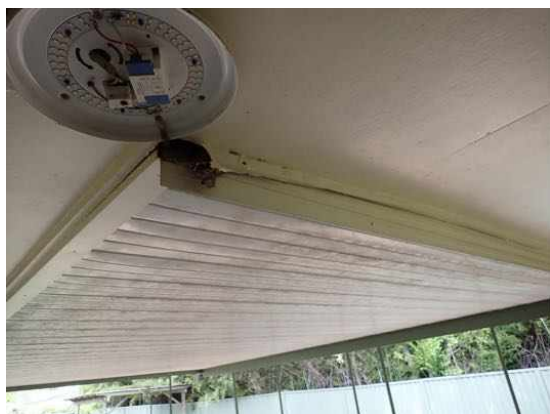
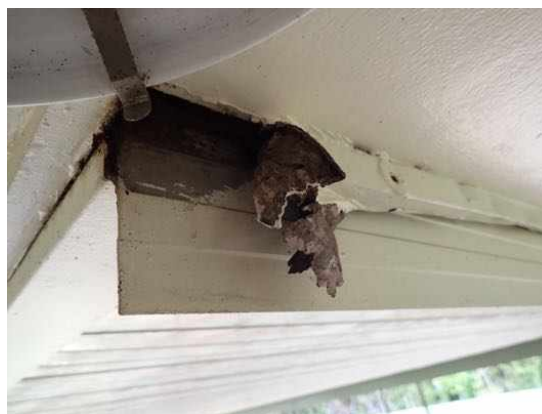
### Finding 5.01

Building:	Main Building
Location:	Fascia boards
Finding:	Fascia Boards and External Timber Trims – Termite Damage and Wood Rot
Information:	Termite damage and wood rot were identified to fascia boards and external timber

trims at isolated sections. This condition indicates timber pest activity and moisture exposure, which may lead to further deterioration if left unaddressed. Further assessment is recommended to determine the extent of damage. Repair or replacement of affected timbers should be carried out as required. Works should be undertaken by a licensed timber pest technician and a suitably qualified carpenter or builder.

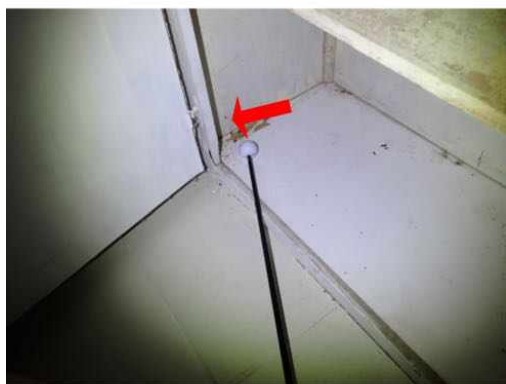
### Finding 5.02

Building:	Main Building
Location:	Laundry
Finding:	Linen Cupboard Door Frame – Termite Damage
Information:	Termite damage was identified to the linen cupboard door frame. This indicates timber pest activity, which may lead to further deterioration if left unaddressed. Further assessment is recommended to determine the extent of damage and whether active infestation is present. Repair or replacement of the affected timber should be carried out as required. Works should be undertaken by a licensed timber pest technician and a suitably qualified carpenter.

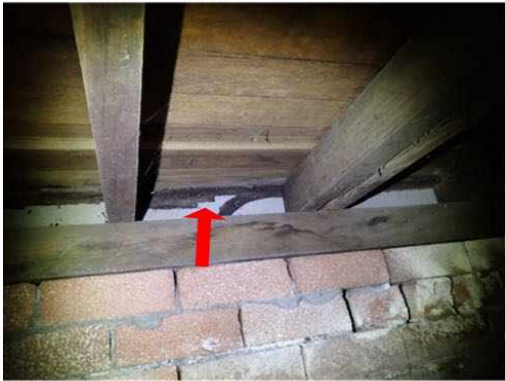
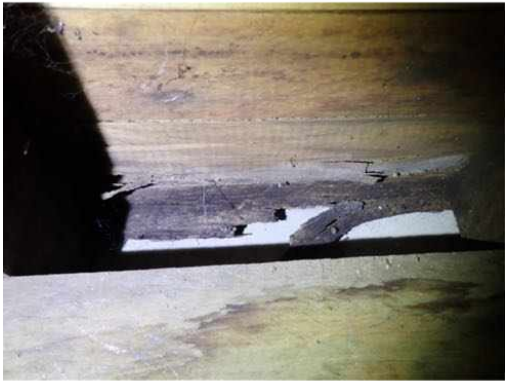
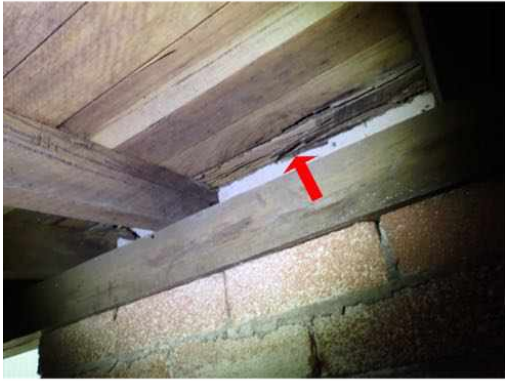
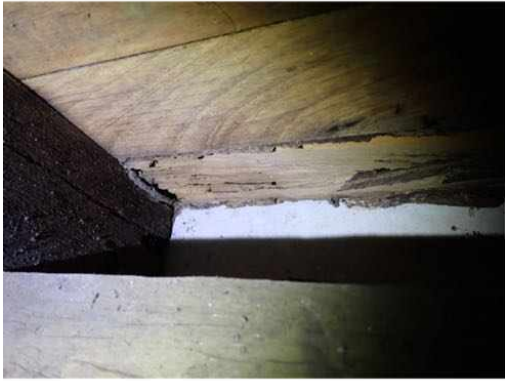
### Finding 5.03

Building:	Main Building
Location:	Subfloor
Finding:	Subfloor – Structural Termite Damage
Information:	Multiple areas of termite damage were identified throughout the subfloor. The extent and nature of the damage are considered structural, indicating a reduction in the load-bearing capacity of affected timbers. Further invasive investigation is required to determine the full extent of damage and whether active infestation is present. Rectification works, including repair or replacement of affected structural timbers, will be required as necessary. Assessment and treatment should be carried out by a

licensed timber pest technician, with rectification works completed by a licensed builder in consultation with a structural engineer if required.

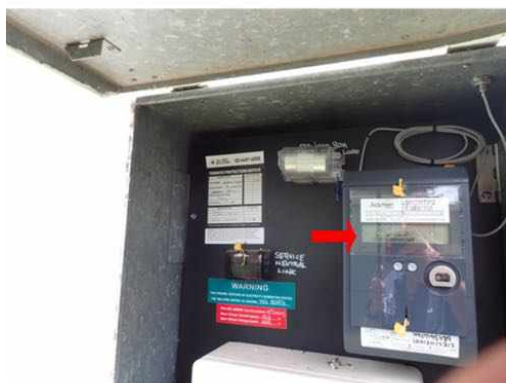
Building:	Main Building
Location:	Electrical Meter box
Finding:	Electrical Supply – Power Disconnected at Time of Inspection
Information:	The electrical power to the property was disconnected at the time of inspection. As a result, the operation of electrical fixtures, fittings, appliances, and systems could not be fully assessed. Any defects relating to the electrical installation may exist but were not observable under these conditions. It is recommended that the electrical system be tested once power is restored. Assessment and any required rectification should be carried out by a licensed electrician.

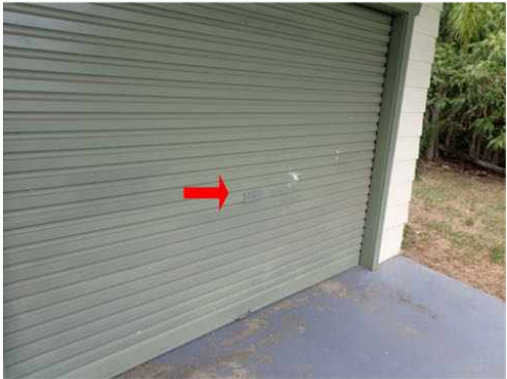
Building:	Main Building
Location:	Garage roller door
Finding:	Garage Roller Door and Ceiling Space – Not Tested / Not Inspected
Information:	The garage roller door was locked at the time of inspection, and there was no electrical power available to operate the door. As a result, the operation and condition of the door and motor (if fitted) could not be fully assessed. In addition, the ceiling manhole was located within the garage, and due to the lack of access, the ceiling space could not be inspected. Defects may exist but were not observable under these conditions. Any required assessment or repairs should be carried out by a garage door specialist or suitably qualified tradesperson once access and power are available.

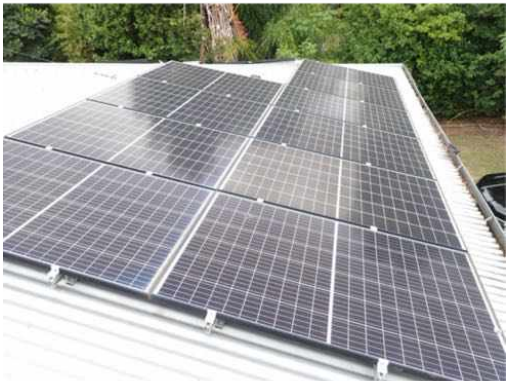
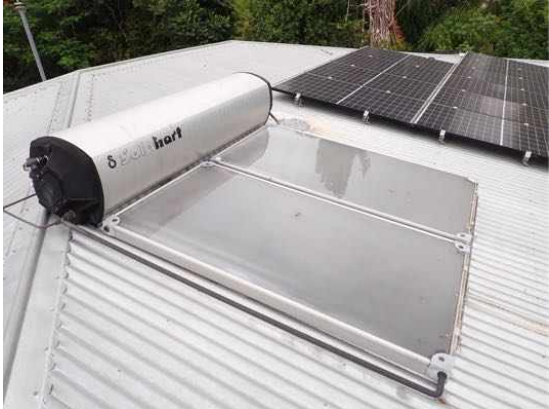
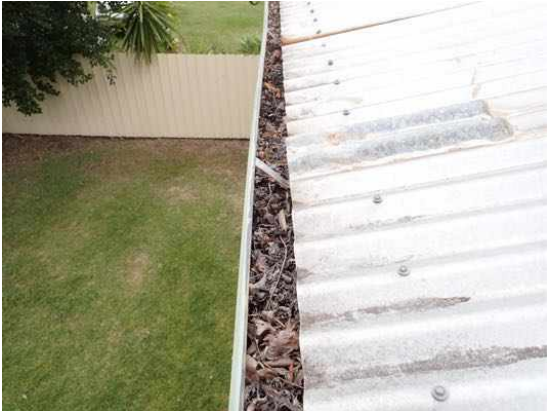
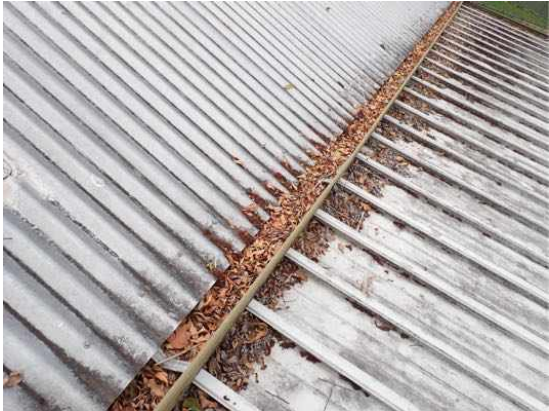
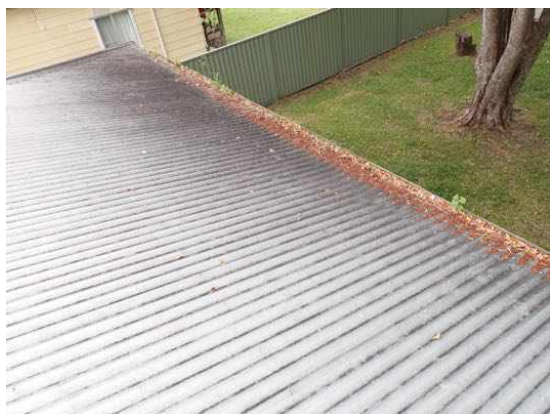
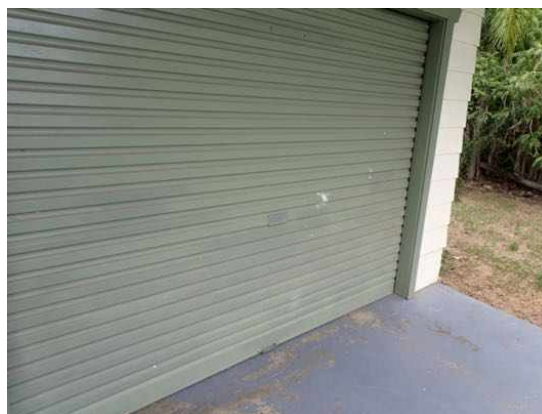
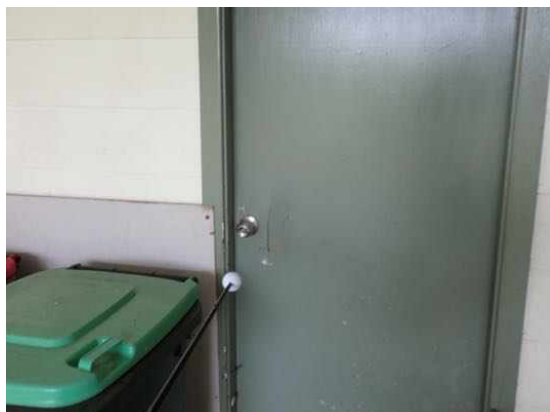
Building: Main Building  
Location: All Areas  
Finding: Additional Photos - Obstructions and Limitations - external area  
Information: These photographs are an indication of the obstructions and limitations which impeded full inspection of the external area at the time of inspection. These obstructions can hide an array of defects and should be removed to allow full inspection to be carried out. A re-inspection is recommended once the areas are made accessible.

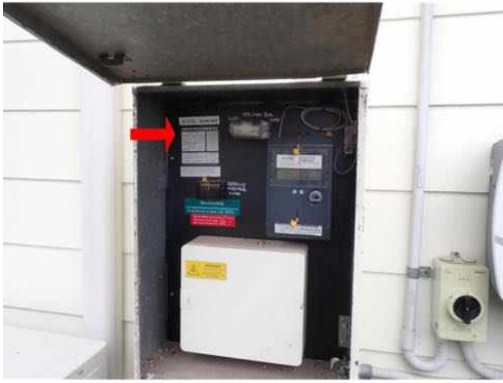
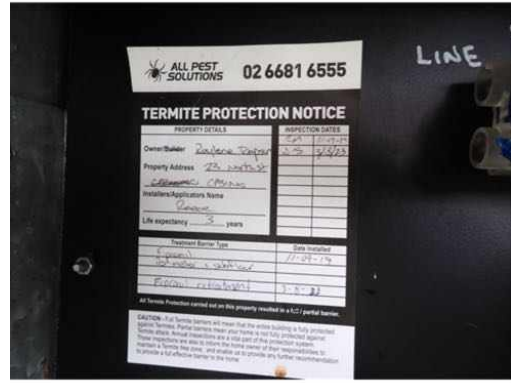
Building:	Main Building
Location:	Meter box
Finding:	Timber Pest Sticker – Electrical Meter Box
Information:	A timber pest management sticker was observed located within the electrical meter box. This indicates that timber pest treatment or inspection works may have been carried out at some stage. Contacting the pest treatment company listed on the sticker is recommended to obtain details of what areas were treated, any ongoing maintenance requirements, and whether a warranty applies. Further assessment or ongoing monitoring should be carried out by a licensed timber pest technician as required.
