Building and Timber Pest Inspection Report

Inspection Date: Thu, 5 Mar 2026

Property Address: 5 Oasis Cres, Yarrowonga VIC 3730,
Australia

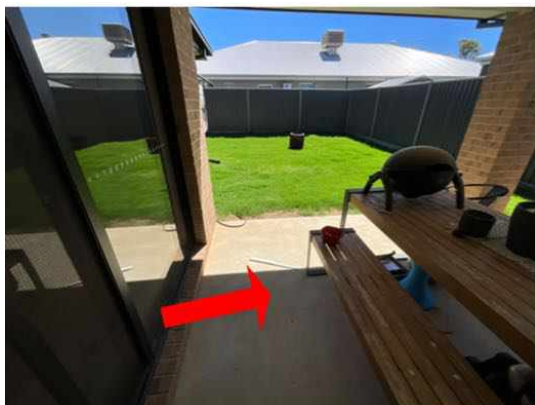
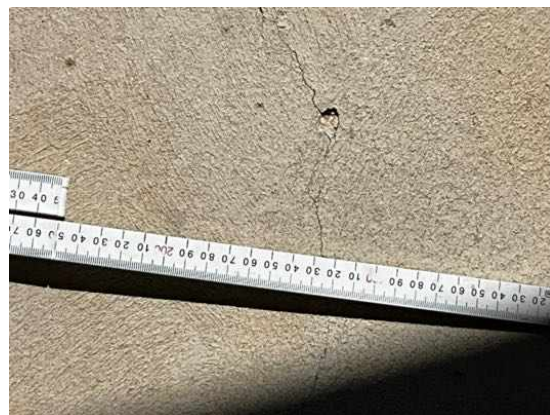
Finding 3.01

Building: Building 1
 Location: Alfresco
 Finding: Cracking - External Concrete Paving Damage Category 1 - Fine (less than 2mm)
 Information: Fine cracks were identified in external concrete paving. Although fine cracks are quite noticeable, they are often only considered to be an appearance defect, and usually do not indicate any structural damage. To be considered a Category 1 or fine crack, the crack is found to be less than 2mm in width.

Generally the cause of a hairline crack in existing concrete paving such as driveways and pathways is indicative of the expansion and contraction of the concrete. Such causes are generally due to environmental factors, such as moisture levels, weather conditions, root systems of nearby trees or the soil types on which they are laid.

Fine cracks may also be due to poor original installation of the concrete. Factors such as poor compaction of the sub surface and/or inadequate reinforcing of the slab may create cracking and other secondary defects.

Monitoring of all cracking should be conducted frequently. Always contact a building inspector should cracks widen, lengthen, or become more numerous.

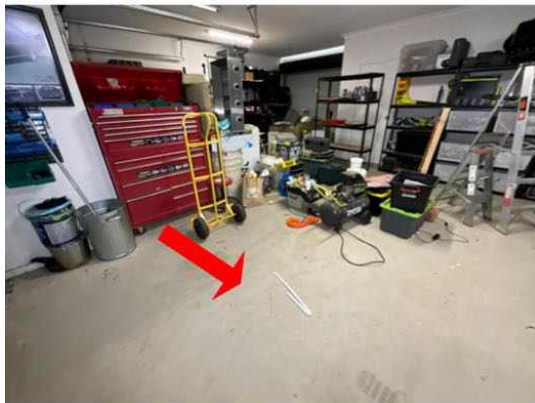
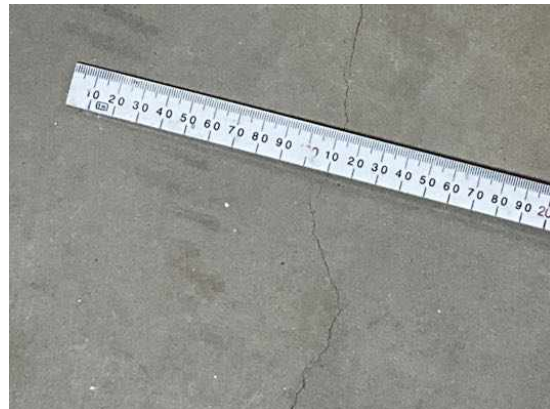
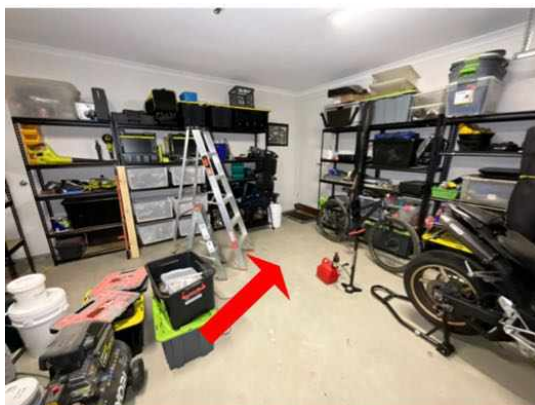
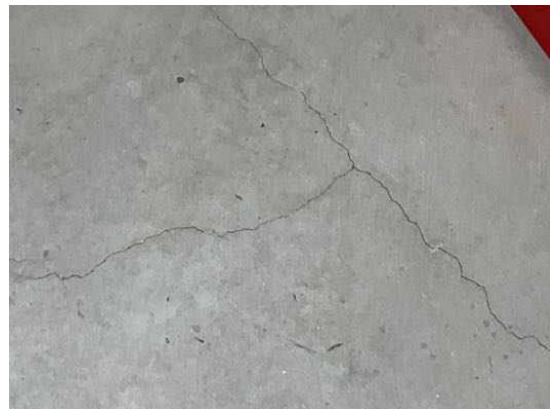
Finding 3.02

Building: Building 1

Location: Garage

Finding: Crack in concrete slab - Category 1

Information: A crack coded as Category 1 was identified in the slab. A Category 1 crack is described as a fine but noticeable crack, with the slab at an otherwise reasonable level.

To be considered Category 1, the approximate width of the crack is less than 1.0mm, or a less than 10mm change in offset when a 3m straight edge is placed over the defect.

Category 1 cracks should be monitored for a period of 12 months. At the end of the monitoring period, identified cracks that are rated greater than Category 2 are considered defects, and require rectification.

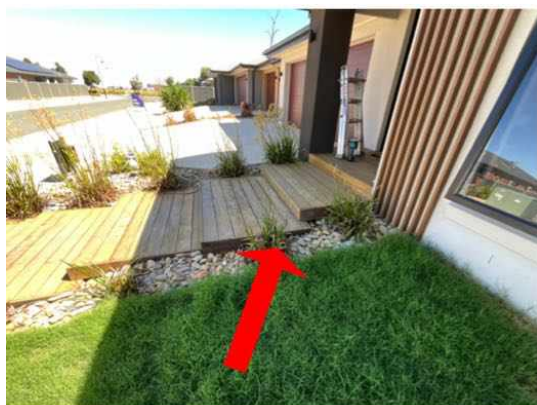
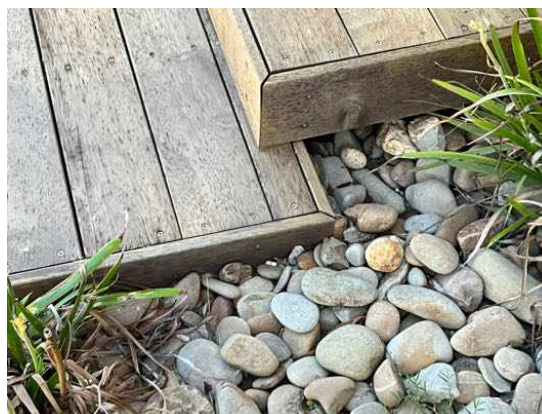
Finding 6.01

Building:	Building 1
Location:	Yard - Front
Finding:	Untreated or non-durable timbers in a hazardous environment
Information:	To reduce the risk of timber pest attack it is essential that timber used in a hazardous environment (e.g. in direct contact with the ground or frequently exposed to damp conditions) is of sufficient durability and/or is adequately preservative treated.

Untreated timbers in direct contact with the ground are likely to develop severe wood rot and/or fungal decay if left unattended creating attraction for subterranean termites to infest the timbers from surrounding areas.

If untreated or non-durable timbers are found to be in a hazardous environment it is highly advised that replacement of these building elements be performed as soon as possible to aid the protection of the property against termite / timber pest attack.

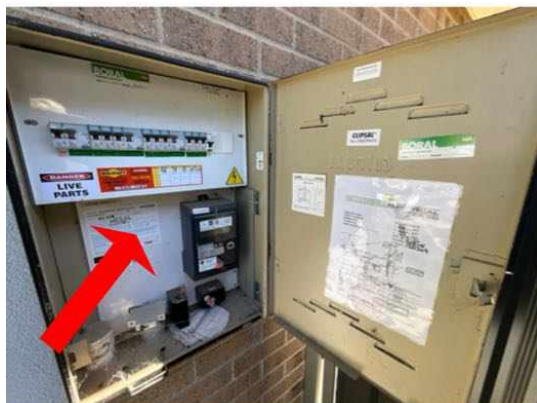
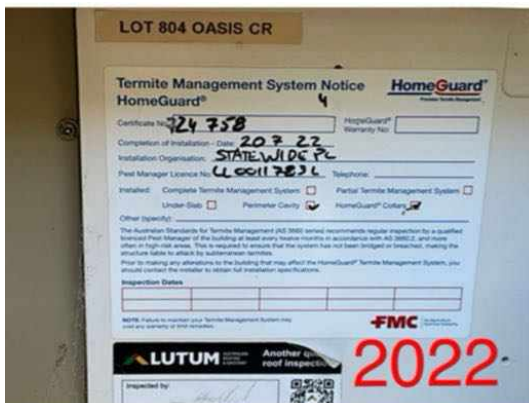
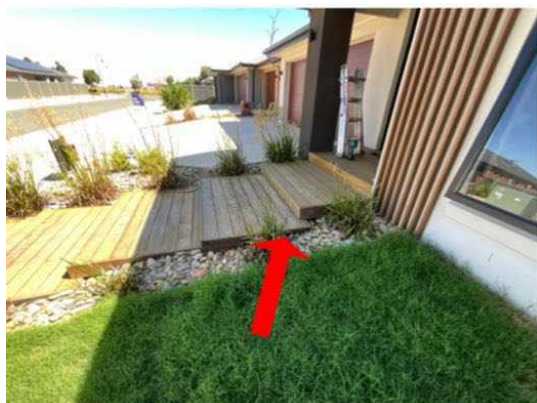
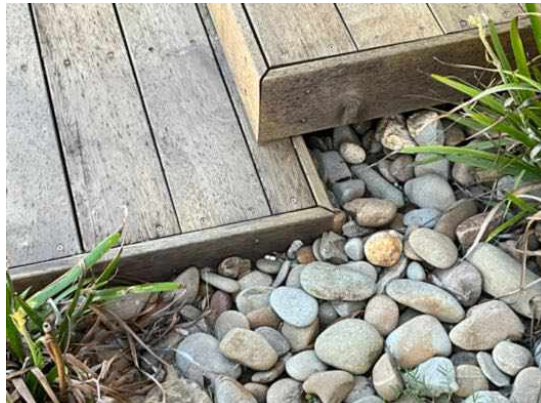
Finding 6.02

Building:	Building 1
Location:	All External Areas
Finding:	Termite Management System- evidence of a chemical installation
Information:	The application of a post-construction chemical termite barrier is highly recommended for all properties, particularly if live termite activity has been found on the site previously. Such barriers are highly effective in preventing termite attack on any timber building elements throughout the property.

A durable notice has been placed in the switchboard unit to indicate current termite barriers. At the time of inspection, it appeared as though a termite management system has been installed. The recency of any treatment cannot be determined.

The client may consider gaining further advice from a pest controller as to the costs and procedures involved with this application. It is recommended that obtaining such advice be a short-term priority.

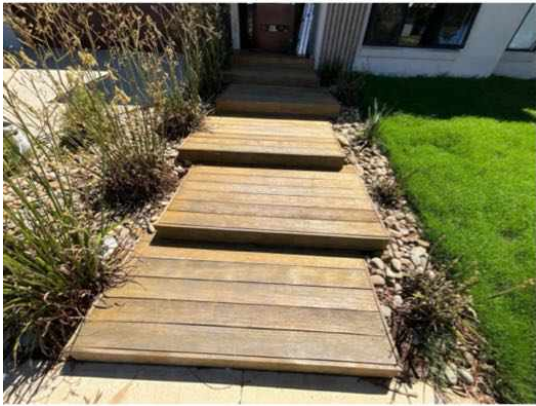
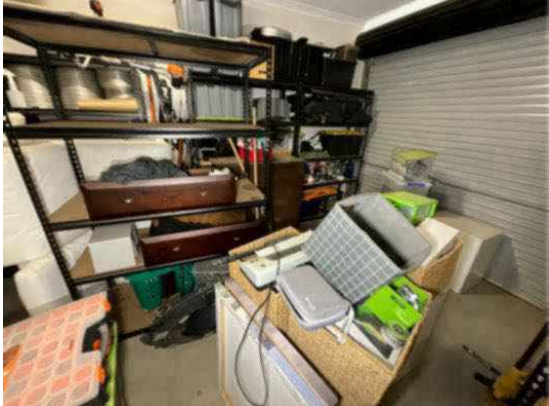
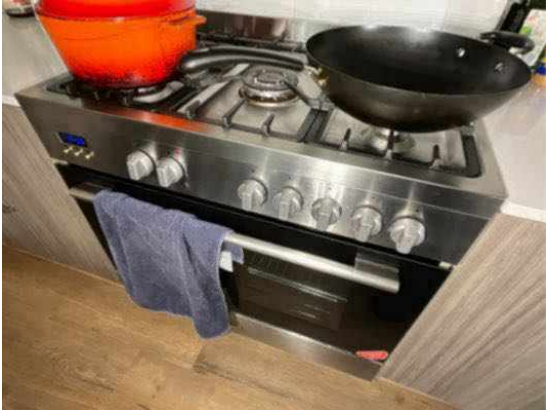
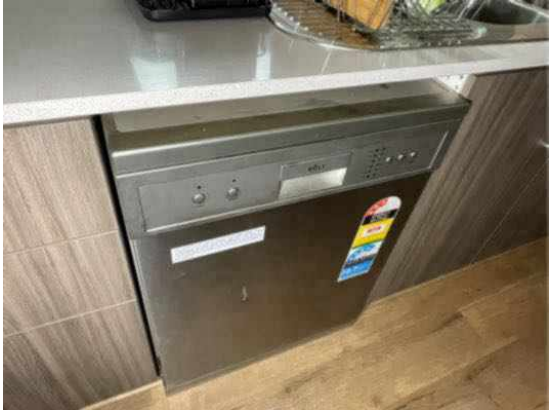
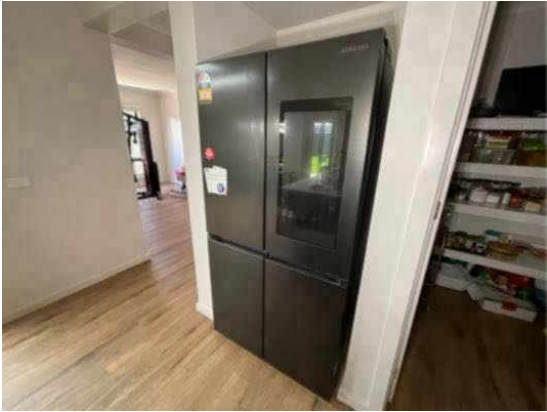
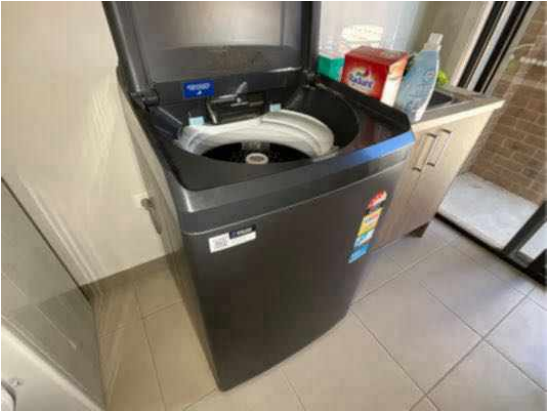
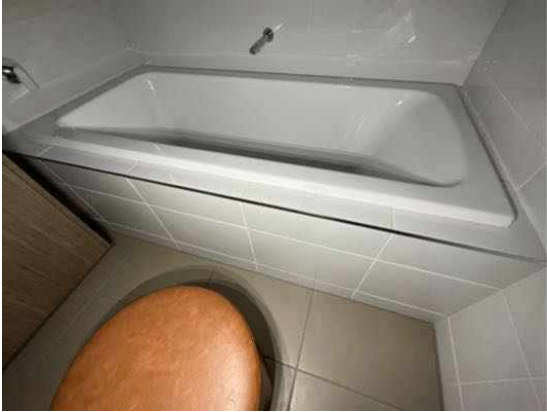
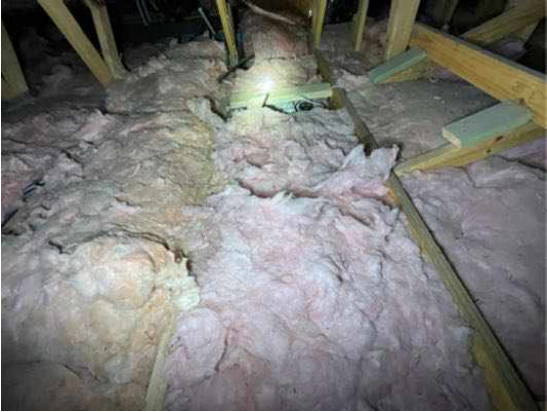
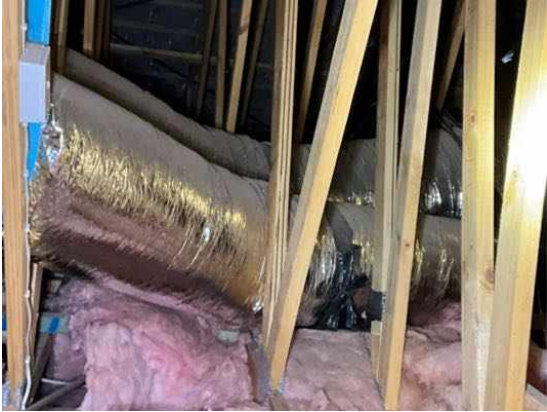
Noted Item

Building: Building 1
Location: All Areas
Finding: Additional Photos - Obstructions and Limitations
Information: These photographs are an indication of the obstructions and limitations which impeded full inspection of the property at the time of inspection. These obstructions can hide an array of defects and should be removed to allow full inspection to be carried out. A re-inspection is recommended once the areas are made accessible.
