Building and Timber Pest Inspection Report

Inspection Date: Thu, 29 Jan 2026

Property Address: 7 Newton St, Shepparton VIC 3630,
Australia, units 1 and 2

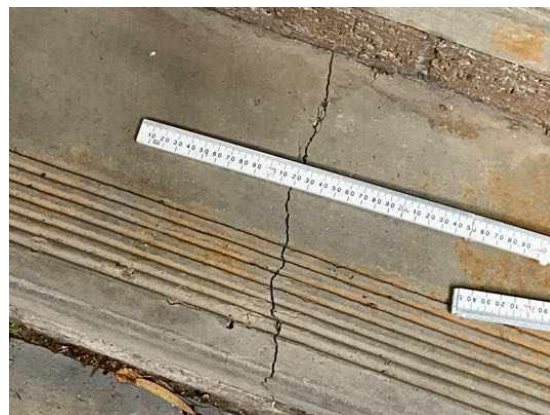
Building: Building 1
 Location: Entry
 Finding: Cracking - External Concrete Paving Damage Category 1 - Fine (less than 2mm)
 Information: Fine cracks were identified in external concrete paving. Although fine cracks are quite noticeable, they are often only considered to be an appearance defect, and usually do not indicate any structural damage. To be considered a Category 1 or fine crack, the crack is found to be less than 2mm in width.

Generally the cause of a hairline crack in existing concrete paving such as driveways and pathways is indicative of the expansion and contraction of the concrete. Such causes are generally due to environmental factors, such as moisture levels, weather conditions, root systems of nearby trees or the soil types on which they are laid.

Fine cracks may also be due to poor original installation of the concrete. Factors such as poor compaction of the sub surface and/or inadequate reinforcing of the slab may create cracking and other secondary defects.

Monitoring of all cracking should be conducted frequently. Always contact a building inspector should cracks widen, lengthen, or become more numerous.

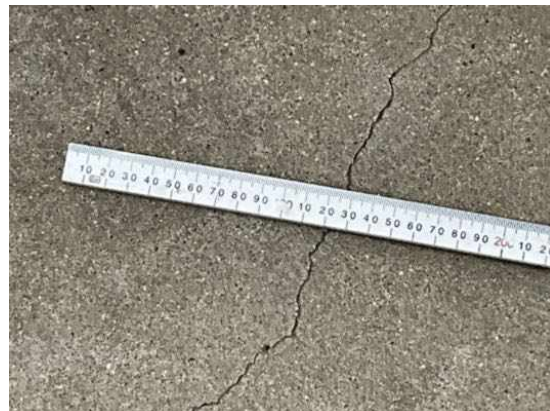
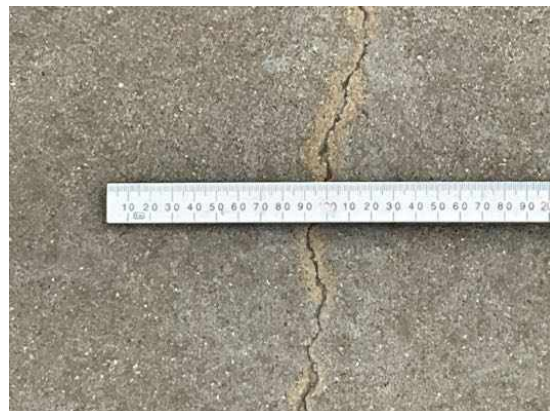
Finding 3.02

Building: Building 1
 Location: Yard - Back, driveway
 Finding: Cracking - External Concrete Paving Damage Category 1 - Fine (less than 2mm)
 Information: Fine cracks were identified in external concrete paving. Although fine cracks are quite noticeable, they are often only considered to be an appearance defect, and usually do not indicate any structural damage. To be considered a Category 1 or fine crack, the crack is found to be less than 2mm in width.

Generally the cause of a hairline crack in existing concrete paving such as driveways and pathways is indicative of the expansion and contraction of the concrete. Such causes are generally due to environmental factors, such as moisture levels, weather conditions, root systems of nearby trees or the soil types on which they are laid.

Fine cracks may also be due to poor original installation of the concrete. Factors such as poor compaction of the sub surface and/or inadequate reinforcing of the slab may create cracking and other secondary defects.

Monitoring of all cracking should be conducted frequently. Always contact a building inspector should cracks widen, lengthen, or become more numerous.

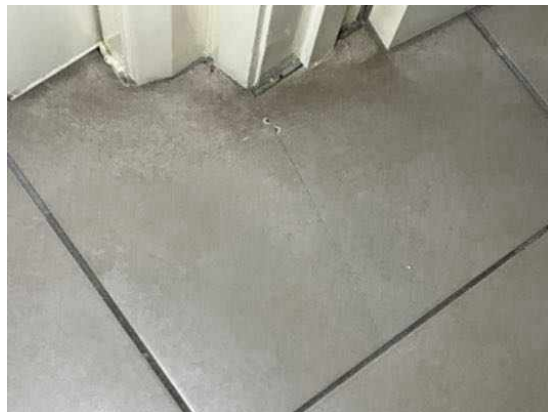
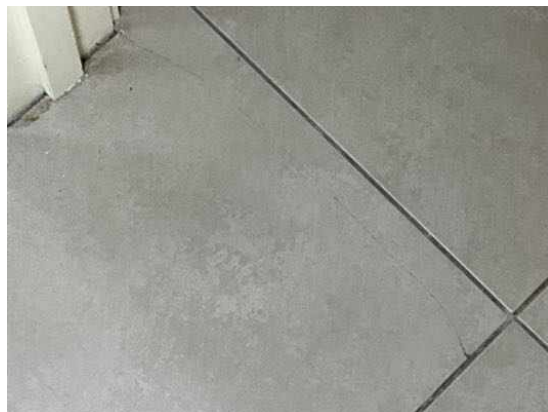
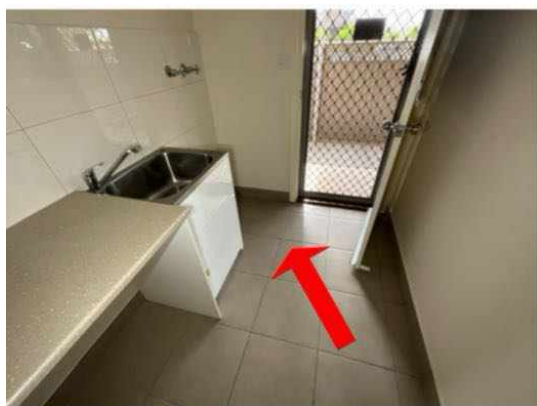
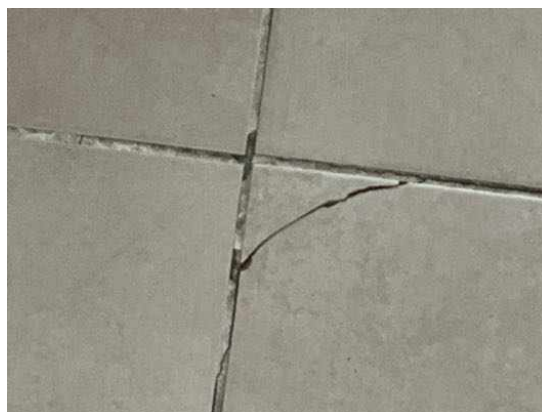
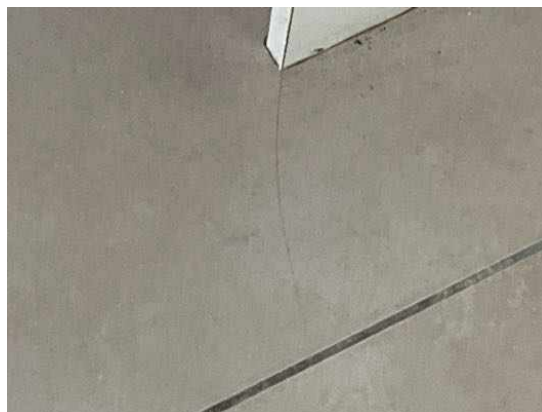
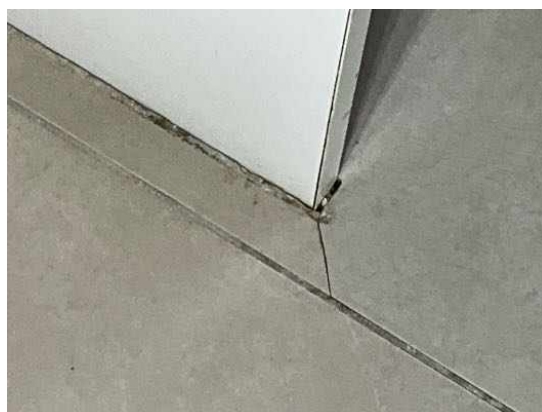
Finding 3.03

Building: Building 2
Location: Hall, laundry, kitchen
Finding: Cracked floor tiles
Information: Cracking in the floor tiles was evident in this area at the time of inspection. It is suspected that this cracking has occurred as a result of minor settlement or impact damage.

Cracked tiles throughout the household detract from the overall appearance of the affected areas however it is unlikely to create or lead to any secondary defects.

While not considered a matter of urgency, replacement of cracked floor tiles is recommended at the clients discretion. A tiling contractor may be appointed to perform these works. Where cracks become more numerous, contact a licensed building inspector for further investigation.

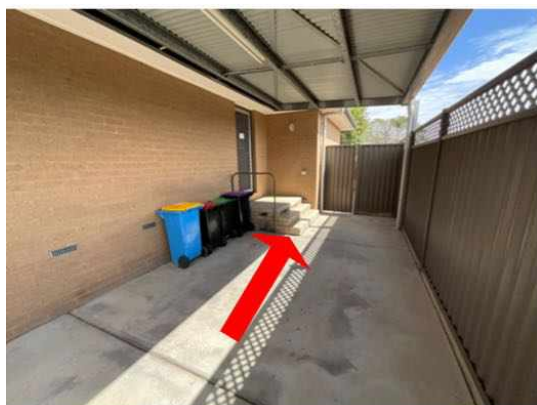
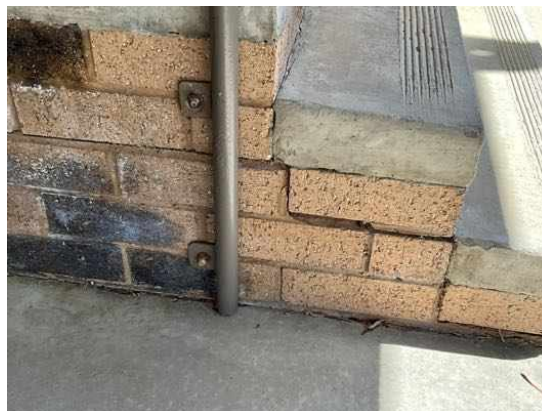
Finding 3.04

Building:	Building 2
Location:	Carport
Finding:	Brickwork- Step cracking
Information:	Step cracking was identified to the brickwork in this area at the time of inspection. Step cracking, which is similar to other forms of cracking, has a variety of possible causes. However, the most common is the subsidence of adjacent footings.

Step cracking is a relatively common defect, and is most likely to occur adjacent to windows, doors and other openings. Mortar failure in the gaps between affected bricks indicates the stresses and tensions affecting the wall.

Minor step cracking can be used as a warning sign to address factors causing stress to the wall, which can include the effect of surrounding trees, water leaks, soil erosion, or even the presence of reactive soils in the surrounding area.

If cracks increase in size or number contact a Licensed builder immediately to make all needed repairs.

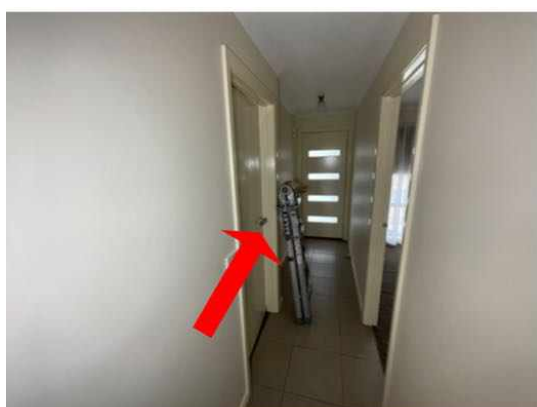
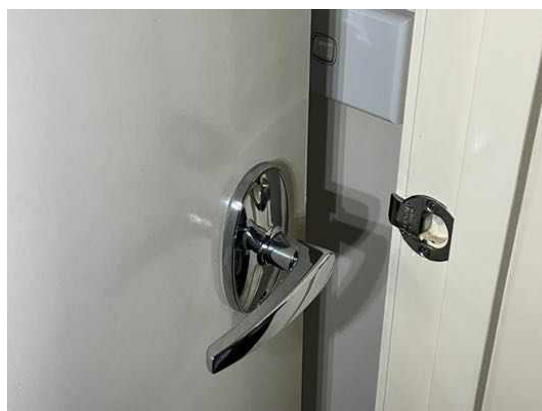
Finding 3.05

Building: Building 2
 Location: Bedroom - Master
 Finding: Door - Striker plate misaligned
 Information: The striker plate to this door appears to have become misaligned and has consequently resulted in the door's operation being compromised.

This is a common defect and is expected in a property of this age, whether being due to substandard installation or general deterioration of the door hardware.

Readjustment of the striker plate is recommended at client discretion. Works such as these can be completed by a general handyman or qualified carpenter.

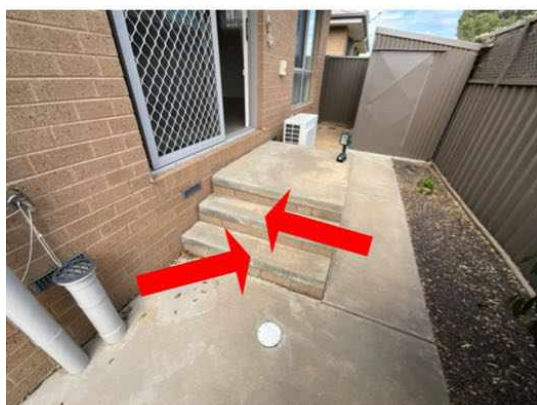
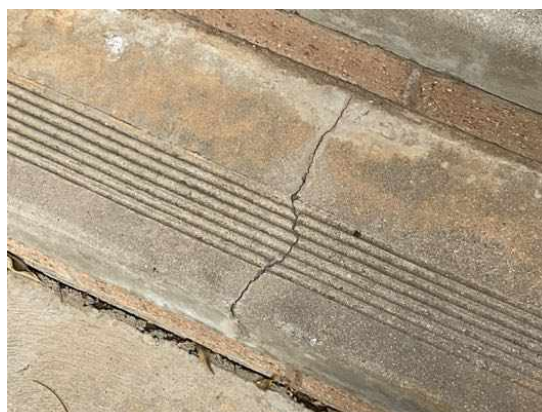
Finding 3.06

Building:	Building 2
Location:	Yard - Back
Finding:	Cracking - External Concrete Paving Damage Category 1 - Fine (less than 2mm)
Information:	Fine cracks were identified in external concrete paving. Although fine cracks are quite noticeable, they are often only considered to be an appearance defect, and usually do not indicate any structural damage. To be considered a Category 1 or fine crack, the crack is found to be less than 2mm in width.

Generally the cause of a hairline crack in existing concrete paving such as driveways and pathways is indicative of the expansion and contraction of the concrete. Such causes are generally due to environmental factors, such as moisture levels, weather conditions, root systems of nearby trees or the soil types on which they are laid.

Fine cracks may also be due to poor original installation of the concrete. Factors such as poor compaction of the sub surface and/or inadequate reinforcing of the slab may create cracking and other secondary defects.

Monitoring of all cracking should be conducted frequently. Always contact a building inspector should cracks widen, lengthen, or become more numerous.

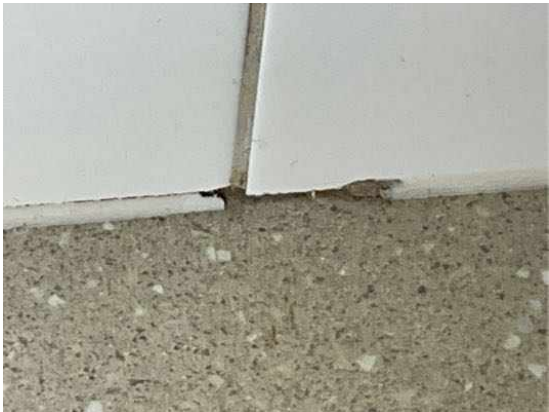
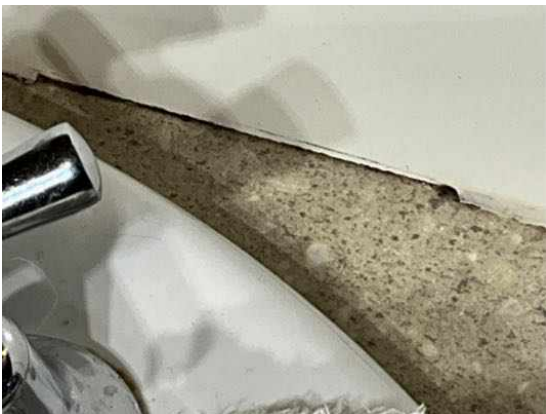
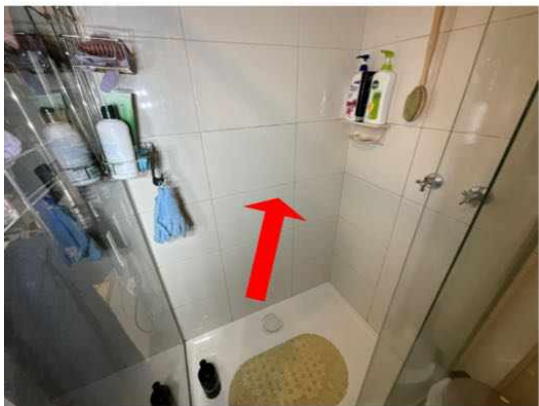
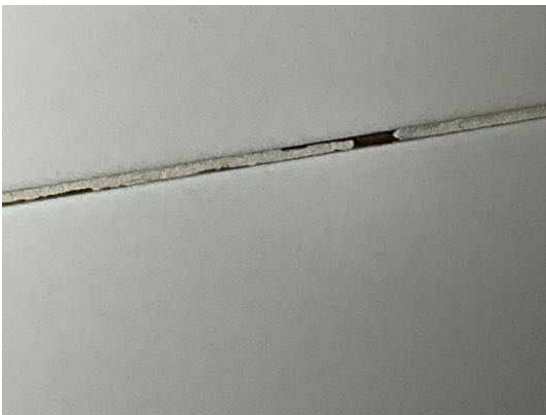
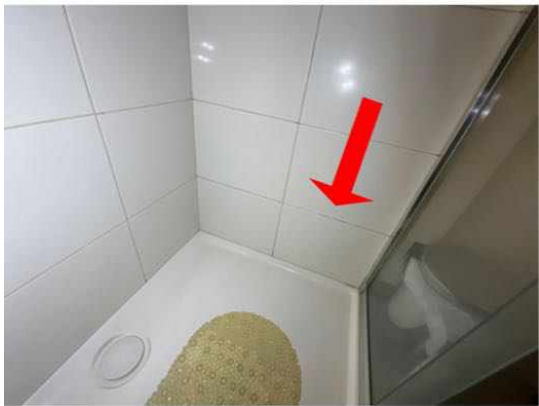
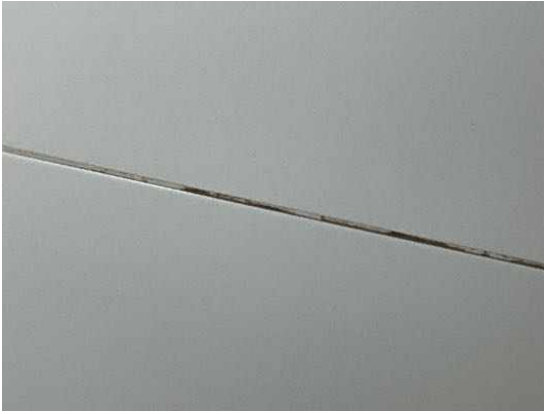
Location: Bathroom
Finding: Inadequate sealant or Grout
Information: This area has a lack of effective Sealant or Grout. This is allowing the ingress of water to the structure inside the wall.

The presence of water encourages Termite attack, Mould and Fungal Decay.

A Tiler or General Handy person must be contacted as soon as possible to effect repairs and prevent further deterioration.

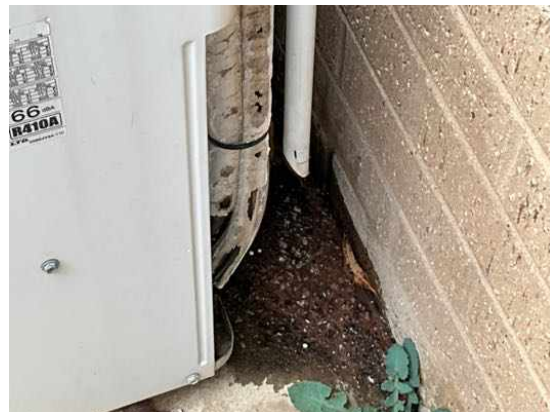
Finding 6.02

Building:	Building 1
Location:	Yard - Back
Finding:	Air conditioner - Disconnected overflow
Information:	The Air Conditioner (A/C) overflow was found to be disconnected from storm water drainage and is creating excessive moisture in the surrounding area.

Such leaking creates an environment which is conducive to an array of defects, including water damage to associated building elements and the attraction of termite or timber pest infestation.

It is highly recommended that a licensed plumber be appointed to connect the A/C overflow in order to prevent such an environment from being created. These minor works should be carried out as soon as possible.

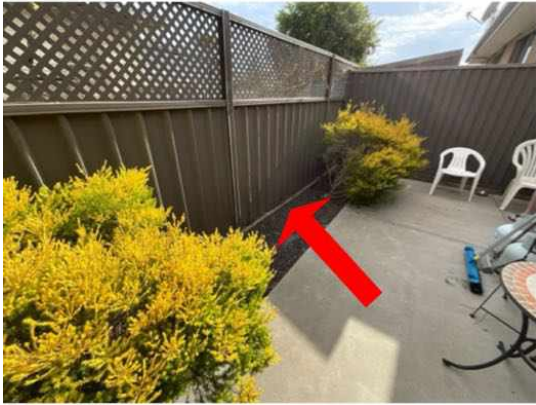
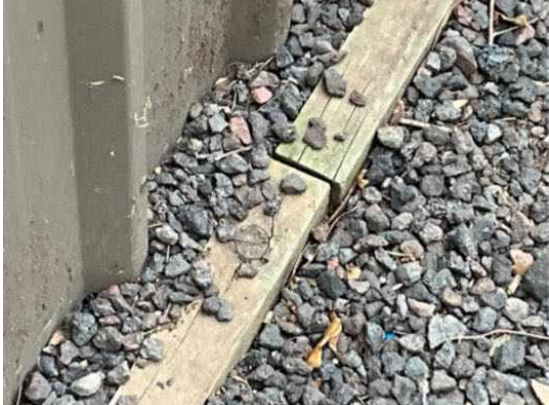
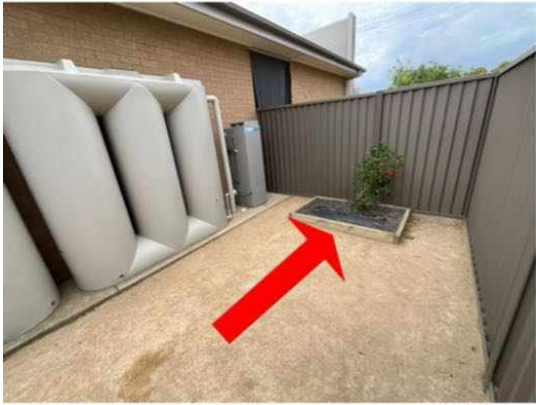
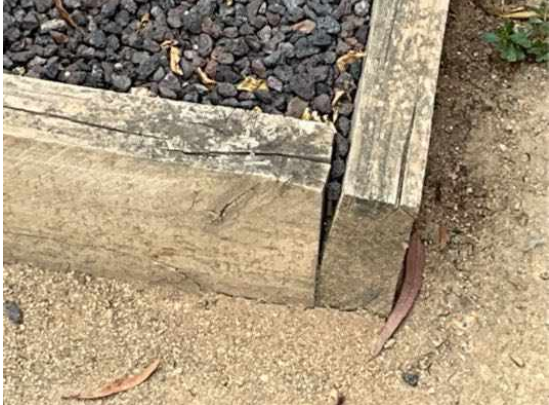
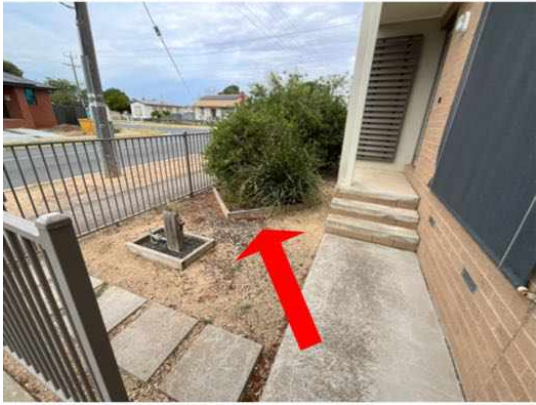
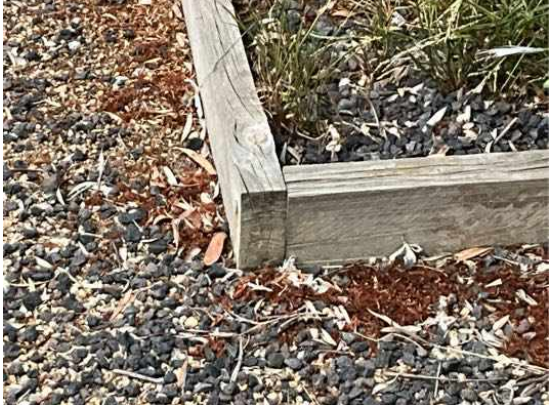
Finding 6.03

Building:	Building 1
Location:	Yard - Back, front
Finding:	Untreated or non-durable timbers in a hazardous environment
Information:	To reduce the risk of timber pest attack it is essential that timber used in a hazardous environment (e.g. in direct contact with the ground or frequently exposed to damp

conditions) is of sufficient durability and/or is adequately preservative treated.

Untreated timbers in direct contact with the ground are likely to develop severe wood rot and/or fungal decay if left unattended creating attraction for subterranean termites to infest the timbers from surrounding areas.

If untreated or non-durable timbers are found to be in a hazardous environment it is highly advised that replacement of these building elements be performed as soon as possible to aid the protection of the property against termite / timber pest attack.

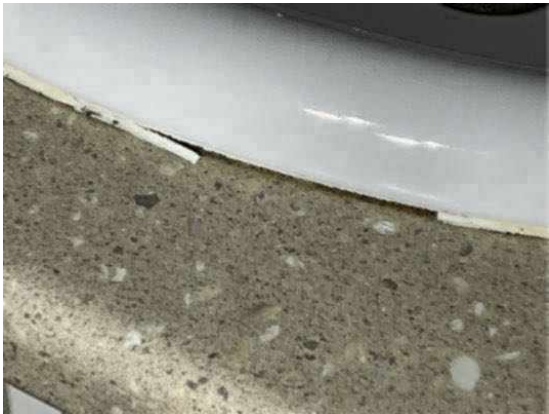
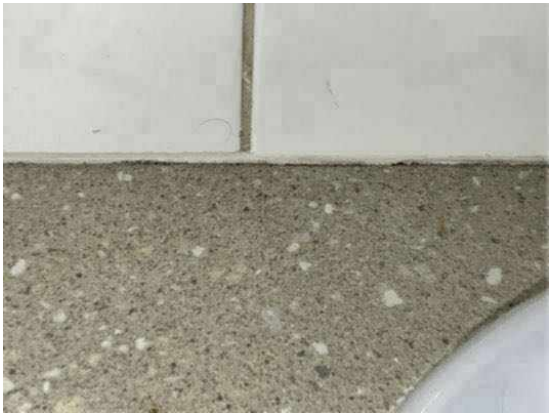
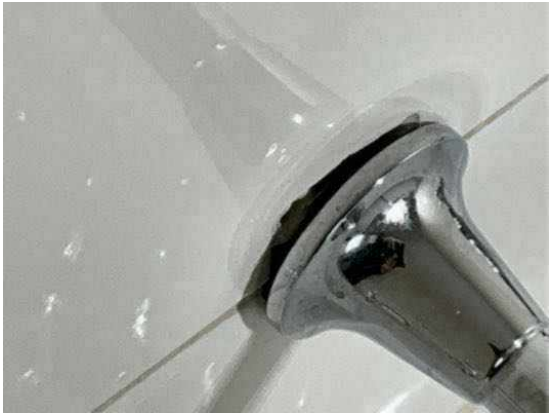
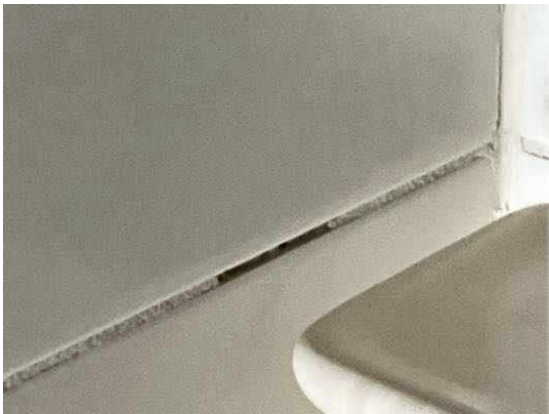
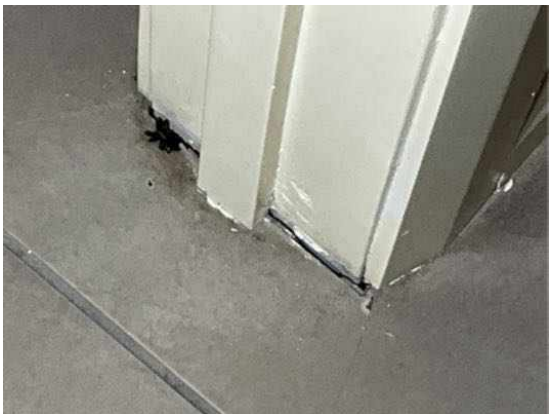
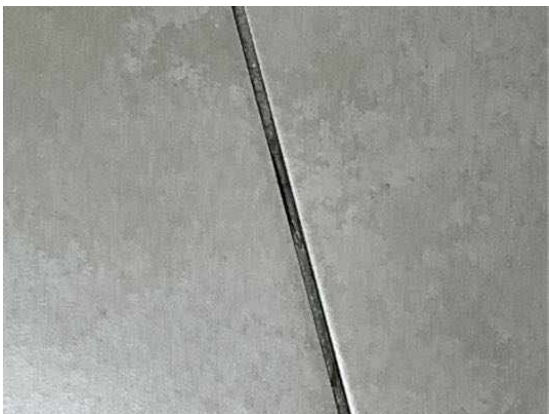
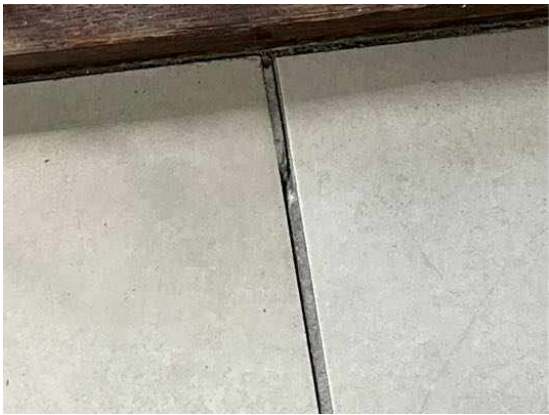
Finding 6.05

Building: Building 2
 Location: Bathroom, Wc, laundry
 Finding: Inadequate sealant or Grout
 Information: This area has a lack of effective Sealant or Grout. This is allowing the ingress of water to the structure inside the wall.

The presence of water encourages Termite attack, Mould and Fungal Decay.

A Tiler or General Handy person must be contacted as soon as possible to effect repairs and prevent further deterioration.

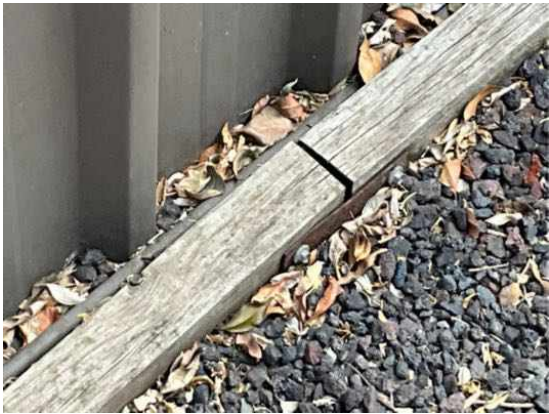
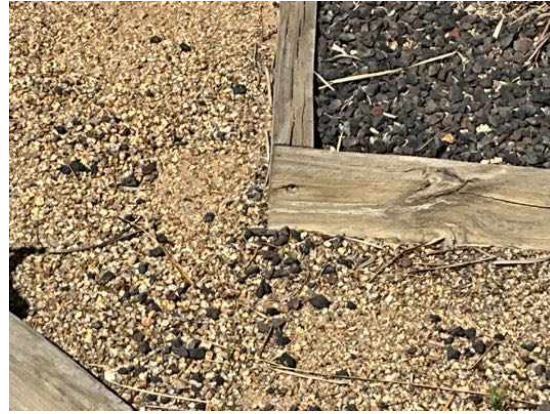
Finding 6.06

Building: Building 2
Location: Yard - Back, front
Finding: Untreated or non-durable timbers in a hazardous environment
Information: To reduce the risk of timber pest attack it is essential that timber used in a hazardous environment (e.g. in direct contact with the ground or frequently exposed to damp conditions) is of sufficient durability and/or is adequately preservative treated.

Untreated timbers in direct contact with the ground are likely to develop severe wood rot and/or fungal decay if left unattended creating attraction for subterranean termites to infest the timbers from surrounding areas.

If untreated or non-durable timbers are found to be in a hazardous environment it is highly advised that replacement of these building elements be performed as soon as possible to aid the protection of the property against termite / timber pest attack.

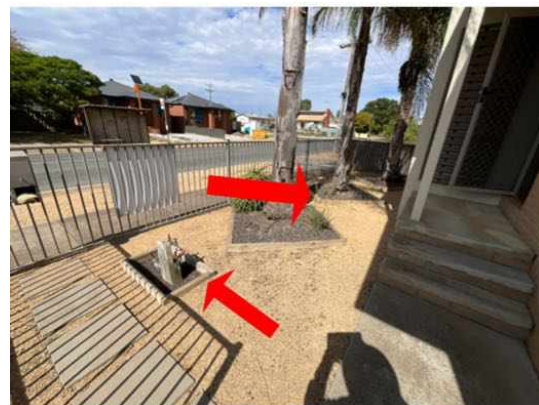
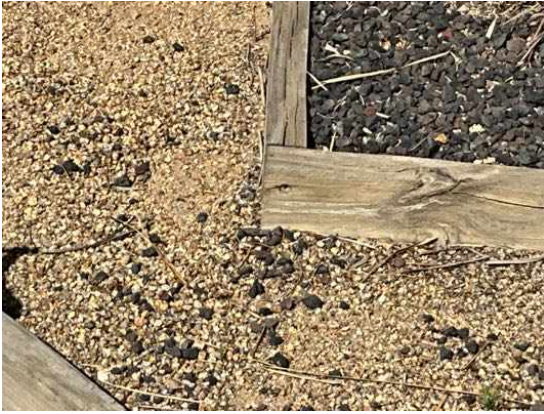
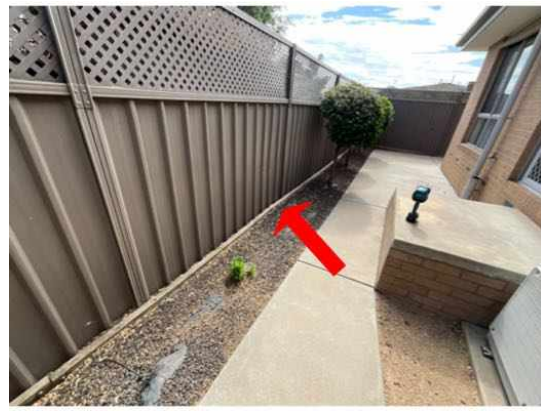
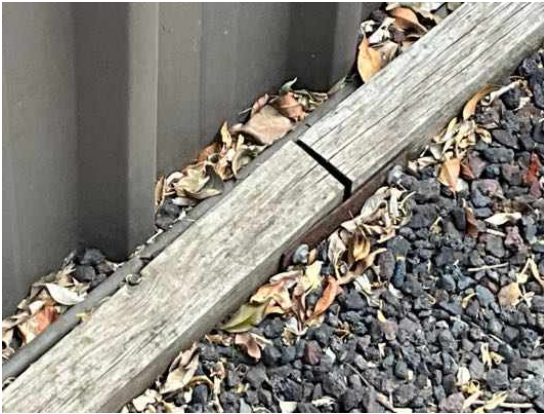
Finding 6.07

Building:	Building 2
Location:	All Areas
Finding:	Termite Management System - no evidence of a chemical installation
Information:	The application of a post-construction chemical termite barrier is highly recommended for all properties, particularly if live termite activity has been found on the site previously. Such barriers are highly effective in preventing termite attack on any timber building elements throughout the property.

A durable notice should be placed in the switchboard unit to indicate current termite barriers. At the time of inspection, it appeared as though no termite management system has been installed, with no evidence to suggest preventative works taking place.

The client may consider gaining further advice from a pest controller as to the costs and procedures involved with this application. It is recommended that obtaining such advice be a short-term priority.

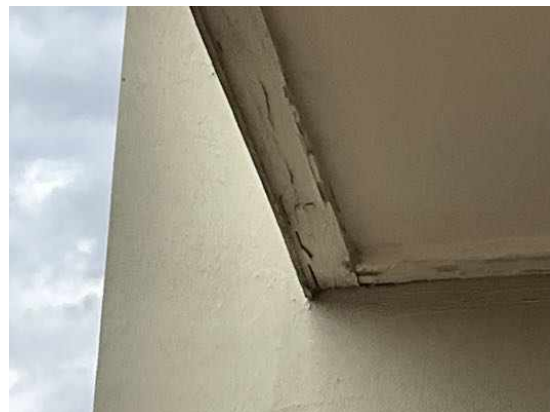
Building: Building 1
 Location: Entry
 Finding: Timber - exposed to weather
 Information: External timbers that are frequently exposed to harsh weather conditions require adequate protection in order to maintain their condition. Where timbers have not been painted or treated adequately, general deterioration is likely to occur at an accelerated rate.

If left unattended, replacement of these timbers is likely to be necessary in the short-term future. Adequate treatment of these timbers is required as soon as possible by a painting contractor or general handyman.

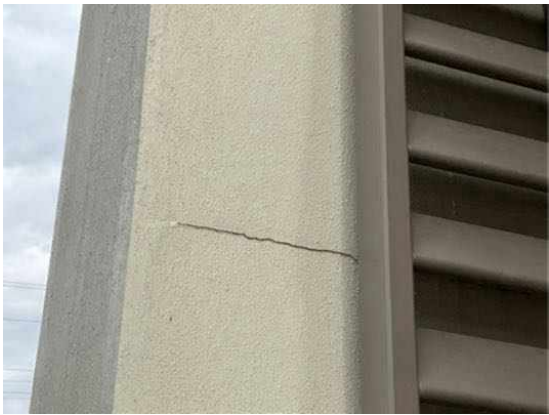
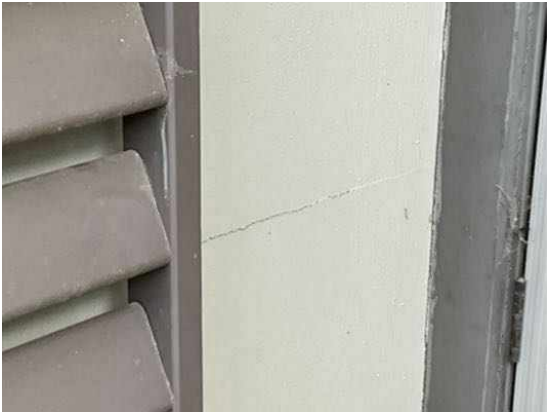
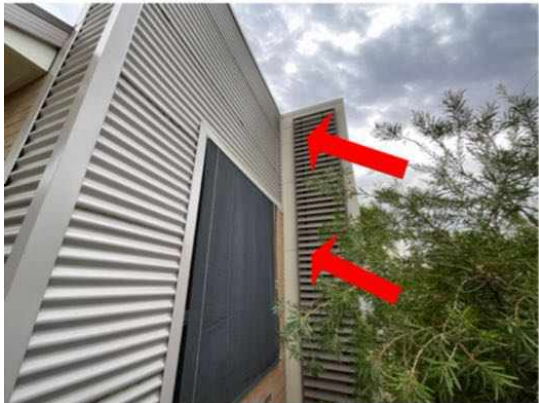
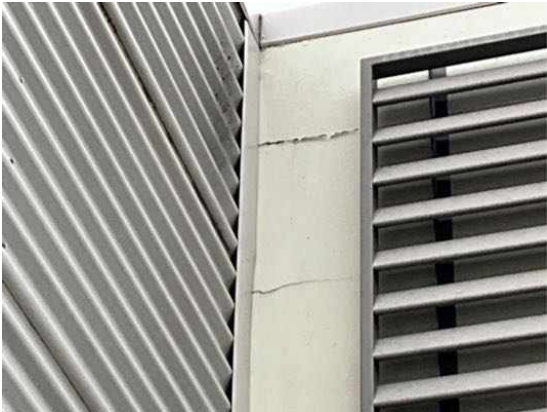
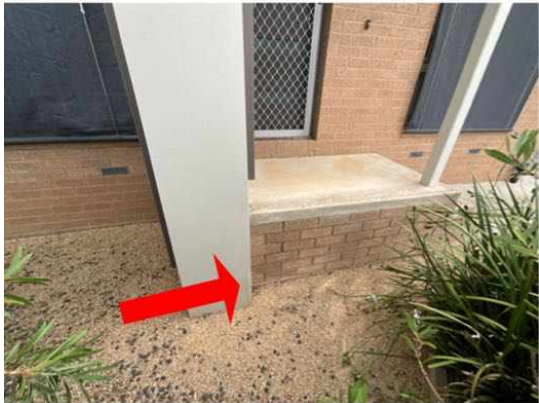
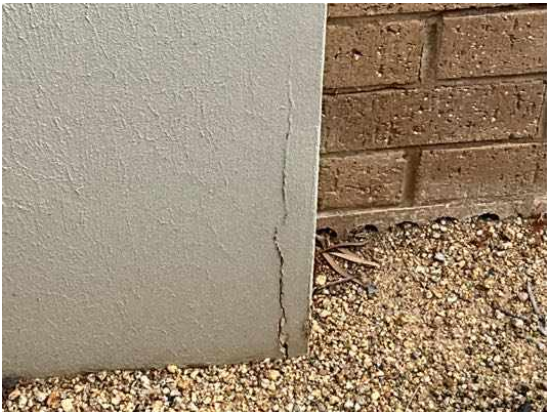
Building: Building 1
 Location: Entry
 Finding: Render- Cracking
 Information: Cracking to the render in this area was identified at the time of inspection.

This type of cracking is often consistent with general dilapidation of the property, and may continue to develop if left unmaintained.

Frequent monitoring should be carried out to identify any further damage.

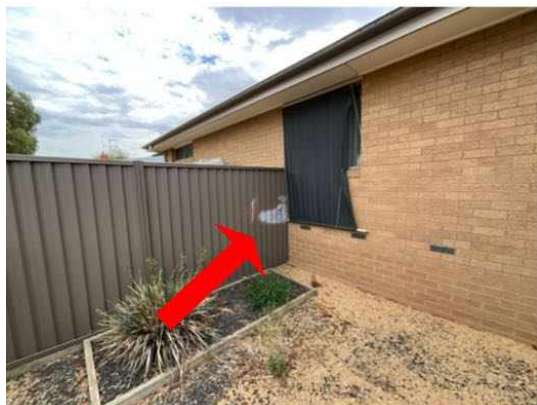
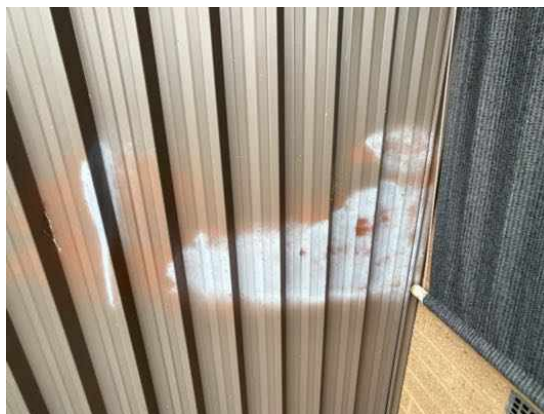
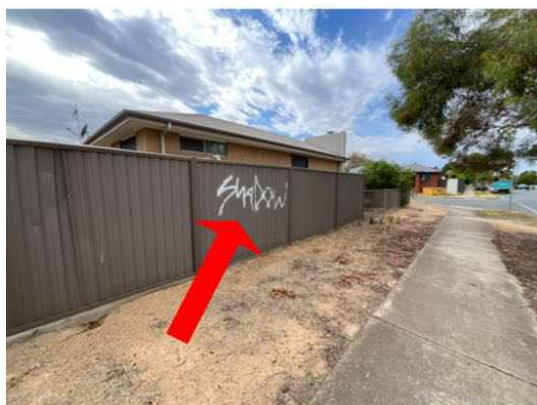
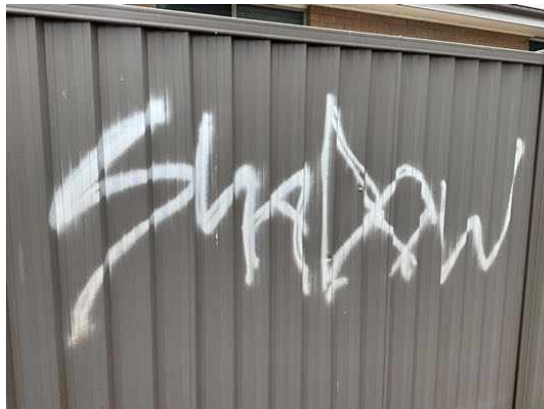
Building: Building 1
 Location: Fence
 Finding: Paint residue
 Information: Several area show a kind of overspray of paint. This is a cosmetic defect in this case.

No action is required except at the discretion of the client.

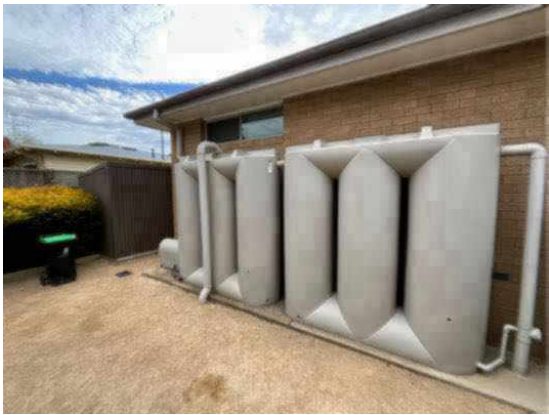
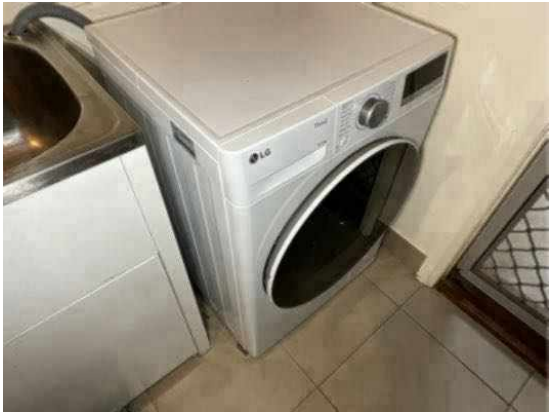
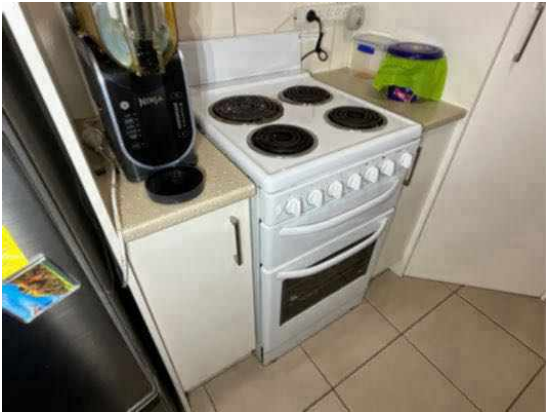
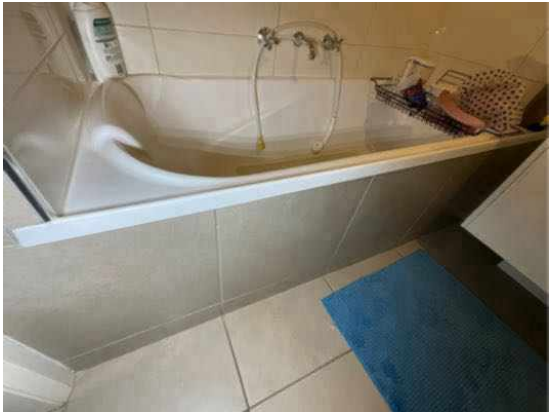
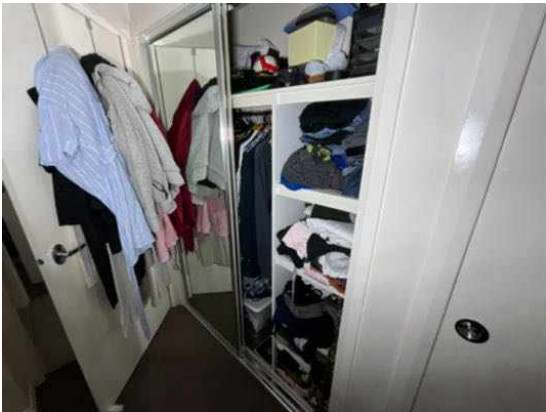
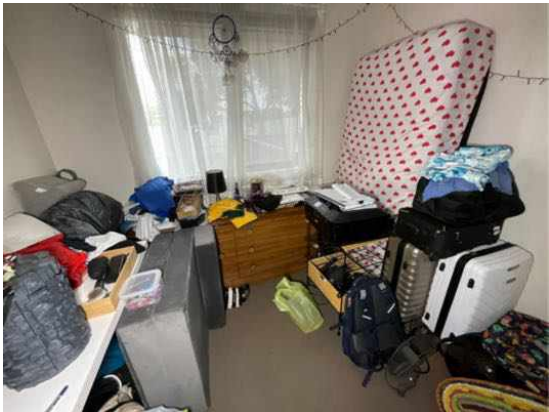
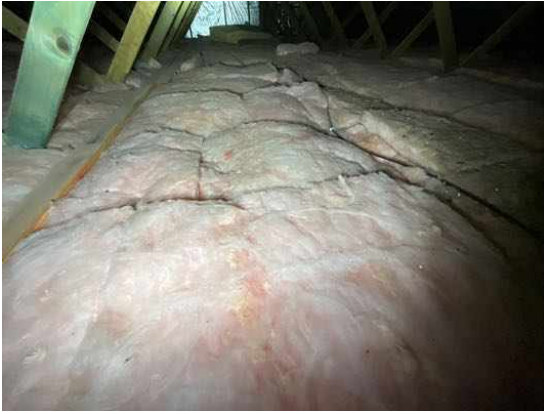
Building: Building 1
 Location: All Areas
 Finding: Additional Photos - Obstructions and Limitations
 Information: These photographs are an indication of the obstructions and limitations which impeded full inspection of the property at the time of inspection. These obstructions can hide an array of defects and should be removed to allow full inspection to be carried out. A re-inspection is recommended once the areas are made accessible.

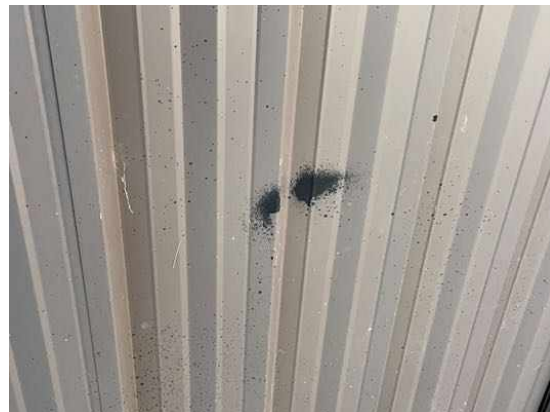
Building: Building 2
 Location: Fence
 Finding: Paint residue
 Information: The fence shows a kind of overspray of paint. This is a cosmetic defect in this case.

No action is required except at the discretion of the client.

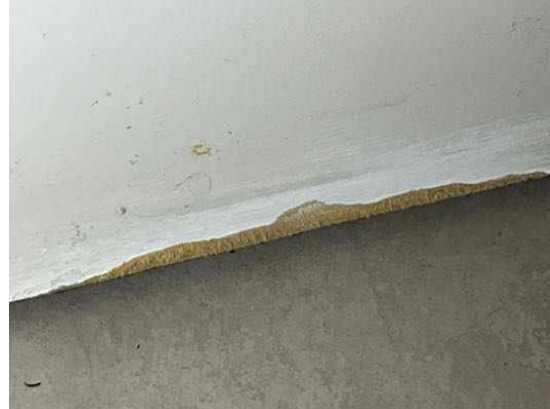
Building: Building 2
 Location: Laundry
 Finding: MDF- Moisture affected
 Information: The Particle board (MDF) in this area has been affected by excess moisture. This moisture has caused swelling of the material. A lack of effective paint or other coating has probably allowed the moisture to penetrate and deteriorate the material over time.

In cases of minor swelling a painter or Handy person could re-paint and restore the area.

In cases where the material is structurally compromised a carpenter or General handy person could be contacted to replace the damaged elements and complete all needed restoration.

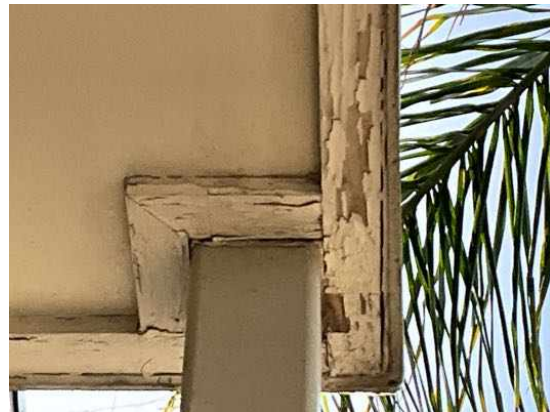
Building: Building 2
 Location: Entry
 Finding: Timber - exposed to weather
 Information: External timbers that are frequently exposed to harsh weather conditions require adequate protection in order to maintain their condition. Where timbers have not been painted or treated adequately, general deterioration is likely to occur at an accelerated rate.

If left unattended, replacement of these timbers is likely to be necessary in the short-term future. Adequate treatment of these timbers is required as soon as possible by a painting contractor or general handyman.

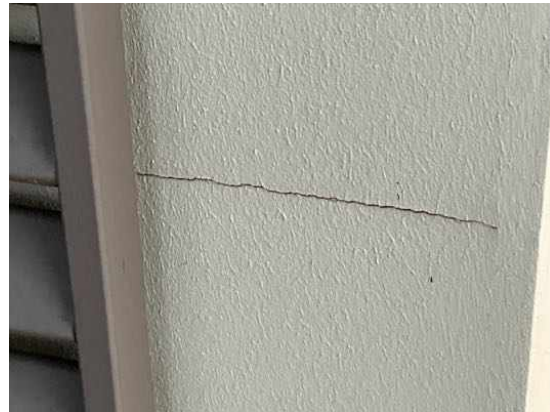
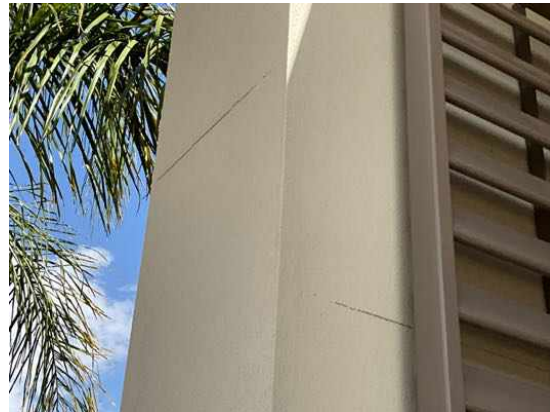
Building: Building 2
 Location: Entry
 Finding: Render- Cracking
 Information: Cracking to the render in this area was identified at the time of inspection.

This type of cracking is often consistent with general dilapidation of the property, and

may continue to develop if left unmaintained.

Frequent monitoring should be carried out to identify any further damage.

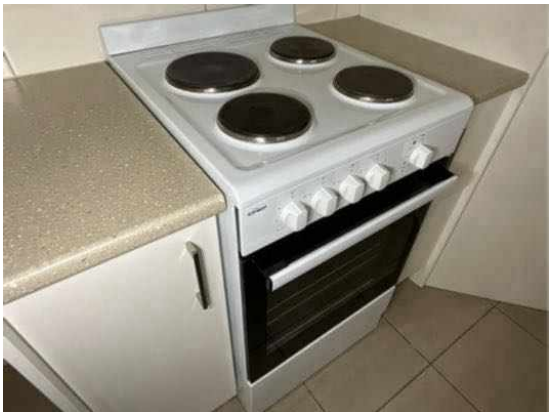
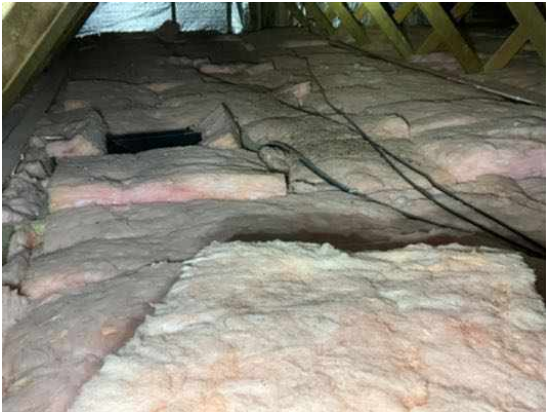
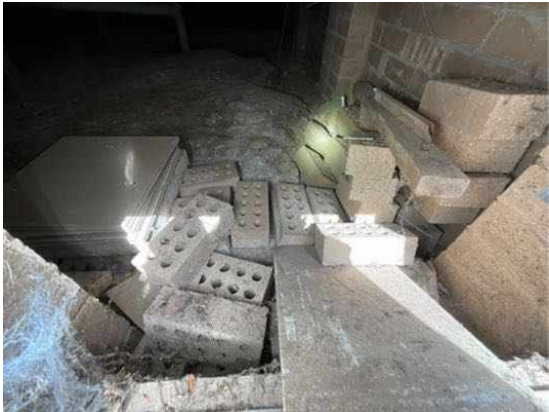
Building:	Building 2
Location:	All Areas
Finding:	Additional Photos - Obstructions and Limitations
Information:	These photographs are an indication of the obstructions and limitations which impeded full inspection of the property at the time of inspection. These obstructions can hide an array of defects and should be removed to allow full inspection to be carried out. A re-inspection is recommended once the areas are made accessible.
