Building Inspection Report

Inspection Date: Wed, 18 Mar 2026

Property Address: 1/19-21 Embankment Grove, Chelsea VIC
3196, Australia

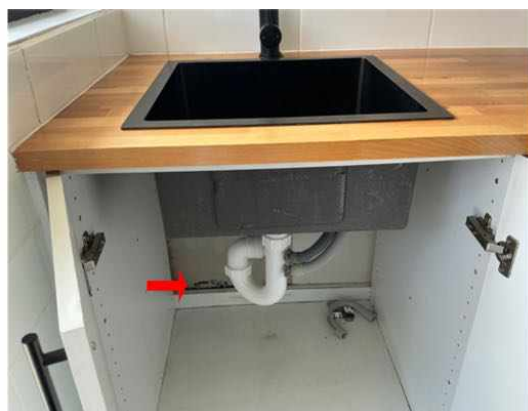
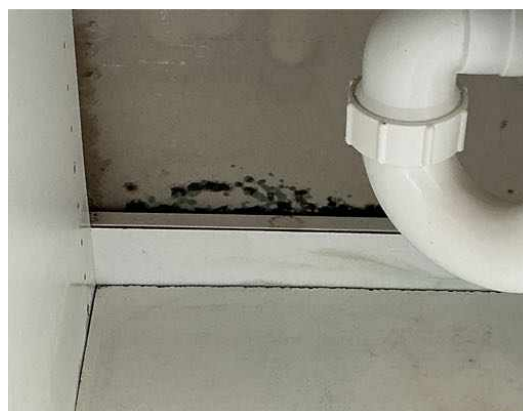
Defects 1.01

Building:	Main Building
Location:	Laundry
Finding:	Mould - Present
Information:	Where evidence of mould growth was noted, there may be environmental, biological or health issues associated with the report. A specialist inspection by a suitably qualified environmental health inspector is warranted, where mould is extensive or where any queries regarding air quality spores or other related issues apply.

Generally, the client is advised to ensure that the general environment is free of moisture and humidity to aid in the prevention of mould formation and development. Any mould found during the inspection should be cleaned immediately by a cleaning contractor or the homeowner as applicable.

Please note that severely affected building elements may require replacement by a registered builder or qualified carpenter.

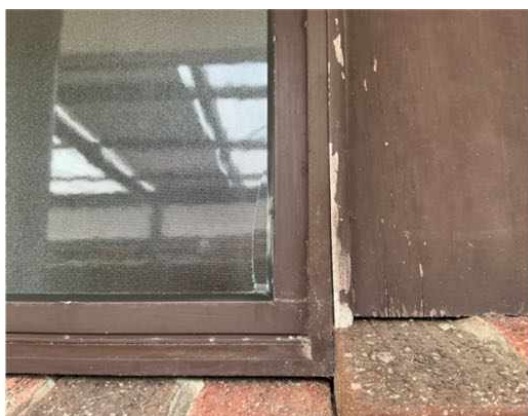
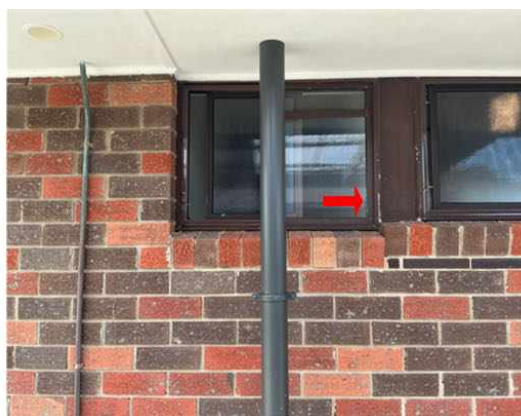
Defects 3.01

Building:	Main Building
Location:	Toilet (WC)
Finding:	Window - Cracked

Information: Cracks were identified in the window in this area. Cracking in windows is generally the result of impact damage, and is likely to develop further when left unmanaged.

The likelihood of this windowpane further cracking and shattering is increased exponentially, providing a safety hazard in the area. The cracked window also impairs the weather tightness of the building, creating potential for minor water leaks.

A qualified glazier is required to repair the window as soon as possible. Depending on the extent of the cracking, replacement of the window may be required. Please be advised that any persons coming into contact with the cracked window should do so with due caution to avoid any personal injury that may ensue.

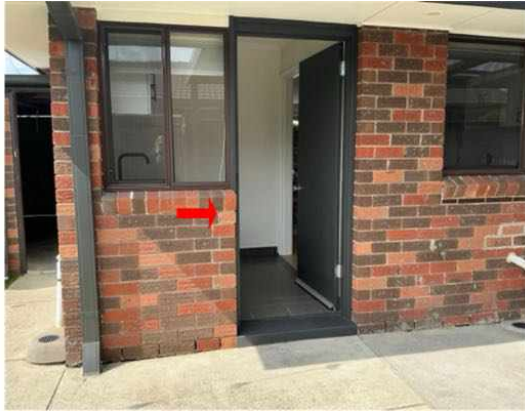
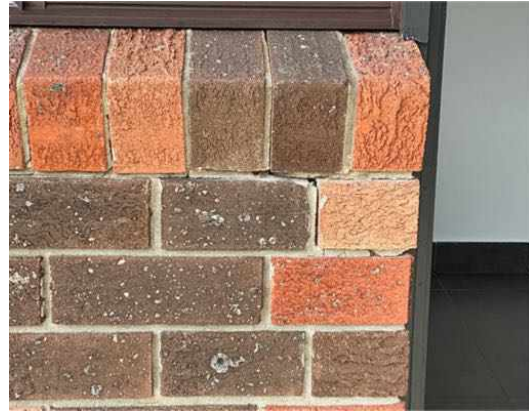
Defects 3.02

Building: Main Building
 Location: Exterior walls - rear
 Finding: Brickwork - Cracking [Fine]
 Information: Although fine cracks are quite noticeable, they are often only considered to be an appearance defect and usually do not indicate any structural damage. Generally, the cause of a fine crack is indicative of a separation between brickwork and mortar throughout the structure, but single bricks may also show cracks of this nature.

Cracking of this nature can generally be repaired with minor filling and should be conducted by a qualified bricklayer.

Always contact a building inspector should cracks widen lengthen or become more numerous.

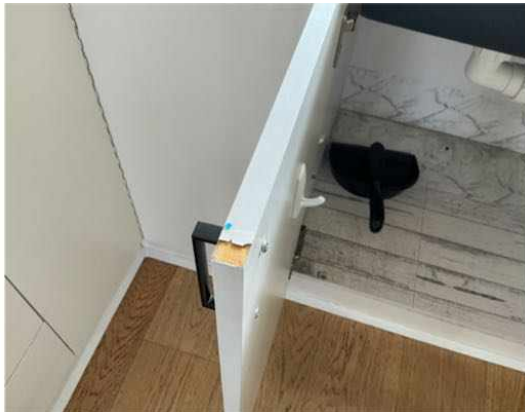
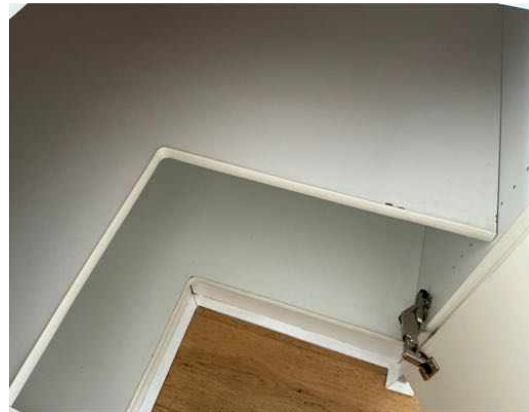
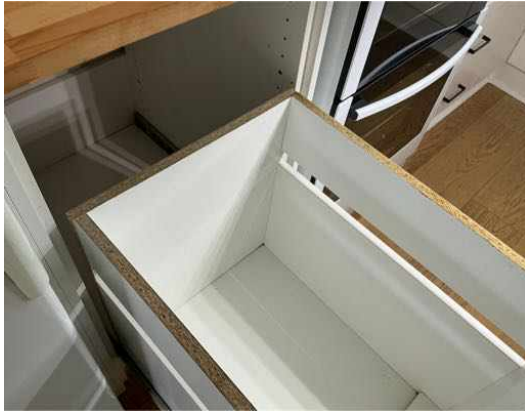
Defects 3.03

Location: Kitchen

Finding: Cabinetry - Loose hinges and deteriorated elements

Information: Several cupboard doors are not level and detract from the operational state of the cabinetry. Upon further inspection, it was noted that the hinges to the cupboard doors have deteriorated over time and, as a result, have come loose from their original fixing. To improve operation of the affected cupboard doors, a general handyman may be appointed to replace the faulty hinges. Such works should be completed at discretion of the client.

Laminate has separated and chipped in some panels, cabinetry may be replaced or repaired at the clients convenience.

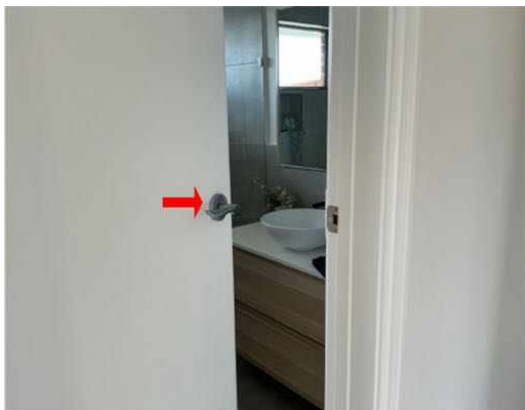
Defects 3.04

Building:	Main Building
Location:	Bathroom
Finding:	Door handle - Not latching
Information:	It was noted that the door in this area was not latching during operation at the time of inspection. Whilst detracting from the functionality of this building element, this minor defect may also be a security risk, and may therefore have serious implications if left unattended.

It is suspected that this defect has occurred due to minor issues with the associated hinges. Such damage is identified as general wear and tear, which is expected for building elements of this age.

A qualified carpenter or general handyperson may be appointed to perform rectification works as necessary, at client discretion. If left unattended, further functional impairment is likely to occur.

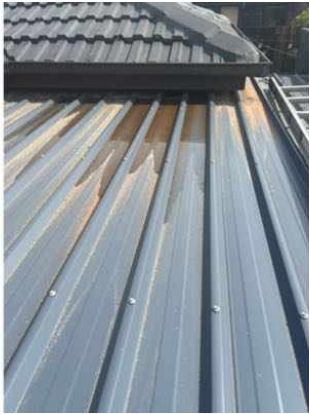
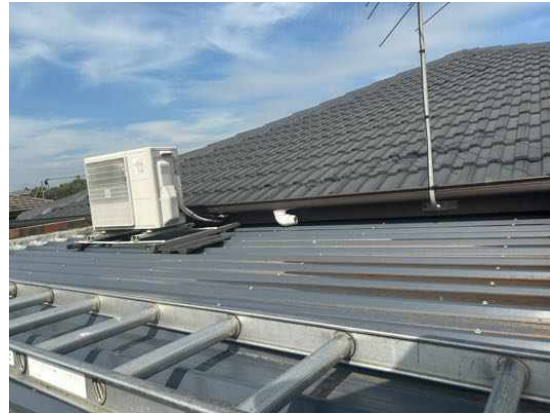
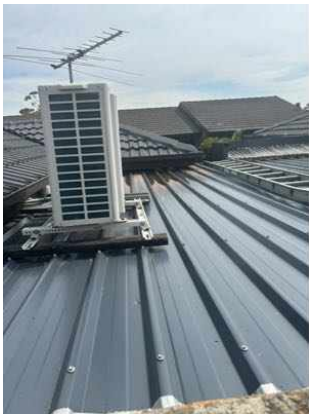
Defects 3.05

Building:	Garage
Location:	Roof Exterior
Finding:	Roof sheets - Water pooling

The roof drainage in sections of the exterior roof appears to be poor, evidenced by water pooling on the roof sheets. This is generally caused by either inadequate roof plumbing or roof structures not effectively draining due to the construction method.

Where water is pooling, rust and deterioration of the roof sheets is imminent if left unattended, which may necessitate major repair works.

Consultation with a roofing plumber is recommended as soon as possible to provide advice on rectification options. Additional works to rectify structural issues with the roof may also be required.

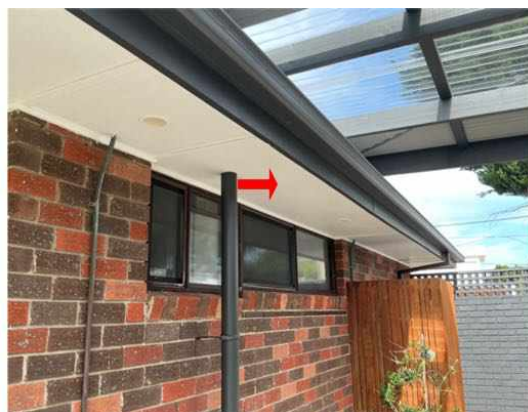
Building: Main Building
 Location: Eaves
 Finding: Asbestos - Suspected ACM Identified on Site
 Information: Reporting on Asbestos is outside the Scope of this Report. This suspected defect is highlighted as a caution only. We suspect, based on our experience in the building industry, that there is a higher risk of the identified building element containing asbestos.

As Asbestos Reporting is outside the scope of this report, we advise that you consider a separate Asbestos Inspection and Condition Audit, which can include the taking of samples for definitive confirmation of the presence of Asbestos.

In the interim, the client is advised to act with caution, especially when considering any damage to building materials general wear and tear renovations extensions demolition and general maintenance activities due to the suspected presence of Asbestos.

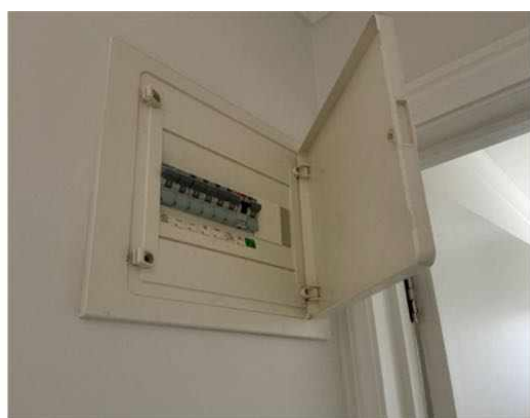
Building: Main Building
 Location: All Areas
 Finding: Termite Management System - no evidence of a chemical installation

Information: The application of a post-construction chemical termite barrier is highly recommended for all properties, particularly if live termite activity has been found on the site previously. Such barriers are highly effective in preventing termite attack on any timber building elements throughout the property.

A durable notice should be placed in the switchboard unit to indicate current termite barriers. At the time of inspection, it appeared as though no termite management system has been installed, with no evidence to suggest preventative works taking place.

The client may consider gaining further advice from a pest controller as to the costs and procedures involved with this application. It is recommended that obtaining such advice be a short-term priority.

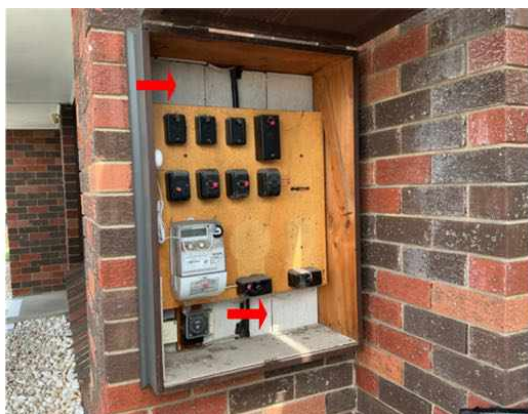
Building: Main Building
Location: Electrical Switchboard
Finding: Asbestos suspected
Information: Many areas of suspected asbestos containing material were found throughout the property as shown in photos. Reporting on Asbestos is outside the Scope of this Report. This suspected defect is highlighted as a caution only. We suspect, based on our experience in the building industry, that there is a higher risk of the identified building elements containing asbestos.

In the interim, the client is advised to act with caution, especially when considering any damage to building materials, general wear and tear, renovations, extensions, demolition and general maintenance activities due to the suspected presence of Asbestos.

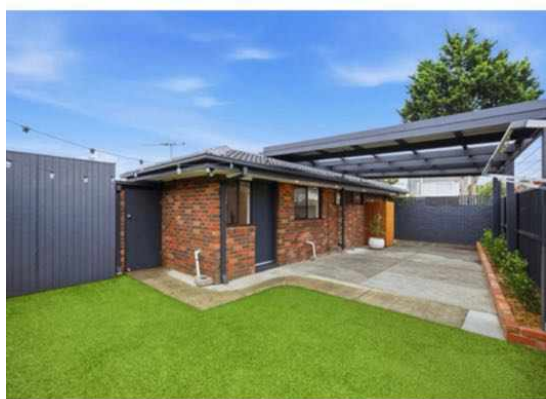
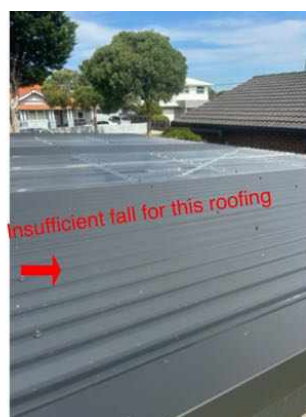
Building:	Main Building
Location:	Electrical Switchboard
Finding:	Additional structure built without a permit (Suspected)
Information:	The pergola structure on the left side of the house is suspected to have been constructed without a building permit. A building permit would be required for the structure.

It is highly advised to request that the current owner provide a Defect report (Owner Builder/Section 137b) for this structure. This would involve a structural engineer or a licenced building surveyor conducting an inspection of the structure and advising of any defects and/or areas of non-compliance in accordance with the current building codes. The current owner should then attend to any issues on this report prior to settlement.

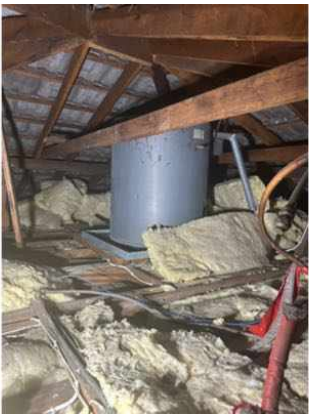
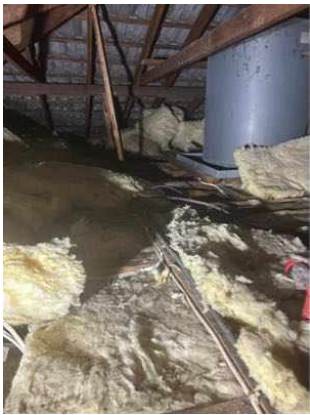
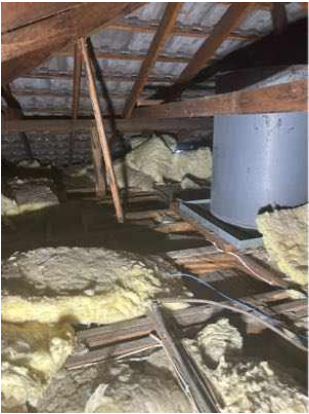
Building:	Main Building
Location:	All Areas
Finding:	Gravity-Fed HWS - Disconnected
Information:	It was noted at the time of inspection that a disconnected gravity-fed hot water system (HWS) remains in this area.

Despite this plumbing structure being unused, it is likely to be storing residual water, and is therefore susceptible to rust and corrosion. If allowed to continue, rust and corrosion is likely to lead to damage to adjoining building elements, and may also make the area susceptible to termite or timber pest activity.

While it is a costly exercise to remove the disused gravity-fed HWS, it is advisable in the short-term future to prevent any further damage to the area. Further consultation with a licensed plumber is required to gain further advice on removal of the structure.
