Building and Timber Pest Inspection Report

Inspection Date: Wed, 25 Mar 2026

Property Address: 5 Kuraji Close, Glenmore Park NSW 2745

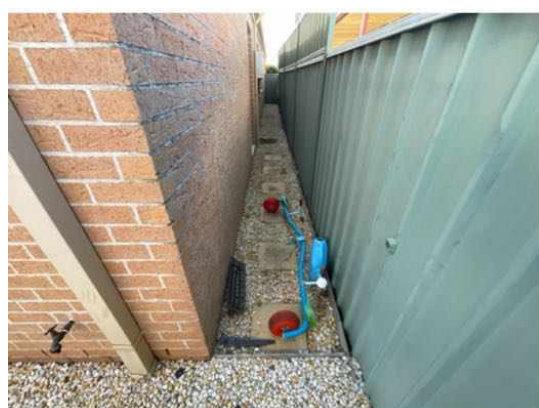
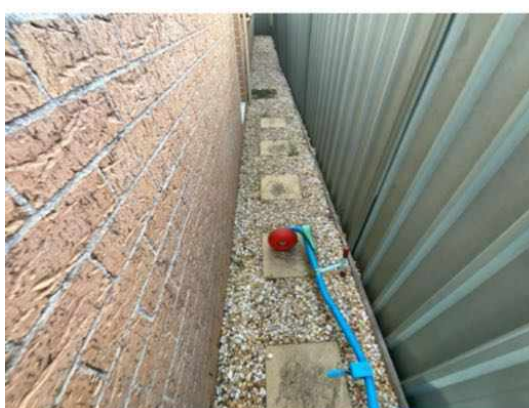
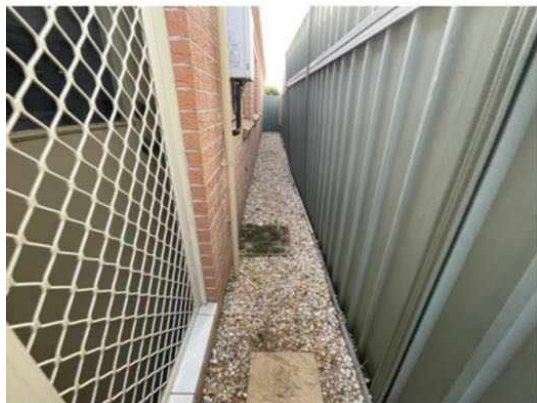
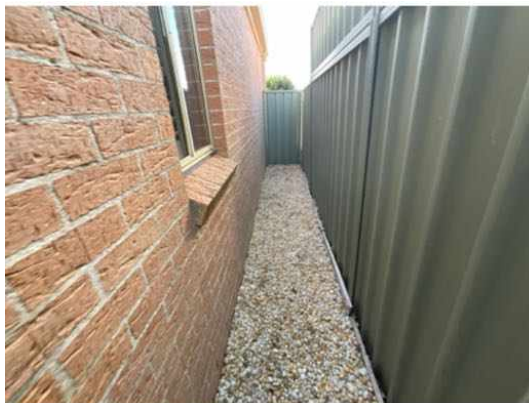
Building: Main Building
Location: Exterior - left side
Finding: Minor Defect – Site/Yard Drainage
Information:

Site drainage in the inspected areas appears to be below average, with no surface drains observed at the time of inspection. Ground surfaces adjacent to the building do not appear to be adequately graded to facilitate effective surface water runoff, however, should be monitored during periods of heavy wet weather as the area currently appeared to be mostly dry.

Failure to meet these minimum drainage falls increases the risk of water ingress, foundation issues, and secondary building defects.

- A licensed plumber and/or landscaping contractor should be engaged to:
 - Evaluate the current site grading and surface runoff conditions
 - Install or upgrade surface water drainage (e.g. strip drains, spoon drains, grated channels) as required
 - Improve grading around the building to ensure water flows away from the structure

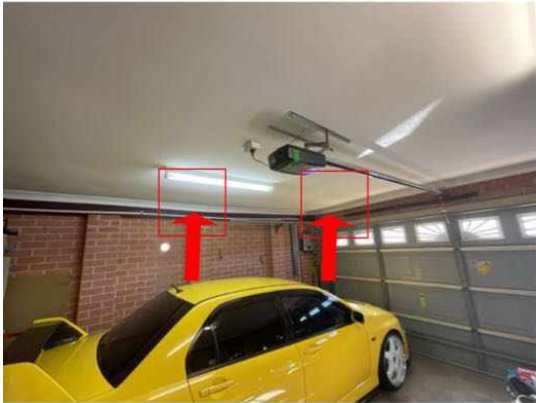
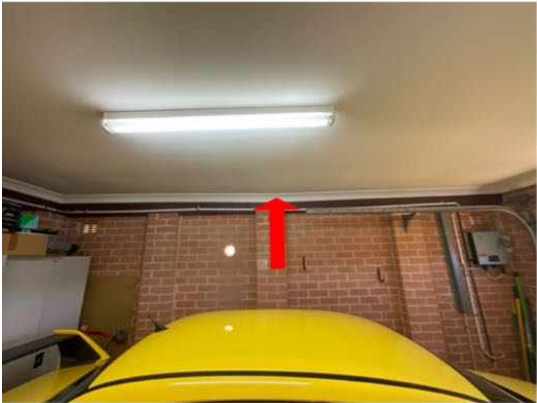
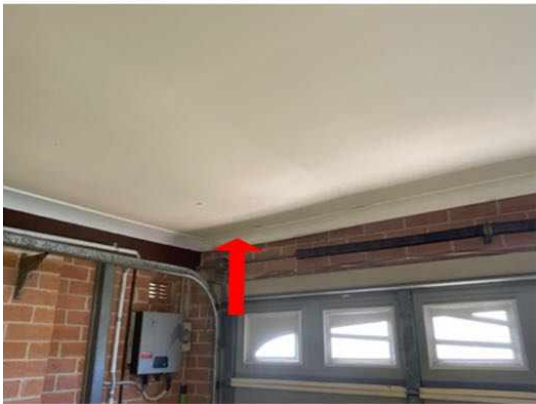
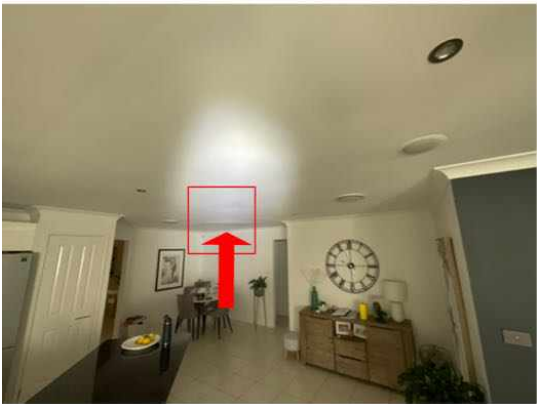
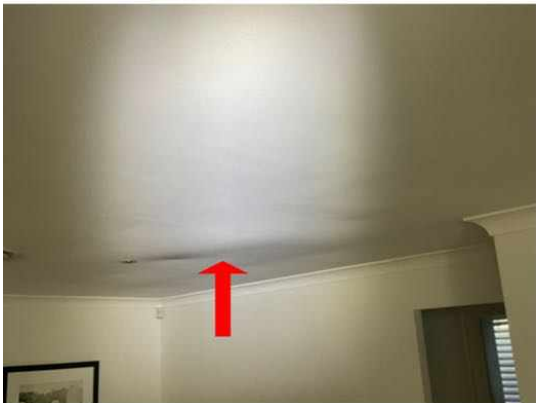
Finding 3.02

Building:	Main Building
Location:	Garage & Dining
Finding:	Ceiling Linings – Localised Sagging
Information:	Observation:

During the inspection, isolated sections of ceiling linings were observed to be uneven and exhibiting sagging, particularly within the garage and dining areas. This condition is relatively common in garage environments and is typically associated with general age-related wear and tear. Contributing factors may include deterioration of original fixings (e.g. nails, screws, or adhesive), as well as exposure to moisture or humidity, potentially exacerbated by inadequate or deteriorated paint coatings.

At the time of inspection, the condition is considered minor and does not appear to affect the immediate structural integrity of the ceiling. However, if left unaddressed, continued deterioration may occur. Progressive sagging can lead to loosening or partial detachment of ceiling sheets, as well as cracking along joints or edges, particularly in areas subject to fluctuating environmental conditions.

It is recommended that the affected areas be monitored and repaired as required. Rectification may involve re-fixing and/or re-gluing ceiling sheets to the supporting framework, typically undertaken by a qualified plasterer or suitable tradesperson. Application of appropriate moisture-resistant coatings may also assist in prolonging the service life of the ceiling, particularly in garage areas.

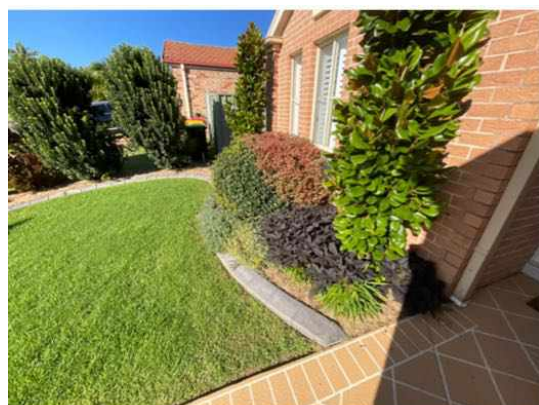
Garden beds were observed directly against the perimeter of the building. This condition can result in water pooling or retention during rainfall or from regular watering/hosing, which may lead to moisture ingress beneath the structure.

- Persistent moisture buildup around the base of the building creates an environment that is conducive to termite activity and timber decay.
- Plants and vegetation close to or in contact with external walls can provide shade and cover, further increasing the likelihood of termite infestation.
- Garden beds may also conceal weep holes, slab edges, or termite barriers, reducing visibility during inspections and allowing for undetected termite entry.

It is strongly recommended that garden beds be removed or relocated away from the building perimeter. Maintaining a clear inspection zone around the structure helps reduce moisture retention and improves visibility during regular pest inspections. This preventative measure significantly lowers the risk of termite ingress and related structural damage.

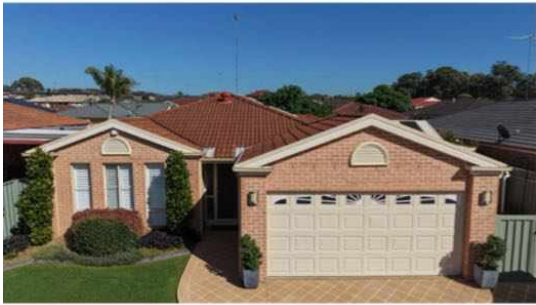
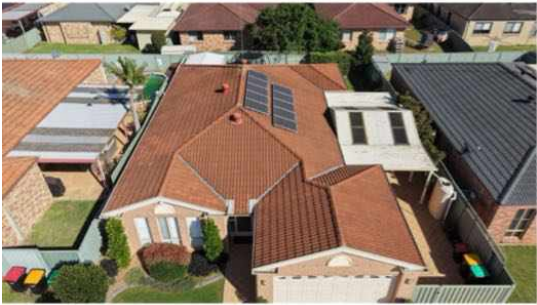
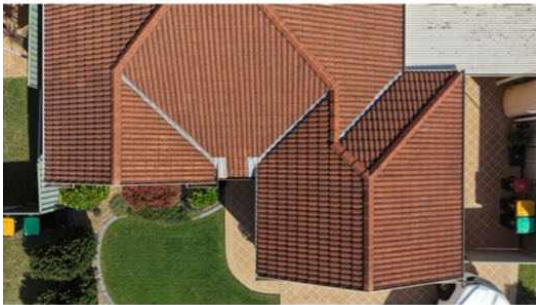
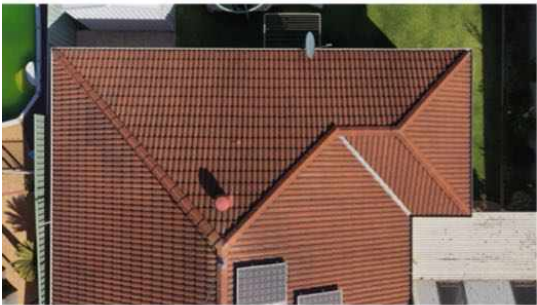
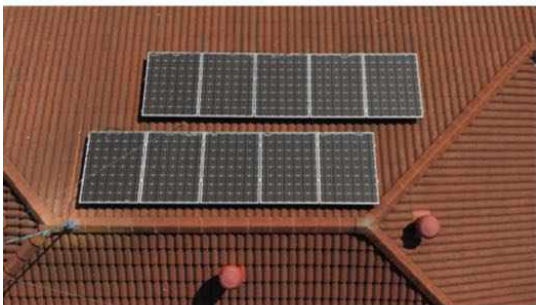
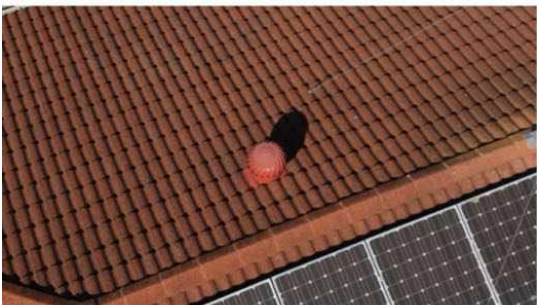
Building: Main Building
 Location: Roof Exterior
 Finding: Roof Tile Assessment

The tiled roof covering was assessed as being in generally sound and serviceable condition at the time of inspection, with no evidence of active leaks observed.

Ongoing maintenance is essential and should include periodic cleaning of gutters and valleys, as well as monitoring and maintenance of ridge pointing and roof penetrations, to ensure continued performance and longevity of the roofing system.

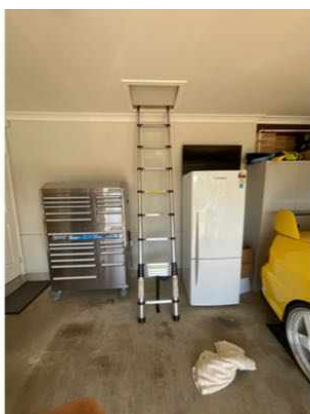
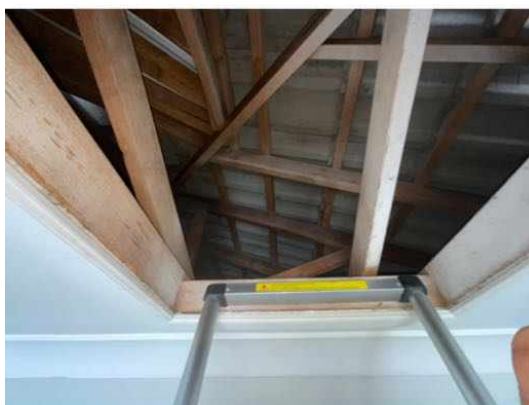
Building: Main Building
Location: Roof Void
Finding: Roof Void – Limited Accessibility..
Information: Observation:

Installation of an additional manhole is recommended to facilitate a re-inspection and enable a more thorough assessment of the roof void in the future. This will help ensure that all structural elements and concealed areas are properly evaluated.

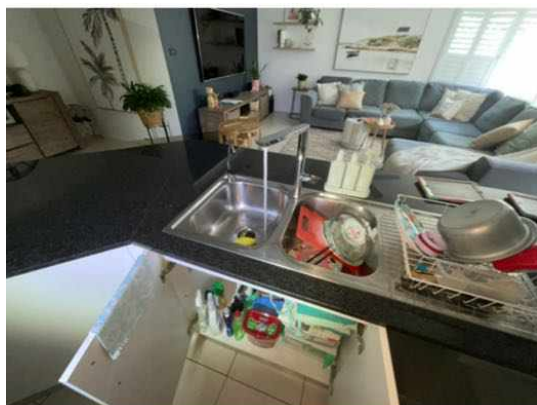
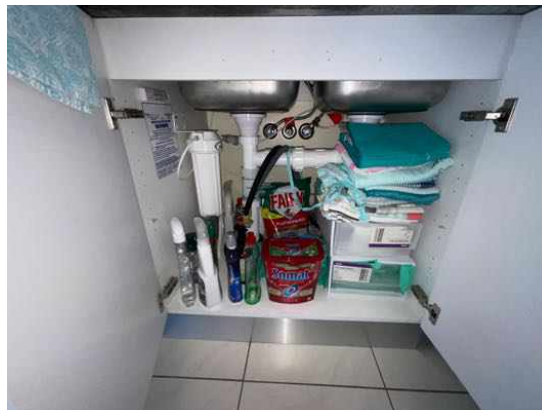
Building: Main Building
 Location: Kitchen
 Finding: Kitchen Sink – Overall Condition & Recommendations.
 Information: Observations:

- Further monitoring and testing are recommended once the tap(s) are in constant use, to identify any drainage issues or signs of slow leaks not evident during the limited inspection.
- It is recommended that the stored items beneath the sink be removed to allow for a full re-inspection of the plumbing and cabinetry, ensuring no concealed defects are present.

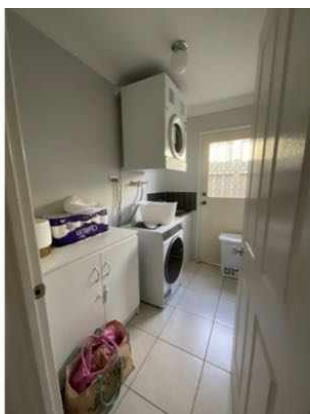
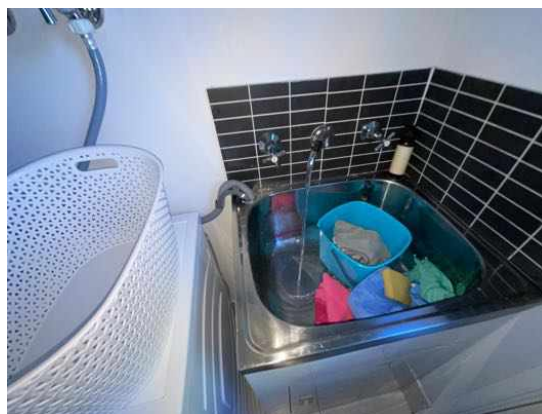
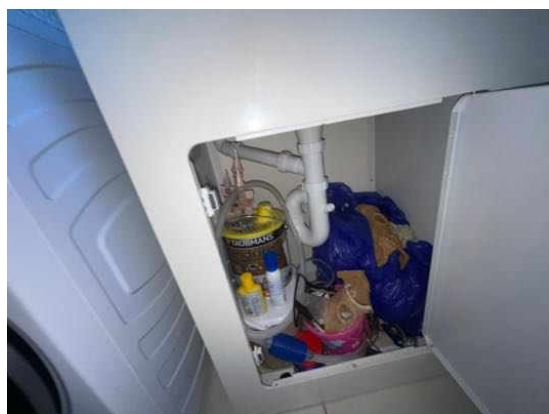
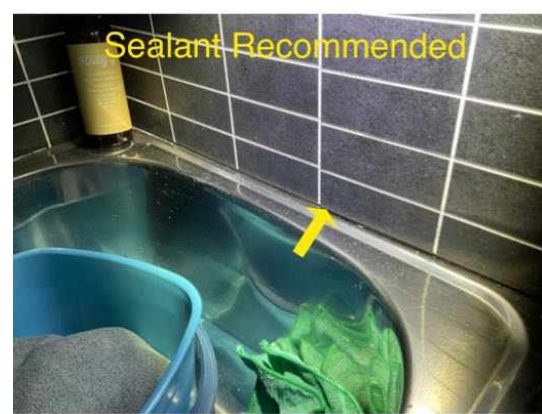
Building: Main Building
 Location: Laundry
 Finding: Laundry - Taps/Plumbing/Drainage.
 Information: Observation: Laundry Tub – Taps, Plumbing, and Cabinetry

- Further monitoring or testing is recommended once the taps are placed into regular use, to ensure no leaks develop over time and that the drainage system continues to perform adequately.
- Flexible and mould-resistant sealant should be applied to junctions between the basin and the wall to prevent water ingress that may lead to damage.
- Regular maintenance and prompt replacement of missing or deteriorated sealant is highly recommended, as this is a common wear-and-tear issue.
- Sealant and grouting in wet areas should be maintained as part of the long-term care and upkeep of the property.
- A sealant specialist or qualified tiling contractor should be appointed to carry out remedial sealing works.
