Building and Timber Pest Inspection Report

Inspection Date: Mon, 16 Mar 2026

Property Address: 48/120-124 Cabramatta Rd E, Cabramatta
NSW 2166, Australia

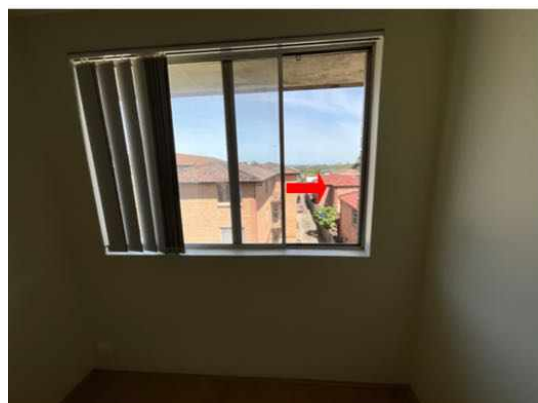
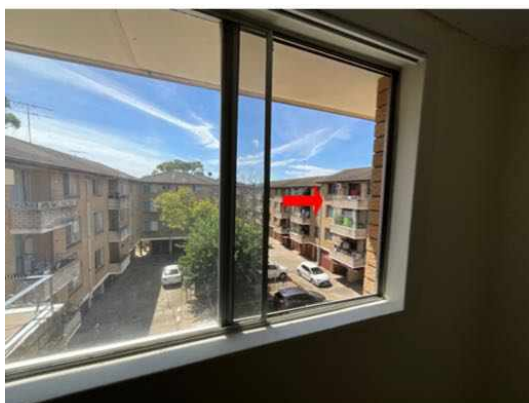
Building:	Main Building
Location:	Windows
Finding:	Window restrictions - Missing
Information:	Window restrictors were found to be missing.

The window safety device standards can be found in clause 30 of the Strata Schemes Management Regulation 2016, and are based on National Construction Code (NCC) requirements that were introduced in 2013. The NCC requirements apply to all openable bedroom windows in residential buildings, including hotels, motels and for all windows in early childhood centres.

Windows need to be locked at 12.5cm when the devices are engaged. The safety devices must be robust and child proof. The alternative is security screens such as bars or grills on the windows so long as they have gaps no bigger than 12.5cm. Flyscreens do not comply unless they are the reinforced security type and capable of resisting the very strong outward pressure which would prevent a child falling through. The laws apply to openable windows in a building within 1700mm of the internal floor and if the internal floor is more than 2m above the ground floor outside.

Windows lack appropriate child locks, creating a safety hazard. Window restrictors must be installed on these Windows immediately for added safety.

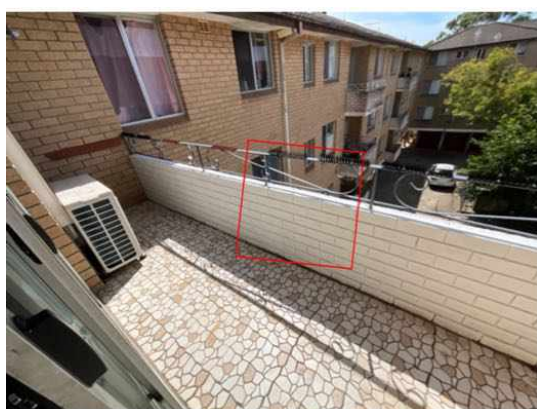
Finding 1.02

Building:	Main Building
Location:	Balcony
Finding:	Balustrade - Suspected Non-Compliance
Information:	The balustrade was measured and found to be less than the present building regulation requirement of 1000mm high. Additionally the gaps between the balustrade cladding

were found to be greater than the present building regulation requirement of 125mm.

This defect creates a potential safety hazard and should be rectified as soon as possible to ensure the safety of the area and to meet present building standards and regulations.

The balcony balustrade was found to be non-compliant, requiring immediate rectifications by a licensed builder.

A licensed builder should be contacted to discuss possible rectification solutions.

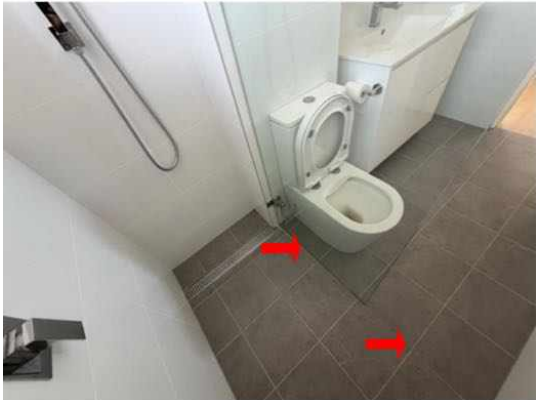
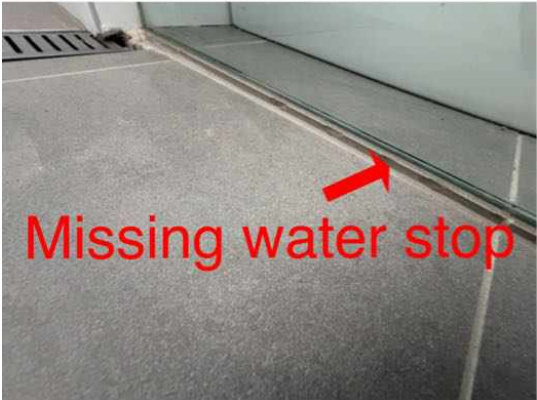
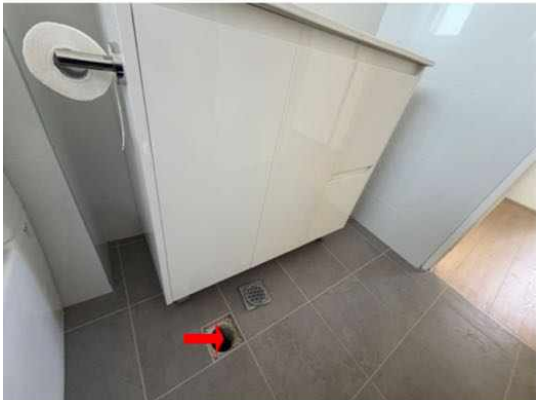
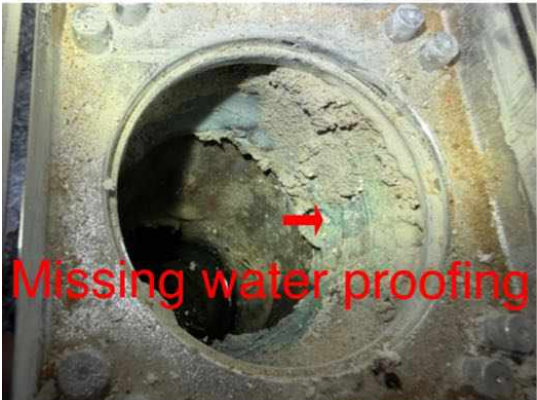
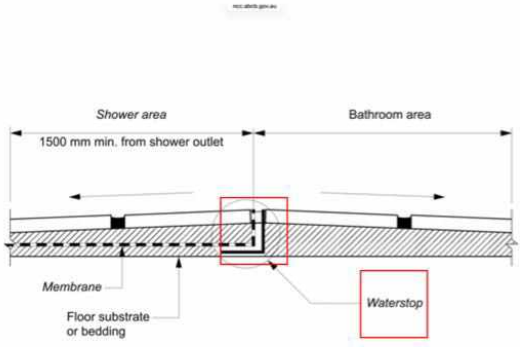
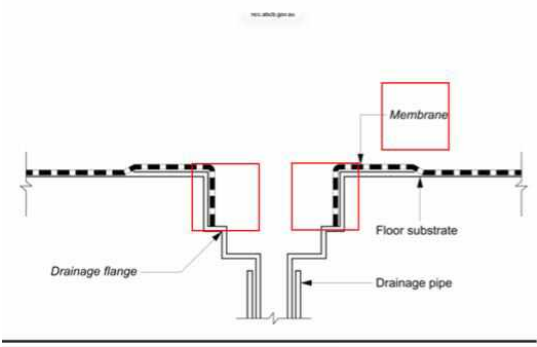
Finding 2.01

Building:	Main Building
Location:	Bathroom
Finding:	Shower waterproofing / water stop - Missing (AS3740)
Information:	The shower area does not appear to have a water stop installed at the floor threshold, and no visible waterproofing termination was observed at the floor waste/drain penetrations.

It is suspected that the bathroom renovation is not compliant to AS3740 and appears to have been completed to a substandard level. Where work is not completed satisfactorily, accelerated deterioration of the associated building elements is likely to occur and secondary defects to surrounding structures may develop.

The absence of a water stop may allow water to escape from the shower area into the surrounding bathroom floor, and inadequate waterproofing at the drain penetrations may permit moisture ingress into the subfloor or slab.

These conditions are not consistent with the intent of AS 3740 - Waterproofing of Domestic Wet Areas, which requires appropriate water stops at shower thresholds and proper waterproofing and sealing at penetrations.

The bathroom renovation does not appear to comply to AS3740. Water stop was not noted to the shower and furthermore waterproofing was not identified to the floor waste penetration. A bathroom specialist must be appointed urgently for assessment and rectifications. Major works should be expected.

A bathroom specialist should assess the works and undertake rectification works as necessary to reduce the risk of water ingress and any associated damages. Major works should be expected.

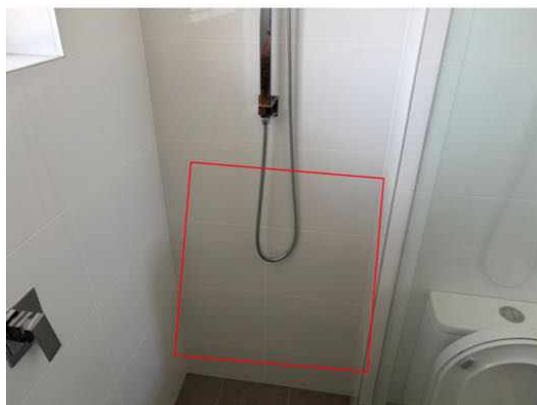
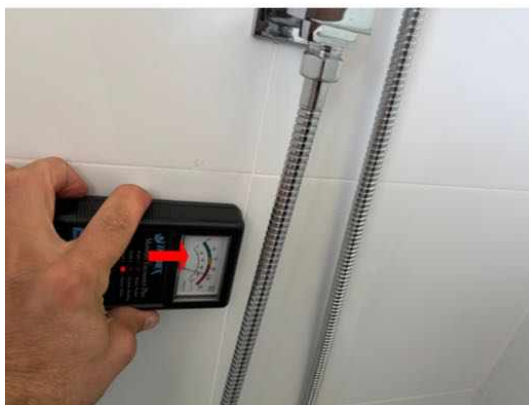
Finding 2.02

Building: Main Building
Location: Bathroom

Finding: Water leak - Suspected
Information: A water leak is suspected in this area as excessive moisture was detected at the time of inspection. Another potential cause maybe moisture ingress behind the tiles from around the wall fittings and penetrations.

Internal water leaks can be detrimental to surrounding building elements; their potential causes include damage to plumbing fittings and fixtures, through to water damage and deterioration of associated building elements.

Attracting termites, corrosion, mould, decay and water damage are potential outcomes where a minor water leak is left unattended. More serious defects may also result, such as electrical hazards, or water damage to structural building elements.

Excess moisture was also identified to the ensuite shower, but also to the surfaces behind the shower. Water damages were also evident, indicative of an internal water leak. A bathroom specialist must be appointed urgently for further assessment and rectifications.

In extreme cases, structural damage may develop due to a prolonged water leak. It is highly advised that internal water leaks be addressed by a licensed plumber as a matter of relative urgency.

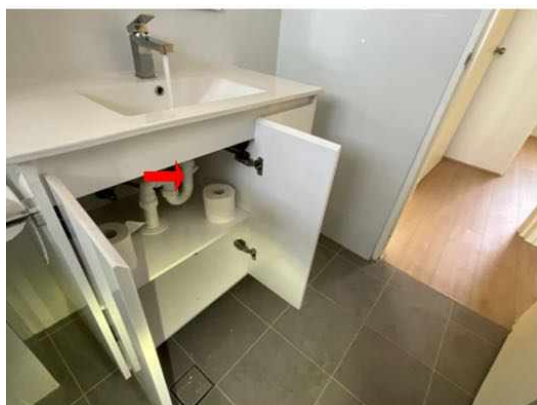
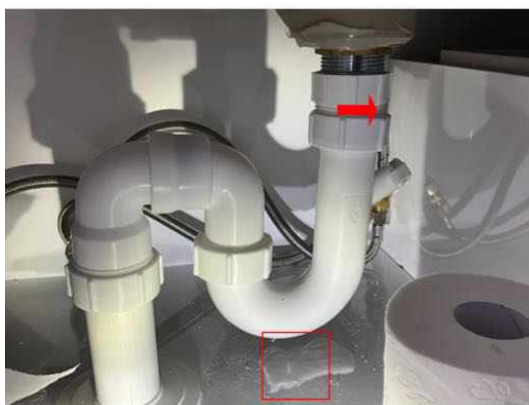
Finding 3.01

Building: Main Building
Location: Bathroom
Finding: Water leak - Active
Information: Generally, water leaks occur when a particular area of the property is not weather or water tight. As the surrounding area was found to be damp at the time of inspection, the leak is considered ongoing and hence requires urgent action.

Regardless of the location, even minor leaks that are left unmanaged can lead to serious damage of associated building elements and result in the need for replacement of building materials. Mould and other hazards such as electrical hazards may also arise if the leak is left to develop.

It is highly advised that the cause of the leak be identified and resolved immediately by

a licensed plumber to prevent any further damage. Depending on the extent of the damage previously sustained, repair and/or replacement of any affected building materials may be required.

- Repair water leak under the bathroom wash basin

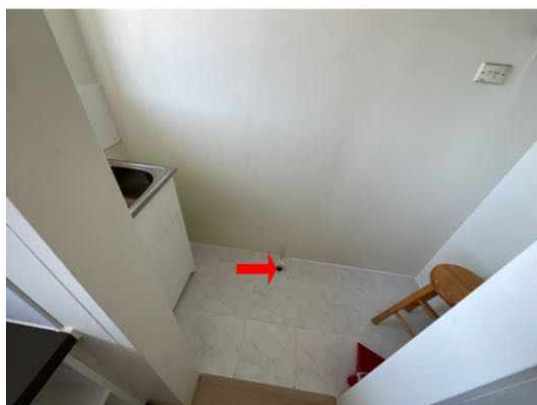
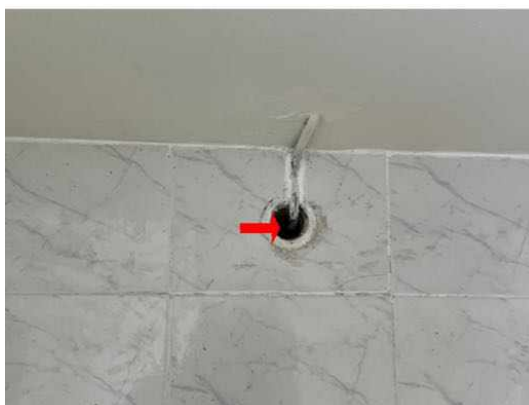
Finding 3.02

Information: At the time of inspection it was noted that connections between above ground pipe work and below ground sewer/storm water systems were incomplete.

Additionally, where sewer pipes are concerned, gases can escape from unsealed connections which can pose a serious health risk.

Engagement of a certified plumber is strongly recommended to ensure all connection points are sealed in accordance with the plumbing construction guidelines.

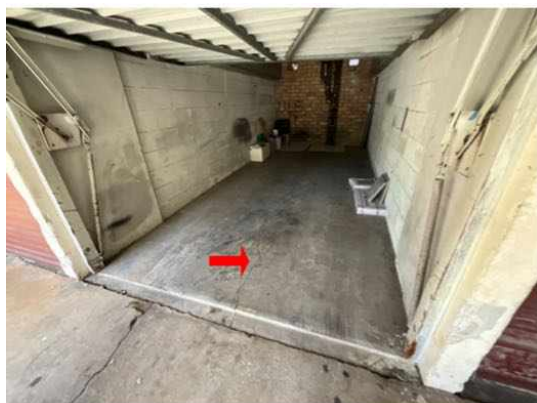
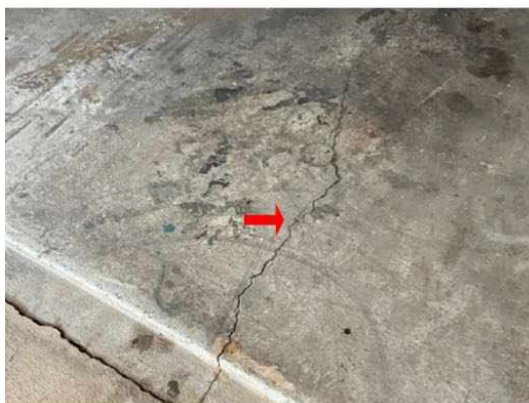
Finding 3.03

Building: Main Building
 Location: Garage
 Finding: Crack in concrete slab - Category 1
 Information: A crack coded as Category 1 was identified in the slab. A Category 1 crack is described as a fine but noticeable crack, with the slab at an otherwise reasonable level.

To be considered Category 1, the approximate width of the crack is less than 1.0mm, or a less than 10mm change in offset when a 3m straight edge is placed over the defect.

Category 1 cracks should be monitored for a period of 12 months. At the end of the monitoring period, identified cracks that are rated greater than Category 2 are considered defects, and require rectification.

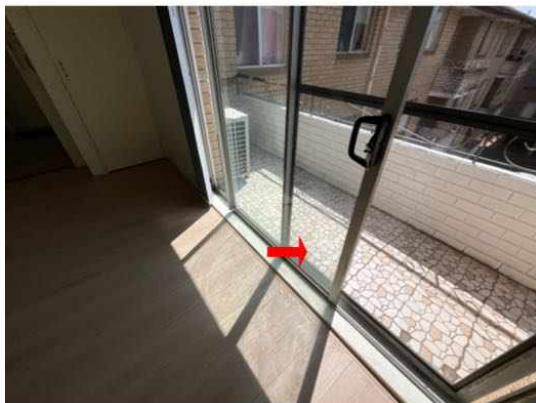
Finding 3.04

Building: Main Building
 Location: Balcony
 Finding: Door - Stiff to slide
 Information:

The door in this area was jammed and difficult to slide along the associated tracks at the time of the inspection. Restricted function of the affected door may pose as a potential safety hazard if required for emergency egress from the building.

Generally, factors such as general age of the building element and a lack of maintenance are the usual causes for this type of defect.

Replacement of door hardware or tracks may be required, as well as minor repairs and cleaning. A registered builder will be required to repair the affected doors.

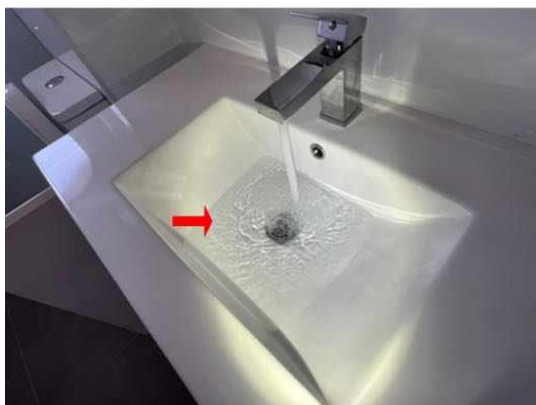
Finding 3.05

Building: Main Building
 Location: Bathroom
 Finding: Sink/basin - slow draining
 Information:

The sink/basin drain appeared to be partially blocked at the time of inspection. Blockages here are usually caused by hair and other debris. If left unmanaged, a lack of general maintenance may lead to the development of more significant defects, such as water damage to surrounding building materials.

A licensed plumber should be appointed to remove the blockage at the client discretion.

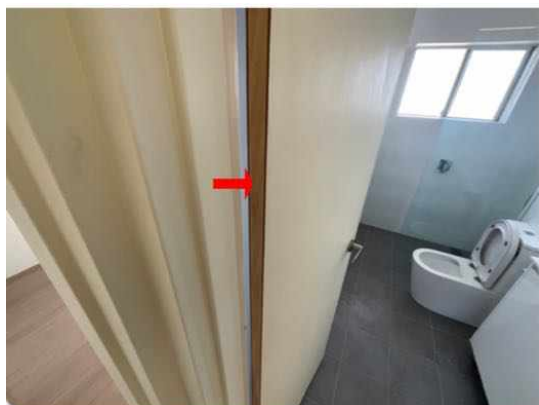
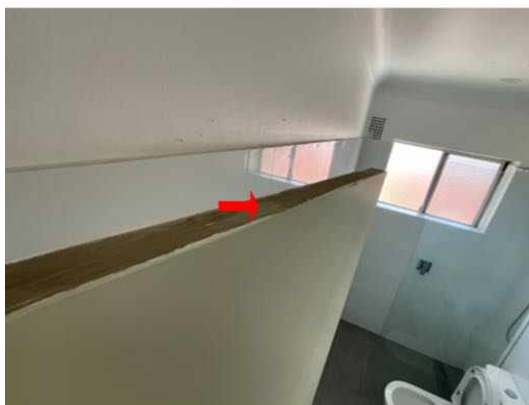
Finding 3.06

Building: Main Building
 Location: Bathroom
 Finding: Paint finish - Incomplete
 Information: The paint finish in this area was identified as being incomplete at the time of inspection.

Whilst incomplete or missing paint finish is generally an appearance defect, it can also lead to the development of secondary building defects over time. Incomplete areas of

paint finish expose the area to moisture, potentially accelerating the deterioration of underlying building materials.

Incomplete paint finishes should be sanded back, filled, leveled and painted, as applicable. Where inadequate or missing paint protection has led to the deterioration of the associated building element, repair and/or replacement of this building element may be required.

A painting contractor should be appointed as soon as possible to perform necessary works to aid the appearance of the affected area and to ensure the area is protected against further deterioration. Alternatively, the homeowner following manufacturer instructions may perform these works.

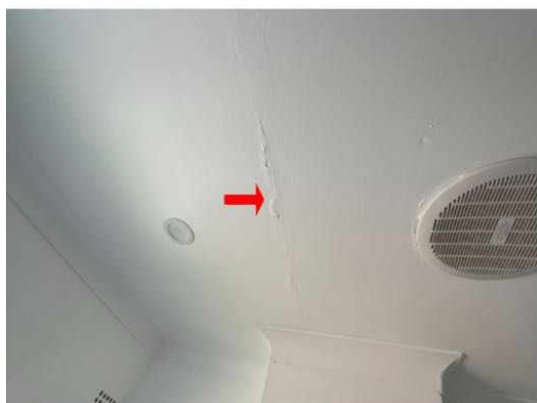
Finding 3.07

Building:	Main Building
Location:	Bathroom
Finding:	Incomplete or substandard works
Information:	The works to this area appear to be incomplete or have been completed to a substandard level.

Works that have not been completed to a satisfactory level create potential for the development of building defects and may impede on the safety and integrity of the overall structure.

It is highly recommended that the relevant trades be appointed to complete these works and ensure the safety of the area and the longevity of all associated building elements.

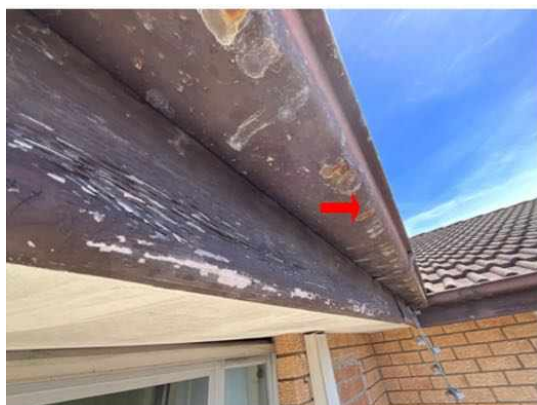
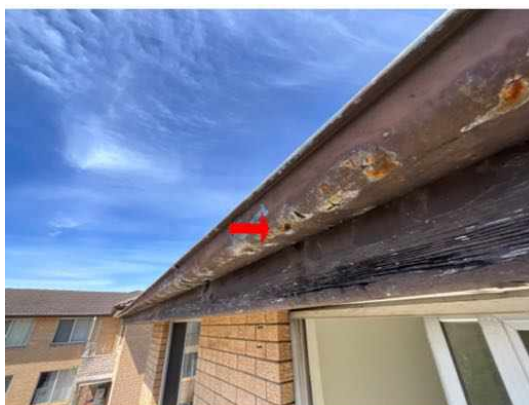
Finding 3.08

Building:	Main Building
Location:	Gutters
Finding:	Roof plumbing - Rusted or corroded
Information:	The roof plumbing has areas of rust and corrosion. It is suspected that this has been caused by blockages, resulting in pooling or standing water, that have prematurely rusted elements of the roof plumbing.

Rusted roof plumbing will generally develop holes and leaks that can affect other building elements with poor drainage of storm water. Poorly drained roof areas will also lead to damp conditions surrounding the base perimeter of the building which, if left unmanaged, can lead to a range of secondary building defects.

Repair and/or replacement of rusted roof plumbing is highly required in order to reinstate the roof drainage system to a fully operational level. To further maintain these areas, gutters should be cleaned frequently, allowing the avoidance of any partial blockages.

A licensed plumber or specialist roof restoration company should be appointed to undertake these works. It is advised that such works be completed as soon as possible to prevent any further damage and deterioration.

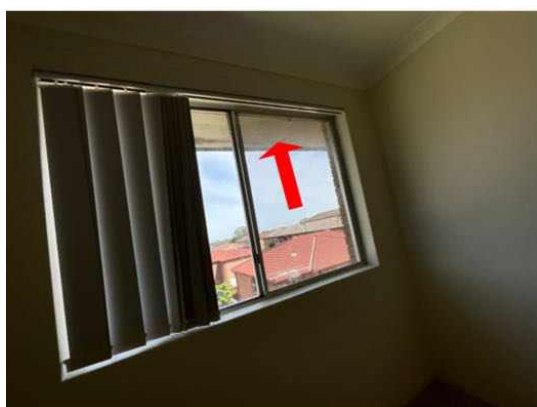
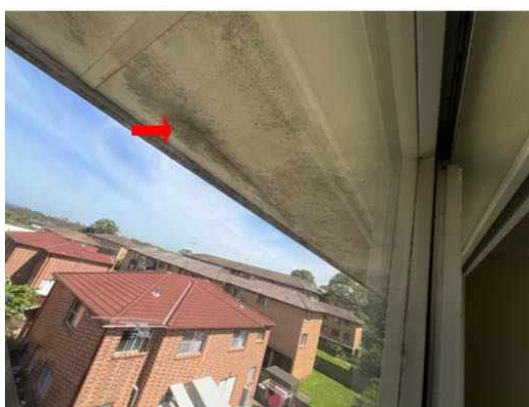
Finding 3.09

Building: Main Building
 Location: Eaves
 Finding: Eaves — Mould Present
 Information: Where evidence of mould growth was noted, there may be environmental, biological or health issues associated with the report. A possible cause could be excess moisture due to overflow of stormwater from the gutters as a result of gutters being blocked.

Generally, the client is advised to ensure that the general environment is free of moisture and humidity to aid in the prevention of mould formation and development. Any mould found during the inspection should be cleaned immediately by a cleaning contractor or the homeowner as applicable.

The client is advised to ensure the gutters are always maintained and free of debris.

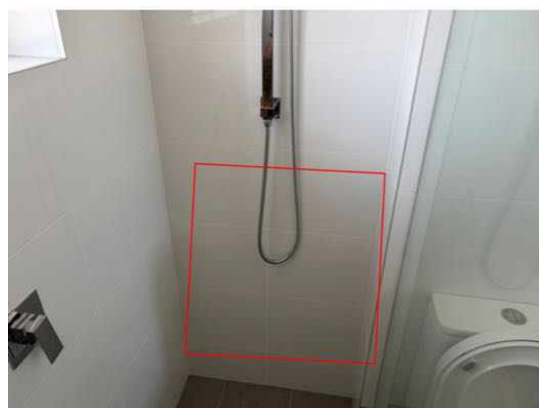
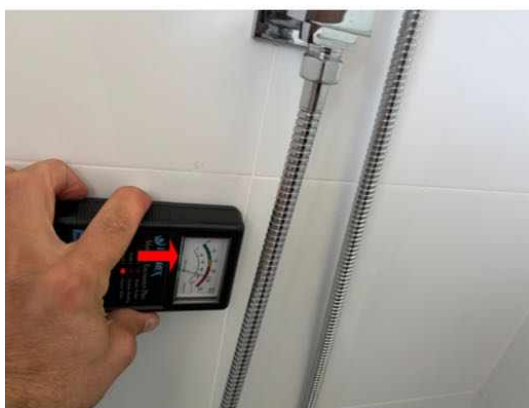
Building: Main Building
 Location: Bathroom
 Finding: Water leak - Suspected
 Information: A water leak is suspected in this area as excessive moisture was detected at the time of inspection. Another potential cause maybe moisture ingress behind the tiles from around the wall fittings and penetrations.

Internal water leaks can be detrimental to surrounding building elements; their potential causes include damage to plumbing fittings and fixtures, through to water damage and deterioration of associated building elements.

Attracting termites, corrosion, mould, decay and water damage are potential outcomes where a minor water leak is left unattended. More serious defects may also result, such as electrical hazards, or water damage to structural building elements.

In extreme cases, structural damage may develop due to a prolonged water leak. It is highly advised that internal water leaks be addressed by a licensed plumber as a matter of relative urgency.
