# Building and Timber Pest Inspection Report

Inspection Date: Tue, 20 Jan 2026

Property Address: 7 Brookside St, Upwey VIC 3158, Australia

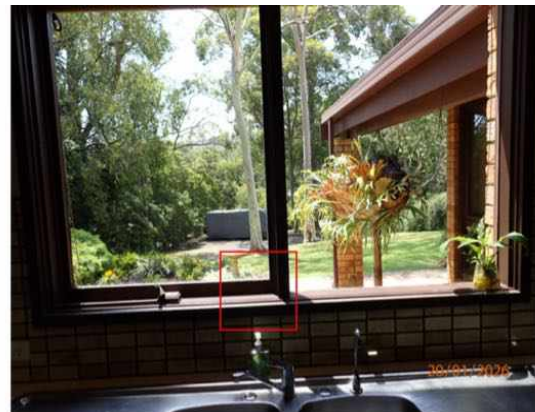
Building: Main Building  
 Location: Kitchen  
 Finding: Window - Cracked  
 Information: Cracks were noted in the installed windows during inspection, posing both safety and structural concerns. Cracked windows increase the risk of shattering and may compromise the security and weather tightness of the property.

If left unaddressed, the cracks could allow moisture infiltration, leading to potential water damage and mold growth around the window frame and nearby walls.

Engage a qualified glazier to assess the damage and determine whether repair or replacement of the window pane is necessary to restore safety and weather resistance. Prompt action is advised to prevent further deterioration.

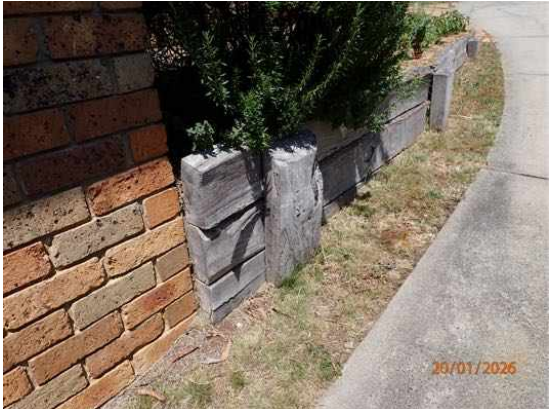
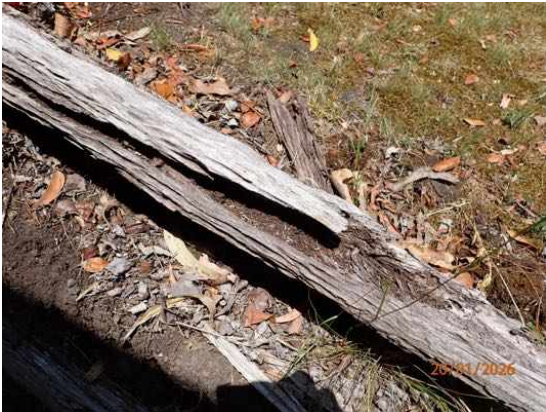
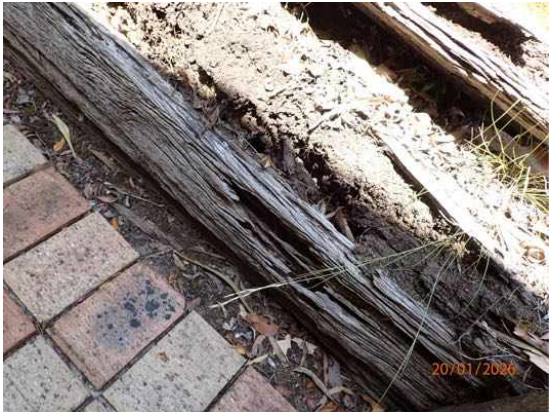
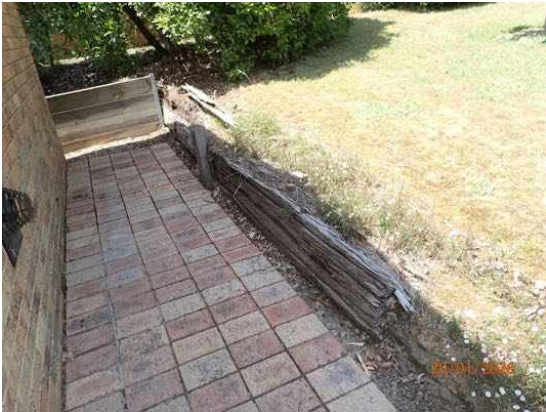
#### Finding 3.02

Building: Main Building  
 Location: All External Areas  
 Finding: Retaining wall - Defective  
 Information: The retaining wall in this area was found to be defective at the time of inspection.

Generally, defective retaining walls are caused by poor original design or material use. However, deteriorated retaining walls may also be a result of substandard construction, poor site drainage or unmanaged stormwater flows.

If left unmanaged, the retaining wall may become a safety hazard if it continues to destabilise. Where retaining walls further rot and decay, an environment is created that is conducive to termite and pest infestation.

Significant repair and replacement should be expected. Where retaining walls are considered structural walls, a structural engineer / surveyor should be consulted regarding required remedial works. Otherwise, a landscaper or retaining wall installer may be appointed to repair or replace the wall, at the discretion of the client.

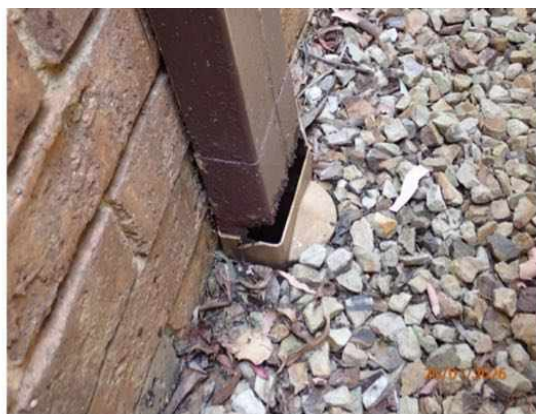
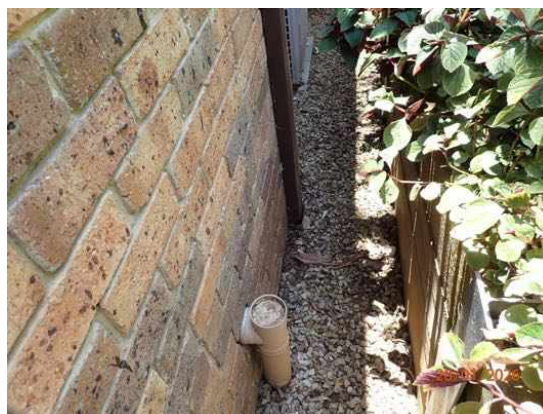
### Finding 3.03

Building:	Main Building
Location:	Exterior walls - left side
Finding:	Down pipe - Rusted or corroded
Information:	This down pipe shows evidence of rusting and corrosion, which is likely to have developed as a result of excessive exposure to moisture and or inadequate coatings.

As surface rust provides no protection to the underlying iron, the deteriorating condition is likely to worsen if not addressed in the short-term future.

Where possible, the use of galvanized (treated) metals or aluminium coated metals aid in rust prevention, as does regular general maintenance. Rust formation can be controlled with coatings, such as paint, that isolate the iron from the environment.

Rusting and corrosion should be managed by ideally removing or limiting the affected surface from exposure to moisture. A registered builder may be appointed to replace any building elements that have been severely affected by rust or water damage.

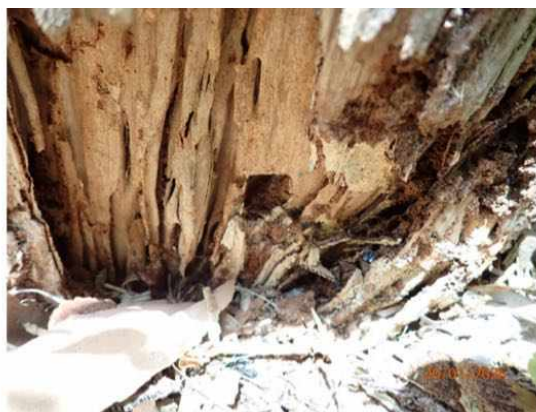
Building:	Main Building
Location:	Exterior walls - front
Finding:	Evidence of termite damage - minor
Information:	Despite no live termite or timber pest activity being indicated, previous termite damage was found to have affected this area. This damage is considered to be inactive and is minor in nature.

It is advised that the area be visually inspected frequently to ensure that the condition of affected building materials does not worsen. At the time of inspection, damage is not structural and is only considered to be superficial.

A building contractor may be appointed to provide a further invasive inspection if further damage is evident.

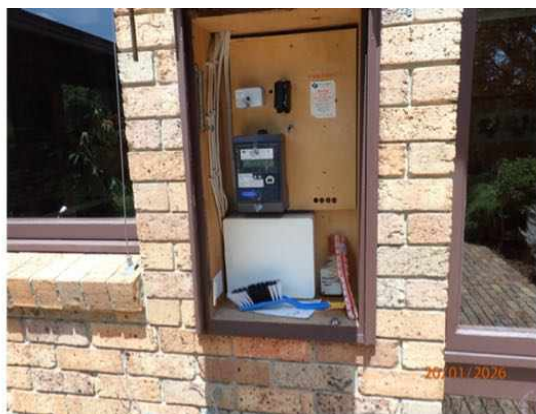
### Finding 6.01

Building:	Main Building
Location:	Meter Box
Finding:	Termite Management System - no evidence of a chemical installation
Information:	The application of a post-construction chemical termite barrier is highly recommended for all properties, particularly if live termite activity has been found on the site previously. Such barriers are highly effective in preventing termite attack on any timber building elements throughout the property.

A durable notice should be placed in the switchboard unit to indicate current termite barriers. At the time of inspection, it appeared as though no termite management system has been installed, with no evidence to suggest preventative works taking place.

The client may consider gaining further advice from a pest controller as to the costs and procedures involved with this application. It is recommended that obtaining such advice be a short-term priority.

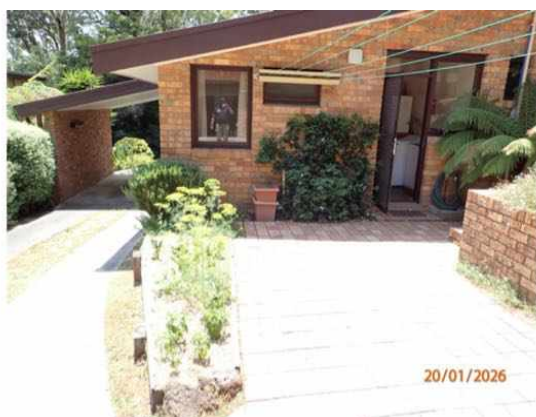
### Finding 6.02

Building:	Main Building
Location:	All External Areas
Finding:	Garden Beds - Conditions Conducive to Termites
Information:	Garden beds were found to be evident abutting the external walls of the property. These garden beds can include untreated timber, and with a combination of moisture from watering hosing can make conditions conducive to termite activity and termite ingress.

It is recommended that the property owner be vigilant in reducing conducive conditions around the property where possible. If conducive conditions are present and not removable periodically inspections should be conducted by a licensed pest controller.

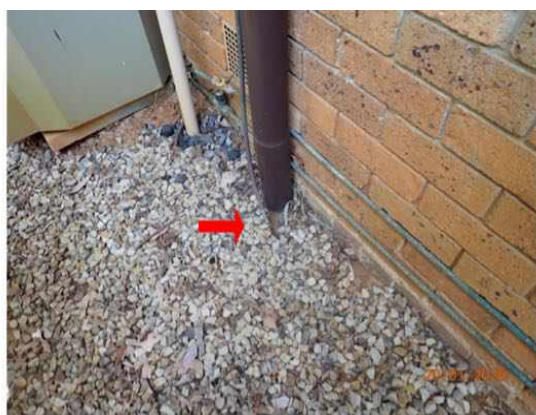
### Finding 6.03

Building:	Main Building
Location:	All External Areas
Finding:	HWS Overflow - Not Connected
Information:	The Hot Water System (HWS) overflow was found to be disconnected from storm water drainage and is creating excessive moisture in the surrounding area.

These damp conditions can lead to secondary defects such as rot, rust or corrosion of associated building elements, the formation of fungal decay, or even the creation of potential slip hazards. When coupled with poor site drainage, pooling of water may also attract termite activity to this area.

It is highly recommended that a licensed plumber be appointed to connect the HWS overflow in order to prevent such an environment from being created. These minor works should be carried out as soon as possible.

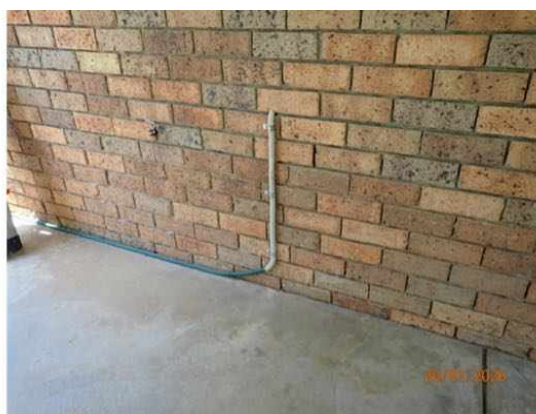
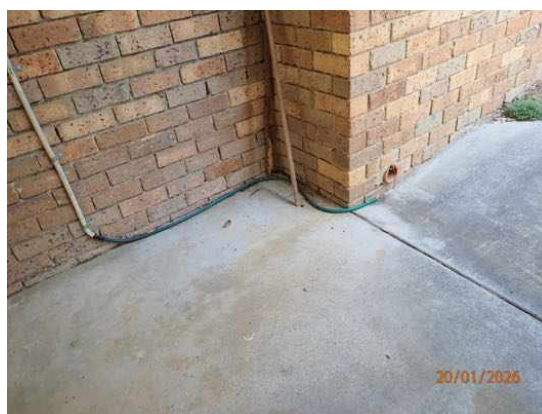
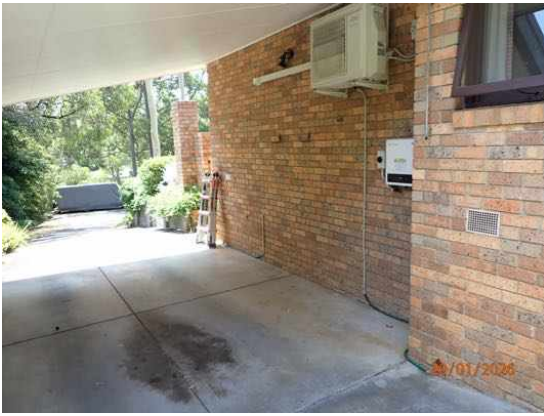
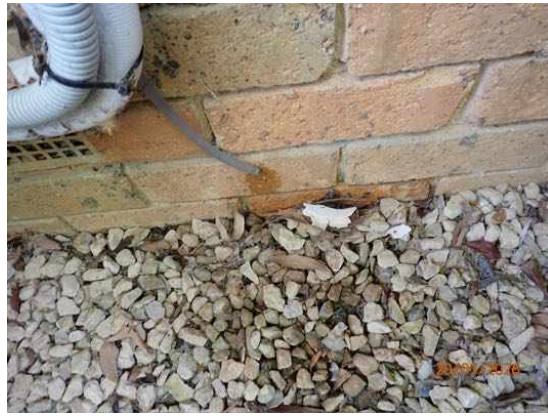
**Finding 6.04**

Building: Main Building  
 Location: All External Areas  
 Finding: Air condition discharge - Not plumbed for drainage  
 Information: The Air condition discharge is not plumbed or connected to suitable drainage, which has resulted in the surrounding area becoming excessively damp. These damp conditions can lead to secondary defects such as rot, rust or corrosion of associated building elements, the formation of fungal decay, or even the creation of potential slip hazards. When coupled with poor site drainage, pooling of water may also attract termite activity to this area. It is highly recommended that a qualified plumber be appointed to install adequate drainage to the overflow. These works will ensure that the area remains dry and free of any secondary defects.

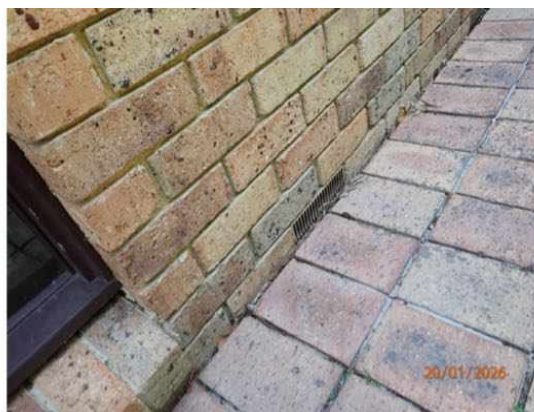
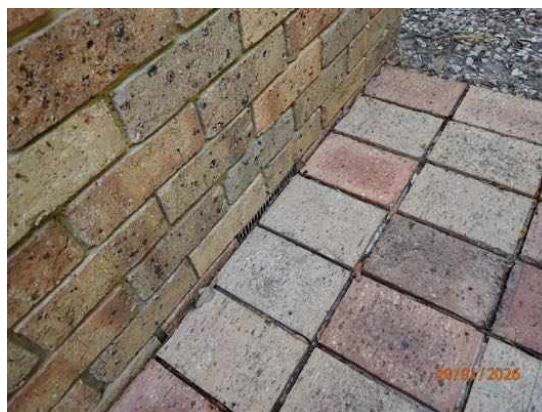
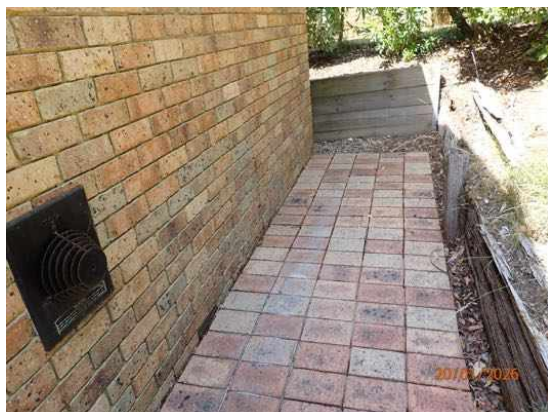
### Finding 6.05

Building:	Main Building
Location:	Exterior walls - front
Finding:	Bridging and Concealment of vents – Timber Pest Conducive Condition
Information:	Bridging occurs when termite barriers or inspection zones are spanned by materials such as soil, paving, or garden beds, allowing subterranean termites to bypass the barrier and access the structure. Similarly, breaching refers to the creation of holes or gaps in termite barriers, enabling direct passage through the protection system.

At the time of inspection, it was noted that while the subfloor vents were not physically blocked, the external ground level had been raised above the lower portion of the vents. This partial coverage can restrict airflow into the subfloor and create concealed entry points for termites, particularly if the ground continues to rise or debris accumulates. Subfloor ventilation is critical for maintaining dry conditions beneath the structure and preventing timber decay, mould growth, and termite attraction.

It is highly recommended that external ground levels be adjusted to ensure the full exposure and functionality of all subfloor vents. A licensed landscaper or builder should be engaged to lower soil or remove obstructions as needed to maintain ventilation and visibility for ongoing termite inspections.

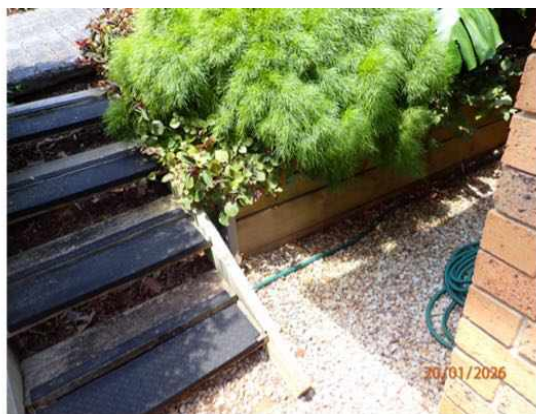
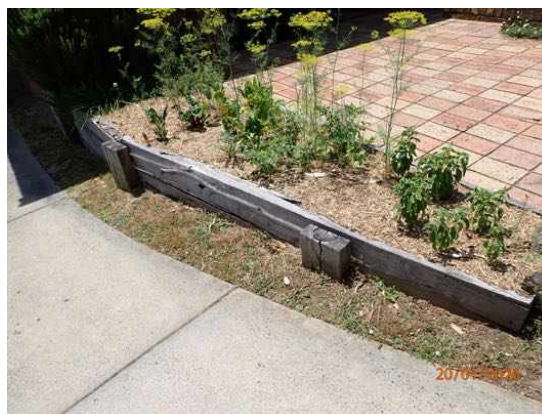
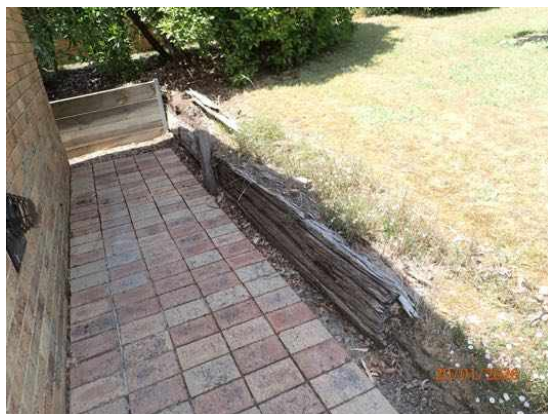
### Finding 6.06

Building:	Main Building
Location:	All External Areas
Finding:	Timber in direct ground contact - conducive to termites
Information:	Where timber elements are in direct contact with the ground and consequently moisture or dampness they become conducive to termite activity. Whether timber is used as a building element part of a fencing structure or stored as an unused item they can provide an environment that is attractive to termite infestation.

When met with excessive moisture timber begins to decay and develop wood rot. Any timbers that are in direct contact with external grounds especially if left untreated or non-durable also provide ingress for subterranean termites into that particular element.

It is recommended that the property owner be vigilant in reducing conducive conditions around the property where possible. The removal of any such materials that may be conducive to termite activity should be removed as soon as possible to minimise the risk of termite attack. If conducive conditions are present and not removable periodically inspections should be conducted by a licensed pest controller.

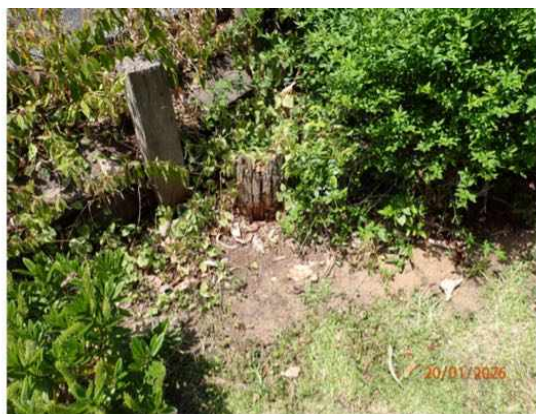
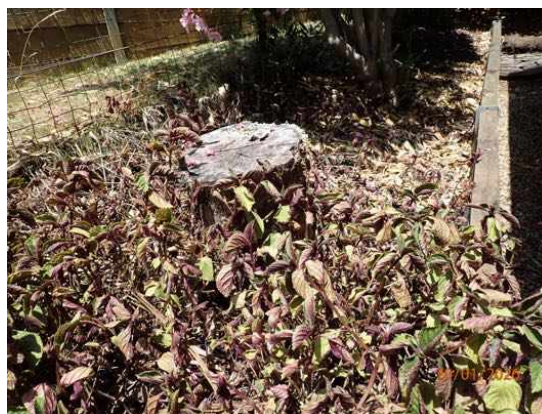
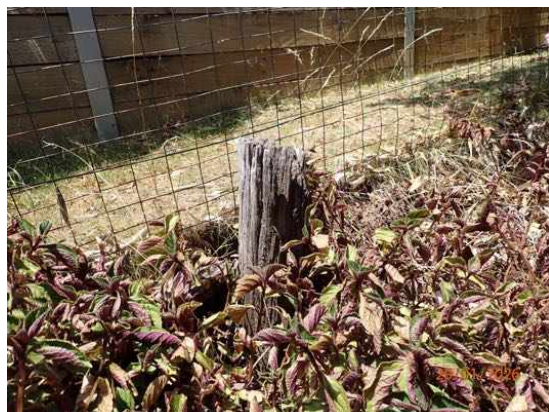
### Finding 6.07

Building:	Main Building
Location:	All External Areas
Finding:	Dead tree stumps
Information:	The storing of timbers and dead tree stumps around the external property increases the risk of termite activity being present. As they are likely to come into contact with weather conditions or excessive moisture wood rot is likely to develop on timbers that are not treated.

It is highly recommended that any stored timbers be immediately removed from areas and dead tree stumps taken out in which they may attract any termite / timber pest attack. Minimisation of risk / prevention of termite attack is far more adequate than dealing with the presence of termite activity.

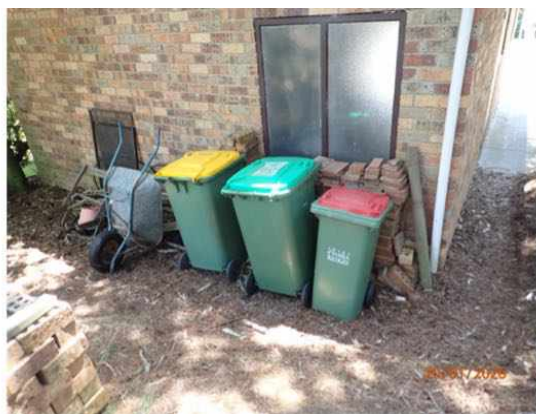
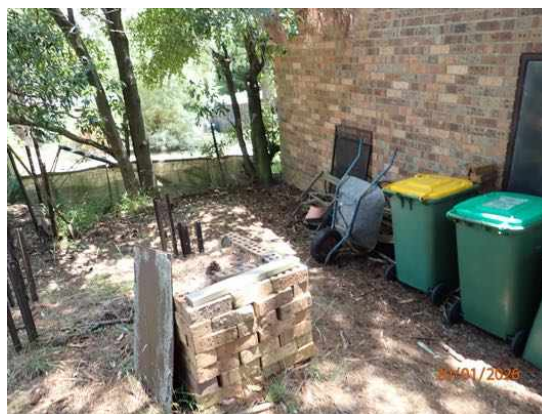
### Finding 6.08

Building:	Main Building
Location:	Exterior walls - rear
Finding:	Stored timbers - external area
Information:	The storing of timbers in the exterior space increases the risk of termite activity being present. As they are likely to come into contact with weather conditions or excessive moisture wood rot is likely to develop on timbers that are not treated.

It is highly recommended that any stored timbers be immediately removed from areas in which they may attract any termite / timber pest attack. Minimisation of risk / prevention of termite attack is far more adequate than dealing with the presence of termite activity.

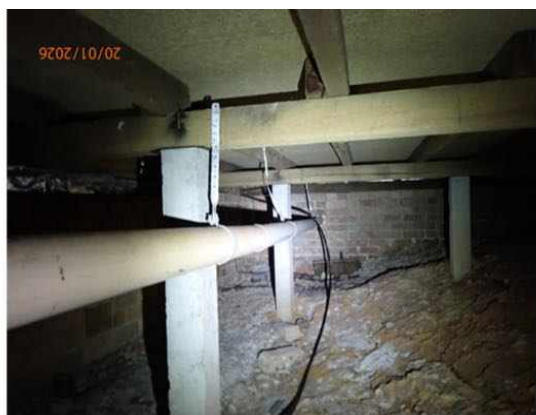
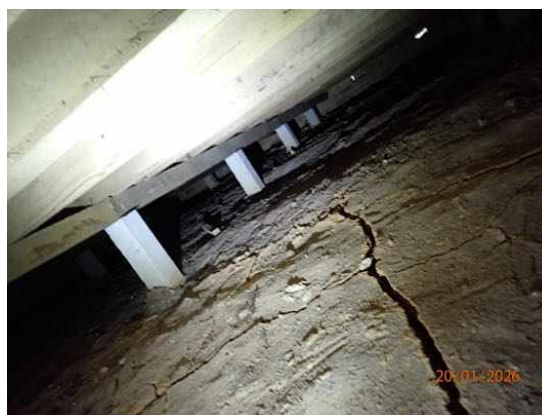
### Finding 6.09

Building: Main Building  
 Location: Subfloor  
 Finding: Ant caps - Not installed  
 Information: Ant caps have not been installed to the subfloor structure at the time of inspection. Generally, ant caps are installed to the intersection between the top of the stumps (or piers) and the subfloor structures.

Where ant caps have not been installed, frequent monitoring of these areas should be carried out in order to identify any signs of termite or timber pest workings.

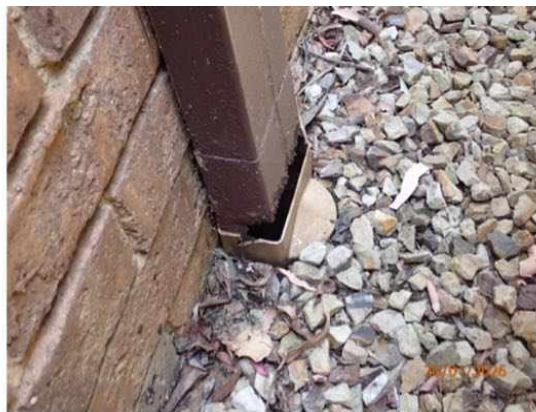
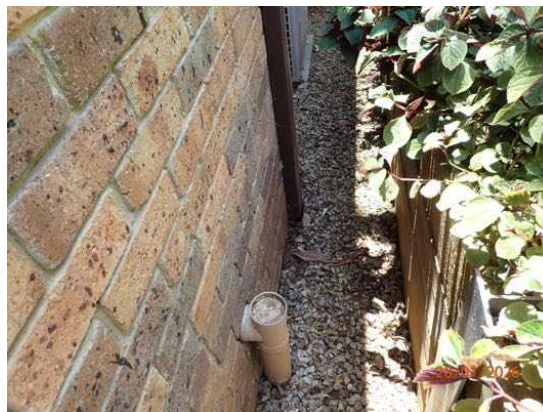
### Finding 6.10

Building: Main Building  
 Location: Exterior walls - left side  
 Finding: Down pipe - connection broken  
 Information: The stormwater downpipe connection to the stormwater drainage was found cracked, creating excessive moisture in the surrounding area.

These damp conditions can lead to secondary defects such as rot, rust, or corrosion

of associated building elements, as well as the formation of fungal decay or potential slip hazards. Additionally, poor site drainage may lead to water pooling, potentially attracting termite activity to this area.

It is highly recommended that a licensed plumber be appointed to connect the downpipes in order to prevent such an environment from being created. These minor works should be carried out as soon as possible.

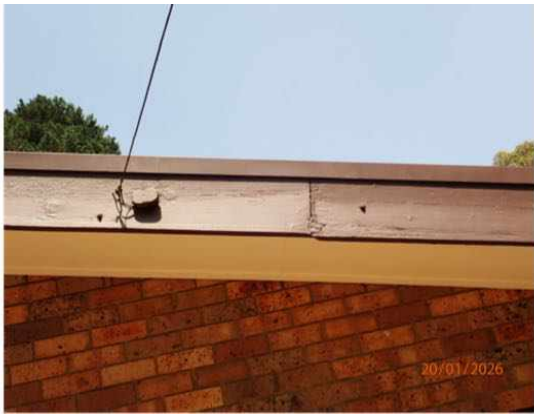
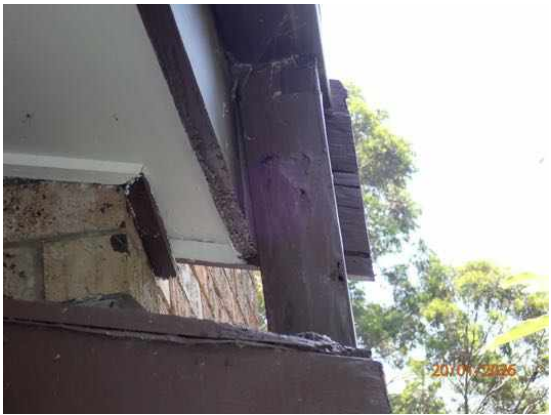
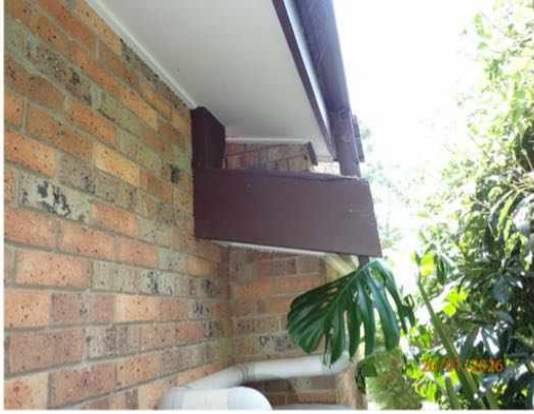
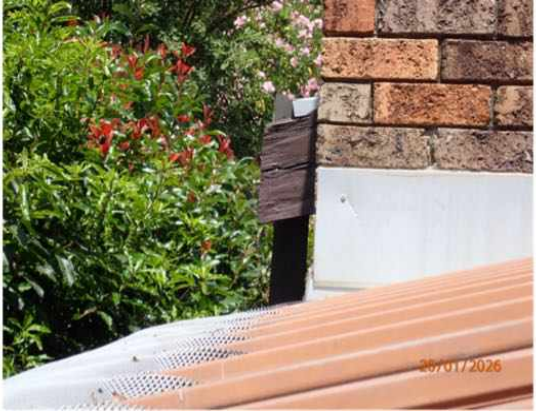
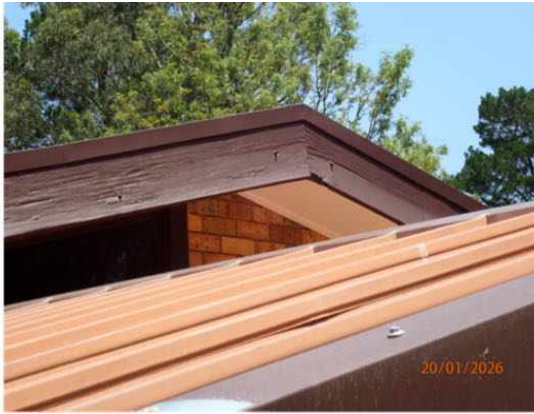
Building:	Main Building
Location:	Roof Exterior
Finding:	Wood rot - Fascia's
Information:	Wood rot was discovered affecting fascias and barges in this area, with evidence of mould on the surface in some areas.

Wood rot, also known as Fungal Decay, poses a significant threat to the structural integrity of fascias and barges. This decay occurs due to prolonged exposure to damp conditions, which may be exacerbated by faults in the roof plumbing, leading to excessive moisture in the affected areas. Additionally, frequent exposure to rain and weather conditions accelerates the deterioration of these building elements.

Immediate action is necessary to address the wood rot and prevent further deterioration. Engaging a roof plumber to inspect all roof plumbing and identify the cause of excessive moisture is essential. Following identification of the root cause, replacement of affected fascias and barges may be required to protect surrounding building elements from further decay. A qualified plumber should be appointed to carry out any necessary remedial works to address the source of moisture. Additionally, a qualified carpenter or registered builder may be needed to replace the affected building materials. Implementing a regular maintenance schedule to inspect and maintain fascias and barges can help prevent future occurrences of wood rot.

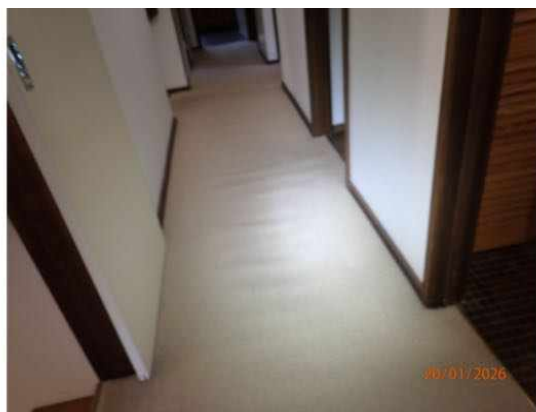
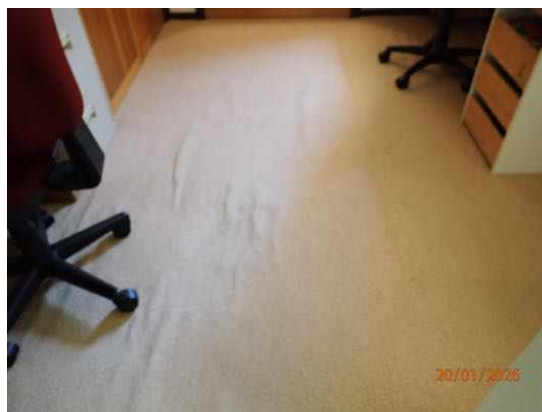
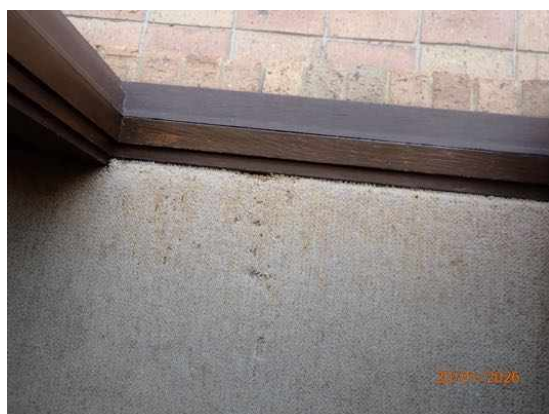
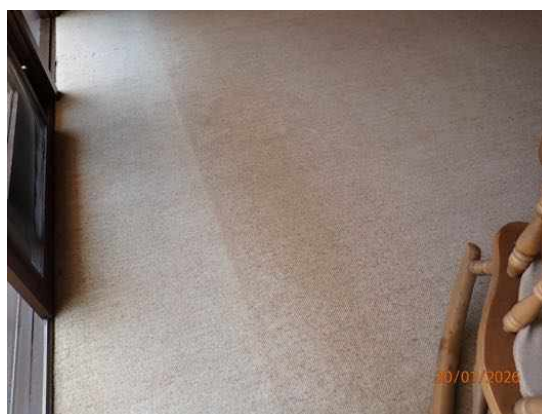
Building: Main Building  
 Location: All Internal Areas  
 Finding: Carpet - Deteriorated  
 Information: Sections of the carpet floor covering in this area appeared to be deteriorated . Although its just an cosmetic defect, a carpet specialist may need to be engaged at the home owners discretion to rectify it.

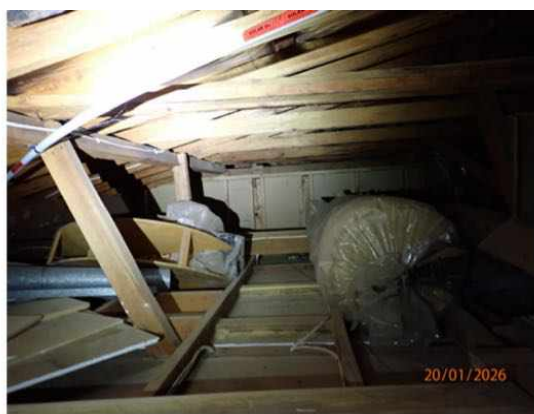
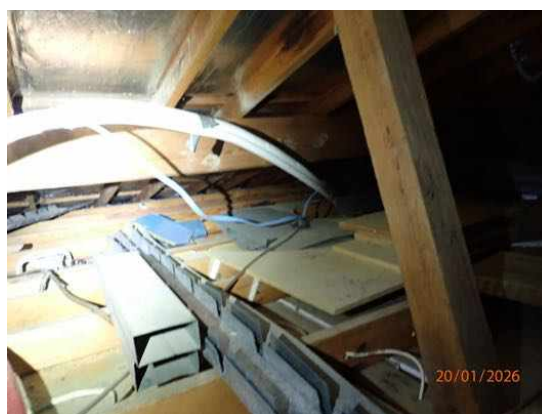
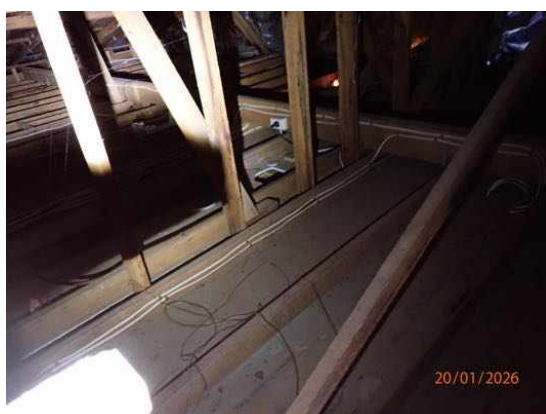
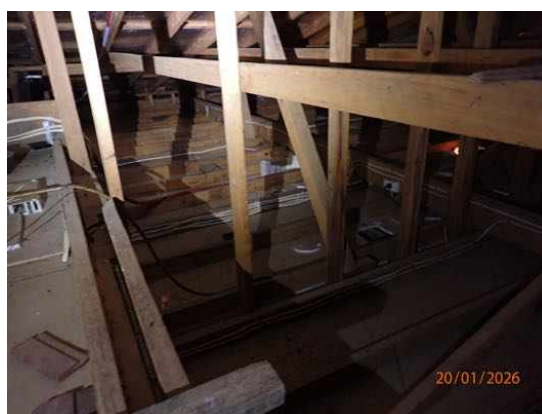
Building: Main Building  
 Location: Roof Void  
 Finding: Insulation - Inadequate  
 Information: Upon inspection of the roof void, it was noted that there is a lack of adequate insulation or uneven coverage in some areas.

It is recommended to engage a qualified insulation installer to assess the current insulation levels and install additional insulation where necessary to meet Australian Standards and improve energy efficiency.

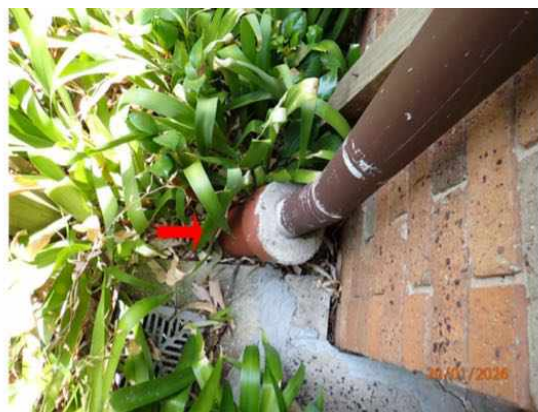
Building: Main Building  
 Location: All External Areas  
 Finding: Terracotta plumbing pipes - Noted  
 Information: During the inspection, it was noted that the stormwater plumbing pipes are made of terracotta. Terracotta pipes, commonly used in older plumbing systems, have certain

Given the characteristics and potential vulnerabilities of terracotta pipes, it is recommended to regularly inspect and maintain these plumbing systems to prevent failures. If issues such as leaks, blockages, or significant wear are identified, it may be necessary to consider replacing the terracotta pipes with more modern materials like PVC, which are less prone to such problems. Engaging a licensed plumber to perform a thorough assessment and undertake any necessary repairs or upgrades is crucial to ensure the proper function and longevity of the stormwater plumbing system.

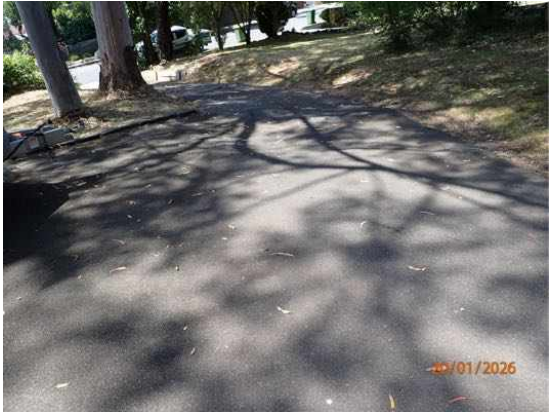
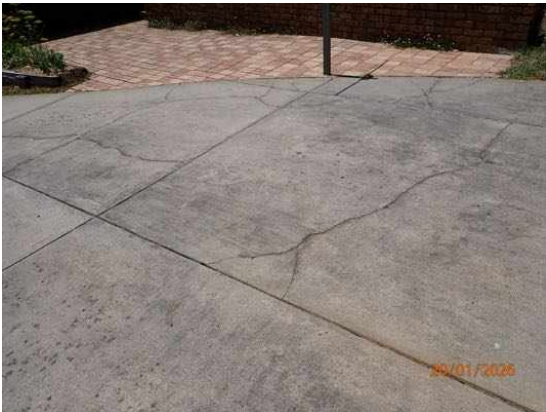
Building: Main Building  
Location: Exterior walls - front  
Finding: Drive way damaged  
Information: The exterior driveway was noted damaged during inspection, with cracking and surface deterioration observed. It is suspected that the damage is due to inadequate construction and ongoing ground movement, compounded by the influence of roots from mature trees located on the property. It is recommended to monitor the condition of the driveway and engage a qualified concreter or registered builder to assess the extent of damage and advise on appropriate remedial works if the deterioration progresses.

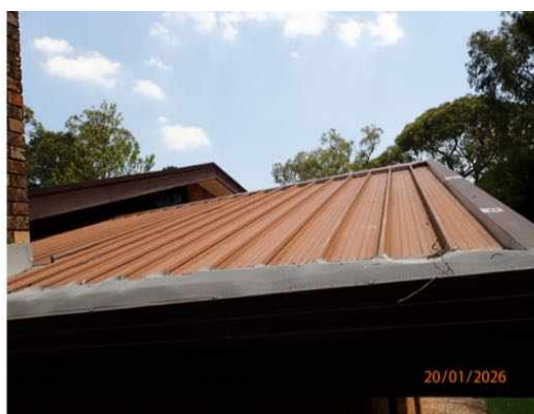
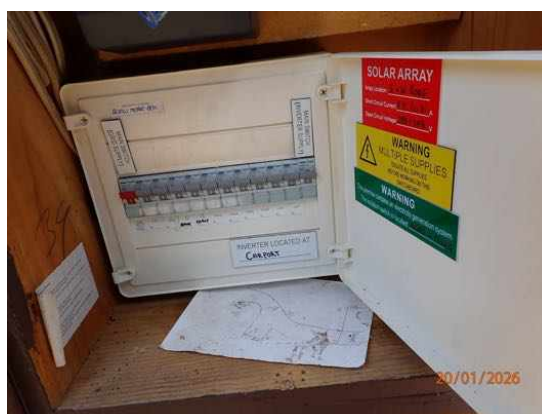
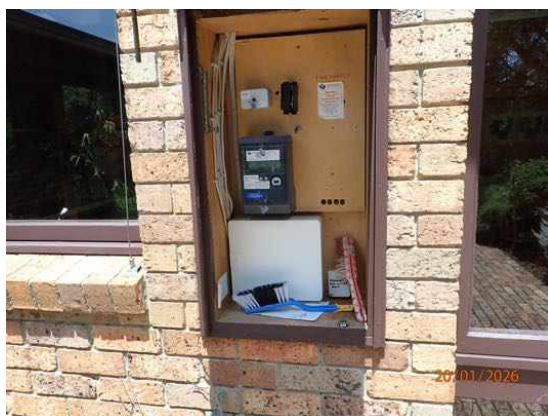
Building: Main Building  
 Location: Meter Box  
 Finding: Electrical Switch Box  
 Information: All electric wiring, meter boxes and appliances need to be checked by a licensed Electrician ensuring any work completed as part of a renovation or extension has been issued with a Certificate of electrical Safety (CES). The checking of any electrical items is out side the scope of this inspection.
