Building and Timber Pest Inspection Report

Inspection Date: Thu, 12 Mar 2026

Property Address: 6 Bugden St, Wodonga VIC 3690, Australia

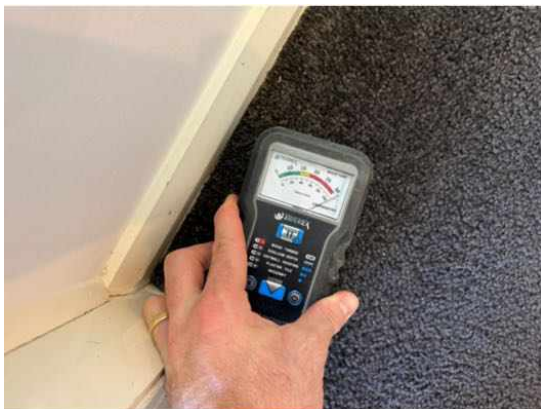
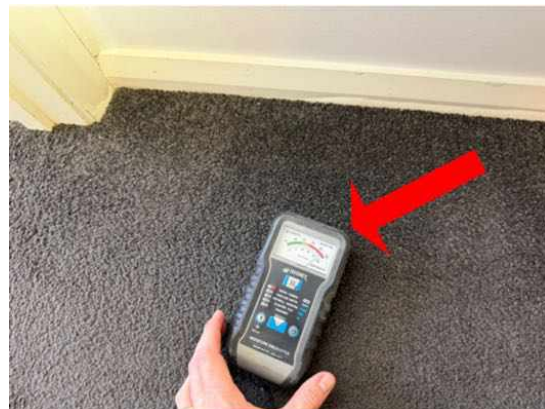
Finding 2.01

Building: Main Building
 Location: End of Hallway
 Finding: Hallway Carpet - High Moisture
 Information: Evidence of high moisture was identified at, but not limited to the carpet at the end of the hallway. Water damage to the surrounding architraves and skirting boards was also identified. Potential causes of leaking include but are not limited to loose or damaged plumbing fittings and fixtures. This also creates an environment conducive to termite activity.

Evidence of high moisture was identified at, but not limited to the carpet at the end of the hallway. Water damage to the surrounding architraves and skirting boards was also identified. Recommend engaging a licensed plumber promptly, to identify the cause of the high moisture & provide remedial works where necessary. A more invasive inspection may reveal secondary defects.

Recommend engaging a licensed plumber promptly, to identify the cause of the high moisture & provide remedial works where necessary. A more invasive inspection may reveal secondary defects.

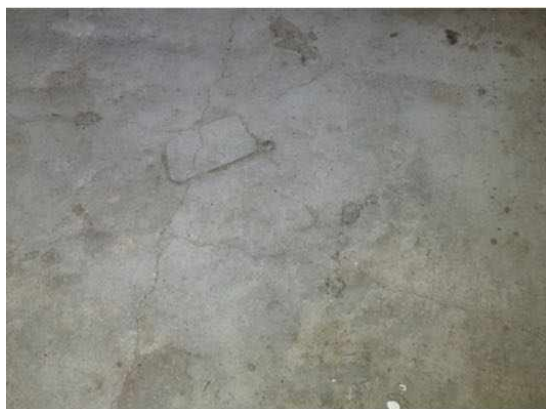
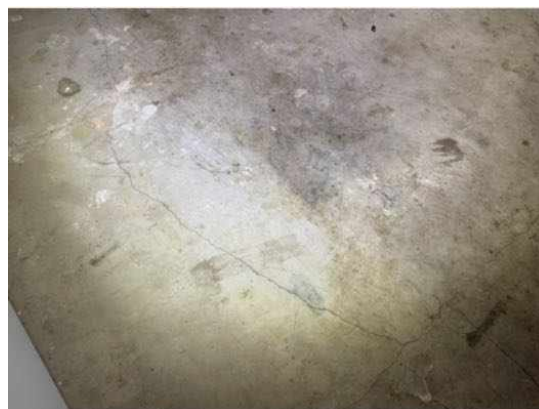
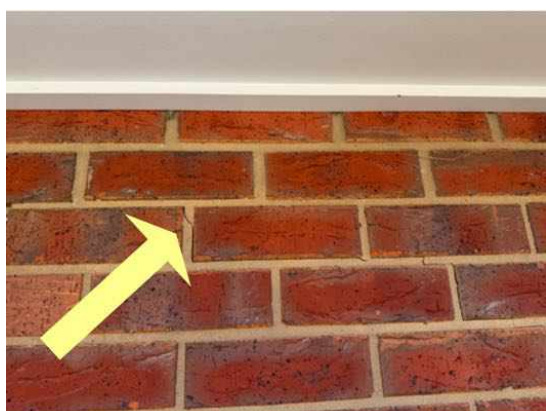
Finding 3.01

Building: Main Building
 Location: Garage, Brickwork
 Finding: Minor Cracking - Garage Slab & Brickwork
 Information: Minor cracking was identified at, but not limited to the garage slab and an area of the brickwork. Cracking in concrete slabs & brickwork is common, and can be caused by

general movement of the footings over time or “settling” of the building after construction.

The client should monitor the cracking. Should the cracking of the garage slab widen, lengthen or become more numerous, a structural engineer should be engaged for further evaluation.

Areas of cracking should be monitored to identify any further movement. Should cracking lengthen, widen, or become more numerous, a structural engineer should be engaged promptly, for further evaluation.

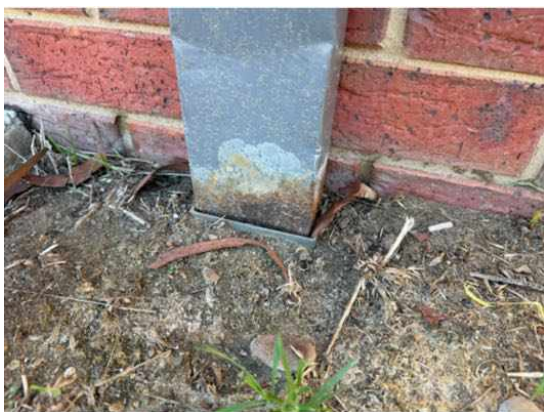
Finding 3.02

Building:	Main Building
Location:	Front Elevation
Finding:	Down-pipe - Rust
Information:	It appears that rust was present at the base of the front down-pipe, likely caused by water pooling at the base. Rusted roof plumbing can eventually develop holes and leaks overtime that can affect other building elements, and create water pooling in the area, if neglected.

Recommend consulting with a licensed plumber specialising in drainage to provide further advice & maintenance works where necessary.

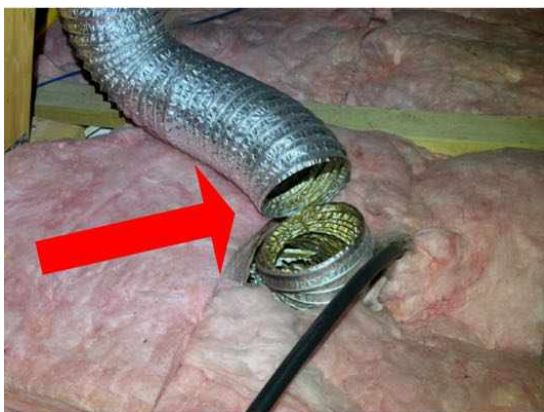
Finding 3.03

Building:	Main Building
Location:	Roof Void
Finding:	Range-hood ducting - disconnected
Information:	The range-hood ducting was found to be disconnected in the roof void at the time of inspection and needs to be re-connected.

This defect inhibits the functionality of the affected system, and is likely to lead to moisture build up in the area if neglected.

Consultation with a licensed electrician is advised at clients convenience, to reconnect the ductwork.

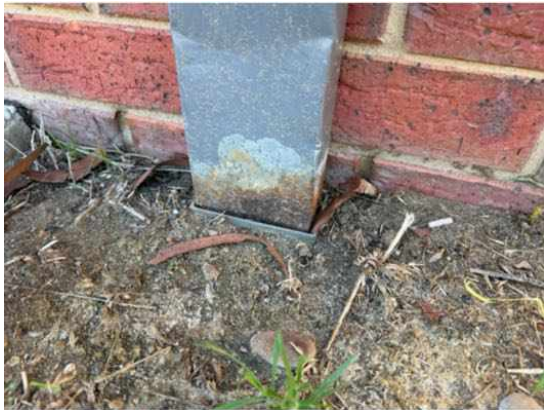
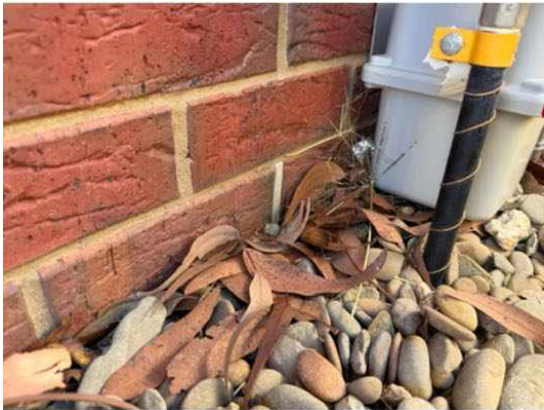
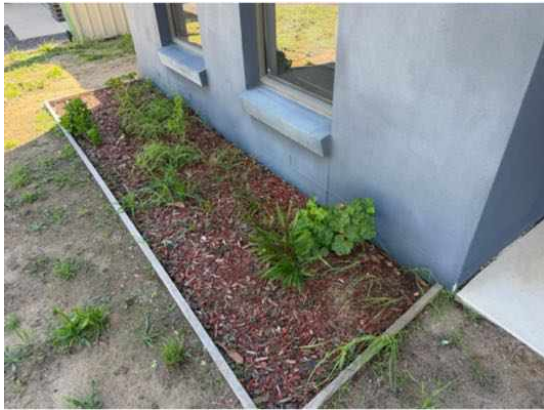
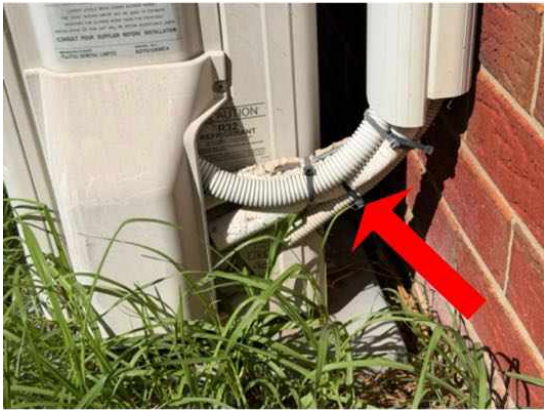
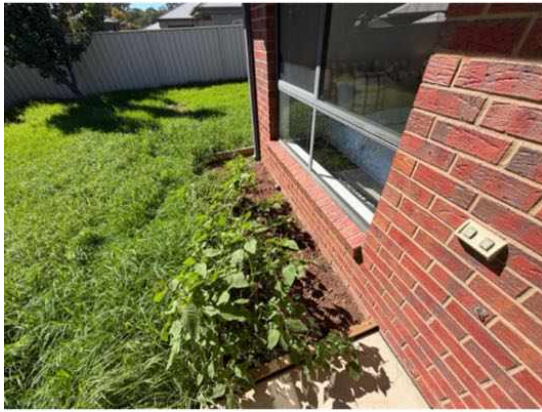
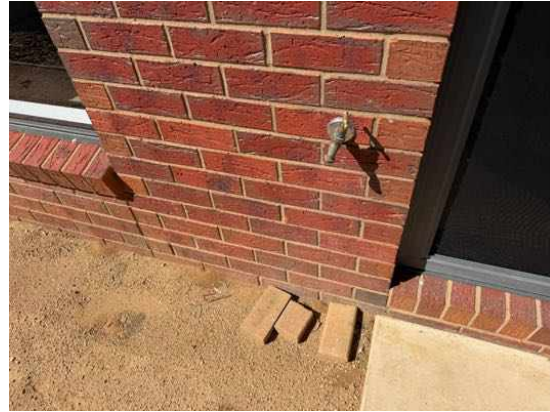
Finding 6.01

Building: Main Building
Location: All external areas
Finding: Potential Water pooling - against property
Information: Potential areas of water pooling around the perimeter of the property were identified.

Where insufficient drainage of taps, & aircon overflows, and garden beds against the house are present, water pooling is likely to occur, and can create areas conducive to timber pests. Recommend consulting with a licensed plumber and/or landscaping contractor to provide further advice.

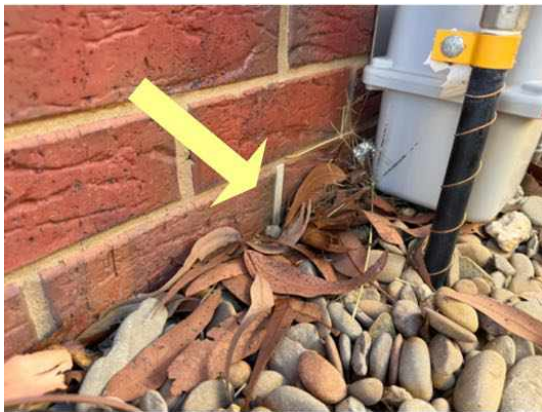
Finding 6.02

Building:	Main Building
Location:	Side of House
Finding:	Weep holes - Blocked
Information:	It appears some weep holes of the brickwork are blocked by the external finished ground level. This can restrict moisture escape and can create conducive conditions to termite activity. This also allows for termites to bypass any termite barriers & allows for concealed entry into the building.

Recommend engaging a licensed landscaping contractor in the short term to lower external ground levels where feasible and restore adequate weep hole drainage and inspection zones. Some plastic caps of the weep-holes were still installed and should be removed.

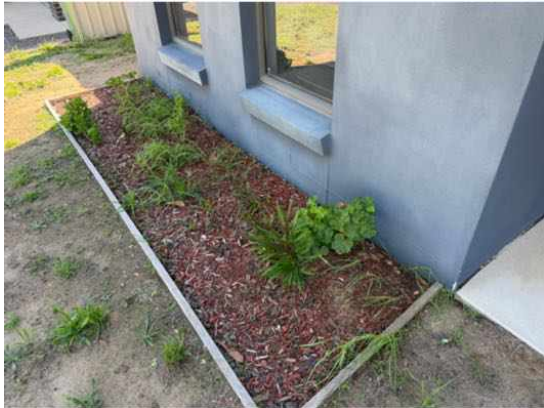
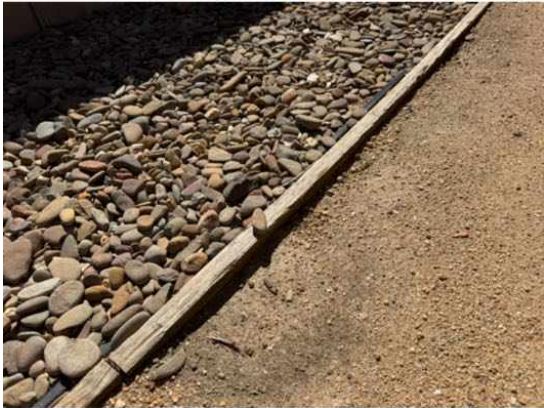
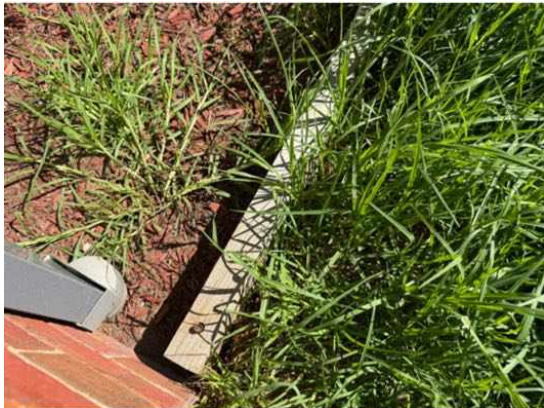
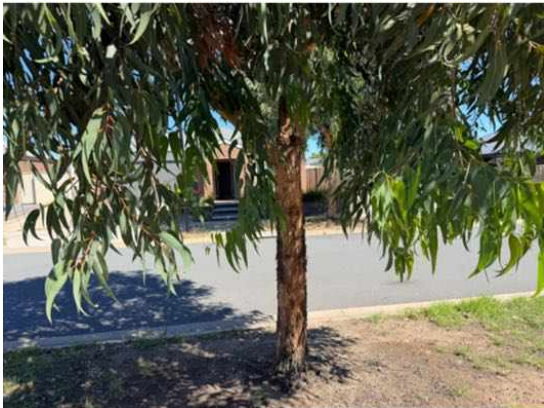
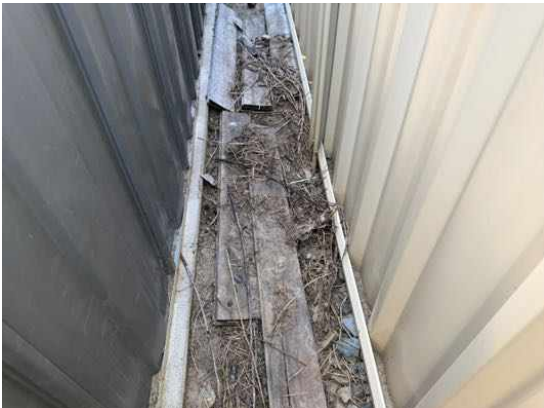
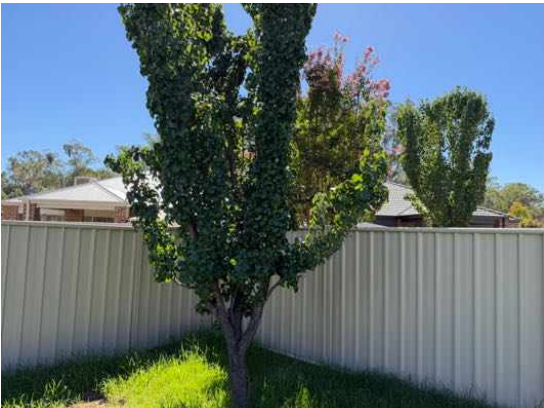
Finding 6.03

Building:	Main Building
Location:	All External Areas
Finding:	Timber in direct ground contact & trees - conducive to termites
Information:	Where timber materials are in direct contact with the ground and consequently moisture, they become conducive to termite activity. The landscaping timbers, timber debris and trees surrounding the building create an environment conducive to termite

activity.

Where feasible, any timbers in direct contact with the ground should be removed and any trees in close proximity to the building should be removed or test drilled (inspected) at least annually to reduce the risk of termite infestation & detect any early signs of termite activity.

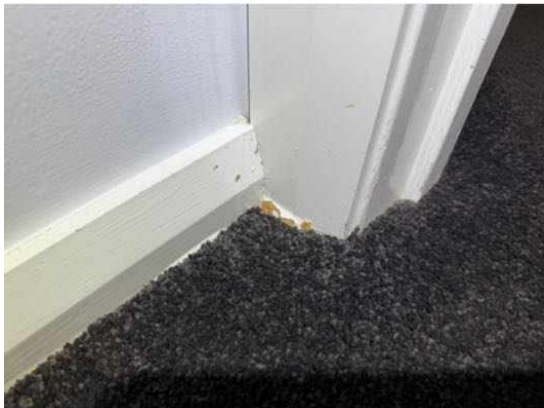
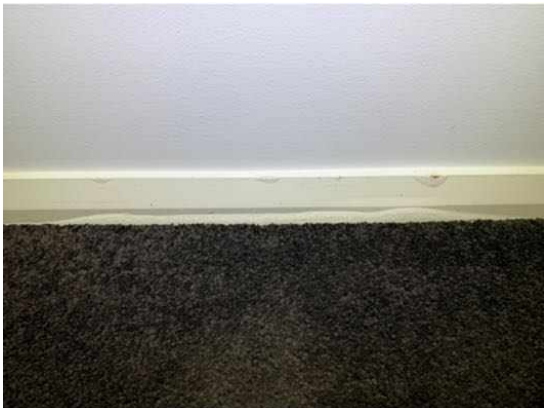
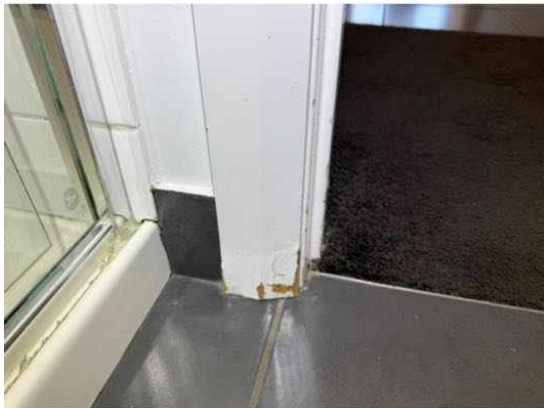
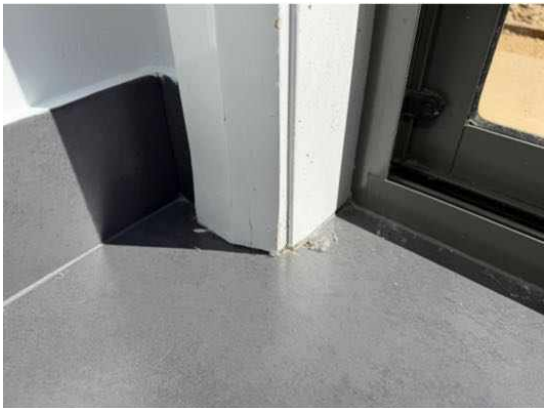
Building: Main Building
 Location: Architraves & Skirting
 Finding: Water Damage - Bathroom & Hallway Architraves
 Information: It appears that the bottom of the architraves and skirting at, but not limited to the end of the hallway, laundry, and bathroom appear to have been affected by water damage. Recommend engaging a licensed painter and/or carpenter to provide maintenance works.

Where high moisture is present (end of the hallway) a licensed plumber should be engaged promptly to provide remedial works.

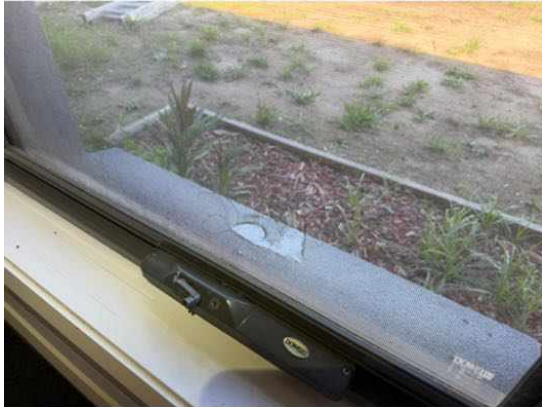
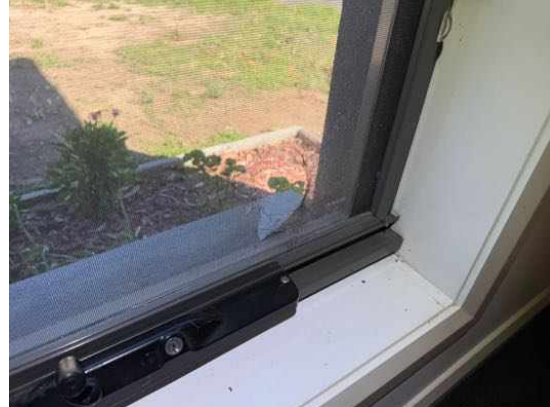
Building: Main Building
 Location: Front Elevation
 Finding: Flyscreens - Damaged
 Information: Some fly screens were found to be damaged and weathered. This inhibits the functionality of the affected fly screens and windows.

Recommend a general handyman to replace flyscreens at clients discretion.

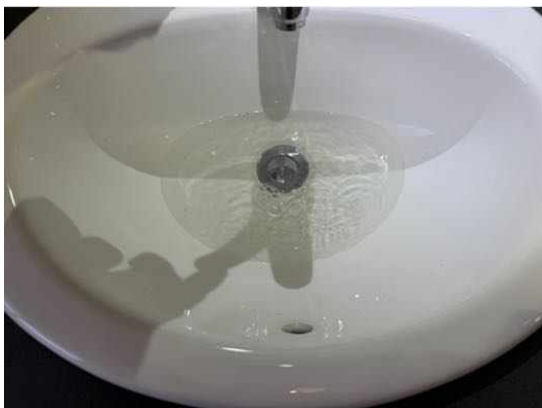
Building: Main Building
 Location: Vanity Sink Plug
 Finding: Sink Plug - Stiff
 Information: It appears that the main bathroom vanity sink plug was stiff, and was not draining. Recommend engaging a licensed plumber at clients discretion to provide maintenance works where necessary.

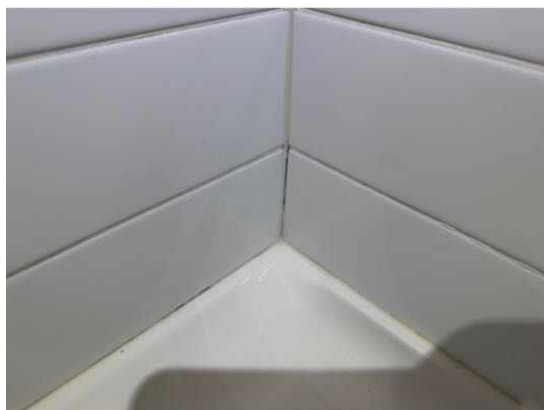
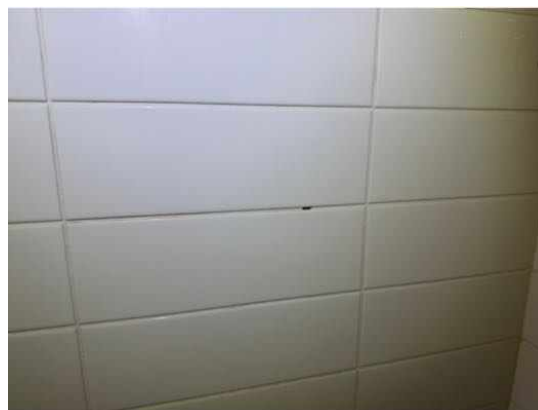
Location: Tiled Areas
 Finding: Sealant and grouting - Monitor & General Maintenance
 Information: It appears that the sealant and grouting in the tiled areas are slightly weathered, a common defect in houses of a similar age.

It is noted for the clients information that sealant and grouting in areas that come into regular contact with water should be maintained.

Should the sealant deteriorate further, a tiling contractor should be engaged to provide maintenance works where necessary to ensure all wet areas are sufficiently sealed.

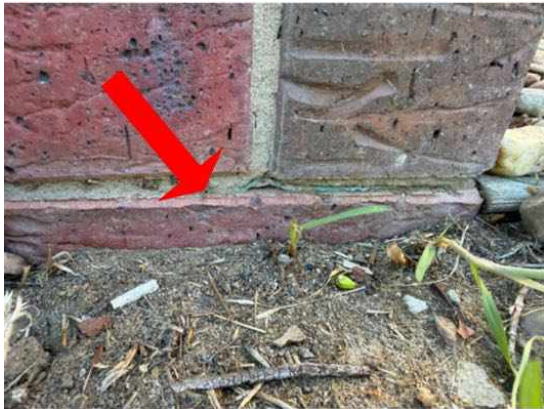
Building: Main Building
 Location: External Brickwork
 Finding: Evidence of a previous termite management system
 Information: It appears that the physical termite barrier has been installed, as it was visible to some areas of the brickwork. It appears that the type of termite system that has been installed is a physical polymer barrier which prevents concealed termite entry into the building and forces termites out into the open.

Recommend consulting with the pest control company that installed the barrier, to provide further advice regarding the system and to provide a future management plan. Regular 12 monthly inspections should be conducted by a qualified termite inspector, to identify any timber-pest activity.
