Building Inspection Report

Inspection Date: Fri, 23 Jan 2026

Property Address: 4/3-5 Atkinson St, Liverpool NSW 2170,
Australia

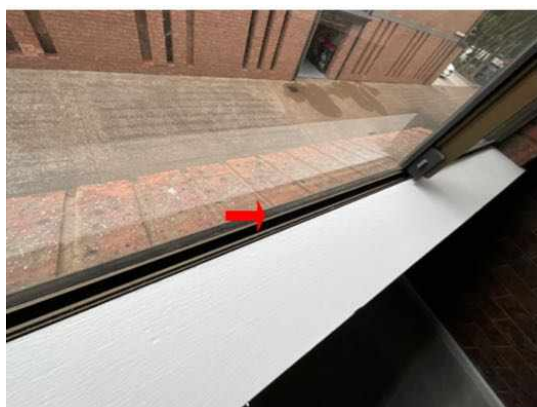
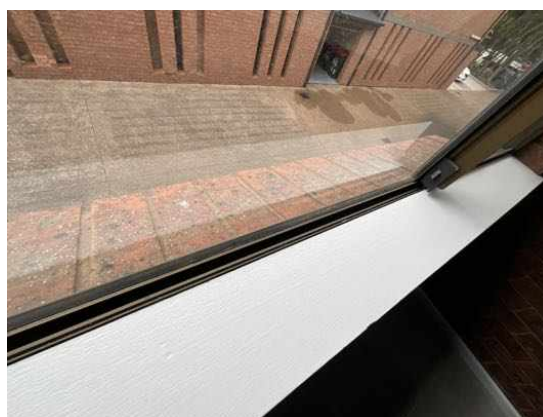
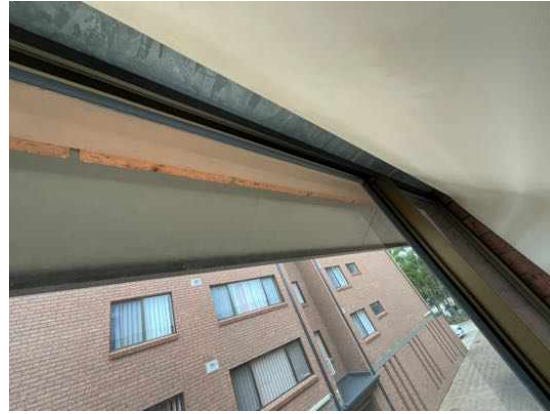
Defects 1.01

| Finding: | Window child lock missing |
| Information: | The window in question lacks a child lock mechanism, which poses a potential safety risk to young occupants in the premises. As per Australian Standards windows accessible to children should be equipped with appropriate child safety locks to prevent accidental opening, reducing the risk of falls and ensuring compliance with safety regulations. |

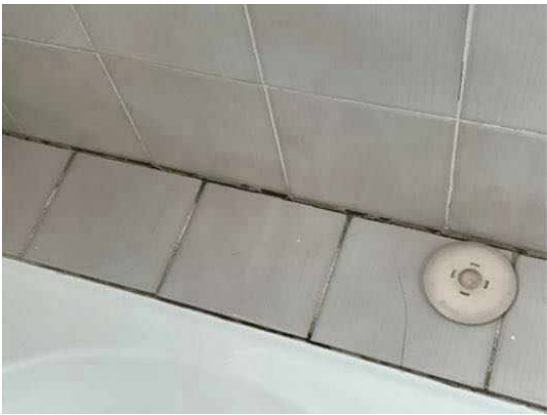
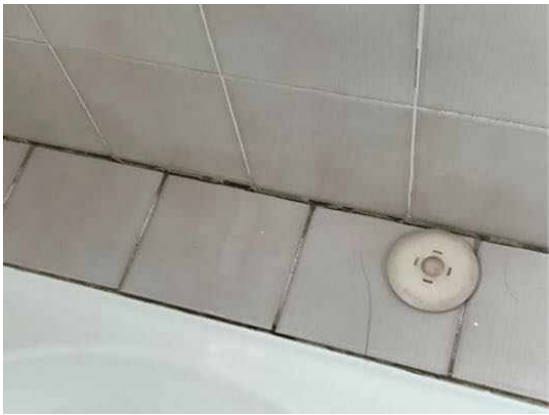
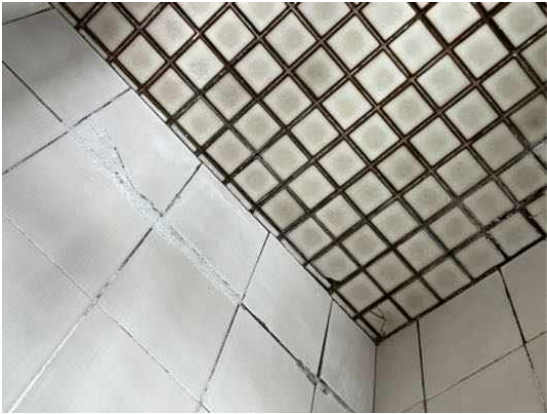
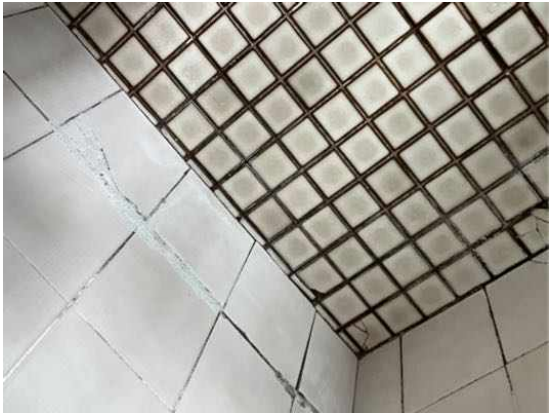
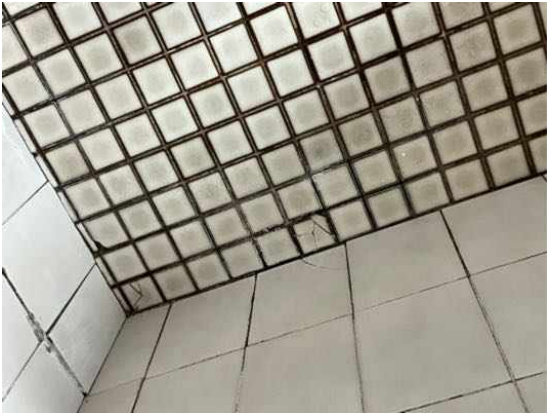
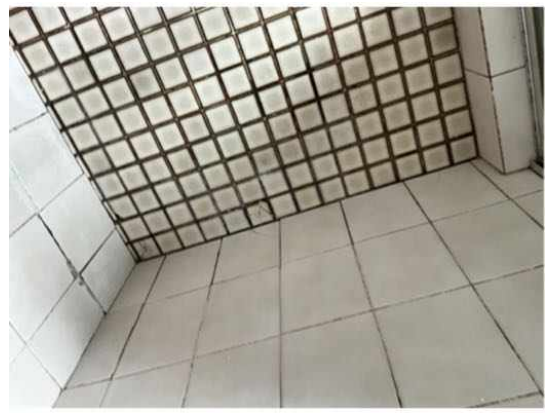
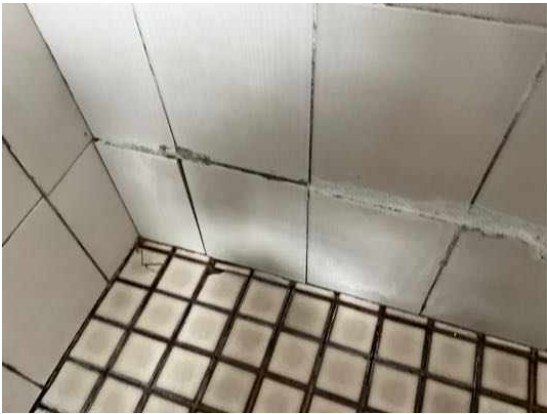
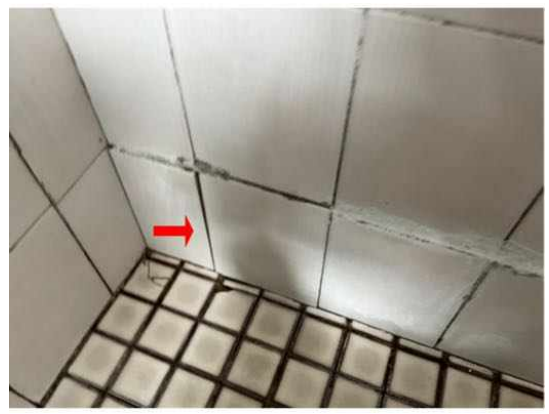
Defects 2.01

| Finding: | Tiles - Cracked or damaged |
| Information: | Cracking was evident to the tiling in this area at the time of inspection. While the cracking appears to be minor, this area is frequently exposed to water, allowing potential for water penetration into adjoining sections of walls or flooring. |

If left unmanaged, water penetration to these areas may lead to subsequent water damage, which is likely necessitate repair work to affected building elements.

A tiling contractor should be appointed to ensure that no further water damage occurs. The re-application of silicone and grouting throughout remaining tile work is also advised, to further protect the area against water penetration.

Where water penetration has led to water damage, appointment of a relevant tradesperson may be required to repair damaged building elements.

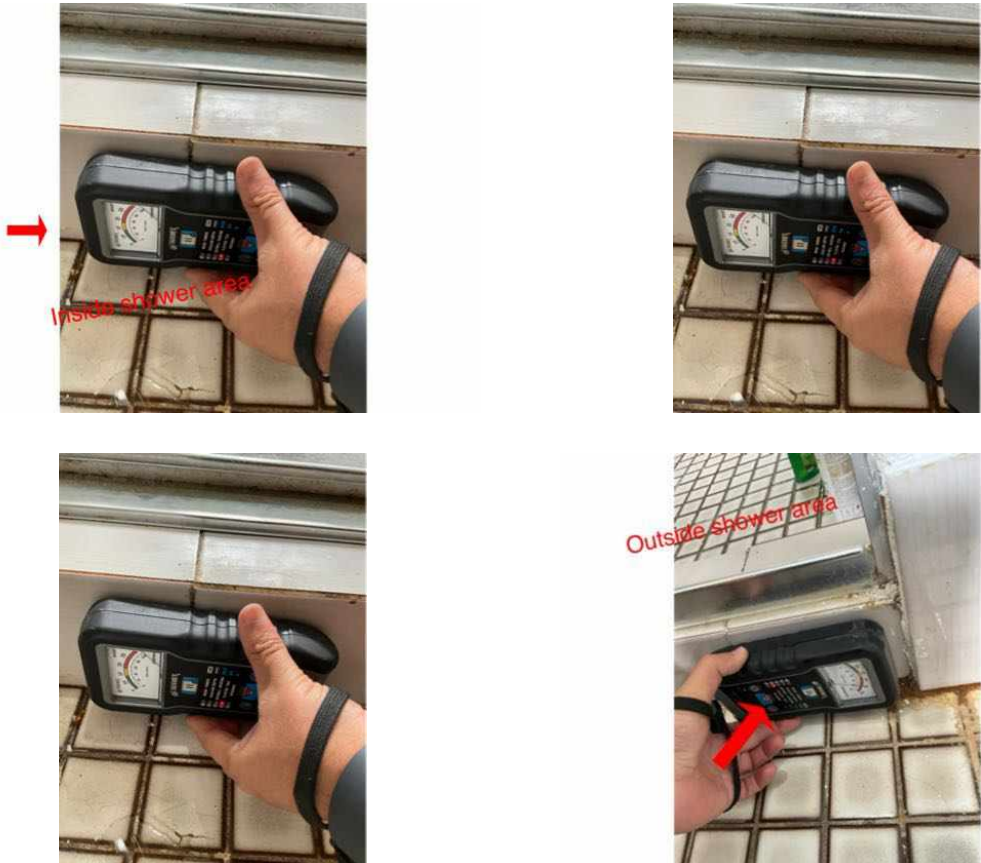
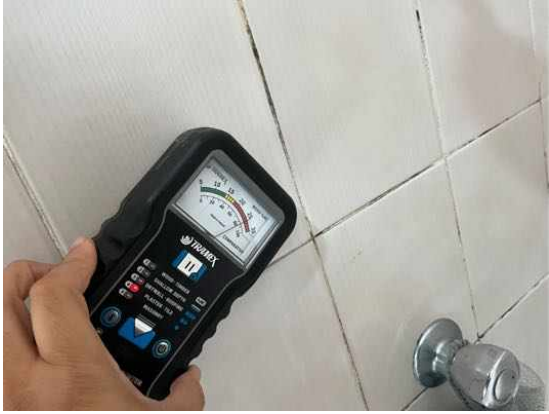
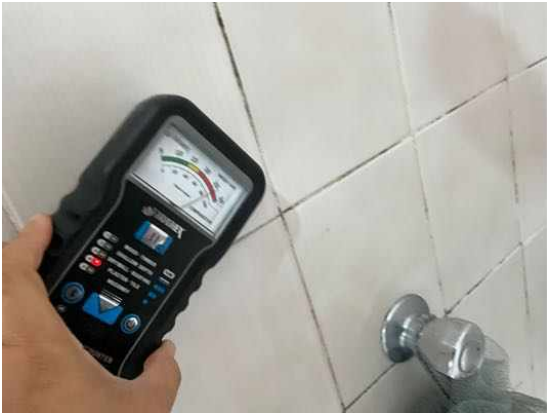
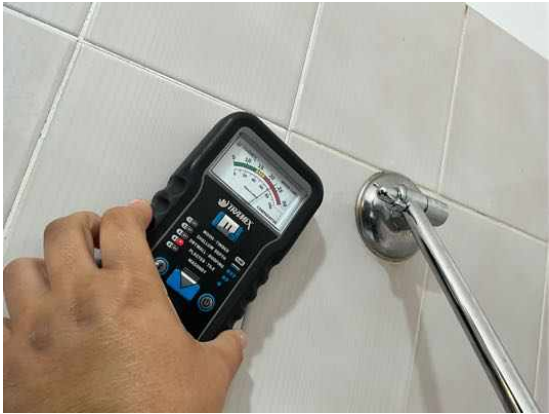
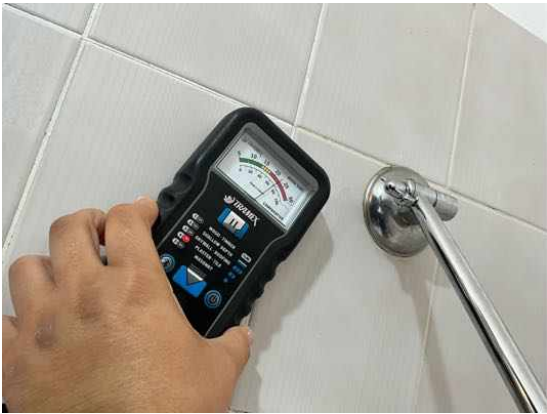
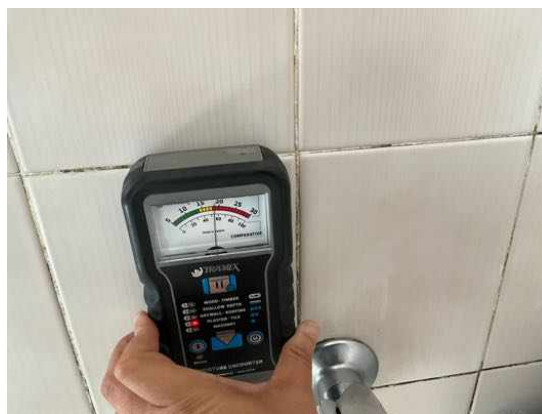
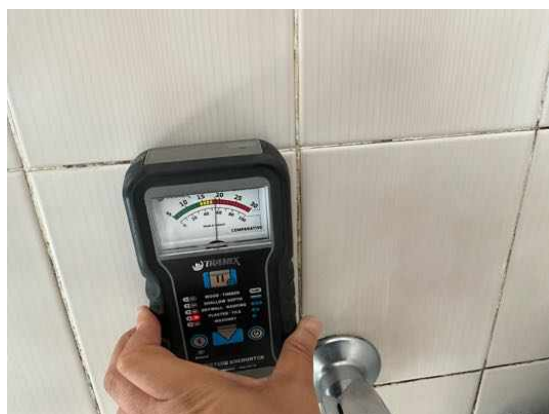
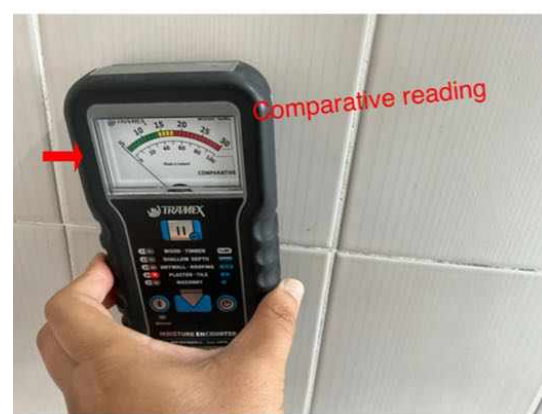
Defects 2.02

Building: Main Building
Location: Bathroom
Finding: Evidence of excessive moisture was present at the time of inspection
Information: Excessive moisture is present behind the bathroom tiles, indicating a potential water leakage issue within the wall.

The prolonged presence of moisture can lead to mold growth, deteriorate the structure, and create an environment conducive to health hazards. Additionally, it may compromise the adhesive holding the tiles, leading to their detachment.

A licensed plumber or a qualified contractor specializing in water damage remediation should investigate the source of the moisture, fix any leaks, and address the damage. Additionally, replacing affected tiles and ensuring proper waterproofing are crucial to preventing future issues.

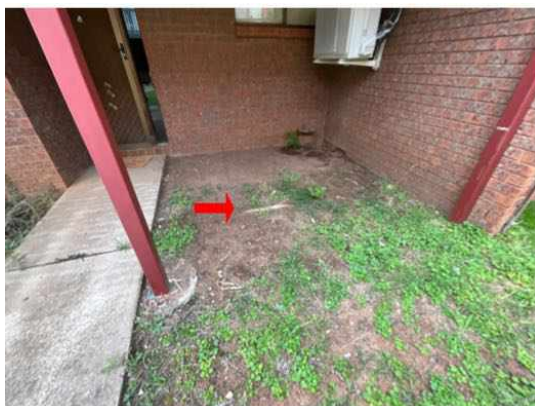
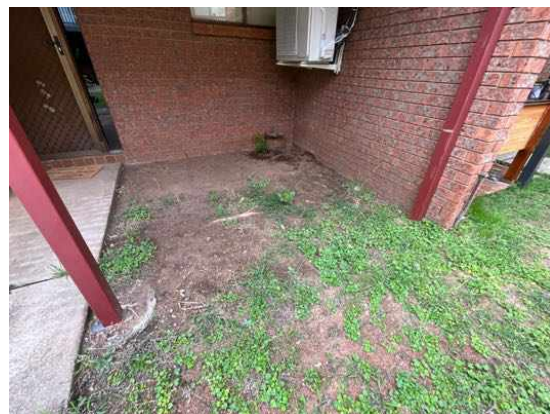
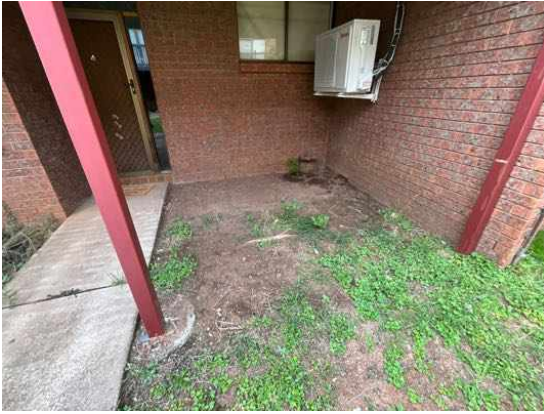
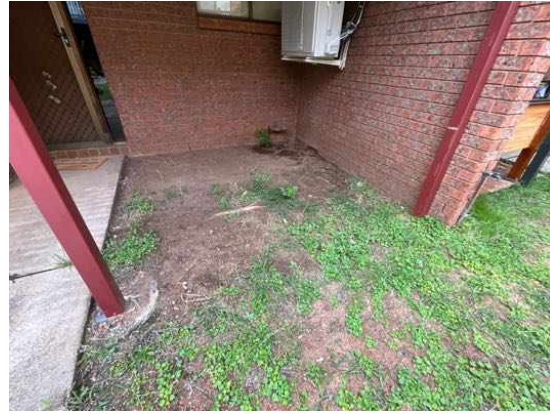
Defects 3.02

Surface water drainage is defective if it is not in accordance with the requirements of the Building Code of Australia.

Such water pooling also increases the risk of termite activity and the development of fungal decay in the area.

Consult a Licensed Plumber regarding the cost of potential site drainage rectification works.

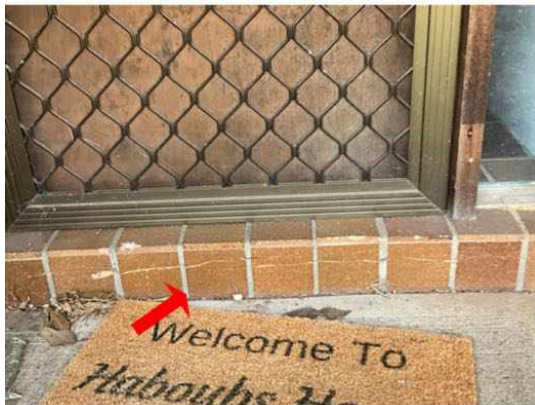
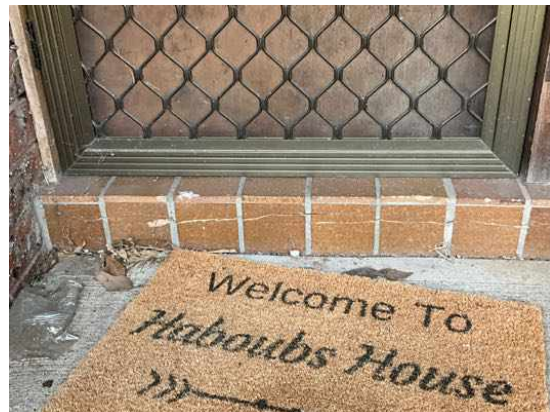
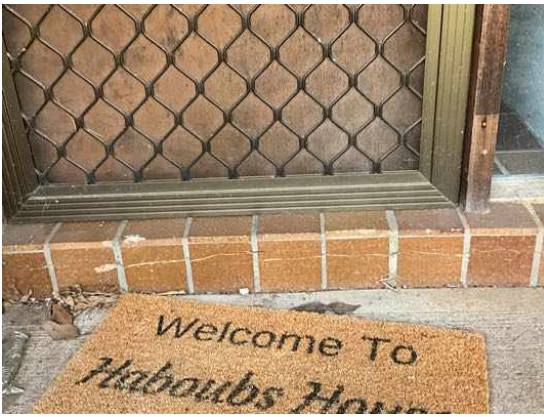
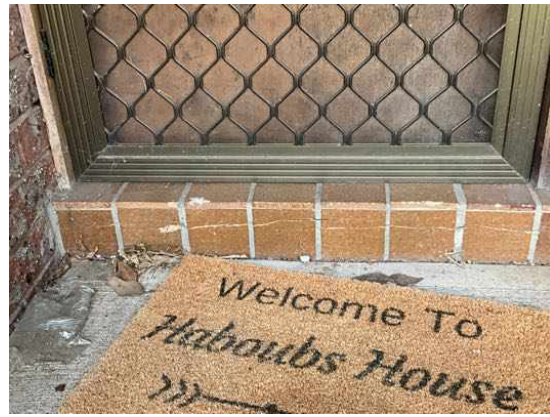
Defects 3.03

Finding: Brickwork - Cracking [Fine]

Information: Although fine cracks are quite noticeable, they are often only considered to be an appearance defect and usually do not indicate any structural damage. Generally, the cause of a fine crack is indicative of a separation between brickwork and mortar throughout the structure, but single bricks may also show cracks of this nature.

Cracking of this nature can generally be repaired with minor filling and should be conducted by a qualified bricklayer.

Always contact a building inspector should cracks widen lengthen or become more numerous.

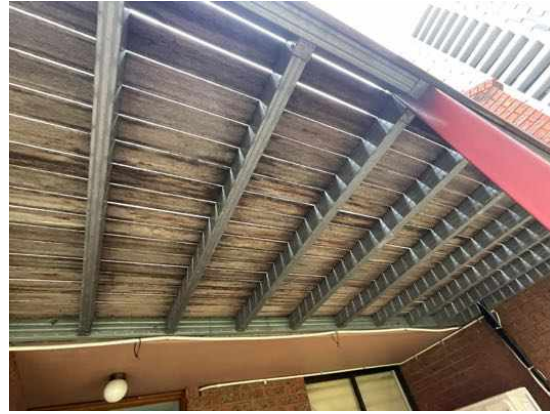
Defects 3.04

External timber structures are also constantly exposed to weather deteriorates in an exhilarate manner, ongoing assessments are required.

It is highly recommended that a structural engineer further, assess the external timber balcony or a deck to inform the client of its load capacity.

Regular maintenance inspections by competent practitioners is needed.

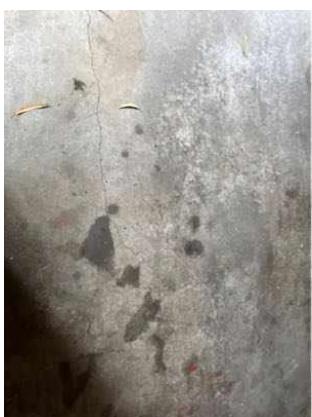
Defects 3.06

| Finding: | Crack in concrete slab - Category 0 |
| Information: | A crack coded as Category 0 was identified in the slab. A Category 0 crack is described as a hairline crack, representing insignificant movement of slab from level. |

The approximate width of the crack to be considered Category 0 is 0.3mm, or change

in offset of less than 8mm when a 3m straight edge is placed over the defect.

No rectification is required at this time. However, all cracking should be monitored over a 12 month period to identify any further damage in the area.

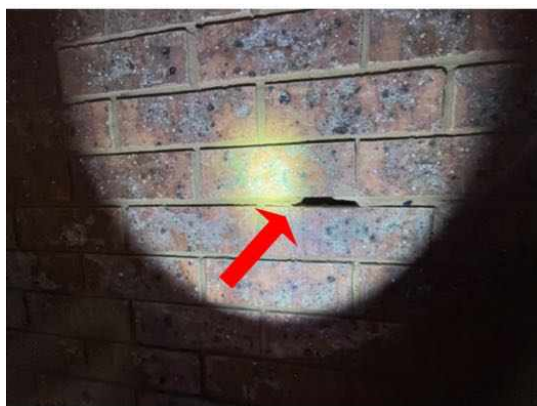
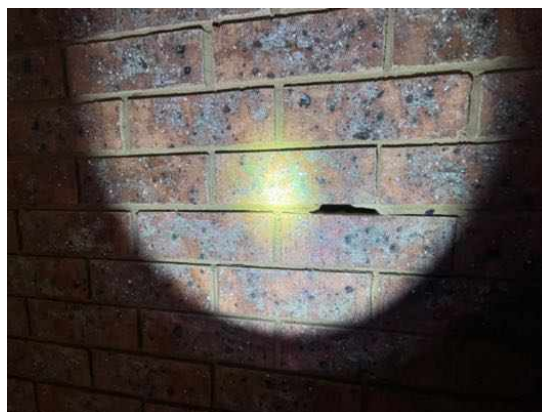
Defects 3.08

| Finding: | Brickwork - Deteriorated mortar |
| Information: | Mortar, or 'bedding', is the material which fills joints and intersections between bricks in masonry walls and structures. Sections of mortar in this brickwork were identified as having deteriorated, which is generally expected for a property of this age and condition. |

Mortar may deteriorate as a result of age of building materials, minor movement of bricks, or frequent exposure to weathering. Mortar should be replaced to ensure that bricks remain in their intended location and to prevent gaps, which would allow water or moisture ingress and secondary damage as a result.

Mortar deterioration can be addressed by a bricklayer where areas of deterioration are localised and easily accessible. Alternatively, appointment of a registered builder is advised, to repoint large areas of decaying mortar. Where secondary structural defects have become evident, consultation with a structural engineer may be required.

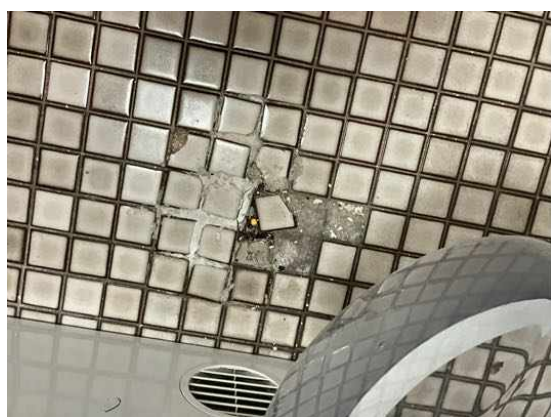
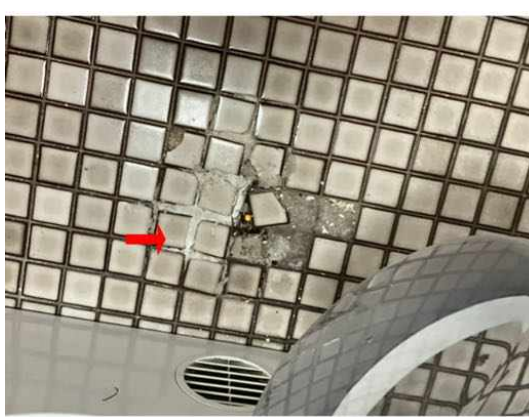
Defects 3.10

| Finding: | Tiles - Cracked or damaged |
| Information: | Cracking was evident to the tiling in this area at the time of inspection. While the |

cracking appears to be minor, this area is frequently exposed to water, allowing potential for water penetration into adjoining sections of walls or flooring.

If left unmanaged, water penetration to these areas may lead to subsequent water damage, which is likely necessitate repair work to affected building elements.

A tiling contractor should be appointed to ensure that no further water damage occurs. The re-application of silicone and grouting throughout remaining tile work is also advised, to further protect the area against water penetration.

Where water penetration has led to water damage, appointment of a relevant tradesperson may be required to repair damaged building elements.

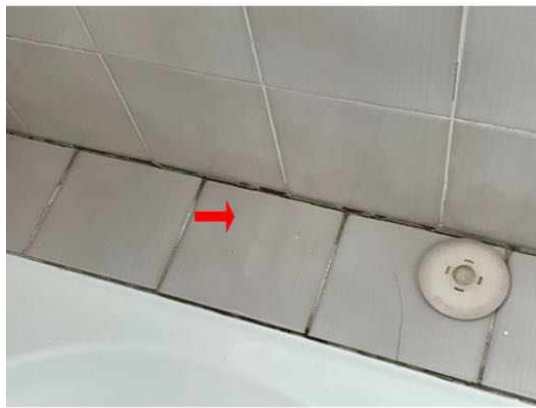
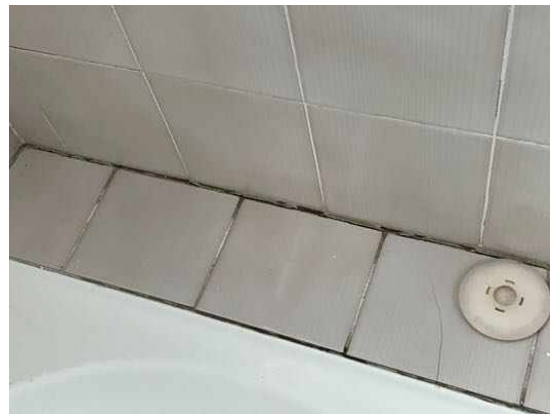
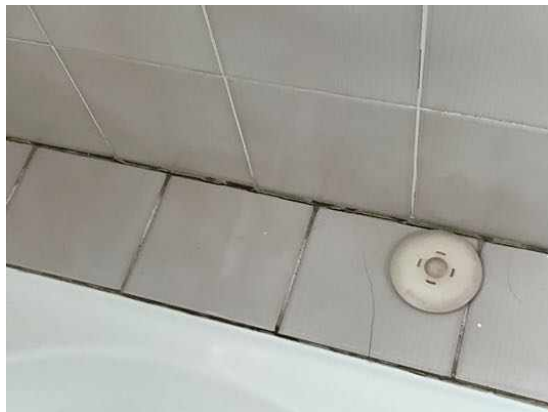
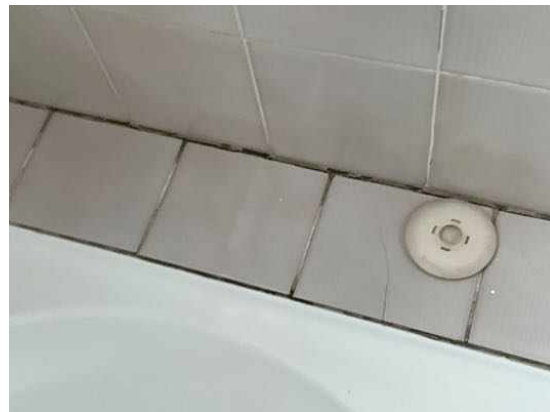
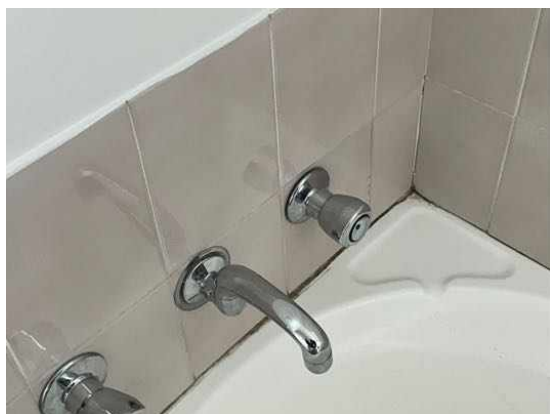
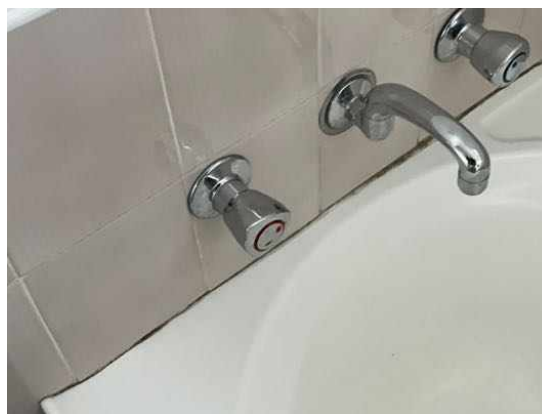
Defects 3.11

| Finding: | Sealant and grouting - Missing or damaged |
| Information: | It was noted on inspection that sealant or grout is degraded to the tiled shower alcove and or other areas of the bathroom. |

Different materials and floor areas move at different rates, generally causing cracking to grout or sealant at this point. A flexible sealant is required to allow for expected expansion and contraction, while keeping the joint water tight and protective of all

There appears to be excessive mould to the sealant and grout which will likely require scraping out and replacement.

Flexible and mould resistant materials should be applied to affected areas to prevent any subsequent water damage that is likely to occur. Regular maintenance and replacement of damage or missing or damaged sealant and grout is highly recommended to the wet areas, as this is a regular wear and tear defect. Sealant and grouting in areas that come into regular contact with water should be maintained for the long term care of your property.

A sealant specialist or tiling contractor should be appointed to complete these works as soon as possible

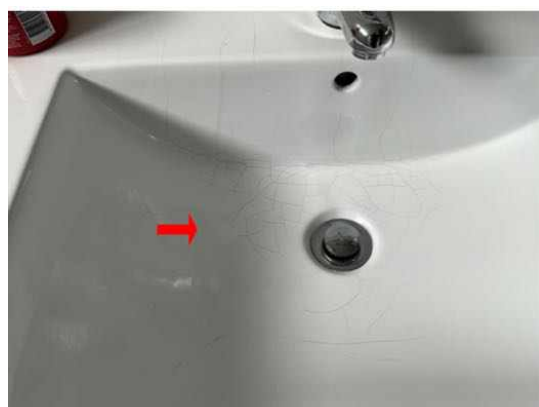
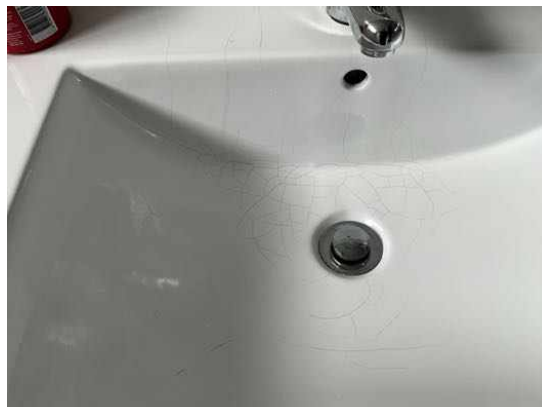
Defects 3.12

Finding: Basin - Cracked

Information: Cracking was evident to the basin at the time of inspection, which is suspected to have been by minor impact damage. While the cracking appears to be minor, any further impact damage sustained by the basin may lead to additional cracking.

As the cracking provides potential ingress for water, secondary water damage may occur to associated cabinetry, walls or flooring, if the cracking is left unmanaged.

Consultation with a plumber regarding basin repair or replacement is required. Remedial works may be required to protect against any further damage.

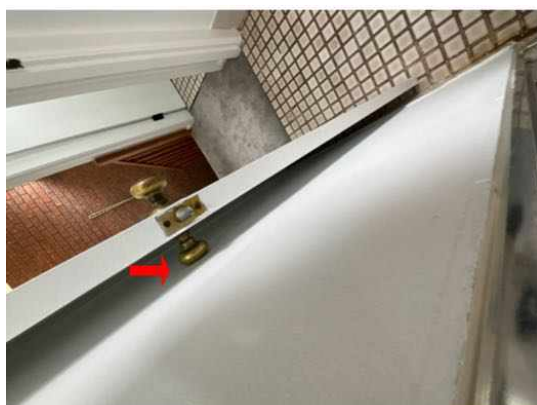
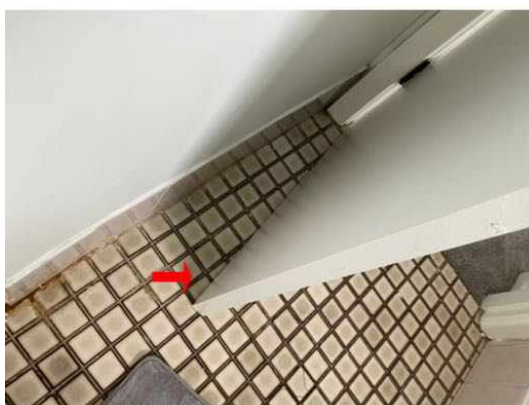
Defects 3.13

Finding: Missing Door Stopper

Information: The door lacks a stopper, which is essential to prevent the door from swinging too far and potentially damaging the wall or the door handle. The absence of a door stopper increases the likelihood of impact damage to both the door and surrounding surfaces

- **Damage Risk:** Moderate risk of damage to the door handle, wall, or door itself from repeated impacts when the door is opened forcefully or by a gust of wind.
- **Wear and Tear Risk:** Increased wear on door hardware and hinges due to the potential for abrupt stops without a dedicated stopper.

- **Engage a Handyperson or Carpenter:** A handyperson or carpenter should install a suitable door stopper to prevent excessive door movement. This could be a floor-mounted or wall-mounted stopper depending on the space and door design.

This issue is a minor defect but should be addressed to prevent potential damage and maintain the integrity of the door and surrounding areas.

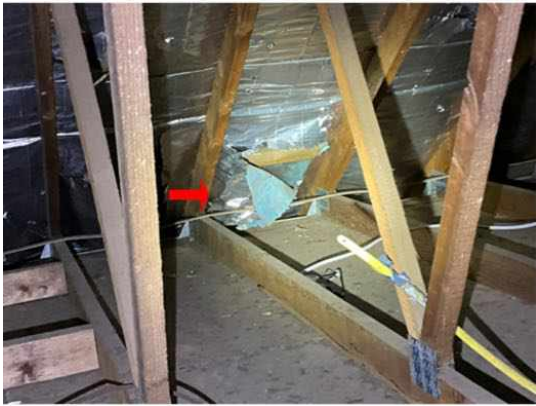
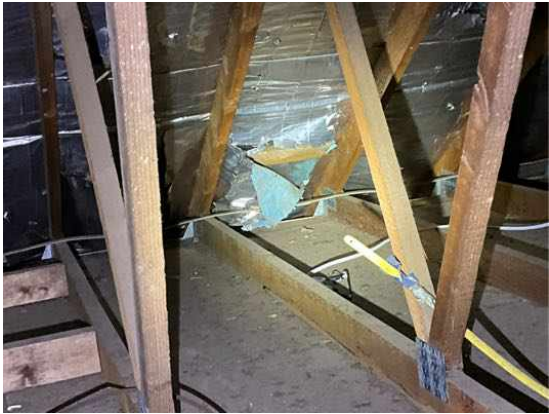
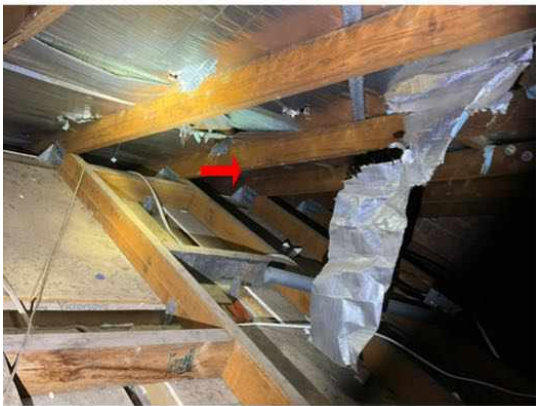
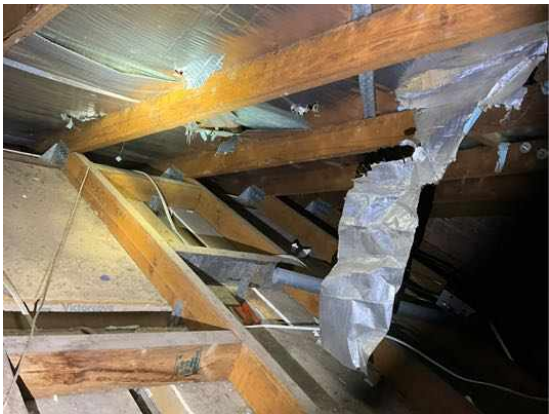
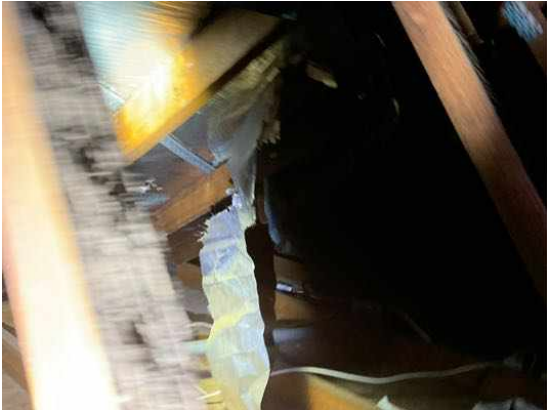
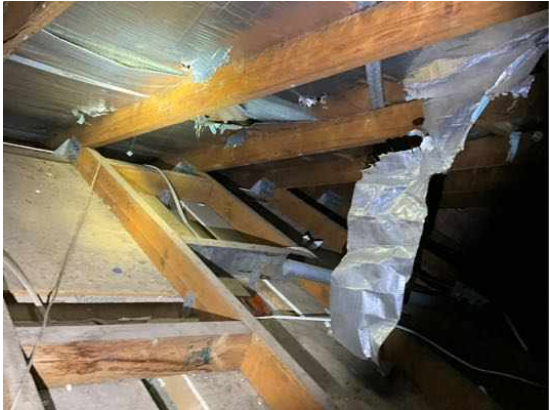
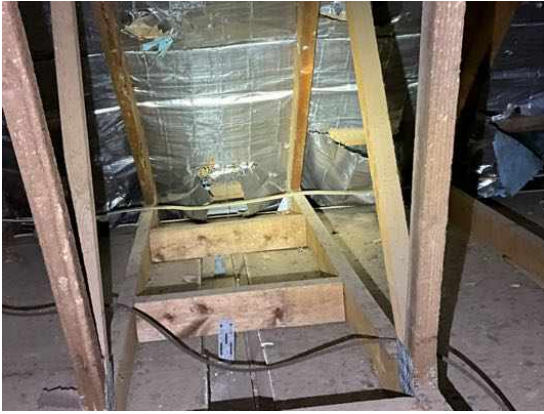
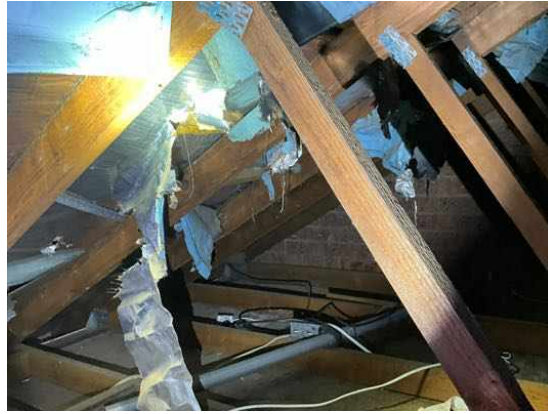
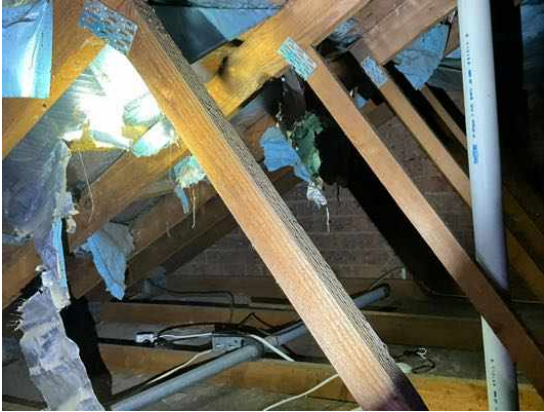
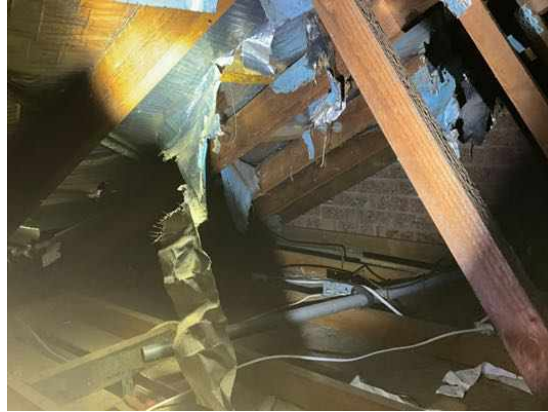
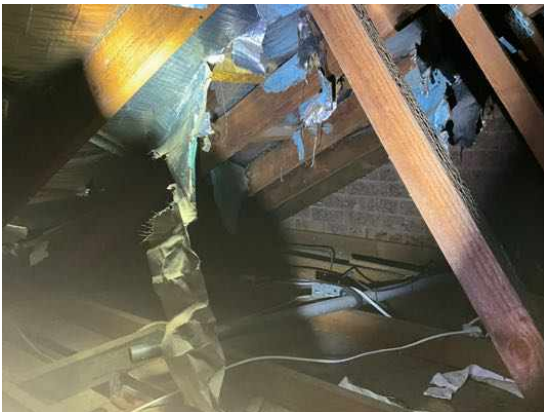
Defects 3.14

| Finding: | Sarking - Damaged |

Where sarking is damaged, both insulation and moisture protection of the property are inhibited. This creates a loss of energy and thus negatively impacts the energy efficiency of the property, allowing potential for moisture ingress from condensation or leaking roof tiles.

It is important to repair any holes or damaged sections of sarking to ensure that the building material is fully functional. A registered builder or qualified carpenter should be consulted to provide further advice on this defect and to perform rectification works at

client discretion.
