# Building Inspection Report

Inspection Date: Fri, 14 Nov 2025

Property Address: 2 Native Rdge, Pakenham VIC 3810,  
Australia

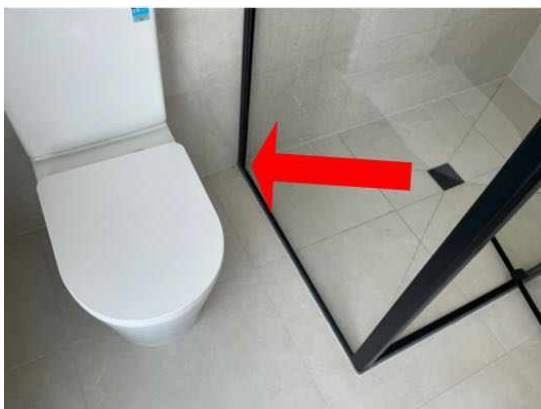
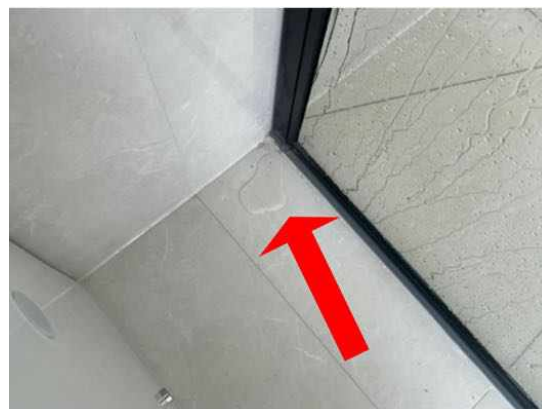
#### Defects 3.01

Building: Main Building  
 Location: Ensuite - Master  
 Finding: Shower screen - Leaking  
 Information: Leaking was evident to the master ensuite's shower screen at the time of inspection. It is suspected that the leaking has occurred as a result of deteriorated or missing caulking to the shower or general ageing of the building elements.

Leaking from the shower where left unattended, is likely to lead to water damage to adjoining flooring and walls. Such damage can lead to water damage and necessitate extensive remedial works being required. Active water leaks may also create an environment that is susceptible to the formation and development of mould.

Appointment of a caulking contractor is required to repair or replace the caulking to the shower area. Such works should be performed as soon as possible to ensure that no further damage occurs.

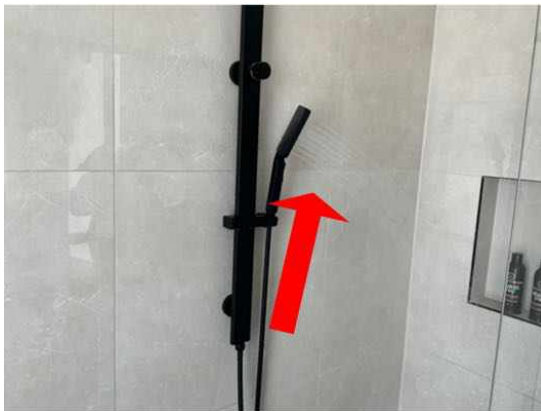
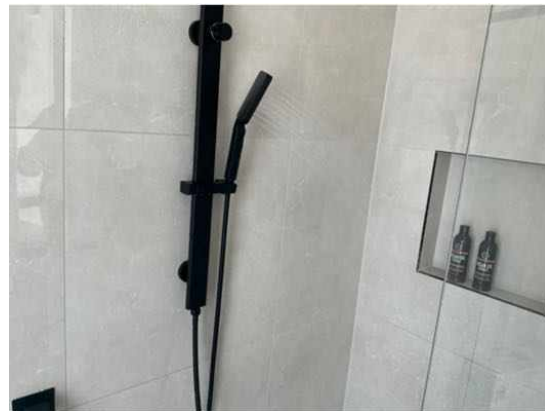
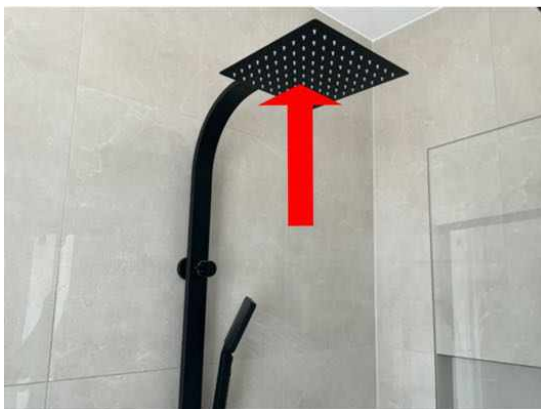
#### Defects 3.02

Building: Main Building  
 Location: Ensuite - Master

Finding: Inadequate Shower Water Pressure and Malfunctioning Shower Head

At the time of inspection, the water pressure in the ensuite shower was observed to be weak. Additionally, the main shower head was not operating effectively, as water was not discharging uniformly through all of the spray holes in the shower head.

This condition may indicate a blockage, internal fault within the shower head, sediment build-up, or a possible issue with the plumbing fixture or water pressure supply. Poor water distribution through the shower head reduces the functionality of the fixture and affects the normal operation of the shower.

A licensed plumber should be engaged to inspect the shower head and associated plumbing components, clean or replace the shower head if required, and rectify the water pressure issue to ensure the shower operates effectively. If the property is under builder's warranty, the builder should arrange for the necessary plumbing rectification works to be carried out.

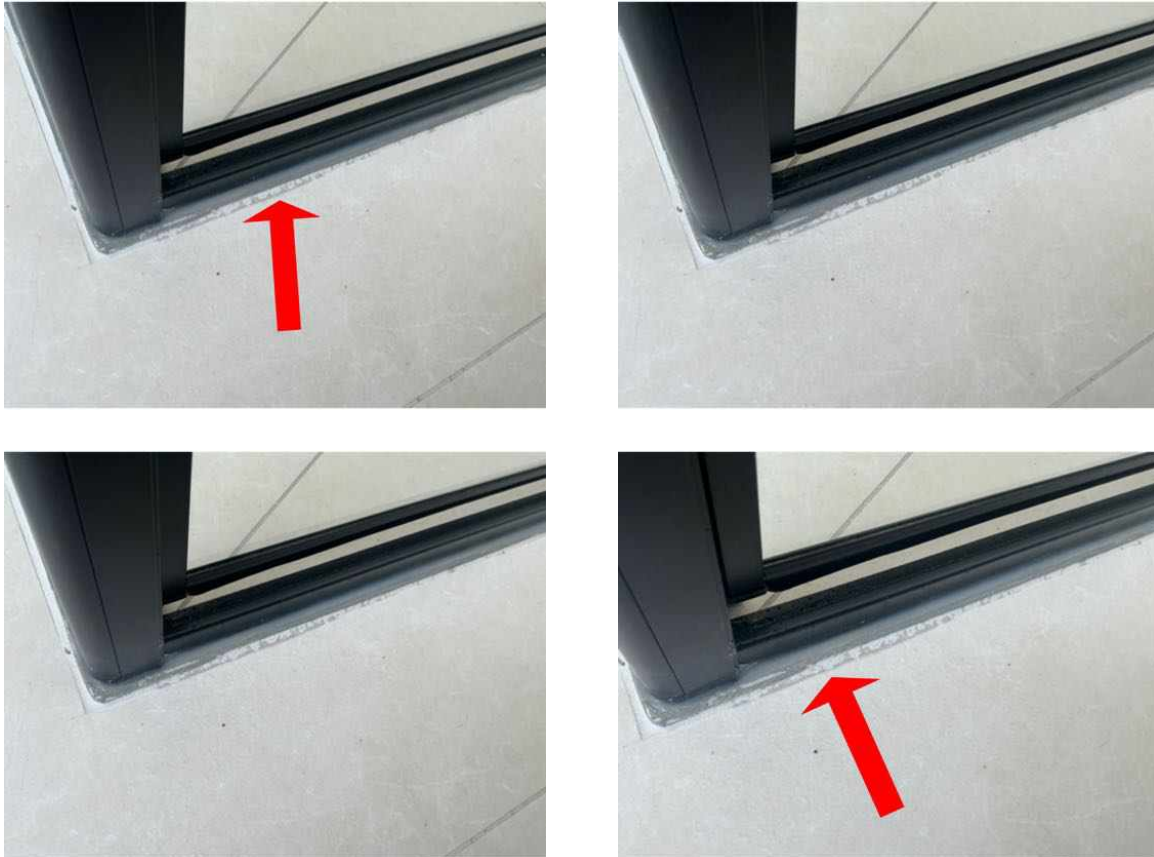
### Defects 3.03

Building: Main Building  
 Location: Ensuite - Master  
 Finding: Defective Caulking to Ensuite Shower  
 Information:

observed to be poorly applied and inconsistent in finish. The sealant appears uneven and inadequately finished in several sections.

It is recommended that the existing caulking be completely removed and the affected areas properly cleaned and prepared. A professional caulking specialist should then reapply a suitable wet-area grade silicone sealant to achieve a neat, continuous, and effective seal.

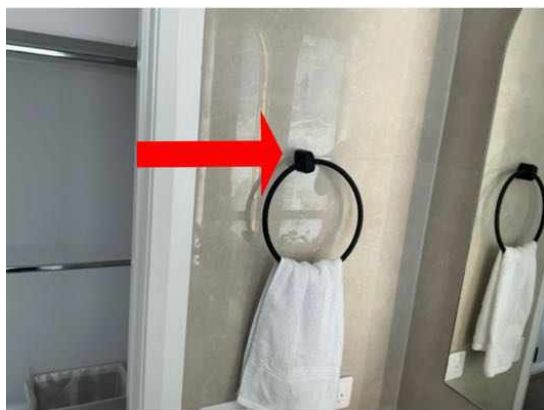
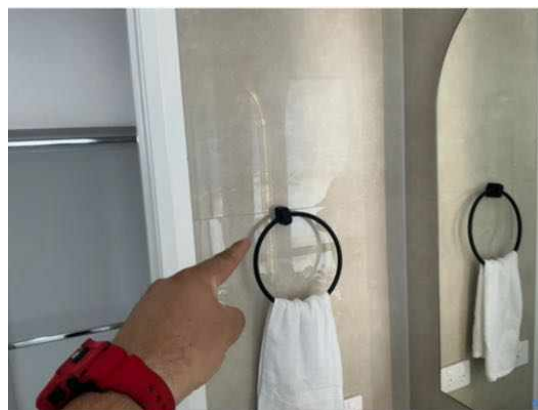
### Defects 3.04

Building:	Main Building
Location:	Ensuite - Master
Finding:	Towel holder - Loose
Information:	Upon visual inspection, we found that the towel holder in the master en-suite is loose. This condition may affect its functionality and could lead to further damage if not addressed.

Re-tightening or replacement of these fixtures is advised to ensure proper use and prevent any subsequent issues. A relevant tradesperson may be appointed to perform these works at the client's discretion.

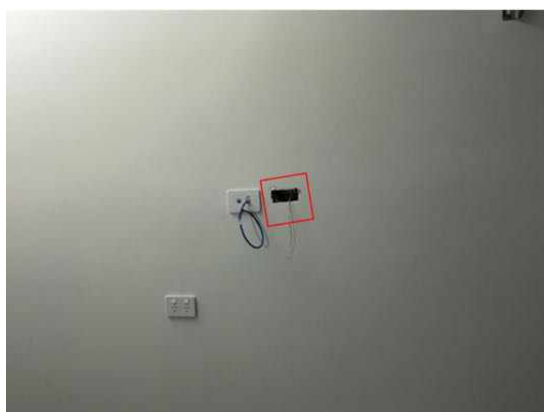
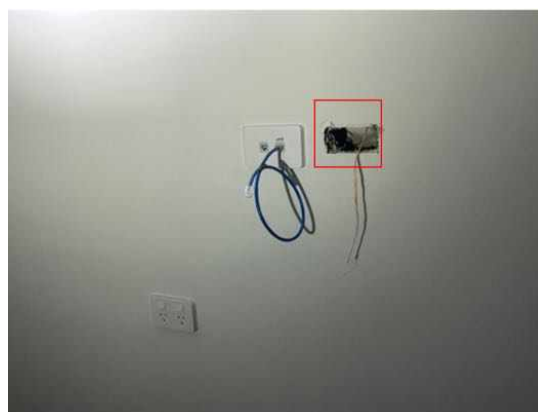
### Defects 3.05

Building: Main Building  
 Location: Garage  
 Finding: Incomplete Electrical/Data Provision and Unfinished Wall Opening in Garage  
 Information:

At the time of inspection, an unfinished wall opening was observed in the garage wall adjacent to the installed data/NVR outlet plate. The opening exposes loose low-voltage cables and the internal cavity of the wall. The wall penetration has not been properly finished, sealed, or fitted with a suitable mounting box or cover plate.

Leaving wiring exposed and wall penetrations unfinished presents a poor workmanship outcome and may allow dust, pests, or debris to enter the wall cavity. It also does not represent a completed or properly finished installation for electrical or communication services.

The builder should arrange for a licensed electrician to properly terminate the cables, install the appropriate wall box and cover plate, and repair and patch the surrounding plasterboard to provide a neat and fully finished installation. The wall surface should then be made good and repainted to match the surrounding finish.

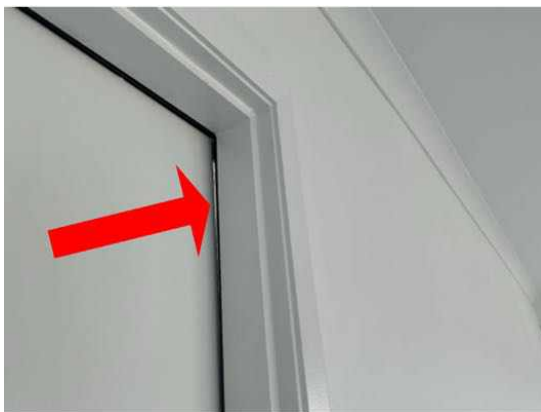
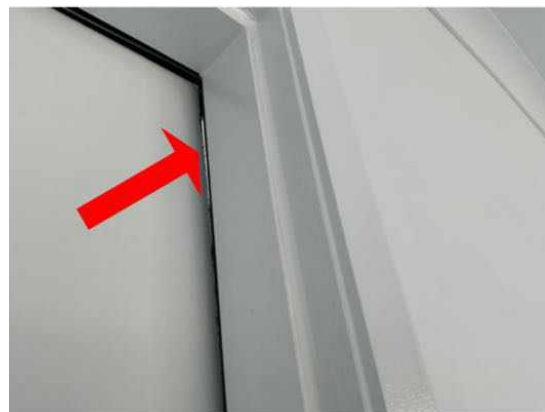
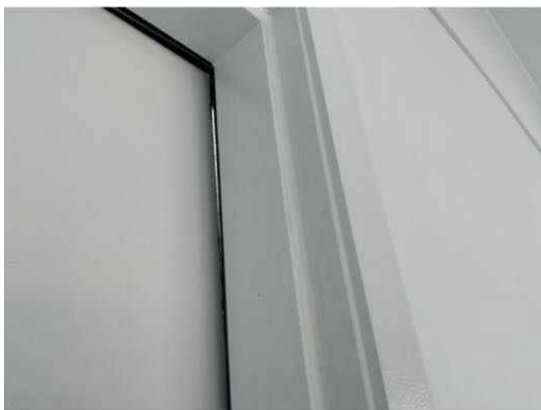
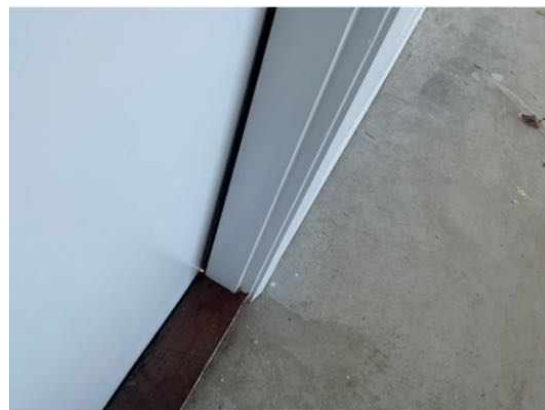
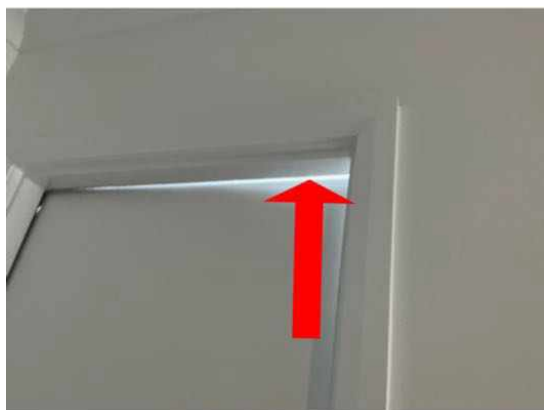
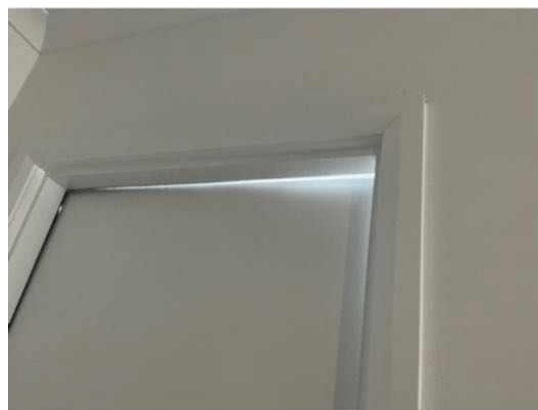
### Defects 3.06

At the time of inspection, the rear access door to the garage was found not to close properly and does not shut tightly against the door frame. The door appears to be misaligned, preventing it from sitting flush within the frame when closed.

A door that does not close or latch properly may compromise security, weather tightness, and normal operation of the door assembly. Proper alignment is required to ensure the door functions as intended and provides an effective seal when closed.

The builder should arrange for a qualified carpenter to return to site to adjust and realign the door, including the hinges, striker plate, and latch mechanism as required, to ensure the door closes smoothly and sits flush within the frame for proper operation and safety.

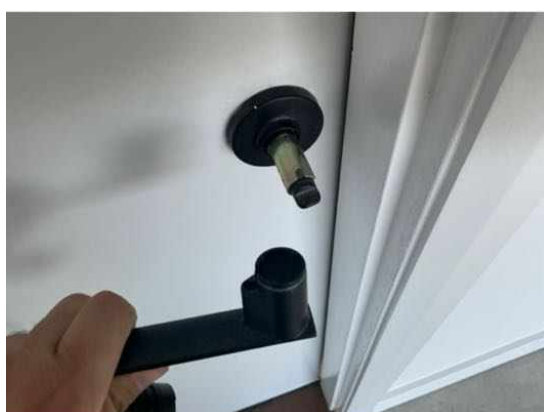
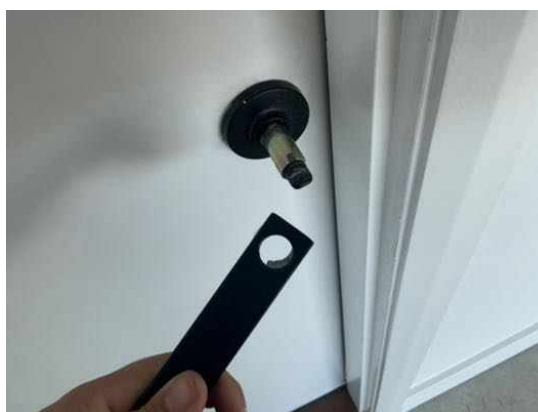
### Defects 3.07

Building: Main Building  
 Location: Garage  
 Finding: Loose and Defective Door Handle – Rear Garage Access Door  
 Information:

At the time of inspection, the door handle to the rear access door of the garage was found to be loose and not operating properly. The handle mechanism does not return smoothly and does not engage or disengage the latch consistently, indicating a possible defect in the handle assembly or improper installation.

A loose or malfunctioning door handle can affect the proper operation and security of the door and may lead to premature failure of the hardware if left unaddressed.

The builder should arrange for a qualified carpenter to return to site to properly secure the door handle assembly and adjust the latch mechanism as required. If the handle unit is found to be defective, it should be replaced with a suitable new door handle set to ensure the door operates smoothly and latches securely.

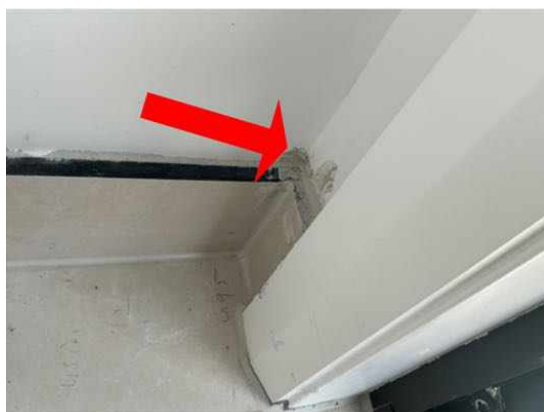
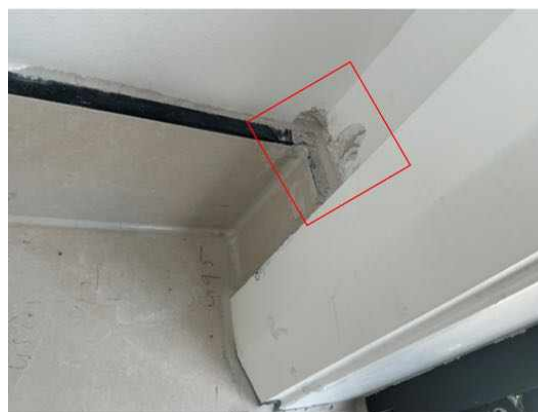
### Defects 3.08

Building: Main Building  
 Location: Laundry  
 Finding: Poor Finishing and Sealant Application – Laundry Door Frame Area

At the time of inspection, the internal corner adjacent to the laundry door frame was observed to have a poor and untidy finish. The sealant applied at the base of the wall was non-uniform and inconsistently applied, resulting in an unsatisfactory visual outcome. The surrounding painted surfaces also appear to have been finished poorly.

Substandard finishing and inconsistent sealant application detract from the overall workmanship and presentation of the dwelling and are not considered an acceptable standard for a newly completed property at handover.

The builder should arrange for a qualified painter/decorator to return to site to properly prepare the affected area, including sanding and smoothing the surfaces as required. The sealant should be removed and reapplied neatly and uniformly, and the wall surfaces should then be repainted to achieve a consistent and professional finish.

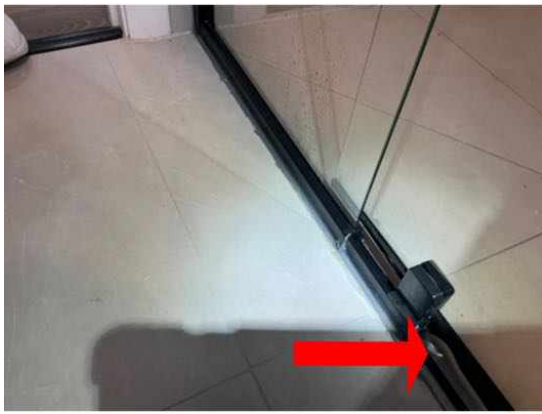
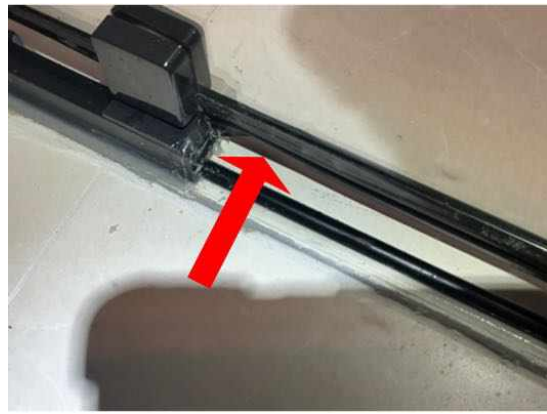
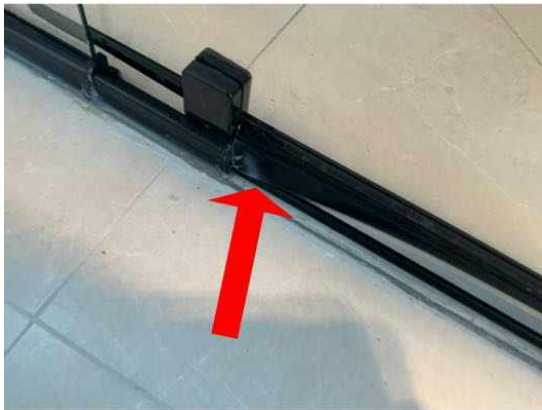
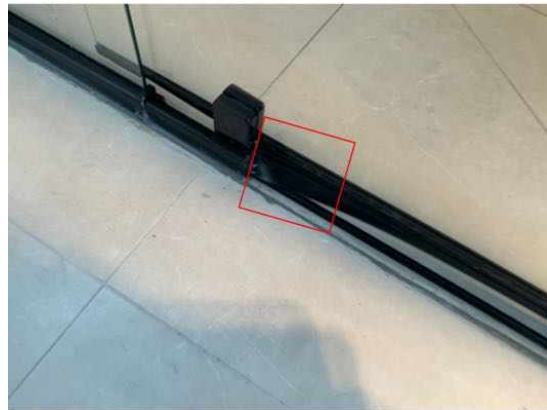
### Defects 3.09

Building: Main Building  
 Location: Bathroom 2  
 Finding: Defective Shower Door Weather Seal – Main Bathroom  
 Information:

At the time of inspection, the weather trim (bottom seal) to the shower screen door in the main bathroom was found to be improperly installed. The trim was observed to move and flip when the shower door is opened and closed, indicating that it has not been securely fitted or correctly installed.

An improperly installed shower door seal may compromise the effectiveness of the shower screen in containing water within the shower area and represents poor workmanship for a newly completed installation.

The builder should arrange for a qualified shower screen installer to remove the existing weather trim and replace it with a suitable new shower door seal. The new trim should be properly fitted and secured to ensure it remains stable during operation of the shower door and functions effectively to prevent water escape.

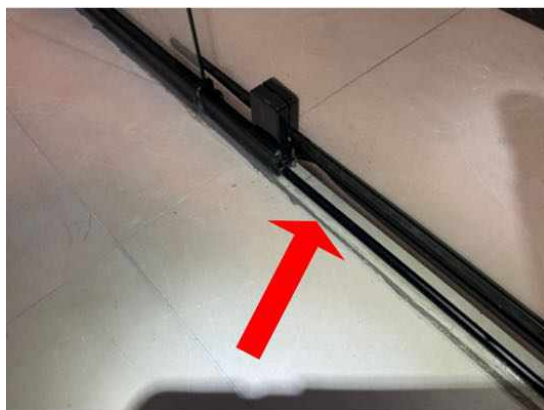
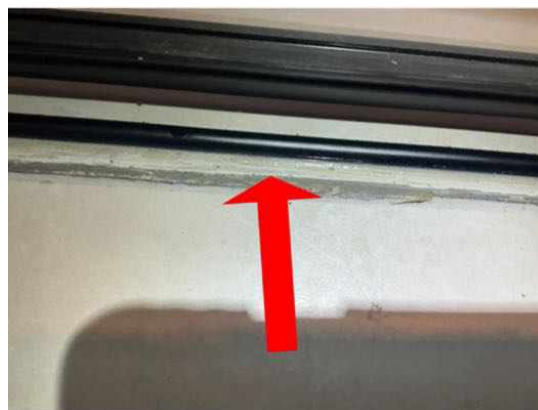
### Defects 3.10

Building: Main Building  
 Location: Bathroom 2  
 Finding: Defective Sealant Application – Main Bathroom Shower Perimeter  
 Information:

At the time of inspection, the sealant application around the external perimeter of the shower in the main bathroom was observed to be poorly executed. The silicone sealant was applied inconsistently, resulting in a non-uniform and untidy finish that does not reflect an acceptable standard of workmanship for a newly completed dwelling.

The builder should arrange for a professional caulking specialist to return to site to completely remove the existing sealant, properly prepare the surfaces, and reapply a suitable wet-area grade silicone sealant in a neat, continuous, and uniform manner.

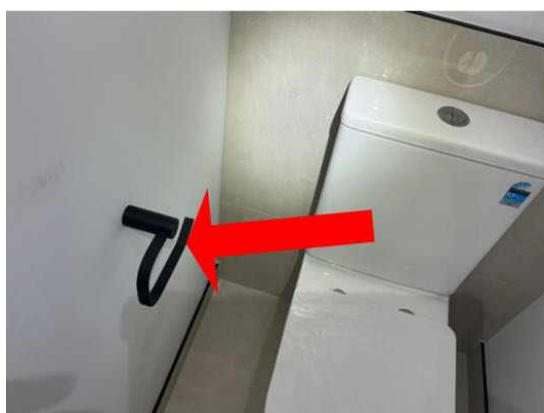
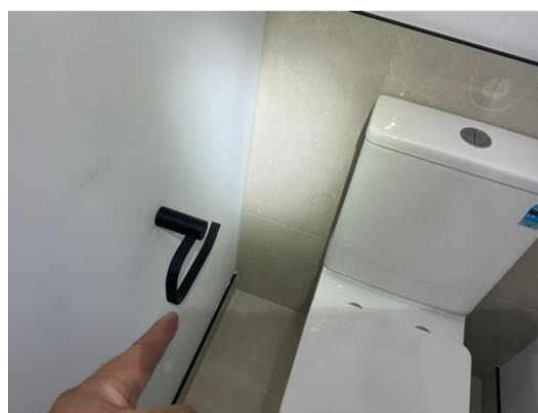
### Defects 3.11

Building:	Main Building
Location:	Toilet (WC)
Finding:	Toilet roll holder - Loose
Information:	The toilet roll holder was found to be loose at the time of inspection. While not a major operational defect, function can deteriorate if the problem is left unmanaged.

It is advised that the homeowner performs remedial works to re-attach the toilet roll holder to its original fixing. A general handyperson may be required to perform these works.

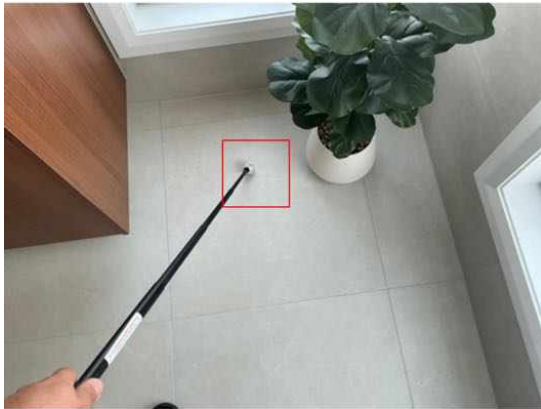
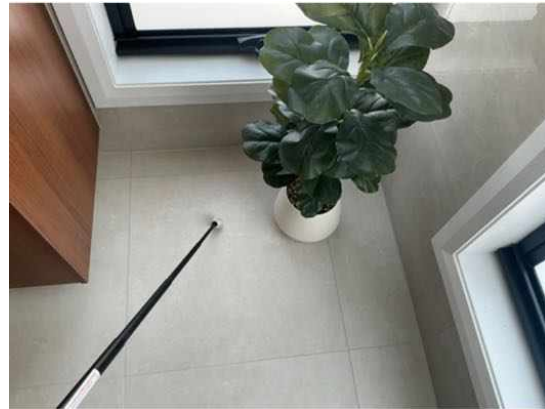
### Defects 3.12

Building:	Main Building
Location:	Ensuite - Master
Finding:	Drummy Floor Tile – Master Ensuite
Information:

As per the photo below, a floor tile located adjacent to the vanity unit in the master ensuite was found to be drummy when tapped during the inspection. This condition indicates that the tile has not been adequately bonded to the substrate beneath, suggesting insufficient adhesive coverage or poor adhesion to the concrete slab.

Drummy tiles are at an increased risk of loosening, cracking, or detaching over time,

particularly in wet areas that experience regular foot traffic and moisture exposure.

The builder should arrange for a qualified tiler to return to site to carefully remove the affected tile, inspect and prepare the substrate as required, and reinstall the tile using an appropriate tile adhesive to ensure full and proper bonding to the slab. The tile should then be re-grouted and finished to match the surrounding tiles.

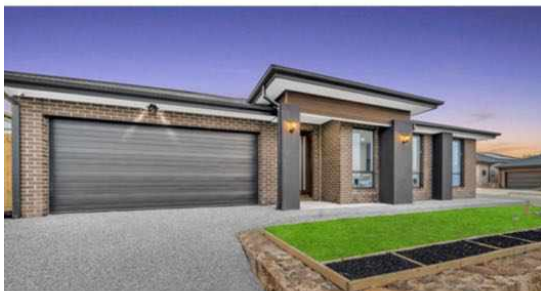
### Defects 3.13

Building: Main Building  
 Location: Front Elevation  
 Finding: Missing Mailbox Installation  
 Information:

At the time of inspection, no mailbox was observed to be installed at the property.

A mailbox is a required external fixture to allow for the delivery of mail and should be installed as part of the completion works of a residential dwelling.

The builder should arrange for the installation of a suitable mailbox at the front boundary of the property in an appropriate and accessible location for postal delivery. The mailbox should be securely installed and compliant with relevant postal service guidelines.

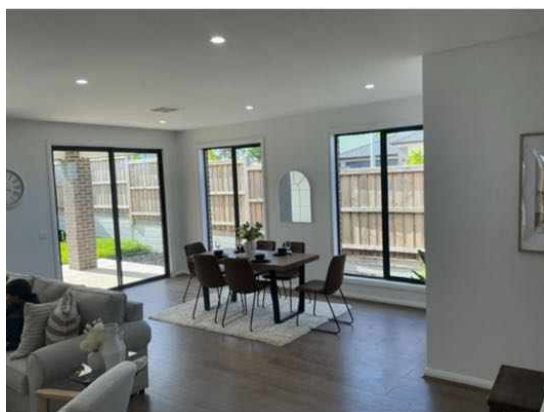
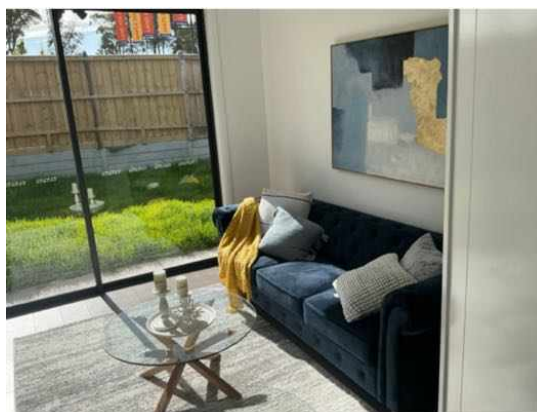
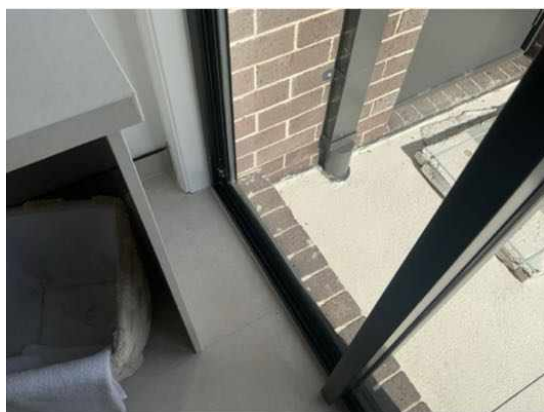
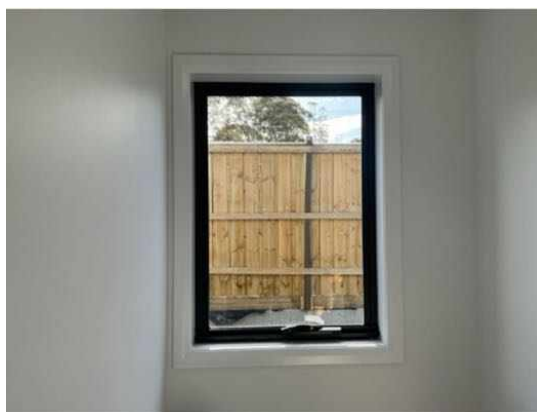
### Defects 3.14

Building: Main Building  
 Location: All Internal Areas  
 Finding: Missing Fly Screens to Windows  
 Information:

At the time of inspection, no fly screens were observed to be installed to the windows throughout the dwelling.

Fly screens are typically included as part of the standard fixtures for a newly completed dwelling and are important to allow occupants to ventilate the home while preventing insects and pests from entering the property.

The builder should arrange for suitable fly screens to be supplied and installed to all applicable openable windows in accordance with the project specifications and standard residential building practice. The fly screens should be securely fitted and operate properly with the window frames.

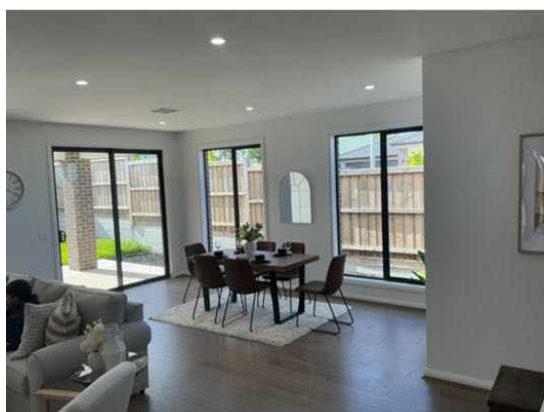
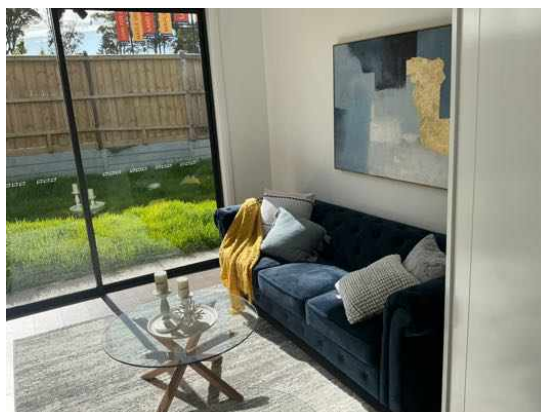
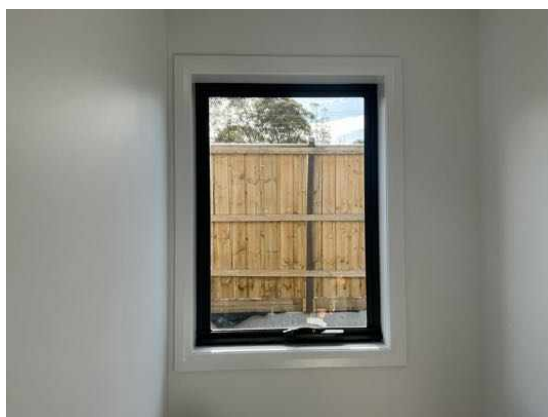
### Defects 3.15

Building: Main Building  
 Location: All Internal Areas  
 Finding: Missing Window Furnishings / Blinds

Information: At the time of inspection, no window furnishings or blinds were observed to be installed to any of the windows throughout the dwelling.

The absence of window coverings affects privacy, light control, and the overall completion of the dwelling at handover. Where window furnishings form part of the building contract or specification, they should be installed prior to practical completion.

The builder should arrange for suitable window furnishings or blinds to be supplied and installed to all applicable windows in accordance with the building contract or project specifications. The installations should be securely fitted and operate smoothly.

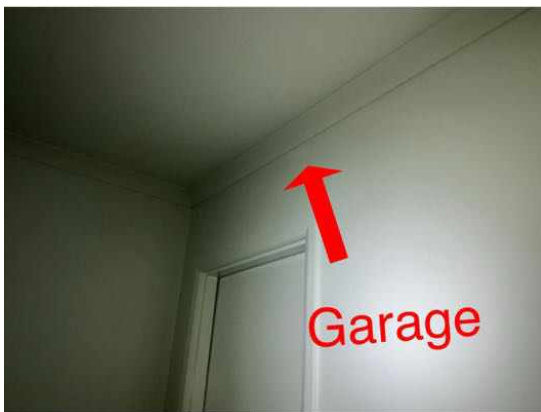
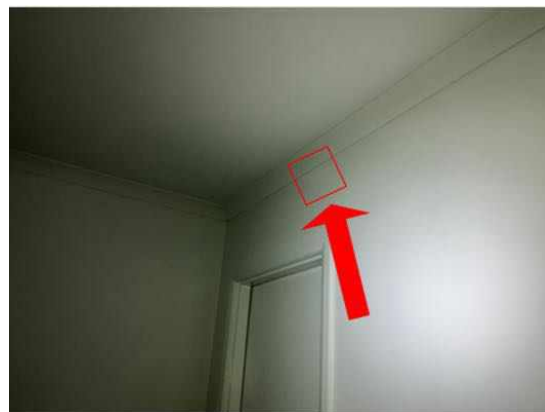
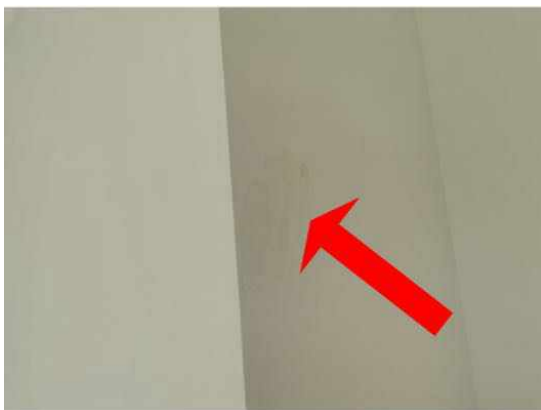
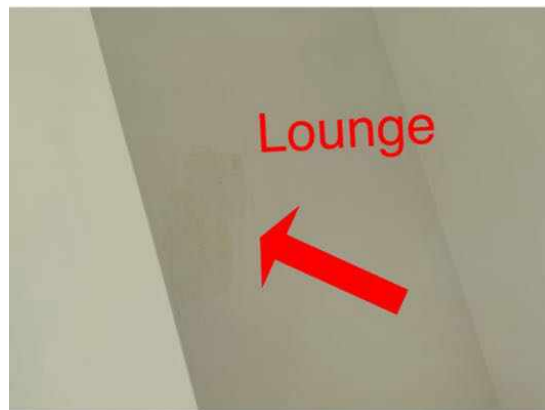
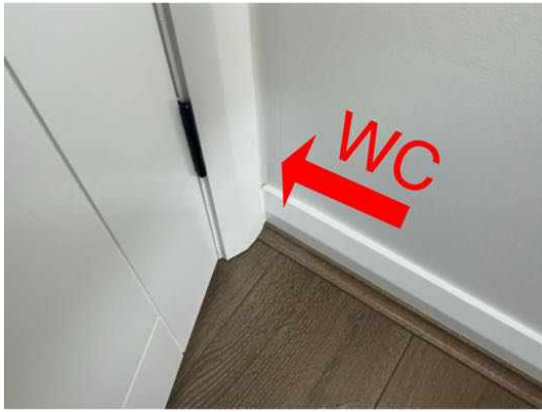
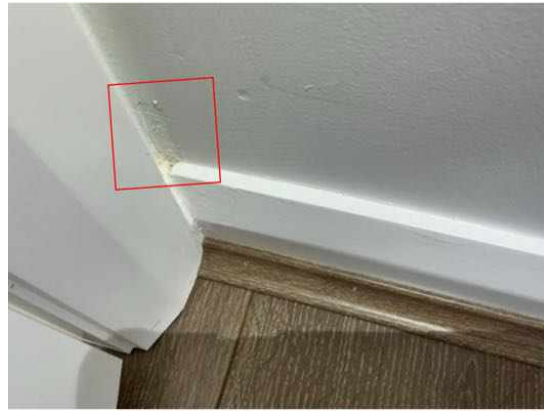
### Defects 3.16

Building: Main Building  
 Location: All Internal Areas  
 Finding: Multiple Paint Finish Defects  
 Information:

At the time of inspection, several paint finish defects were observed in different areas of the dwelling. These included a section above the garage access door where the paint colour appears inconsistent with the surrounding surface, noticeable paint discolouration to the wall in the lounge room, and poor paint finish near the skirting

boards in the WC. In addition, certain areas showed inconsistent paint application and finish, indicating inadequate surface preparation prior to painting.

Such defects detract from the overall presentation and workmanship of the property and are not consistent with the expected finish of a newly completed dwelling.

The builder should arrange for a qualified painter/decorator to return to site to inspect the affected areas, properly prepare the surfaces where required, including sanding and surface preparation, and repaint the areas to achieve a consistent colour and uniform finish matching the surrounding surfaces.

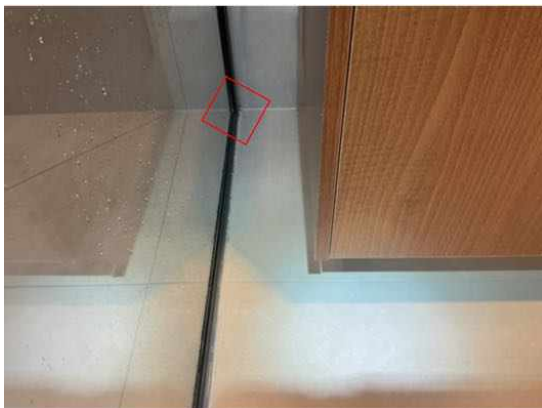
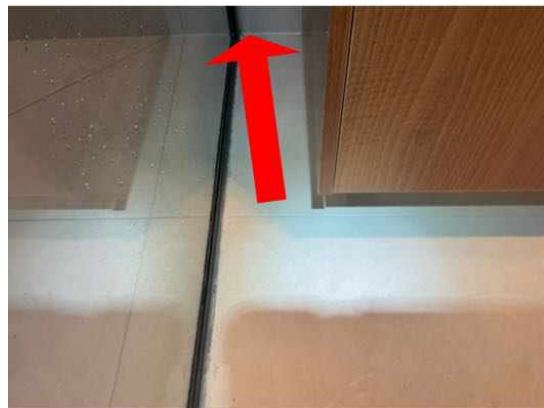
### Defects 3.17

Building:	Main Building
Location:	Bathroom 2
Finding:	Shower screen - Leaking
Information:	Leaking was evident to the general bathroom's shower screen at the time of inspection. It is suspected that the leaking has occurred as a result of deteriorated or missing caulking to the shower or general ageing of the building elements.

Leaking from the shower where left unattended, is likely to lead to water damage to adjoining flooring and walls. Such damage can lead to water damage and necessitate extensive remedial works being required. Active water leaks may also create an environment that is susceptible to the formation and development of mould.

Appointment of a caulking contractor is required to repair or replace the caulking to the shower area. Such works should be performed as soon as possible to ensure that no further damage occurs.

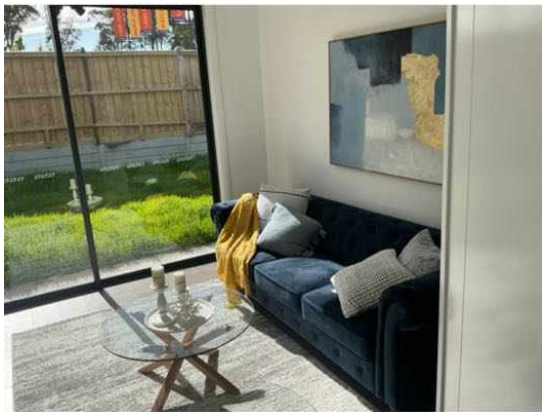
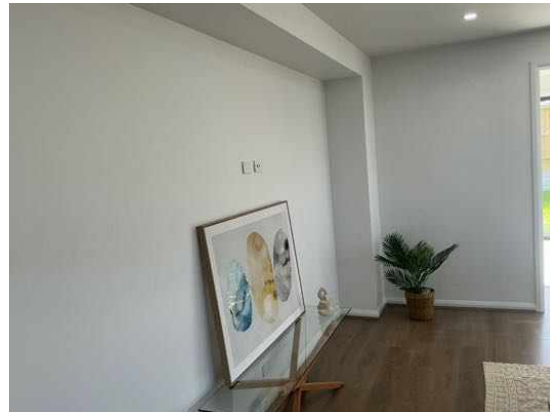
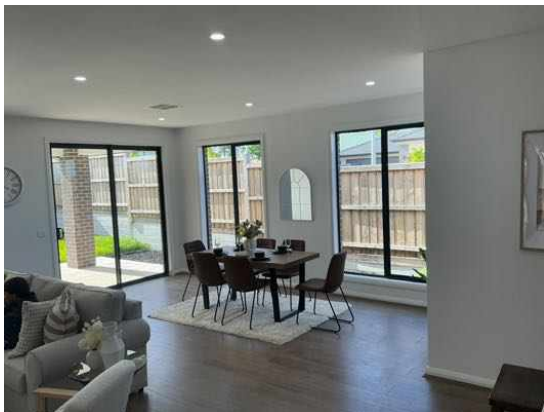
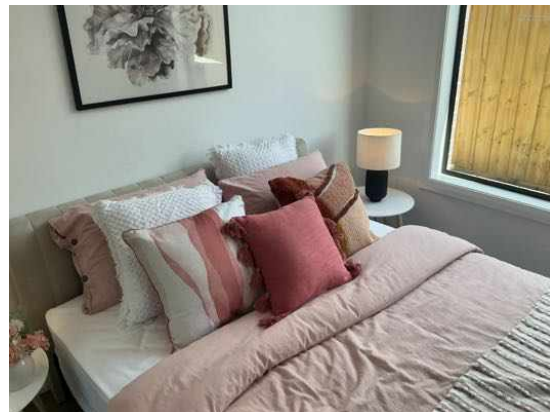
#### Noted Item

Building: Main Building  
 Location: All Areas  
 Finding: Obstructions and Limitations - Interior  
 Information: These photographs are an indication of the obstructions and limitations which impeded the inspection of the internal areas of the property at the time of inspection. These obstructions can hide an array of defects and should be removed to allow full inspection to be carried out. A re-inspection is recommended once the areas are made accessible.

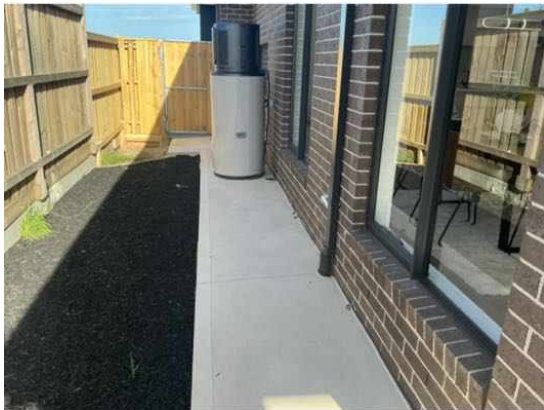
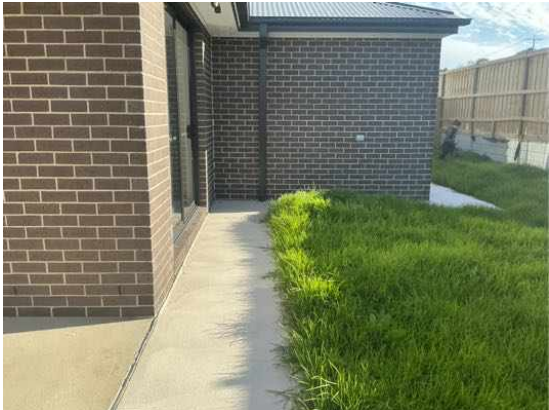
#### Noted Item

Building: Main Building  
 Location: All External Areas  
 Finding: Obstructions and Limitations - Exterior  
 Information: These photographs are an indication of the obstructions and limitations which impeded the inspection of the external areas of the property at the time of inspection.

These obstructions can hide an array of defects and should be removed to allow full inspection to be carried out. A re-inspection is recommended once the areas are made accessible.
