## Building and Timber Pest Inspection Report

Inspection Date: Sat, 7 Feb 2026

Property Address: 14/818 Victoria Rd, Ryde NSW 2112,  
Australia

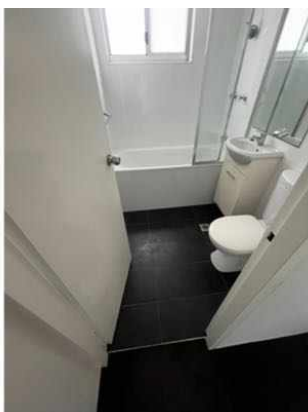
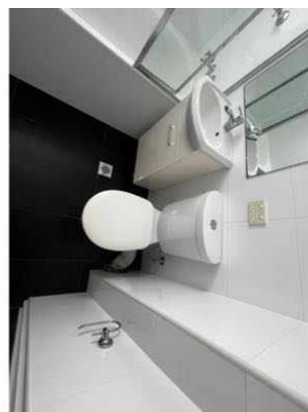
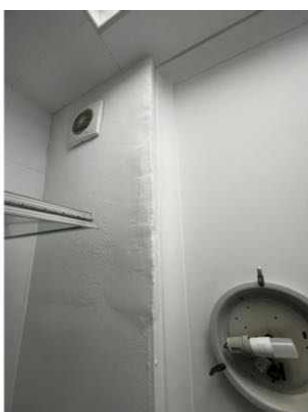
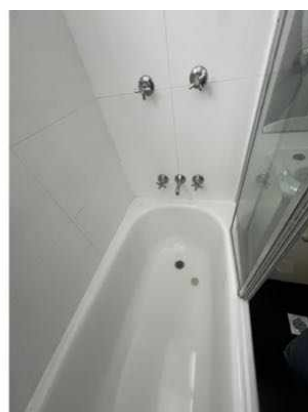
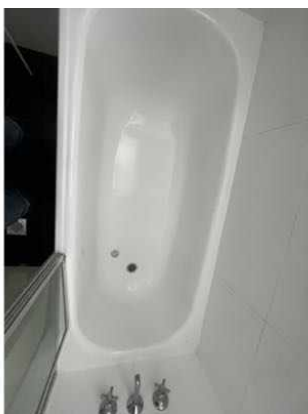
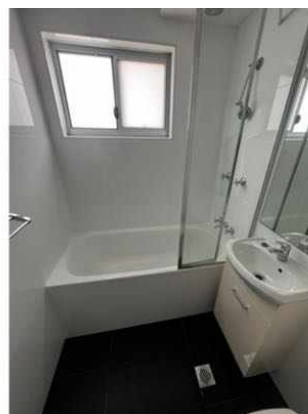
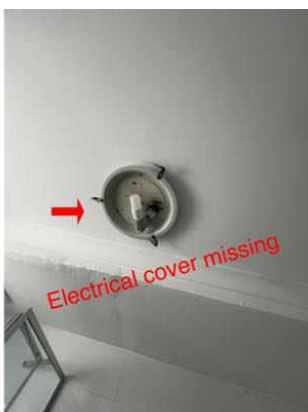
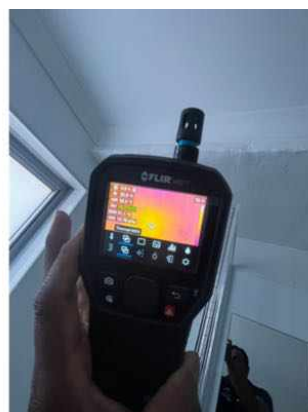
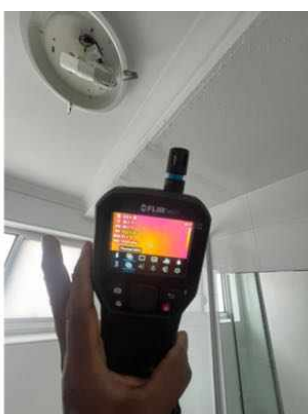
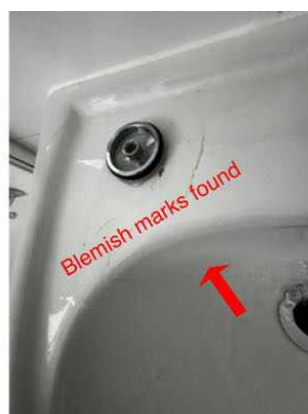
#### Finding 3.01

Building: Main Building  
Location: Bathroom >  
Finding: For information only  
Information: No remedial works are required at the current time.

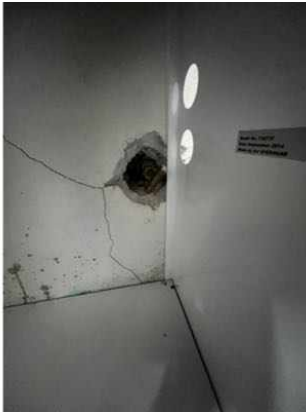
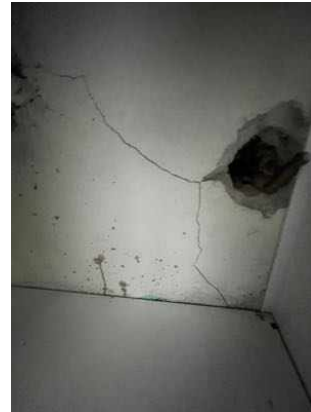
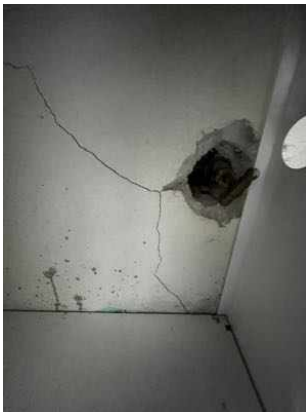
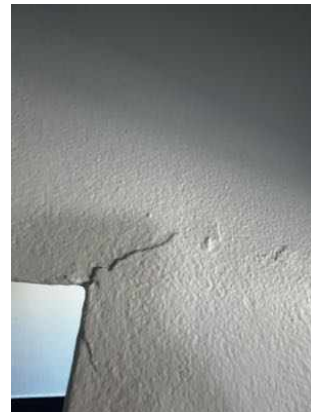
### Finding 3.02

Building:	Main Building
Location:	Laundry Tub area
Finding:	Render cracking - Evident
Information:	Noticeable cracks are a result of many primary defects. Such causes may include age, general wear and tear, expected building movement, general expansion/contraction of building materials in different weather conditions, and/or minor failings in the installation or application of building materials.

The most important cause for the crack of render could be the moisture being trapped between the render and the wall. It could be also be due to poor application and also the sub standard matériels being used.

Extreme heat and cold weather could have also impacted the settlement of applied render. It can also be the cause of Base coat being expanded more than the Top coat being applied.

Relevant tradespeople, Licensed Renderer , Licensed Builder should be consulted before arriving at a decision to take action as they can further do an invasive inspection and remedy the situation.

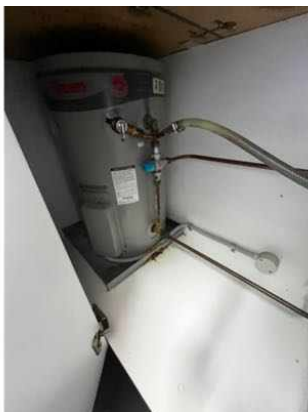
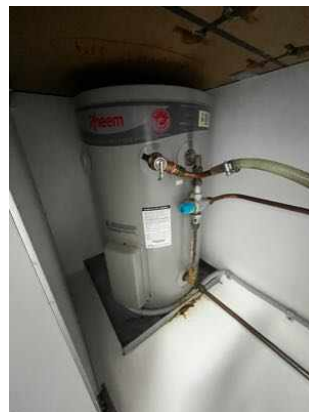
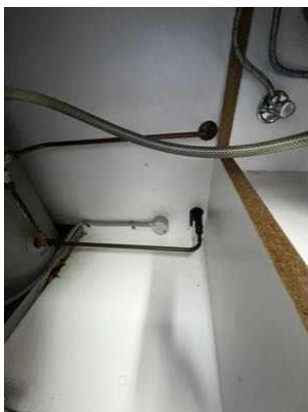
### Finding 3.03

Building:	Main Building
Location:	Laundry
Finding:	Hot Water Unit
Information:	The Hot Water Unit could not be inspected as there was no power at the property.

Water pressure appears to be normal, however, this is not an opinion of a licensed plumber. No water hammer was noted when taps are turned off fast.

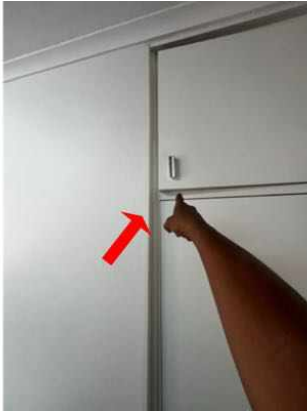
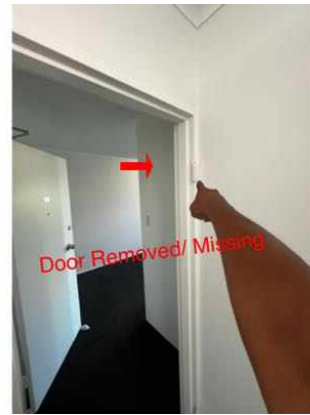
### Finding 3.04

Building:	Main Building
Location:	Bedroom
Finding:	Door - Binding/jamming
Information:	At the time of inspection, it was noted that the Pantry Door was not sufficiently binding.

Binding and/or jamming of this door is evident during standard operation. This defect inhibits the functionality of the affected door as well as creating potential for secondary defects to associated building elements.

A door that binds to the associated door frame may have several causes, ranging from minor defects, such as poor installation of the door or deteriorated hinges.

For minor causes, a qualified carpenter or general handyperson should be appointed to perform minor rectification works at client discretion.

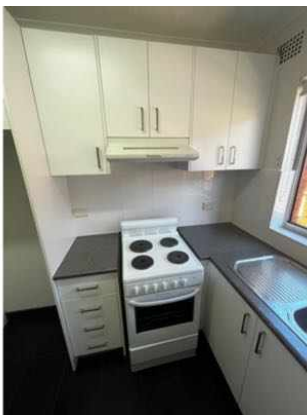
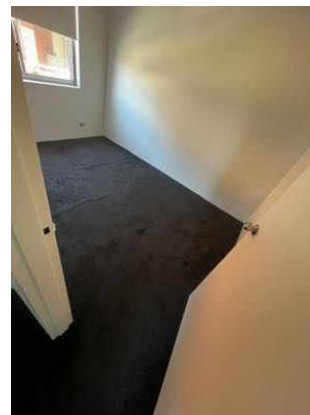
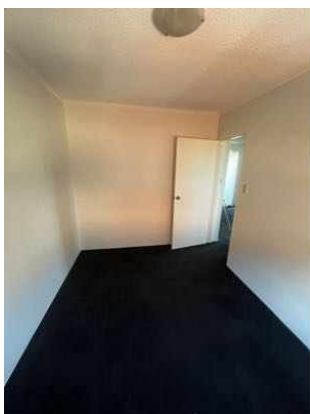
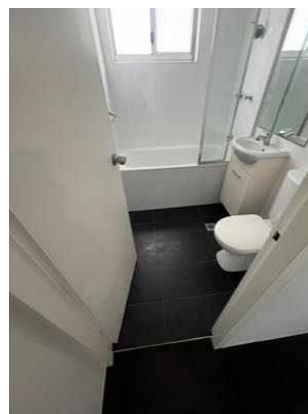
### Finding 6.01

Building:	Main Building
Location:	All Areas
Finding:	Additional Photos - Obstructions and Limitations
Information:	These photographs are an indication of the obstructions and limitations which impeded full inspection of the property at the time of inspection. These obstructions can hide an array of defects and should be removed to allow full inspection to be carried out. A re-inspection is recommended once the areas are made accessible.

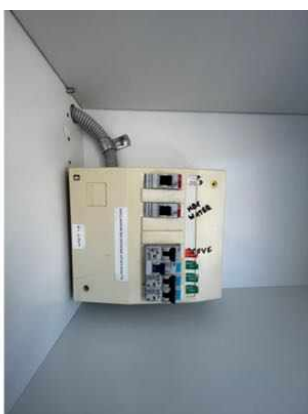
### Finding 6.02

Building:	Main Building
Location:	Electrical Switchboard
Finding:	Termite Management System - no evidence of a chemical installation no Durable Notice
Information:	The application of a post-construction chemical termite barrier is highly recommended for all properties, particularly if live termite activity has been found on the site previously. Such barriers are highly effective in preventing termite attack on any timber building elements throughout the property.

A durable notice should be placed in the switchboard unit to indicate current termite barriers. At the time of inspection, it appeared as though no termite management system has been installed, with no evidence to suggest preventative works taking place.

The client may consider gaining further advice from a pest controller as to the costs and procedures involved with this application. It is recommended that obtaining such advice be a short-term priority.

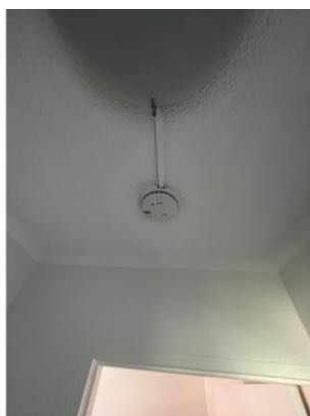
Building: Main Building  
 Location: All Internal Areas  
 Finding: Smoke Detector and Alarms  
 Information: Reporting on Smoke Detectors or Alarms, including hard wired smoke detection systems and their legislative requirements, is outside the Scope of this Report.

Additionally, it is advised that all smoke detectors be tested by the homeowner on a monthly basis.

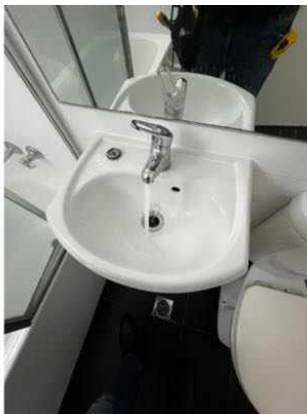
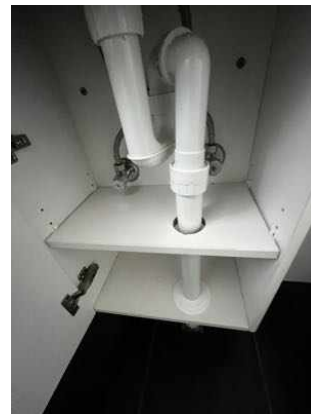
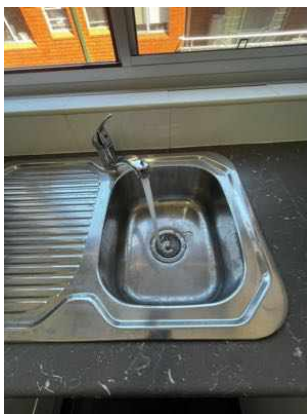
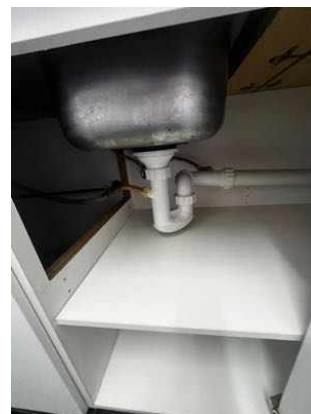
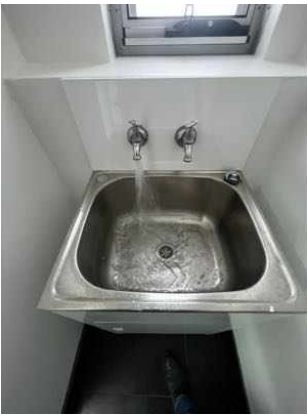
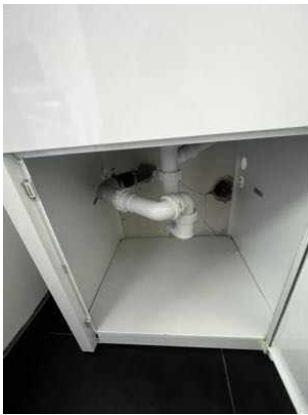
Building: Main Building  
Location: Kitchen/ Bathroom  
Finding: Cabinetry Plumbing - Kitchen/ Bathroom  
Information: All cupboards where sinks and basins with drainage plumbing were inspected and no evidence of leaks were present at the time of inspection.

If damp or wet conditions do occur there are many consequences including the development of fungal decay and/or wood rot, swelling or water damage to building materials.

NOTE: Please be aware that although cupboards have had a thorough inspection, obstructions in cupboards may conceal potential water damage, prevent a full inspection and conditions can change after the initial inspection was carried out, therefore damage may be found after obstructions are removed.

For your information only no remedial works are required at the time of inspection.
