Building Inspection Report

Inspection Date: Wed, 1 Apr 2026

Property Address: 210/32 Alice St, Newtown NSW 2042,
Australia

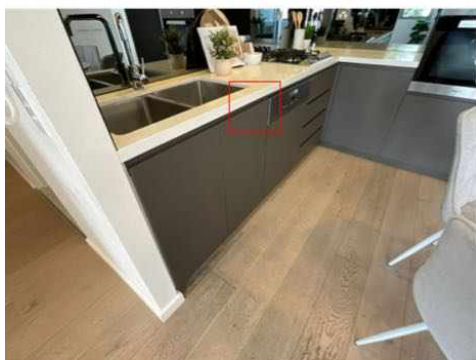
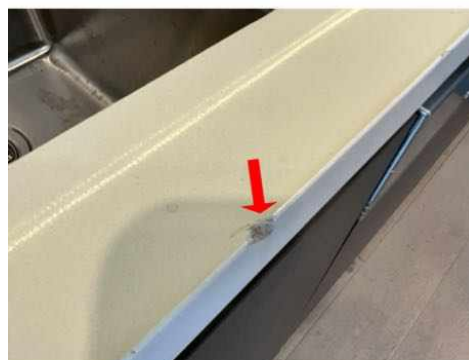
Defects 3.01

Building: Main Building
 Location: Kitchen
 Finding: Stone Bench top - Chipped
 Information: Chipping was evident to the bench top at the time of inspection, which is suspected to have been caused by minor impact damage.

This is generally only ever an appearance defect and no secondary defects are likely to occur

Consultation with a cabinet maker or stone specialist regarding repair or replacement is required. Remedial works may be required to protect against any further damage.

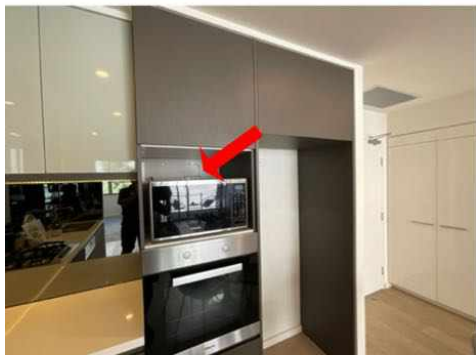
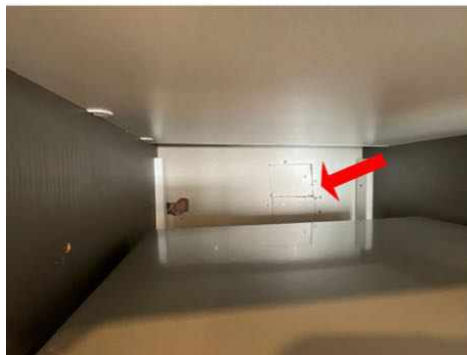
Defects 3.02

Building: Main Building
 Location: Kitchen
 Finding: Remedial works-identified
 Information: Remedial works have been identified during the inspection.

It is recommended that further evaluation be carried out by a licensed builder to

determine the extent of the works and whether any additional repairs are required.

It is also advised to obtain clarification from the vendor regarding the nature and extent of the works undertaken, and whether any warranties or guarantees apply.

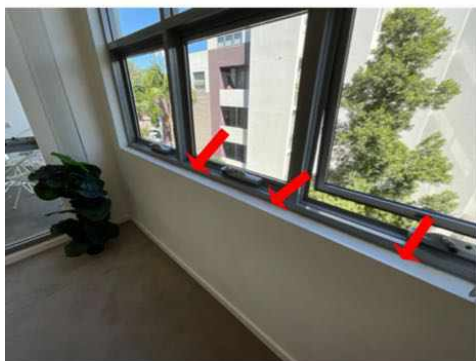
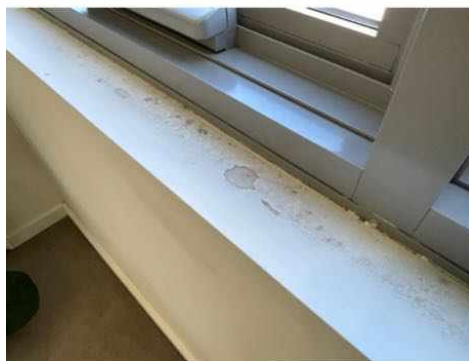
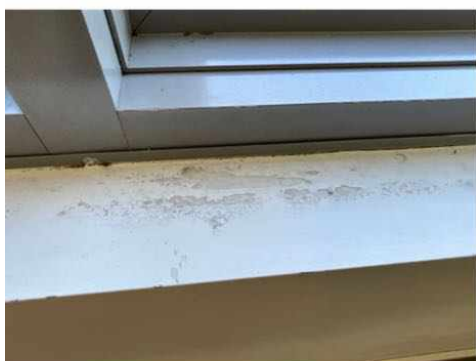
Defects 3.03

Building:	Main Building
Location:	Bedroom
Finding:	Painted surface -Peeling and/or bubbling
Information:	Sections of paint including but not limited to the photos in this report were found to have bubbled and/or peeled.

Bubbling or peeling paint occurs when there is a failure of adhesion between the paint and the surface it's applied on.

This is generally an indication of excessive moisture in the area.

Excessive moisture is the key cause of peeling paint on ceilings and walls (interior and exterior)

When water saturates through the coats of paint, it makes the layers detach from the surface. This develops into bubbling or peeling paint.

Another cause of peeling and bubbling paint may be inadequately ventilated houses which can create high humidity and extreme condensation, causing peeling paint. High humidity triggers moisture build-up on walls leading to bubbling of the layers. This results in peeling layers of paint.

While peeling/bubbling paint seems minor, the presence of excessive moisture can have major implications on associated building elements if left unattended.

A remedial builder should be engaged to identify and rectify the cause of the excessive moisture prior to contacting a painter to repaint any areas with peeling and /or bubbling paint.

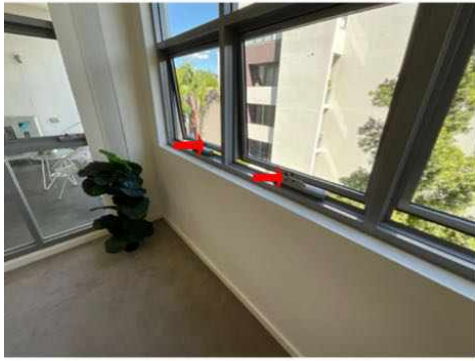
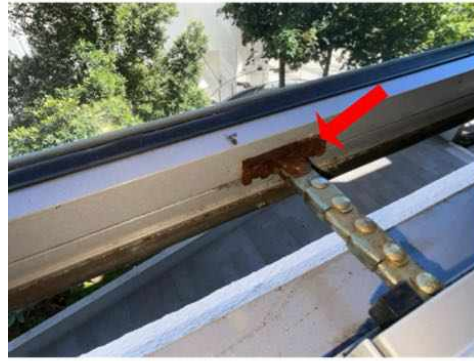
Defects 3.04

Building:	Main Building
Location:	Bedroom
Finding:	Building element - Rusted or corroded
Information:	This building element shows evidence of rusting and corrosion, which is likely to have developed as a result of excessive exposure to moisture and or inadequate coatings.

As surface rust provides no protection to the underlying iron, the deteriorating condition is likely to worsen if not addressed in the short-term future.

Where possible, the use of galvanized (treated) metals or aluminium coated metals aid in rust prevention, as does regular general maintenance. Rust formation can be controlled with coatings, such as paint, that isolate the iron from the environment.

Rusting and corrosion should be managed by ideally removing or limiting the affected surface from exposure to moisture. A registered builder may be appointed to replace any building elements that have been severely affected by rust or water damage.

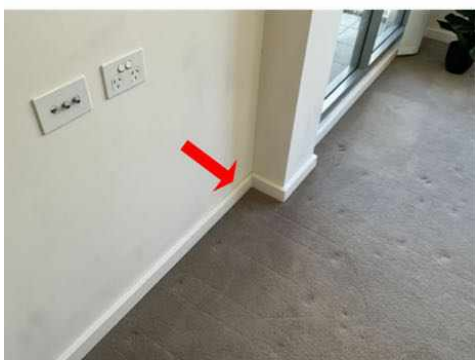
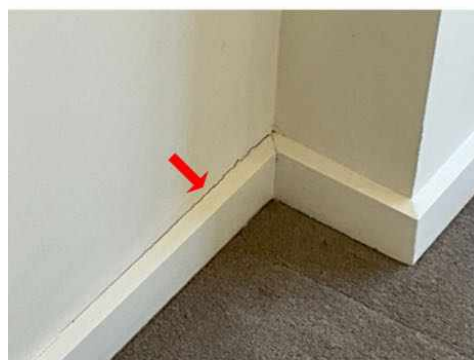
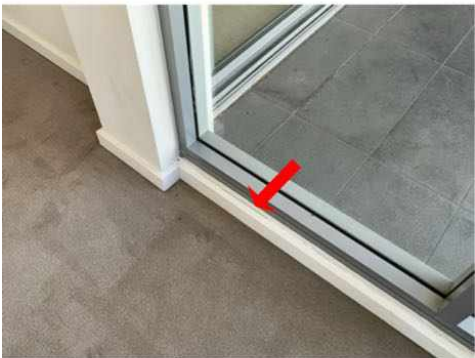
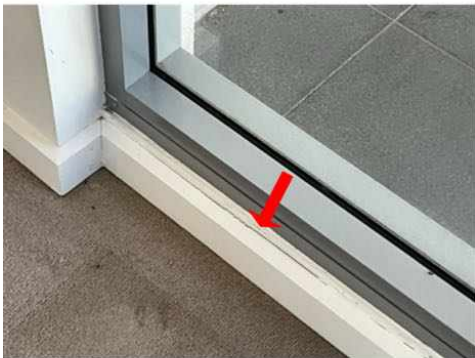
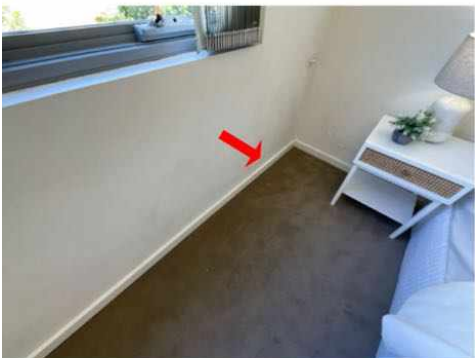
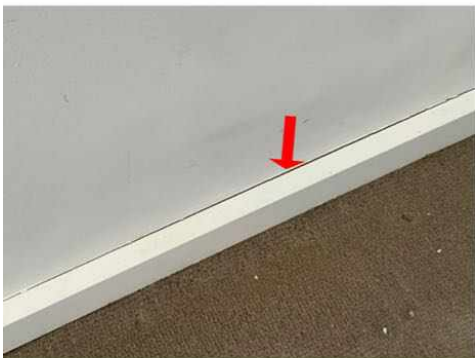
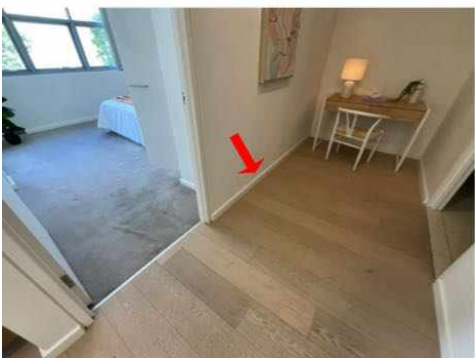
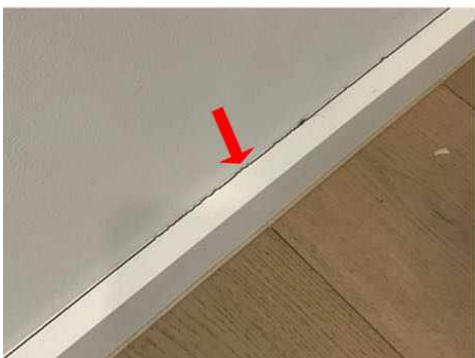
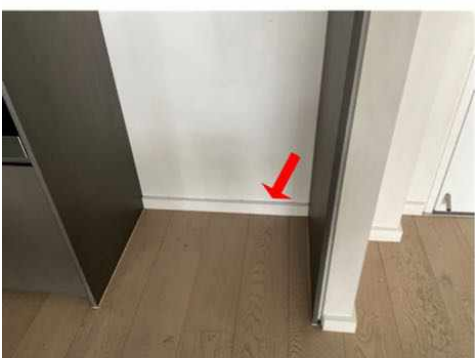
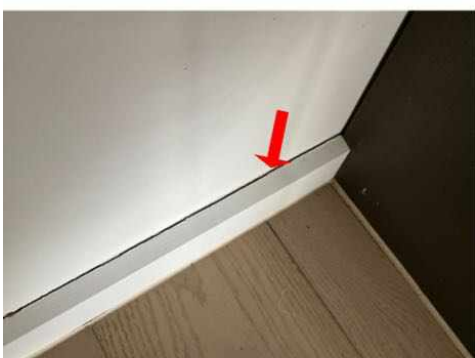
Defects 3.05

Building:	Main Building
Location:	All Areas
Finding:	Skirting - Loose
Information:	The skirting in several areas throughout the property is loose.

Loose skirting boards in a building can result from a variety of causes, including poor initial installation, deterioration of adhesive or fixings over time, moisture ingress causing timber expansion or warping, or structural movement within walls or floors.

In older buildings, settlement or changes in humidity levels may exacerbate these issues.

Rectification involves identifying the underlying cause—such as fixing water leaks or addressing movement—and then reattaching the skirting using appropriate methods, such as nails, screws, or construction adhesive.

In cases of damage or significant warping, replacement of affected sections may be necessary to restore a secure and neat finish.

A licensed carpenter should be appointed to perform rectification works as necessary at discretion of the client.

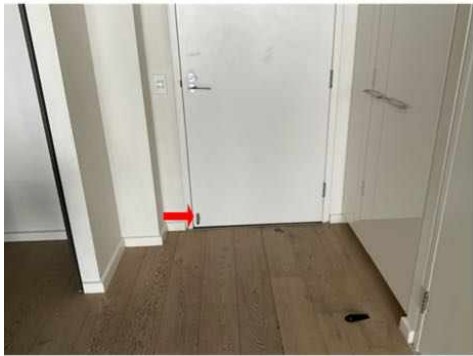
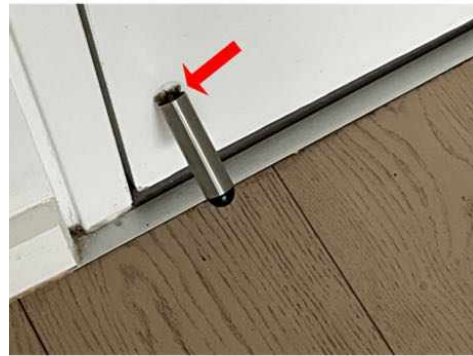
Defects 3.06

Building: Main Building
Location: Entry
Finding: Damaged door stop.
Information: These type of defects generally occur when the building materials have either aged and decayed, or as a result of impact damage (accidental or deliberate).

Repair and/or replacement of the damaged elements is advised to ensure that additional secondary defects do not arise as a consequence.

Such works are necessary, as all building elements play a key role in the operation and function of the overall structure and its performance.

Relevant tradespersons should be appointed to repair or replace the affected building elements prior to any subsequent damage being caused.

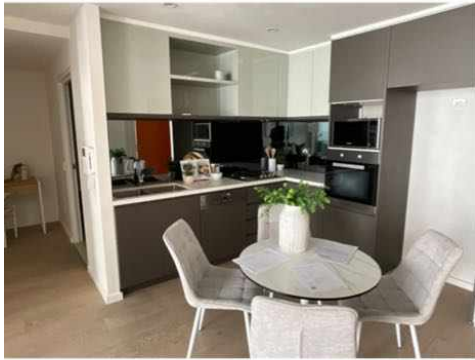
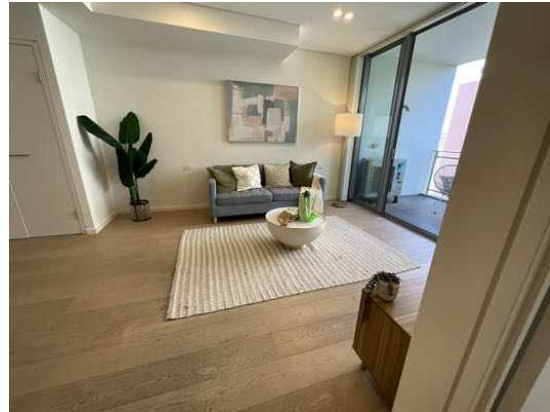
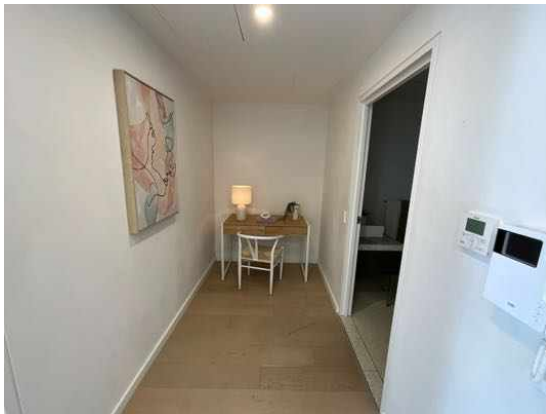
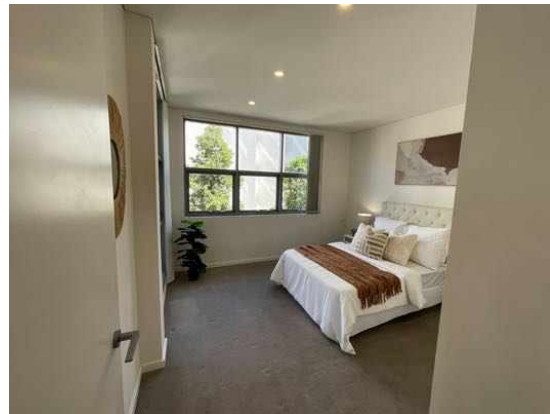
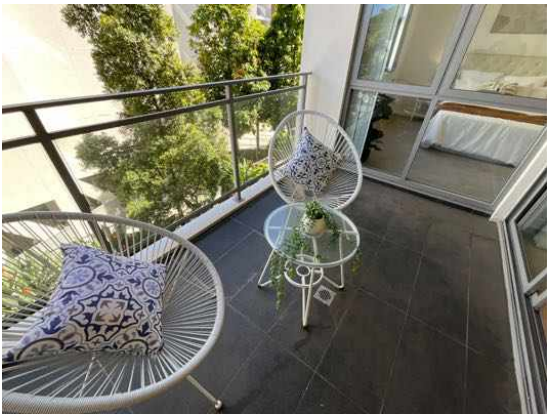
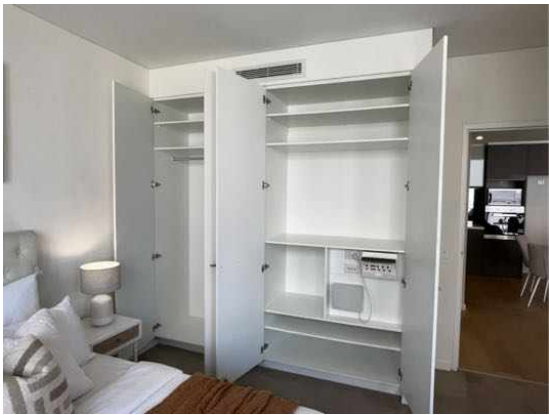
Building: Main Building
Location: All Areas
Finding: Additional Photos - Obstructions and Limitations
Information: These photographs are an indication of the obstructions and limitations which impeded full inspection of the property at the time of inspection. These obstructions can hide an array of defects and should be removed to allow full inspection to be carried out. A re-inspection is recommended once the areas are made accessible.

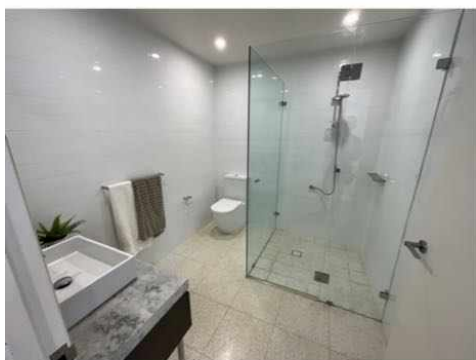
Building: Main Building
 Location: All Areas
 Finding: Water Proofing Membranes
 Information: Internal Water Proofing Membranes, are crucial in preventing water ingress into the property.

It is important to know that the Membrane System used is to Australian Standards and has been installed correctly.

With older property's where this information is unavailable all wet areas should be monitored. If any leaks, water staining, peeling or bubbling of the paint become evident to any adjacent walls or ceilings below a licensed builder or waterproofing specialist is recommended to investigate further.

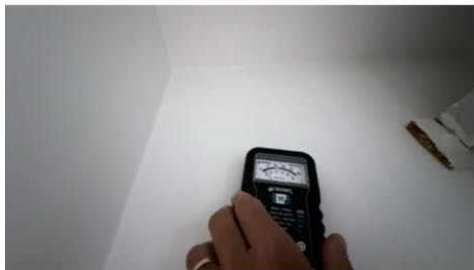
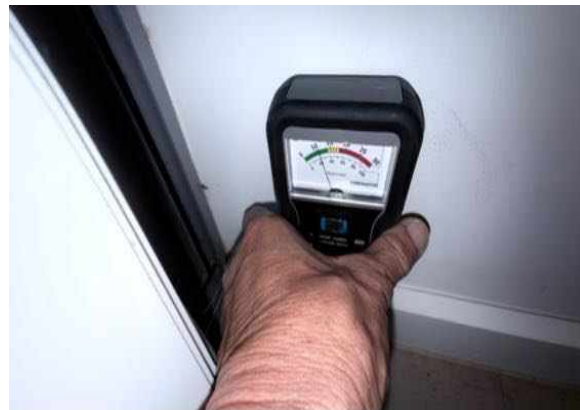
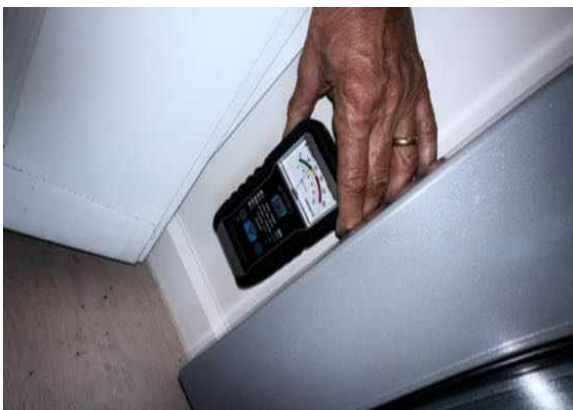
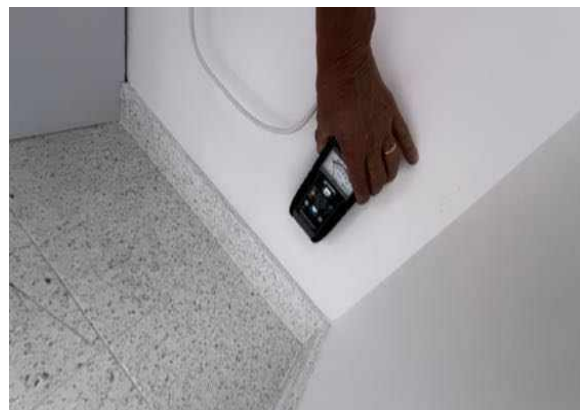
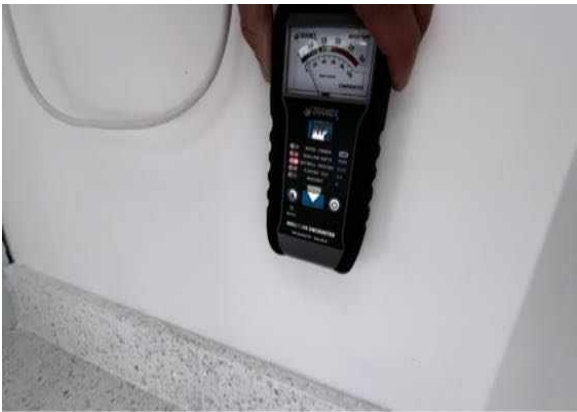
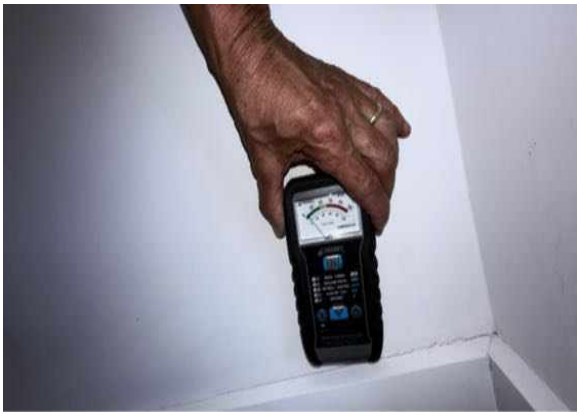
Finding: Moisture readings

Information: At the time of inspection, low moisture readings were noted in several accessible areas of the property, including, but not limited to, those shown in the accompanying photographs.
