Building and Timber Pest Inspection Report

Inspection Date: Tue, 13 Jan 2026

Property Address: 23 Langland St, Tumbarumba NSW 2653,
Australia

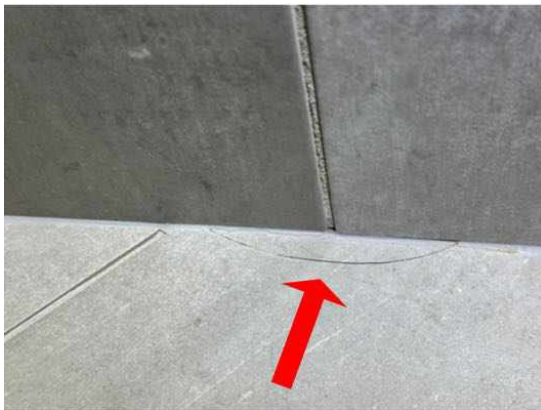
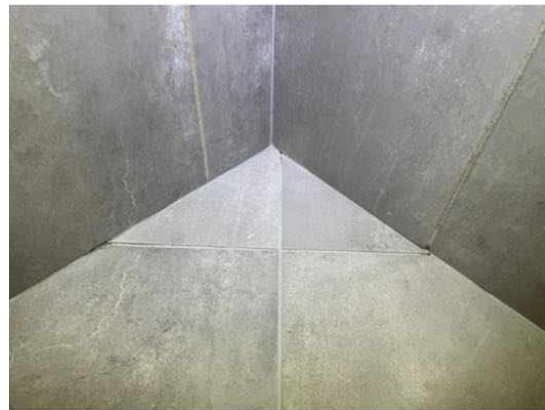
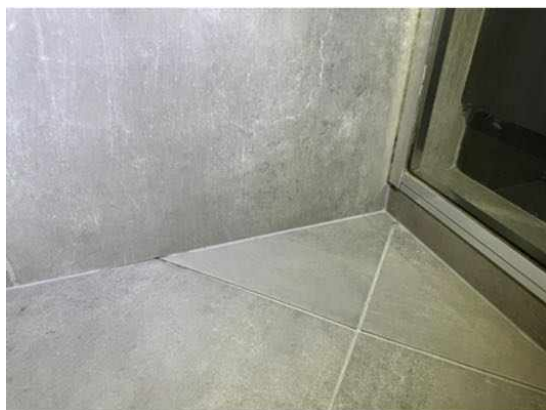
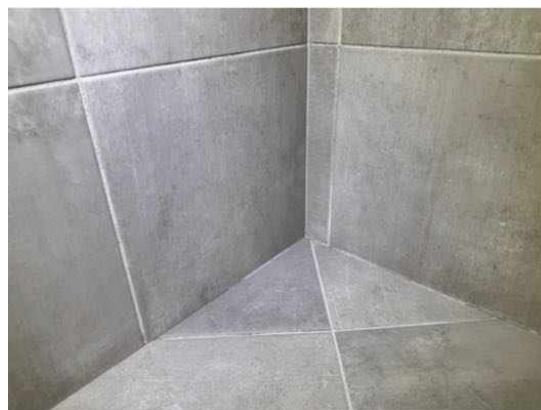
Finding 3.01

Location: Tiled Areas

Finding: Sealant / grouting - deteriorated or missing & Cracked Tiles

Information: It appears that the sealant and grout has deteriorated in some tiled areas, a common defect in buildings of a similar age. A minor crack was also noted to the shower tiling, which can allow for moisture ingress behind the tiles, if neglected.

Sealant and grouting in areas that come into regular contact with water should be maintained for the long term care of your property. Recommend engaging a licensed tiling contractor, to provide maintenance works.

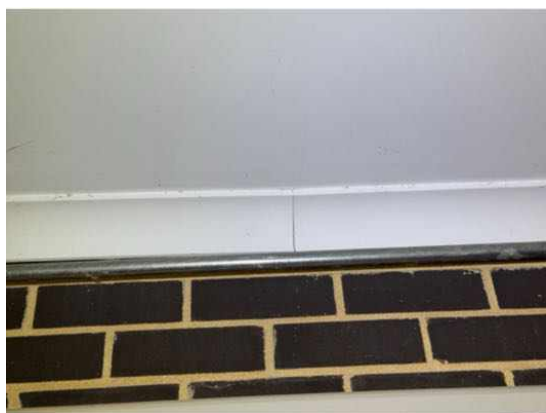
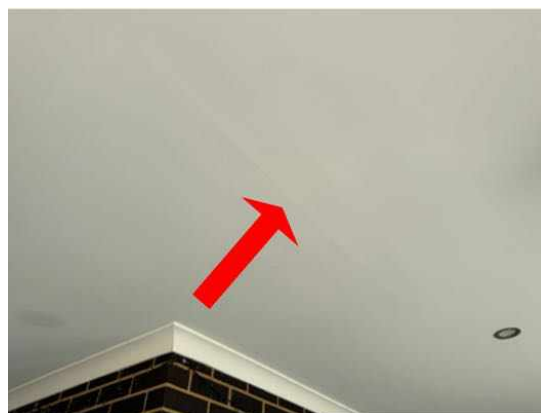
Finding 3.02

Building: Main Building
 Location: Cornice, Patio
 Finding: Plaster - Cracking
 Information: There appears to be minor cracking in some areas of the cornice & patio ceiling. Cracking of this type is common in buildings of a similar age. It is advised that the client monitor these areas.

Should cracking widen, lengthen, or become more numerous, the client should consult with their building inspector for further evaluation.

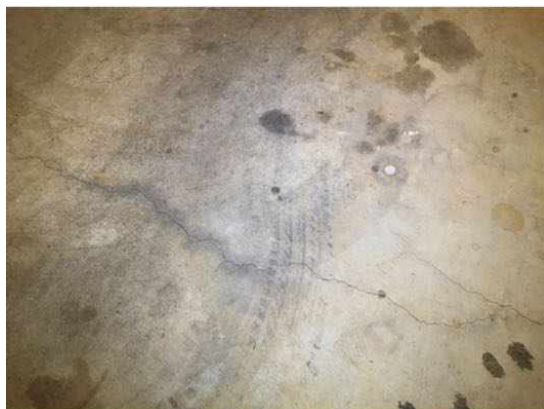
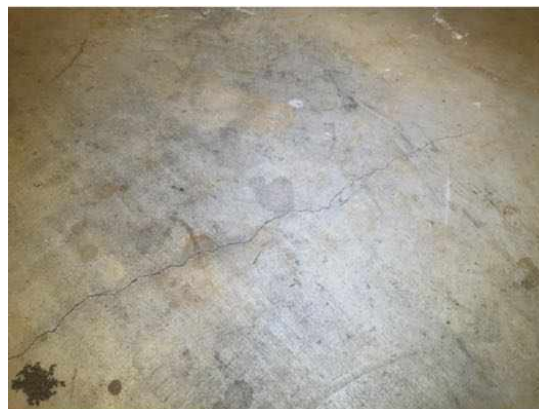
Finding 3.03

Building: Main Building
 Location: Garage
 Finding: Cracking - Garage Slab
 Information: Minor cracking was identified in the garage slab. Cracking in concrete slabs is common, and can be caused by general movement of the footings over time or "settling" of the building after construction.

The client should monitor the cracking. Should the cracking of the garage slab widen, lengthen or become more numerous, a structural engineer should be engaged for

further evaluation.

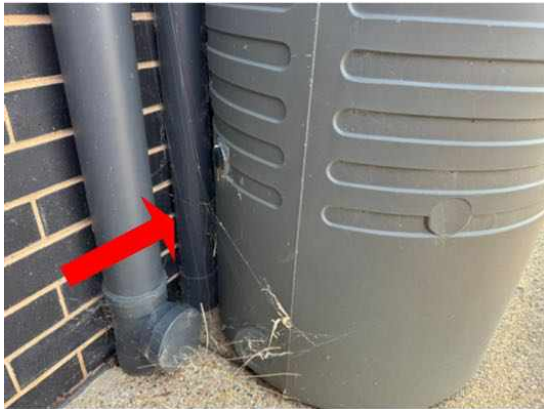
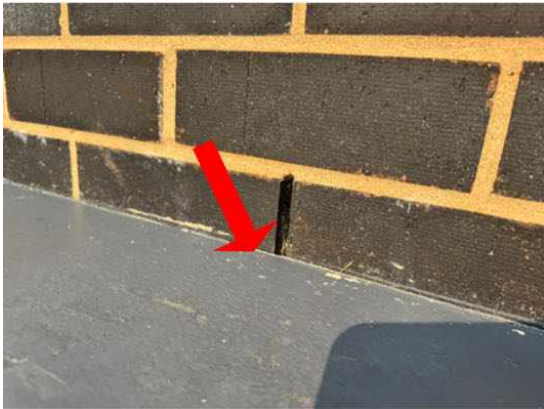
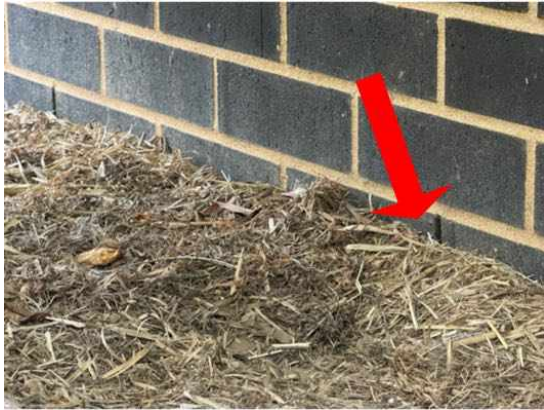
Finding 6.01

Building:	Main Building
Location:	External Areas
Finding:	Bridging of physical termite barrier
Information:	Bridging occurs where ground levels or items against the building conceal termite entry by bypassing termite management systems. A 75 mm clearance beneath weep holes and physical termite barriers is recommended to allow for early detection. In some areas around the building, finished ground levels reduce this clearance, creating bridging points and allowing for concealed termite entry.

These areas should be regularly inspected by a qualified inspector, and where feasible, external ground levels should be lowered to reinstate an adequate inspection zone. Recommend consulting with a landscaping contractor to provide further advice.

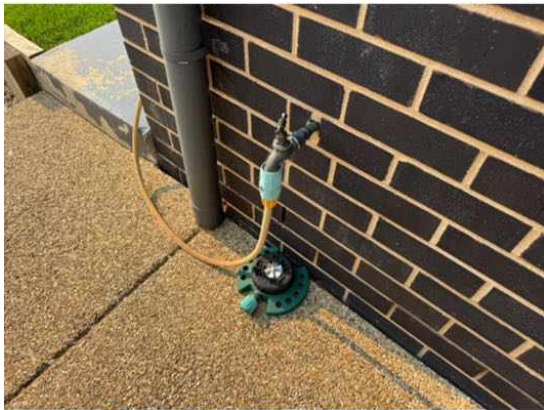
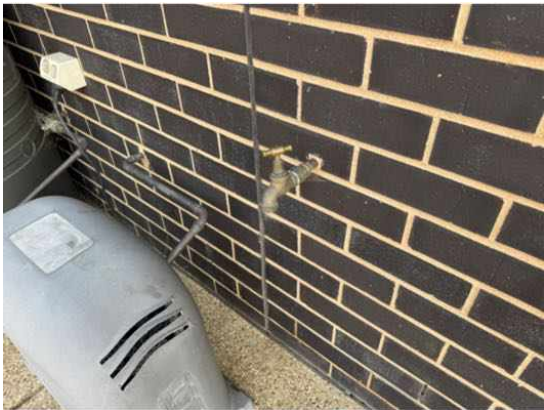
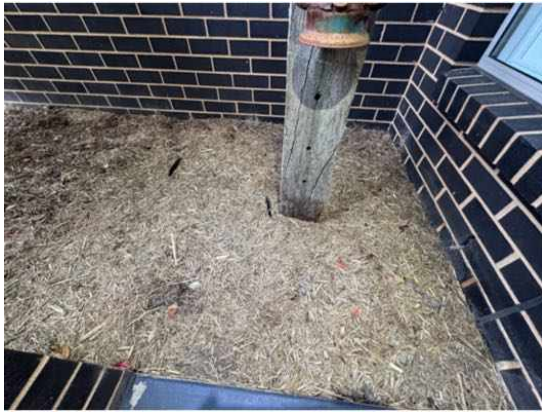
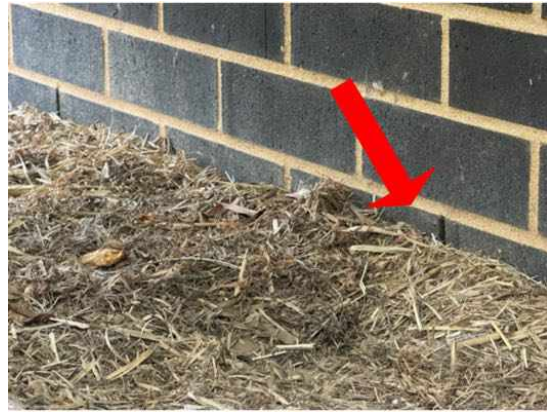
Finding 6.02

Building: Main Building
 Location: All external areas
 Finding: Potential Water pooling - against property
 Information: Potential areas of water pooling around the perimeter of the property were identified. Where insufficient drainage of taps, weep-holes, and garden beds against the house are present, water pooling is likely to occur, and can create areas conducive to timber pests.

Recommend consulting with a licensed plumber and/or landscaping contractor to provide further advice.

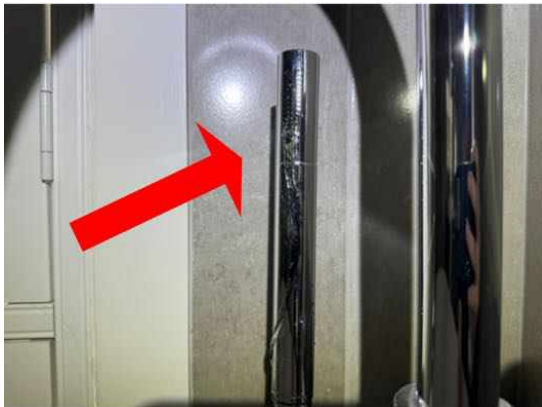
Finding 6.03

Building: Main Building
 Location: Ensuite Bath Tap
 Finding: Tap - Leaking
 Information:

It appears that the ensuite bath tap was leaking at the time of inspection. This is a relatively common defect that is consistent with general ageing of the building element. Areas of leaking create an environment conducive to termite activity & water pooling in the area. Recommend engaging a licensed plumber, to provide maintenance works.

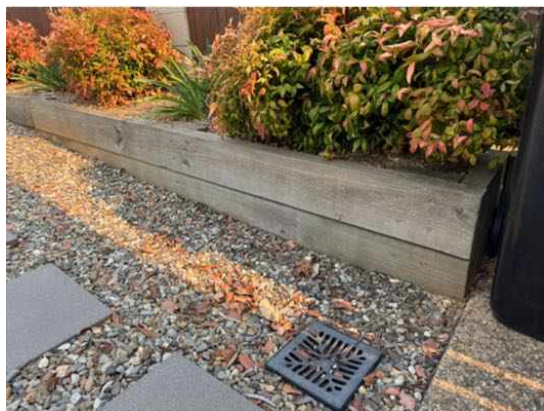
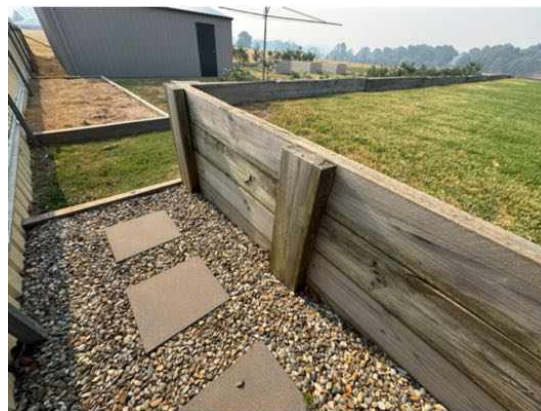
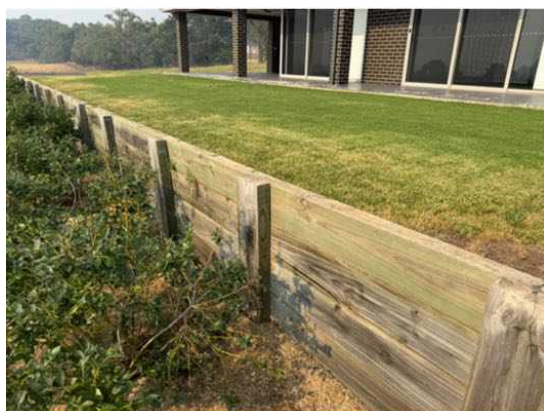
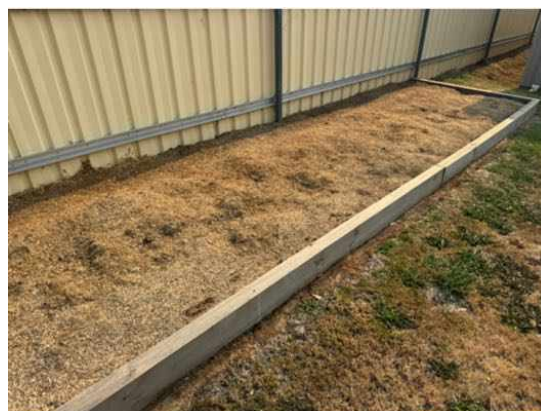
Finding 6.04

Building: Main Building
 Location: All External Areas
 Finding: Timber in direct ground contact - conducive to termites
 Information:

Where timber materials are in direct contact with the ground and consequently moisture, they become conducive to termite activity. The landscaping timbers create an environment conducive to termite infestation.

Where feasible, any timbers in direct contact with the ground are recommended to be removed and/or inspected frequently to reduce the risk of termite infestation & detect any early signs of termite activity.

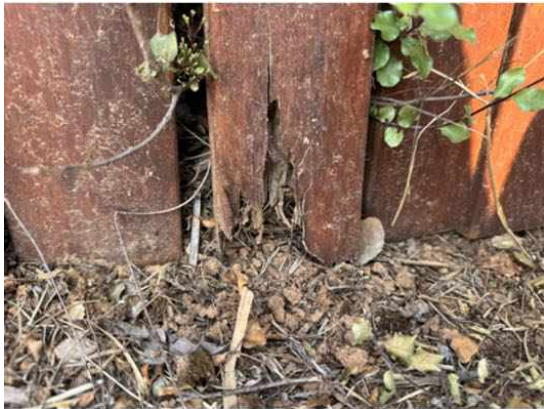
Finding 8.01

Building:	Main Building
Location:	Fence
Finding:	Evidence of wood borer damage identified (powder-post)
Information:	Evidence of previous Lyctus Borer (powder-post beetle) damage was identified at but not limited to the base of a fence panel. Wood borer damage is generally considered superficial damage to the affected timber. As no live wood borer activity was identified treatment is not required.

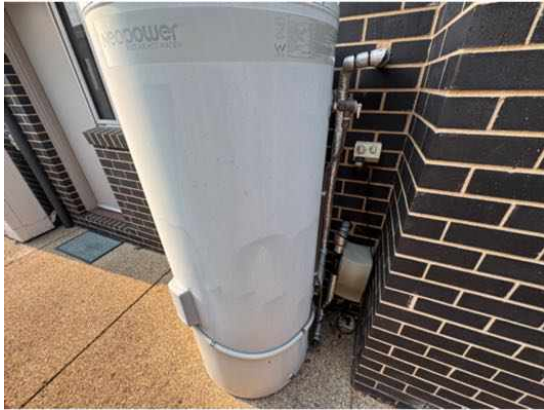
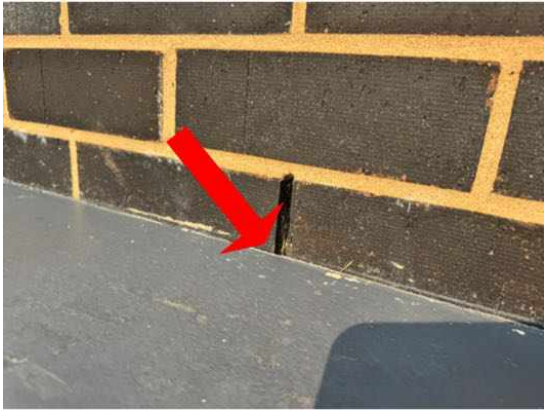
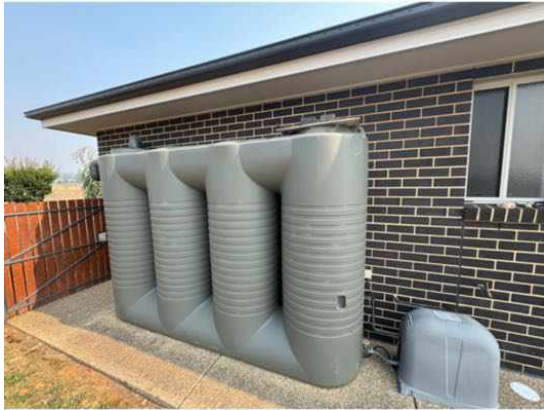
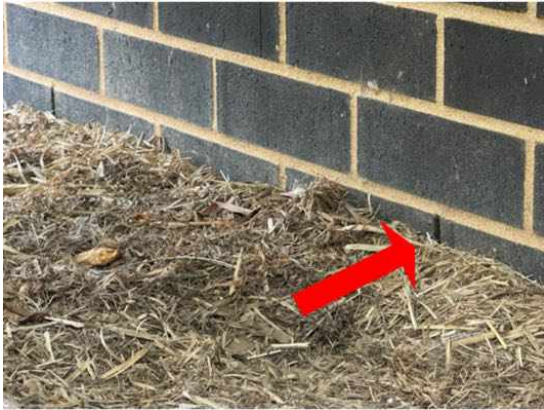
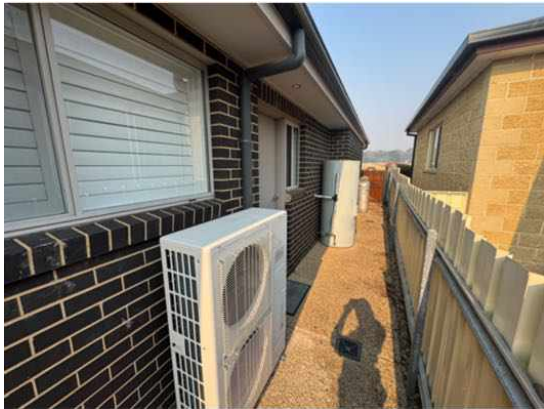
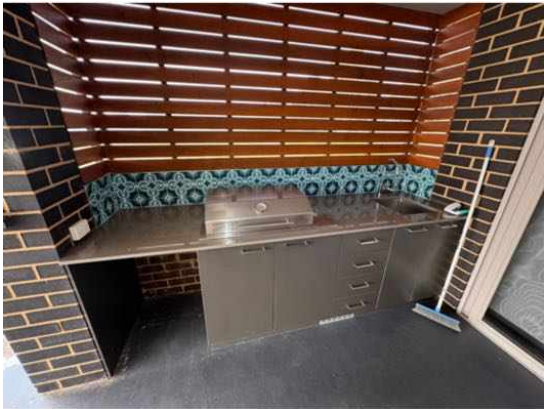
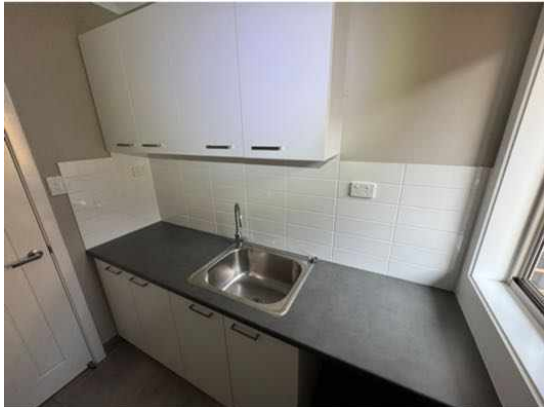
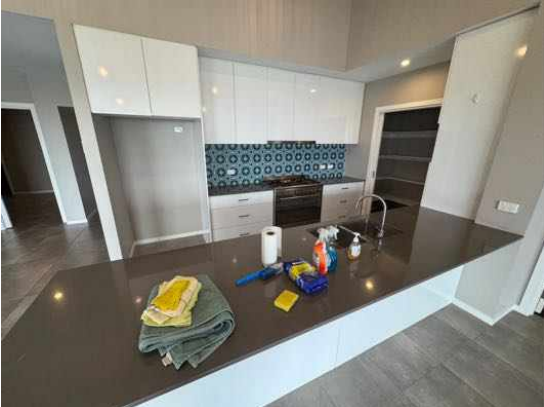
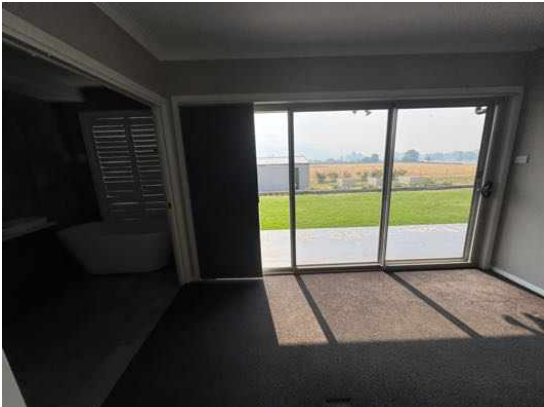
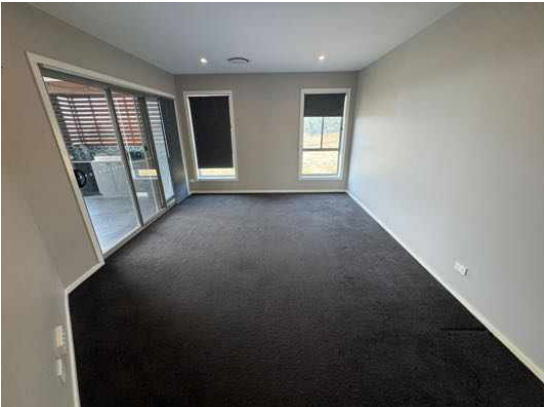
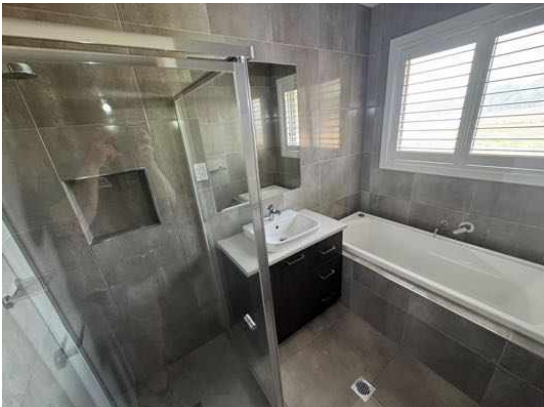
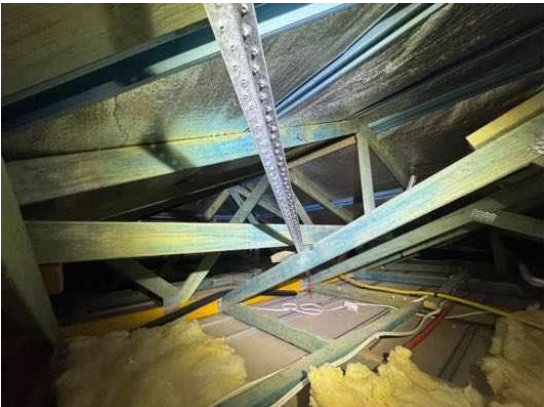
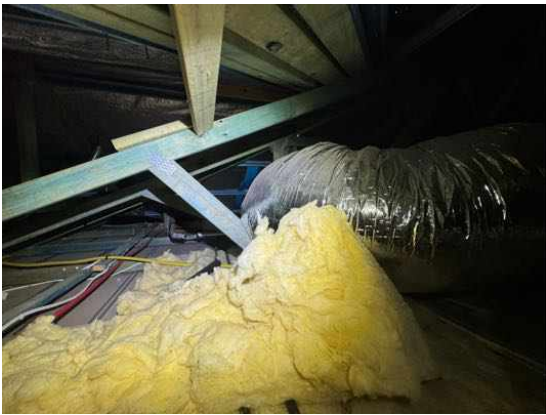
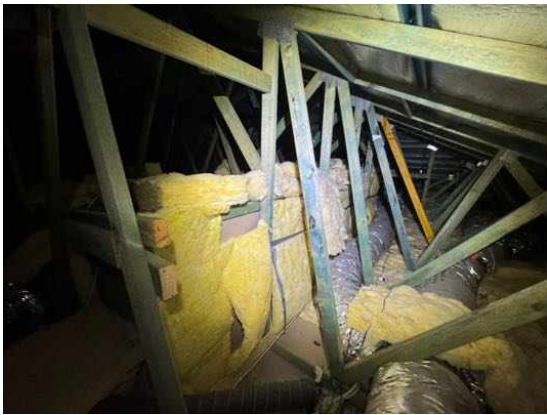
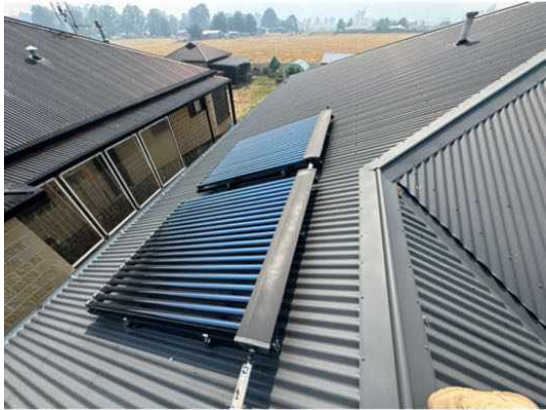
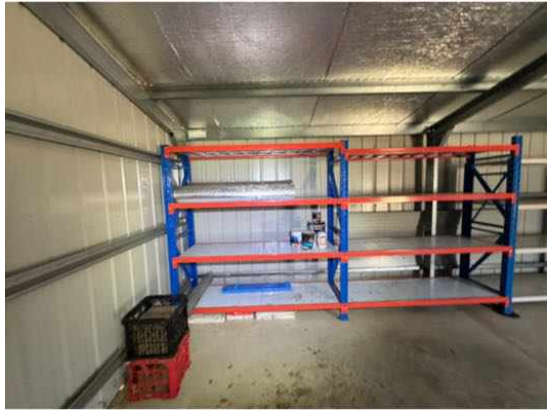
Building: Main Building
Location: All Areas
Finding: Additional Photos - Obstructions and Limitations
Information: These photographs are an indication of the obstructions and limitations which impeded full inspection of the property at the time of inspection. These obstructions can hide an array of defects and should be removed to allow full inspection to be carried out. A re-inspection is recommended once the areas are made accessible.

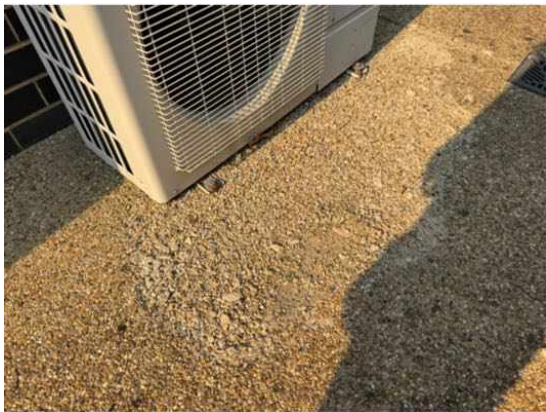
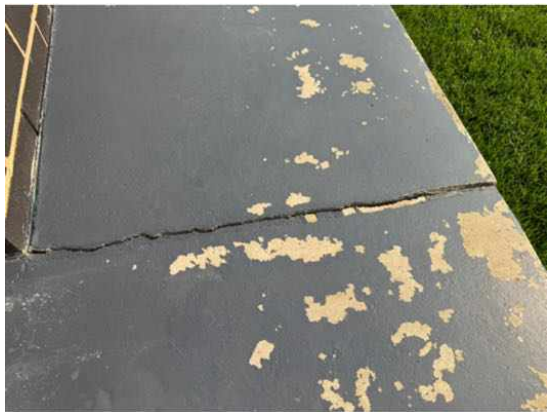
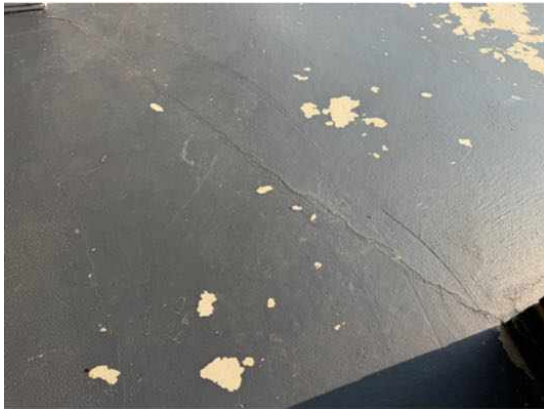
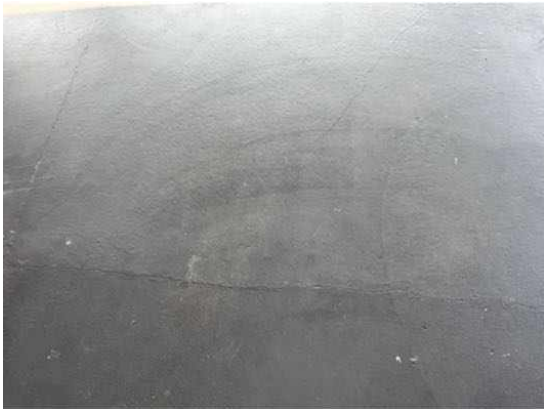
Building: Main Building
 Location: Pavement, Patio Slab
 Finding: Cracking & Deterioration - Pavement
 Information: It was noted there is cracking in areas of the pavement and patio slab. Cracks in the pavement are a common occurrence in houses of a similar age.

Recommend that the client monitor the cracking. A licensed concreter can be engaged at clients discretion, should cracks widen, lengthen, or become more numerous.

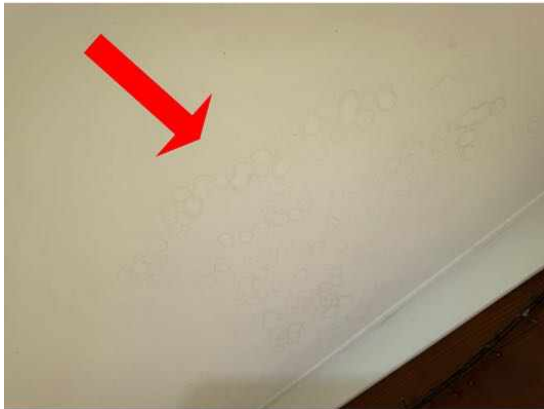
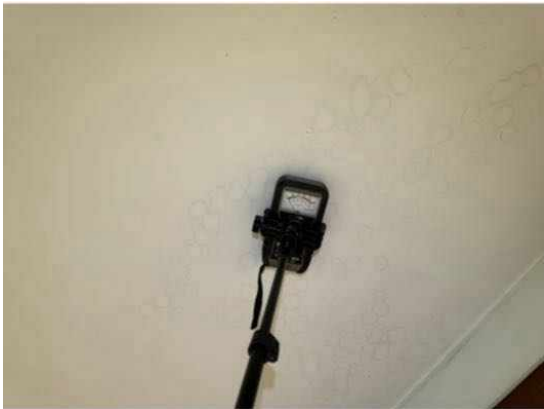
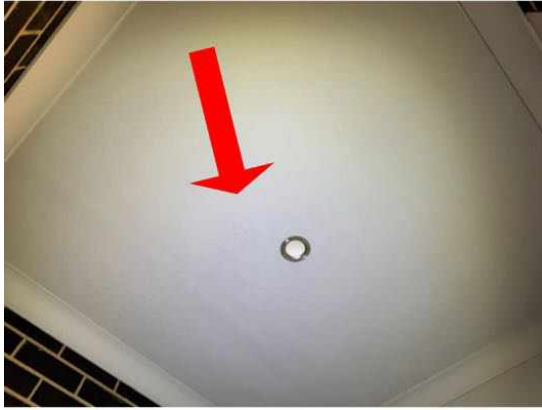
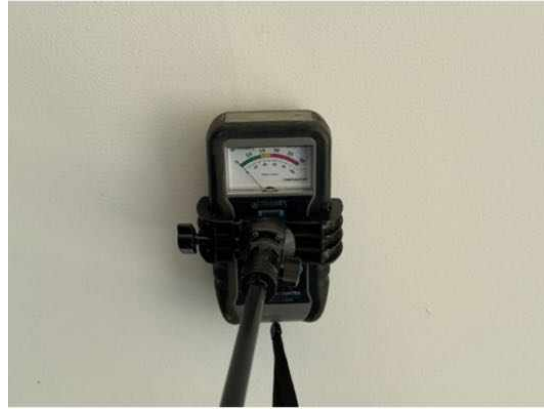
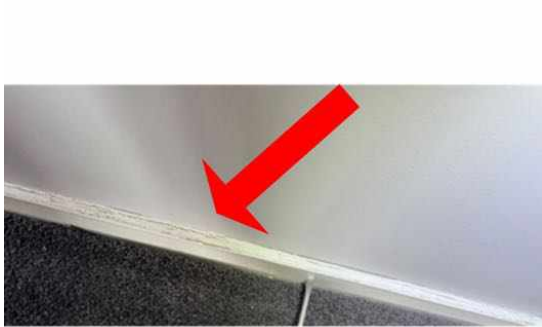
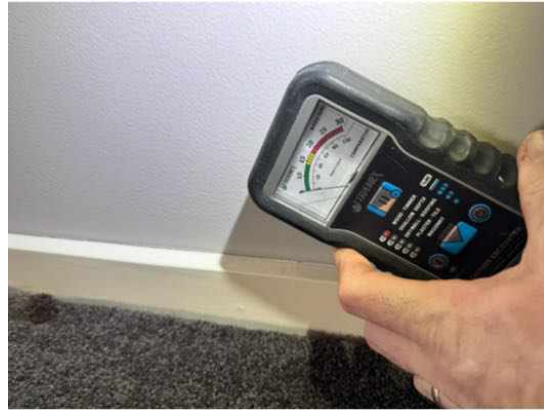
Building: Main Building
Location: Patio & Entry Ceiling, Lounge Room Skirting
Finding: Staining Present
Information: It appears that water staining was present at, but not limited to, the patio & entry ceiling and to the lounge room skirting opposite the bathroom. Potential causes of leaking include deteriorated roof cladding or damaged plumbing fittings and fixtures. No high moisture was evident in these areas at the time of inspection.

It is recommended that the client monitor these areas and engage a licensed plumber promptly, should the leak persist or return.

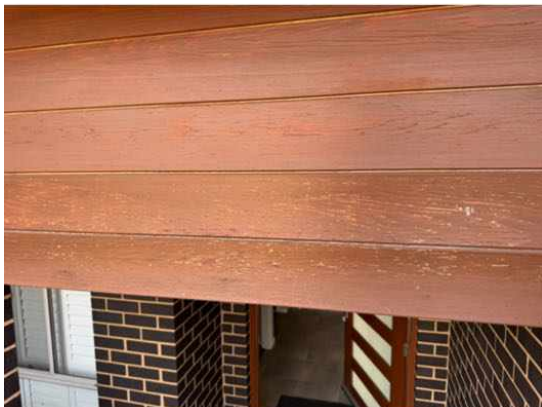
Building:	Main Building
Location:	Timber Cladding
Finding:	External Timbers - Weathering
Information:	Areas of general weathering were identified at but not limited to the front timber cladding. A licensed painter can be engaged at client's discretion, to provide maintenance works where necessary, to prolong the life of the material.

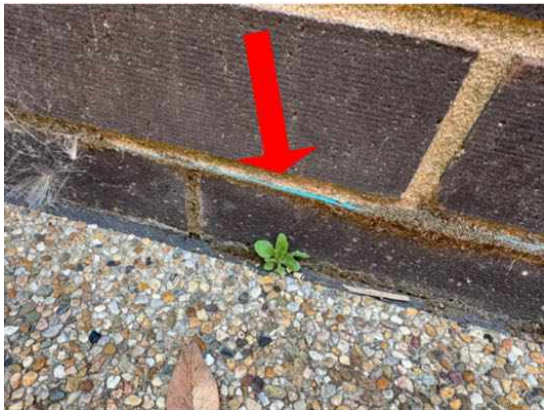
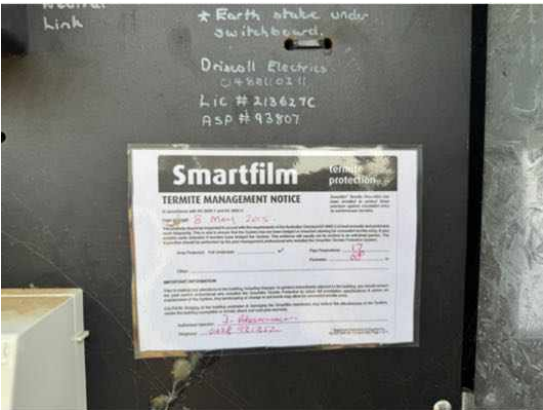
Building: Main Building
Location: All Internal Areas
Finding: Evidence of a termite management system (physical barrier)
Information: A durable notice has been installed in the meter box, indicating that a termite management system has been installed. The type of termite system that has been installed is a physical barrier which prevents concealed termite entry into the building and forces termites out into the open.

Regular 12 monthly inspections should be conducted by a qualified termite inspector, to identify any early signs of timber-pest activity.
