Building and Timber Pest Inspection Report

Inspection Date: Mon, 23 Mar 2026

Property Address: 16/12-14 Darcy Road, Westmead, NSW
2145

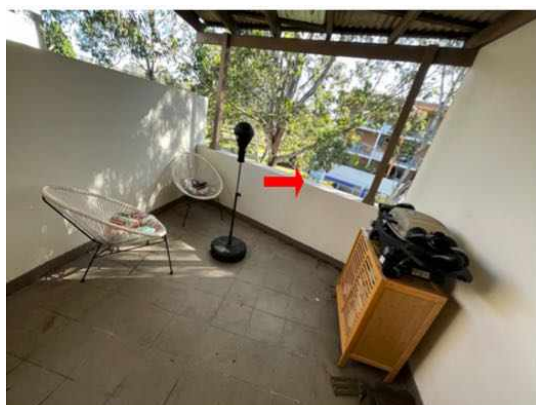
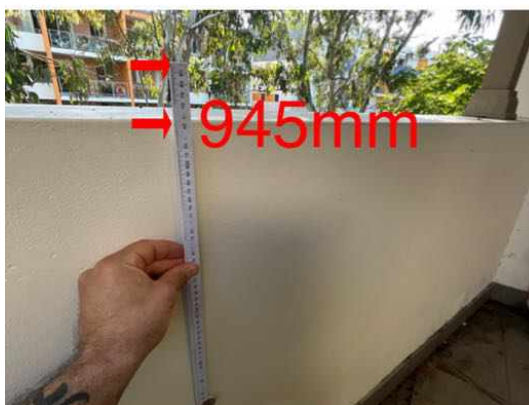
Finding 1.01

Building:	Main Building
Location:	Balcony
Finding:	Balustrade - Suspected Non-Compliance
Information:	The balustrade was measured and found to less than the present building regulation requirement of 1000mm high.

As with all constructions, compliance for a particular dwelling need only meet the regulations of the build date and not necessarily future changes to specific building regulations.

Some changes to the building regulations are made to ensure the safety of all inhabitants and balustrades are definitely one of those crucial regulations.

This defect creates a potential safety hazard and should be rectified as soon as possible to ensure the safety of the area and to meet present building standards and regulations.

The balcony balustrade was found to be non-compliant, requiring immediate rectifications by a licensed builder.

A licensed builder should be contacted to discuss possible rectification solutions.

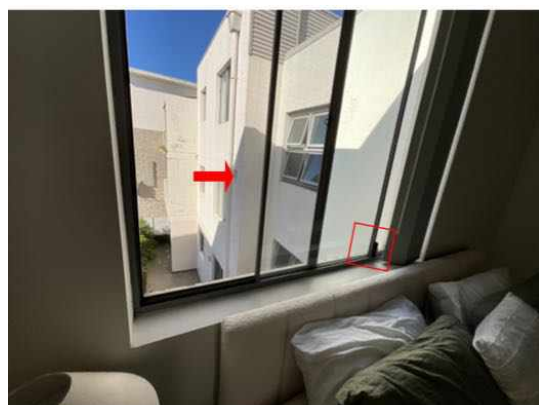
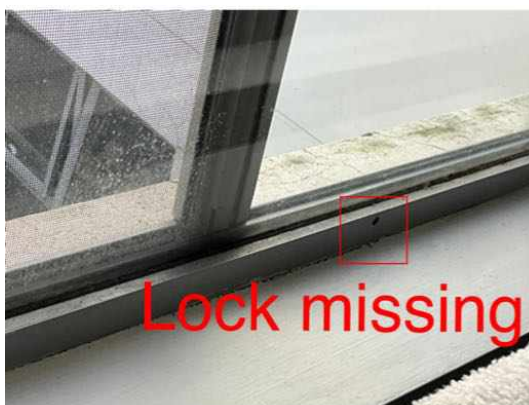
Finding 1.02

Building:	Main Building
Location:	Bedroom
Finding:	Window restrictions - Missing
Information:	Window restrictors were found to be missing.

The window safety device standards can be found in clause 30 of the Strata Schemes Management Regulation 2016, and are based on National Construction Code (NCC)

requirements that were introduced in 2013. The NCC requirements apply to all openable bedroom windows in residential buildings, including hotels, motels and for all windows in early childhood centres.

Bedroom window lacks appropriate child lock, creating a safety hazard. Window restrictor must be installed on these Window immediately for added safety.

Windows need to be locked at 12.5cm when the devices are engaged. The safety devices must be robust and child proof. The alternative is security screens such as bars or grills on the windows so long as they have gaps no bigger than 12.5cm. Flyscreens do not comply unless they are the reinforced security type and capable of resisting the very strong outward pressure which would prevent a child falling through. The laws apply to openable windows in a building within 1700mm of the internal floor and if the internal floor is more than 2m above the ground floor outside.

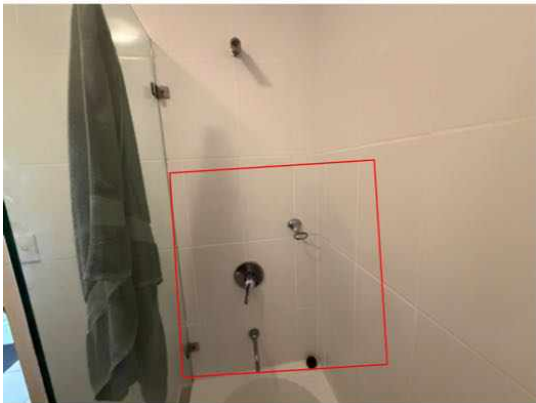
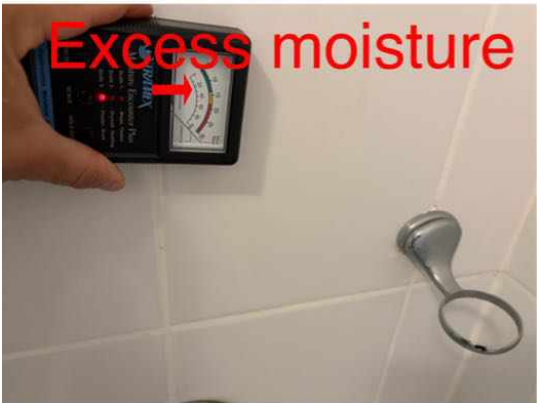
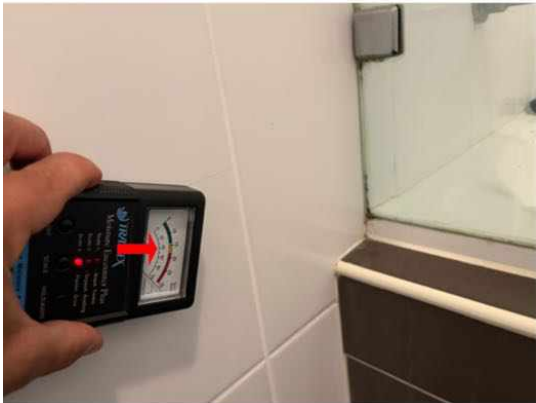
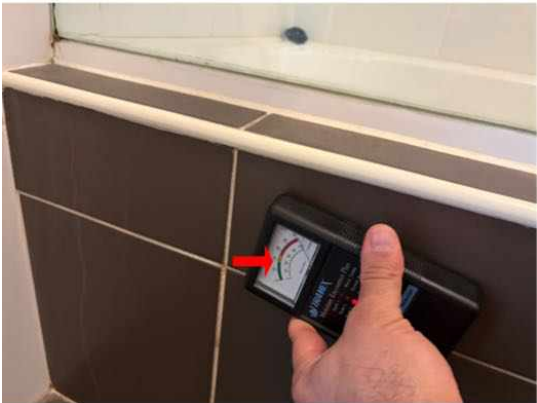
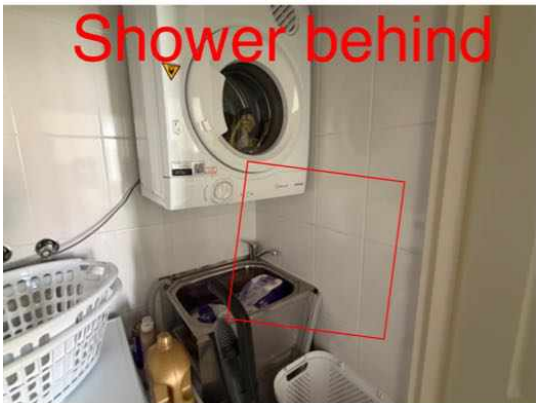
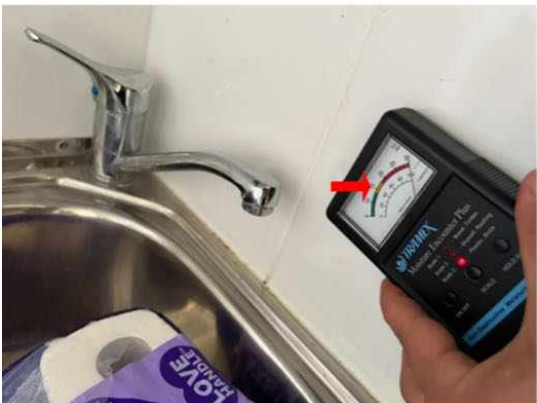
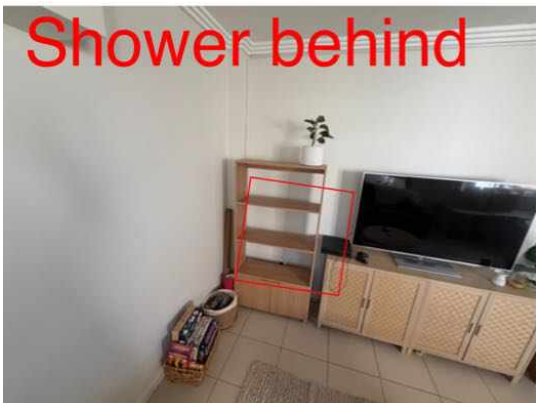
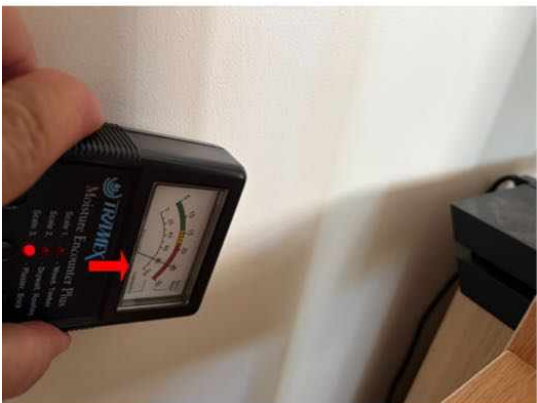
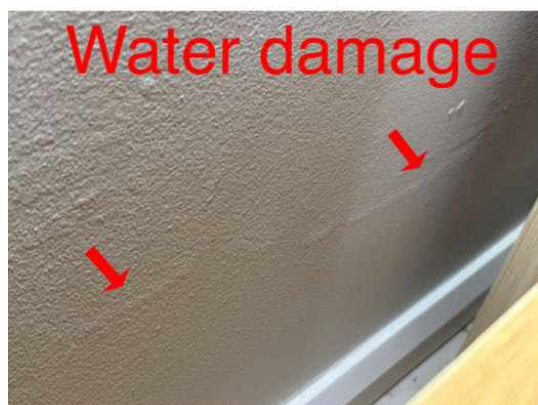
Finding 2.01

Building:	Main Building
Location:	Bathroom
Finding:	Waterproofing damage - Suspected
Information:	Excessive moisture was detected in these areas at the time of inspection. Internal water leaks can be detrimental to surrounding building elements. The potential cause in this area is damage to the waterproofing membrane inside the shower recess.

Attracting termites, corrosion, mould, decay and water damage are potential outcomes where a minor water leak is left unattended. More serious defects may also result, such as electrical hazards, or water damage to structural building elements.

Excessive moisture was identified to the walls in the shower as well as walls behind the shower. It is suspected that an active water leak is affecting the shower, but also the waterproofing membrane to have damaged as a result of continuous contact with such moisture. This was particularly evident by water damage to the launderoom wall, behind the shower. A bathroom specialist must be appointed immediately for further assessment and carrying out any required rectifications. Major works must be expected.

In extreme cases, structural damage may develop due to a prolonged water leak. It is highly advised that this issue be addressed immediately by a bathroom specialist as a matter of relative urgency.

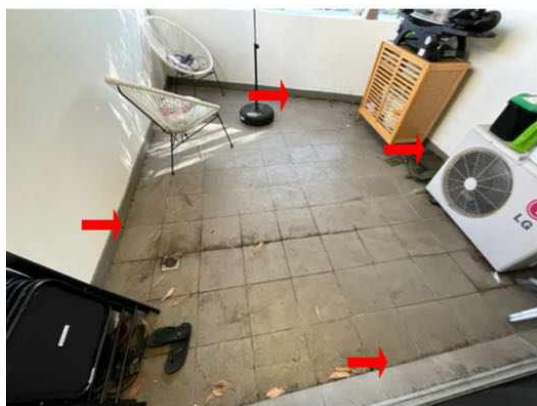
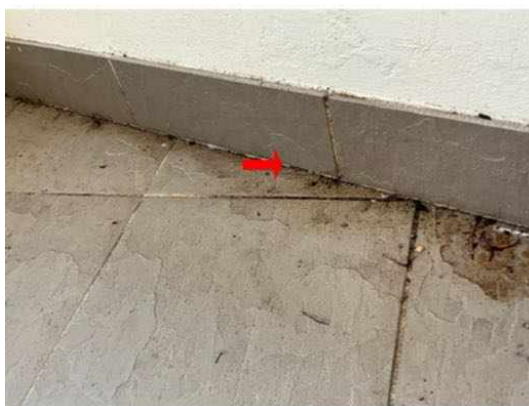
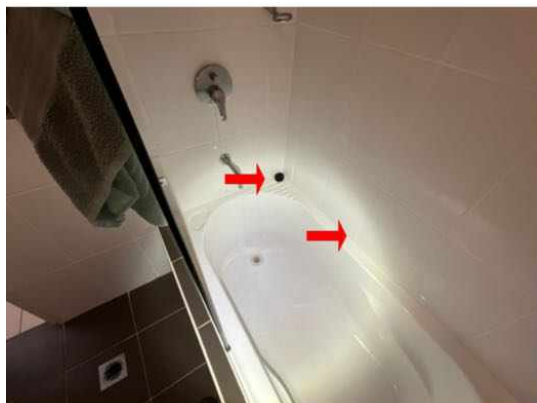
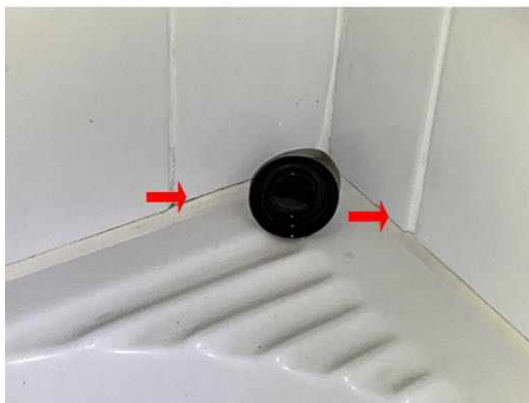
Finding 3.01

Building:	Main Building
Location:	All Wet Areas
Finding:	Sealant and grouting - Missing or damaged
Information:

It was noted on inspection that sealant or grout is degraded to this area.

Different materials and floor areas move at different rates, generally causing cracking to grout or sealant at this point. A flexible sealant is required to allow for expected expansion and contraction, while keeping the joint water tight and protective of all associated building materials.

Flexible and mould resistant materials should be applied to affected areas to prevent any subsequent water damage that is likely to occur. Regular maintenance and replacement of damage or missing or damaged sealant and grout is highly recommended to the wet areas, as this is a regular wear and tear defect. Sealant and grouting in areas that come into regular contact with water should be maintained for the long term care of your property.

A sealant specialist should be appointed to complete these works as soon as possible.

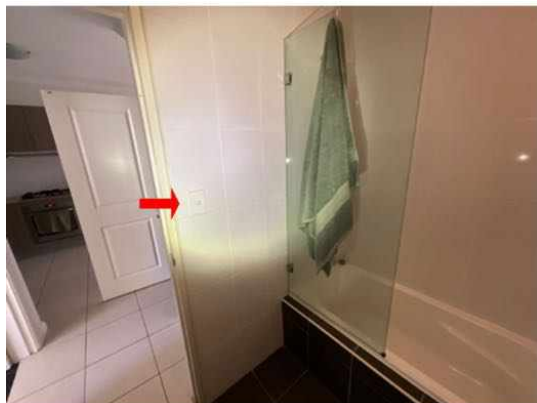
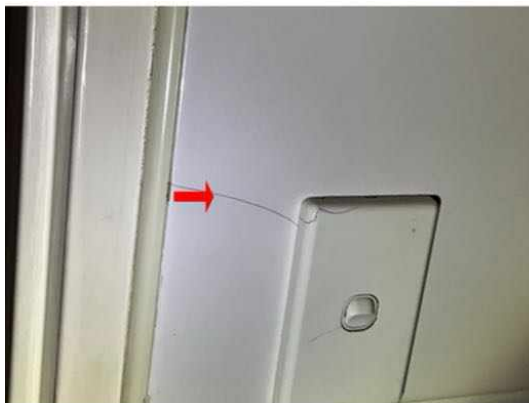
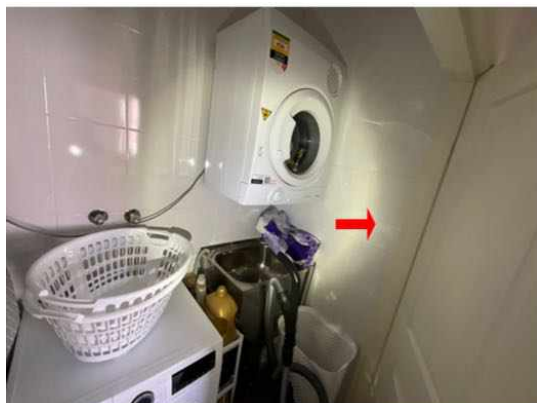
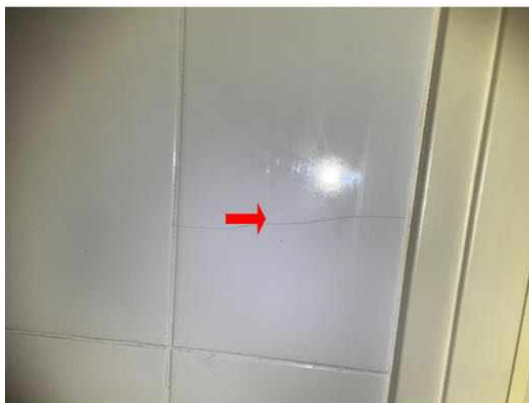
Finding 3.02

Building:	Main Building
Location:	Bathroom, laundry
Finding:	Wet area tiles - Cracked or damaged
Information:	Cracking was evident to the tiling in this area at the time of inspection. While the cracking appears to be minor, this area is frequently exposed to water, allowing potential for water penetration into adjoining sections of walls or flooring.

If left unmanaged, water penetration to these areas may lead to subsequent water damage, which is likely necessitate repair work to affected building elements.

A bathroom specialist should be appointed to determine the integrity of the bathroom waterproofing membrane. If the membrane was found to be intact then relatively minor works to replace the cracked tiles should be carried out to ensure no further damage occurs. The re-application of silicone and grouting throughout remaining tile work is also advised, to further protect the area against water penetration.

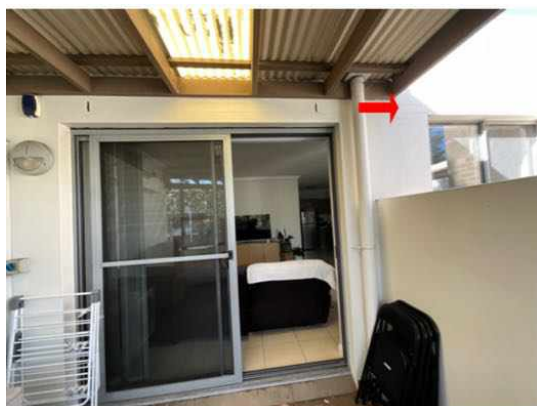
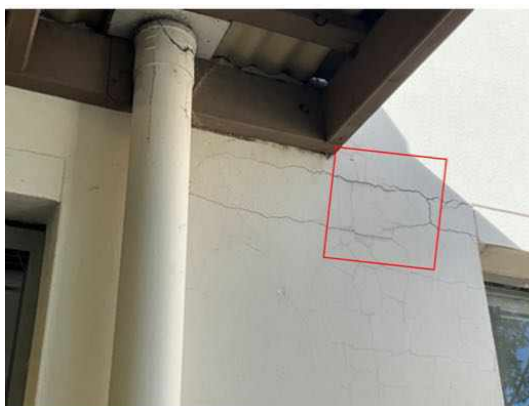
Finding 3.03

Building:	Main Building
Location:	Balcony
Finding:	External render — Cracked (minor)
Information:	Rendered surfaces were identified to be cracked at the time of inspection. The width of these cracks are under 1mm and are not significant.

This generally does not indicate a structural defect and may be due to poor workmanship during construction. Other causes include age, general wear and tear, expected building movement, general expansion/contraction of building materials in different weather conditions, and/or minor failings in the installation or application of building materials.

Any exposure to moisture is capable of causing rendered areas to become drummy and/or crack further. A licensed renderer or painter should be appointed for rectification works in short term.

Always contact your building inspector should cracks widen, lengthen, or become more numerous.

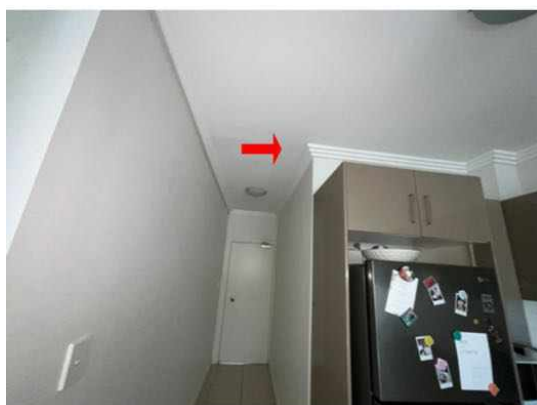
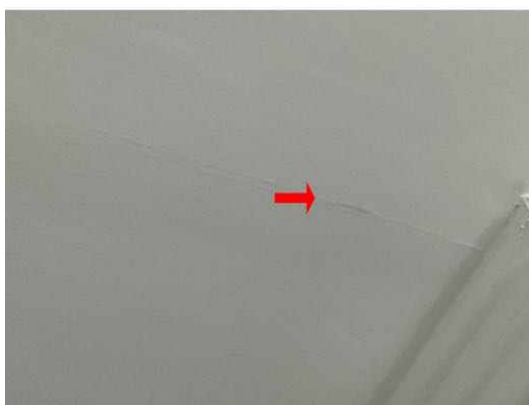
Finding 3.04

Building: Main Building

Location: Kitchen

Finding: Cracking - Damage Category 1 - Fine (up to 1mm)

Information: Although fine cracks are quite noticeable, they are often only considered to be an appearance defect, and usually do not indicate any structural damage. Generally, the cause of a fine crack is indicative of a separation between building materials and finishes (e.g. paint, plaster, etc.) along joints.

Cracking of this nature can generally be repaired with minor sanding, filling and/or repainting. Such works should be performed by a qualified painter or a general handyman.

Monitoring of all cracking should be conducted frequently. Always contact a building inspector should cracks widen, lengthen, or become more numerous.

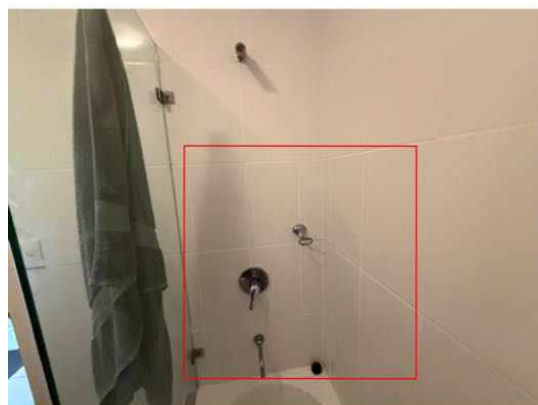
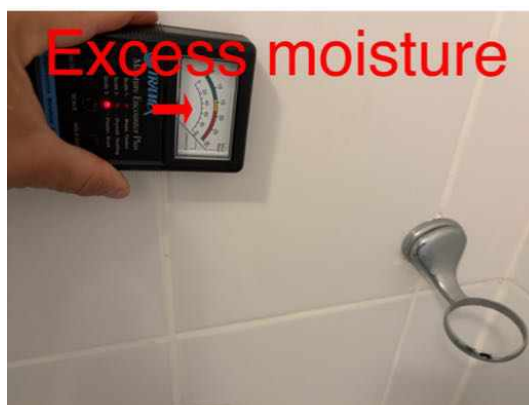
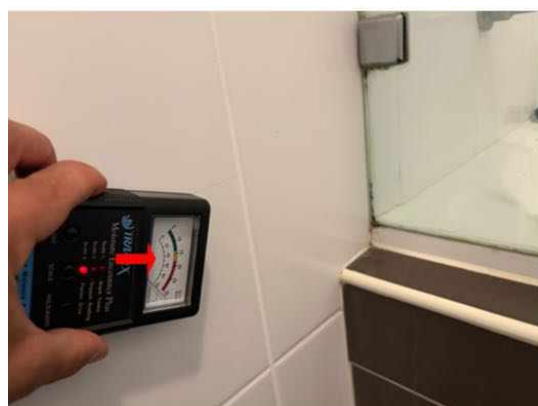
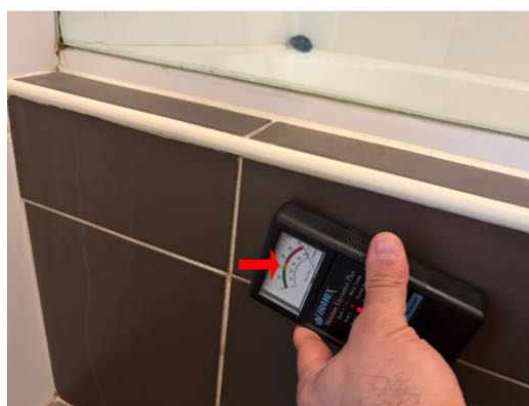
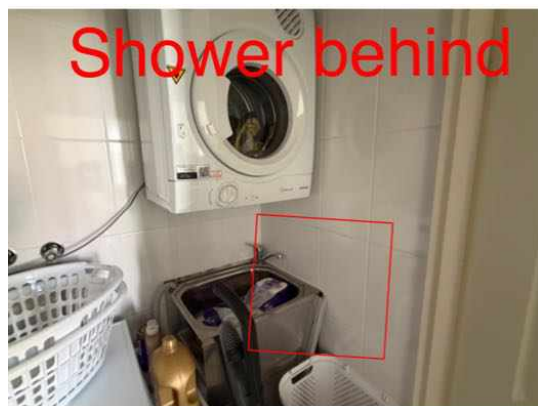
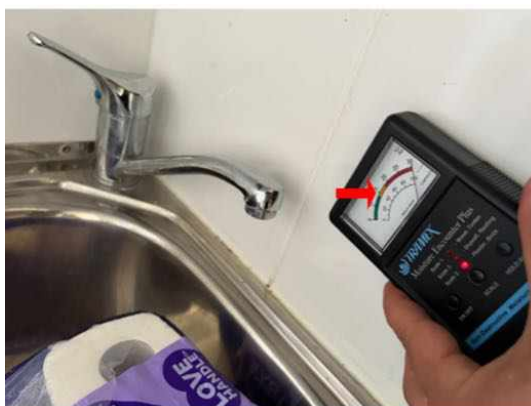
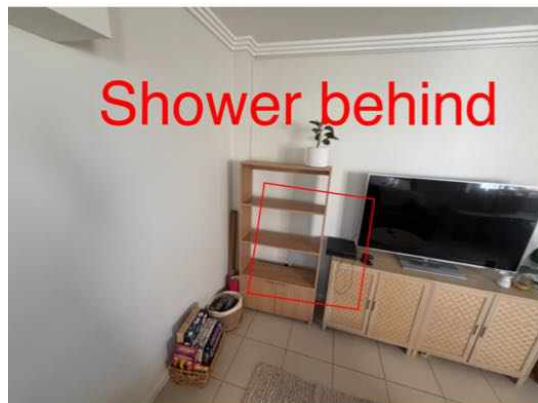
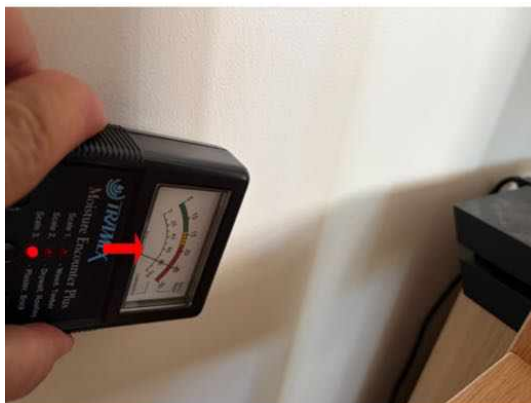
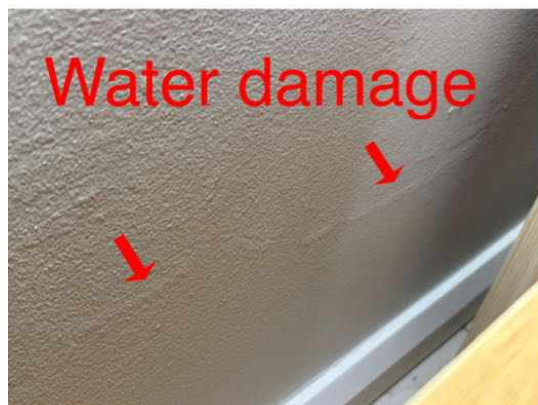
Finding 6.01

Building: Main Building

Location: Bathroom

Finding: Waterproofing damage - Suspected

Information: Excessive moisture was detected in these areas at the time of inspection. Internal water leaks can be detrimental to surrounding building elements. The potential cause in this area is damage to the waterproofing membrane inside the shower recess.

Attracting termites, corrosion, mould, decay and water damage are potential outcomes where a minor water leak is left unattended. More serious defects may also result, such as electrical hazards, or water damage to structural building elements.

In extreme cases, structural damage may develop due to a prolonged water leak. It is highly advised that this issue be addressed immediately by a bathroom specialist as a matter of relative urgency.
