Building Inspection Report

Inspection Date: Thu, 2 Apr 2026

Property Address: 43 Willow Dr, Hampton Park VIC 3976,
Australia

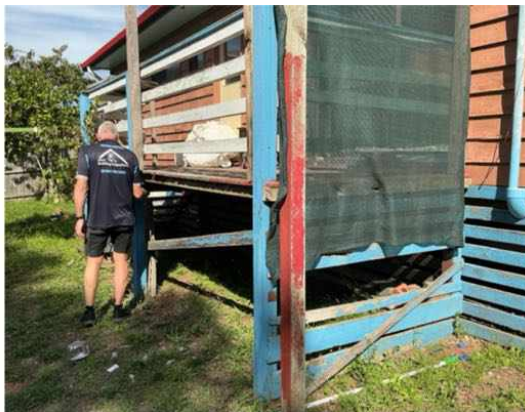
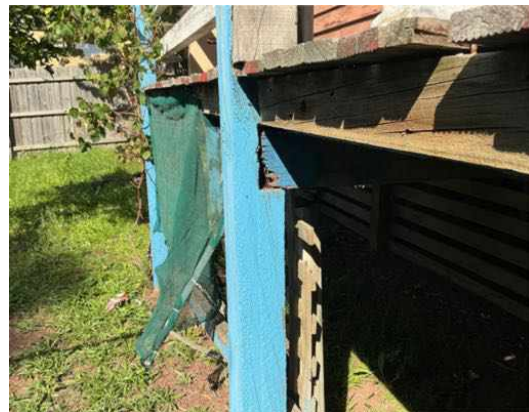
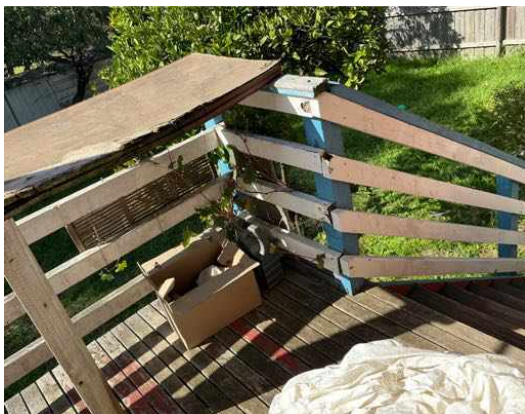
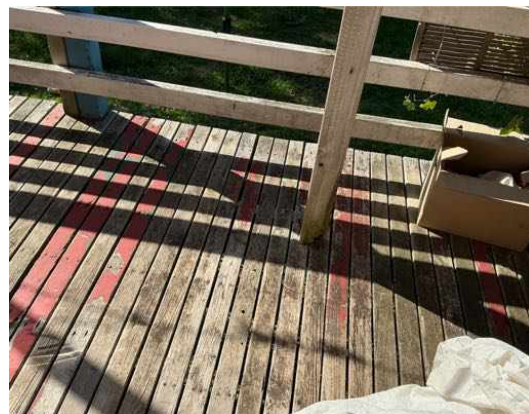
Defects 1.01

External timber structures are also constantly exposed to weather elements and can deteriorate in an accelerated manner, ongoing assessments are required.

It is highly recommended that a Structural Engineer further assess the external timber balcony or deck to inform the client of its load capacity. Regular maintenance inspections by competent practitioners is needed.

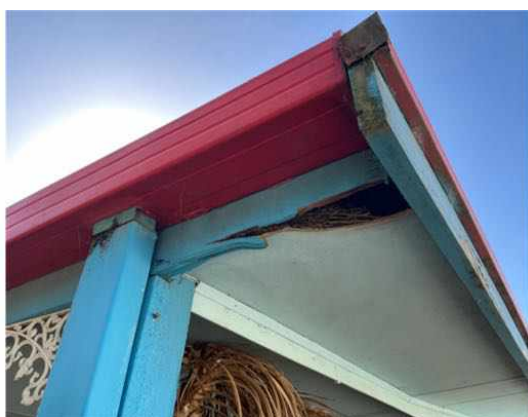
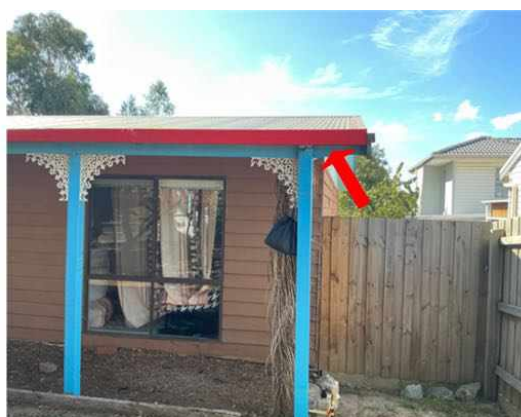
Defects 1.02

Building:	Main Building
Location:	Front Elevation

Finding: Eaves - Damaged
 Information: The eaves around the external property were found to be in a visibly poor condition. The damage may have been sustained as a result of a number of possible causes, including poor roof drainage, leaking roof plumbing or minor impact damage.

The damage to the eave sheeting in this area detracts from the appearance of the structure, as well as potentially compromising the structural integrity of the roofing area.

Where eaves show moderate to severe damage, remedial works may be required. Where water damage is suspected as being the underlying cause, appointment of a licensed plumber is advised as a matter of urgency to identify the source of the water leak.

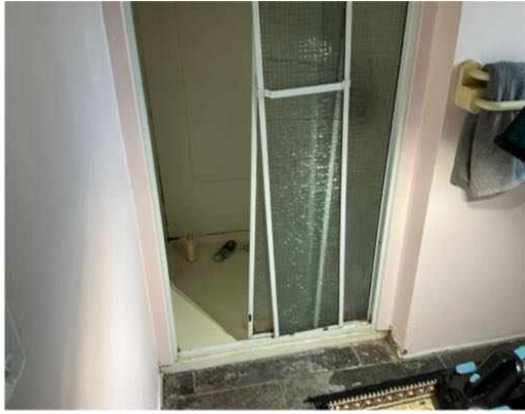
Defects 1.03

Building: Main Building
 Location: Bathroom
 Finding: Shower screen - Cracked
 Information: Cracking was evident to the shower screen at the time of inspection, which is suspected to be due to accidental impact damage.

While the cracking appears to be minor, any further impact may lead to additional cracking and or shattering of the shower screen, creating a potential safety hazard in the area. Further damage would almost certainly necessitate replacement of the entire shower screen.

A qualified glazier is required to repair the shower screen as soon as possible. Please be advised that any persons coming into contact with the cracked shower screen should do so with due caution to avoid any personal injury that may ensue.

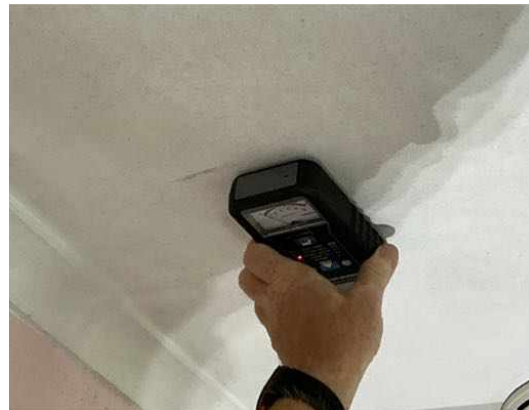
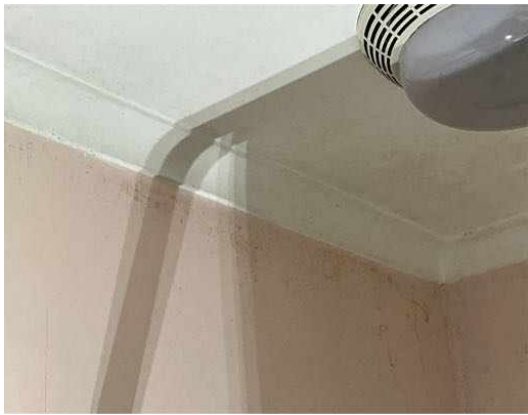
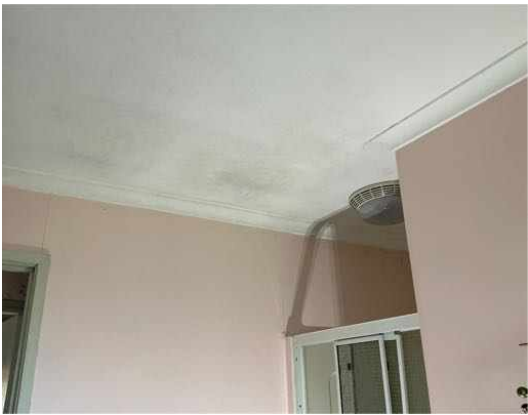
Defects 1.04

Information: Where evidence of mould growth was noted, there may be environmental, biological or health issues associated with the report. A specialist inspection by a suitably qualified environmental health inspector is warranted, where mould is extensive or where any queries regarding air quality spores or other related issues apply.

Generally, the client is advised to ensure that the general environment is free of moisture and humidity to aid in the prevention of mould formation and development. Any mould found during the inspection should be cleaned immediately by a cleaning contractor or the homeowner as applicable.

Please note that severely affected building elements may require replacement by a registered builder or qualified carpenter.

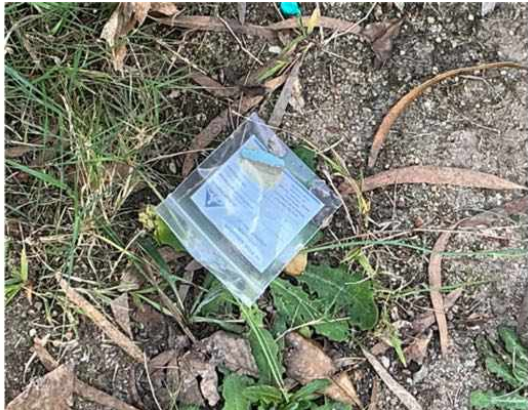
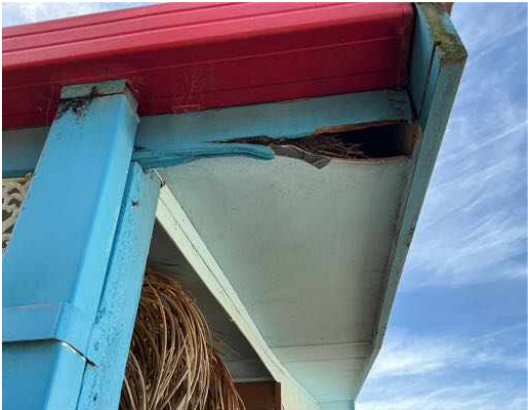
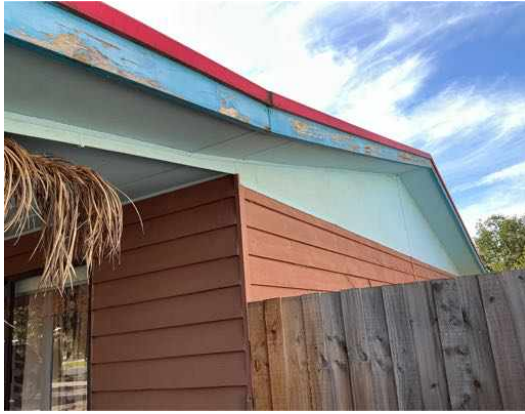
Defects 1.05

Building: Main Building
Location: Eaves and Gable end
Finding: Asbestos - Suspected ACM Identified on Site
Information: Reporting on Asbestos is outside the Scope of this Report. This suspected defect is highlighted as a caution only. We suspect, based on our experience in the building industry, that there is a higher risk of the identified building element containing asbestos.

As Asbestos Reporting is outside the scope of this report, we advise that you consider a separate Asbestos Inspection and Condition Audit, which can include the taking of samples for definitive confirmation of the presence of Asbestos.

In the interim, the client is advised to act with caution, especially when considering any damage to building materials general wear and tear renovations extensions demolition and general maintenance activities due to the suspected presence of Asbestos.

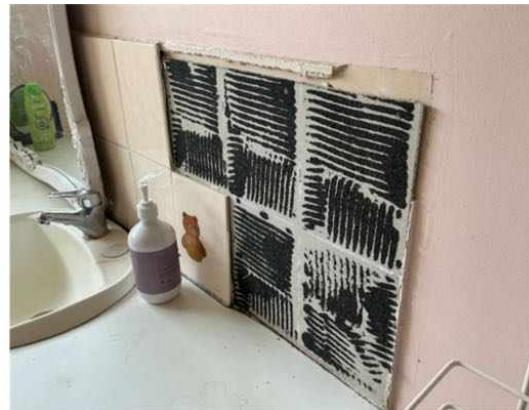
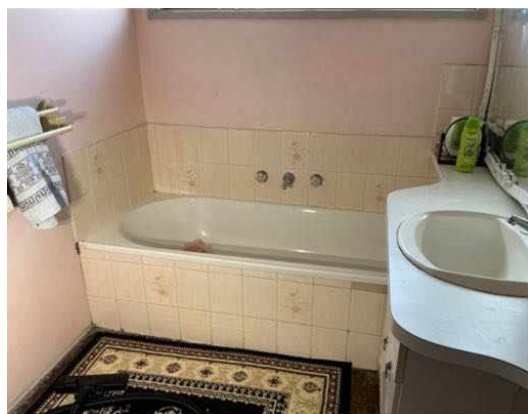
Defects 1.06

Information: Reporting on Asbestos is outside the Scope of this Report. This suspected defect is highlighted as a caution only. We suspect, based on our experience in the building industry, that there is a higher risk of the identified building element containing asbestos.

As Asbestos Reporting is outside the scope of this report, we advise that you consider a separate Asbestos Inspection and Condition Audit, which can include the taking of samples for definitive confirmation of the presence of Asbestos.

In the interim, the client is advised to act with caution, especially when considering any damage to building materials general wear and tear renovations extensions demolition and general maintenance activities due to the suspected presence of Asbestos.

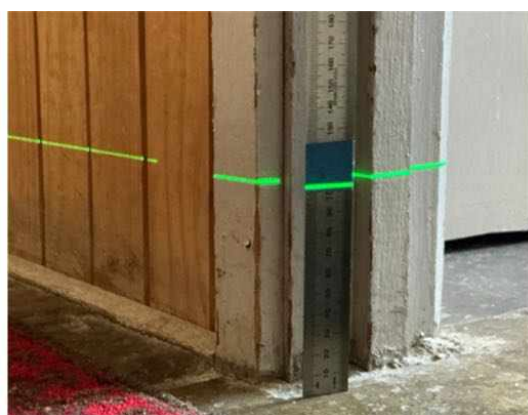
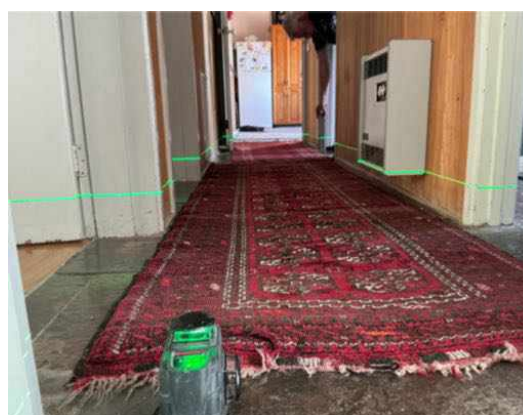
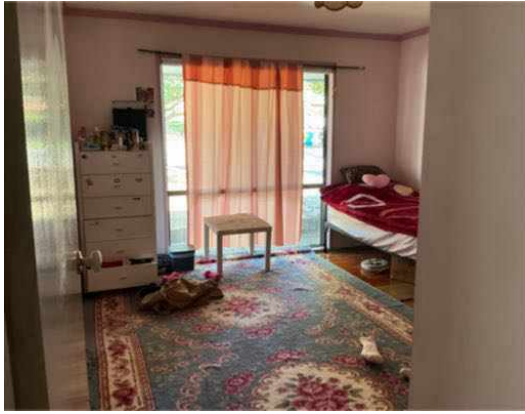
Defects 2.01

Building:	Main Building
Location:	All Areas
Finding:	Flooring - Uneven (25mm)
Information:	The internal flooring in this area is out of level and uneven. Uneven flooring is likely to indicate minor defects such as expected movement of the foundations of the property, but may also indicate subsidence of the associated subfloor stumps.

2/flooring was found to be uneven and beyond tolerance at the time of inspection.

Uneven flooring is likely to may minor defects such as expected movement of the foundations of the property, but may also indicate subsidence of the associated subfloor stumps.

It is advised that the flooring be closely monitored to identify any further movement. Where flooring remains relatively unchanged for an extended period of time (i.e. several months), it is likely that this defect has been caused by expected movement of the foundations of the property.

However, where flooring is uneven further, potentially invasive inspection of the subfloor structures and stumps in this area is required. In this case, works to repair are likely to be required, and would be carried out by a registered builder specialising in re-stumping.

Where flooring is uneven and beyond tolerance, further, potentially invasive inspection of the subfloor structures and stumps in this area is required. In this case, works to repair are likely to be required, and would be carried out by a registered builder specialising in re-stumping.

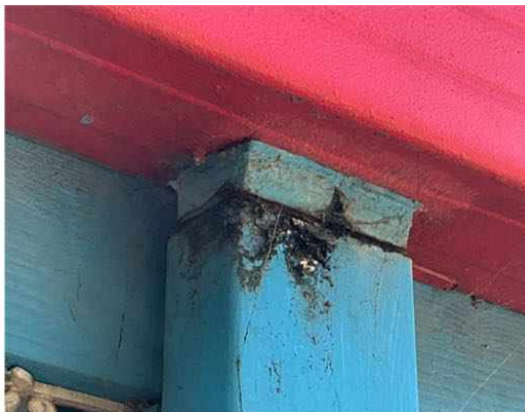
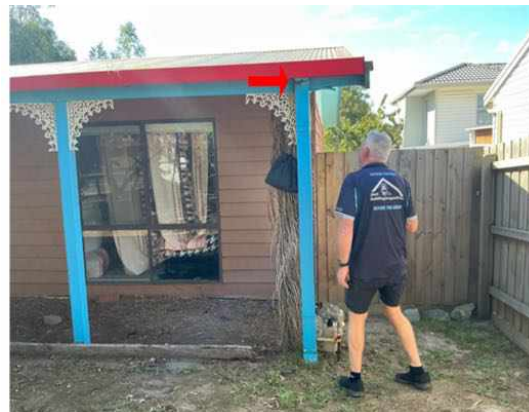
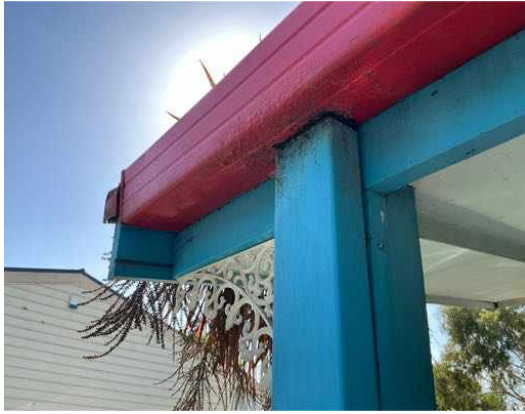
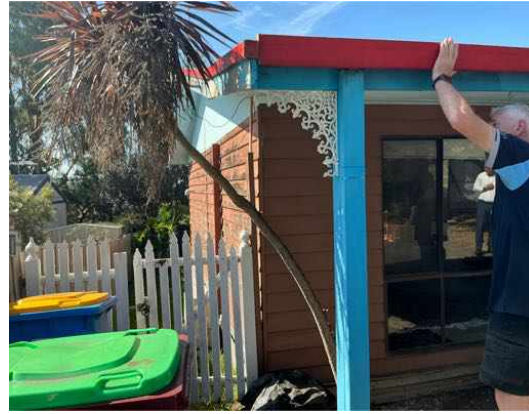
Defects 2.02

Building: Main Building
 Location: Front Elevation
 Finding: Stormwater drain - Not connected
 Information: The roof plumbing is not adequately connected to stormwater drainage on the site. This disconnection negatively impacts the functional capacity of the roof plumbing.

Where roof plumbing doesn't drain adequately, the area at the base perimeter can become excessively damp, potentially creating an environment that is susceptible to rust and corrosion of surrounding building elements, as well as attracting termites and other pests.

3/Stormwater was found to be disconnected at the front of the property with deterioration of gutters

It is highly recommended that a plumber be appointed to further inspect the area and to install adequate drainage equipment where necessary.

A specialist roof plumber should be engaged to inspect all roof plumbing and replace where required.

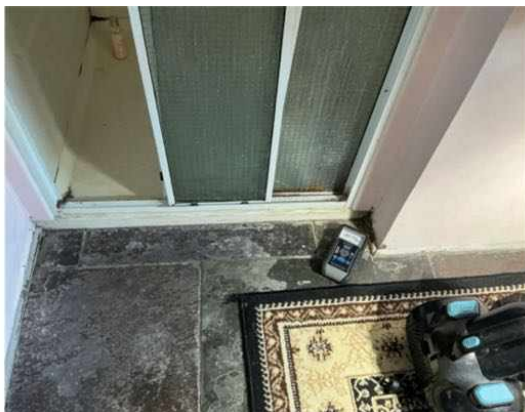
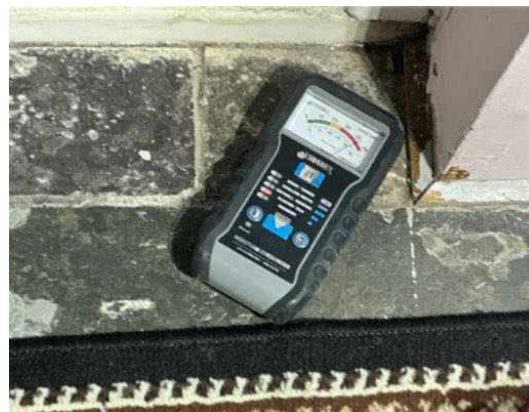
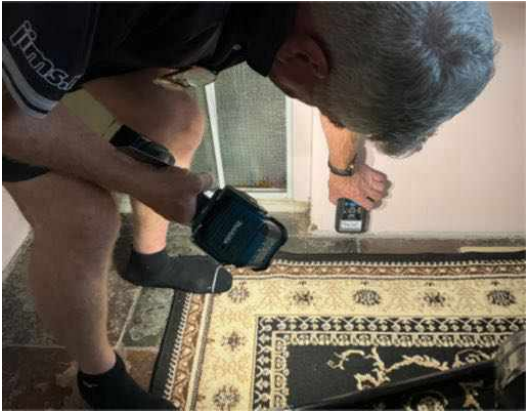
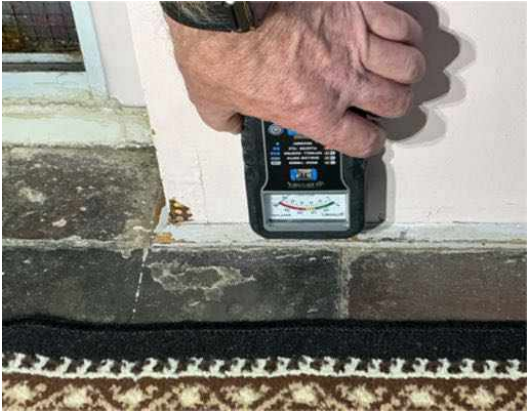
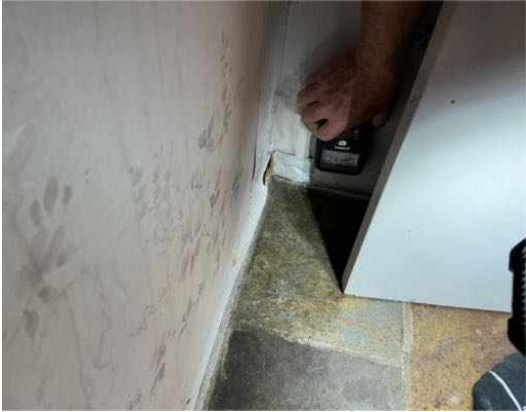
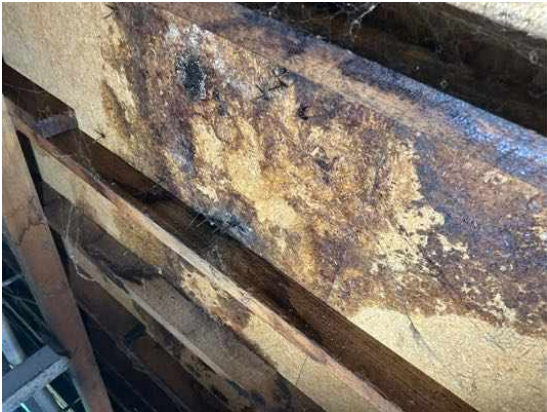
Defects 2.03

Finding: Shower - Leaking

Information: Leaking was evident to the shower area at the time of inspection as shown in photos with the moisture meter. It is suspected that the leaking has occurred as a result of general ageing of the building elements.

Leaking from the shower base, where left unattended, is likely to lead to water damage to adjoining flooring and walls. Leaking can lead to water damage and necessitate extensive remedial works being required. Active water leaks may also create an environment that is susceptible to the formation and development of mould.

1/ Leaking was evident to the bathroom and shower area at the time of inspection as shown in photos with the moisture meter. It is suspected that the leaking has occurred as a result of general ageing of the building elements. Evidence of damaged Timbers and mould were found in the subfloor under the bathroom and laundry areas as well.

Appointment of a tiling contractor is required to replace the shower the bathroom waterproofing and tiling. Such works should be performed as soon as possible to ensure that no further damage occurs.

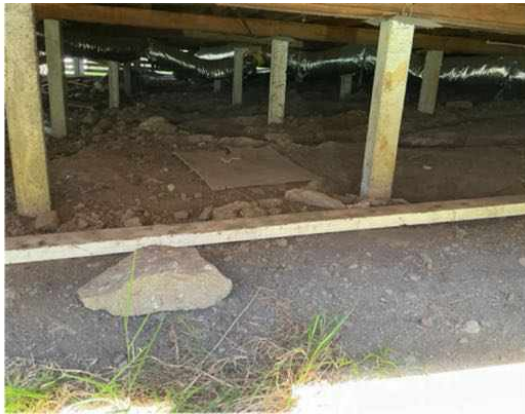
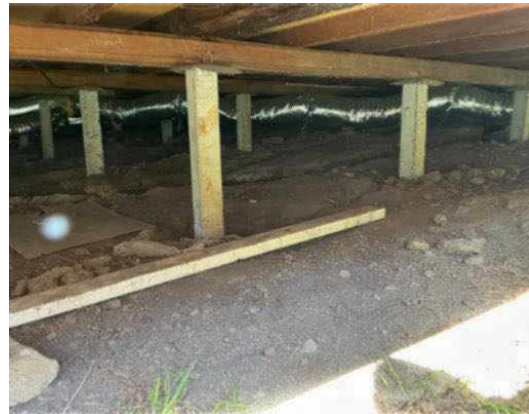
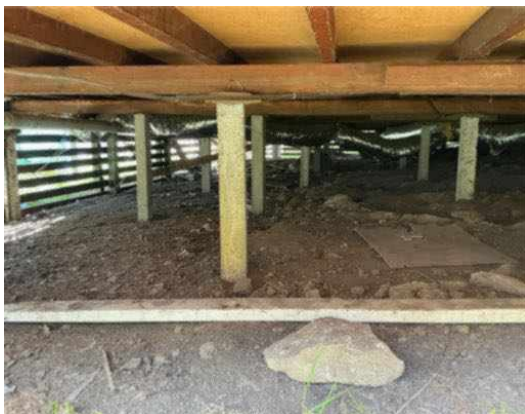
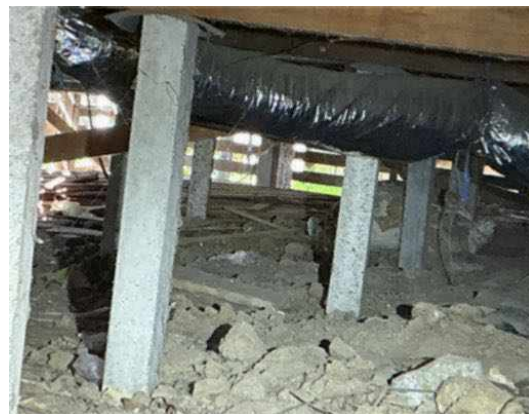
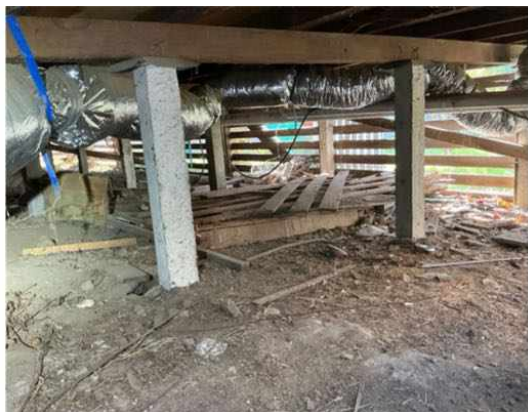
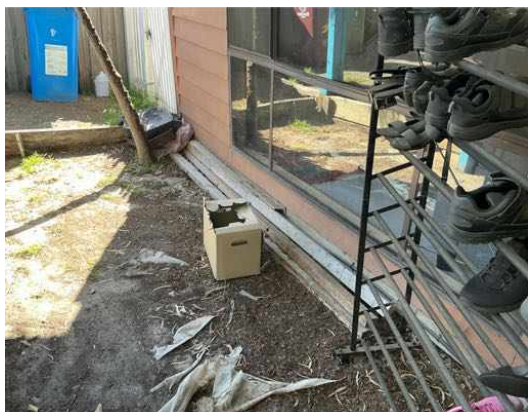
Defects 3.01

Building:	Main Building
Location:	Subfloor
Finding:	Stored timbers - subfloor space or external area
Information:	The storing of timbers in the subfloor space or around the external property increases the risk of termite activity being present. As they are likely to come into contact with weather conditions or excessive moisture wood rot is likely to develop on timbers that are not treated.

It is highly recommended that any stored timbers be immediately removed from areas in which they may attract any termite / timber pest attack. Minimisation of risk / prevention of termite attack is far more adequate than dealing with the presence of termite activity.

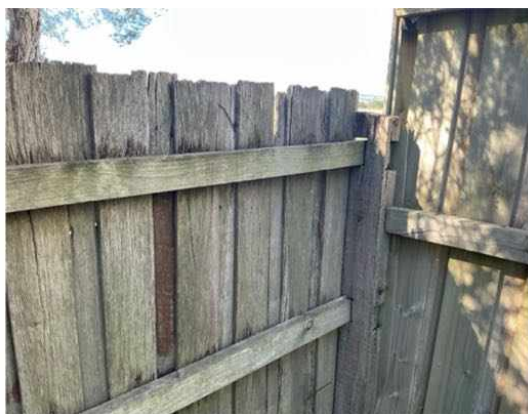
Defects 3.02

Building:	Main Building
Location:	Rear Elevation
Finding:	Fencing - Deteriorated
Information:	It was noted at the time of inspection that sections of the fencing throughout the property have deteriorated. Typically fencing deteriorates due to age and or wear, rot and or rust which is generally expected for a structure of this age, due to prolonged exposure to weather conditions. Sometimes inadequate installation or maintenance can be to blame.

If left unattended, it is likely that further damage will occur. It is suspected that repair of several elements of the fencing may be required however replacement may be a consideration of the client also.

A licensed fencing contractor should be appointed to provide further advice and perform rectification works as necessary.

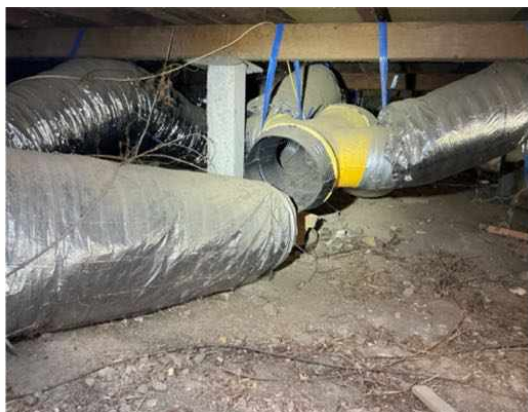
Defects 3.03

Building:	Main Building
Location:	Subfloor
Finding:	Heating / Cooling Ducts - damaged
Information:	The heating/cooling ducts were found to be damaged and not at a fully operational level. Generally, damage to ducts occurs as a result of aging and material deterioration, but impact damage or pest damage may also be the underlying cause.

The damage sustained by the ducts detracts from the energy efficiency of the property. The airflow within the property is likely to be restricted, particularly in areas where ducting shows signs of major damage.

A heating/cooling specialist should be appointed to provide further advice on remedial work options and to perform any works deemed necessary.

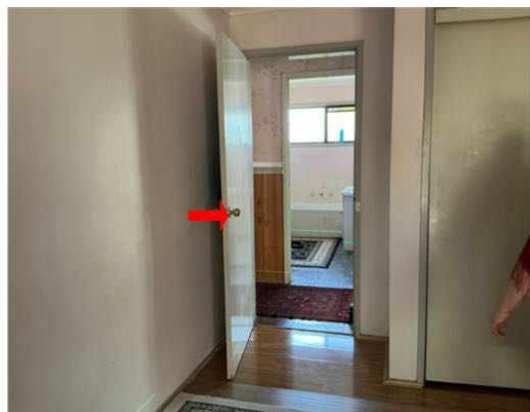
Defects 3.04

Building:	Main Building
Location:	Bedroom
Finding:	Door handle - Not latching
Information:	It was noted that the door in this area was not latching during operation at the time of inspection. Whilst detracting from the functionality of this building element, this minor

defect may also be a security risk, and may therefore have serious implications if left unattended.

It is suspected that this defect has occurred due to minor issues with the associated hinges. Such damage is identified as general wear and tear, which is expected for building elements of this age.

A qualified carpenter or general handyperson may be appointed to perform rectification works as necessary, at client discretion. If left unattended, further functional impairment is likely to occur.

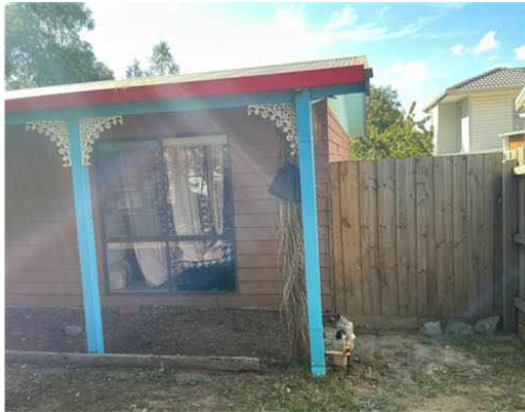
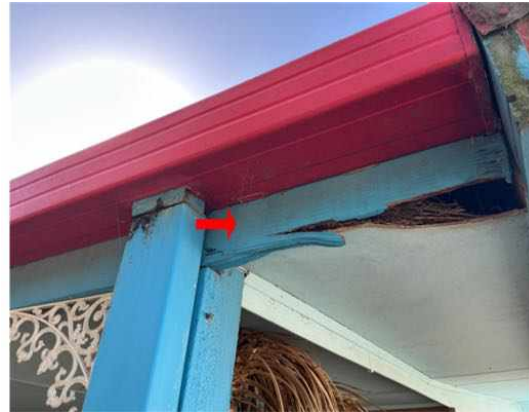
Defects 3.05

Building:	Main Building
Location:	Front Elevation
Finding:	Fascias - Wood rot
Information:	Wood rot was found to be affecting fascias and barges in this area, evidenced by the presence of mould on the surface in some areas. Wood rot, also known as Fungal Decay, occurs when timbers and other cellulose building materials are exposed to damp conditions on an ongoing basis.

It is likely that this wood rot has developed as a result of faults in the roof plumbing, creating excessive moisture in this areas. Frequent exposure to rain and other weather conditions also make fascias and barges susceptible to accelerated deterioration.

Early intervention and regular maintenance will prolong the useful life of these building elements. Prior to any works being performed, the cause of the moisture that has created the visible wood rot should be identified and addressed in a suitable manner.

It is advised that a roof plumber be appointed to inspect all roof plumbing and subsequently identify the cause of the wood rot. Replacement of affected fascias and barges may then be a necessary step in protecting surrounding building elements from such deterioration.

A qualified plumber may be appointed to assess the cause of excessive moisture and

to provide advice on any remedial works as required. A qualified carpenter or registered builder may also be required to replace affected building materials.

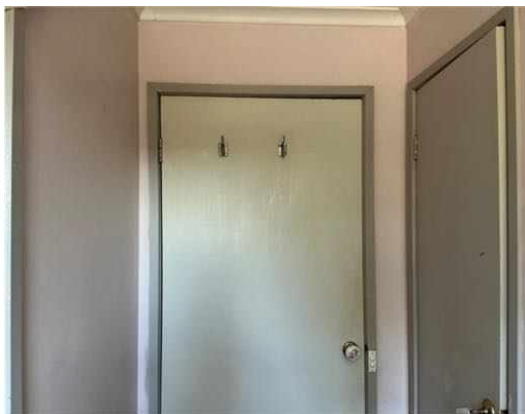
Defects 3.06

Building: Main Building
 Location: Laundry
 Finding: Door - Gap
 Information: A significant gap was identified between the door and door frame in this area. Where large gaps to the head or foot of door frames appear, it may indicate a variety of defects, ranging from uneven framework, sagging hinges or uneven flooring.

A gap to the head of the door may also indicate movement of the foundation of the property, which is a common occurrence and does not indicate structural damage.

A qualified carpenter should be appointed to perform remedial works to restore the door to a fully operational level.

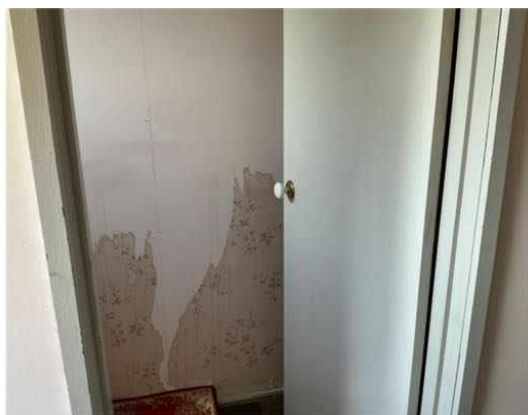
Defects 3.07

Building: Main Building
 Location: Toilet
 Finding: Door - Binding/jamming

Information: Binding and/or jamming of this door is evident during standard operation. This defect inhibits the functionality of the affected door as well as creating potential for secondary defects to associated building elements, such as damage to the floor covering.

A door that binds to flooring or to the associated door frame may have several causes, ranging from minor defects, such as poor installation of the door or deteriorated hinges, through to major structural issues, such as damage to subfloor structures.

Where door binding/jamming appears to indicate major structural issues, a registered builder specialising in re-stumping should be appointed to provide an estimate on the cost of rectification.

For minor causes, a qualified carpenter or general handyperson should be appointed to perform minor rectification works at client discretion.

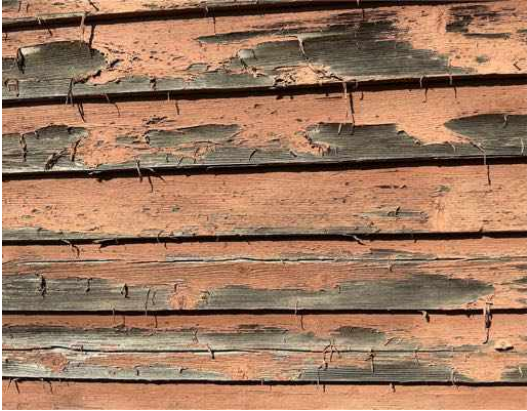
Building:	Main Building
Location:	All Areas
Finding:	External painting deteriorated
Information:	Much of the external paintwork including but not limited to windows, fascias, guttering, veranda and other external fitments have been neglected and require attention to prepare and re-paint.

Whilst incomplete or missing paint finish is generally an appearance defect, it can also lead to the development of secondary building defects over time. Incomplete areas of paint finish expose the area to moisture, potentially accelerating the deterioration of underlying building materials.

Degraded paint finishes should be sanded back, filled, leveled and painted, as applicable. Where inadequate or missing paint protection has led to the deterioration of the associated building element, repair and/or replacement of this building element may be required.

A painting contractor should be appointed as soon as possible to perform necessary works to aid the appearance of the affected area and to ensure the area is protected against further deterioration. Alternatively, the homeowner following manufacturer instructions may perform these works.

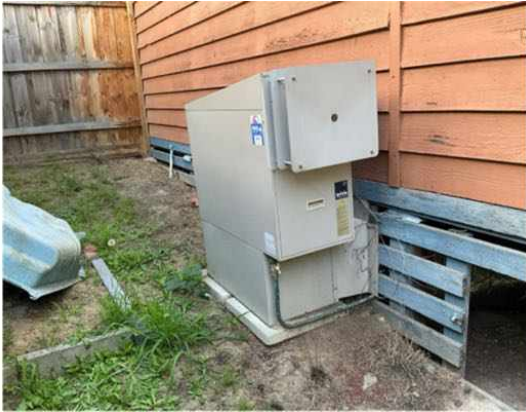
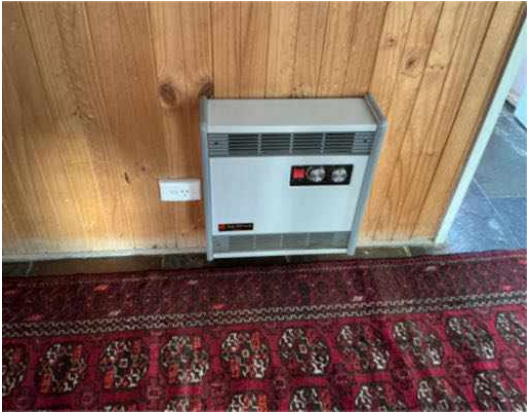
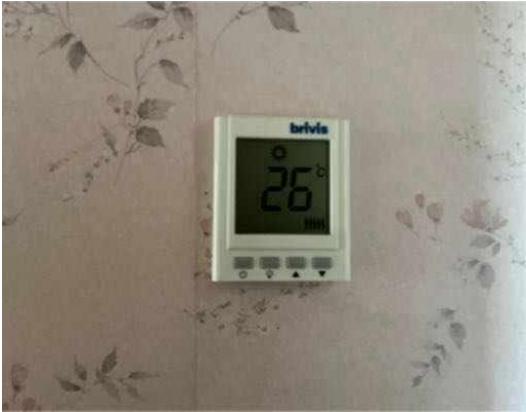
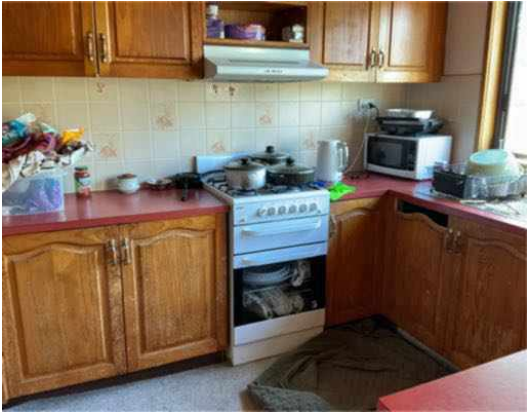
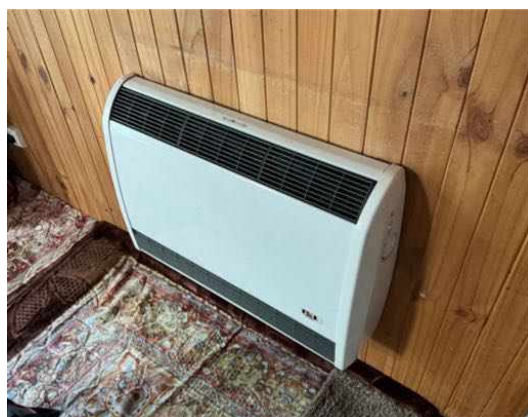
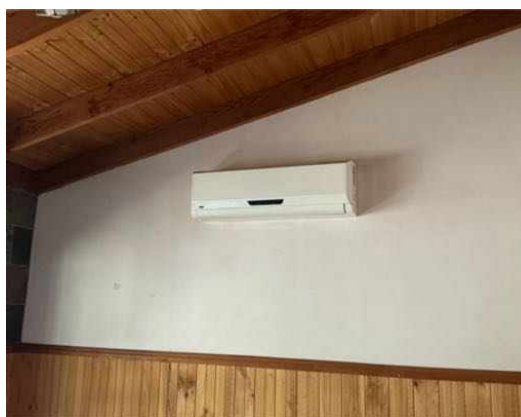
Building: Main Building
 Location: All Appliances
 Finding: Warranty - Expired
 Information: Where appliances are beyond their warranty period, the owner should be prepared to meet the cost of replacement or repair of the item at any time. The operation of the appliance can not be guaranteed and further inspection by an appropriately qualified tradesperson may be required.

Tenants advised that ducted heating and wall heating are both inoperable, heating ducts were found to be disconnected under the house.

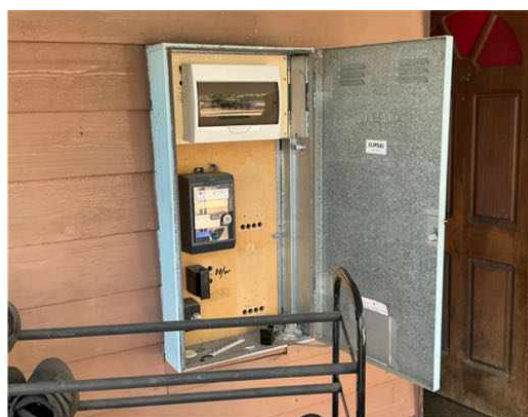
Building:	Main Building
Location:	Electrical Switchboard
Finding:	Termite Management System - no evidence of a chemical installation
Information:	The application of a post-construction chemical termite barrier is highly recommended for all properties, particularly if live termite activity has been found on the site previously. Such barriers are highly effective in preventing termite attack on any timber building elements throughout the property.

A durable notice should be placed in the switchboard unit to indicate current termite barriers. At the time of inspection, it appeared as though no termite management system has been installed, with no evidence to suggest preventative works taking place.

The client may consider gaining further advice from a pest controller as to the costs and procedures involved with this application. It is recommended that obtaining such advice be a short-term priority.

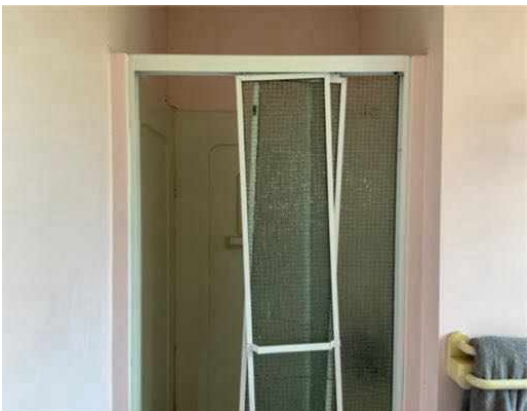
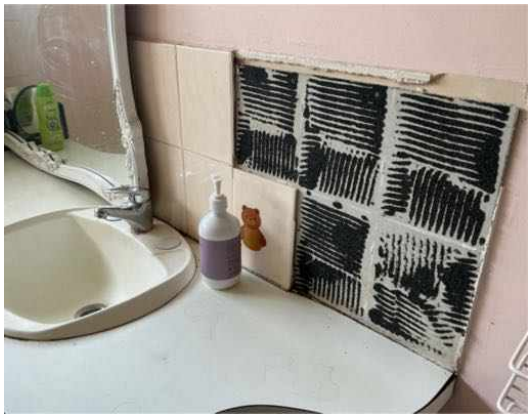
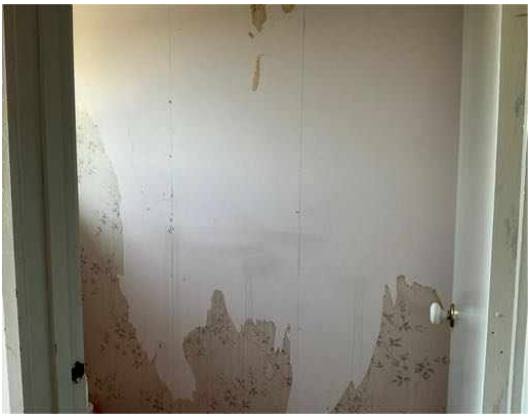
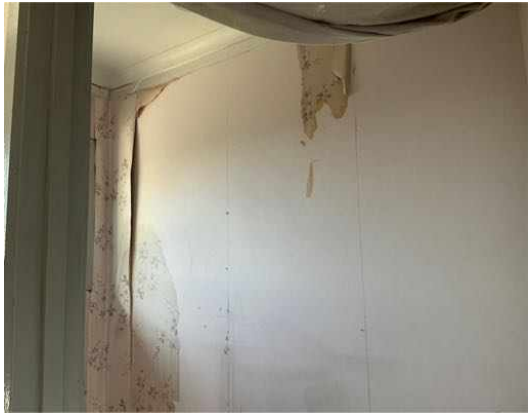
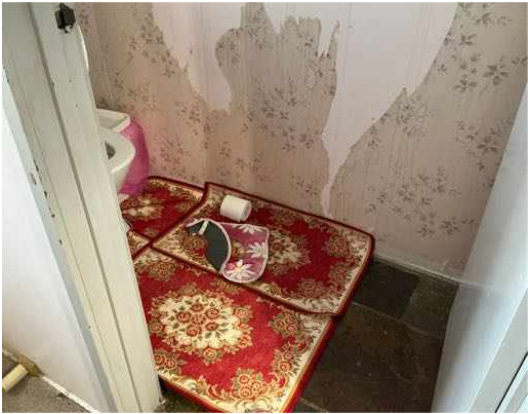
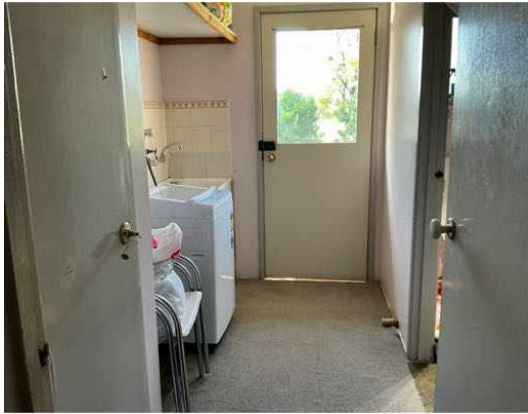
Finding: Deteriorated elements
Information: It was identified that many items around the home have suffered from environmental effects and wear and tear with replacement required.

Secondary defects are likely if the issue is not addressed.

Elements such as bolts and structural brackets may require the services of a builder where replacement is required other wise a carpenter, handy man, cabinet maker and painter can attend to the more general replacement requirements.
