Building and Timber Pest Inspection Report

Inspection Date: Tue, 24 Feb 2026

Property Address: 4/40 Royal Ave, Glen Huntly VIC 3163,
Australia

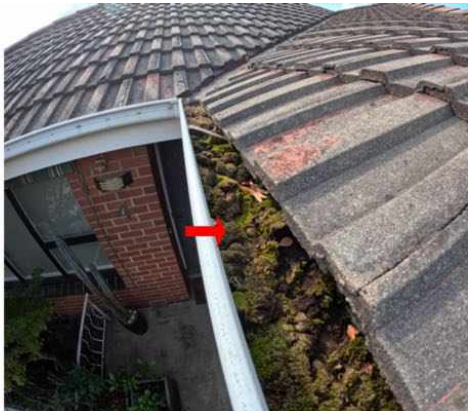
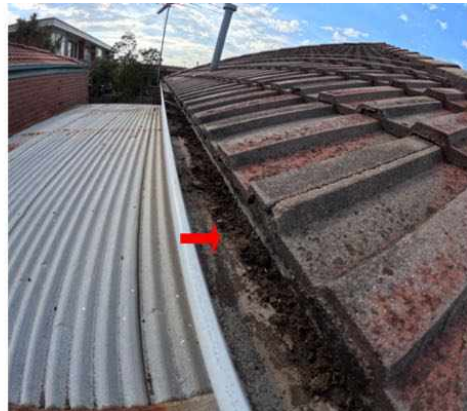
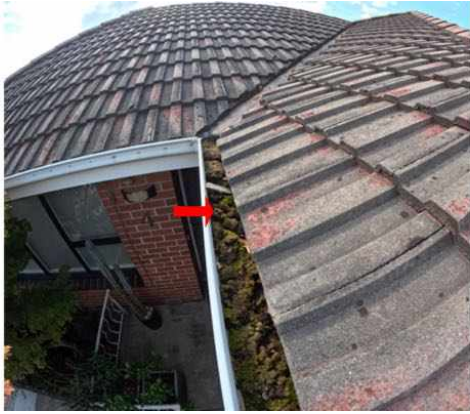
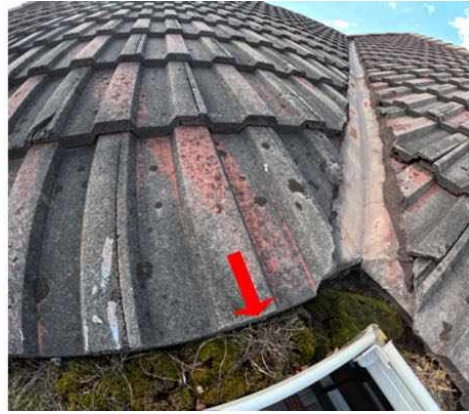
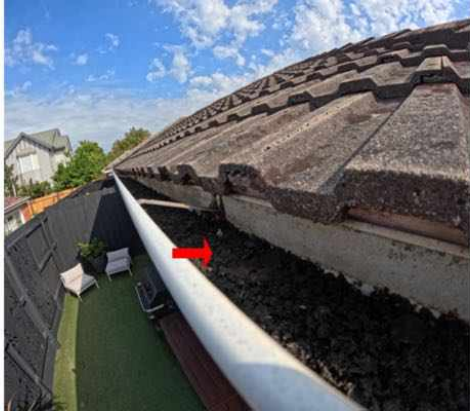
Finding 3.01

Building:	Main Building
Location:	Roof Exterior
Finding:	Gutter debris accumulation and inadequate drainage
Information:	The gutters exhibit debris accumulation (e.g., leaves, dirt) and green organic growth (algae/moss), indicating water pooling due to inadequate drainage. This poses risks of blockages, overflow during rainfall, and potential damage to fascia boards, walls, or foundations. Prolonged moisture retention may accelerate corrosion and attract pests. Immediate action is advised: clear debris, flush gutters and downpipes, remove organic growth, and inspect gutter slope/downpipe functionality.

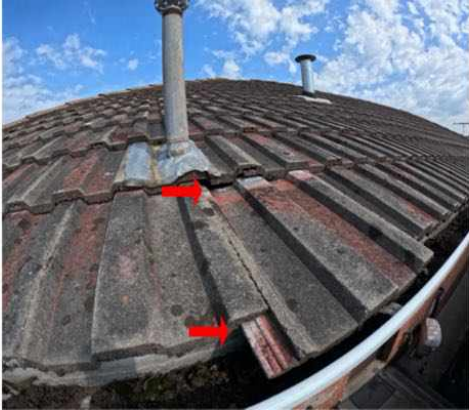
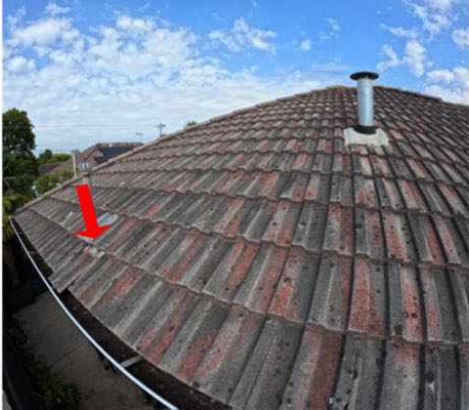
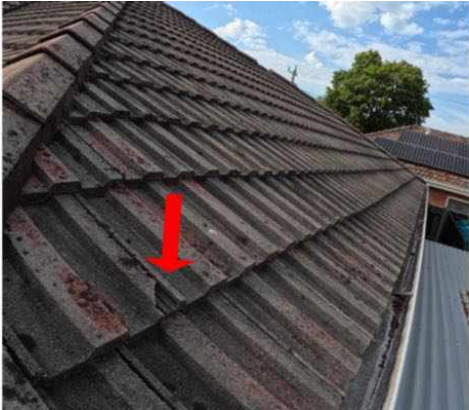
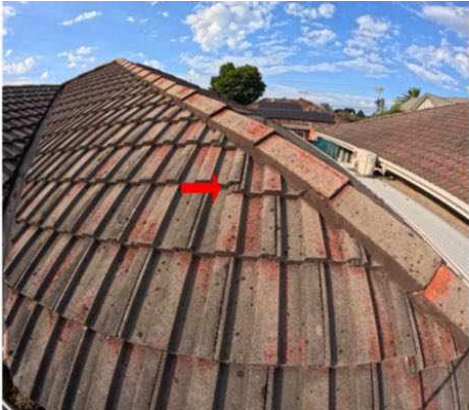
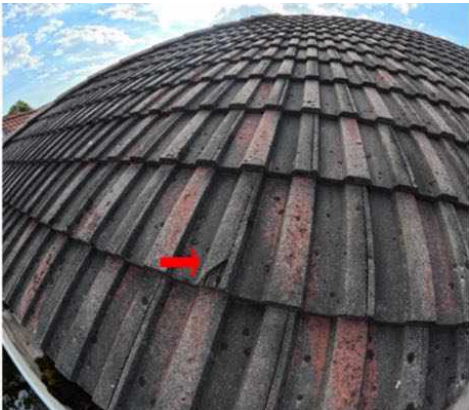
Finding 3.02

Building:	Main Building
Location:	Roof Exterior
Finding:	Roof tiles - Weathered
Information:	Upon inspection of the exterior roofing, the majority of roof tiles were considered to be in a fair condition. While weathering of the tiles is consistent with the age of the property, maintenance works are required.

Isolated areas of mortar have come loose in the valleys and minor cracking is also present. Re-pointing and re-sealing the may be considered as an interim solution by the client to help preserve and extend the life span of the tiles.

Where left unmanaged, deteriorating roof tiles are likely to lead to a number of secondary defects, including minor water leaks and weather exposure to internal roofing structures.

Efflorescence was observed on the underside of the roofing material. This is identified by the white, powdery staining that forms when moisture within the material dissolves salts, which are then carried to the surface and deposited as the water evaporates.

While efflorescence itself is not structurally damaging, it indicates that moisture is penetrating or accumulating in the roof covering. If left unaddressed, ongoing moisture exposure may contribute to deterioration of roofing materials and encourage timber

decay or corrosion of fixings.

It is recommended to monitor the area for signs of active leaks and ensure roof drainage and ventilation are adequate. If moisture ingress persists, a licensed roofing contractor should be engaged to investigate and carry out necessary rectification works.

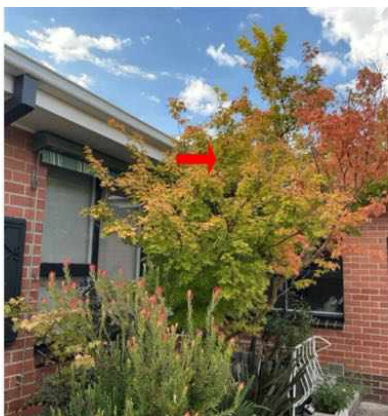
Finding 3.03

Gutters are a critical part of the building's management of storm water and rain. It is therefore important that they be kept clear to prevent secondary damage to associated building elements, including exterior and interior walls, ceiling linings and any adjoining building elements. Where gutters are blocked, pooling of rainwater is likely to occur, fast-tracking rust and corrosion of the roof plumbing elements.

It is highly advised that all overhanging tree branches be removed as soon as possible to prevent any further damage. Repair and/or replacement of sections of damaged guttering may also be required where the extent of the damage necessitates.

Such works should be performed by the homeowner; however, appointment of a landscape contractor or an arborist may be required. Consultation with a licensed roof plumber is required where guttering has been damaged.

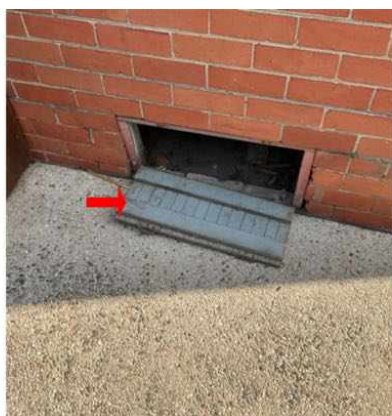
Finding 3.04

Building: Main Building
Location: Yard - Back
Finding: Subfloor access door – detached
Information: The subfloor access door was observed to be detached and not securely fixed to the opening at the time of inspection.

This condition may allow pest entry, moisture intrusion, and reduces the effectiveness of subfloor ventilation control.

Engage a builder or carpenter to refix or replace the subfloor access door and ensure it is securely fitted and vermin-resistant.

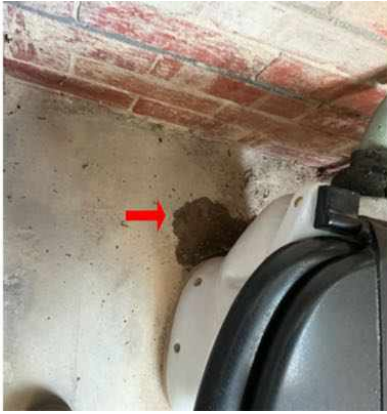
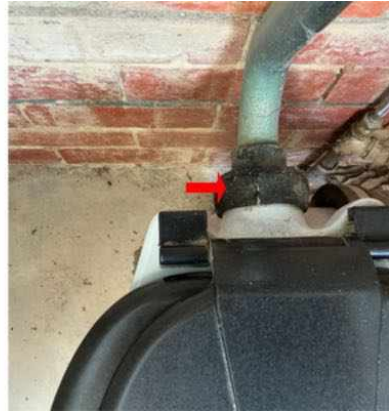
Finding 3.05

Building: Main Building
Location: Garage
Finding: Toilet plumbing – leakage observed
Information: Water leakage was observed at the toilet connection area when the toilet was operated, with associated moisture staining noted to the adjacent floor.

Ongoing leakage may lead to moisture damage, mould growth, and deterioration of surrounding building elements if not rectified.

Engage a licensed plumber to inspect the toilet connections, rectify the leak, and test the installation to ensure it is fully watertight.

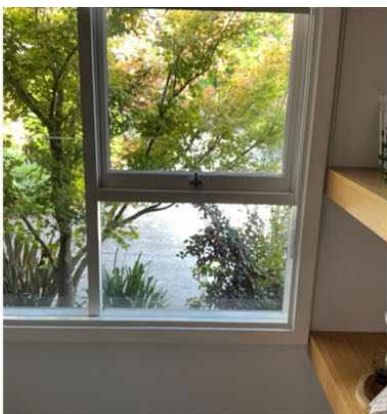
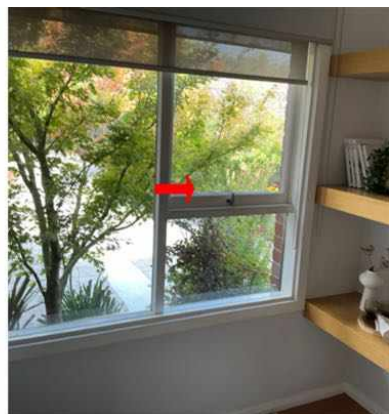
Finding 3.06

Building:	Main Building
Location:	Bedroom
Finding:	Window – jammed/inoperable
Information:	The window was jammed and could not be opened at the time of inspection.

Inoperable windows may affect natural ventilation and may present a safety concern where the window is intended for egress or emergency escape.

Engage a qualified window technician or carpenter to inspect the window mechanism, rectify the fault, and ensure the window operates smoothly and safely.

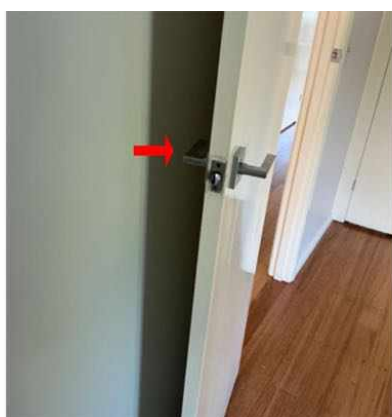
Finding 3.07

Building:	Main Building
Location:	Bedroom
Finding:	Door stop - Missing
Information:	The door stop is missing or is inadequate to stop the door handle from damaging the wall. Although some building elements may seem irrelevant or unnecessary, all building elements play a key role in the operation and function of the overall structure and its performance.

Re-installation or replacement of the door stop is advised as soon as possible to prevent any subsequent damage to the door or associated structures. A general handyman may be appointed to perform these works at client discretion.

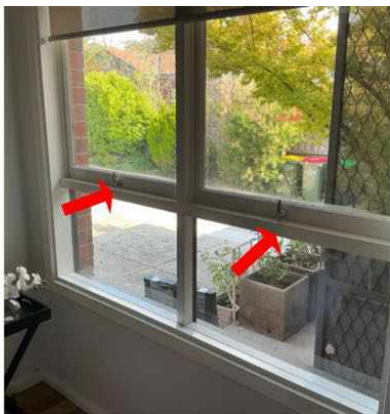
Finding 3.08

Building:	Main Building
Location:	Bedroom
Finding:	Window – jammed/inoperable
Information:	The window was jammed and could not be opened at the time of inspection.

Inoperable windows may affect natural ventilation and may present a safety concern where the window is intended for egress or emergency escape.

Engage a qualified window technician or carpenter to inspect the window mechanism, rectify the fault, and ensure the window operates smoothly and safely.

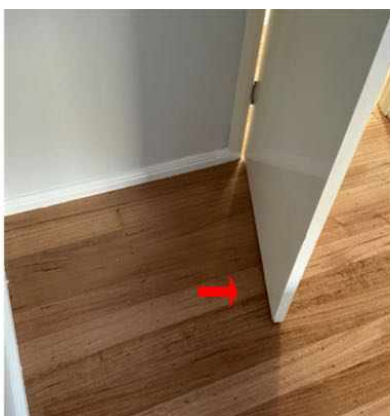
Finding 3.09

Building:	Main Building
Location:	Bedroom 2
Finding:	Door stop - Missing
Information:	The door stop is missing or is inadequate to stop the door handle from damaging the wall. Although some building elements may seem irrelevant or unnecessary, all building elements play a key role in the operation and function of the overall structure and its performance.

Re-installation or replacement of the door stop is advised as soon as possible to prevent any subsequent damage to the door or associated structures. A general handyman may be appointed to perform these works at client discretion.

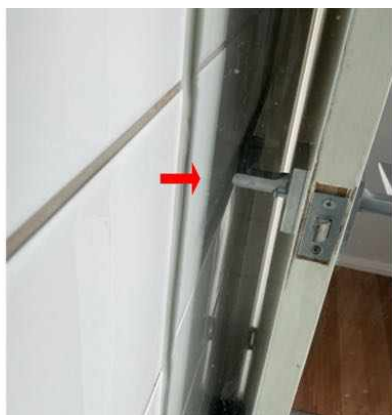
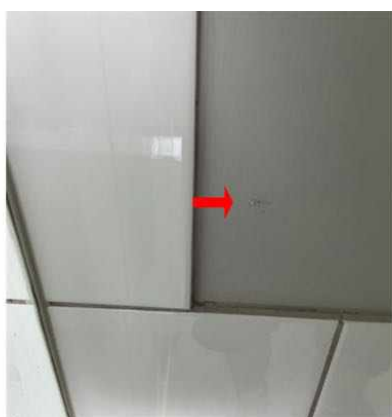
Finding 3.10

Building:	Main Building
Location:	Bathroom
Finding:	Door stop missing — damaged
Information:	The door stop is missing behind the door. This has resulted in visible impact damage to the wall.

Continued use without a door stop may lead to further damage to the wall, fittings, or

door hardware.

It is recommended to install an appropriate door stop or bumper to prevent further impact damage and to repair the affected wall area as required.

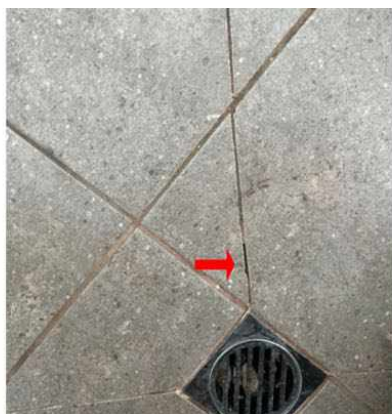
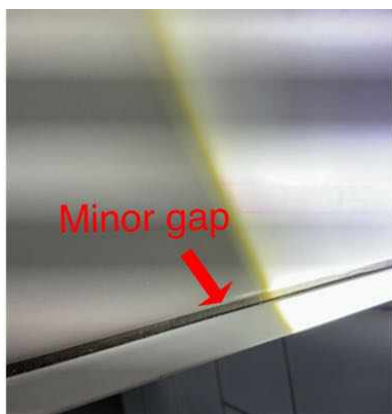
Finding 3.11

Building:	Main Building
Location:	Bathroom
Finding:	Sealant and grout deteriorate
Information:	The compromised sealant and deterioration of grout may allow water to penetrate into the substrate beneath the tiles. Over time, this can lead to deterioration of the underlying waterproofing membrane, increasing the risk of moisture ingress and potential structural damage.

It is recommended that a licensed waterproofing contractor be engaged to remove the degraded sealant, repair or replace the deteriorated grout, and reapply suitable waterproof-grade sealant. These works should be carried out as soon as possible to prevent further water penetration and damage to the balcony structure.

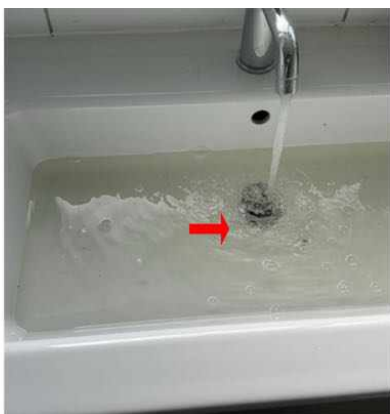
Finding 3.12

Building:	Main Building
Location:	Bathroom
Finding:	Basin – Slow Drainage
Information:	The basin was observed to drain slowly during testing. Water pooled and took an extended period to clear after use, indicating a partial blockage or restriction within the waste pipe, trap, or drain outlet.

Have the basin waste pipe and trap inspected and cleared by a licensed plumber. If recurring, further investigation may be required to check for underlying issues such as pipe slope, venting problems, or buildup in concealed sections.

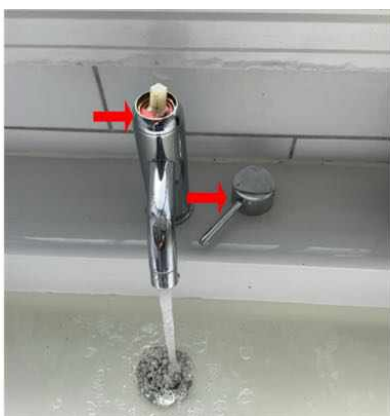
Finding 3.13

Building:	Main Building
Location:	Bathroom
Finding:	Basin mixer tap – handle detached
Information:	The mixer tap handle was observed to detach/fall off when the tap was operated.

A loose or detached handle can affect normal operation and may indicate internal wear or fastening failure, which could worsen with continued use.

Engage a licensed plumber to repair or replace the mixer tap handle assembly and ensure the tap operates securely and correctly.

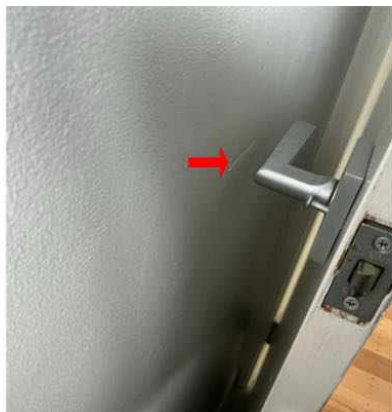
Finding 3.14

Building:	Main Building
Location:	Toilet (WC)
Finding:	Door stop missing – damaged
Information:	The door stop is missing behind the bedroom door. This has resulted in visible impact damage to the wall.

Continued use without a door stop may lead to further damage to the wall, fittings, or door hardware.

It is recommended to install an appropriate door stop or bumper to prevent further impact damage and to repair the affected wall area as required.

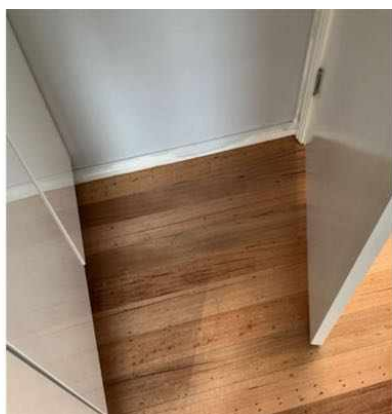
Finding 3.15

Building:	Main Building
Location:	Laundry
Finding:	Door stop - Missing
Information:	The door stop is missing or is inadequate to stop the door handle from damaging the wall. Although some building elements may seem irrelevant or unnecessary, all building elements play a key role in the operation and function of the overall structure and its performance.

Re-installation or replacement of the door stop is advised as soon as possible to prevent any subsequent damage to the door or associated structures. A general handyman may be appointed to perform these works at client discretion.

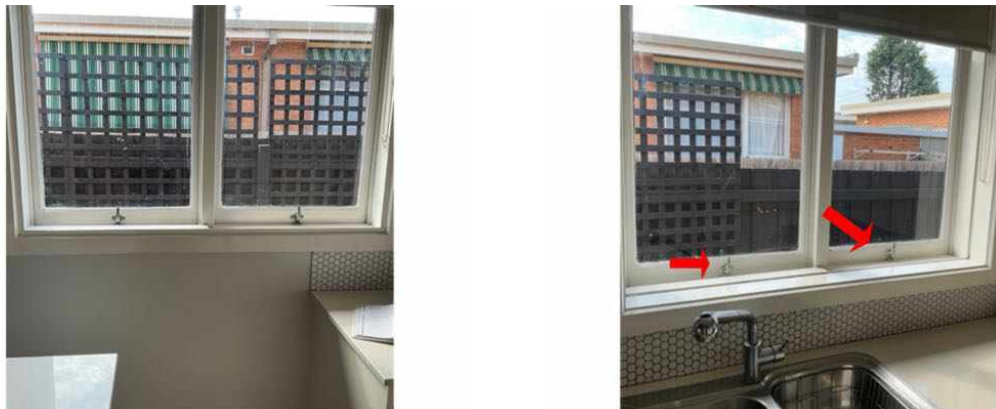
Finding 3.16

Building:	Main Building
Location:	Kitchen
Finding:	Window – jammed/inoperable
Information:	The window was jammed and could not be opened at the time of inspection.

Inoperable windows may affect natural ventilation and may present a safety concern where the window is intended for egress or emergency escape.

Engage a qualified window technician or carpenter to inspect the window mechanism, rectify the fault, and ensure the window operates smoothly and safely.

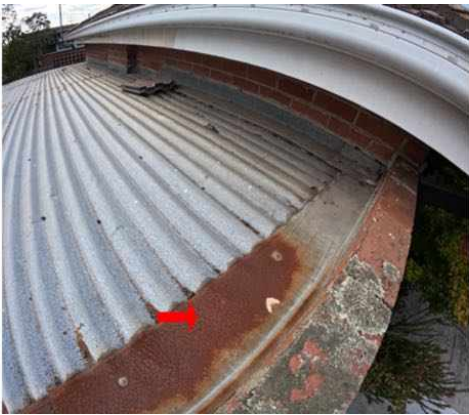
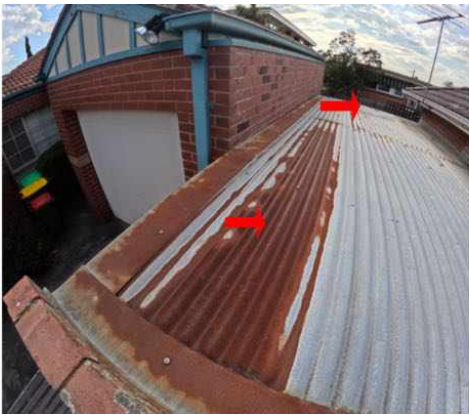
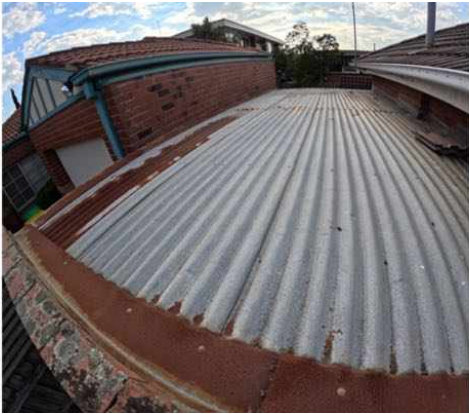
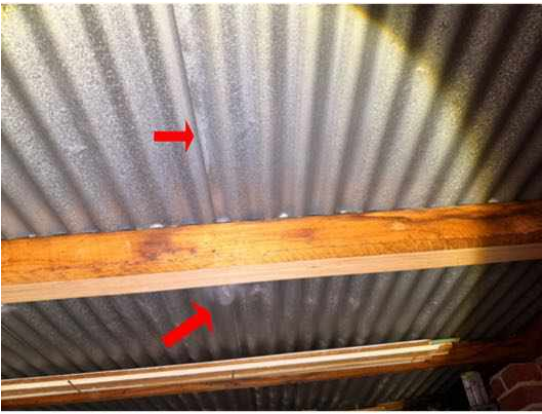
Finding 3.17

Building:	Main Building
Location:	Roof Exterior
Finding:	Garage roof/ceiling – Corrosion & possible moisture-related damage
Information:	At the time of inspection, the corrugated garage roof sheets/flashings showed significant corrosion. The garage ceiling lining appeared to be recently painted, and dark staining was noted to garage ceiling timbers.

Corrosion can lead to perforation and water ingress. The repainting may conceal previous moisture staining, and the darkened timbers may indicate past or ongoing moisture exposure, which can result in timber deterioration and recurring internal damage.

- Corrosion to the garage roof sheeting and dark staining to timbers suggest possible past or ongoing moisture exposure.

Engage a licensed roofing plumber/roofing contractor to investigate for leaks and assess the roof condition, then repair/replace affected sheets/flashings as required; once watertight, have a builder/carpenter assess the stained timbers and complete any necessary repairs/replacement before further cosmetic painting.

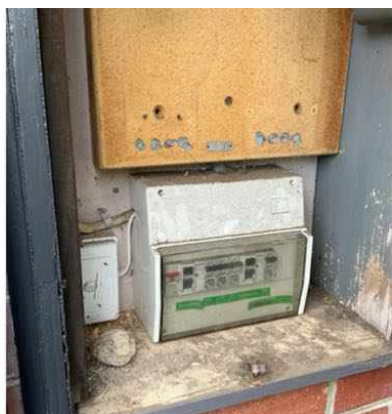
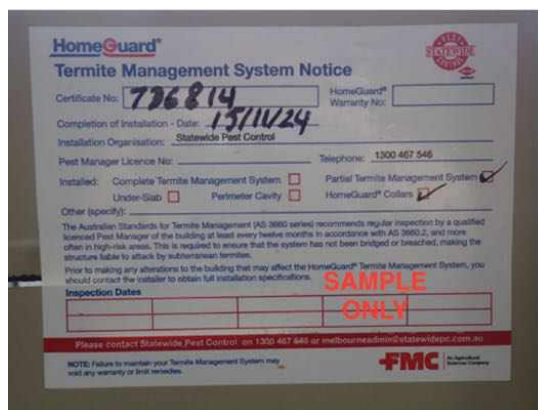
Building:	Main Building
Location:	Electrical switchboard
Finding:	Termite Management System - no evidence of a chemical installation
Information:	The application of a post-construction chemical termite barrier is highly recommended for all properties, particularly if live termite activity has been found on the site previously. Such barriers are highly effective in preventing termite attack on any timber building elements throughout the property.

The client may consider gaining further advice from a pest controller as to the costs and procedures involved with this application. It is recommended that obtaining such advice be a short-term priority.

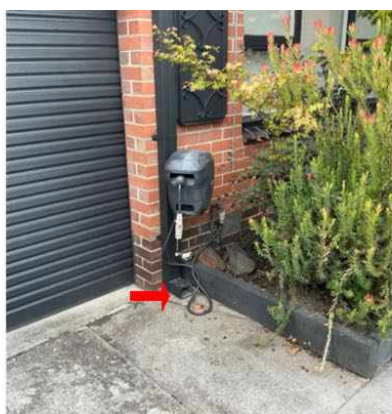
Finding 6.02

Building: Main Building
 Location: Downpipes
 Finding: Downpipe(s)-not connected
 Information: The roof plumbing is not adequately connected to the stormwater drainage system on site. This disconnection reduces the functional performance of the roof plumbing.

Where roof plumbing does not drain adequately, water can discharge directly to the soil around the building perimeter, leading to excessive damp conditions. Over time, this may contribute to rust and corrosion of nearby building elements and create conditions that can attract termites and other pests. Prolonged water discharge to soil can also potentially contribute to structural movement.

It is recommended that a licensed plumber further inspect the area and install appropriate drainage connections where required.

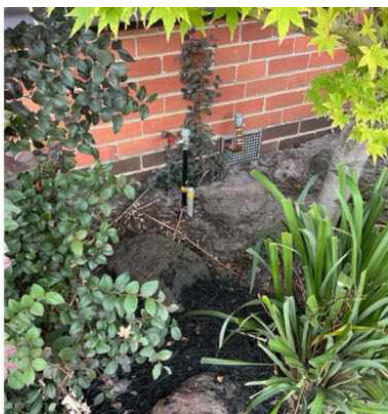
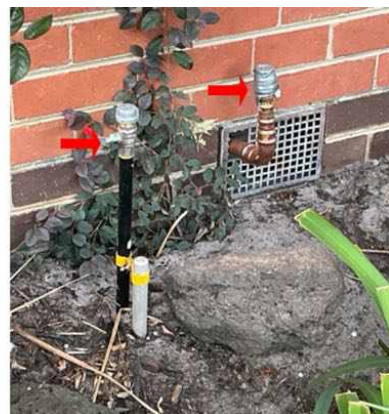
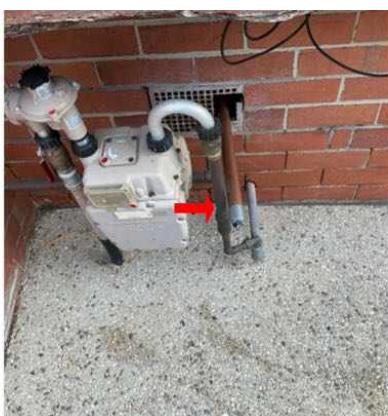
Unverified or non-compliant gas work may present a potential gas leak or safety risk if not installed and tested by a licensed professional.

Recommendation: Engage a licensed gas fitter to inspect the installation, pressure test the system, and confirm the gas service complies with current safety requirements.

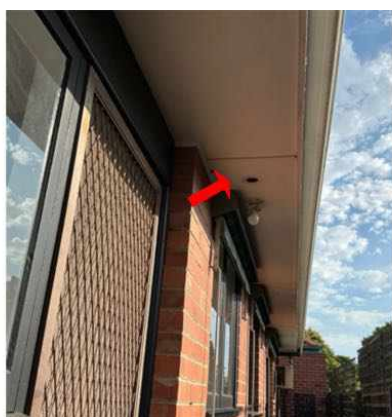
Building: Main Building
 Location: Eaves
 Finding: Asbestos - Suspected ACM Identified on Site

Information: Reporting on Asbestos is outside the Scope of this Report. This suspected defect is highlighted as a caution only. We suspect, based on our experience in the building industry, that there is a higher risk of the identified building element containing asbestos.

As Asbestos Reporting is outside the scope of this report, we advise that you consider a separate Asbestos Inspection and Condition Audit, which can include the taking of samples for definitive confirmation of the presence of Asbestos.

In the interim, the client is advised to act with caution, especially when considering any damage to building materials general wear and tear renovations extensions demolition and general maintenance activities due to the suspected presence of Asbestos.

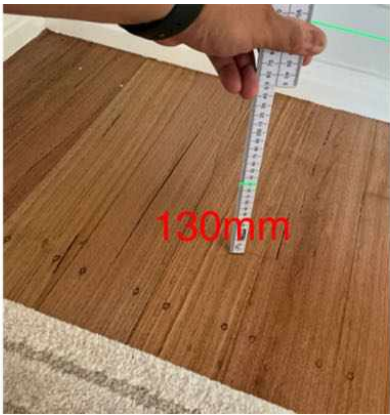
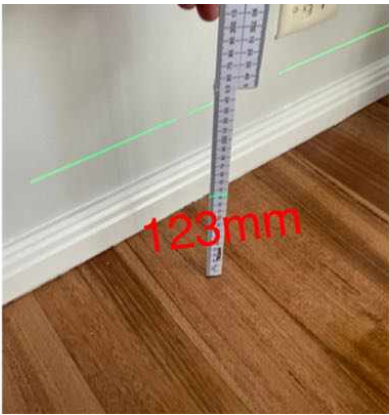
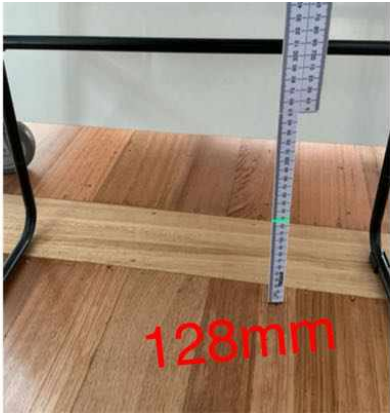
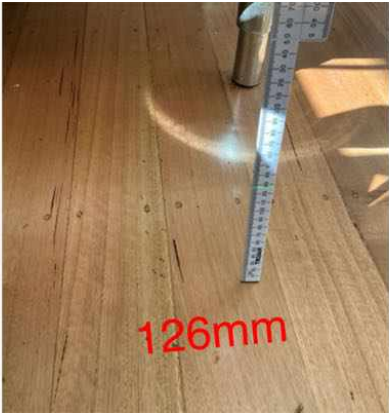
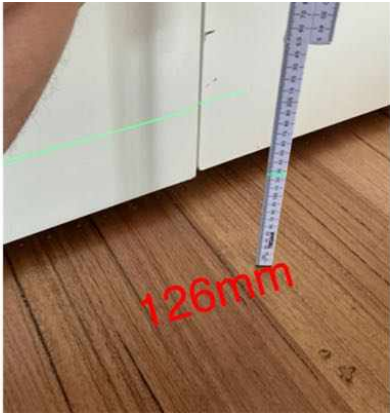
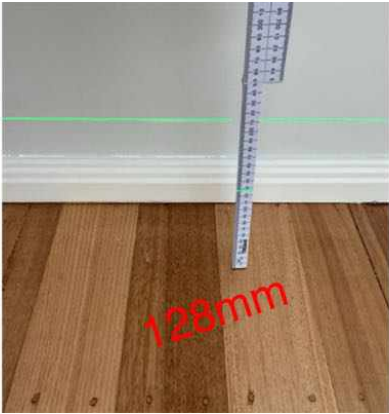
Building: Main Building
 Location: All Areas
 Finding: floor unevenness - v4
 Information: The standard laser level was positioned 125 mm above the floor, as shown in the photo. The measured floor deviation across the room ranges from the lowest point to the highest point by approximately 10mm

Considering the age of the property and no visible significant cracks were observed at time of inspection. This degree of settlement is generally within an acceptable range for a building of its era.
