Building and Timber Pest Inspection Report

Inspection Date: Wed, 11 Mar 2026

Property Address: 62/7 Cinnabar Pl, Kallangur QLD 4503,
Australia

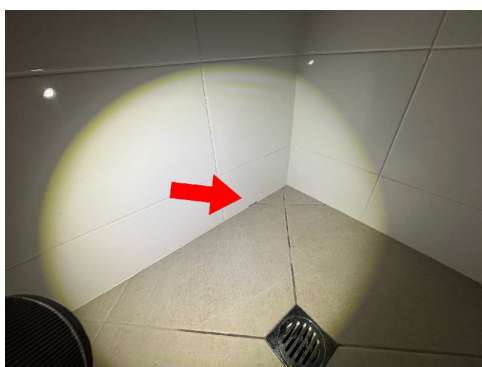
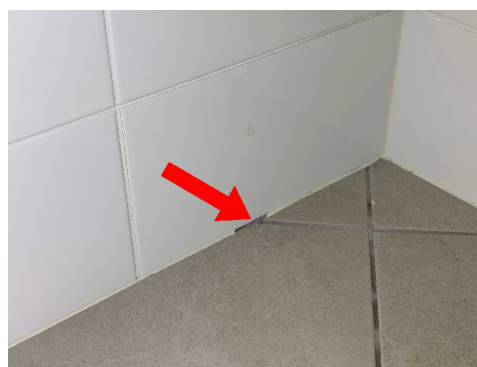
Finding 3.01

Finding: Family bathroom - sealant deteriorating

Information: At the time of the inspection it was noticed that the sealant in the shower of the family bathroom was deteriorating.

Sealant is used in tiled areas to prevent moisture from entering the wall cavity and causing damage to the building elements.

If it is not addressed, damage to building elements may occur and would require invasive works to rectify any damage.

A building maintenance professional or sealant applicator should be appointed to replace all sealant as a matter of urgency.

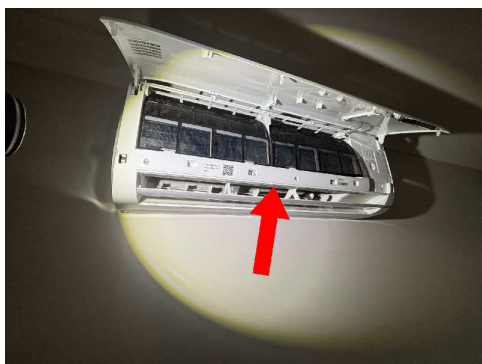
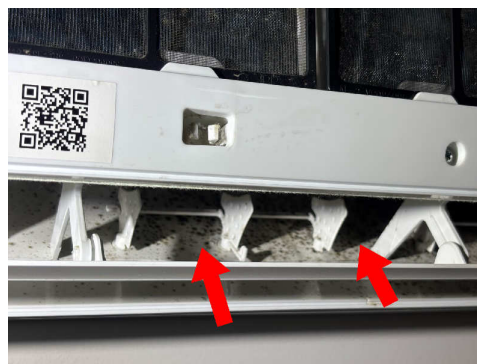
Finding 3.03

Location:	Master bedroom
Finding:	Mould in air conditioning unit
Information:	<p>At the time of the inspection, it was noted that there is mould to the wall mounted air conditioning unit in the master bedroom. Lack of maintenance may be a contributing factor.</p> <p>The air conditioner should not be used until it is cleaned.</p> <p>A specialist air conditioning cleaning company should be engaged to carry out a full clean to all the units in the dwelling. This should be done as a matter of urgency.</p>

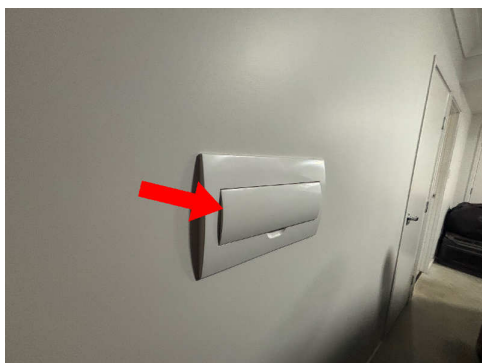
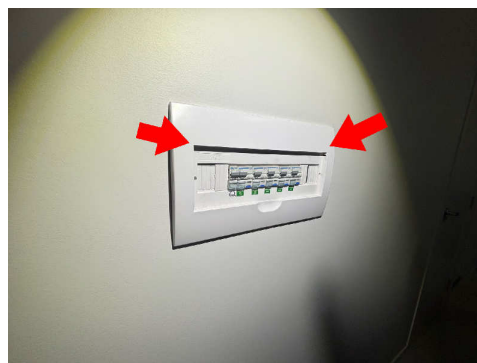
Building:	Main Building
Location:	Garage
Finding:	Garage - switchboard cover broken
Information:	<p>At the time of the inspection, it was noted that the cover for the electrical switchboard in the garage was broken. The cover falls off when opened.</p> <p>A licensed electrician could be engaged to replace the broken cover. This can be done at the clients discretion.</p>

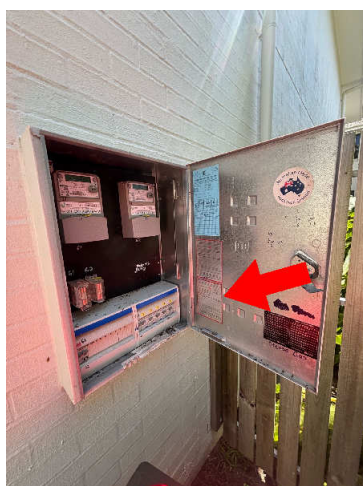
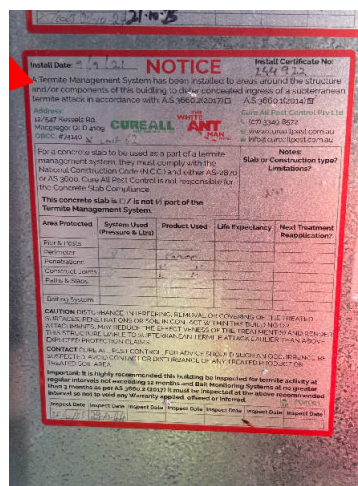
Finding 9.01

Finding: Evidence of a physical termite management system was identified.

At the time of the inspection, evidence of a physical termite management system was found by way of a durable notice in the electricity meter box on the exterior wall of unit 61.

A physical termite barrier was installed to the slab penetrations, perimeter and construction joints during construction. The durable notice is dated the 09/09/2021.

A physical termite barrier does not eliminate termites. A physical termite barrier is designed to expose concealed termite activity which will be found during a visual inspection.

The client may wish to enquire of the body corporate as to the nature of the termite management plan for the complex and individual units. Also, are annual termite inspections carried out and up to date.

A termite and timber pest technician should be engaged to carry out annual termite inspections as per AS 3660 in order to further protect the dwelling. Annual termite inspections must be carried out in partnership with any termite treatment system, physical or chemical, as no termite treatment system can be expected to be 100% effective.

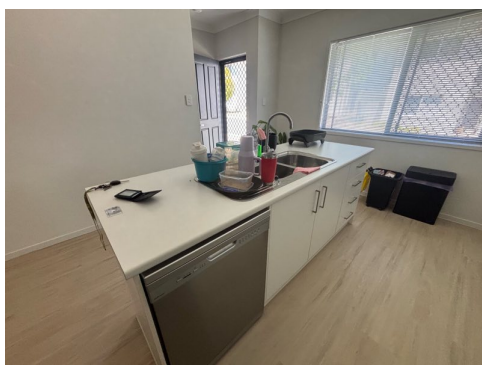
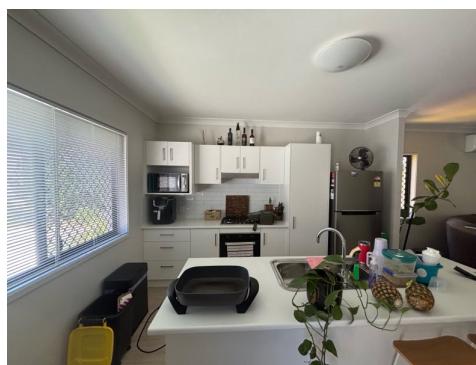
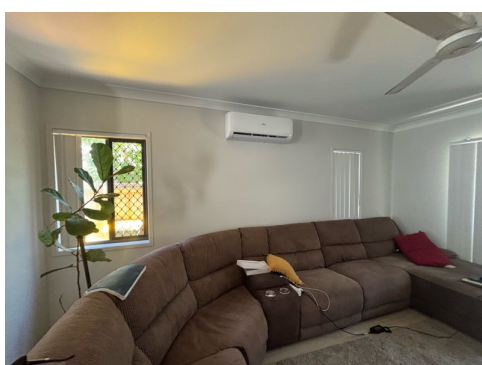
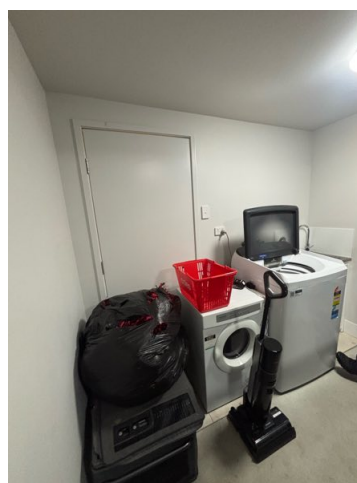
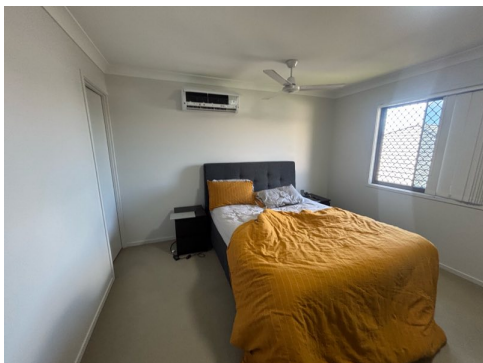
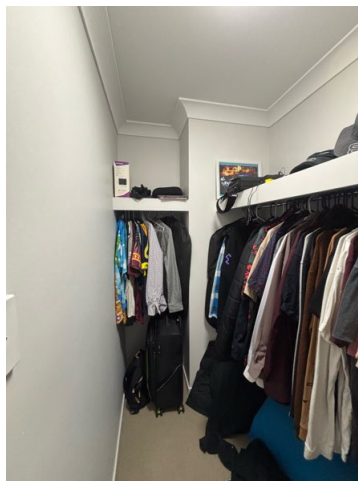
Finding: Obstructions and Limitations - Internal areas

Information: These photographs are an indication of the obstructions and limitations which impeded full inspection of the property of the internal areas at the time of inspection. These obstructions can hide an array of defects and should be removed to allow full inspection to be carried out. A re-inspection is recommended once the areas are made accessible.

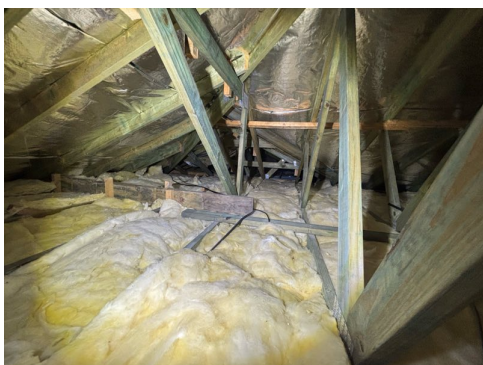
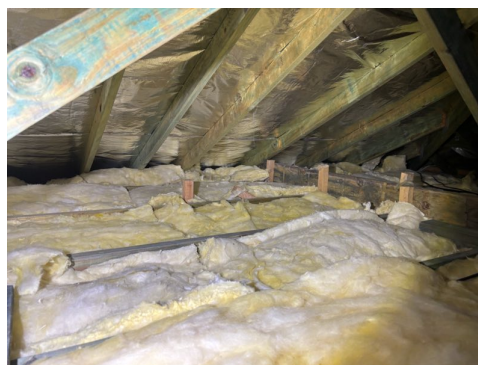
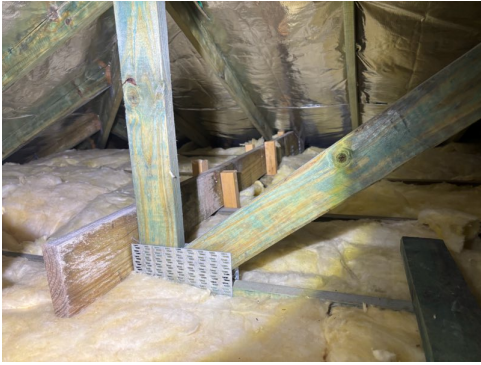
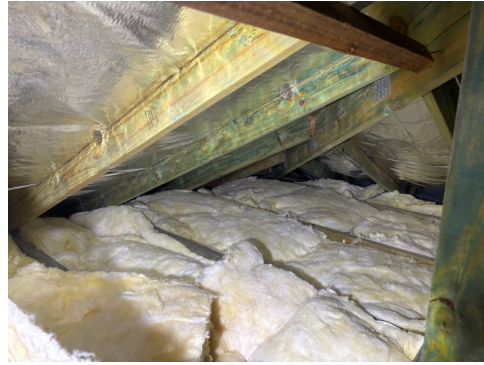
Finding: Obstructions and Limitations - Roof cavity

Information: These photographs are an indication of the obstructions and limitations which impeded full inspection of the property of the roof cavity at the time of inspection. These obstructions can hide an array of defects and should be removed to allow full inspection to be carried out. A re-inspection is recommended once the areas are made accessible.
