Building Inspection Report

Inspection Date: Thu, 12 Mar 2026

Property Address: 1118/243 Pyrmont St, Pyrmont NSW 2009,
Australia

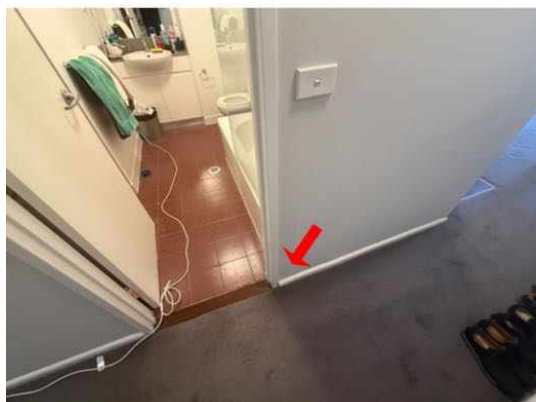
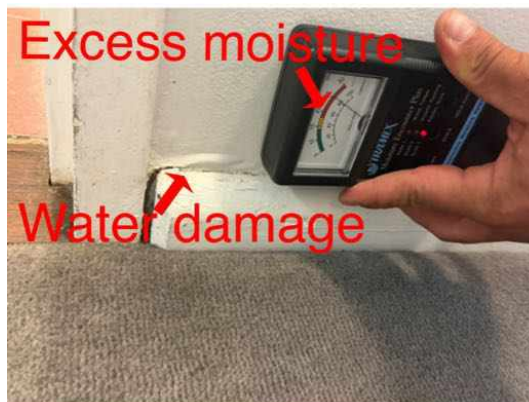
Defects 2.01

Building: Main Building
 Location: Hallway
 Finding: Water leak suspected - Internal
 Information: A water leak is suspected in this area at the time of inspection. Internal water leaks can be detrimental to surrounding building elements; their potential causes include damage to plumbing fittings and fixtures, through to water damage and deterioration of associated building elements.

Rust, corrosion, decay and water damage are potential outcomes where a minor water leak is left unattended. More serious defects may also result, such as electrical hazards, or water damage to structural building elements.

An internal water leak is suspected just outside of the bathroom to the hallway. A licensed plumber must be appointed urgently for assessment and repairs.

In extreme cases, structural damage may develop due to a prolonged water leak. It is highly advised that internal water leaks be addressed by a licensed plumber as a matter of relative urgency.

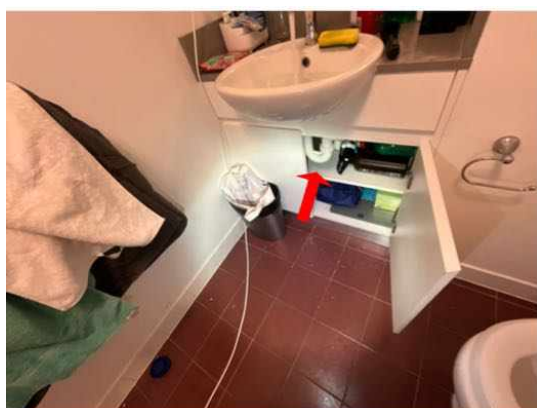
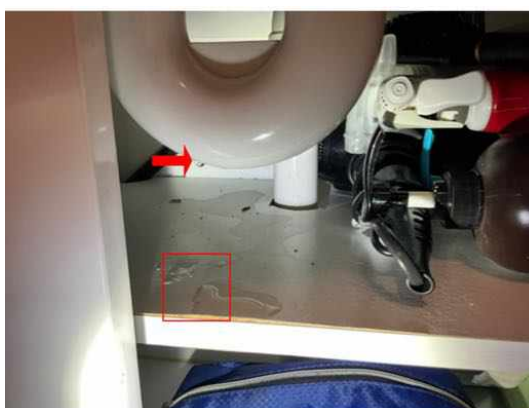
Defects 3.01

Building: Main Building
 Location: Bathroom
 Finding: Water leak - Active

Information: Generally, water leaks occur when a particular area of the property is not weather or water tight. As the surrounding area was found to be damp at the time of inspection, the leak is considered ongoing and hence requires urgent action.

Regardless of the location, even minor leaks that are left unmanaged can lead to serious damage of associated building elements and result in the need for replacement of building materials. Mould and other hazards such as electrical hazards may also arise if the leak is left to develop.

It is highly advised that the cause of the leak be identified and resolved immediately by a licensed plumber to prevent any further damage. Depending on the extent of the damage previously sustained, repair and/or replacement of any affected building materials may be required.

- Repair the water leak under the wash basin

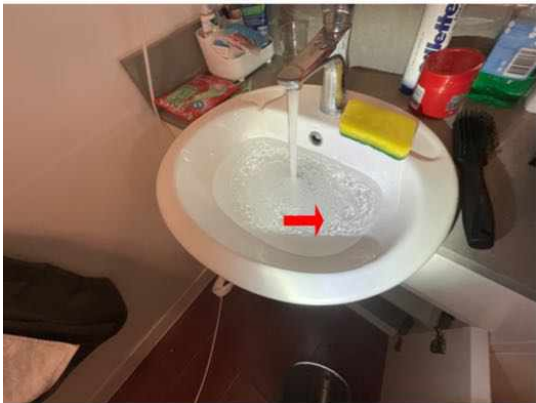
Defects 3.02

Building: Main Building
 Location: Bathroom
 Finding: Sink/basin - slow draining
 Information:

The sink/basin drain appeared to be partially blocked at the time of inspection. Blockages here are usually caused by hair and other debris. If left unmanaged, a lack of general maintenance may lead to the development of more significant defects, such as water damage to surrounding building materials.

A licensed plumber should be appointed to remove the blockage at the client discretion.

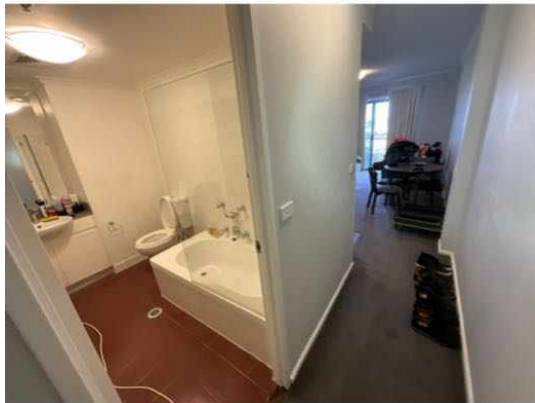
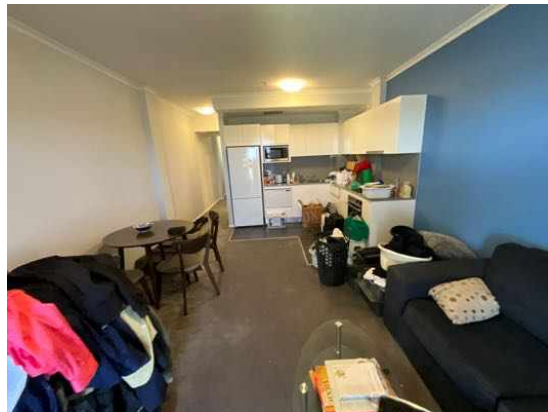
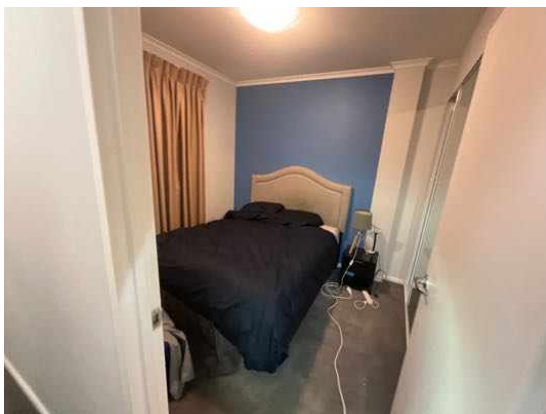
Building: Main Building
 Location: All Areas
 Finding: Additional Photos - Obstructions and Limitations
 Information:

These photographs are an indication of the obstructions and limitations which impeded full inspection of the property at the time of inspection. These obstructions can hide an array of defects and should be removed to allow full inspection to be carried out. A re-inspection is recommended once the areas are made accessible.
