# Building and Timber Pest Inspection Report

Inspection Date: Fri, 13 Feb 2026

Property Address: 8 Somerset Rd, Yallourn North VIC 3825,  
Australia

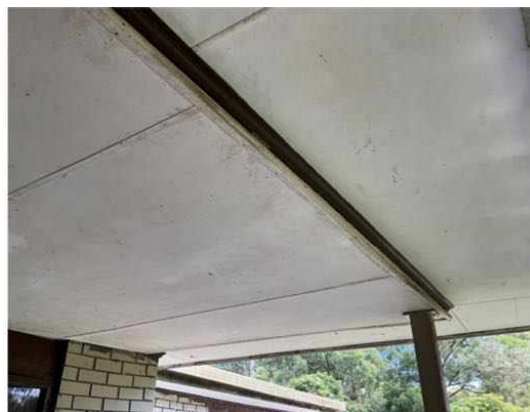
Building:	Main Building
Location:	All Areas
Finding:	Asbestos - Suspected ACM Identified on Site
Information:	Eaves were suspected to contain asbestos at the time of inspection. Reporting on Asbestos is outside the Scope of this Report. This suspected defect is highlighted as a caution only. We suspect, based on our experience in the building industry, that there is a higher risk of the identified building element containing asbestos.

As Asbestos Reporting is outside the scope of this report, we advise that you consider a separate Asbestos Inspection and Condition Audit, which can include the taking of samples for definitive confirmation of the presence of Asbestos.

In the interim, the client is advised to act with caution, especially when considering any damage to building materials general wear and tear renovations extensions demolition and general maintenance activities due to the suspected presence of Asbestos.

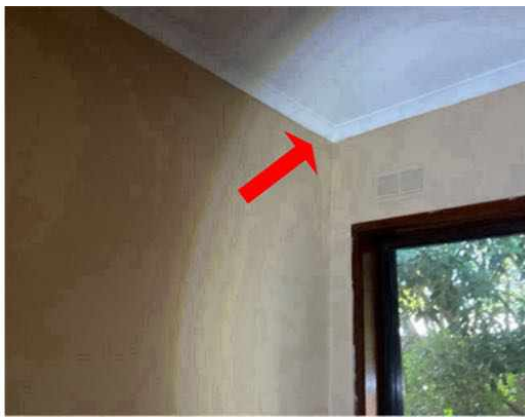
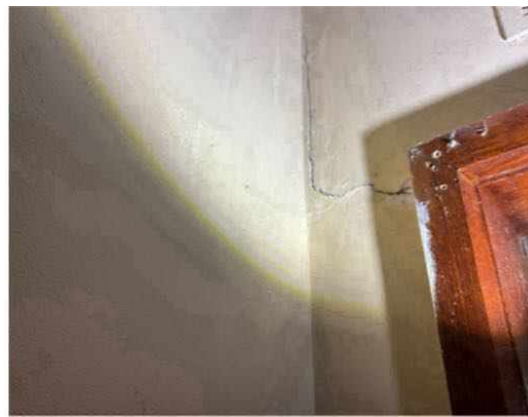
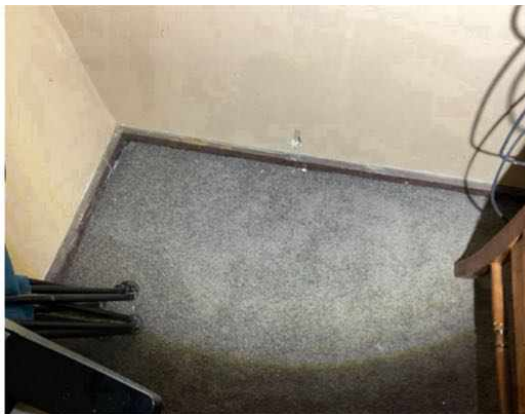
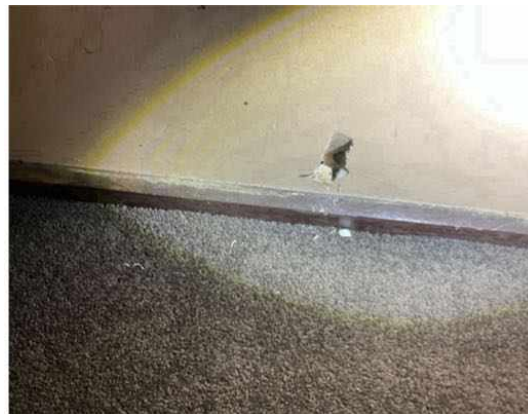
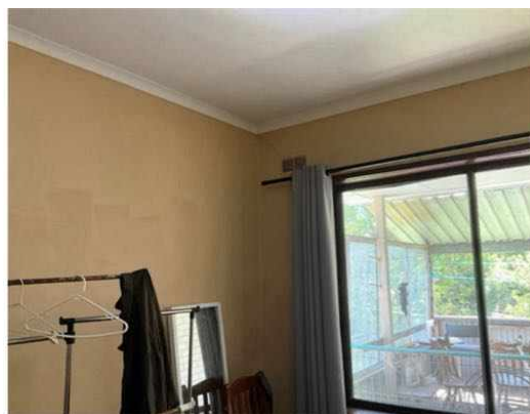
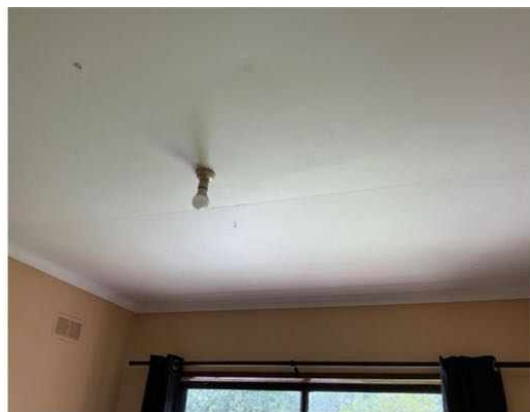
#### Finding 2.01

Building:	Main Building
Location:	All Areas
Finding:	Major Internal Cracking Indicative of Structural Movement
Information:	Several significant cracks were observed to internal walls during the inspection. The extent and pattern of cracking are suggestive of structural movement rather than minor cosmetic settlement. Cracks of this nature may be associated with foundation movement, footing settlement, slab heave, or structural stress within load-bearing

Structural movement can compromise the integrity of the building over time and may lead to further cracking, distortion of door and window frames, and potential instability if not properly assessed and addressed. Ongoing movement may result in progressive damage to both structural and non-structural components.

It is strongly recommended that a qualified structural engineer be engaged to conduct a detailed assessment to determine the cause, extent, and required remedial measures. Depending on the findings, solutions may include structural rectification works and/or installation of appropriate expansion/control joints where applicable. Remedial works should be carried out in accordance with engineering recommendations.

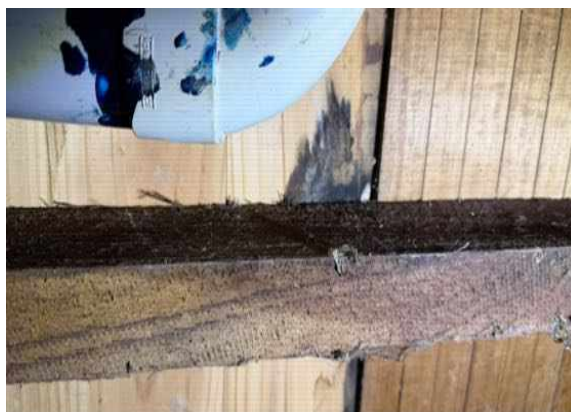
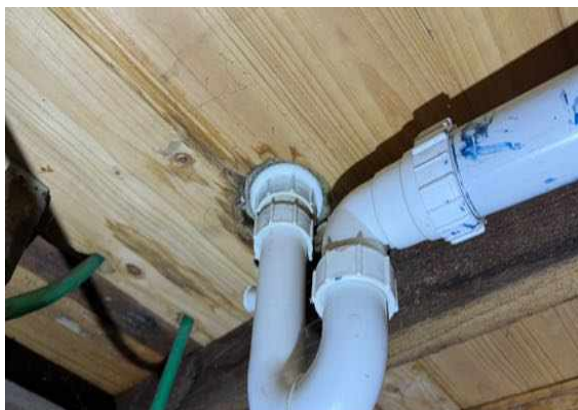
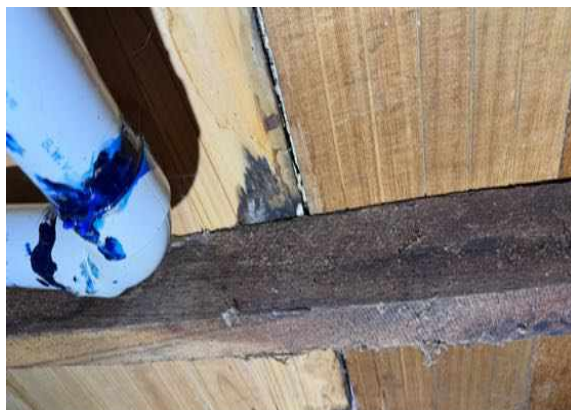
## Finding 2.02

Building:	Main Building
Location:	Subfloor
Finding:	Active Water Leakage Observed in Subfloor Area
Information:	Active water leakage was observed within the subfloor area during the inspection, located in proximity to plumbing pipework. Visible moisture and wet conditions were noted around the affected section. The source of the leak could not be fully determined due to the non-invasive nature of the inspection; however, the presence of active water indicates a plumbing defect requiring urgent attention.

Ongoing water leakage within a subfloor environment can lead to timber decay, fungal growth, corrosion of metal components, and conditions conducive to termite infestation. Prolonged dampness may also compromise structural integrity of floor framing members and create unhealthy environmental conditions.

This is considered a major defect. Immediate assessment and rectification by a licensed plumber is strongly recommended to identify and repair the source of leakage. Following repairs, the affected area should be allowed to dry thoroughly and any damaged structural elements should be assessed and repaired as necessary by a suitably qualified tradesperson.

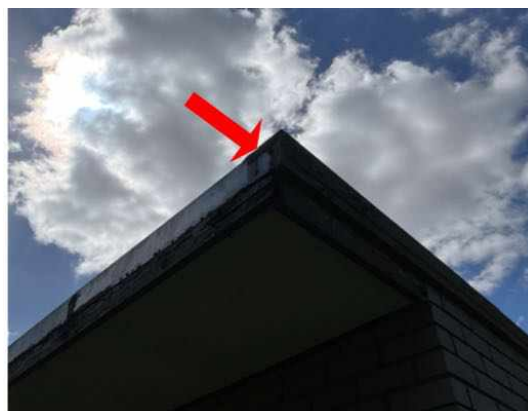
### Finding 3.01

Building:	Main Building
Location:	Roof Exterior
Finding:	Wood rot - Fascias
Information:	Fascias and barges in this area shows evidence of wood rot. Wood rot, also known as Fungal Decay, occurs when timbers and other cellulose building materials are exposed to damp conditions on an ongoing basis. This could be the result of exposure to weathering over a prolonged period of time, or the attraction of excessive moisture from other abutting building materials.

It is likely that this wood rot has developed as a result of faults in the roof plumbing, creating excessive moisture in this area. Frequent exposure to rain and other weather conditions also make fascia's and barges susceptible to accelerated deterioration.

Early intervention and regular maintenance, particularly of exterior timbers, will prolong the useful life of these building elements. Prior to any works being performed, the cause of the moisture that has created the visible wood rot should be identified and addressed in a suitable manner. Replacement of affected timbers may then be a necessary step in protecting surrounding building elements from such deterioration.

A qualified plumber may be appointed to assess the cause of excessive moisture and to provide advice on any remedial works as required. A qualified carpenter or registered builder may also be required to replace affected building materials.

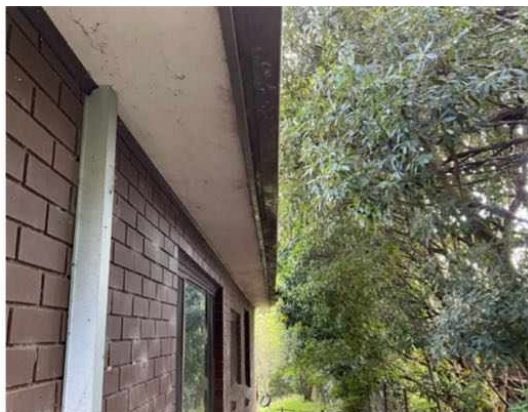
### Finding 3.02

Building:	Main Building
Location:	All Areas
Finding:	Trees - Overhanging and filling gutters
Information:	Overhanging trees often result in excessive amounts of leaf debris accumulating in gutters.

Gutters are a critical part of the building's management of storm water and rain. It is therefore important that they be kept clear to prevent secondary damage to associated building elements, including exterior and interior walls, ceiling linings and any adjoining building elements. Where gutters are blocked, pooling of rainwater is likely to occur, fast-tracking rust and corrosion of the roof plumbing elements.

It is highly advised that all overhanging tree branches be removed as soon as possible to prevent any further damage. Repair and/or replacement of sections of damaged guttering may also be required where the extent of the damage necessitates.

Such works should be performed by the homeowner; however, appointment of a landscape contractor or an arborist may be required. Consultation with a licensed roof plumber is required where guttering has been damaged.

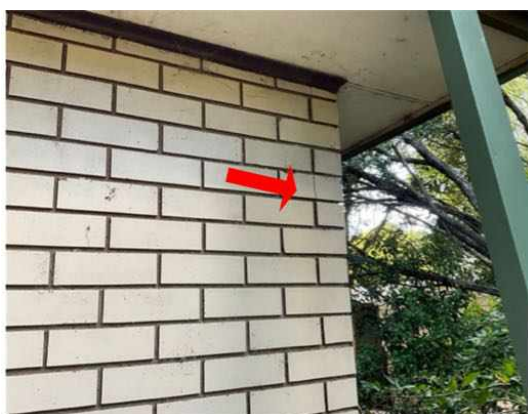
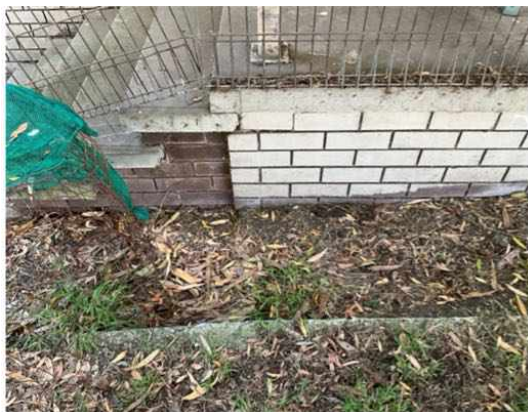
### Finding 3.03

Finding: Minor Cracking and Mortar Deterioration to Brickwork

Information: Several minor cracks were observed in the brickwork during the inspection. In addition, sections of mortar joints were noted to be deteriorated. The cracking appears consistent with minor movement and general age-related wear, while the mortar deterioration is likely due to weather exposure and normal building settlement over time.

If left unaddressed, deteriorated mortar joints may allow moisture ingress into the brickwork, which can contribute to further deterioration, potential damp-related issues, and accelerated wear of masonry components. Although the cracks observed are minor in nature, ongoing movement could lead to further separation if not monitored.

It is recommended that a qualified bricklayer or registered builder assess the affected areas and undertake repointing of deteriorated mortar joints as required. The cracks should be monitored for any signs of progression, and further investigation should be arranged if significant movement is noted.

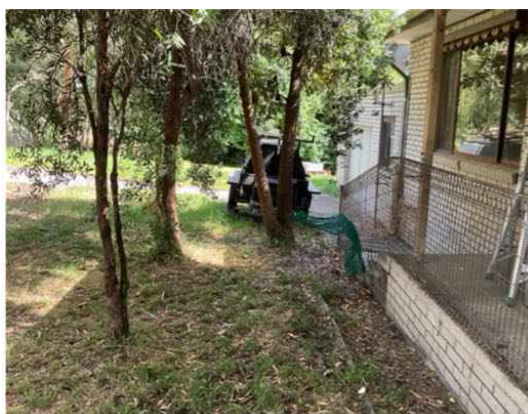
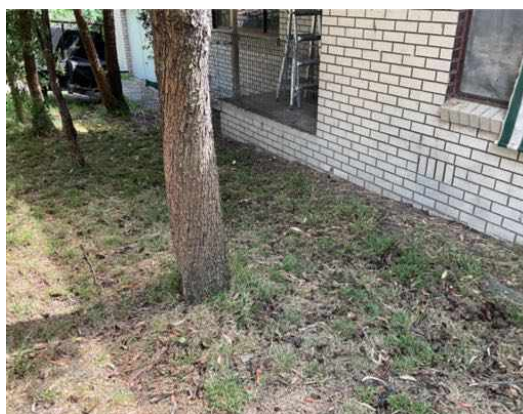
### Finding 3.04

Building:	Main Building
Location:	Exterior walls - front
Finding:	Tree Located in Close Proximity to Building – Potential for Structural Impact
Information:	A tree was observed to be located in close proximity to the external wall of the dwelling in this area. Vegetation planted too close to building structures can pose a risk to the structural integrity of footings and foundations over time, particularly in reactive clay soils. Tree roots have the potential to extract moisture from the surrounding soil, which may lead to ground movement and uneven settlement, commonly referred to as subsidence.

Minor cracking was noted in the wall area adjacent to the tree. While the cracking appears non-structural at this stage, its location suggests a possible relationship with nearby vegetation. If left unaddressed, root growth and continued moisture variation in the soil could contribute to further movement, leading to more significant cracking or structural distortion.

It is recommended that an arborist or structural engineer be consulted to assess the type, size, and impact potential of the tree. Monitoring of the cracking and ongoing inspection of the area is advised. Depending on the assessment, root management strategies, installation of root barriers, or controlled removal of the tree may be necessary to prevent future structural issues.

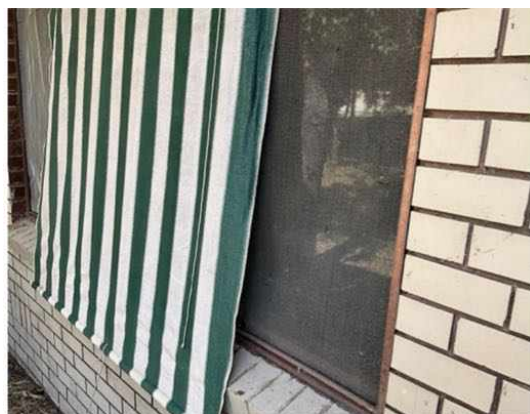
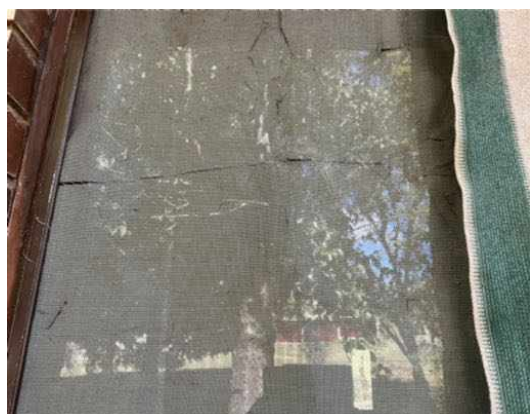
### Finding 3.05

Building:	Main Building
Location:	All Internal Areas
Finding:	Flyscreens - Damanged
Information:	Flyscreens were found to be damaged to the windows at the time of inspection. Whether the flyscreens have not been installed properly of damaged post-installation, it detracts from the complete operational state of the window.

Where not repaired, damaged flyscreens allow pest and insect ingress into the adjoining rooms. It is advised that all damaged building elements be replaced in order to ensure the full function of all building structures.

A general handyerson or a repairer may be appointed to repair flyscreens at the discretion of the client.

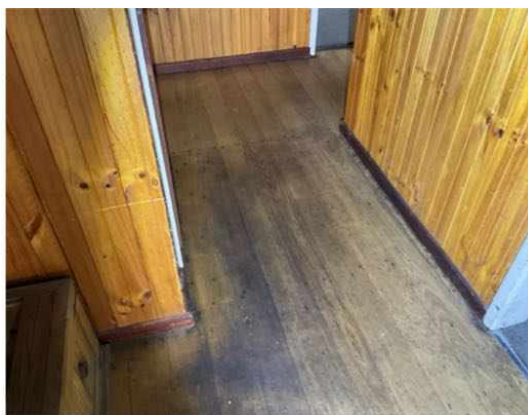
### Finding 3.06

Building:	Main Building
Location:	All Areas
Finding:	Flooring - Uneven
Information:	The internal flooring in this area is out of level and uneven. Uneven flooring is likely to indicate minor defects such as expected movement of the foundations of the

It is advised that the flooring be closely monitored to identify any further movement. Where flooring remains relatively unchanged for an extended period of time (i.e. several months), it is likely that this defect has been caused by expected movement of the foundations of the property.

However, where flooring is uneven further, potentially invasive inspection of the subfloor structures and stumps in this area is required. In this case, works to repair are likely to be required, and would be carried out by a registered builder specialising in re-stumping.

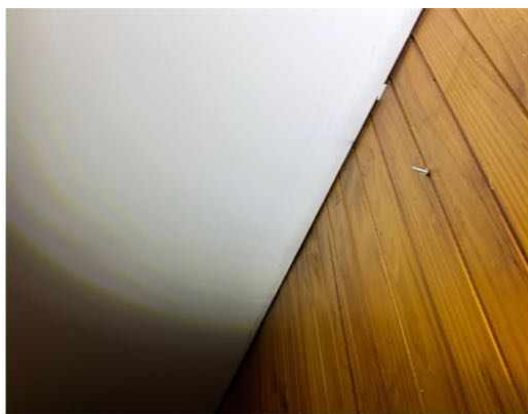
### Finding 3.07

Building:	Main Building
Location:	All Areas
Finding:	Gaps Observed at Ceiling Edges
Information:	Gaps were observed at the junction between the ceiling lining and adjoining walls during the inspection. These separations are commonly associated with minor building movement, shrinkage of framing timbers, or general settlement over time. The gaps appeared localised and were noted at the perimeter edges of the ceiling.

If left unaddressed, these gaps may allow air infiltration, dust entry, and in some cases minor pest access. Ongoing movement could result in further separation or cosmetic deterioration of the ceiling finishes.

It is recommended that the affected areas be monitored for any progression. Where required, a qualified tradesperson may seal and reinstate the ceiling junction using appropriate flexible fillers and repaint to maintain a neat and finished appearance. Further investigation should be undertaken if the gaps increase in size or are accompanied by cracking elsewhere.

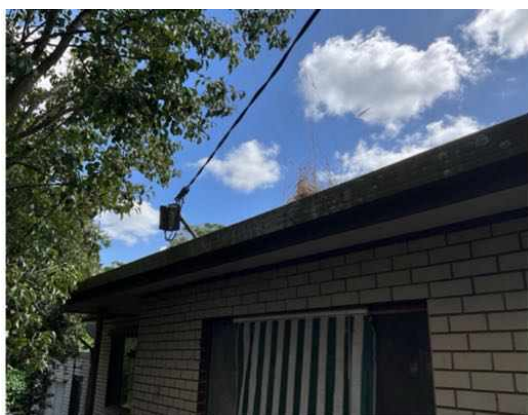
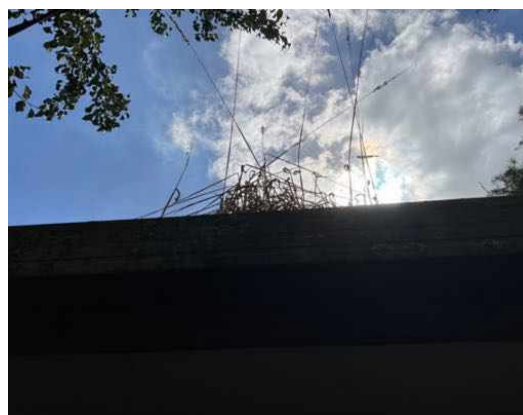
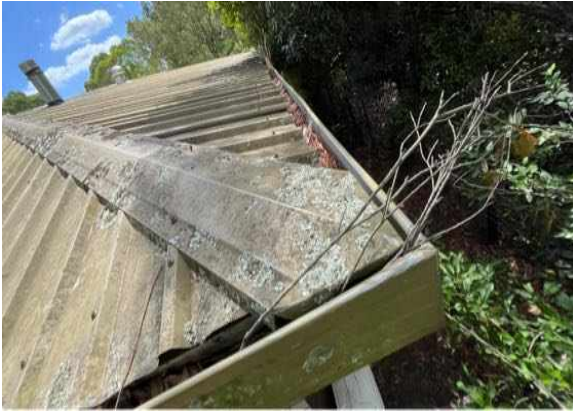
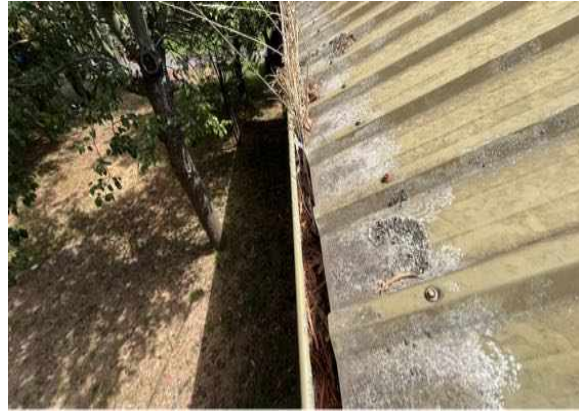
### Finding 3.08

Building:	Main Building
Location:	Roof Exterior
Finding:	Gutters - Partially Blocked
Information:	Roof plumbing structures, such as guttering and downpipes, should be free of all debris to prevent blockages. Blockages of the guttering and downpipes will lead to pooling and accumulated water overflows, which is likely to subsequently flood eaves and exterior walls.

Blocked gutters are likely to lead to high levels of moisture in the affected areas. Such moisture will not only cause rust and decay of the associated building materials, but can also provide conditions that are conducive to termite and timber pest activity. Blockages in gutters should therefore be removed immediately to ensure dry conditions are maintained.

Consult a Licensed Plumber for further specific advice on remedial works that may be required. In the interim, it is highly advised that blocked gutters be removed by the homeowner or a general handyperson as a matter of urgency.

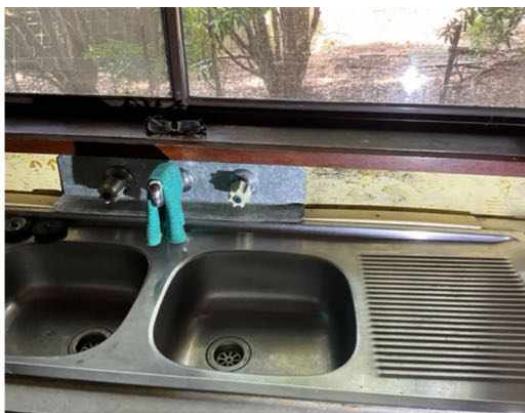
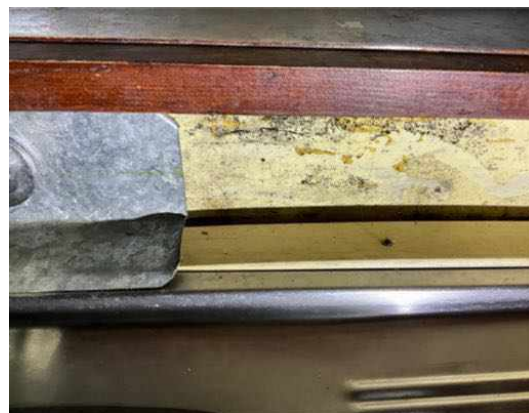
### Finding 3.09

Building:	Main Building
Location:	All Areas
Finding:	Suspected Mould Growth and Musty Odour Noted Internally
Information:	During the inspection, suspected mould-like staining was observed within the kitchen area. In addition, a noticeable musty odour was present throughout the dwelling at the time of inspection. These conditions may be indicative of elevated moisture levels, inadequate ventilation, past water ingress, or concealed dampness within wall, ceiling, or flooring components. The assessment was limited to a visual and non-invasive inspection.

The presence of mould and persistent musty odours can indicate ongoing moisture issues and may contribute to deterioration of building materials over time. Prolonged damp conditions may also pose potential health concerns for occupants, particularly those sensitive to mould spores.

Further investigation is strongly recommended to identify and rectify the source of moisture. Assessment by a qualified building professional and/or mould remediation specialist may be required. Remedial action should address both the moisture source and any affected materials to prevent recurrence.

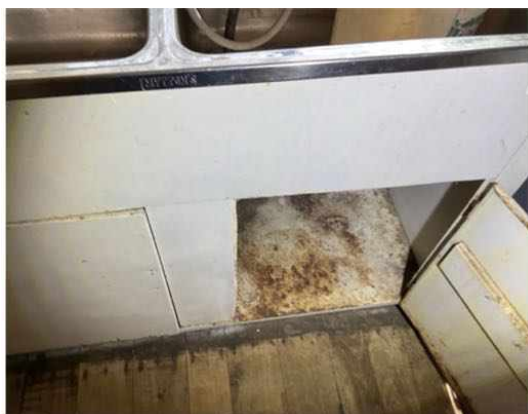
### Finding 3.10

Building: Main Building  
 Location: Laundry  
 Finding: Rusting to Laundry Sink  
 Information: Rusting was observed to the laundry sink at the time of inspection. The corrosion appears consistent with age-related wear and prolonged exposure to moisture, which is common in wet areas such as laundries. Surface deterioration was noted to the metal components.

If left unaddressed, ongoing corrosion may result in further material degradation, potential perforation of the sink basin, and water leakage into surrounding cabinetry or flooring. Continued moisture exposure may also accelerate deterioration of adjacent fixtures.

It is recommended that the affected sink be assessed by a licensed plumber and repaired or replaced as necessary. Prompt attention will help prevent potential leakage and maintain the serviceability of the fixture.

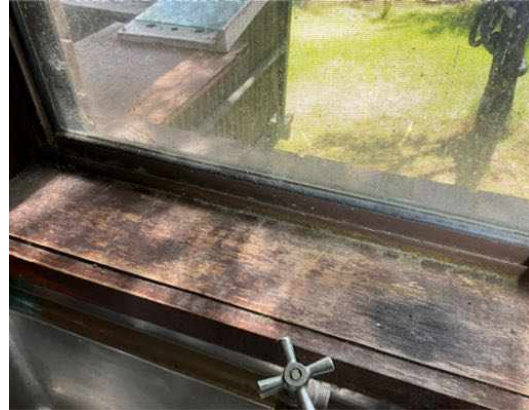
### Finding 3.11

Building: Main Building  
 Location: All Areas  
 Finding: Weathered Window Reveal  
 Information: A weathered reveal was observed in this area at the time of inspection. This deterioration is minor in nature and may be due to age, sun exposure, or intermittent moisture contact.

If left unmanaged, continued weathering may allow moisture to penetrate the surrounding materials, potentially leading to staining, decay, or further deterioration of the window frame and adjoining wall surfaces.

It is recommended that this area be regularly monitored for any signs of water ingress. If deterioration progresses or moisture is detected, a qualified carpenter or painter should be engaged to repair and reseal the affected section to prevent further damage.

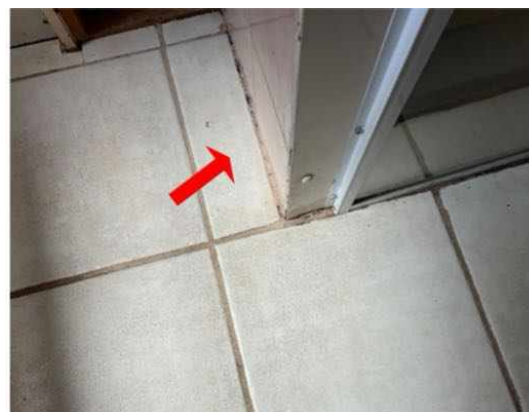
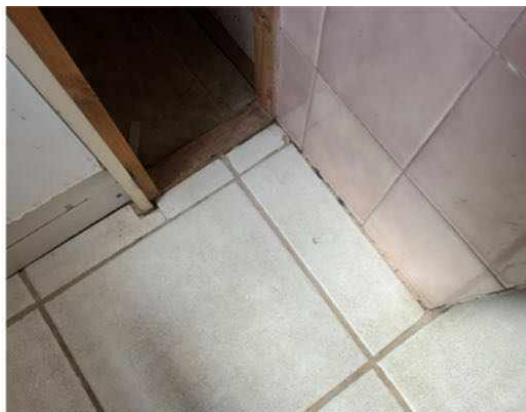
### Finding 3.12

Finding: Deteriorated Grout to External Shower Area

Information: Deterioration of grout was observed to tiled surfaces within the external shower area during the inspection. Sections of grout were noted to be cracked, recessed, or missing between tiles. This condition is commonly associated with weather exposure, movement, and general wear over time, particularly in external wet areas.

Deteriorated grout may allow water penetration beneath the tiled surface, potentially leading to moisture ingress into the substrate. Prolonged exposure to moisture can result in loosening of tiles, deterioration of underlying materials, and potential structural or waterproofing issues if left unaddressed.

It is recommended that the affected areas be regouted by a suitably qualified tiler or registered builder. The underlying waterproofing membrane (if applicable) should also be assessed to ensure continued water resistance and prevent further damage.

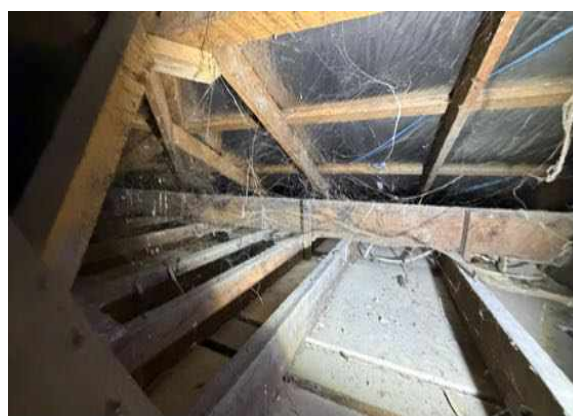
### Finding 3.13

Building:	Main Building
Location:	Roof Void
Finding:	Absence of Insulation in Roof Cavity
Information:	No thermal insulation was observed within the roof cavity at the time of inspection. The roof space appeared to be uninsulated, which may be inconsistent with current energy efficiency expectations under modern building standards. The assessment was limited to a visual inspection of accessible areas only.

It is recommended that a qualified insulation installer assess the roof cavity and install appropriate ceiling insulation in accordance with current NCC requirements and manufacturer specifications. Care should be taken to maintain clearances around electrical fittings and ensure compliance with safety standards.

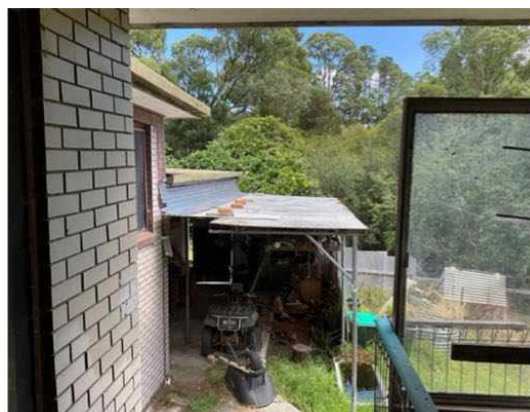
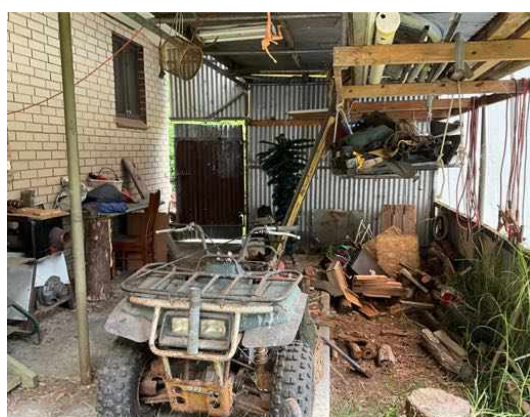
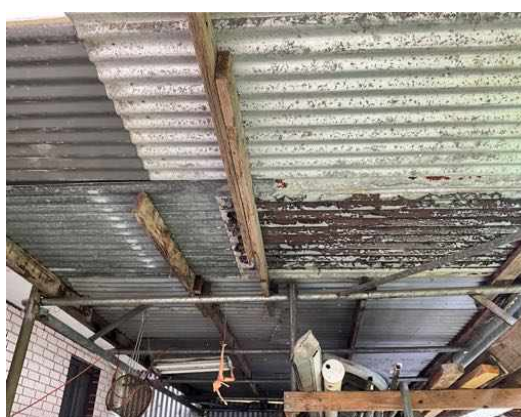
### Finding 3.14

Finding: Deteriorated structures  
 Information: Gutters missing rusting observed

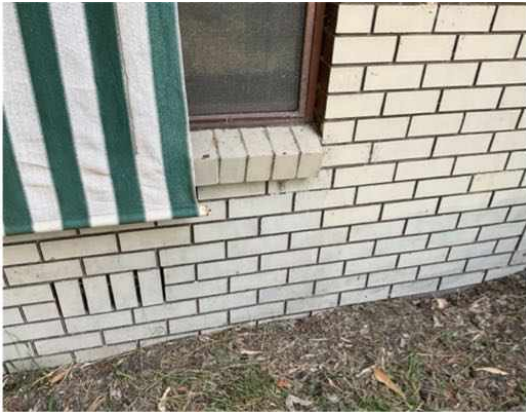
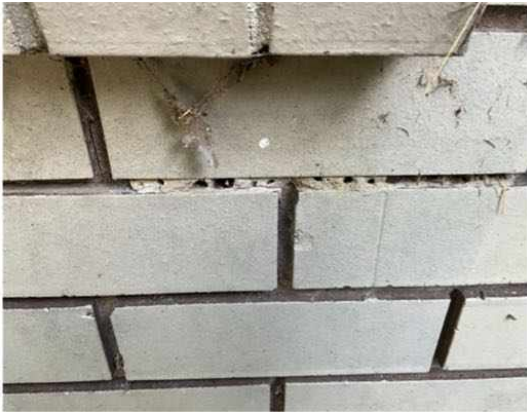
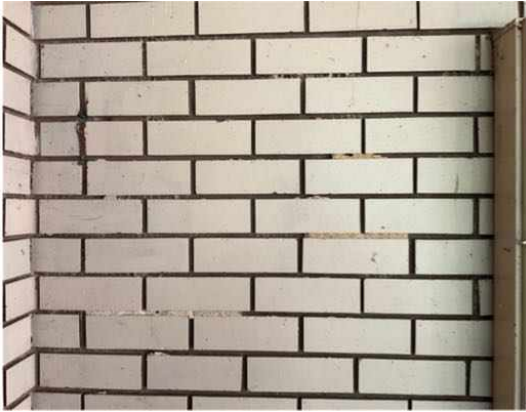
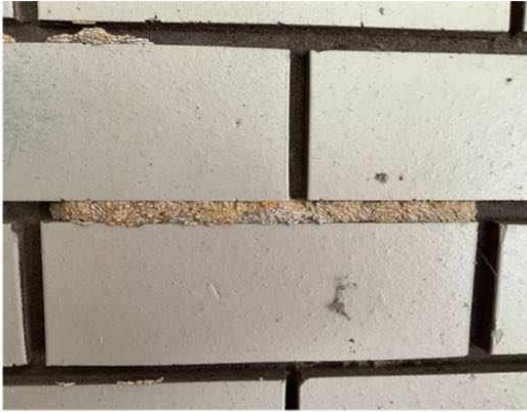
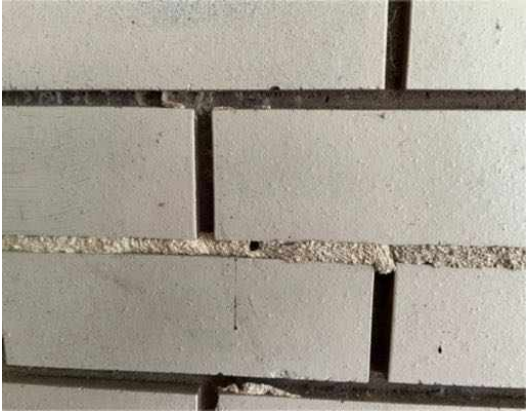
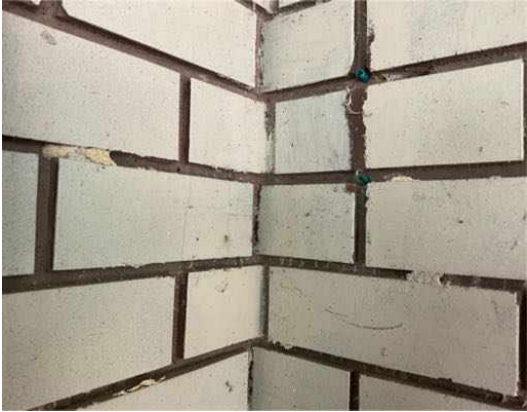
and/or appropriate treatment measures may be required. Regular annual timber pest inspections should be maintained in accordance with AS 3660 and AS 4349.3 to monitor and manage termite risk.

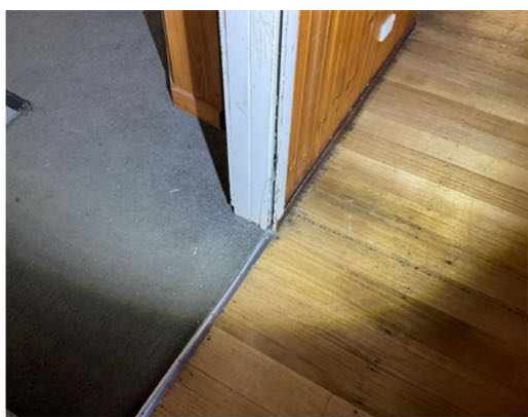
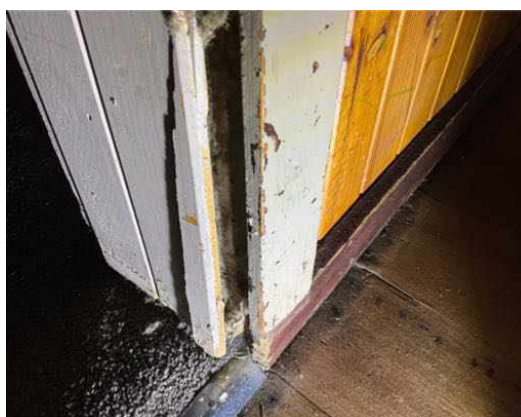
**Finding 5.02**

Building: Main Building  
Location: All Areas  
Finding: Suspected Termite Damage to Timber Architraves  
Information: During the inspection, timber architraves exhibited signs consistent with possible termite damage. Indicators such as surface irregularities and material deterioration were noted; however, confirmation of active infestation could not be determined due

An invasive inspection by a licensed timber pest management professional is strongly recommended to confirm the presence or absence of active termite activity and to assess the extent of any damage. Appropriate treatment and repairs should be undertaken based on specialist findings.

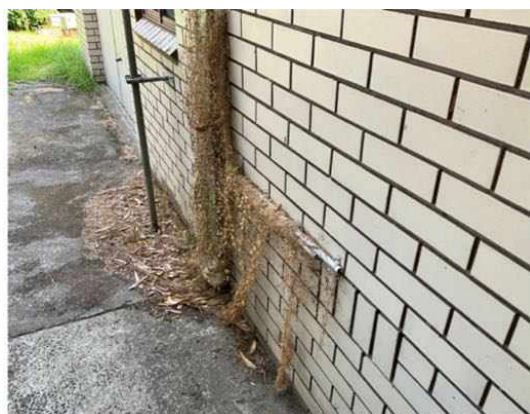
### Finding 6.02

Building:	Main Building
Location:	All External Areas
Finding:	Air conditioner - Disconnected overflow
Information:	The Air Conditioner (A/C) overflow was found to be disconnected from storm water drainage and is creating excessive moisture in the surrounding area.

It is highly recommended that a licensed plumber be appointed to connect the A/C overflow in order to prevent such an environment from being created. These minor works should be carried out as soon as possible.

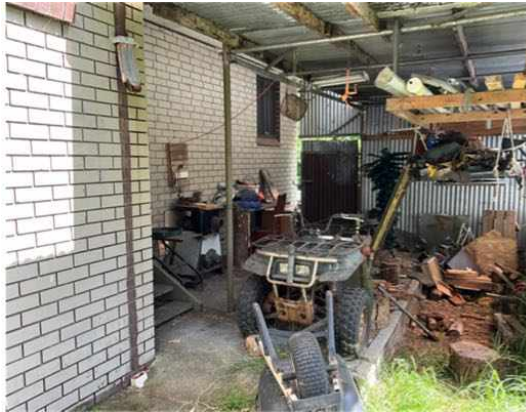
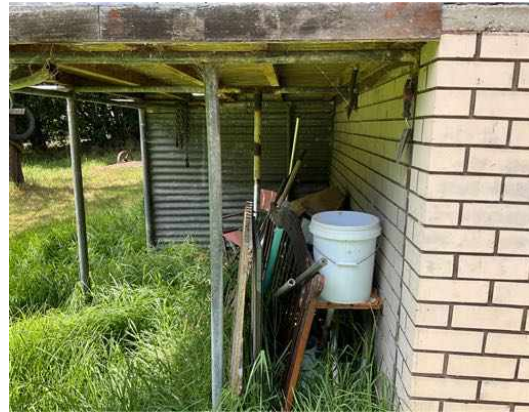
### Finding 6.03

Building:	Main Building
Location:	All External Areas
Finding:	Bridging - Attachments to Buildings
Information:	Bridging occurs when items against a building provide a concealed entry point for termites into the building or by passing around a termite management system.

Building attachments of this nature need to be frequently inspected for termite activity by a qualified inspector.

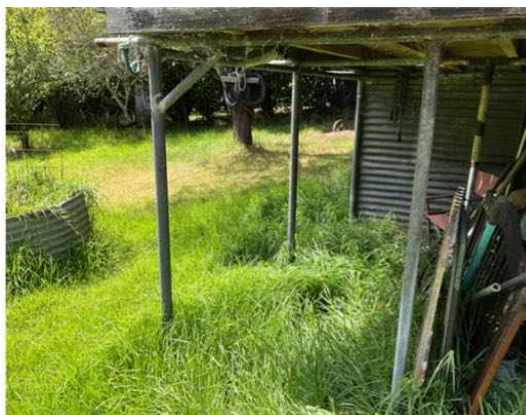
#### Finding 6.04

Building:	Main Building
Location:	All External Areas
Finding:	Garden Beds - Conditions Conducive to Termites
Information:	Garden beds were found to be evident in the garden area. These garden beds can include untreated timber, and with a combination of moisture from watering hosing can make conditions conducive to termite activity and termite ingress.

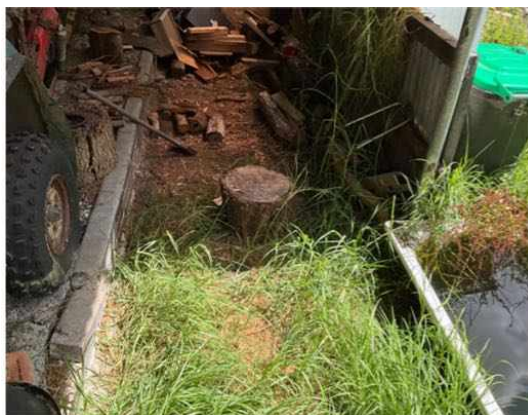
#### Finding 6.05

Building:	Main Building
Location:	All External Areas
Finding:	Building materials in direct ground contact - conducive to termites
Information:	Where timber elements are in direct contact with the ground and consequently

The removal of any such materials that may be conducive to termite activity should be removed as soon as possible to minimise the risk of termite attack.
