Building Inspection Report

Inspection Date: Wed, 25 Feb 2026

Property Address: 15 Merlot Rd, Pakenham VIC 3810,
Australia

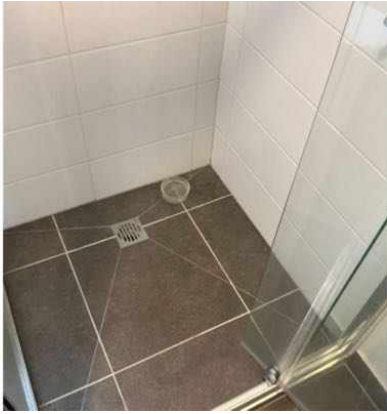
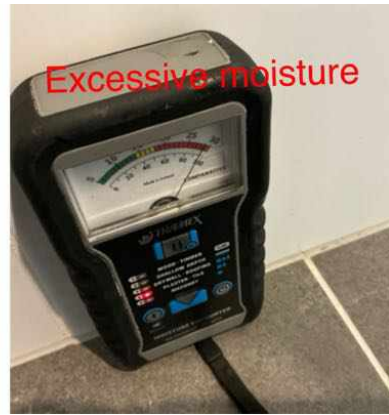
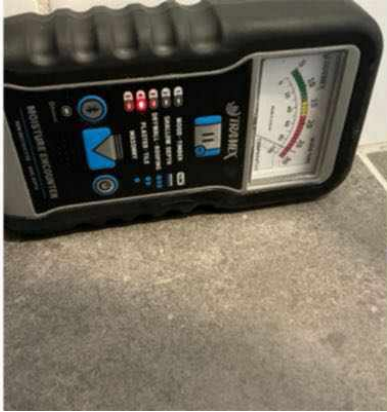
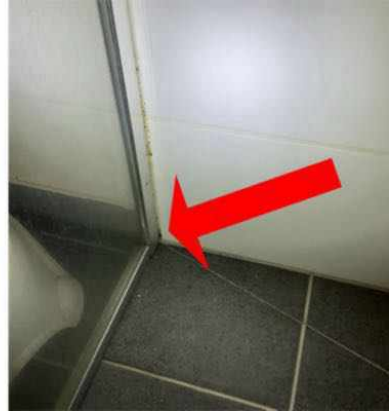
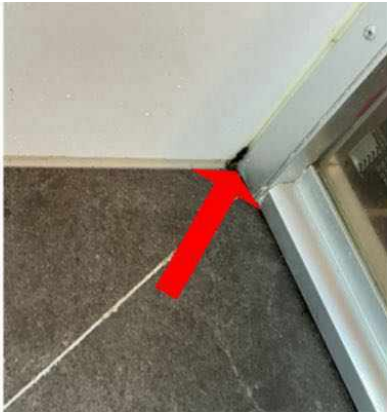
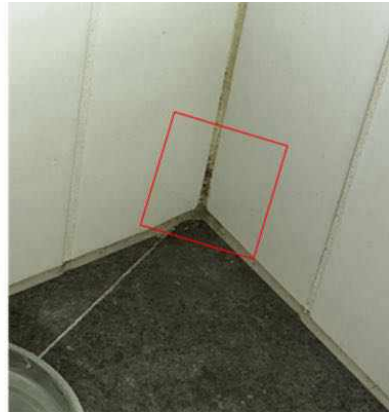
Defects 3.01

Building:	Main Building
Location:	Ensuite - Master
Finding:	Damp and Grout Deterioration in Shower Alcove
Information:	During the inspection of the master ensuite shower, damp was detected to the lower 300mm of wall within the tiled alcove using a non-invasive moisture meter. This is a common defect in wet areas and is likely the result of moisture permeating through deteriorated grout and degraded sealant. Excessive mould growth was observed on both the grout lines and sealant, particularly in areas that appear to retain frequent moisture.

Grout and sealant in wet areas naturally deteriorate over time due to regular movement between materials and the constant presence of water. If left unmanaged, these conditions allow moisture to penetrate surfaces, promoting the growth of mould and fungi, which can lead to decay of building materials and potential health risks. The World Health Organisation has identified that excess indoor moisture facilitates microbial growth, releasing airborne spores and allergens associated with various respiratory and health issues.

It is recommended that all affected grout and sealant be removed and replaced using flexible, mould-resistant materials to accommodate movement and maintain a water-tight seal. Regular maintenance of these materials is essential to prolong the integrity of wet area finishes and prevent moisture-related damage. A qualified sealant specialist, tiler, or bathroom maintenance contractor should be engaged to carry out the necessary remedial works as soon as possible. Further investigation by a plumber may also be warranted to rule out any internal leaks contributing to the damp condition.

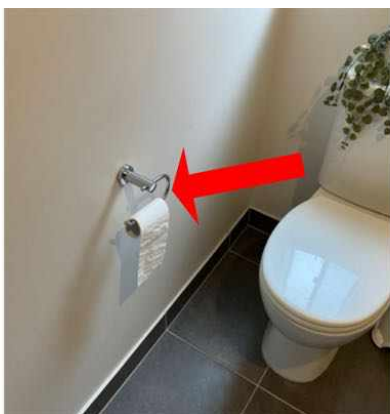
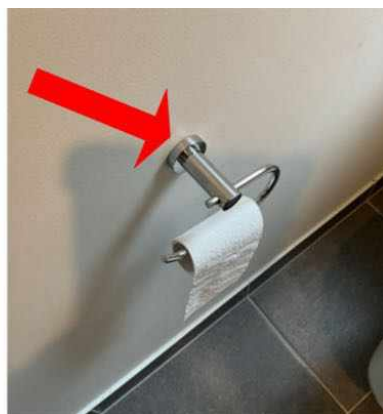
Defects 3.02

Building:	Main Building
Location:	Ensuite - Master
Finding:	Toilet roll holder - Loose
Information:	The toilet roll holder was found to be loose at the time of inspection. While not a major operational defect, function can deteriorate if the problem is left unmanaged.

It is advised that the homeowner performs remedial works to re-attach the toilet roll holder to its original fixing. A general handyperson may be required to perform these works.

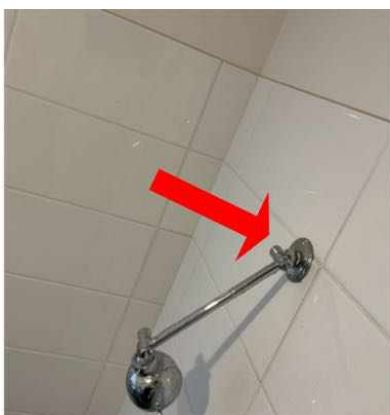
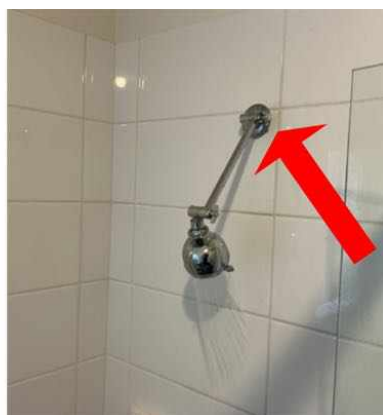
Defects 3.03

Building:	Main Building
Location:	Ensuite - Master
Finding:	Defective Shower Head in Master Ensuite Bathroom
Information:	Upon visual inspection, it was observed that the shower head in the master ensuite bathroom is defective. This damage prevents the proper operation of the shower, hindering its functionality.

It is recommended that a licensed plumber be engaged as soon as possible to assess and repair or replace the shower head to restore proper use of the shower.

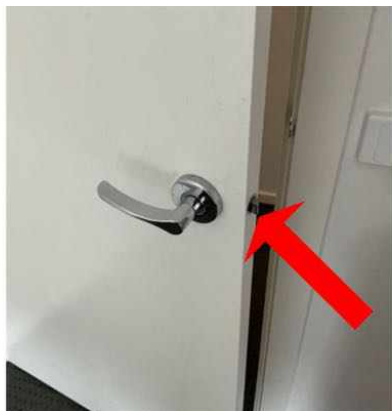
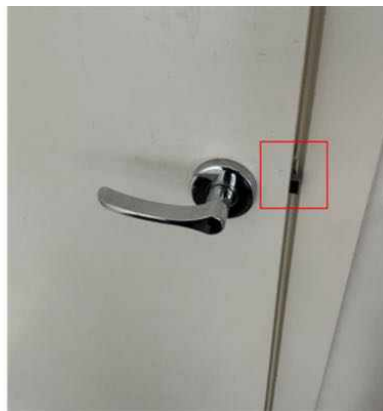
Defects 3.04

Building:	Main Building
Location:	Bedroom 2
Finding:	Door handle - Not latching
Information:	It was noted that the door in bedroom 2 was not latching during operation at the time of inspection. Whilst detracting from the functionality of this building element, this minor defect may also be a security risk, and may therefore have serious implications if left unattended.

It is suspected that this defect has occurred due to minor issues with the associated

hinges. Such damage is identified as general wear and tear, which is expected for building elements of this age.

A qualified carpenter or general handyperson may be appointed to perform rectification works as necessary, at client discretion. If left unattended, further functional impairment is likely to occur.

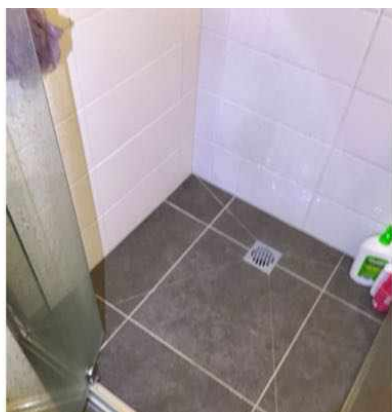
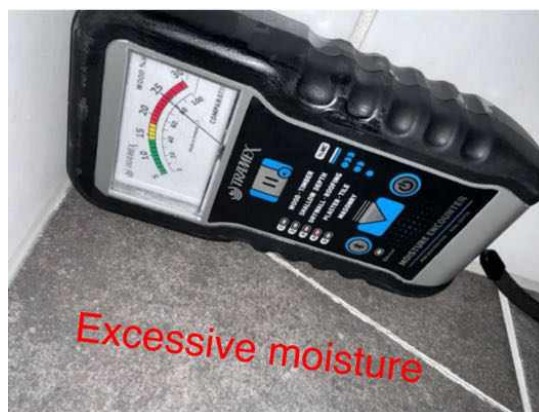
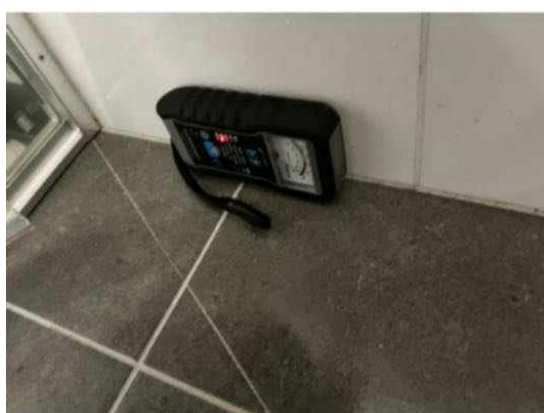
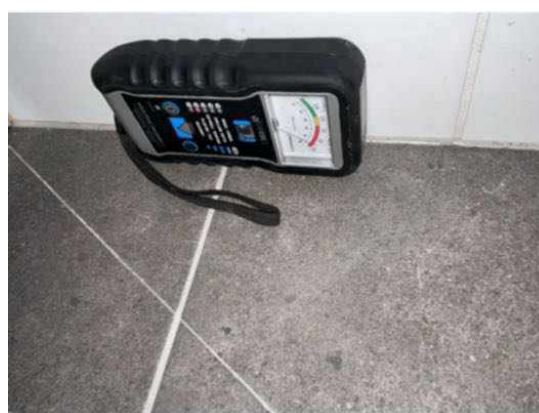
Defects 3.05

Building:	Main Building
Location:	Bathroom 2
Finding:	Shower - Damp
Information:	Damp is evident to the lower 300mm of wall to the shower alcove. This defect is quite common, and is suspected to have been caused by moisture permeating through the grouting in this area, which shows evidence of deterioration. Leaking pipes within the adjoining wall is also a possible cause.

Damp (or structural damp) refers to the presence of unwanted moisture in the structure of a building, either as the result of intrusion from outside, or condensation from within the structure. In the shower area, internal water leaks or other sources of excessive moisture are generally the cause of damp.

Unmanaged damp in the shower recess is likely to facilitate the formation and development of mould and fungi growth, decaying associated building materials and compromising their structural integrity. It is important to address damp conditions, as the World Health Organisation notes that excess moisture leads - on almost all indoor materials - to growth of microbes such as moulds, fungi and bacteria, which subsequently emit spores and other matter into the indoor air. Exposure to these contaminants is associated with a wide range of respiratory and other health-related problems.

Consultation with a qualified plumber or bathroom specialist is advised immediately to identify the cause of damp and to perform remedial works as required. Where excessive mould growth is present, further inspection by a specialist environmental health inspector should also be considered.

Always ensure that sealant and grout is in good condition to prevent any moisture issues occurring in the future.

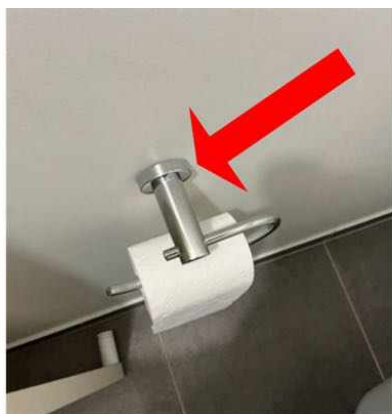
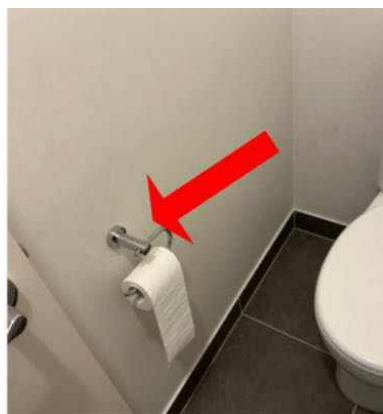
Defects 3.06

Building:	Main Building
Location:	Toilet (WC)
Finding:	Toilet roll holder - Loose
Information:	The toilet roll holder was found to be loose at the time of inspection. While not a major operational defect, function can deteriorate if the problem is left unmanaged.

It is advised that the homeowner performs remedial works to re-attach the toilet roll holder to its original fixing. A general handyman may be required to perform these works.

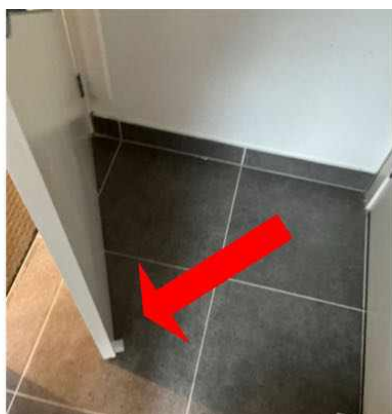
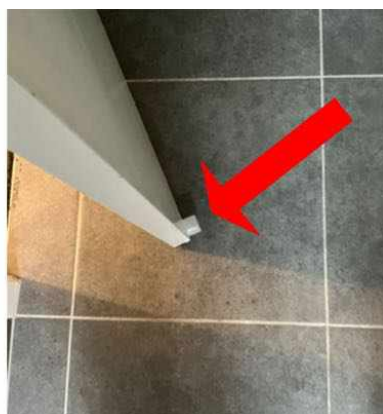
Defects 3.07

Building:	Main Building
Location:	Laundry
Finding:	Door stop - Missing
Information:	The door stop is missing or is inadequate to stop the door handle from damaging the wall. Although some building elements may seem irrelevant or unnecessary, all building elements play a key role in the operation and function of the overall structure and its performance.

Re-installation or replacement of the door stop is advised as soon as possible to prevent any subsequent damage to the door or associated structures. A general handyman may be appointed to perform these works at client discretion.

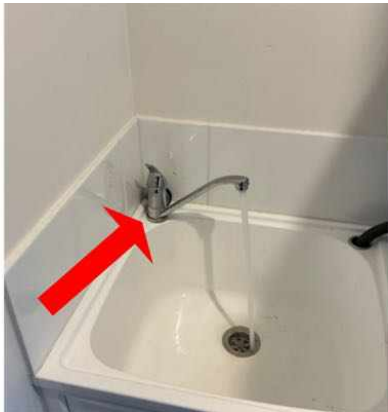
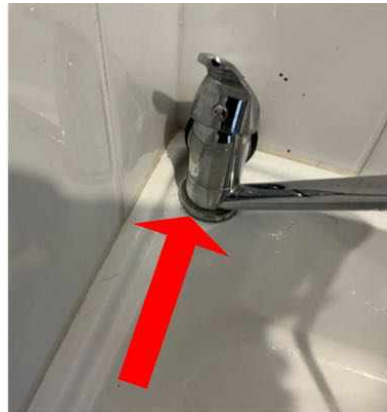
Defects 3.08

Building:	Main Building
Location:	Laundry
Finding:	Tap - Loose
Information:	The tap in the laundry sink has deteriorated with age, and is consequently loose. This tap being loose creates potential for water leaks and subsequent water damage to the surrounding area.

Where taps or spouts are loose, a qualified plumber should be appointed to re-fix the plumbing fitting.

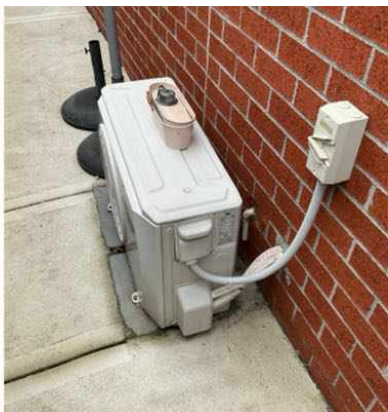
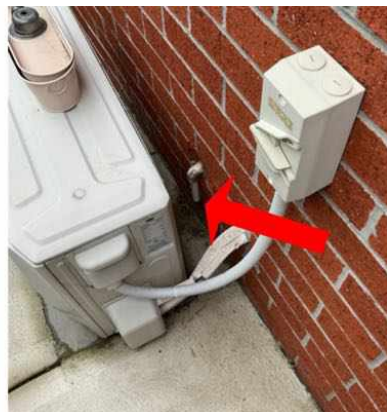
Defects 3.09

Information: Upon inspection, it was found that the AC overflow is not plumbed or connected to suitable drainage. This could lead to the surrounding area becoming excessively damp, which in turn may cause secondary defects such as rot, rust, corrosion of associated building elements, and the formation of fungal decay. In addition, prolonged damp conditions could create potential slip hazards. Poor site drainage may exacerbate the issue, potentially attracting termite activity to the area.

We recommend that a licensed plumber be appointed to properly plumb the AC overflow and connect it to suitable drainage. This will help ensure that the area remains dry and free from secondary defects.

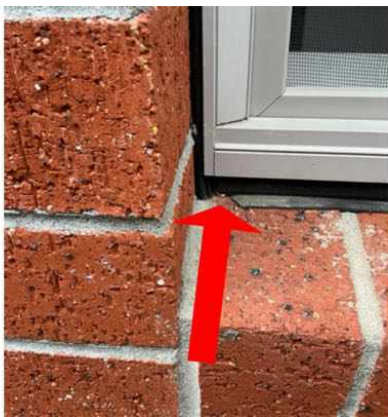
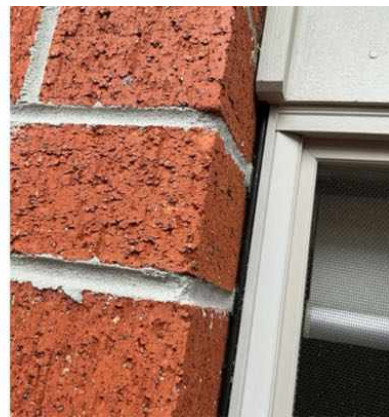
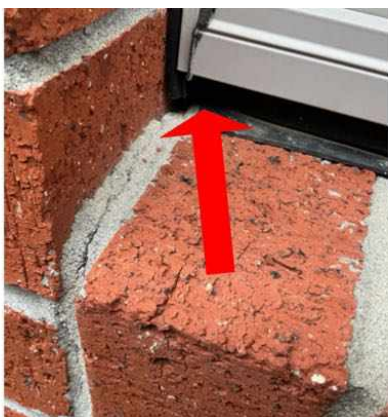
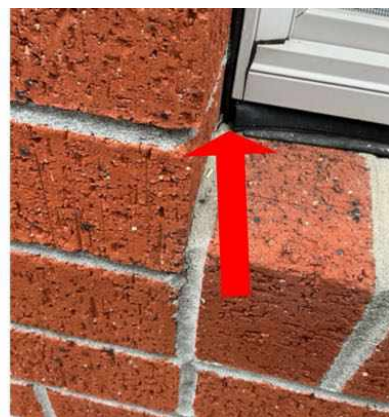
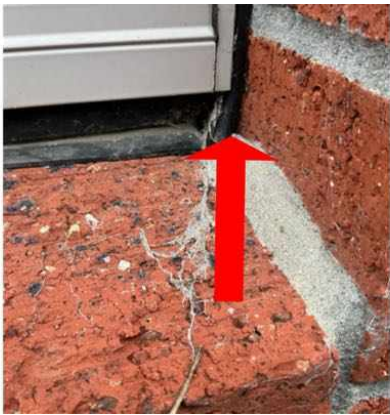
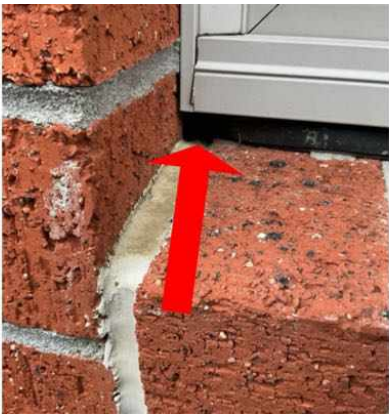
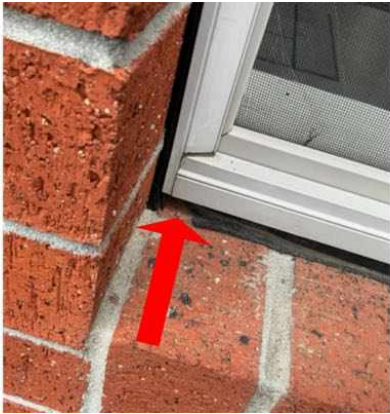
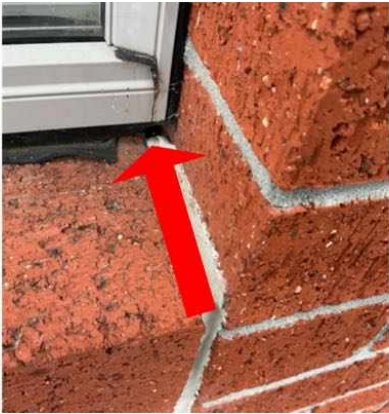
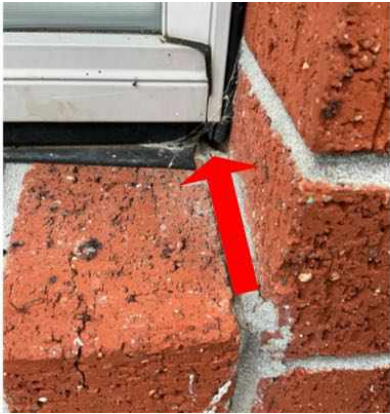
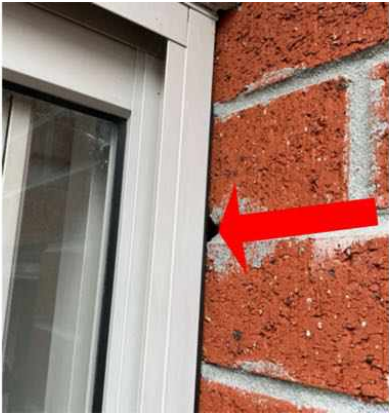
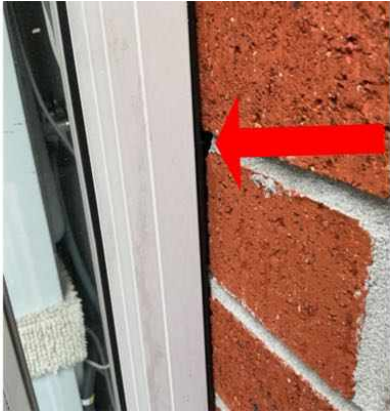
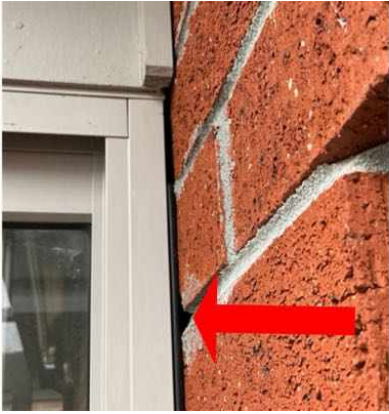
Defects 3.10

Information: Multiple gaps were identified between the external window frames and the adjoining brickwork across several elevations. These gaps appear to be the result of either poor or inconsistent sealant application during installation, or deterioration of the original sealant over time.

Unsealed or poorly sealed gaps can allow moisture ingress, wind-driven rain, draughts, and provide potential entry points for pests. Ongoing exposure to moisture may also contribute to internal dampness and premature deterioration of surrounding building elements.

A qualified handyman or registered builder should apply a consistent, waterproof, flexible exterior-grade sealant around all affected windows to ensure adequate weatherproofing and protection against moisture and pest entry.

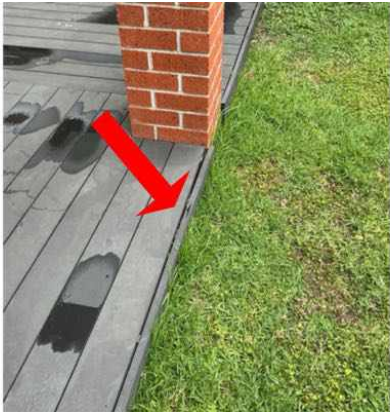
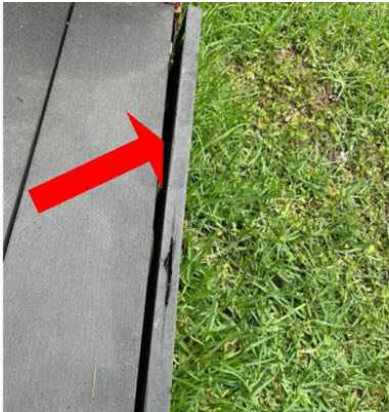
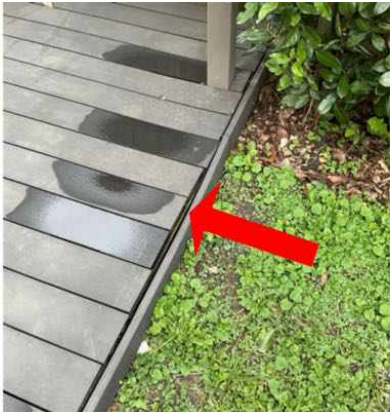
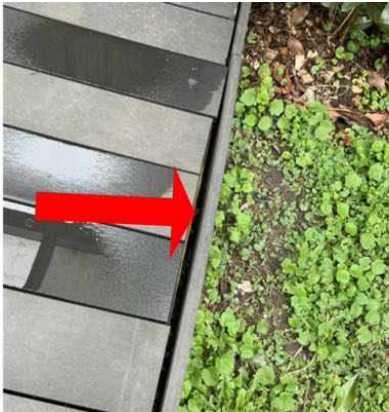
Defects 3.11

Building: Main Building
Location: Pergola
Finding: Decking Edge Board Damage and Localised Ponding
Information:

The external deck perimeter edge board (fascia/trim) was observed to have a longitudinal split with localised material separation. Surface water ponding was also noted in isolated areas of the deck, indicating minor low points and limited surface drainage.

The split to the edge board may allow moisture ingress and could worsen over time if not secured, potentially leading to further separation or localised deterioration. Ongoing ponding can contribute to premature surface wear and increased slip risk, particularly if drainage is not improved.

It is recommended that a qualified carpenter or decking installer attend to secure and repair the split edge board by re-fixing and sealing the affected section in accordance with the manufacturer’s installation requirements. The installer should also assess the deck surface levels and drainage performance and make minor adjustments where necessary to reduce standing water and improve runoff.

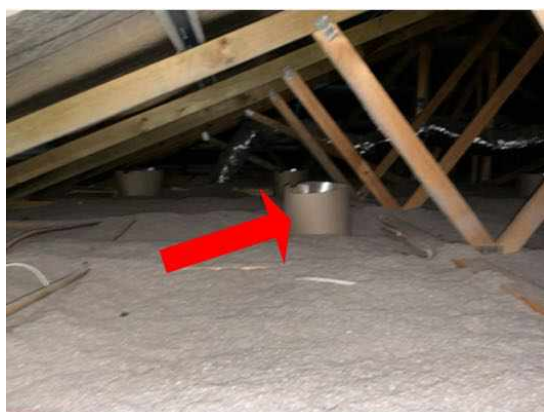
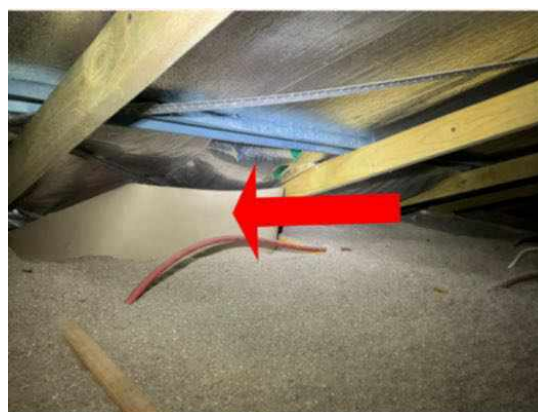
Defects 3.12

Location: Roof Void
 Finding: Bathroom Exhaust Fans Not Ducted to External Atmosphere
 Information: The exhaust fans installed in the bathrooms were observed to be discharging directly into the roof cavity rather than being ducted to the external atmosphere. This configuration does not comply with best practice ventilation standards, as it allows moist air to accumulate within the roof space.

Prolonged moisture build-up in the roof cavity can lead to elevated humidity levels, which may contribute to mould growth, timber decay, and potential damage to insulation or other roof components over time.

It is recommended that a licensed ventilation specialist or electrician be engaged to install compliant ducting that vents the exhaust air to the outside of the building, in accordance with current building regulations and ventilation standards.

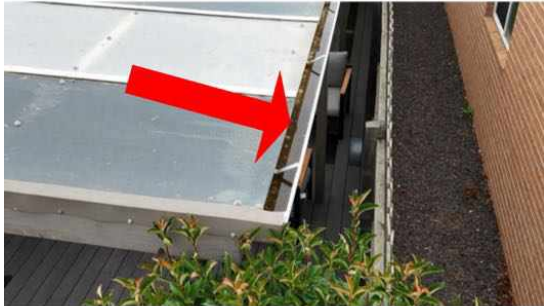
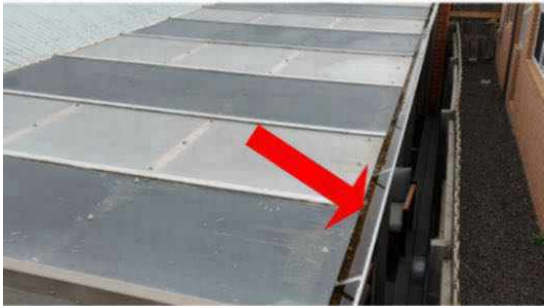
Defects 3.13

Building: Main Building
 Location: Pergola
 Finding: Gutters - Water pooling
 Information: Water was found to be pooling in sections of the roof guttering. This is generally a secondary defect caused by blocked or partially blocked gutters. Such blockages and subsequent water pooling are likely to lead to rust and water damage to associated structures if left unattended.

Any areas of guttering that shows evidence of water pooling should be checked for partial or full blockages and any secondary damage that may have occurred as a result. Depending on the extent of the damage, building elements may require repair and/or replacement to ensure adequate roof drainage and function of exterior plumbing system.

A roofing plumber should be appointed as soon as possible to rectify this issue. It is highly advised that all gutters be maintained on a frequent basis to ensure the condition of roof plumbing.

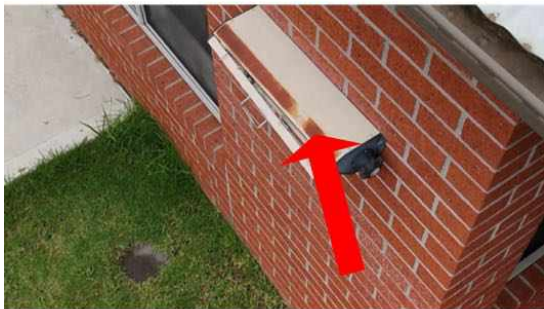
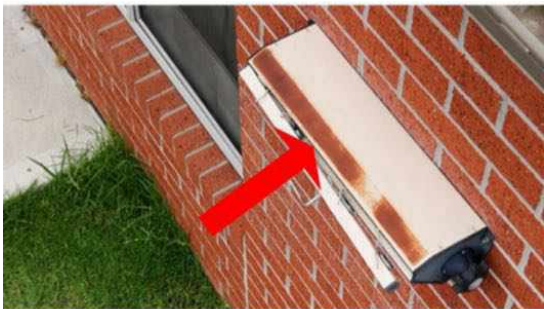
Defects 3.14

Building: Main Building
Location: Yard - Back
Finding: Rusting to Wall-Mounted Clothesline
Information:

The external wall-mounted fold-down clothesline was observed to have surface corrosion to the upper metal casing/lid. Rust staining is visible across the top surface, consistent with weather exposure and deterioration of the protective coating.

Surface corrosion, if left untreated, may progress and lead to further material deterioration, potential perforation of the metal casing, and reduced structural integrity of the clothesline over time. Continued exposure to moisture will accelerate the corrosion process.

It is recommended that a qualified handyman or maintenance contractor clean back the affected areas to sound metal, treat the surface with an appropriate rust inhibitor/primer, and apply protective exterior-grade coating. The unit should also be assessed to ensure fixings remain secure and structurally sound.

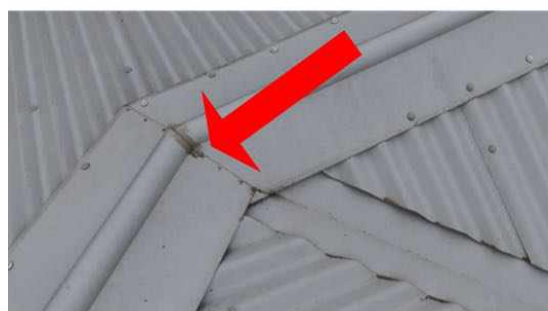
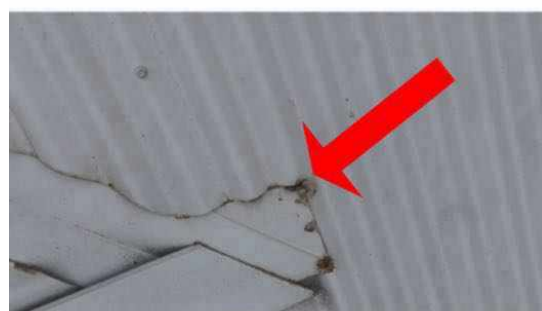
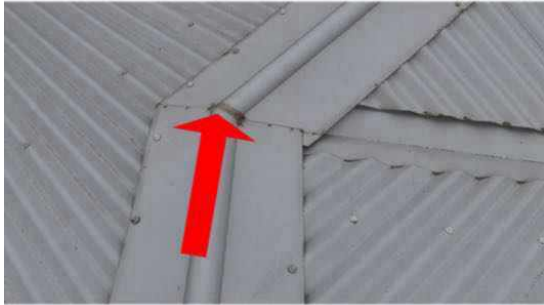
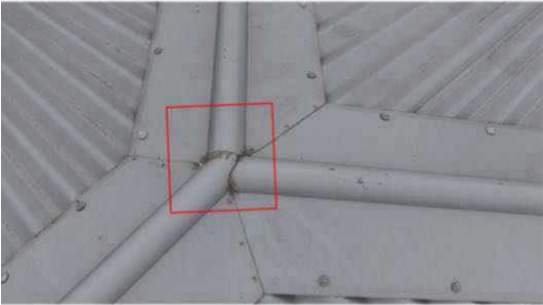
Building: Main Building
 Location: Roof Exterior
 Finding: Roof Flashing Junction Sealing
 Information:

The roof capping and barge flashing junctions were observed to have standard lapped metal connections without visible sealant at certain joints. Minor surface staining was noted at some junction points; however, fixings appear present and the laps appear mechanically secured.

In typical Colorbond roofing installations, lapped flashings are not always required to be sealed provided adequate overlap, correct fall, and appropriate fixing has been achieved in accordance with manufacturer specifications and relevant Australian Standards. Based on a visual inspection only, no obvious open gaps or displacement were observed.

As a precautionary measure, it is recommended that the roof be monitored for any signs of water ingress, particularly following heavy or wind-driven rain. Should leakage be identified, a licensed roof plumber should assess the affected junctions and apply appropriate weatherproof sealing where required.
