# Building and Timber Pest Inspection Report

Inspection Date: Thu, 9 Apr 2026

Property Address: 95 Bellevue Ave, Rosanna VIC 3084,  
Australia

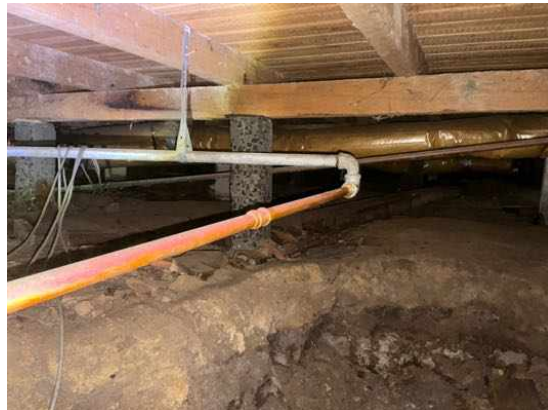
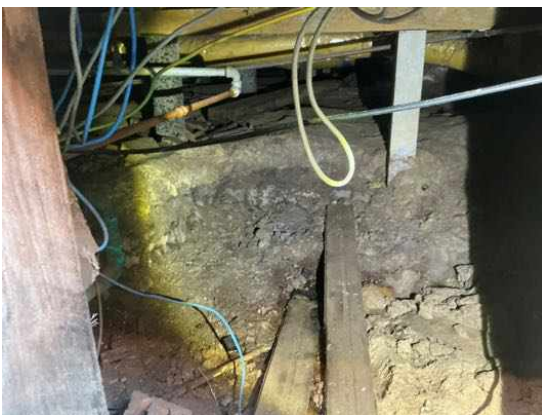
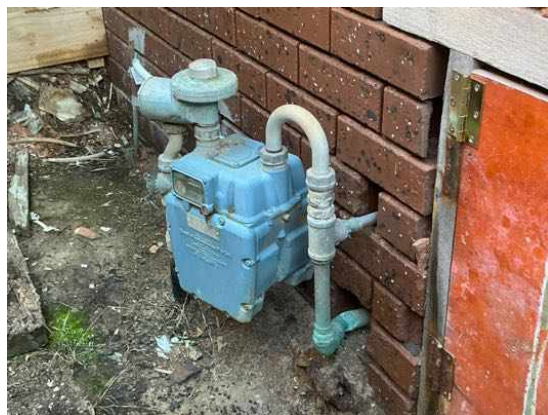
Building: Main Building  
Location: Subfloor  
Finding: Gas leak/dangerous/subfloor inspection terminated  
Information: It was noted at the time of the inspection that the gas pipe to the left-hand side of the subfloor door was not crimped, was loose and came apart. This caused a serious gas leak which filled the subfloor with gas.

The inspection of the subfloor had to be terminated due to safety reasons and it is recommended that the inspection of the sub for be completed once the area is made safe.

Some observations of the subfloor were listed within the body of report prior to the gas leak becoming known.

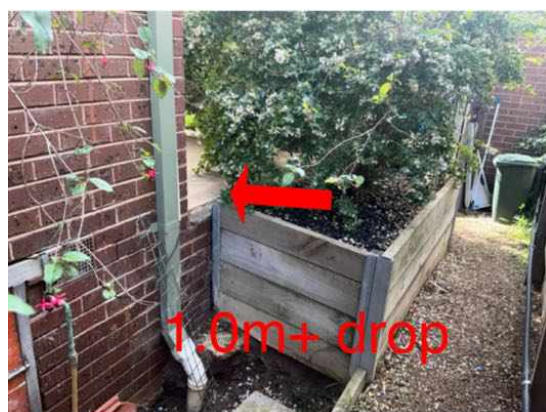
## Finding 1.02

Building:	Main Building
Location:	Verandah
Finding:	No handrail fall hazard
Information:	It was noted at the time of the inspection that the height of the veranda was over 1 m. No handrail was in place to prevent a fall hazard.

It is noted that the current building regulations require a handrail for veranda and decking over the height of 1 m.

This fall hazard should be reviewed by a qualified carpenter immediately

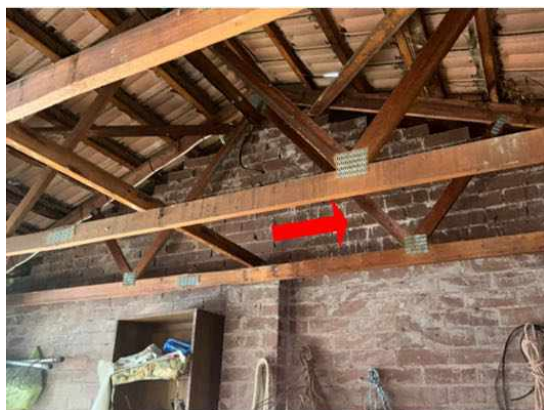
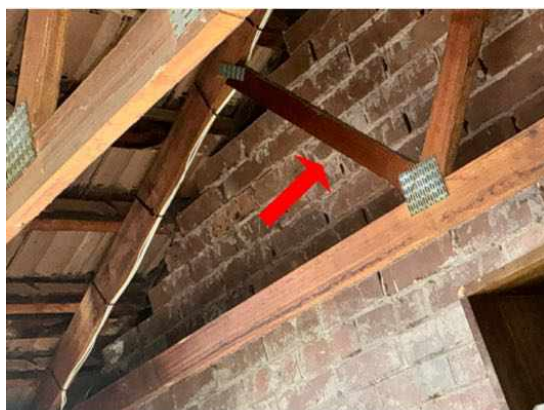
### Finding 2.01

Building:	Main Building
Location:	Garage
Finding:	No brick ties to masonry Gable end
Information:	It was noted at the time of the inspection that the brick Gable ends to the garage were constructed of single skin brickwork and were not tied with brick ties to the timber structure. It appears that the building has been constructed in this manner, however the brickwork could become unstable and create a safety hazard.

Building regulations have always stated Brickwork should be tied to the timber structure at 400 mm or 600 mm centres depending on timber supports spacing..

A registered builder or bricklayer should be engaged to review immediately

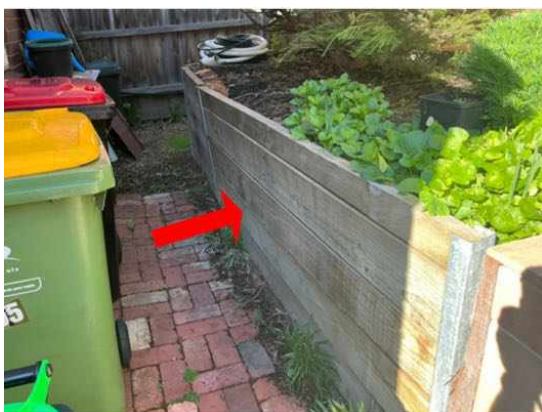
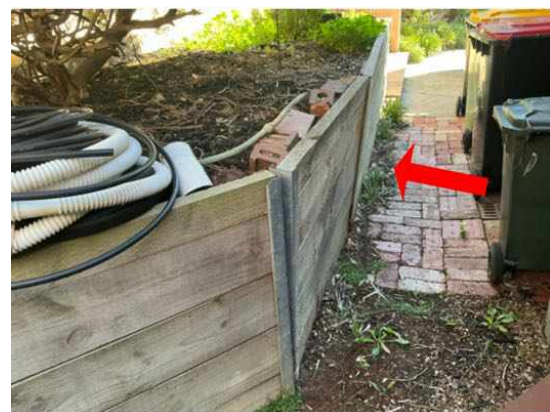
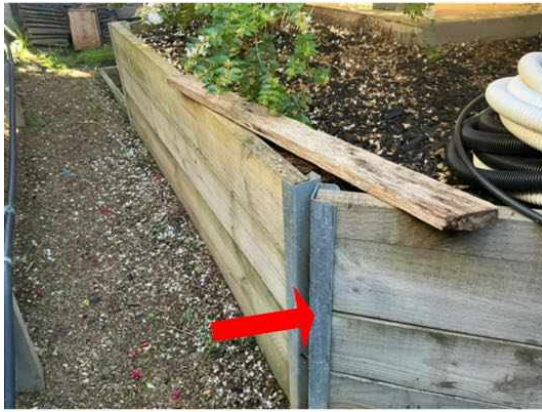
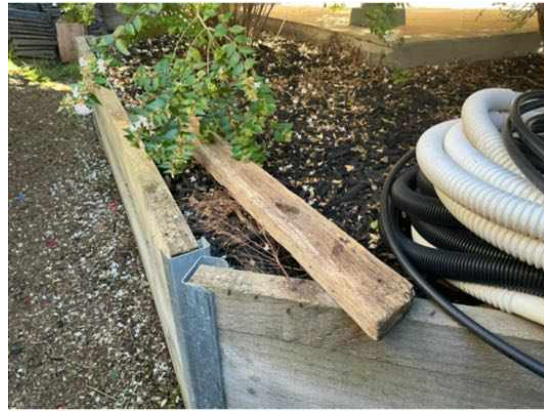
Finding: Retaining wall - Defective

Information: The retaining wall in the front yard was found to be defective at the time of inspection. Generally, defective retaining walls are caused by poor original design or material use. However, deteriorated retaining walls may also be a result of substandard construction, poor site drainage or unmanaged stormwater flows.

If left unmanaged, the retaining wall may become a safety hazard if it continues to destabilise. Where retaining walls further rot and decay, an environment is created that is conducive to termite and pest infestation.

Significant repair and replacement should be expected. Where retaining walls are considered structural walls, a structural engineer / surveyor should be consulted regarding required remedial works. Otherwise, a landscaper or retaining wall installer may be appointed to repair or replace the wall, at the discretion of the client.

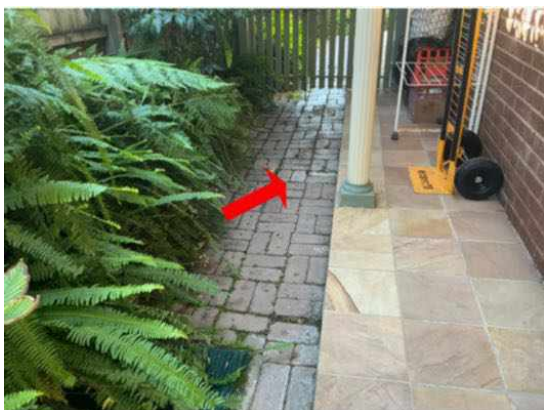
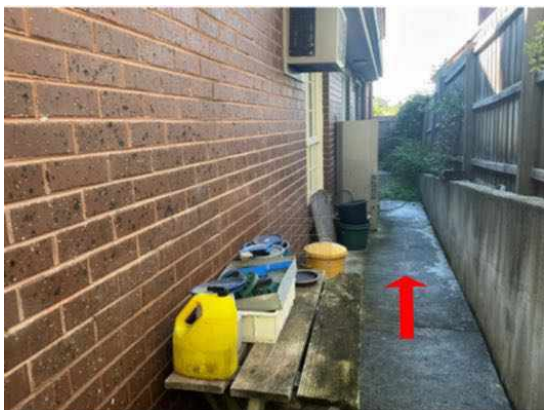
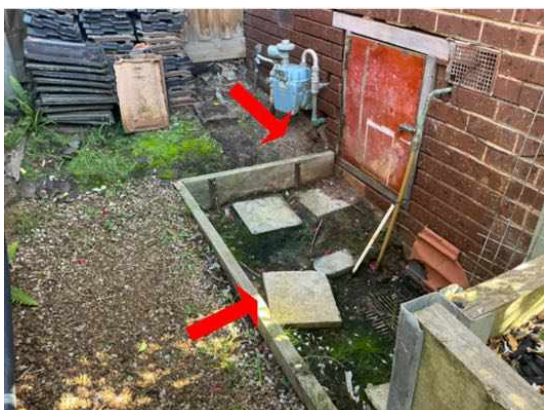
### Finding 3.03

Building:	Main Building
Location:	All External Areas
Finding:	Site drainage - Inadequate
Information:	The site drainage around the entire building area was found to be inadequate at the time of inspection, creating potential for subsequent water damage to associated building elements.

Where site drainage is inadequate, installation of an Agricultural (Aggie) Drain may be required. A qualified plumber should be appointed to further inspect the property and perform any remedial works as necessary. Water damage and secondary defects are likely to occur if left unmanaged.

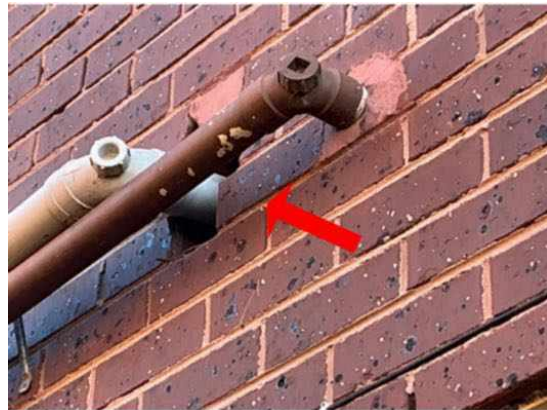
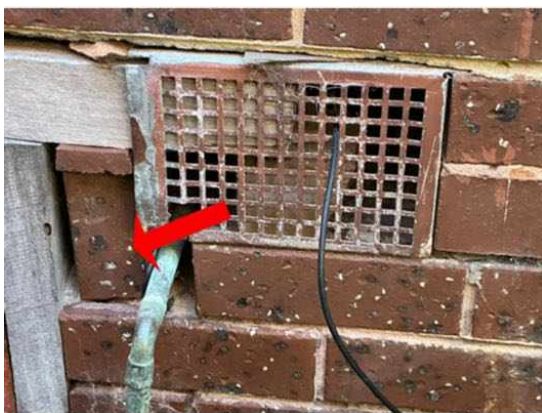
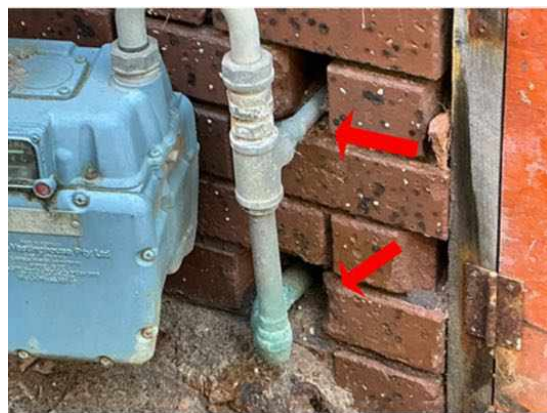
### Finding 3.04

Building: Main Building  
 Location: Exterior walls - left side  
 Finding: Incomplete or substandard works  
 Information: The brickwork to the left-hand side elevation to the building appears to be incomplete or have been completed to a substandard level.

Works that have not been completed to a satisfactory level create potential for the development of building defects and may impede on the safety and integrity of the overall structure.

It is highly recommended that a qualified bricklayer be appointed to complete these

works and ensure the safety of the area and the longevity of all associated building elements.

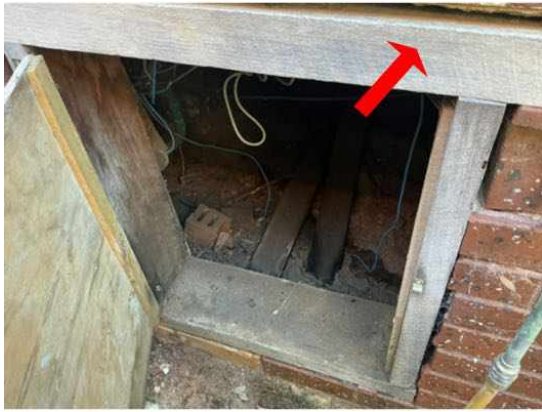
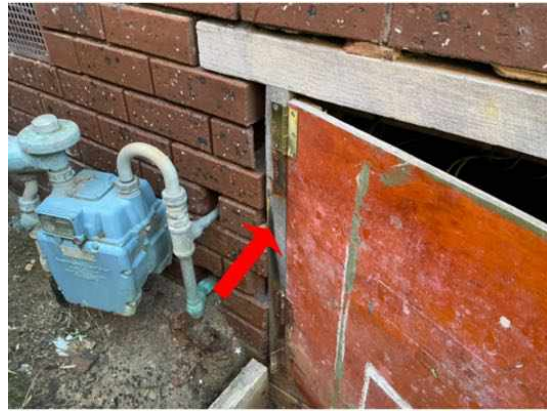
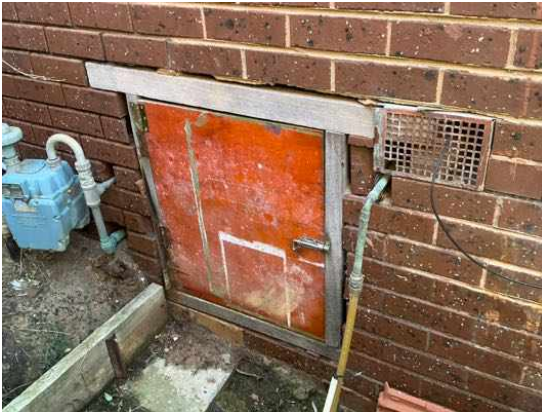
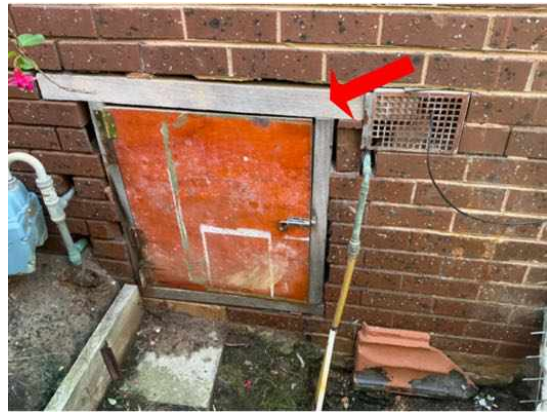
### Finding 3.05

Building:	Main Building
Location:	Subfloor
Finding:	Incomplete or substandard works/subfloor door and frame
Information:	The works to the subfloor door appear to be incomplete or have been completed to a substandard level.

Works that have not been completed to a satisfactory level create potential for the development of building defects and may impede on the safety and integrity of the overall structure.

It is highly recommended that the relevant trades be appointed to complete these works and ensure the safety of the area and the longevity of all associated building elements.

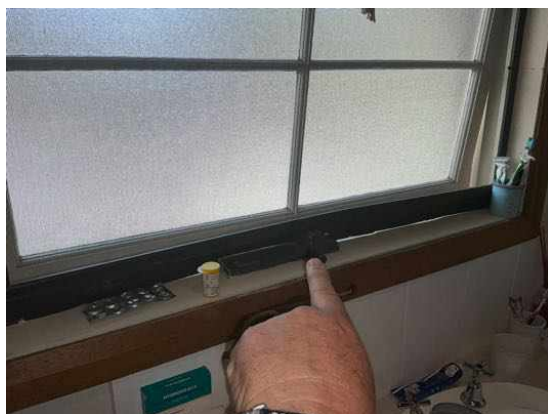
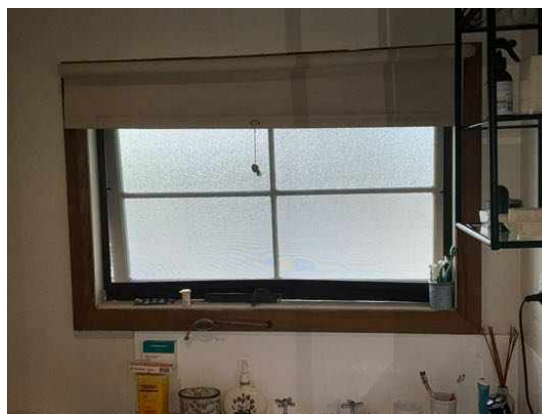
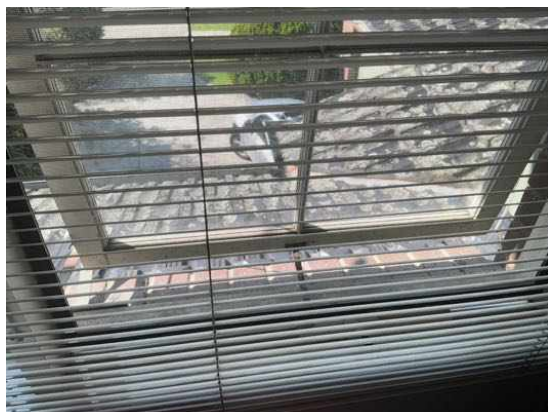
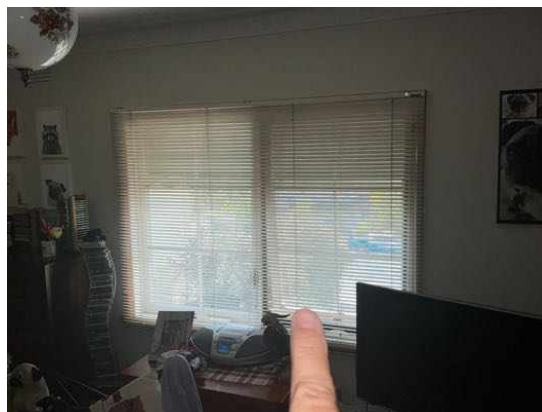
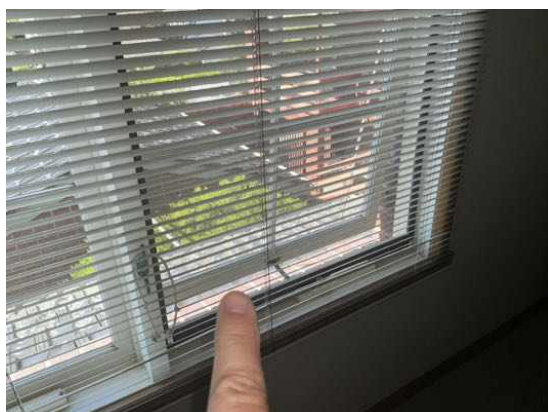
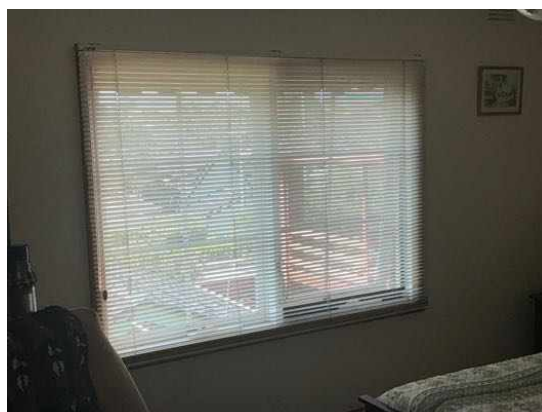
### Finding 3.06

Building:	Main Building
Location:	All Internal Areas
Finding:	Windows awning /unopenable- stiff to operate
Information:	Sashes are the moveable panes of window . Each sash is provided with winder and hinges and/or compression weather-stripping, which act to hold the window in place in one position.At present the windows cannot be opened or are stiff.

The sashes require adjustment to allow the window to function as intended. Such works may be completed by a qualified carpenter or registered builder.At the owners discretion.

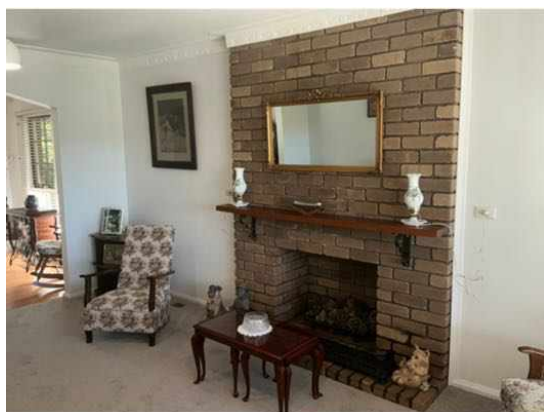
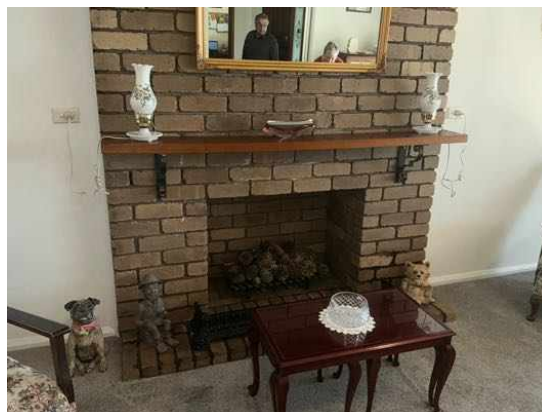
Finding: Chimney and fireplace  
 Information: It was observed that a fire place and chimney were part of the building.

Defective and soot clogged unmaintained chimney flues are a major fire hazard.

It is important to have the chimney and fire box fully checked by a fire place specialist prior to operation.

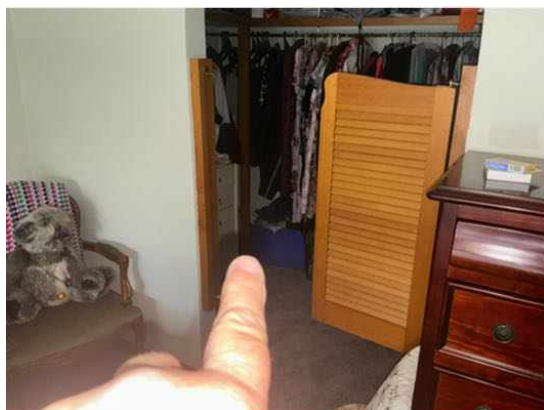
Location: Walk In Robe  
 Finding: Saloon door walking robe  
 Information: It was noted at the time of the inspection that a saloon door to the double doors in the walk-in robe was missing. Although this is an aesthetic defect it detracts from the overall appeal of the building

A qualified carpenter should be engaged to review at the owners discretion

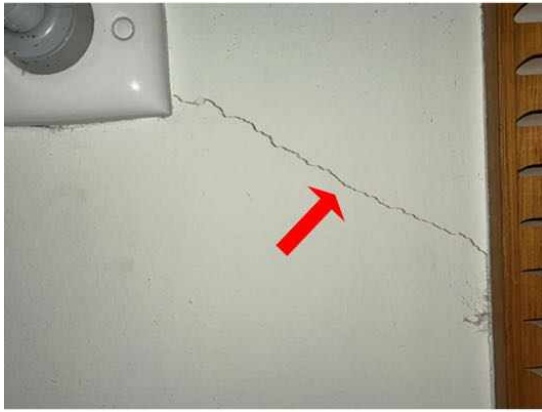
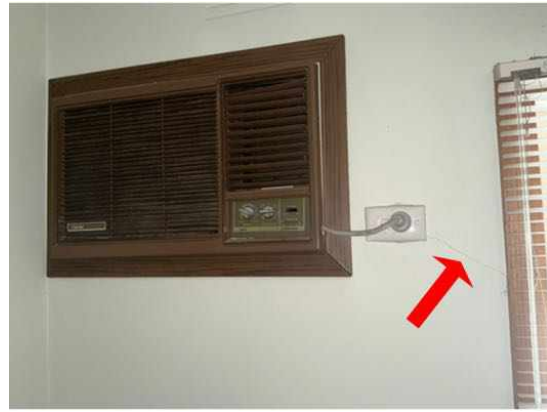
### Finding 3.11

Building: Main Building  
 Location: Bedroom - Master  
 Finding: Cracking - Damage Category 1 - Fine (up to 1mm)  
 Information: Although fine cracks are quite noticeable, they are often only considered to be an appearance defect, and usually do not indicate any structural damage. Generally, the cause of a fine crack is indicative of a separation between building materials and finishes (e.g. paint, plaster, etc.) along joins.

Cracking of this nature can generally be repaired with minor sanding, filling and/or repainting. Such works should be performed by a qualified painter or a general handyman.

Monitoring of all cracking should be conducted frequently. Always contact a building inspector should cracks widen, lengthen, or become more numerous.

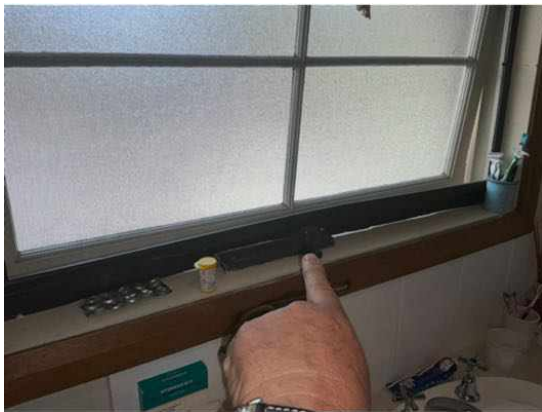
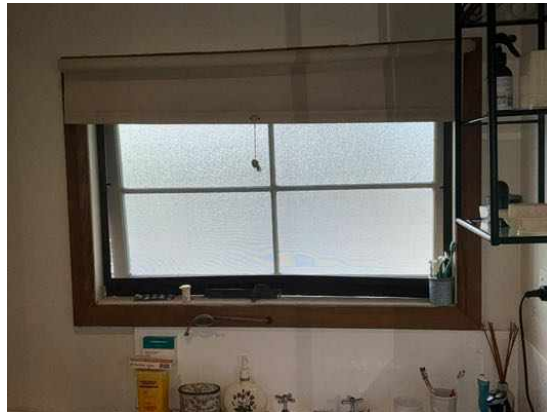
### Finding 3.12

Building: Main Building  
 Location: Ensuite - Master  
 Finding: Fly wire screen damaged  
 Information: It was observed at the fly wire screen to the ensuite window was damaged at the time of the inspection showing deterioration and tear damage

Fly wires are required to prevent the invasion of mosquitoes and other airborne insect pests

A general handyman should be engaged to review at the owners discretion

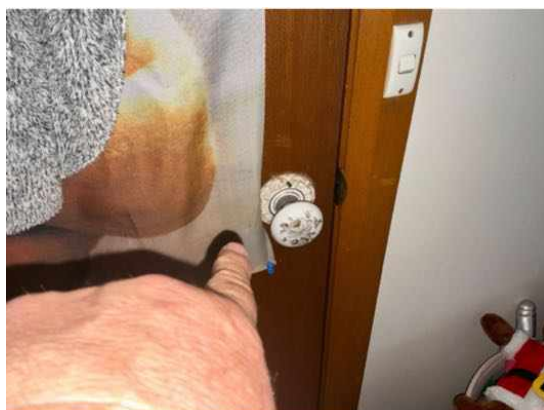
### Finding 3.13

Building: Main Building  
 Location: Bedroom 2  
 Finding: Door handle loose  
 Information: The door handle was found to be loose.

Unattended to the handle could fall off and make the door inoperative.

A carpenter/handy man should be appointed immediately to review and adjust at the owners discretion.

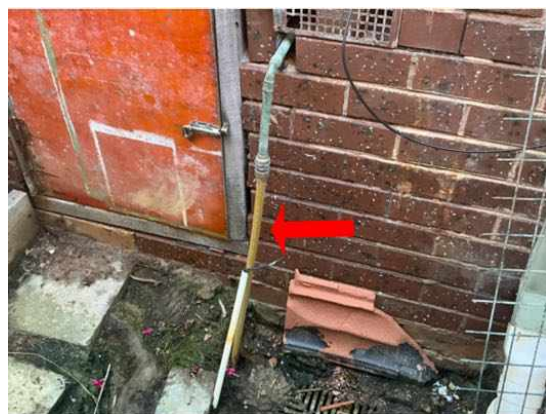
Building:	Main Building
Location:	Exterior walls - left side
Finding:	PVC gas pipe not UV protected
Information:	It was observed at the time of the inspection that the PVC gas pipe to the RHS of the subfloor door was not adequately protected from UV radiation.

UV radiation can prematurely deteriorate plastic plumbing fittings and should be protected with a suitable material.

A licensed gas permit should be engaged to review as soon as possible

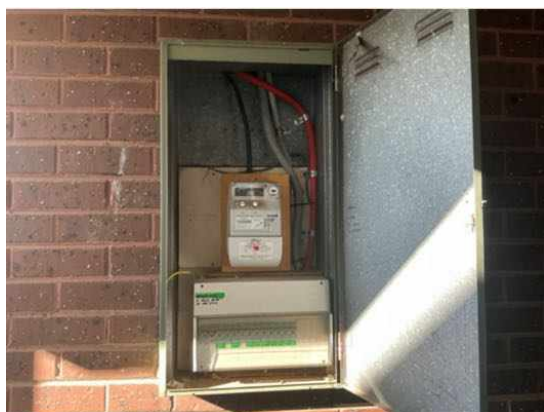
Building:	Main Building
Location:	Meter Box
Finding:	Termite Management System - no evidence of a chemical installation
Information:	The application of a post-construction chemical termite barrier is highly recommended for all properties, particularly if live termite activity has been found on the site previously. Such barriers are highly effective in preventing termite attack on any timber building elements throughout the property.

A durable notice should be placed in the switchboard unit to indicate current termite barriers. At the time of inspection, it appeared as though no termite management system has been installed, with no evidence to suggest preventative works taking place.

The client may consider gaining further advice from a pest controller as to the costs and procedures involved with this application. It is recommended that obtaining such advice be a short-term priority.

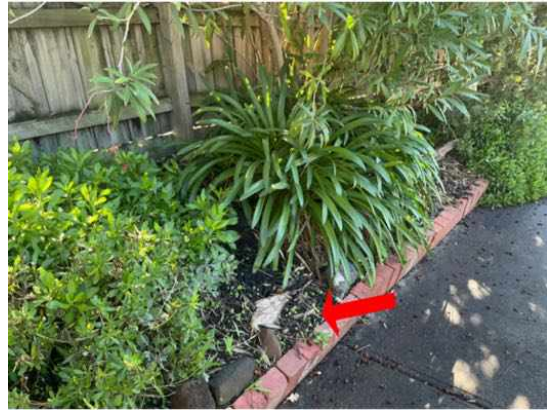
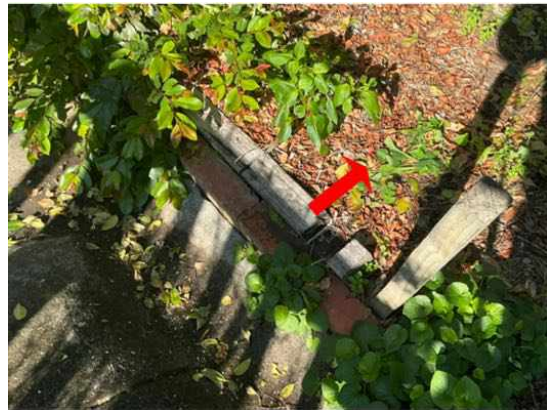
### Finding 6.03

Building:	Main Building
Location:	All External Areas
Finding:	Garden Beds - Conditions Conducive to Termites
Information:	Garden beds were found to be evident in the garden area. These garden beds can include untreated timber, and with a combination of moisture from watering hosing can make conditions conducive to termite activity and termite ingress.

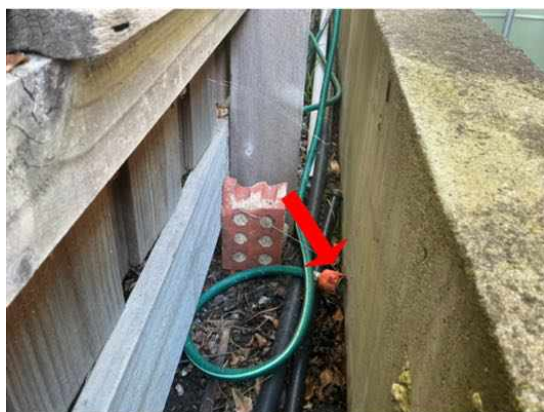
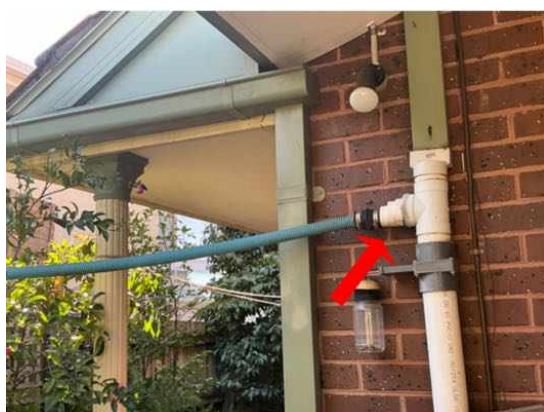
Location: All External Areas  
Finding: Air conditioner and hot water heater condenser pipe not connected  
Information: The A/C and water heater condenser overflow where found to be disconnected from the stormwater system and is creating excessive moisture to the surrounding area.

Unattended to the foundation material to the building could become saturated and unstable. This could lead to movement and cracking of rigid building elements.

A licensed plumber should be engaged to review as soon as possible.

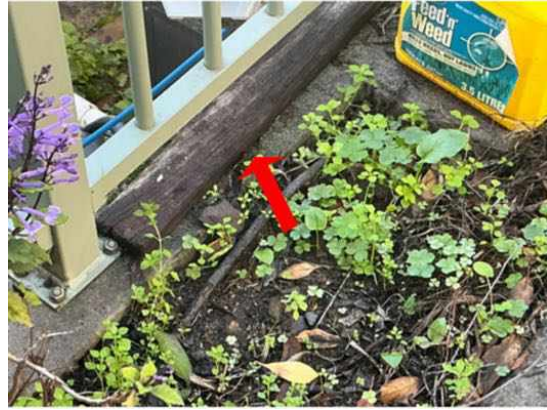
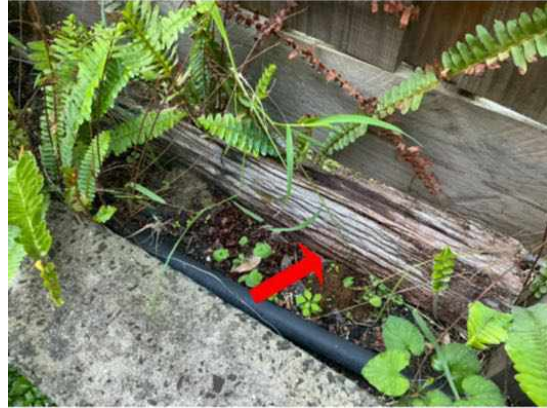
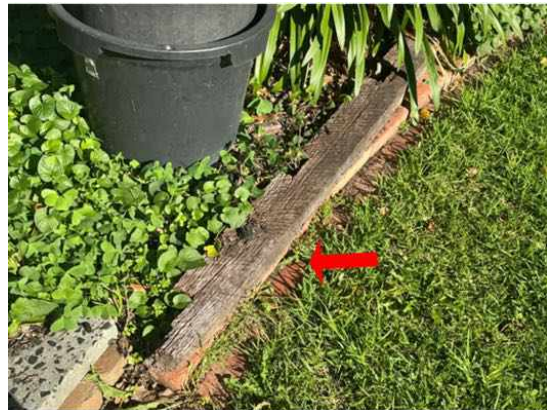
In this case although the affected timber element is in a decaying state the extent of any visible damage appears to be localised to a specific area and is yet to spread to other parts of the building element or affect adjoining structures. The fungal decay is therefore likely to be of a relatively superficial nature with minimal impact on the structural integrity or tensile strength of the timber element.

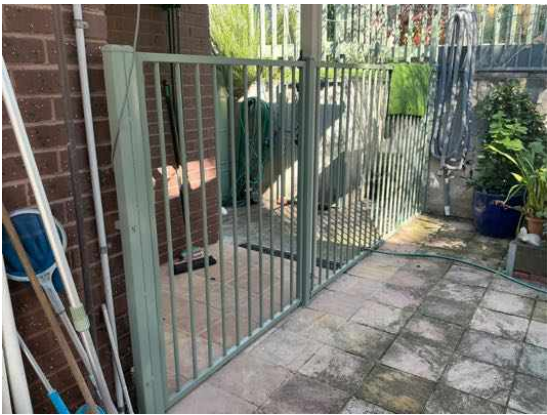
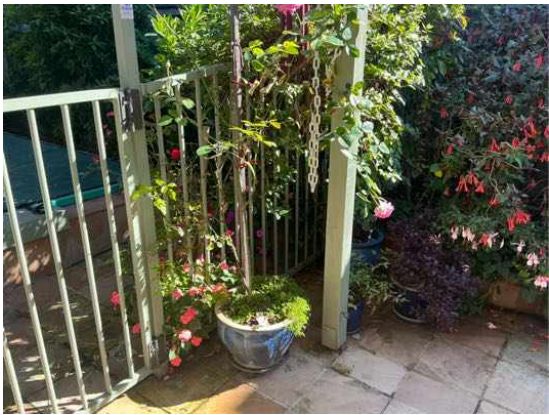
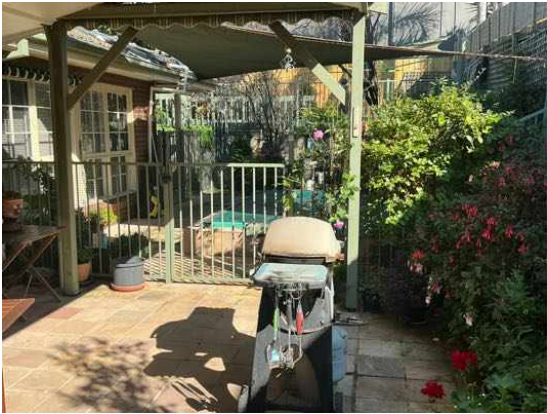
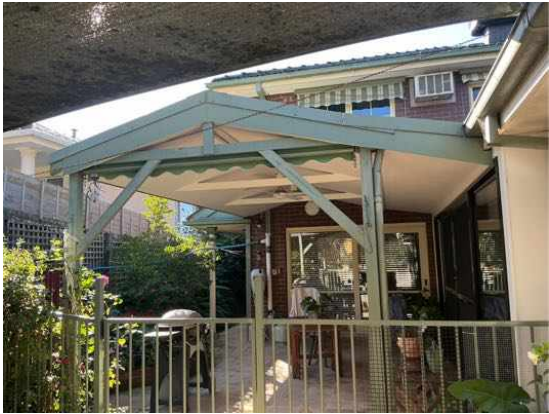
Building: Main Building  
 Location: Yard - Side  
 Finding: Pool fencing - Inspection required  
 Information: It is suspected that areas of the pool fencing may not comply with Australian Standards. Assessment of the pool area is required.

Please note that this inspection does not cover pool fencing and other pool fittings and fixtures. It is highly advised that a specialist be appointed to inspect the pool and surrounding area and provide advice on rectification works that may be required.
