# Building and Timber Pest Inspection Report

Inspection Date: Fri, 9 Jan 2026

Property Address: 16 James Cook Pkwy, Shell Cove NSW  
2529, Australia

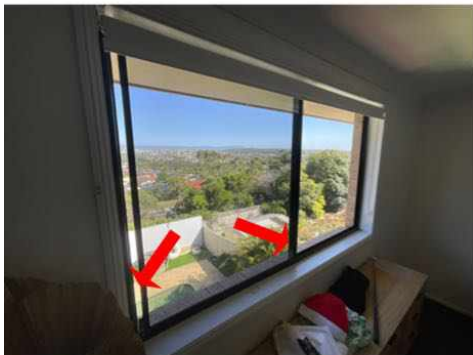
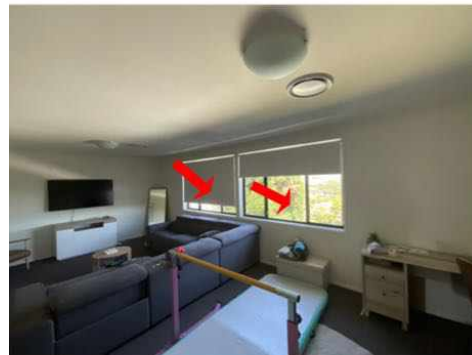
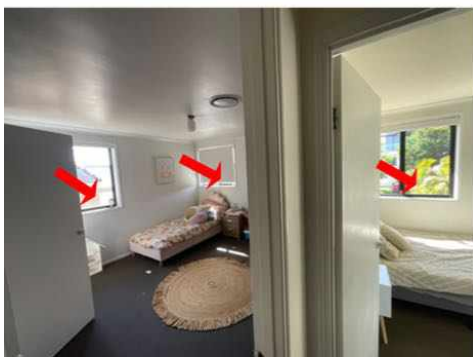
Building:	Building 1
Location:	Most upper windows
Finding:	Window opening restrictors missing.
Information:	The Building Code of Australia rules require all openable windows (where the internal floor is more than 2m above the ground outside) in residential rooms to be fitted with a suitable screen or restrictor. Windows located 1.7m above the floor level do not require protection.

Window restrictors are required where people who are vulnerable to the risk of falling have access to windows. This means all windows above ground level which do not have another fall prevention safety measure in place, such as a balcony or balustrade should have a restrictor.

These need to be added urgently for the safety of all persons.

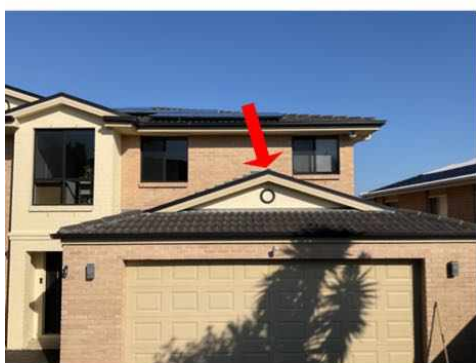
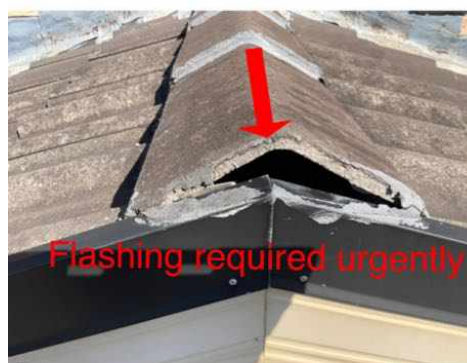
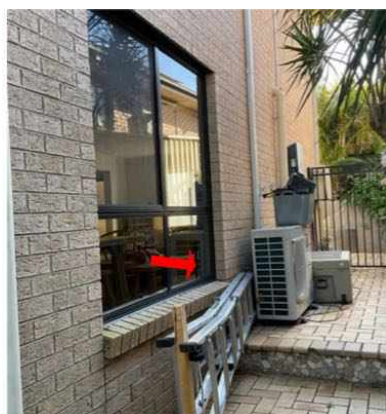
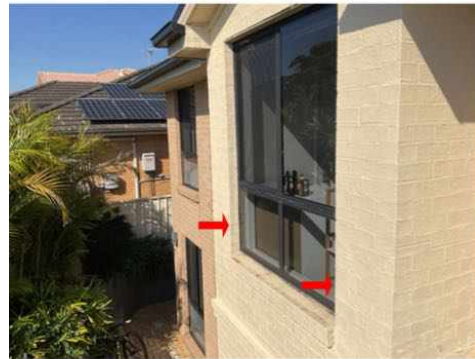
## Finding 2.01

Building: Building 1  
 Location: Exterior walls  
 Finding: Sealant (external) - missing  
 Information: It was noted on inspection that areas of external sealant was missing to areas of the external windows and garage roof. The hole in the garage roof (pictured 1 & 2) is described in this report as a major defect due to the potential damage this hole can cause to the garage. This hole requires urgent flashings. The window photos after this are minor defects.

Flexible sealants should be applied to these affected areas to prevent any subsequent water damage that is likely to occur. All windows on the property should be checked and sealant around the perimeter of any windows with gaps should be applied if required.

A sealant specialist or skilled handy person should be appointed to complete these works as soon as possible

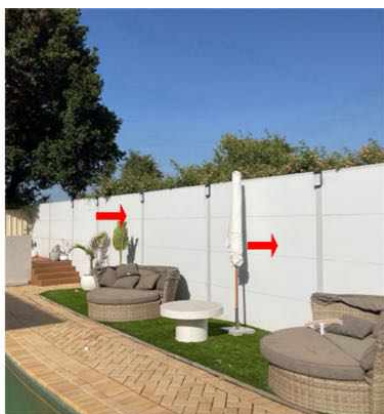
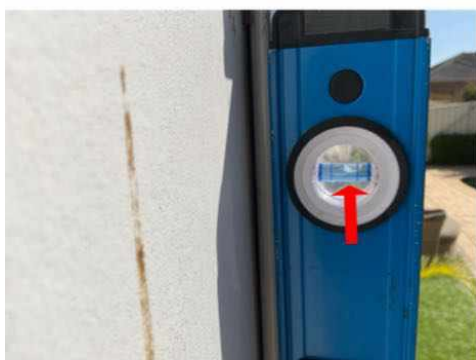
### Finding 3.01

Building:	Building 1
Location:	Pictured rear and rear right fences/lattice
Finding:	Fences damaged - leaning
Information:	Evidence of damage to the pictured fences was identified at the time of the inspection. The likely cause of the rear fence leaning is not enough concrete used in the post footings. If left unmanaged this fence may deteriorate further.

It is suggest a fencing contractor be engaged for rectification when convenient.

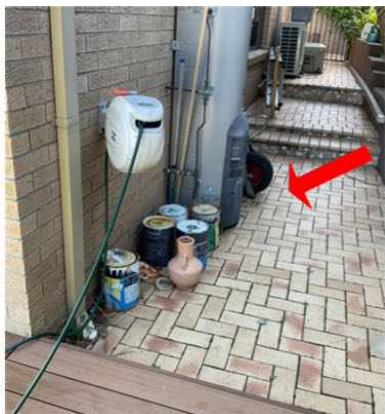
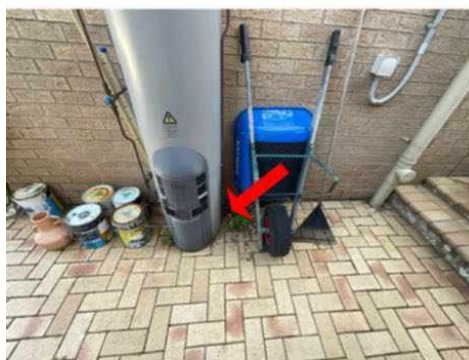
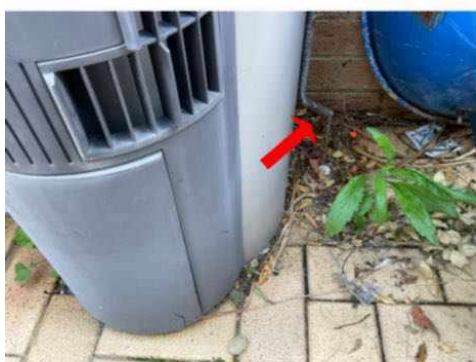
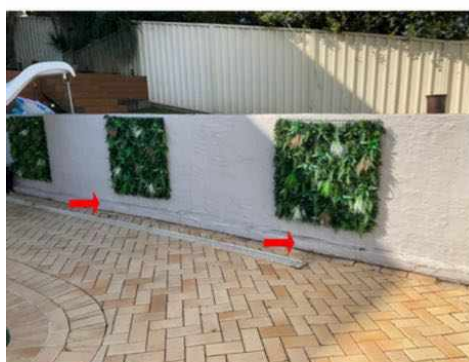
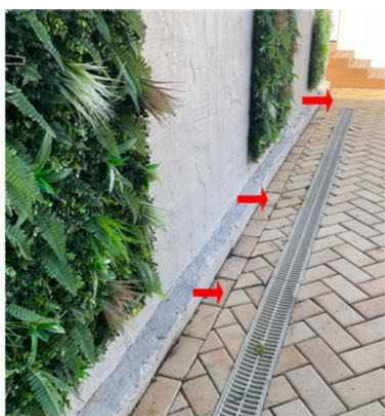
Building:	Building 1
Location:	Walls
Finding:	Site drainage - Inadequate
Information:	The site drainage in this left rear area was found to be inadequate at the time of inspection, creating potential for subsequent water damage to associated building elements.

The air conditioners (on both sides of the house) and hot water system overflows run against the house walls. The left paving adjacent to the left rear house and left rear retaining walls is lower than the surrounding area allowing rainwater to pool.

It is important that water does not lie against the base of walls; surrounding paths and ground levels should be sloped to drain water away from walls. Downpipes should not discharge stormwater onto lower walls or plinths. Stormwater should be carried away by large, regularly cleaned drains. Ground levels may need to be lowered to expose a buried DPC.

Where site drainage is inadequate, installation of an Agricultural (Aggie) Drain may be required. A qualified plumber should be appointed to further inspect the property and perform any remedial works as necessary. Secondary defects are likely to occur if left unmanaged.

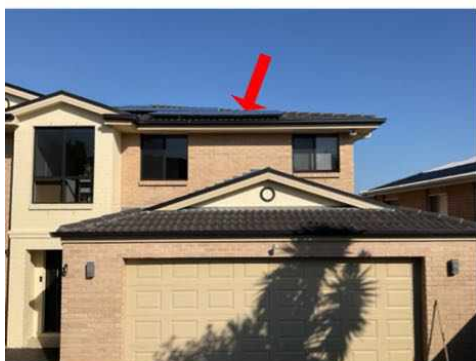
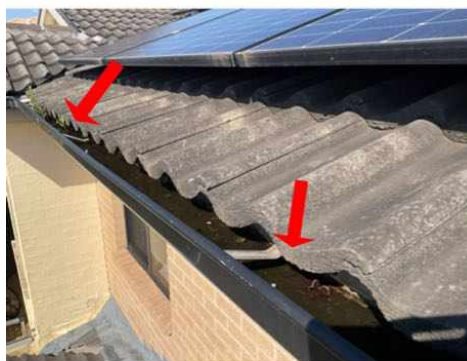
### Finding 3.04

Building:	Building 1
Location:	Roof Exterior
Finding:	Gutter - Insufficient fall
Information:	There is an insufficient fall in the upper front gutters, which means that the angle of this gutter is inadequate for rainwater to drain away. This has resulted in pooling of water in the area, creating the potential for water damage to nearby areas. This is likely to lead to further defects if not repaired. All gutters should be checked as some were inaccessible. Adjustment by a roofing contractor is required as soon as possible to prevent any damage to this area.

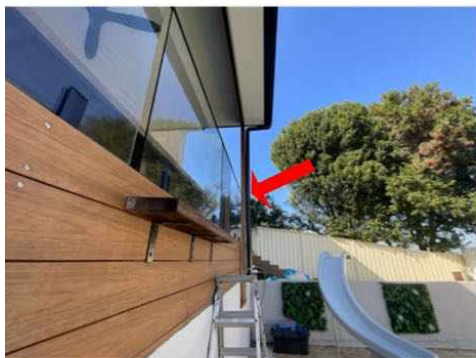
### Finding 3.05

Building:	Building 1
Location:	Pictured areas
Finding:	Additional fixings to pipes
Information:	Evidence of insufficient fixings were evident to these pipes. This downpipe and drain need additional fixings to affix to the adjoining wall ensure its longevity. Some pipe and gutter brackets around the house walls also showed rust.

A carpenter, plumber or skilled handy person should add additional fixings to this area as soon as possible to limit potential damage.

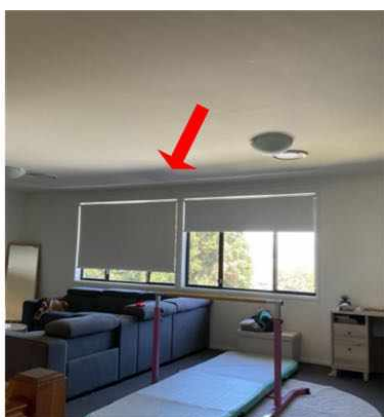
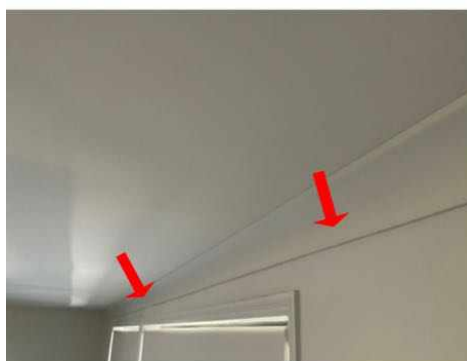
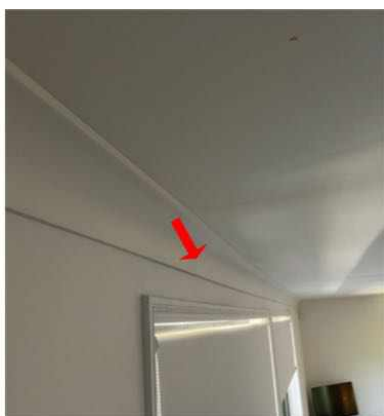
Building: Building 1  
 Location: Upper lounge north west ceiling/cornice  
 Finding: Ceiling - minor deflection evident  
 Information: The ceiling in this upper room was found to have a minor deflection at the time of inspection. Repainting was also evident to some upper level cornice areas. Sagging or deflection to the fixed ceiling structure generally indicates that the building materials have swollen, due to contact with water, or that fixings (e.g. nails or glue) have become loose and require reattachment (no moisture was found at the time of the inspection).

In some cases, sagging ceiling linings may also indicate that there are structural issues, causing surfaces to warp, twist or sag, or that structural timber elements have been weakened from termite activity. Where sagging appears to be major, appointment of a structural engineer is advised to further inspect the property and identify the cause of the damage and determine the rectification works.

ceiling sheets, may be required. Such works may be performed by relevant tradespeople, such as plasterers and painters. Where excessive moisture has caused the roofing structure to swell and sag, the source of the water leak should primarily be identified prior to any remedial works being performed.

An invasive inspection to remove roof tiles or plaster to check this area for the cause can be undertaken. The second floor roof above this area had no safe access.

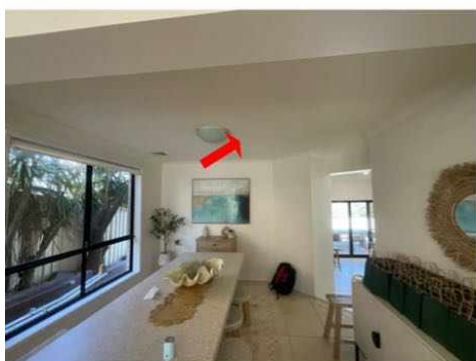
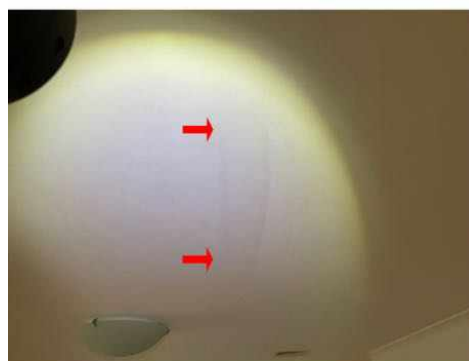
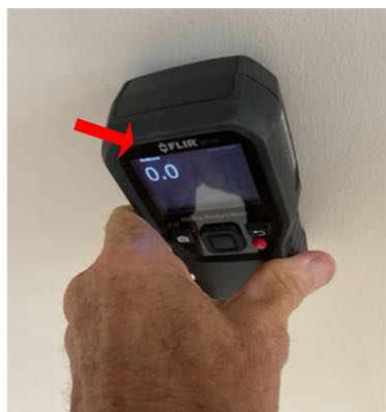
### Finding 3.08

Building:	Building 1
Location:	Dining room under bathroom
Finding:	Ceiling - Water stained
Information:	Water staining to ceiling linings in this dining area was evident at the time of inspection. Water staining indicates that surfaces have been exposed to excessive moisture over time. The minerals and other elements in the water lead to staining, which may graduate to corrosion and deterioration if left unmanaged.

While mostly an appearance defect, water staining can be indicative of more serious defects, which may be currently concealed by interior ceilings.

Conversely, where water staining is old and inactive, which it appears here due to no moisture found with all taps and shower run for 5-10 minutes, the affected building materials may be repaired or replaced at client discretion.

Where water staining is active, a licensed plumber must be consulted to identify the cause of the staining and to provide advice on any reparation works that may be required. Replacement of any damaged structures is advised.

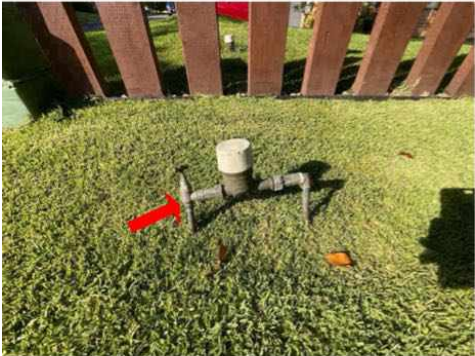
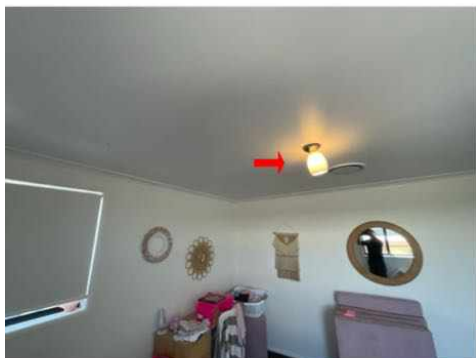
### Finding 3.09

Building: Building 1  
 Location: Pictured external areas  
 Finding: Building elements - Damaged  
 Information: Evidence of minor missing or damaged areas was identified at the time of the inspection. These include -

1. The water meter has minor impact damage not affecting its function.
2. Some path brickwork is loose requiring refixing. One rear entry brick has cracked.
3. The right front tap has a small leak from the handle (water pictured not from this

leak).

5. The bedroom light fitting is loose.

A carpenter and plumber would be the trades responsible for rectification of these areas when convenient.

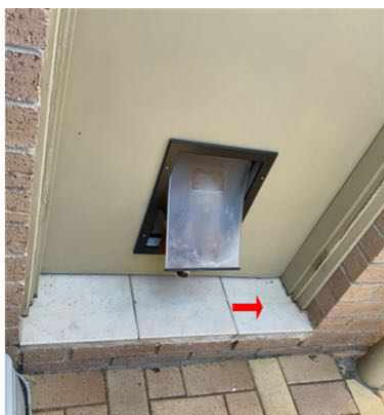
### Finding 3.10

Building:	Building 1
Location:	Entry areas, kitchen
Finding:	Tiles cracked, chipped
Information:	Cracked, chipped and cut (old renovations) tiles were evident in these pictured areas at the time of inspection. It is suspected that this cracking has occurred as a result of minor settlement and impact damage. Cracked tiles throughout the household detract from the overall appearance of the affected areas. In wet areas of kitchens and bathrooms, it can lead to water damage of adjoining walls and floors.

Replacement of cracked tiles is recommended as soon as possible. A tiling contractor may be appointed to perform these works. Where cracks become more numerous, contact a licensed building inspector for further investigation.

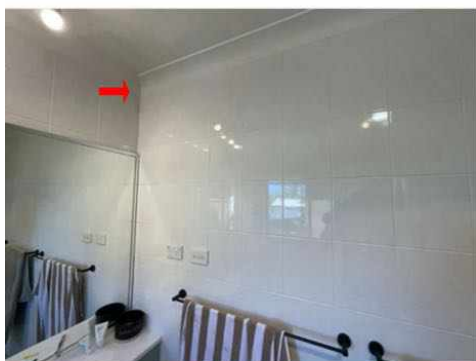
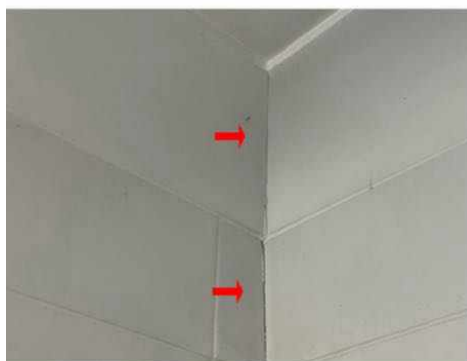
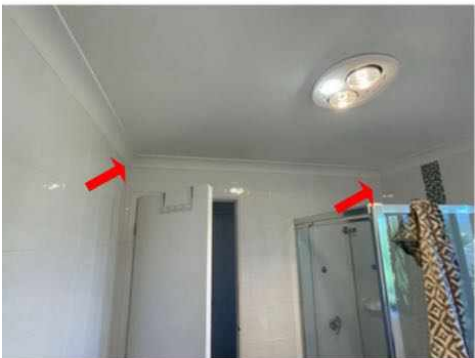
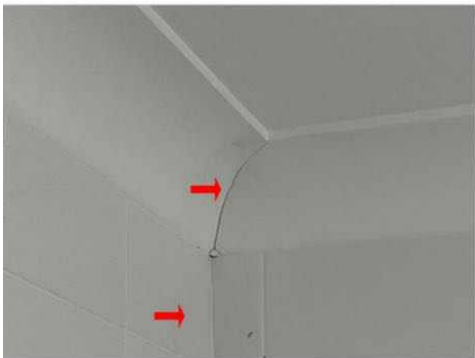
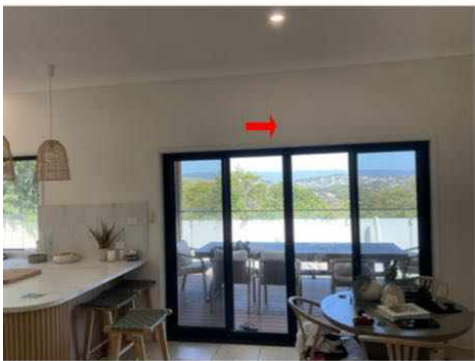
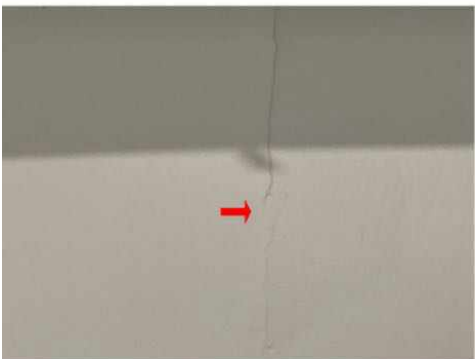
Building:	Building 1
Location:	Bathrooms and other areas
Finding:	Cracking & other damage - Damage Category 1 - Fine (up to 1mm)
Information:	Although fine cracks and impact damage are quite noticeable, they are often only considered to be an appearance defect, and usually do not indicate any structural damage. Generally, the cause of a fine crack is indicative of a separation between building materials and finishes (e.g. paint, plaster, etc.) along joins.

Over a dozen areas of plaster impact damage was found throughout, most were repaired but not repainted.

Cracking of this nature can generally be repaired with minor sanding, filling and/or repainting. Such works should be performed by a qualified painter or a general handyman.

Monitoring of all cracking should be conducted frequently. Always contact a building inspector should cracks widen, lengthen, or become more numerous.

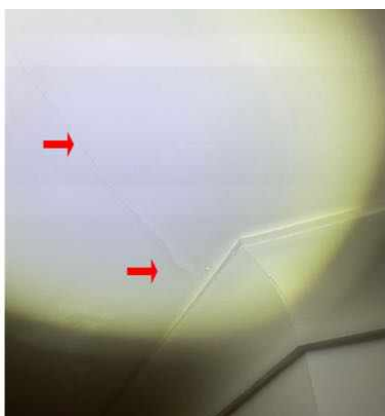
**Finding 3.13**

Building: Building 1  
Location: Pictured areas  
Finding: Plaster - Cracking noticeable  
Information: There were several cracks and or crack repairs evident to the upper stairs and hall plaster ceilings areas.

Noticeable cracks are a common occurrence and are a likely result of age expected building movement, general expansion, and/or contraction of building materials in different weather conditions. This area may have had previous water damage or impact from persons accessing the ceiling void.

It is highly advised that a qualified plasterer be appointed to provide necessary works to repair these areas. Such works should be conducted as soon as possible.

Always monitor these cracks annually and contact a building inspector should cracks widen, lengthen, or become more numerous.

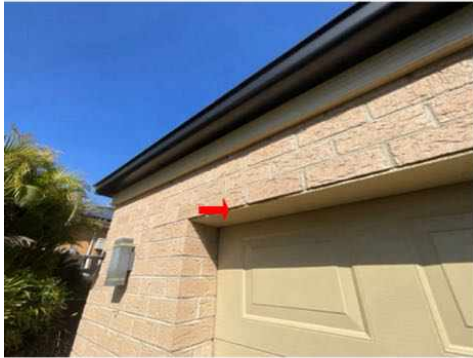
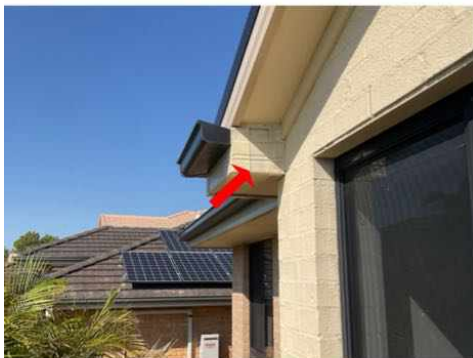
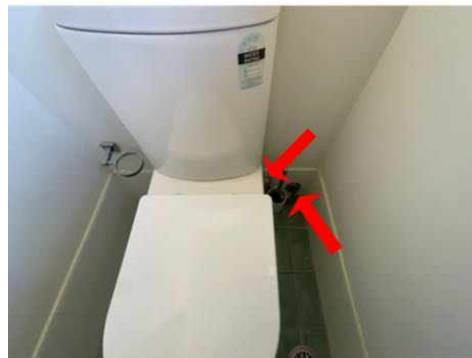
### Finding 3.14

Building:	Building 1
Location:	Garage lintel, roof and internal areas
Finding:	Building elements - Rusted or corroded
Information:	These building element shows evidence of minor rusting and corrosion, which is likely to have developed as a result of excessive exposure to moisture and or inadequate coatings.

As surface rust provides no protection to the underlying iron, the deteriorating condition is likely to worsen if not addressed in the short-term future.

Rusting and corrosion should be managed by ideally removing or limiting the affected surface from exposure to moisture. A registered builder may be appointed to replace

any building elements that have been severely affected by rust or water damage.

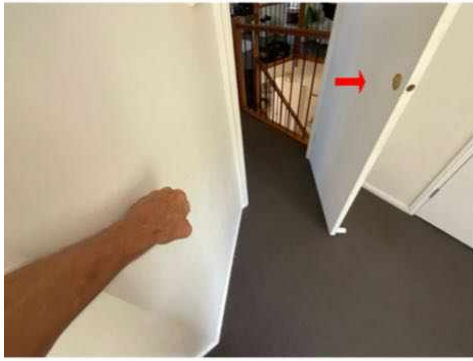
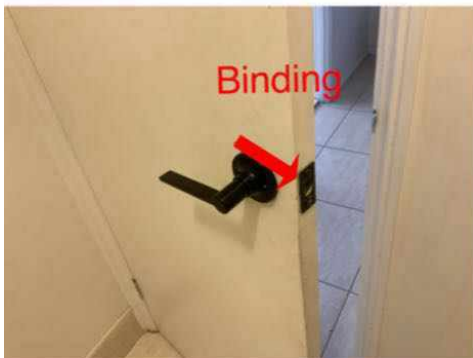
Building:	Building 1
Location:	Pictured areas
Finding:	Doors - Missing handle, loose, binding, delaminating
Information:	One bedroom door has a handle missing, one has a loose handle and the lower toilet door is binding on the frame. The laundry door is delamination and needs repair, the rear garage door has rotted requiring replacement. Although some building elements may seem irrelevant or unnecessary, all building elements play a key role in the operation and function of the overall structure and its performance.

Replacement or repair of these doors is advised . A building maintenance person can perform these works at client discretion.

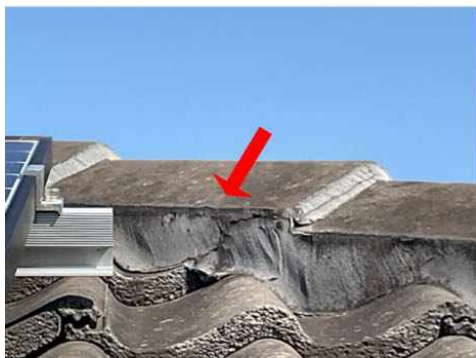
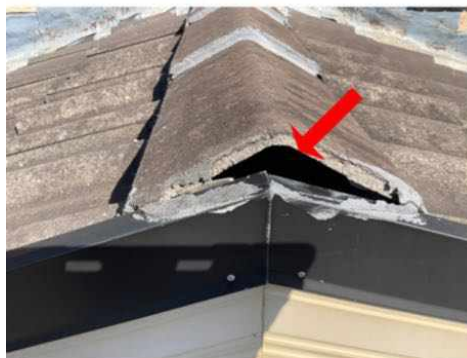
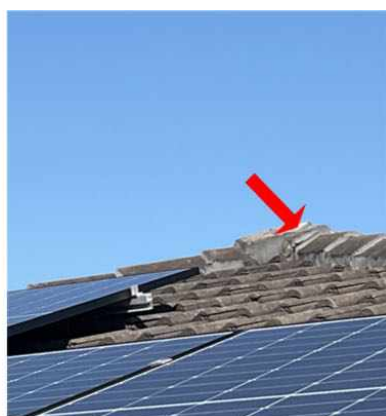
### Finding 3.17

Building: Building 1  
 Location: Roof Exterior  
 Finding: Roof tiles - Weathered  
 Information: Upon inspection of the exterior roofing, the majority of roof tiles appear to be in good condition (the upper roof could only be inspected from the front lower roof).

Where left unmanaged, deteriorating roof tiles are likely to lead to a number of secondary defects, including minor water leaks and weather exposure to internal roofing structures.

Consultation with a roofing contractor is highly advised to gain advice on cost of remedial works that may be required in the short to medium term. Remedial works are likely to increase the longevity of the exterior roofing structure.

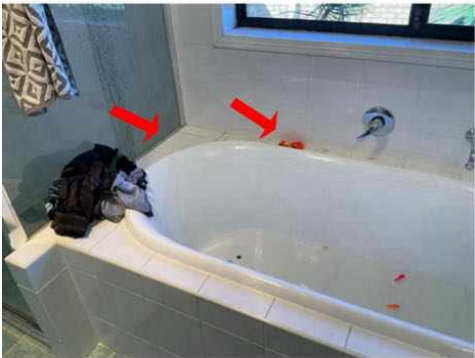
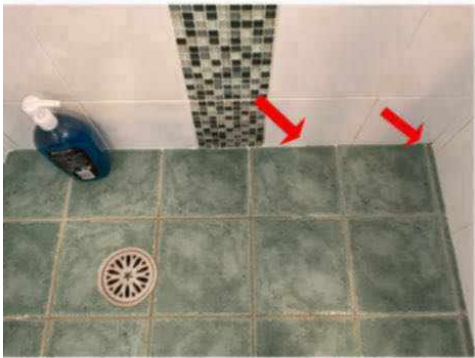
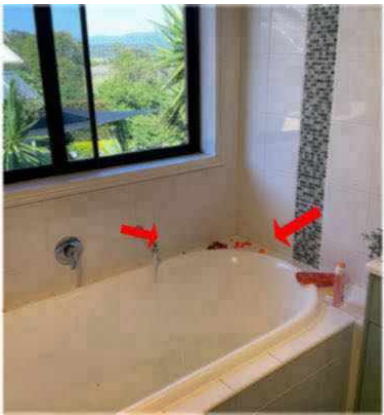
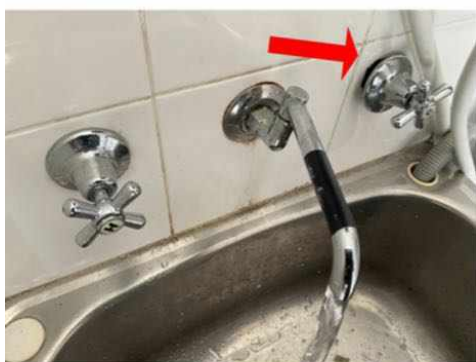
### Finding 3.18

Building:	Building 1
Location:	Bathrooms and laundry
Finding:	Sealant and grouting - Missing or damaged
Information:	It was noted on inspection that sealant or grout is degraded to these pictured areas.

replacement of damage or missing or damaged sealant and grout is highly recommended to the wet areas, as this is a regular wear and tear defect. Sealant and grouting in areas that come into regular contact with water should be maintained for the long term care of your property.

A sealant specialist or tiling contractor should be appointed to complete these works as soon as possible

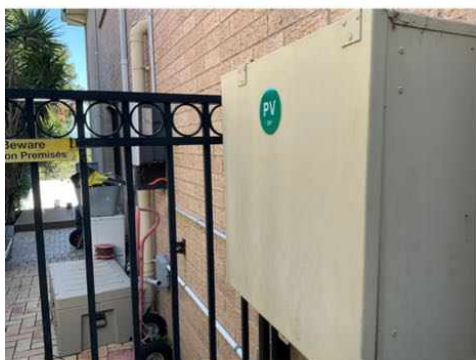
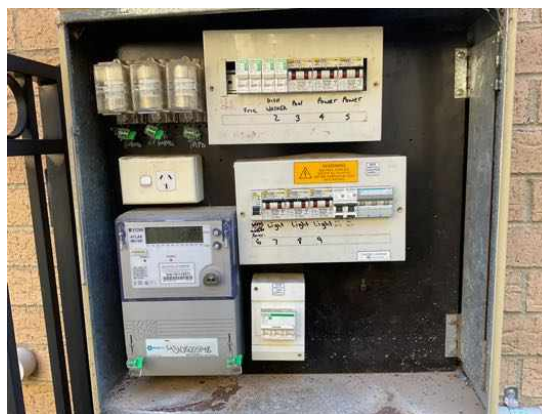
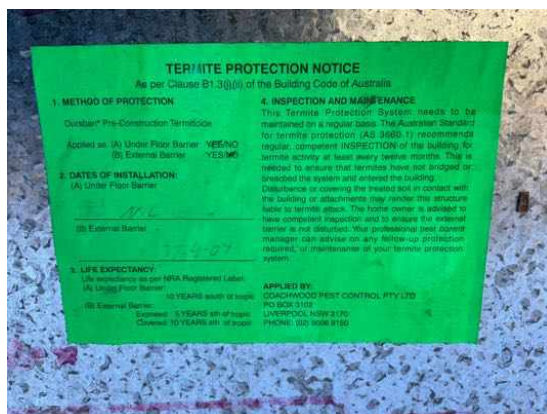
A durable notice should be placed in the switchboard unit to indicate current termite barriers. At the time of inspection, no durable notice was evident and it appeared as though no chemical termite management system has been installed, with no evidence to suggest preventative works taking place since the property was built.

The client may consider gaining further advice from a pest controller as to the costs and procedures involved with a 'chemical' application. It is recommended that obtaining such advice be a short-term priority.

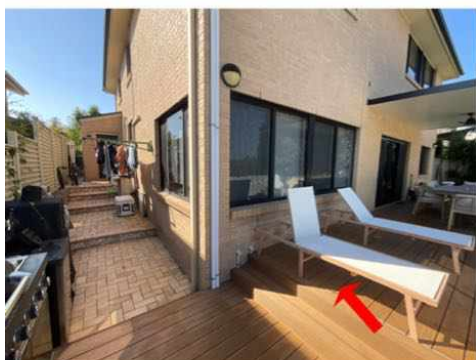
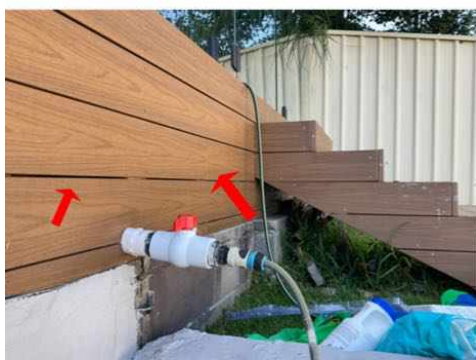
## Finding 6.02

Building:	Building 1
Location:	Yard - front
Finding:	Bridging - decking
Information:	Where decking obstructs inspection of building elements, also known as bridging as it provides a bridging point for the access of termites, full inspection can not be achieved. Consequently moisture or dampness may be present and the areas becomes conducive to termite activity. Decks against or very close to buildings provide cover, shade and can provide an environment that is attractive to termite infestation.
	Leaving a small gap between decking and the building walls will assist greatly in preventing Bridging from occurring.

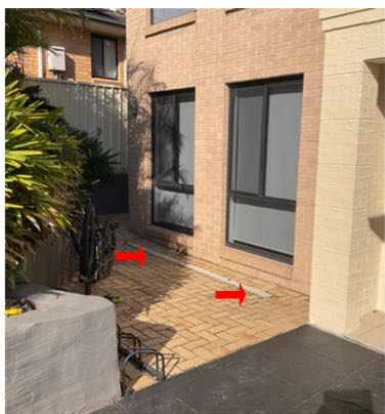
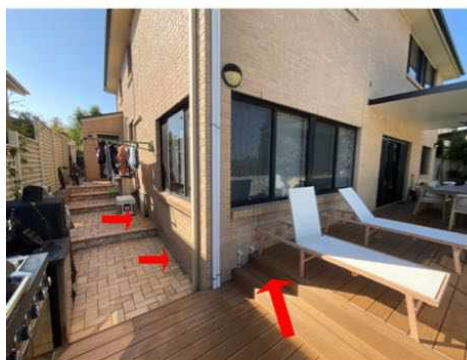
### Finding 6.03

Building:	Building 1
Location:	Exterior walls
Finding:	Slab Edge - Exposure
Information:	An inspection zone of at least 75mm in relation to the exposed slab edge, between the bottom brick and the perimeter pavement, is required. This inspection zone should be maintained in order to force termites into the open where they can be detected more readily during regular inspections. The slab edge should not be concealed by anything that may prevent inspection of the area, including render, landscaping, soil, turf, paving, concrete cladding or other structures.

Where the slab edge cannot be properly inspected, it is highly recommended that termite or timber pest inspections be carried out every 6-12 months to aid protection of the property against infestation.

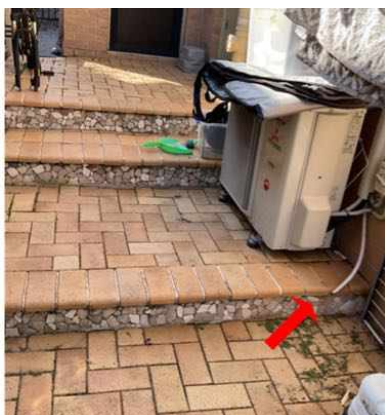
### Finding 6.04

Building:	Building 1
Location:	Pictured external wall areas
Finding:	Overflows - Not plumbed for drainage
Information:	The pictured overflow pipes are not plumbed or connected to suitable drainage. These areas can lead to secondary defects such as rot, rust or corrosion of associated building elements, the formation of fungal decay, or even the creation of potential slip hazards. When coupled with poor site drainage, pooling of water may also attract termite activity to this area. It is highly recommended that a qualified plumber be appointed to install adequate drainage to these areas. These works will ensure that the area remains dry and free of any secondary defects.

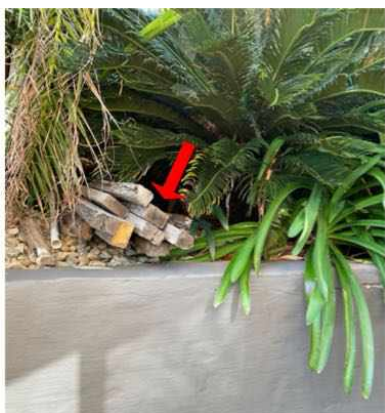
### Finding 6.05

Building:	Building 1
Location:	Yard - Back
Finding:	Timber in contact with the ground
Information:	Any timbers in direct ground contact provide opportunity for concealed termite entry and are likely to be subject to premature rot and decay as the soil retains moisture or damp conditions against the timbers.

timber is promoting mould and wood rot and is very attractive to termites.

Frequent pest inspections are advised to readily identify any termite activity in these areas.
