Building Inspection Report

Inspection Date: Mon, 16 Mar 2026

Property Address: unit125 /151-153 Mudjimba Beach Rd,
Mudjimba QLD 4564, Australia

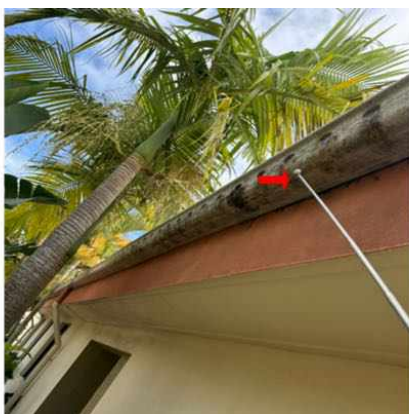
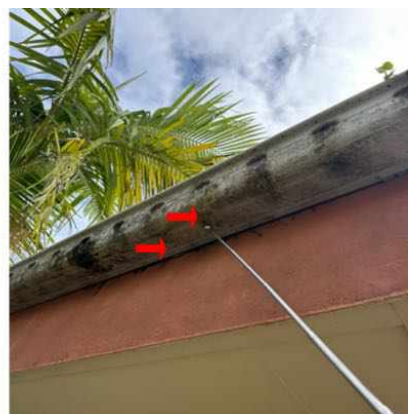
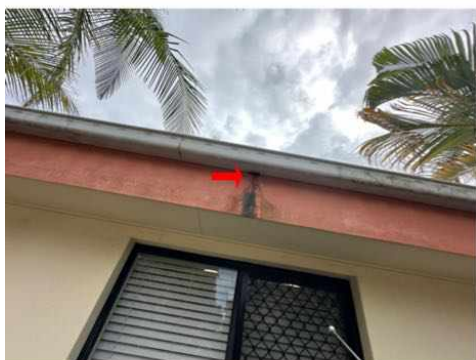
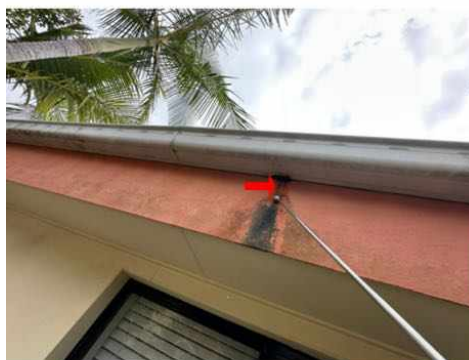
Defects 3.01

Location: Roof Exterior

Finding: Gutter - Rusted

Information: This gutter shows evidence of rusting and corrosion, which is likely to have developed as a result of excessive exposure to moisture from incorrect fall to downpipes and or a build up of leaves and debris.

As surface rust provides no protection to the underlying iron, the deteriorating condition is likely to worsen if not addressed in the short-term future.

Rusting and corrosion should be managed by ideally removing or limiting the affected surface from exposure to build up of leaves and debris. A roofing contractor be appointed to replace any gutters that have been severely affected by rust or water damage.

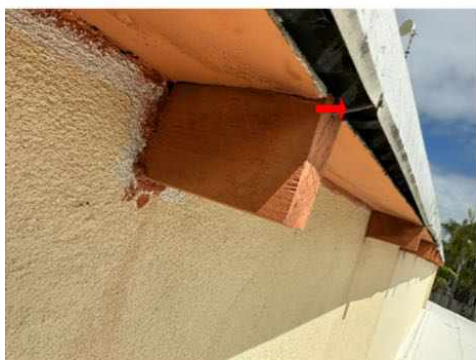
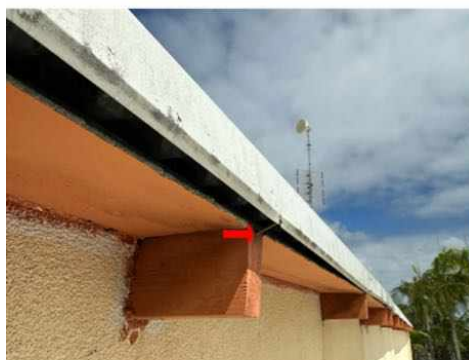
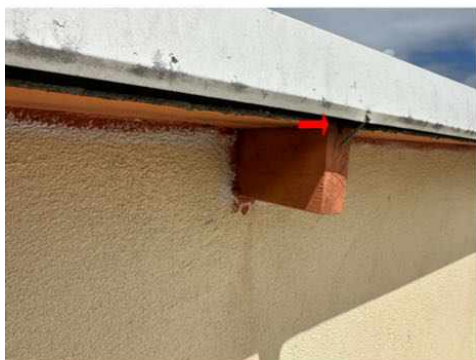
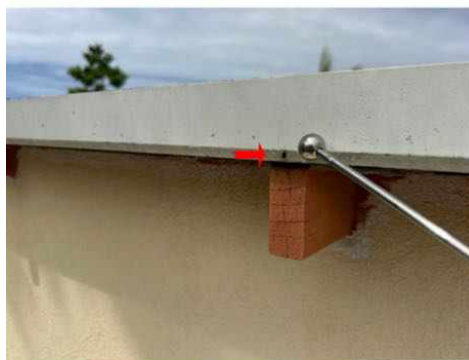
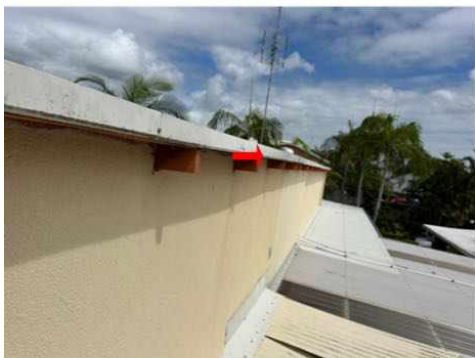
Defects 3.02

Location: Roof Exterior

Finding: Roof - Loose flashing

Information: This barge flashing was loose on the day of inspection and several of the nails have come loose or missing from the end of the truss tales.

Recommend a roofing contractor be engaged to ref fix this barge flashing to the end of the truss tales

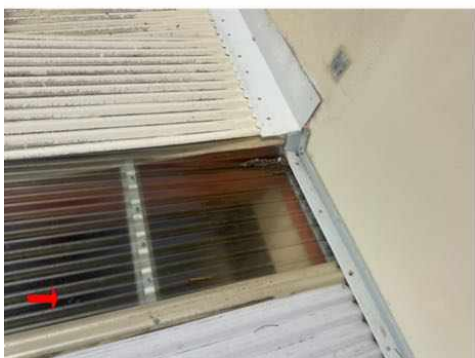
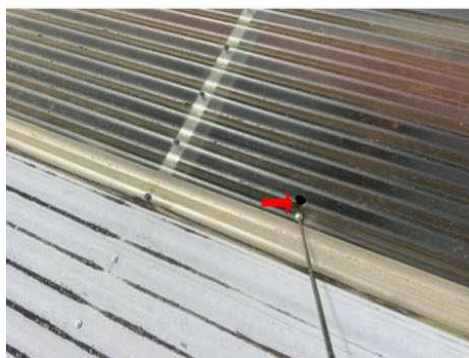
Defects 3.03

Building:	Main Building
Location:	Roof Exterior
Finding:	Alsenite roof sheet - holes
Information:	Upon inspection of the exterior roofing, it was found that the alsenite roof sheets has a hole in the sheet , recommend a roofing contractor be engaged to replace this damaged alsenite roof sheet.

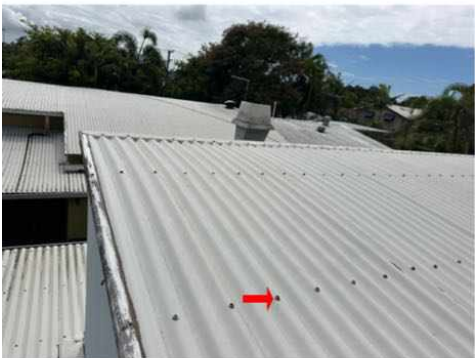
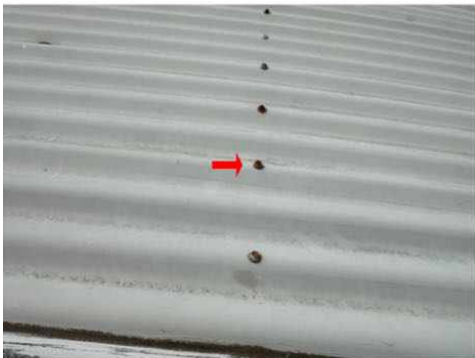
Defects 3.04

Building:	Main Building
Location:	Roof Exterior
Finding:	Roof screws - Rusted
Information:	These roof screws shows evidence of rusting and corrosion, which is likely to have developed as a result of excessive exposure to moisture and or inadequate coatings.

As surface rust provides no protection to the underlying iron, the deteriorating condition is likely to worsen if not addressed in the short-term future.

Recommend roof screws be replaced in the near future by a roof plumber or experienced handyman.

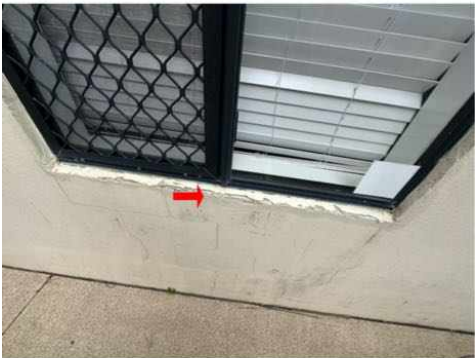
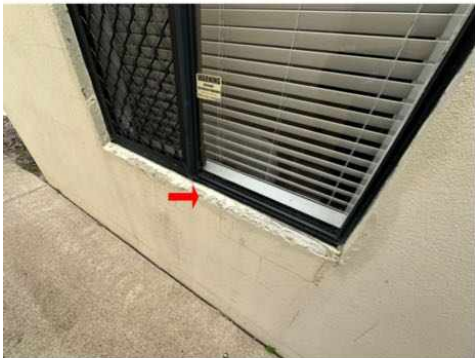
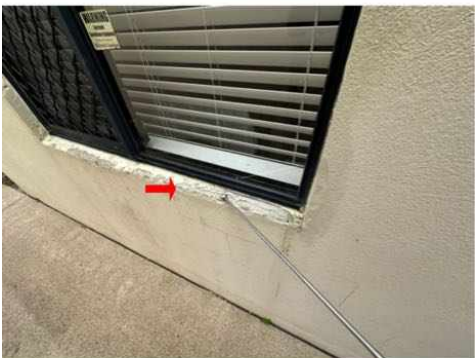
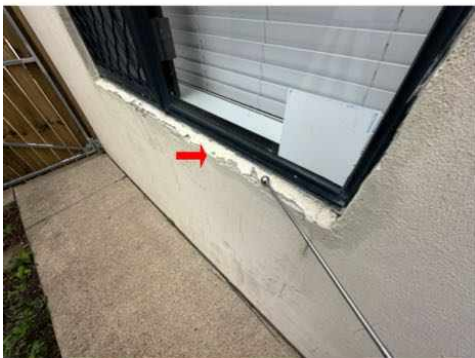
Defects 3.05

Building: Main Building
Location: Exterior walls - rear
Finding: Damage to rendered windowsills
Information: There was evidence of damage to the two back windowsills on the day of inspection, recommend a render up being engaged to repair these damaged windowsills

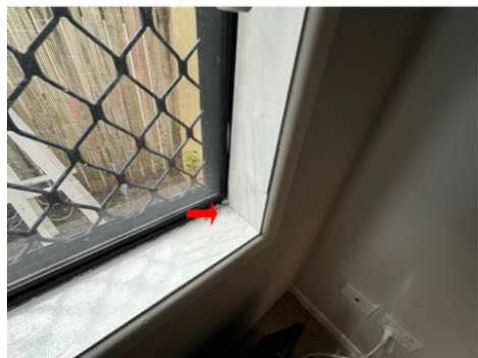
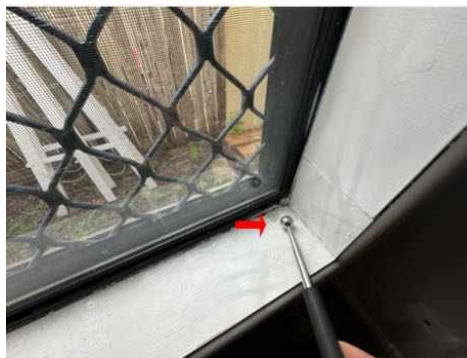
Defects 3.06

Building: Main Building
Location: Bedroom

Finding:	Wood Rot
Information:	This timber window reveal shows evidence of wood rot. Wood rot, also known as Fungal Decay, occurs when timbers and other cellulose building materials are exposed to damp conditions on an ongoing basis. This will be the result of exposure to weathering over a prolonged period of time. Early intervention and regular maintenance, particularly of exterior timbers, will prolong the useful life of these mouldings. A qualified carpenter or handyman may also be required to replace affected eave mouldings at owners discretion

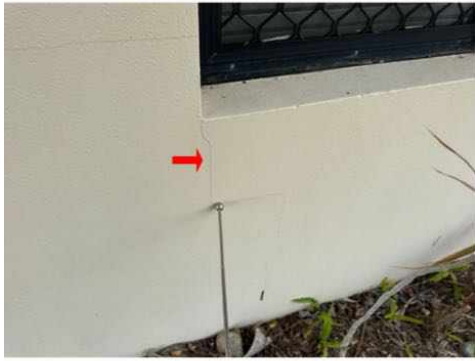
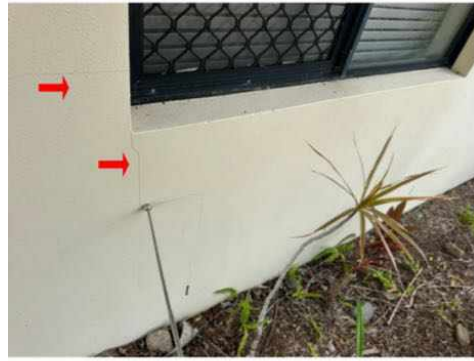
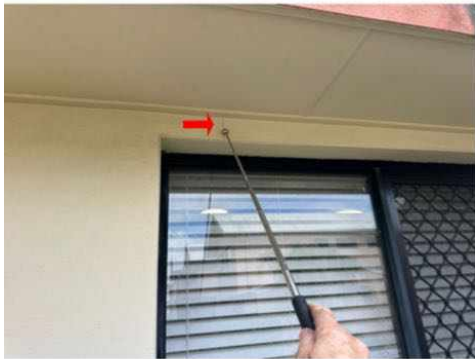
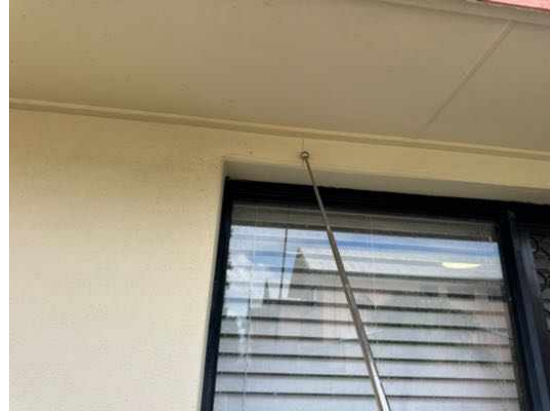
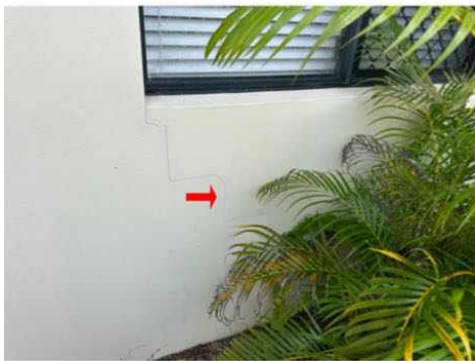
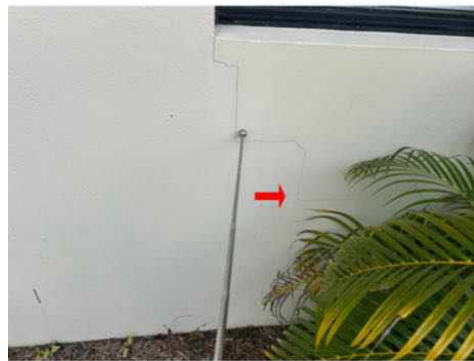
Defects 3.07

Building:	Main Building
Location:	Exterior walls - front
Finding:	Brickwork - Step cracking minor
Information:	Step cracking was identified to the brickwork in this area at the time of inspection. Step cracking, which is similar to other forms of cracking, has a variety of possible causes. However, the most common is the subsidence of adjacent footings.

Step cracking is a relatively common defect, and is most likely to occur adjacent to windows, doors and other openings. Mortar failure in the gaps between affected bricks indicates the stresses and tensions affecting the wall.

Where step cracking is extensive or severe, the client is advised to consult a structural engineer. Minor step cracking can be used as a warning sign to address factors causing stress to the wall, which can include the effect of surrounding trees, water leaks, soil erosion, or even the presence of reactive soils in the surrounding area.

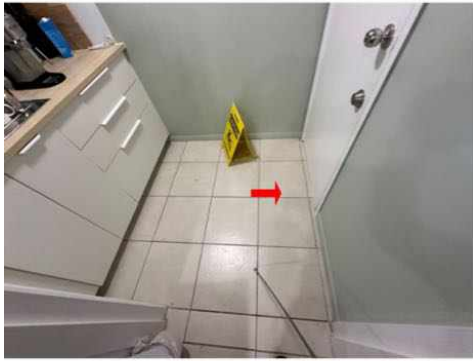
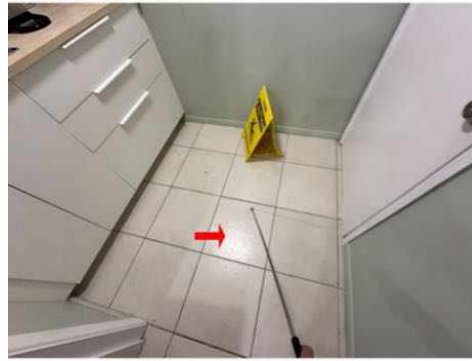
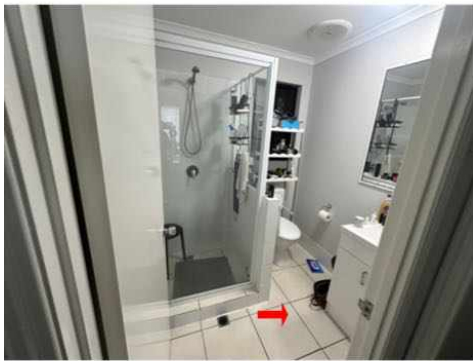
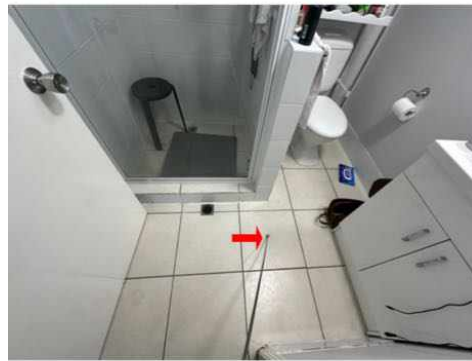
Defects 3.08

Building: Main Building
 Location: Bathroom in unit ,kitchenette in office
 Finding: Tiles - Drummy
 Information:

Drummy tiles were identified at the time of inspection. The term 'drummy' refers to tiles that have become detached from their fixing, despite otherwise being in relatively good condition. Such defects are generally caused by physical or moisture damage to the area. Drummy tiled areas may also be a direct result of poor workmanship during the construction process.

Drummy floor tiles don't generally pose any immediate problems and may be repaired or replaced at owners discretion.

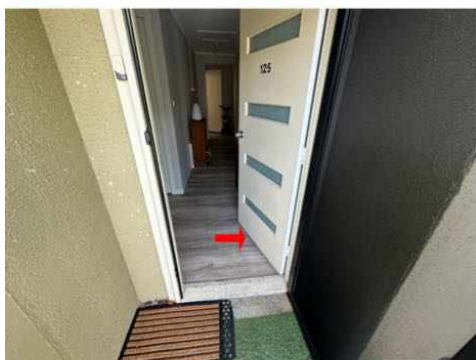
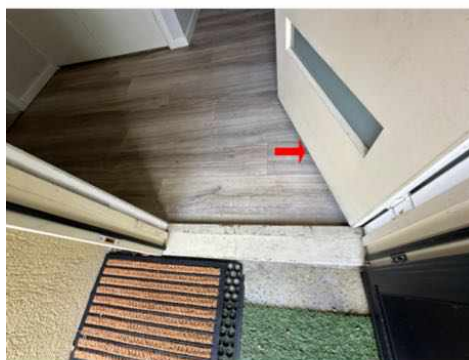
Defects 3.09

Building:	Main Building
Location:	Entry
Finding:	Weather seals - Not installed
Information:	Upon inspection of this exterior entry door , it was noted that weather seals have not been installed.

Without adequate sealing, rainwater is likely to seep under these doors and create moisture problems and other secondary defects. The application of seals, in conjunction with routine maintenance, will work to prevent water ingress in these areas, and will aid the longevity of the flooring and associated building materials.

It is highly advised that such works be performed by a qualified carpenter as soon as possible.

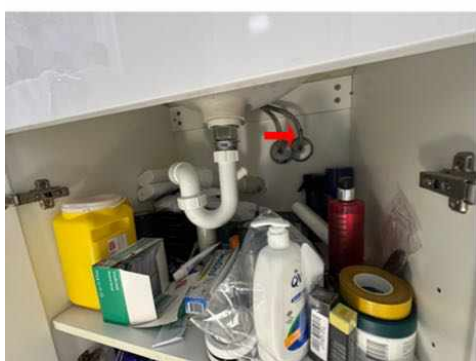
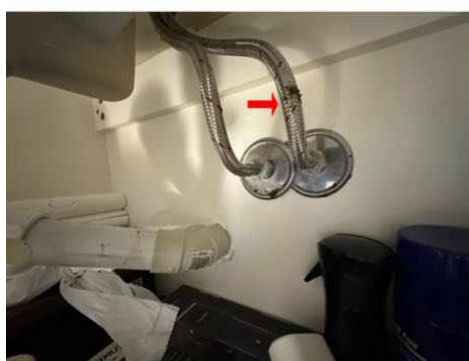
Defects 3.10

Building: Main Building
 Location: Bathroom
 Finding: Flexible hose.- Rusted
 Information: This flexible hose shows evidence of rusting , which is likely to have developed as a result of excessive exposure to moisture and age

Recommend a plumber be engaged to replace this bathroom vanity sink flexible hose to eliminate the risk of water damage to this area.

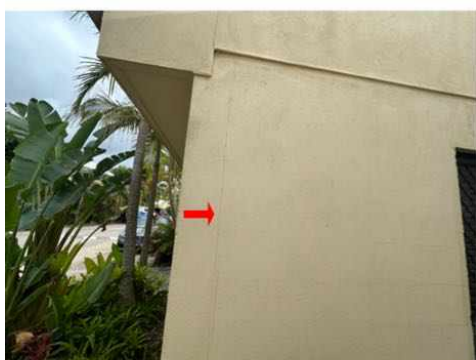
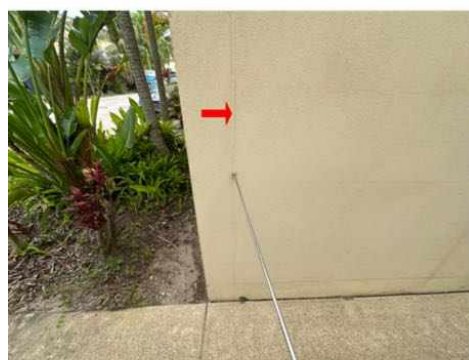
Defects 3.12

Building:	Main Building
Location:	Exterior walls - right side
Finding:	Blockwork -cracking minor
Information:	Cracking was identified to the blockwork in this corner at the time of inspection. cracking, has a variety of possible causes. However, the most common is the subsidence of adjacent footings.

Cracking is a relatively common defect, and is most likely to occur adjacent to windows, doors and other openings.

Where cracking is extensive or severe, the client is advised to consult a structural engineer. Minor cracking can be used as a warning sign to address factors causing stress to the wall, which can include the effect of surrounding trees, water leaks, soil erosion, or even the presence of reactive soils in the surrounding area.

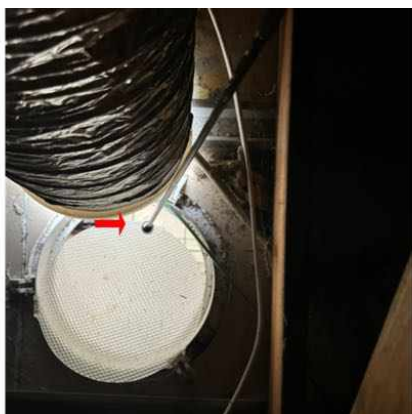
Defects 3.13

Building:	Main Building
Location:	Roof Void
Finding:	Skylight - Damaged tube
Information:	The skylight tube has disconnected from the ceiling surround ,recommend a handyman be engaged to repair this damaged skylight tube and refix to the ceiling surround

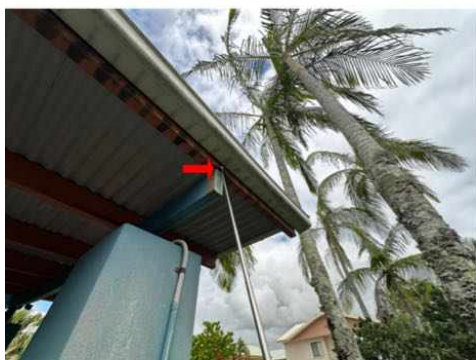
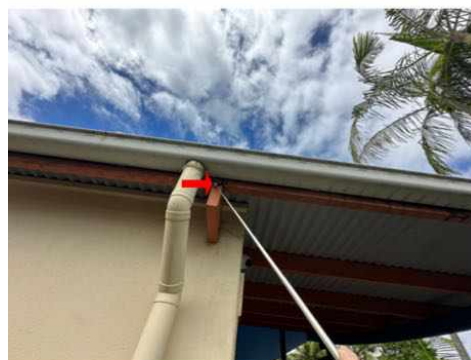
Defects 3.14

Location: Eaves

Finding: Wood Rot

Information: This timber rafter and roof batten shows evidence of minor wood rot. Wood rot, also known as Fungal Decay, occurs when timbers and other cellulose building materials are exposed to damp conditions on an ongoing basis. This could be the result of exposure to weathering over a prolonged period of time and generally age of the house. Early intervention and regular maintenance, particularly of exterior timbers, will prolong the useful life of these building elements. Prior to any works being performed, the cause of the moisture that has created the visible wood rot should be identified and addressed in a suitable manner. Replacement of affected timbers may then be a necessary step in protecting surrounding building elements from such deterioration. A qualified carpenter or handyman may also be required to replace affected building materials.

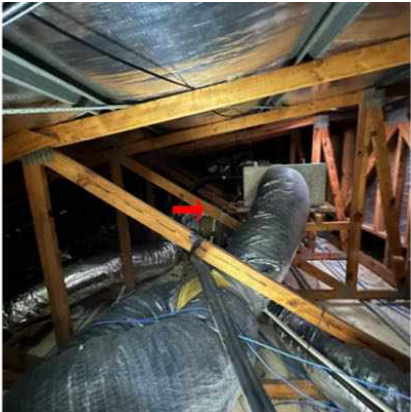
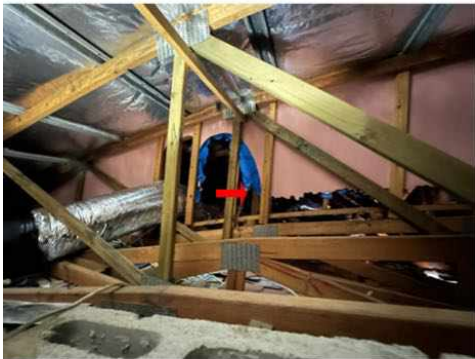
There was no fire separation between the back livable area of the property and the front office section of this property , recommend fire separation between these areas be further investigated

Building: Main Building
Location: Roof Void
Finding: Fire separation- Missing
Information: There was no fire separation between the office and back unit on the day of inspection, recommend further investigation into fire separation between these two buildings be sought
