Building Inspection Report

Inspection Date: Tue, 17 Mar 2026

Property Address: 1/223 Elgar Rd, Surrey Hills VIC 3127,
Australia

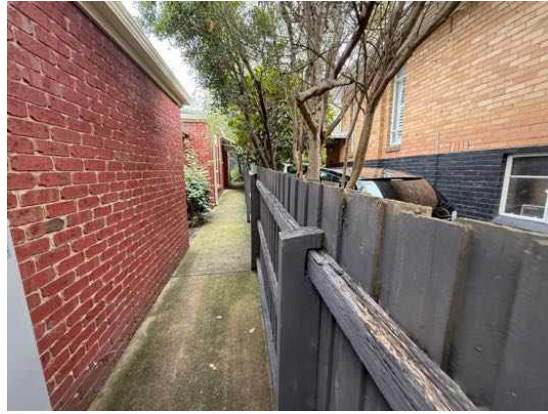
Defects 3.01

Building: Building 1
Location: All Areas > All Areas
Finding: Wood rot affecting the perimeter fencing
Information: Wood rot was observed to be affecting the perimeter post and rail fences at the time of the inspection. This wood rot is suspected to have developed due to timber in contact with the ground and over a prolonged period of time due to frequent weather exposure, which is expected in a property of this age and condition.

Always ensure exterior timbers are not in contact with the ground or soil as this will accelerate damage and deterioration to the timber, if left unmanaged further damage is highly likely to occur. To maintain the condition of the external timber building elements, any affected areas should be substituted as soon as possible with pre-treated replacements. Where weatherboards have rotted due to excessive moisture other than rain penetration, the cause of the moisture should be identified and reduced as deemed necessary. A qualified carpenter should be appointed to repair and replace rotting building elements and materials in the near future.

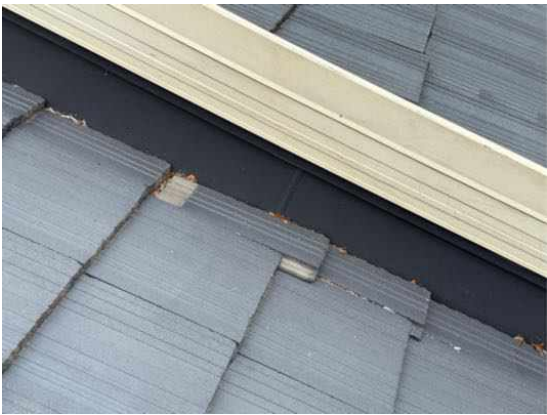
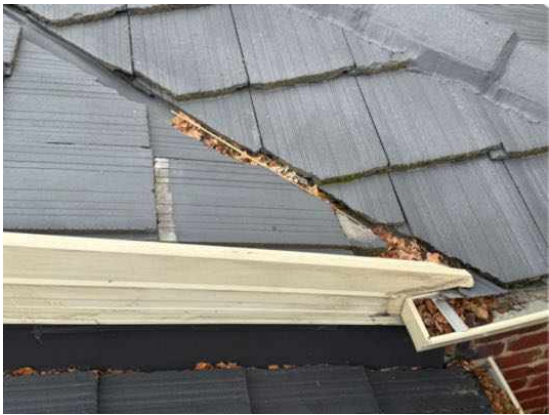
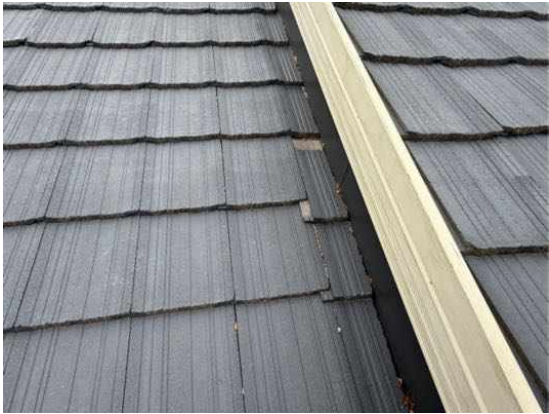
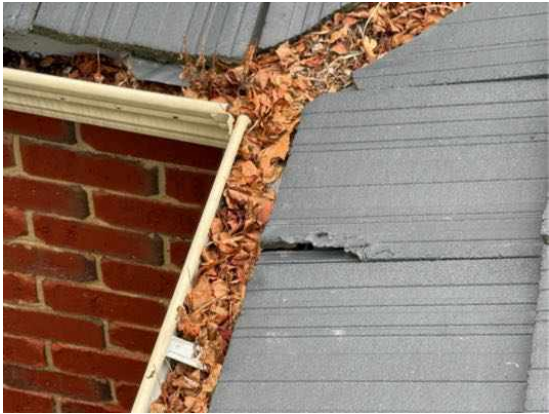
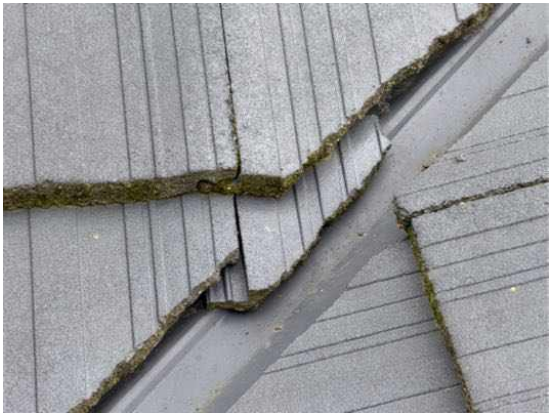
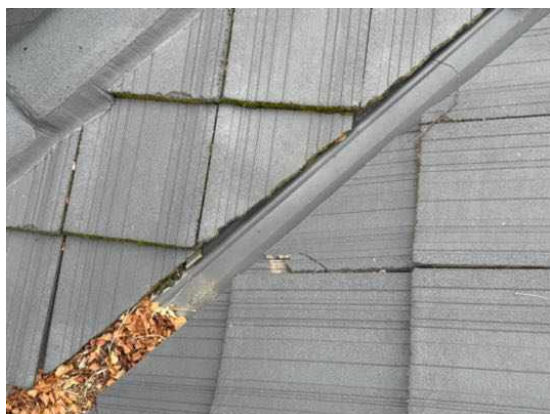
Defects 3.02

Building:	Building 1
Location:	All Areas > All Areas
Finding:	Roof tiles - broken, chipped, roof tiles dislodged and slippage
Information:	Upon inspection of the roof tiles, it was observed that numerous roof tiles (more than normal), have slipped down or have been dislodged from their original positions and have not been repositioned before the roof restoration was completed and shows very poor workmanship and poor trade practices. It is unknown if roof structures or other building elements show any damage or deterioration that may have been as a result of dislodged roof tiles. An invasive inspection is recommended to investigate for any repairs deemed to be required. This type of defect requires immediate attention and

repair, before further damage and deterioration can occur.

Numerous roof tiles may slip over time due to a number of minor causes, including not placed correctly upon installation, not stuck down on the top of valley irons, flashings, roof tile chips and breakages, failings in the adjoining battens, or fixings that may have failed. In this case I suspect that tiles have just slipped or dislodged from the original positions overtime, these roof tiles when readjusted should receive some form of fixing to fix them down. Either by a good adhesive or a good quality silicon sealant. Roof tiles that have moved from their original position may allow water penetration into the roof void, exposing roofing structures to excessive moisture.

Upon inspection of the roof tiles, it was observed that numerous roof tiles have slipped down or have been dislodged from their original positions and have not been repositioned before the roof restoration was completed, this has shown very poor workmanship and poor trade practices. It is unknown if roof structures or other building elements show any damage or deterioration that may have been as a result of dislodged roof tiles. An invasive inspection is recommended to investigate for any repairs deemed to be required. This type of defect requires immediate attention and repair, before further damage and deterioration can occur.

This creates an environment that is conducive to water damage and accelerated deterioration of all associated building elements below these areas. Replacement of broken, loose or missing roofing tiles is also highly recommended immediately or in the short term future to prevent the development of any secondary defects overtime if left unmanaged. A roofing plumber or roof tiler should be appointed to complete such works as deemed to be necessary.

Numerous roof tiles may slip over time due to a number of minor causes, including not placed correctly upon installation, not stuck down on the top of valley irons, flashings, roof tile chips and breakages, failings in the adjoining battens, or fixings that may have failed. In this case I suspect that tiles have just slipped or dislodged from the original positions overtime, these roof tiles when readjusted should receive some form of fixing to fix them down. Either by a good adhesive or a good quality silicon sealant. Roof tiles that have moved from their original position may allow water penetration into the roof void, exposing roofing structures to excessive moisture. This creates an environment that is conducive to water damage and accelerated deterioration of all associated building elements below these areas. Replacement of broken, loose or missing roofing tiles is also highly recommended immediately or in the short term future to prevent the development of any secondary defects overtime if left unmanaged. A roofing plumber or roof tiler should be appointed to complete such works as deemed to be necessary.

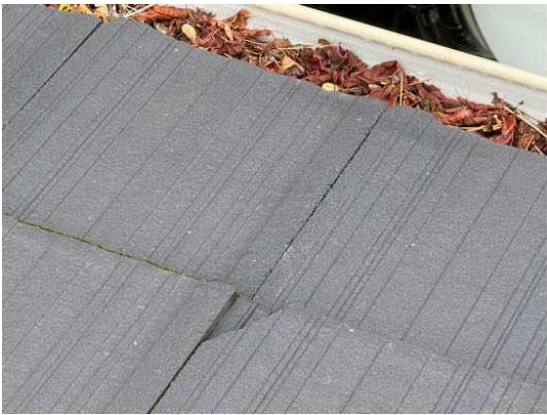
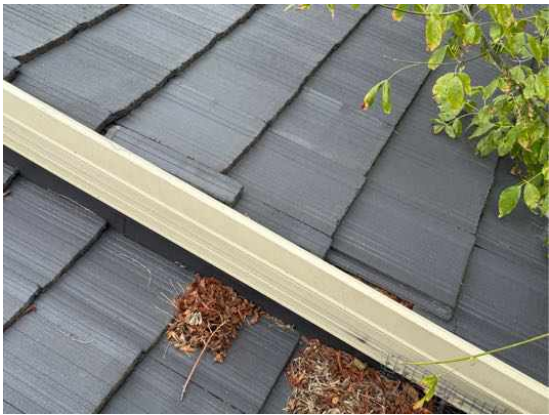
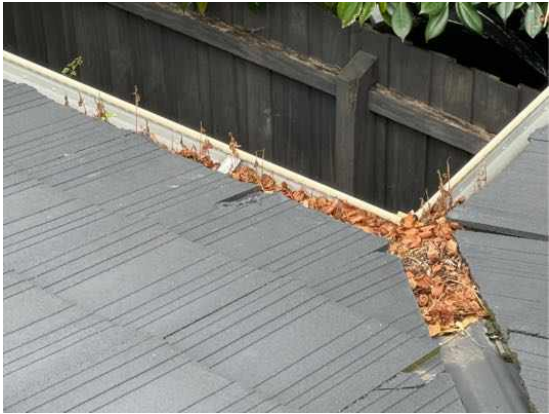
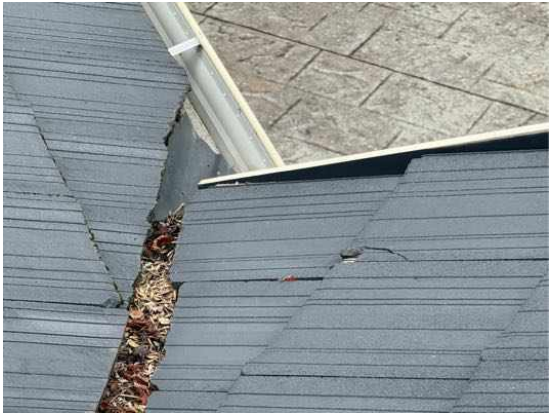
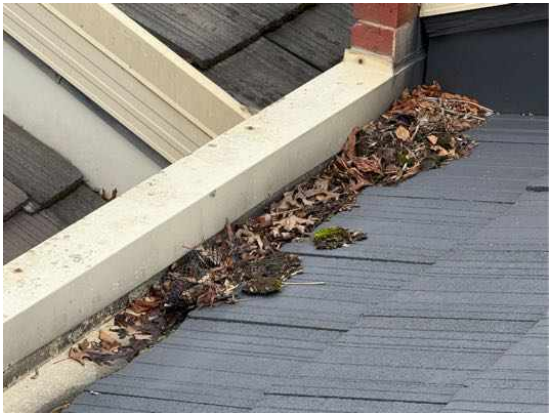
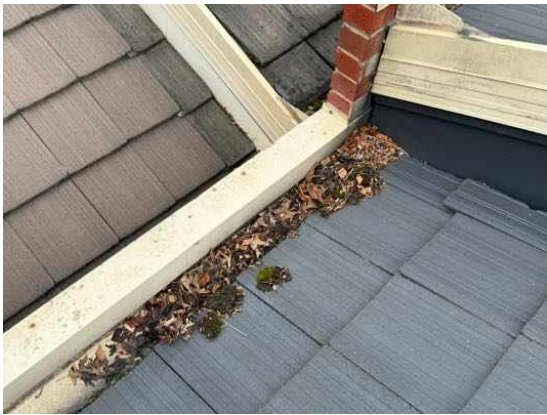
Defects 3.03

Building:	Building 1
Location:	All Areas > All Areas
Finding:	Gutters - Blocked
Information:	Roof plumbing structures, such as guttering and downpipes, should be free of all debris to prevent blockages. Blockages of the guttering and downpipes will lead to pooling and accumulated water overflows, which is likely to subsequently flood eaves and exterior walls. Blocked gutters are likely to lead to high levels of moisture in the affected areas. Such moisture will not only cause rust and decay of the associated building materials, but can also provide conditions that are conducive to termite and timber pest activity. Blockages in gutters should therefore be removed immediately to ensure dry conditions are maintained.

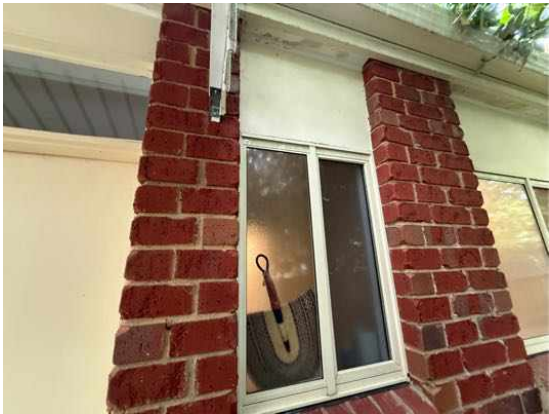
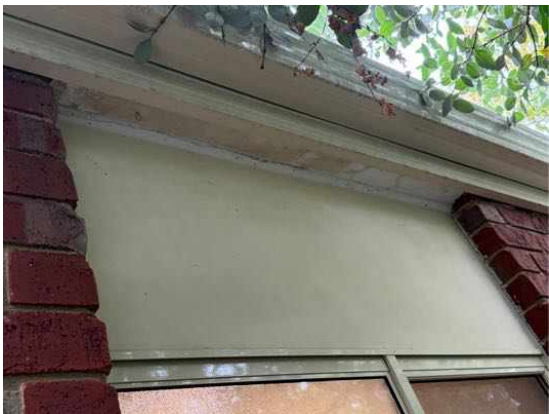
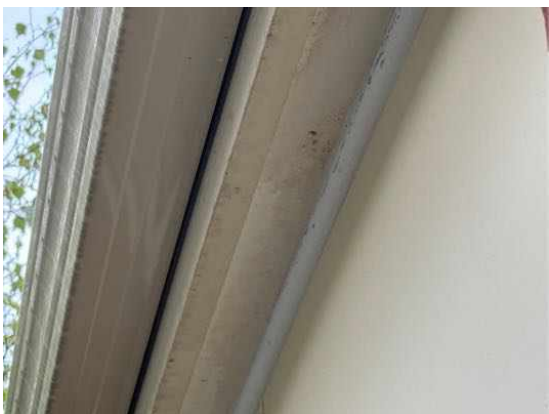
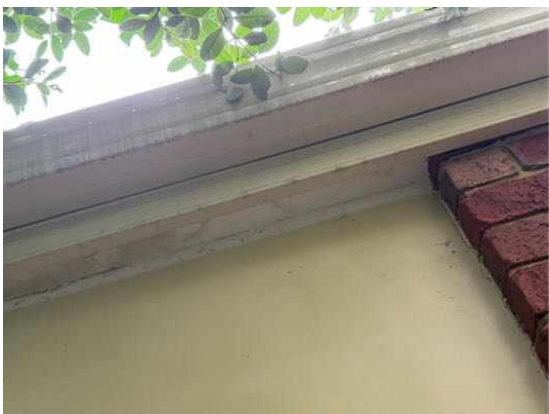
Defects 3.04

Building: Building 1
Location: All Areas > All Areas
Finding: Exterior window eaves soffits appeared to be damaged from suspected previous overwhelmed gutters
Information: The exterior window eaves soffits appeared to be damaged from suspected previous overwhelmed gutters. Window soffits to the right hand side rear areas of the home were observed to showing signs of water and moisture stains. This type of damage is highly suspected to have been as a result of the trees overhanging this area of the roof and filling the guttering with excessive leaf matter and debris causing the gutters and down-pipes to be overwhelmed during heavier rain periods. No definitive answer for

these moisture stains was confirmed on the day of the inspection, further investigation will be required.

Where moisture staining is evident, the primary requirement is to identify and rectify the source of the excessive moisture and or roof leak. The damage to the soffit sheeting in this area detracts from the appearance of the structure, as well as potentially compromising the structural integrity of the adjoining wall and roof areas. Where eaves show moderate to severe damage, remedial works are suspected to be required. Where water damage is suspected as being the underlying cause, appointment of a licensed builder, carpenter is recommended to identify the source of the water leak and repair any areas deemed to be necessary. This should happen in the short term future.

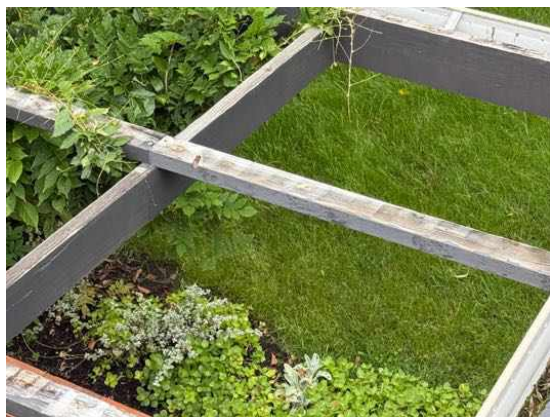
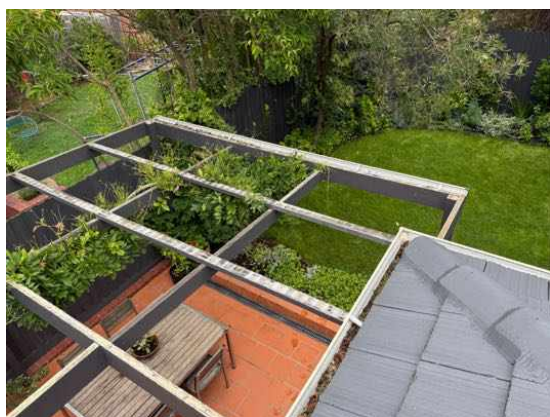
Defects 3.05

Building:	Building 1
Location:	All Areas > All Areas
Finding:	Rear pergola roof was observed to be missing covering and aged and deteriorated
Information:	The rear pergola roof was observed to have been removed and now missing at the time of the inspection. Replacement of this roof covering is recommended to cover vulnerable roof members to wood rot and to promote some protection from the extreme weather conditions to this area. Failure to cover or re-new the roof covering may result in accelerated deterioration of other associated roof members on the pergola and associated building elements. A licensed builder and registered roofing plumber can be appointed to restore the roof covering to this area.

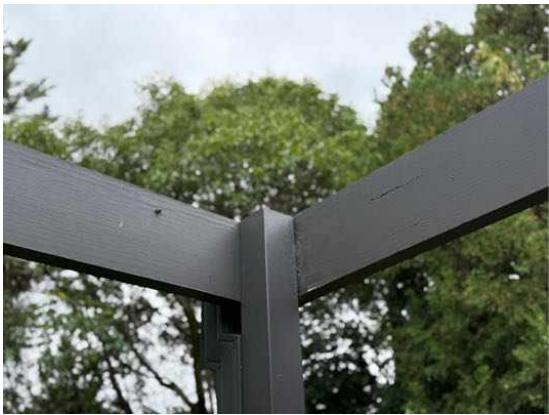
Defects 3.06

Building:	Building 1
Location:	All Areas > All Areas
Finding:	Back pergola roof brackets and bolts to the pergola posts
Information:	Although some building elements may seem irrelevant or unnecessary at the time, all building elements play a key role in the operation and function of the overall structure and its performance as it ages. All the roof brackets and bolts adjoining posts to beams that are missing to this pergola roof structure should be installed, to ensure that when the roof structure ages and begins to deteriorate these roof brackets and bolts will keep these types of structures stable for longer.

Exposure to the exterior weather conditions it is likely to make exterior timber age and deteriorate at an accelerated rate. The appropriate and relevant tradespersons should be appointed, to install, maintain or replace the missing building elements or materials.

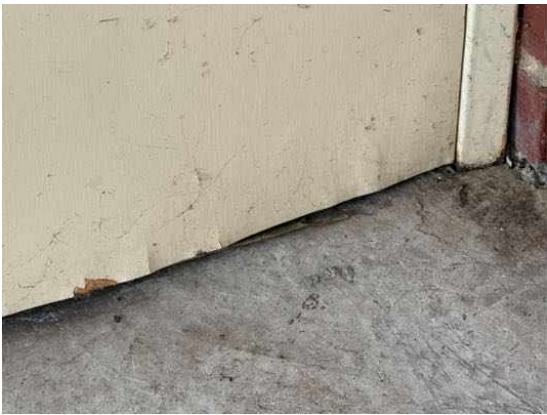
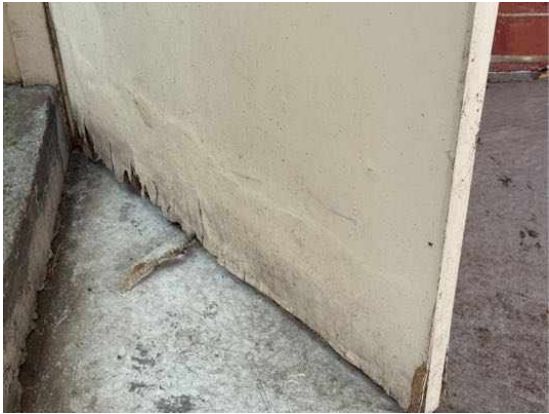
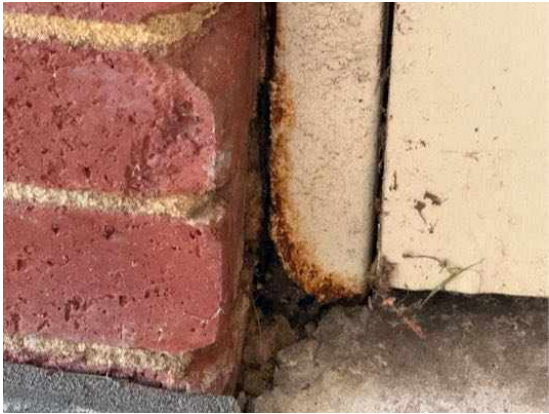
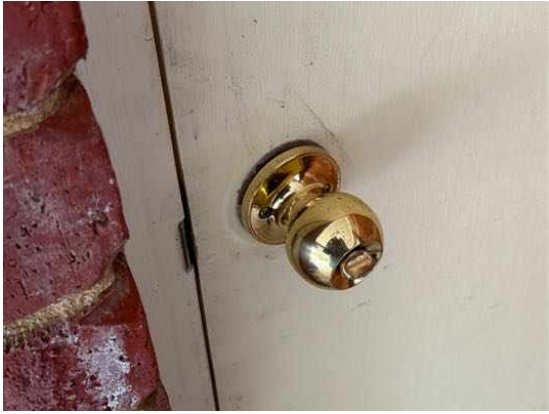
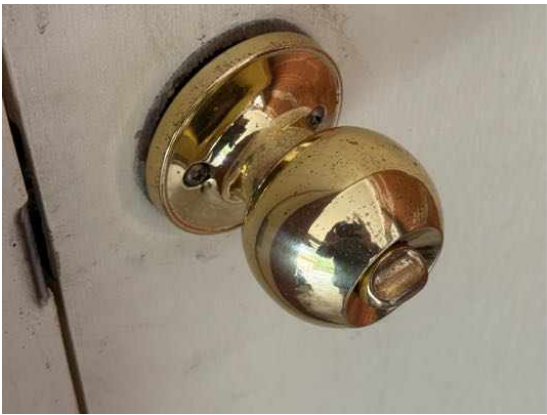
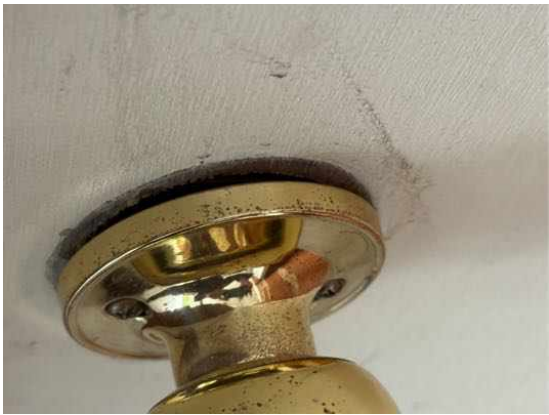
Defects 3.08

Building:	Building 1
Location:	Rear garage door > All Areas
Finding:	Damage to the back and bottom of the garage door
Information:	The back and bottom of the garage door was observed to show excessive moisture damage and appears to be swollen due to this moisture. This type of damage is suspected to be consistent with an un-sealed door. A qualified carpenter should be appointed to replace this door. The door should be then thoroughly sealed on the bottom especially and all other sides to prevent accelerated future moisture damage and deterioration.

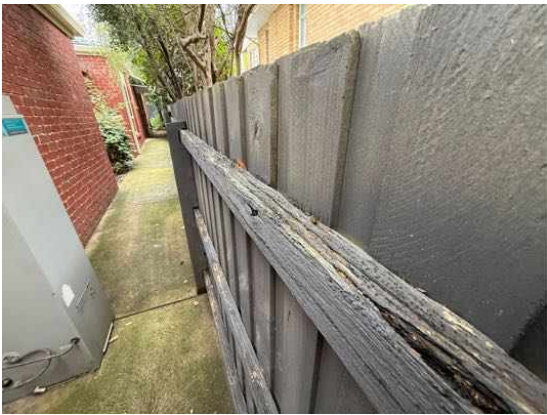
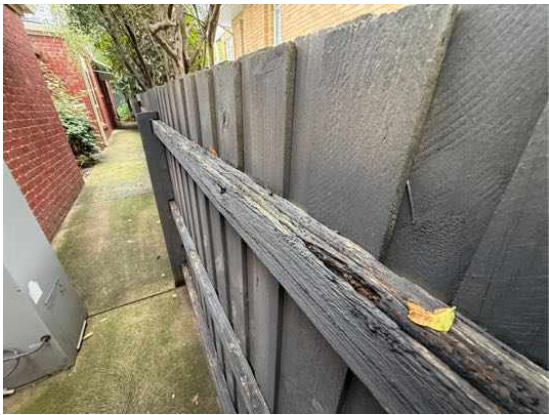
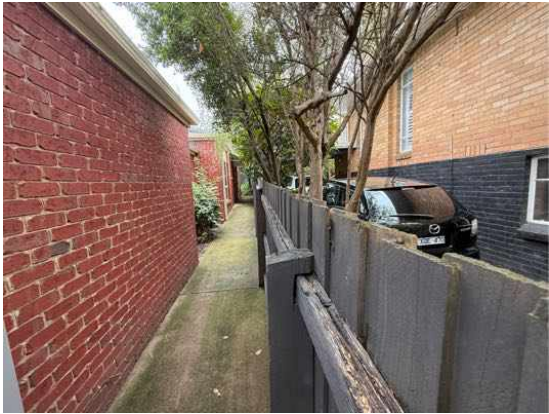
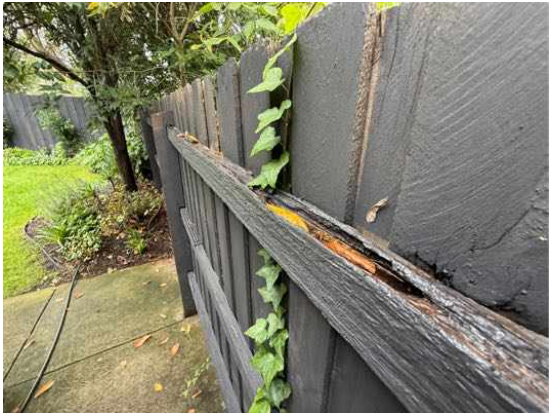
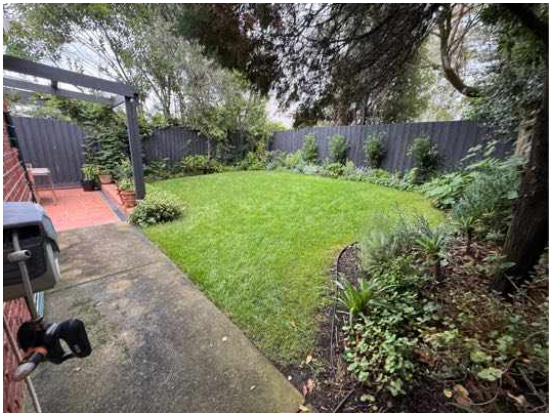
Defects 3.09

Building: Building 1
Location: All Areas > All Areas
Finding: Post and rail fences
Information: Post and rail fences showed damage and deterioration at the time of the inspection. This deterioration is suspected to have developed over a prolonged period of time due to frequent weather exposure, which is expected in a property of this age and condition. Left unmanaged, further deterioration is likely to develop further, necessitating in extensive repair or replacement areas of the timber fences, this will depend on the age and deterioration and or wood rot, further damage is suspected of occur. To maintain the condition of the external timber building elements, any affected areas should be substituted as soon as possible with pre-treated replacements. A qualified fencing contractor should be appointed to repair and replace post and rail fencing where deemed to be necessary.

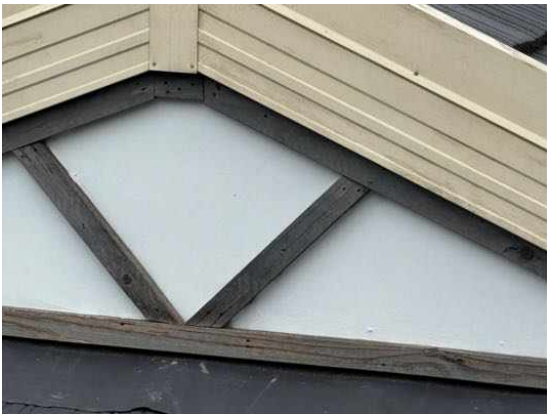
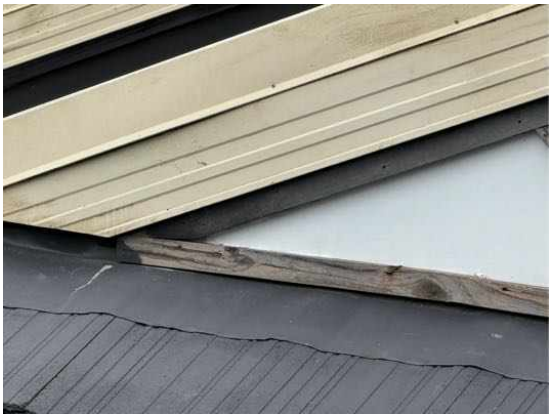
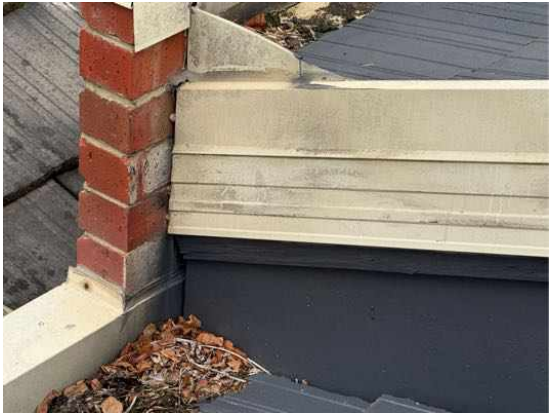
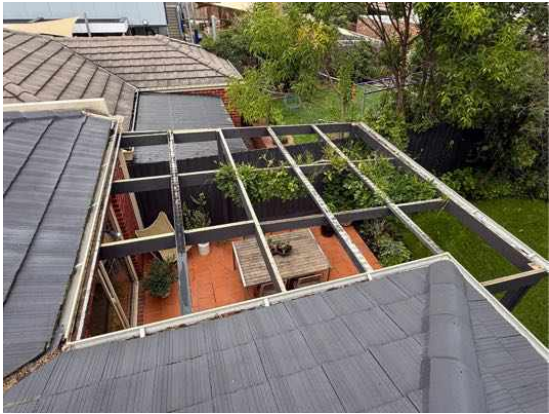
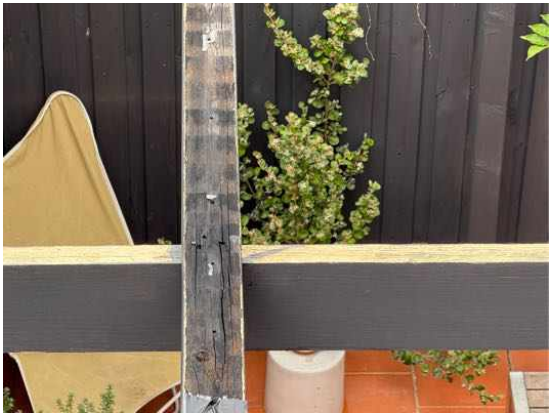
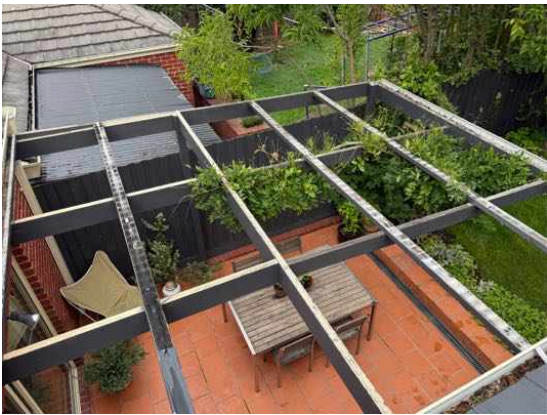
Defects 3.10

Building:	Building 1
Location:	All Areas > All Areas
Finding:	Wood rot
Information:	Wood rot is suspected to be affecting some minor areas on the rear pergola, post and rail fences and other building elements around the exterior areas. Wood rot, also known as Fungal Decay, occurs when timbers and other cellulose building materials are exposed to damp conditions on an ongoing basis. The frequent exposure to rain and extreme weather conditions also make many building elements susceptible to accelerated deterioration.

Early intervention and regular maintenance such as painting will prolong the useful life of these building elements. Prior to any works being performed, the cause of the moisture that has created the visible wood rot should be identified and addressed in a suitable manner. Replacement of affected building elements may then be a necessary step in protecting surrounding areas from such deterioration. A qualified carpenter or registered builder may also be required to replace affected building materials.

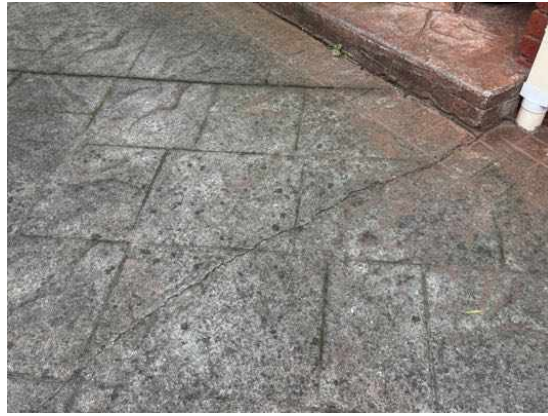
Defects 3.11

Building: Building 1
Location: All Areas > All Areas
Finding: Concrete driveway cracks
Information: Numerous cracks on the driveway were observed at the time of the inspection. Concrete cracks are a common occurrence as a result of many primary defects. Such causes may include age, general wear and tear, expected building movement, general expansion/contraction of building materials in different weather conditions, and/or minor failings in the installation or application of building materials. Monitoring of all cracking should be conducted periodically. Contact a relevant tradespersons should cracks become trip hazards for occupants.

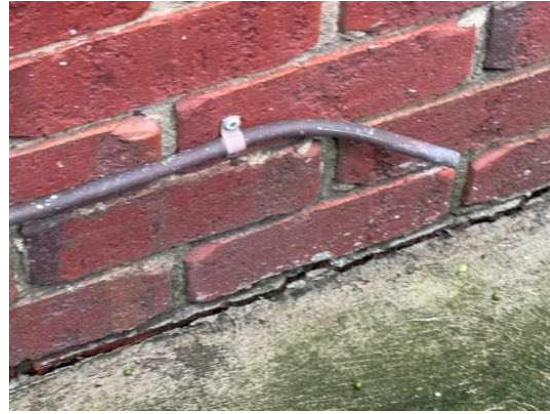
Defects 3.12

Building:	Building 1
Location:	All Areas > All Areas
Finding:	HWS Overflow - Not Connected
Information:	The Hot Water System (HWS) overflow was found to be disconnected from storm water drainage and may be or in the future create excessive moisture in the surrounding area.

These damp conditions can lead to secondary defects such as rot, rust or corrosion of associated building elements, the formation of fungal decay, or even the creation of potential slip hazards. When coupled with poor site drainage, pooling of water may also attract termite activity to this area.

It is highly recommended that a licensed plumber be appointed to connect the HWS overflow in order to prevent such an environment from being created. These minor works should be carried out as soon as possible.

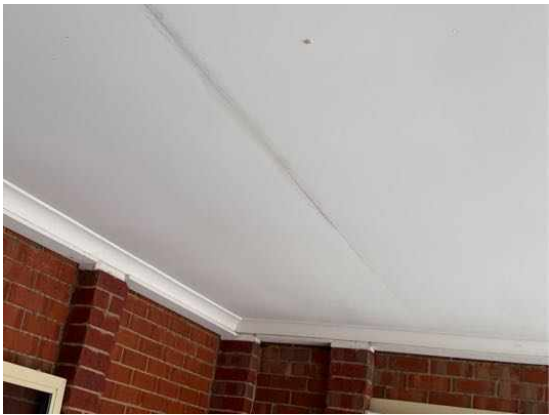
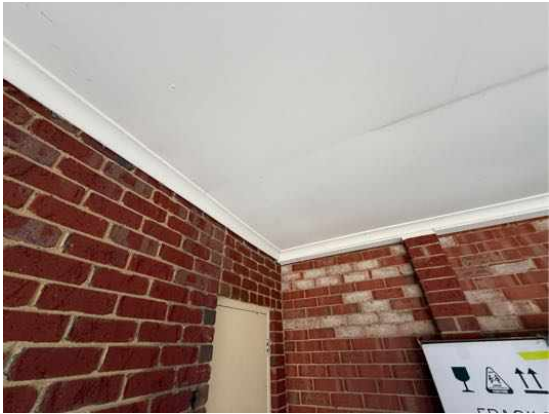
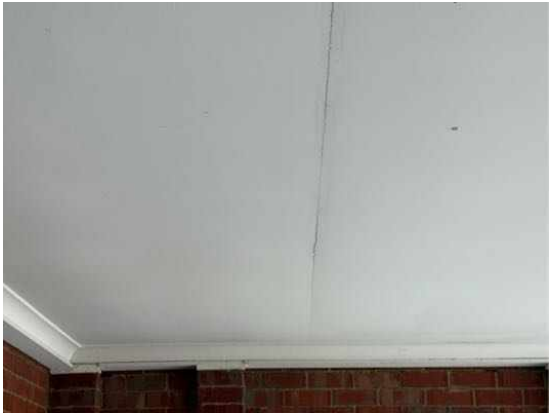
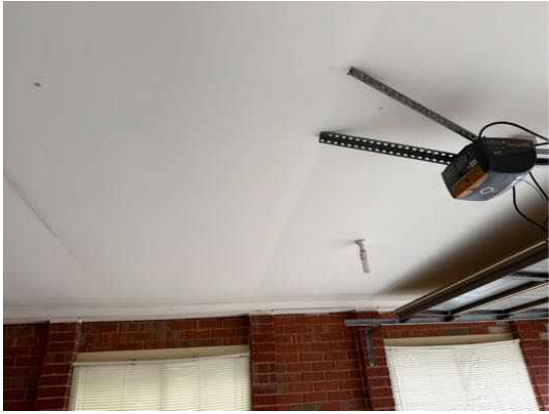
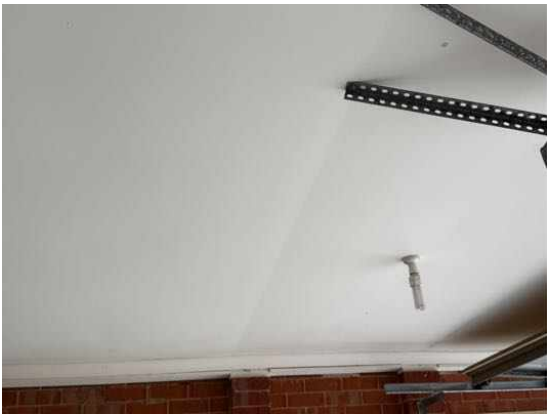
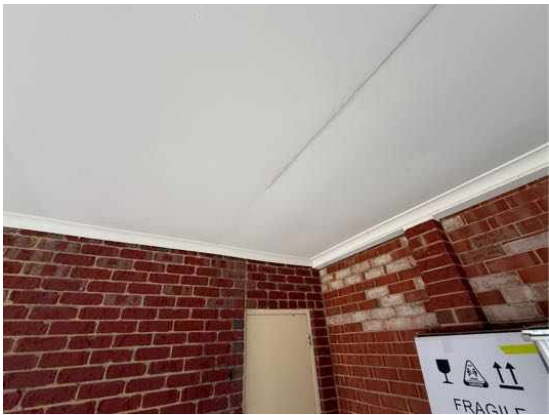
Defects 3.13

Building:	Building 1
Location:	Garage ceiling > All Areas
Finding:	Garage ceiling linings showed suspected previous excessive moisture damage and deterioration
Information:	At the time of the inspection the garage ceiling linings showed suspected previous excessive moisture damage and deterioration from suspected overwhelmed guttering and down-pipes due to trees overhanging filling gutters with excessive amounts of leaf matter and debris. The exterior roof showed the guttering to be reasonably clear of leaf matter and debris however gutters may have been overwhelmed at some time from excessive rain and extreme weather conditions, no other visible conclusive answer to where moisture stains and or leaks may be coming from.

At the time of the inspection the garage ceiling linings showed suspected previous excessive moisture damage and deterioration from suspected overwhelmed guttering and down-pipes due to trees overhanging filling gutters with excessive amounts of leaf matter and debris. The exterior roof showed the guttering to be reasonably clear of leaf matter and debris however gutters may have been overwhelmed at some time from excessive rain and extreme weather conditions, no other visible conclusive answer to where moisture stains and or leaks may be coming from. It is recommended that

It is recommended that the client firstly appoint a qualified arborist to remove as much overhanging trees and limbs away from the roof areas to prevent future overwhelmed gutters and down-pipes. Secondly a qualified gutter cleaning company to periodically clean and remove any leaf matter and debris from the gutters. It is unknown as to the time as to when this damage has occurred. It is very important that this type of defect get rectified in the short term future due to the development of mould and mildew within the plaster linings. The plaster linings will require total removal of any areas of the affected ceiling to ensure mould buildup does not occur. If left unmanaged secondary deterioration is likely to occur. The moisture to these areas may also have affected the roof structure and deteriorate adjoining building elements.

Poorly drained roof areas can and will lead to excessive damp and wet conditions to the adjoining areas which can lead to a range of secondary building defects. A licensed builder and or licensed roof plumber should be appointed to further investigate these areas for damage and deterioration. Where deemed to be necessary these areas will require an invasive inspection which may require removing roof tiles and the affected plaster linings for a more thorough look and assessment.

the client firstly appoint a qualified arborist to remove as much overhanging trees and limbs away from the roof areas to prevent future overwhelmed gutters and down-pipes. Secondly a qualified gutter cleaning company to periodically clean and remove any leaf matter and debris from the gutters. It is unknown as to the time as to when this damage has occurred. It is very important that this type of defect get rectified in the short term future due to the development of mould and mildew within the plaster linings. The plaster linings will require total removal of any areas of the affected ceiling to ensure mould buildup does not occur. If left unmanaged secondary deterioration is likely to occur. The moisture to these areas may also have affected the roof structure and deteriorate adjoining building elements. Poorly drained roof areas can and will lead to excessive damp and wet conditions to the adjoining areas which can lead to a range of secondary building defects. A licensed builder and or licensed roof plumber should be appointed to further investigate these areas for damage and deterioration. Where deemed to be necessary these areas will require an invasive inspection which may require removing roof tiles and the affected plaster linings for a more thorough look and assessment.

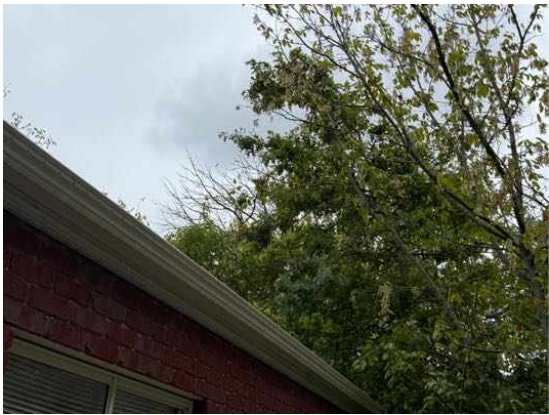
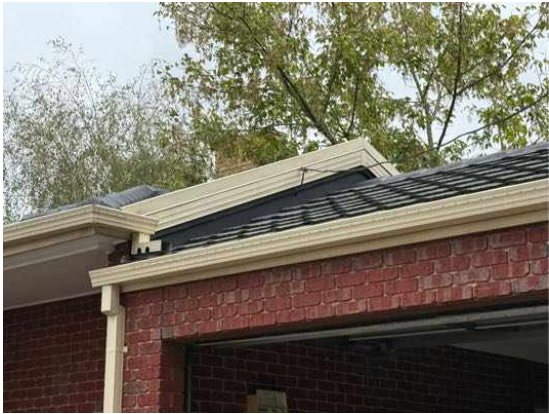
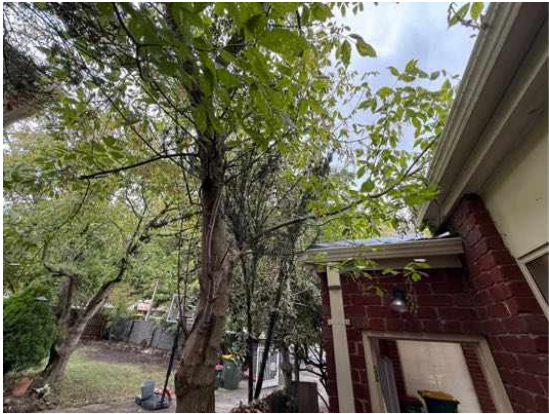
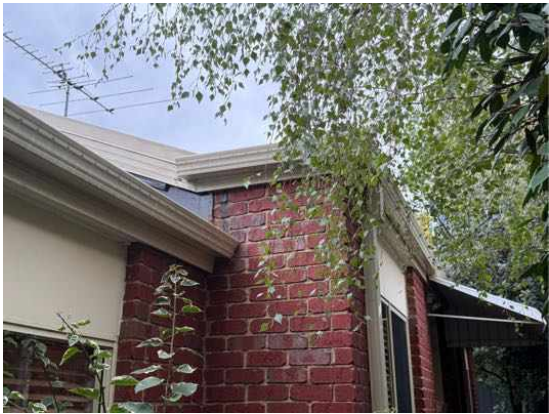
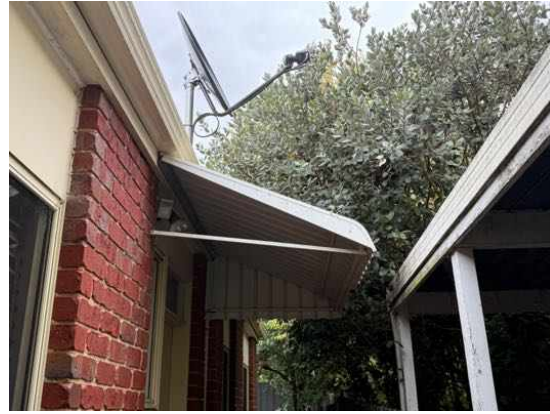
Noted Item

Building:	Building 1
Location:	All Areas > All Areas
Finding:	Trees - Overhanging and filling gutters
Information:	Overhanging trees often result in excessive amounts of leaf debris accumulating in gutters. Gutters are a critical part of the building's management of storm water and rain. It is therefore important that they be kept clear to prevent secondary damage to associated building elements, including exterior and interior walls, ceiling linings and any adjoining building elements. Where gutters get blocked from excessive leaf matter, water pooling is highly likely to occur more frequently, fast-tracking, rust and corrosion of the roof plumbing elements and making these areas even more susceptible to secondary defects

It is highly recommended that if at all possible, all overhanging tree branches be removed to prevent further damage. Such works can be performed by the homeowner; however, appointment of a landscape contractor or an arborist may be required. Consultation with a licensed roof plumber is required where guttering has been damaged.

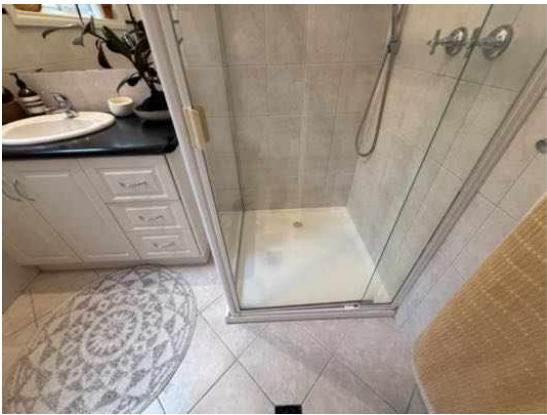
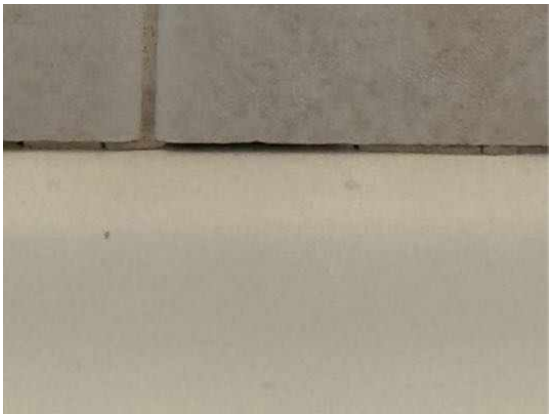
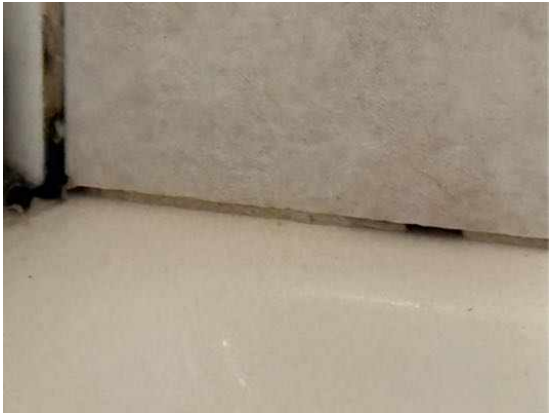
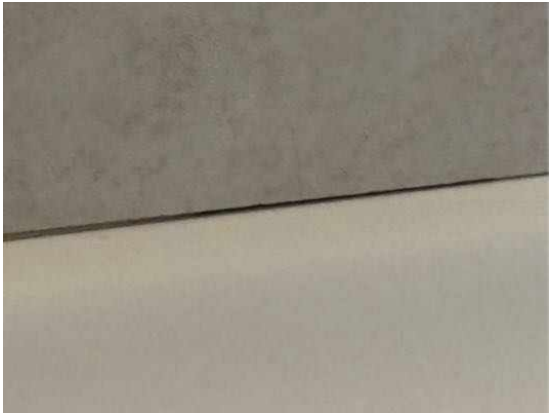
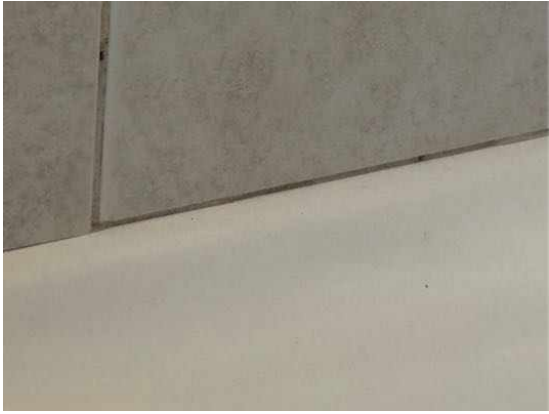
Noted Item

Building:	Building 1
Location:	Bathroom > All Areas
Finding:	Grout and sealant maintenance
Information:	It was observed that grout and sealant had been dislodged from the bottom of the tiled shower alcove in the bathrooms. These types of areas require thorough and frequent maintenance and cleaning to ensure water and moisture does not exit the shower and penetrate and of the tile substrate areas. It is also very important to the laundry and kitchen areas to ensure these areas remain watertight at all times. It is highly recommended that the client appoint a professional wall and floor tiler to provide remedial work to rectify the shower floor grout and sealant before any water

damage to the adjoining areas can occur.

Grout and sealant were observed to have been either deteriorated, dislodged or missing, in these types of wet areas if not rectified and maintained adequately it is highly likely that these areas will have accelerated damage and deterioration to the substrate as well as more serious secondary defects to the adjoining floor and wall structures. Regular maintenance and replacement of grout to any holes or damaged sealant is highly recommended to the wet areas, as this is a regular wear and tear defect. Sealant and grouting in areas that come into regular contact with water should be maintained for the long term care of your property.

Different materials on the walls and floor areas move at different rates, generally causing cracking to grout or sealant at these points. A flexible sealant is required to allow for expected expansion and contraction, while keeping the joint water tight and protective of all associated building structures and materials. Flexible and mould resistant materials should be applied to affected areas to prevent any subsequent water damage that is likely to occur if left unmanaged. A sealant specialist or tiling contractor should be appointed to complete these works immediately or as soon as possible.
