# Building and Timber Pest Inspection Report

Inspection Date: Mon, 19 Jan 2026

Property Address: 3/14-16 Ramona St, Quakers Hill NSW  
2763, Australia

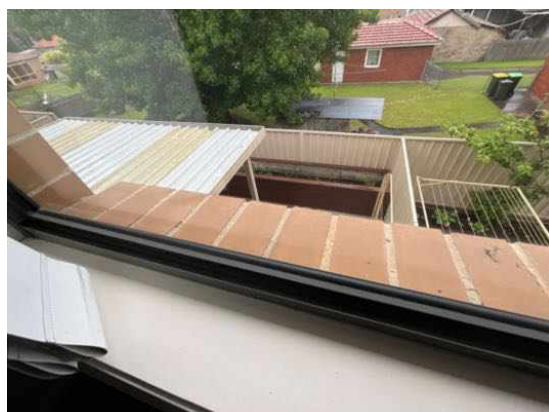
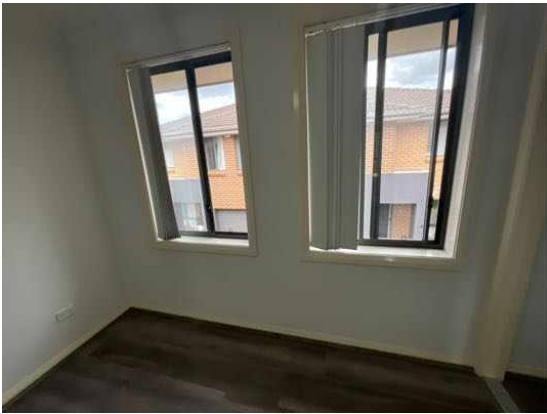
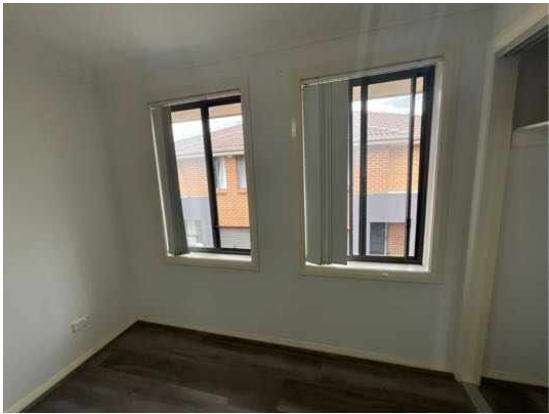
#### Finding 1.01

Building:	Main Building
Location:	All Areas
Finding:	Window child lock missing
Information:	The window in question lacks a child lock mechanism, which poses a potential safety risk to young occupants in the premises. As per Australian Standards windows accessible to children should be equipped with appropriate child safety locks to prevent accidental opening, reducing the risk of falls and ensuring compliance with safety regulations.

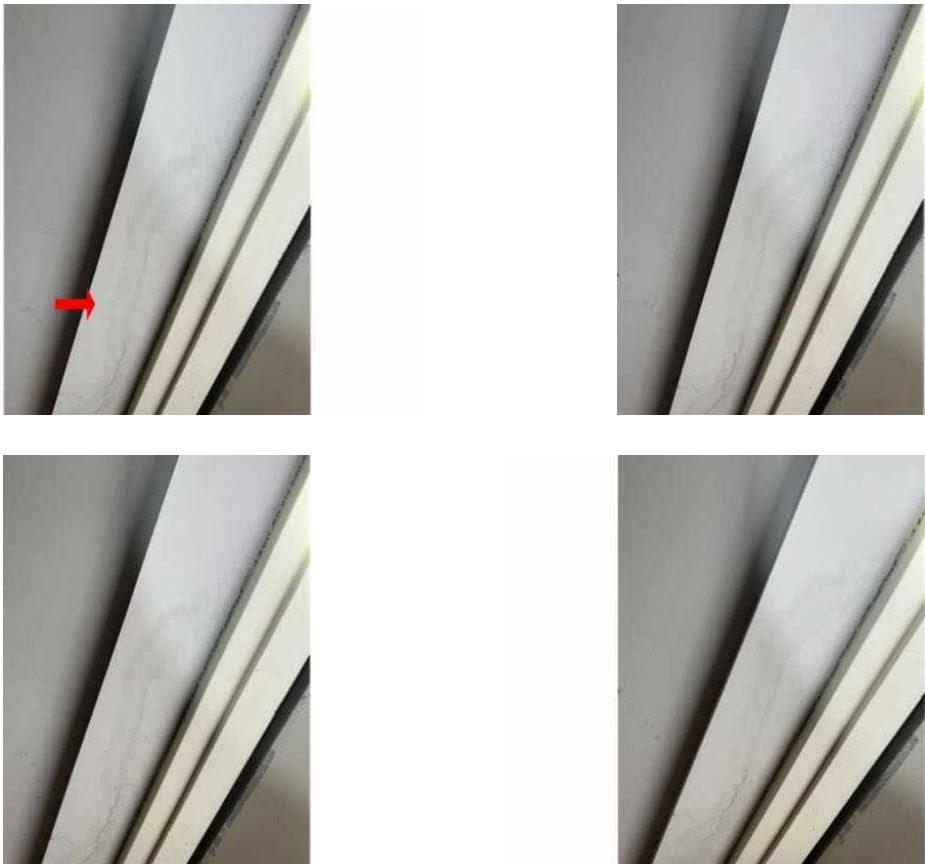
## Finding 2.01

Building: Main Building  
Location: Garage  
Finding: Water damage  
Information: The area has sustained water damage resulting in potential structural issues. This damage compromises both the aesthetic and functional aspects.

1 **Plumber:** If the water damage is due to plumbing issues, a plumber can fix leaks and ensure there are no further water-related problems.

2 **General Contractor:** If the damage is extensive and affects the surrounding area, a general contractor can coordinate the repair work, including any related structural or cosmetic repairs.

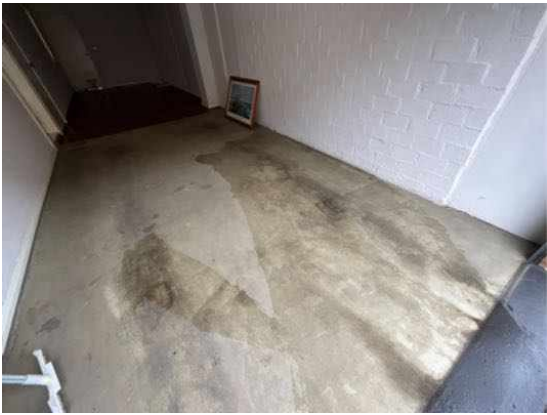
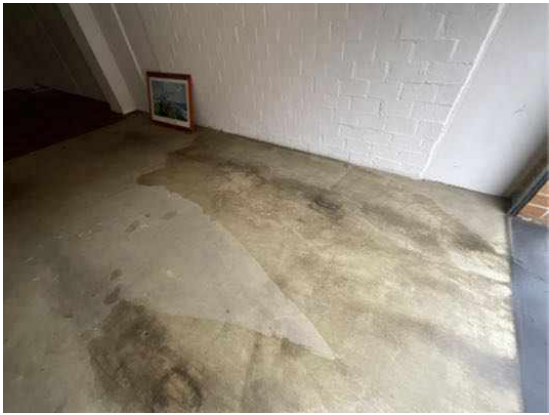
Building:	Main Building
Location:	Garage
Finding:	Garage Floor – Water Ingress / Flooding
Information:	Evidence of water ingress was observed to the garage floor, with visible pooling and damp staining along the slab surface adjacent to the internal wall and near the garage opening. This indicates recent or ongoing water entry into the garage area.

- Inadequate surface drainage or negative fall at the garage entry
- Stormwater runoff entering under the garage door during rainfall
- Blocked or insufficient floor waste / drainage
- Rising damp or moisture migration through the slab edge (where applicable)

- Slip hazard due to wet floor conditions
- Potential deterioration of concrete slab and wall finishes over time
- Increased risk of mould growth and moisture-related damage
- Damage to stored items and garage contents

Further investigation by a licensed plumber or drainage contractor is recommended to identify the source of water ingress. Rectification may include improving surface drainage, installing or upgrading drainage systems, sealing slab joints, and ensuring

appropriate falls away from the garage entry. Ongoing monitoring is advised until rectification is completed.

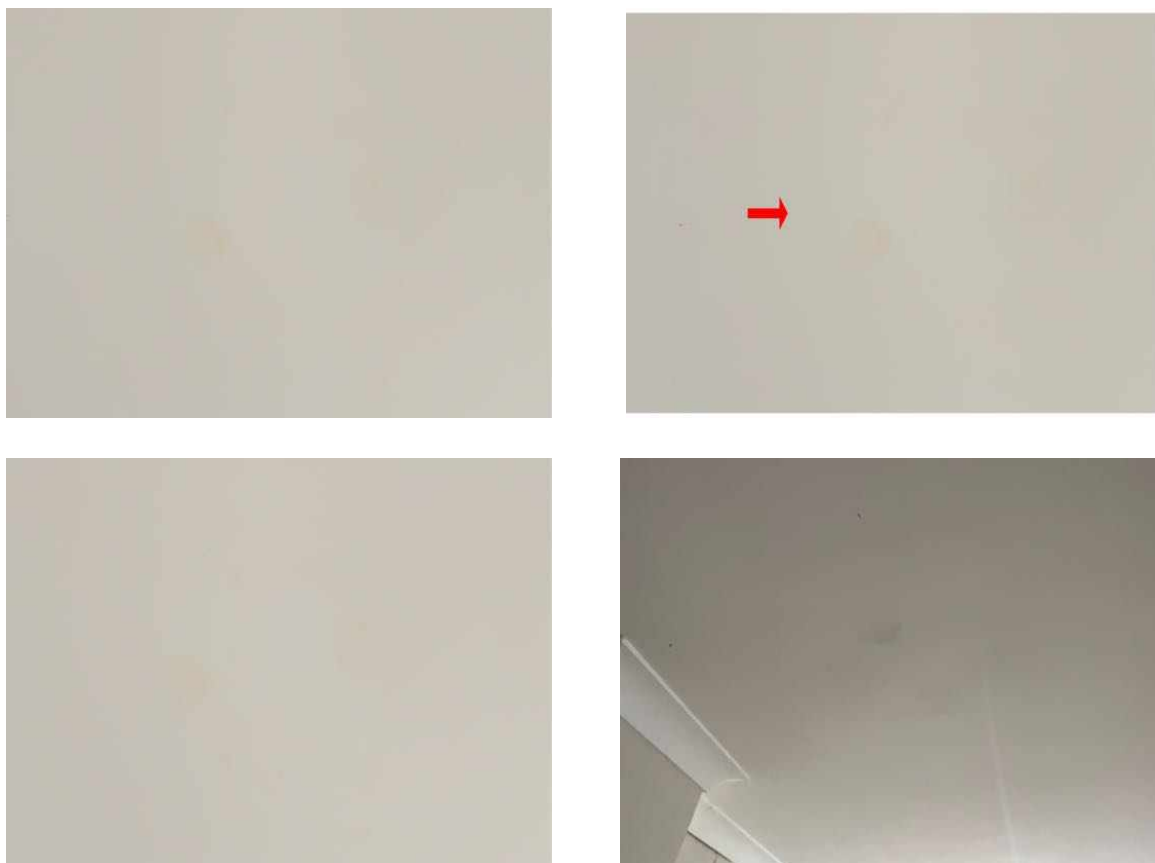
### Finding 3.02

Finding: Water staining

Information: Water staining was evident in this area at the time of inspection. Water staining indicates that surfaces have been exposed to excessive moisture over time. The minerals and other elements in the water lead to staining, which may graduate to corrosion and deterioration if left unmanaged.

While mostly an appearance defect, water staining can be indicative of more serious defects, which may be currently concealed by other building elements.

Where water staining is active, a licensed plumber must be consulted to identify the cause of the staining and to provide advice on any reparation works that may be required. Replacement of any broken or damaged structures is advised.

Conversely, where water staining is old and inactive, affected building materials may be repaired or replaced at client discretion. A qualified carpenter or registered builder may be appointed to perform these works.

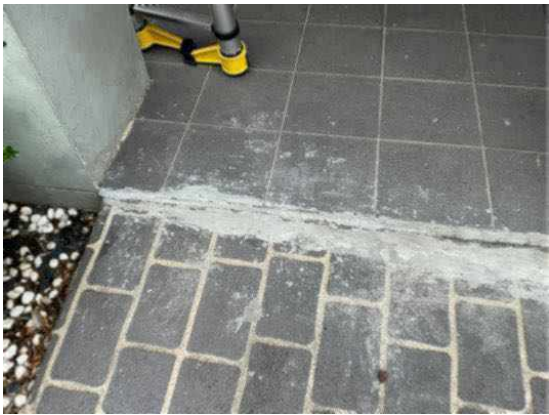
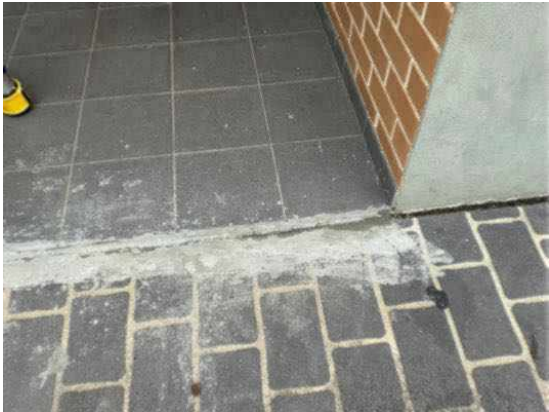
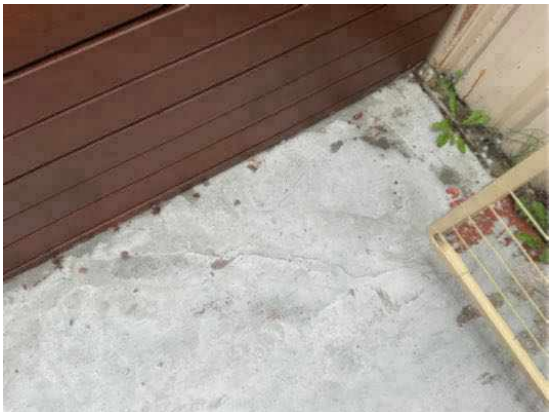
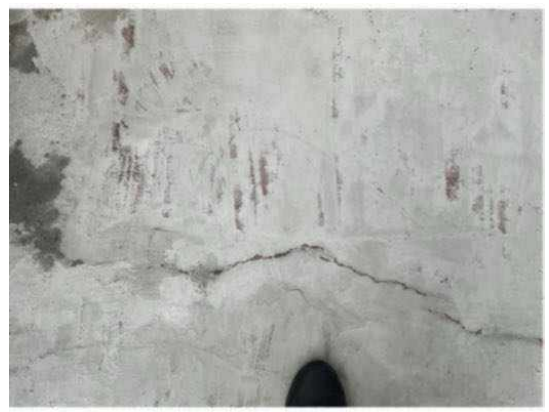
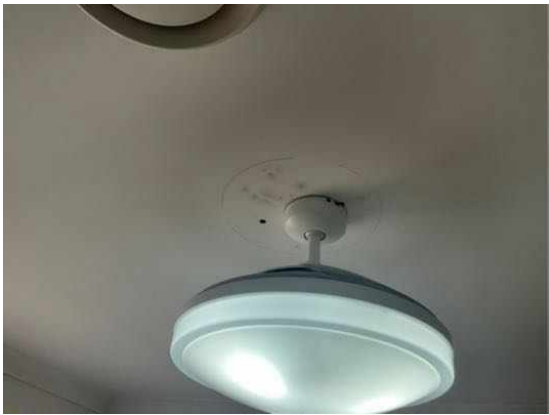
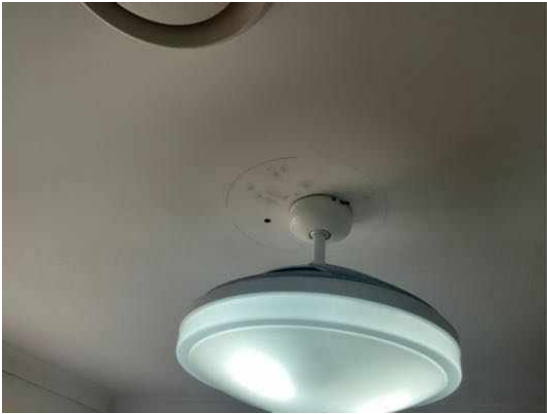
### Finding 3.03

Building:	Main Building
Location:	All Areas
Finding:	Poor workmanship
Information:	The structure exhibits signs of poor workmanship, evident in various aspects of construction and finishing.

Risk: Poor workmanship poses a range of risks, including compromised structural integrity, potential safety hazards, and a decreased lifespan of the structure. It may also lead to aesthetic and functional issues.

Resolution: A qualified contractor or construction professional should be consulted to assess and address the poor workmanship. They can implement corrective measures to ensure structural soundness, safety, and overall quality of the construction.

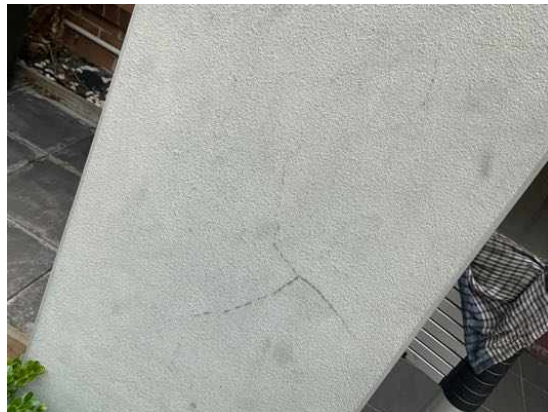
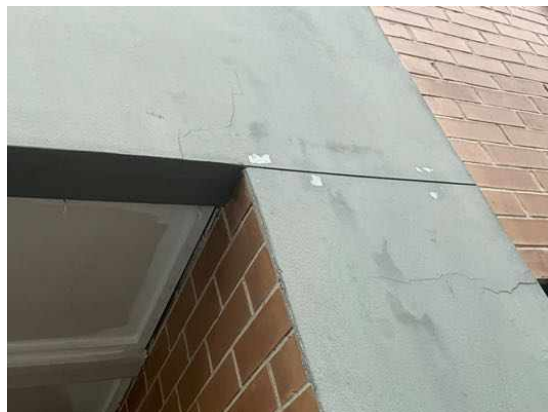
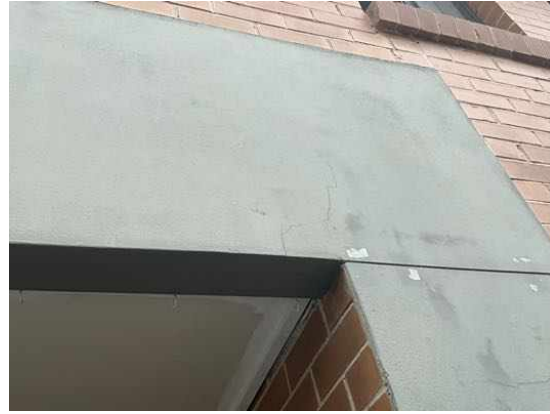
**Finding 3.04**

Building: Main Building  
 Location: Front Elevation  
 Finding: Deteriorated Rendering  
 Information: The rendering on the exterior walls of the building is deteriorating, showing signs of cracking, peeling, and flaking. This can be attributed to weathering, moisture ingress, or poor initial application.

- **\*\*Structural Damage:\*\*** Deteriorated rendering can allow moisture to penetrate the underlying structure, leading to further damage, weakening the integrity of the building,

- **Safety Concerns:** Loose or falling render poses a safety hazard to occupants and passersby.

- **Professional Plasterer or Renderer:** A skilled plasterer or renderer should be engaged to assess the extent of the damage, remove the deteriorated rendering, and apply a new, high-quality render to the affected areas.

- **General Contractor:** For extensive damage, a general contractor may be necessary to coordinate the repair work, ensuring that any underlying structural issues are also addressed.

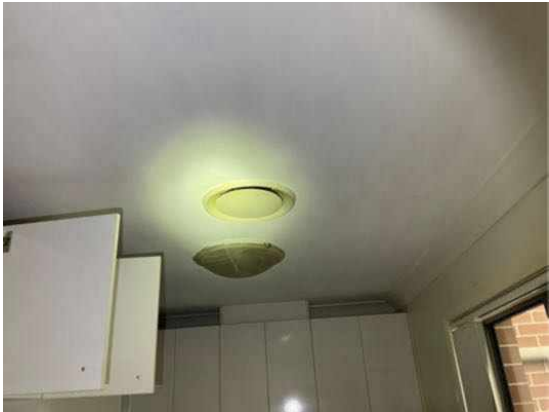
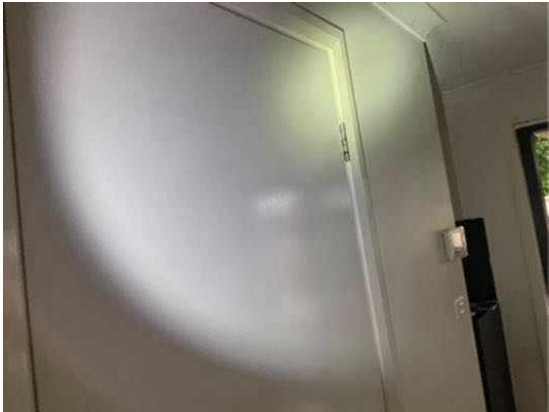
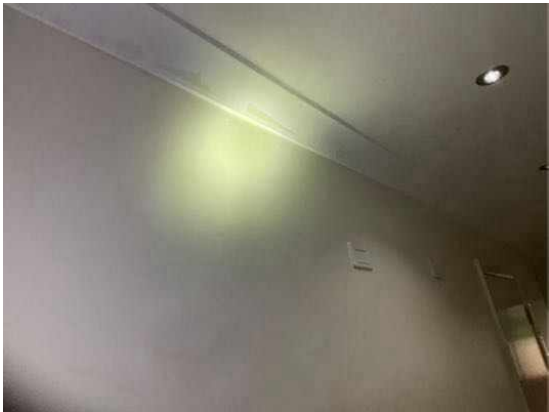
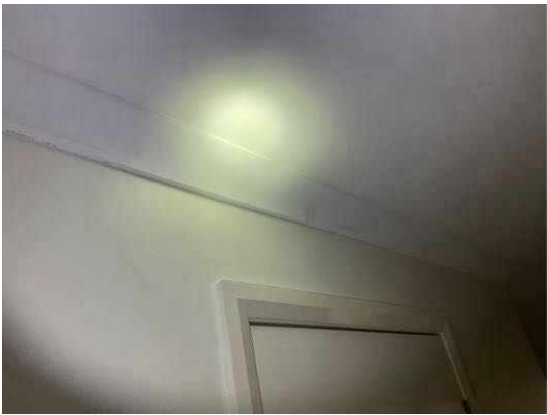
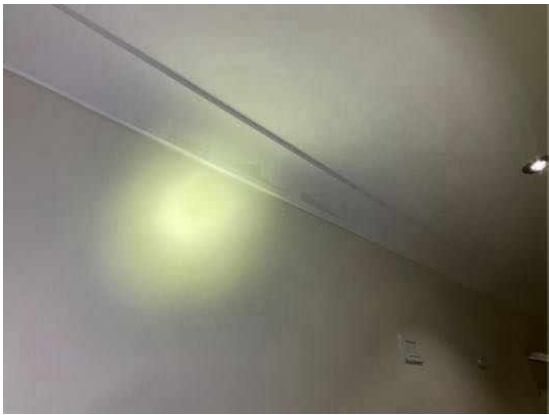
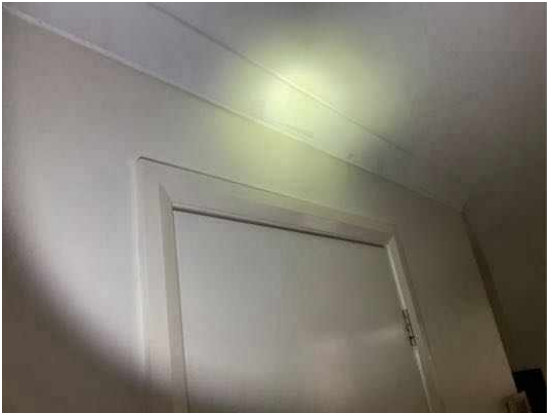
### Finding 3.05

Building:	Main Building
Location:	All Areas
Finding:	Paint - Substandard
Information:	Areas were identified where the surface finish of the painting is substandard and this is considered a defect.

Any irregularity in the surface which is visible from a normal viewing position is considered a defect. Marks may also be a result of fault by other tradespeople throughout the construction process.

Defective surface finish of paintwork is marked with an arrow to the below photos in the following locations.

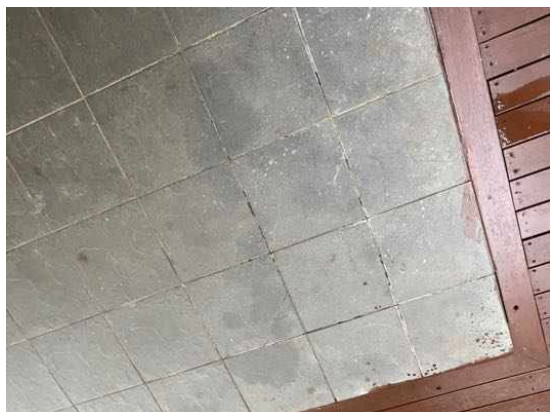
### Finding 3.06

Building:	Main Building
Location:	Yard - Back
Finding:	Grouting - Missing or damaged
Information:	It was noted on inspection that sealant or grout is Missing or damaged. A flexible sealant is required to allow for expected expansion and contraction, while keeping the joint water tight and protective of all associated building materials.

Flexible and mould resistant materials should be applied to affected areas to prevent any subsequent water damage that is likely to occur. Regular maintenance and replacement of damage or missing or damaged sealant and grout is highly recommended , as this is a regular wear and tear defect.

A sealant specialist or tiling contractor should be appointed to complete these works as soon as possible

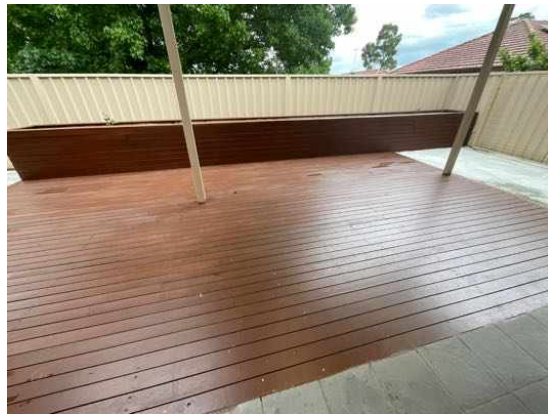
### Finding 3.07

Building:	Main Building
Location:	Deck
Finding:	External timber balcony or deck-structural stability
Information:	The load capacity of the external balcony or deck could not be verified during the inspection.

External timber structures are also constantly exposed to weather deteriorates in an exhilarate manner, ongoing assessments are required.

It is highly recommended that a structural engineer further, assess the external timber balcony or a deck to inform the client of its load capacity.

Regular maintenance inspections by competent practitioners is needed.

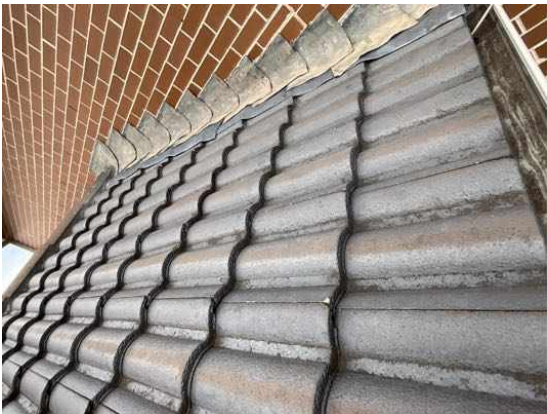
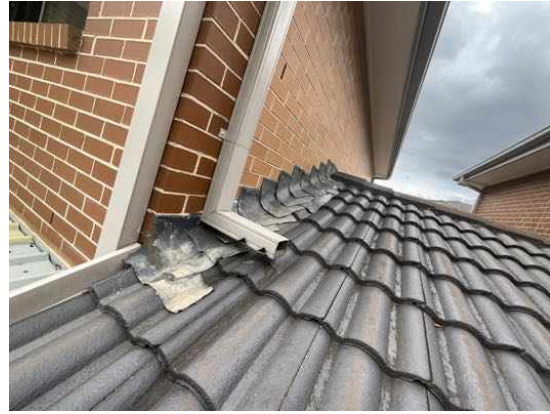
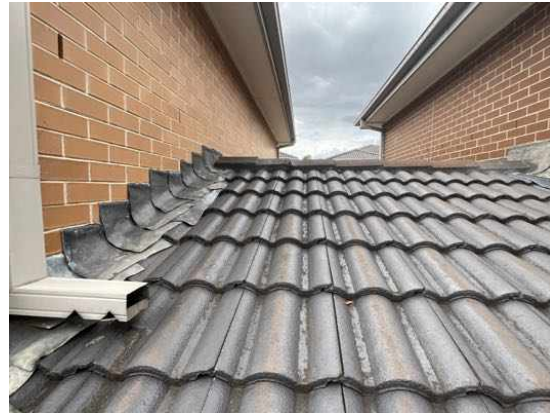
### Finding 3.08

Information: Inspection of the roof revealed widespread weathering to the tiled roof surface. The tiles show loss of surface finish, colour fading, and age-related deterioration typical of older roof coverings. Although no significant cracking was noted, weathering can lead to increased porosity, reduced water-shedding capability, and a higher risk of future cracking or displacement during adverse weather conditions.

A licensed roofer should be engaged to undertake a closer inspection, carry out routine maintenance, and replace any tiles that may be compromised. Ongoing

monitoring is recommended due to the age and condition of the roof covering.

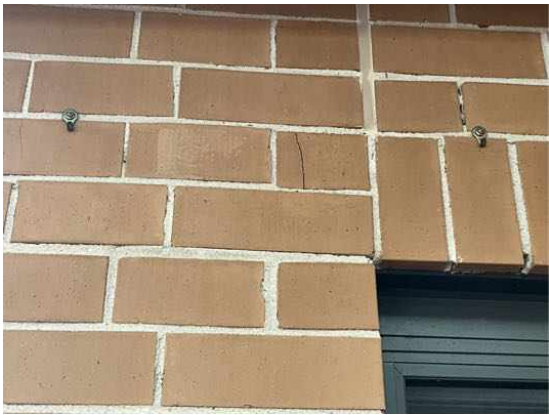
### Finding 3.09

Building:	Main Building
Location:	Exterior walls - rear
Finding:	Brickwork - Cracking [Fine]
Information:	Although fine cracks are quite noticeable, they are often only considered to be an appearance defect and usually do not indicate any structural damage. Generally, the cause of a fine crack is indicative of a separation between brickwork and mortar throughout the structure, but single bricks may also show cracks of this nature.

Cracking of this nature can generally be repaired with minor filling and should be conducted by a qualified bricklayer.

Always contact a building inspector should cracks widen lengthen or become more numerous.

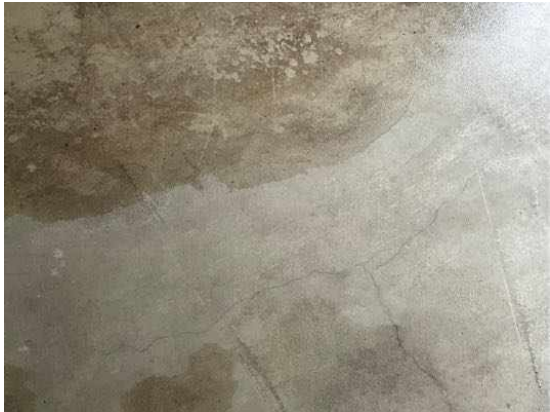
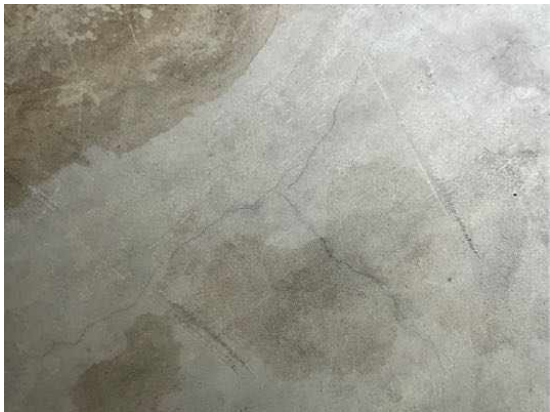
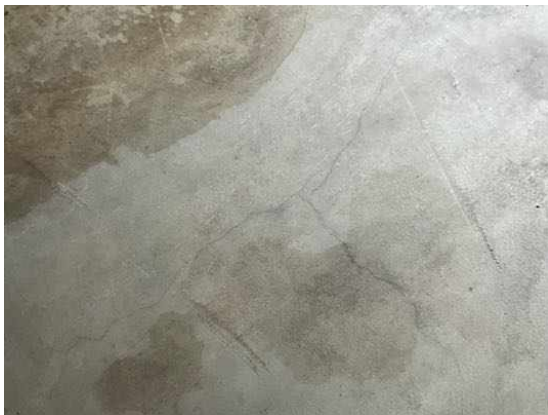
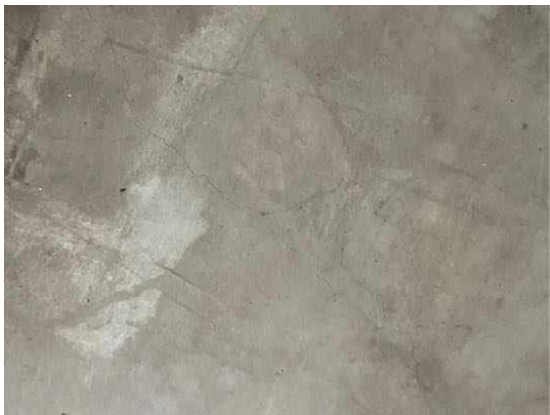
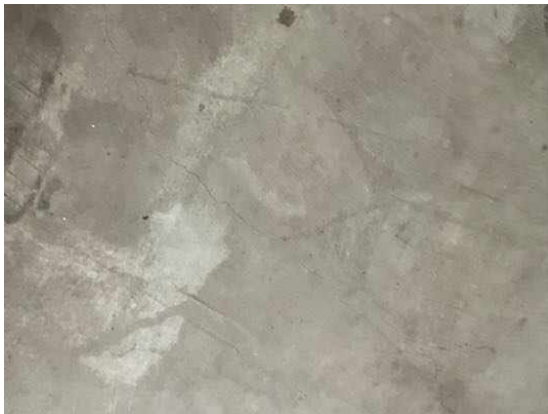
**Finding 3.10**

Building: Main Building  
Location: All Areas  
Finding: Crack in concrete slab - Category 0  
Information: A crack coded as Category 0 was identified in the slab. A Category 0 crack is described as a hairline crack, representing insignificant movement of slab from level.

The approximate width of the crack to be considered Category 0 is 0.3mm, or change in offset of less than 8mm when a 3m straight edge is placed over the defect.

No rectification is required at this time. However, all cracking should be monitored over a 12 month period to identify any further damage in the area.

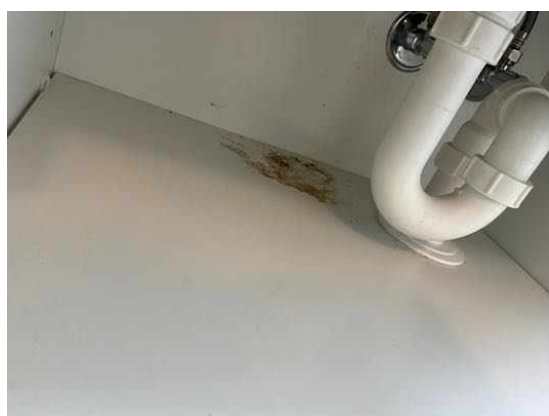
Finding: Water damage / Vanity  
Information: "The vanity in the shower area has sustained water damage, resulting in swelling and discoloration of the wood, as well as potential structural issues. This damage compromises both the aesthetic and functional aspects of the vanity."

1. **Carpenter or Woodworker:** They can assess and repair the damage to the vanity, potentially replacing any irreparable parts.
2. **Plumber:** If the water damage is due to plumbing issues, a plumber can fix leaks and ensure there are no further water-related problems.
3. **General Contractor:** If the damage is extensive and affects the surrounding area, a general contractor can coordinate the repair work, including both the vanity and any related structural or cosmetic repairs.

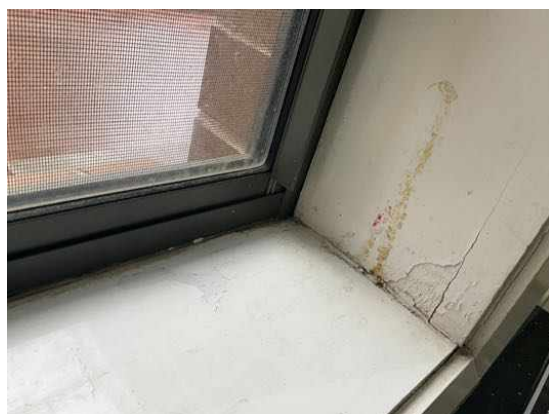
Finding: Water staining

Information: Water staining was evident in this area at the time of inspection. Water staining indicates that surfaces have been exposed to excessive moisture over time. The minerals and other elements in the water lead to staining, which may graduate to corrosion and deterioration if left unmanaged.

While mostly an appearance defect, water staining can be indicative of more serious defects, which may be currently concealed by other building elements.

Where water staining is active, a licensed plumber must be consulted to identify the cause of the staining and to provide advice on any reparation works that may be required. Replacement of any broken or damaged structures is advised.

Conversely, where water staining is old and inactive, affected building materials may be repaired or replaced at client discretion. A qualified carpenter or registered builder may be appointed to perform these works.

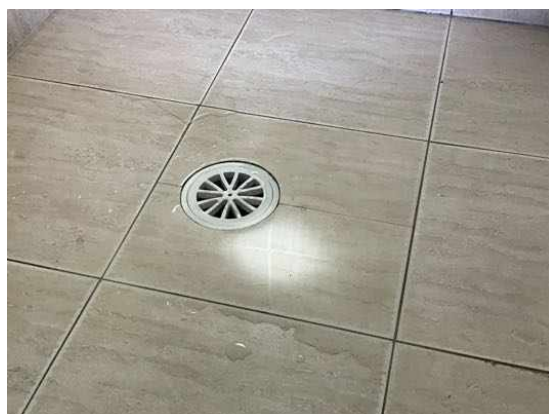
### Finding 3.15

Building:	Main Building
Location:	Ensuite
Finding:	Shower base - Water pooling
Information:	Evidence of water pooling around the floor waste in the shower recess was noticed at the time of inspection. It is suspected that this excessive moisture is attributed to insufficient fall in the shower floor tiles.

This pooling is minor overall but is still considered unsatisfactory, as standard tiling practices would not permit this situation to occur. Pooling water around floor wastes can create a slip hazard in extreme cases and create conditions that are conducive to mould growth over time. Where left unmanaged, the degradation of sealant and grouting is also likely to occur, possibly necessitating further repair works.

Remedial works may involve some sections of tiling and flooring repair and replacement. A tiling contractor or bathroom specialist should be appointed to provide further advice on reparation options and to perform works as necessary.

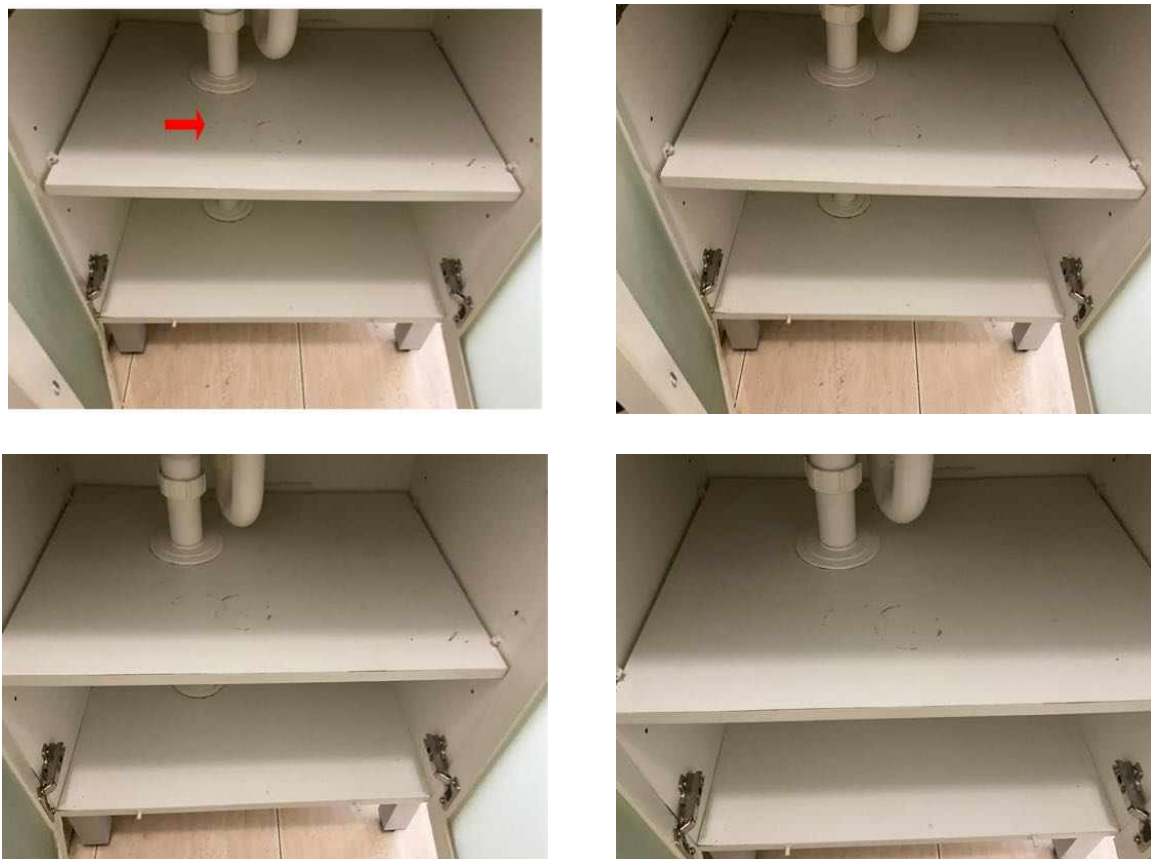
### Finding 3.16

Building:	Main Building
Location:	Bathroom
Finding:	Water damage / Vanity
Information:	"The vanity in the shower area has sustained water damage, resulting in swelling and discoloration of the wood, as well as potential structural issues. This damage compromises both the aesthetic and functional aspects of the vanity."

1. **Carpenter or Woodworker:** They can assess and repair the damage to the vanity, potentially replacing any irreparable parts.
2. **Plumber:** If the water damage is due to plumbing issues, a plumber can fix leaks and ensure there are no further water-related problems.
3. **General Contractor:** If the damage is extensive and affects the surrounding area, a general contractor can coordinate the repair work, including both the vanity and any related structural or cosmetic repairs.

Make sure to obtain quotes from these professionals to determine the most cost-effective and efficient solution for your specific situation.

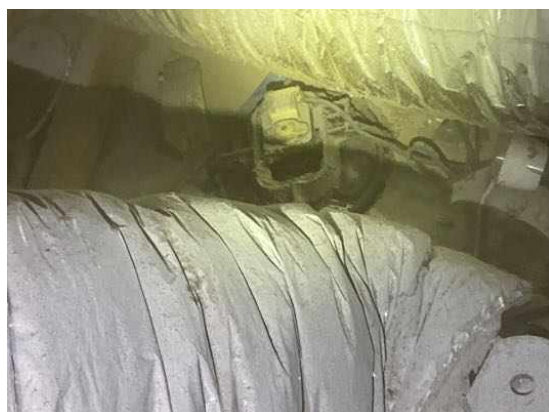
### Finding 3.20

Building: Main Building  
 Location: Roof Void  
 Finding: Exhaust fan not vented out  
 Information: The exhaust fan located within the roof void is not appropriately ducted to the external atmosphere and is currently discharging moist air directly into the roof space. This is considered a defect under AS 4349.1, as it does not meet the minimum standard of residential building performance expected under normal residential building practices.

It is recommended that the exhaust fan be modified by a licensed HVAC contractor or qualified builder, ensuring it is properly ducted to discharge externally in accordance with manufacturer specifications, the National Construction Code (NCC), and applicable Australian Standards.

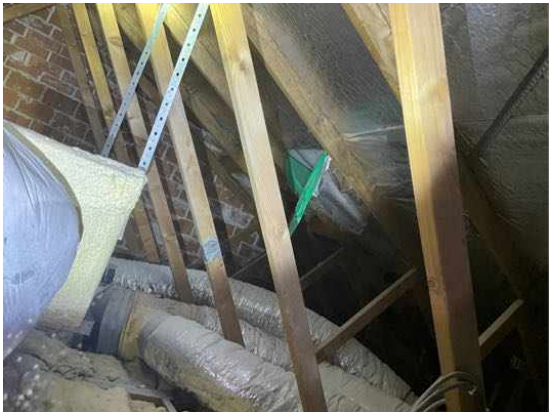
### Finding 3.21

Building:	Main Building
Location:	Roof Void
Finding:	Sarking - Damaged
Information:	Sarking, a laminated aluminium foil applied to the interior of the roof covering, assists in insulating the property and acting as a vapour-barrier to the roof void and, subsequently, to the household.

It is important to repair any holes or damaged sections of sarking to ensure that the building material is fully functional. A registered builder or qualified carpenter should be consulted to provide further advice on this defect and to perform rectification works at

client discretion.

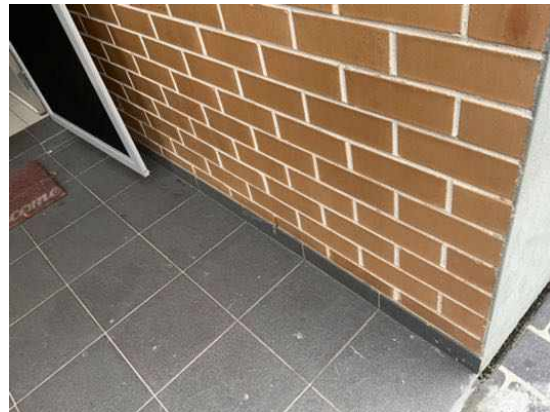
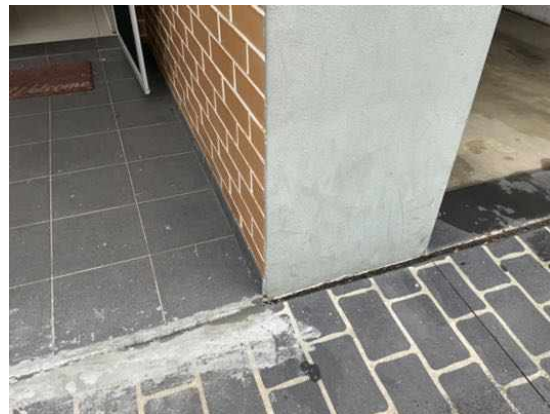
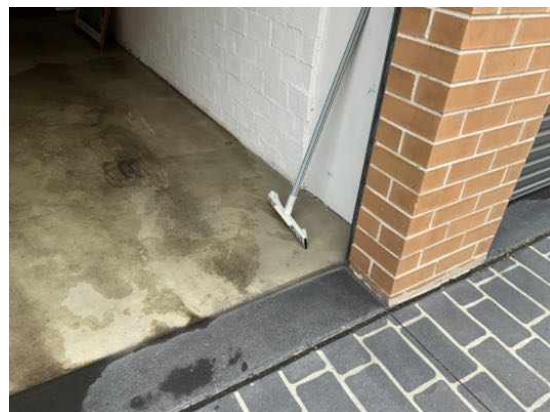
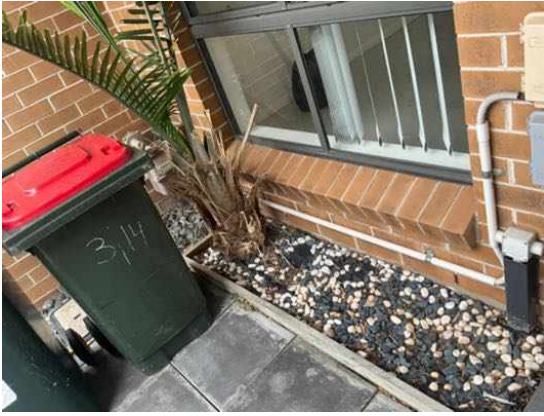
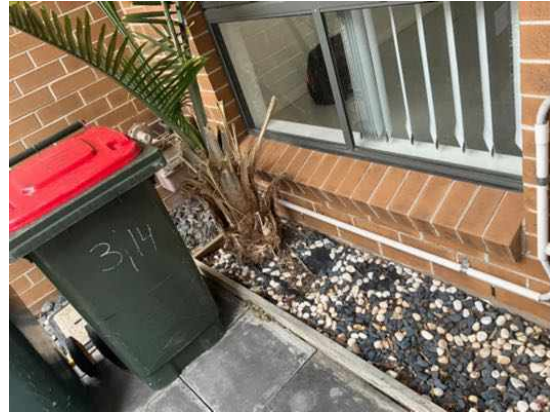
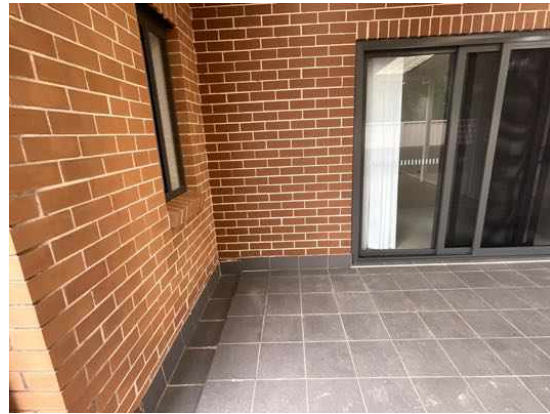
If the slab edge is not properly exposed there is a high risk of termite attack. Sometimes, in order to determine the type of slab, a suitably qualified person such as an architect or builder may be required to consult the construction plans.

Where the slab edge cannot be properly inspected, it is highly recommended that termite or timber pest inspections be carried out every 6-12 months to aid protection of the property against infestation.

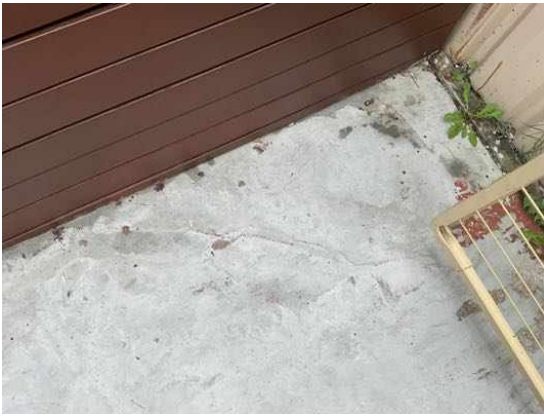
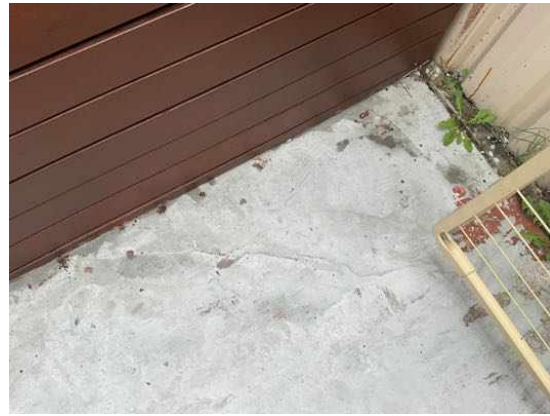
### Finding 6.03

Building: Main Building  
 Location: All Areas  
 Finding: Bridging or Obstruction Conducive environment for Termites  
 Information: Bridging of termite barriers occurs when termites bridge (usually by building a mud tunnel) a termite barrier or inspection zone or where termites have a passage, allowing them to bridge the barrier.

To prevent this, it's important to keep timber elevated and away from direct ground contact. Regular inspections and proper termite control measures are also essential to protect your wooden structures from termite damage.

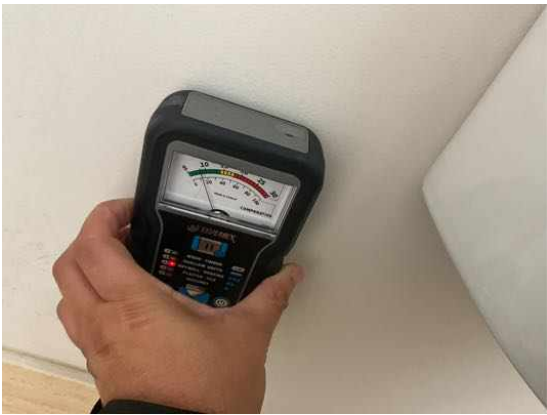
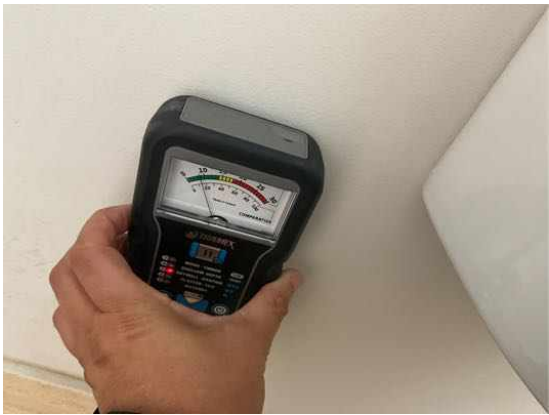
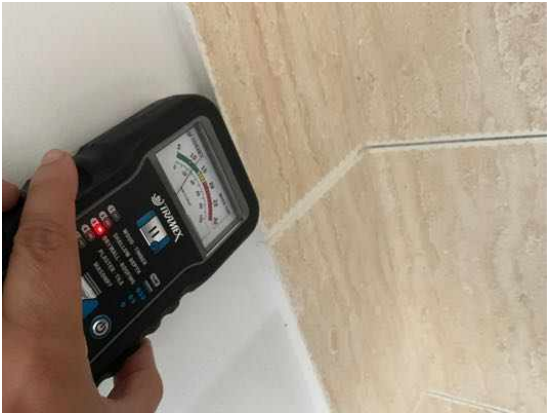
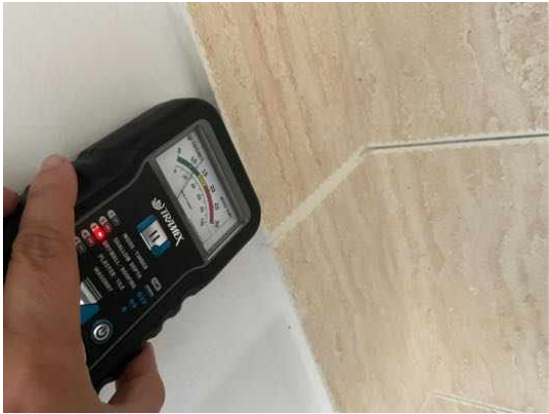
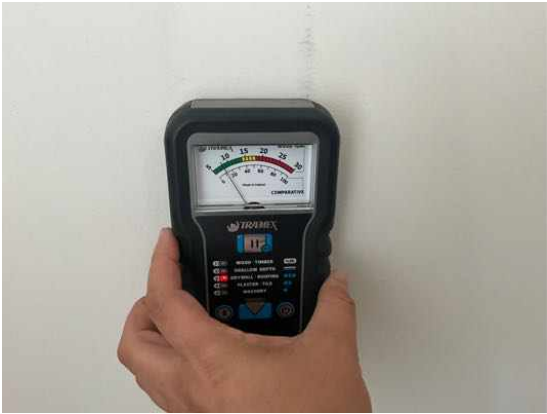
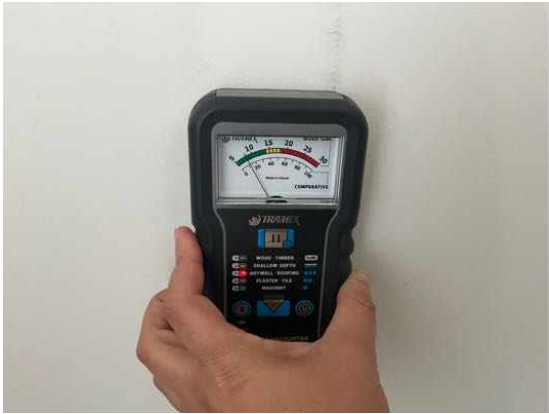
### Finding 6.06

Building:	Main Building
Location:	Bathroom
Finding:	Excessive moisture - Conducive to Timber pest
Information:	Excessive moisture can attract termites and produce conditions that promote fungal growth and wood decay.

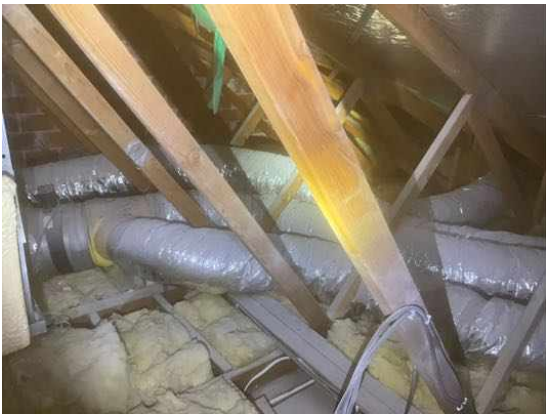
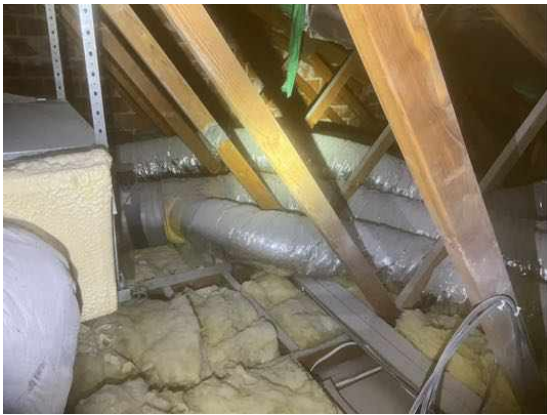
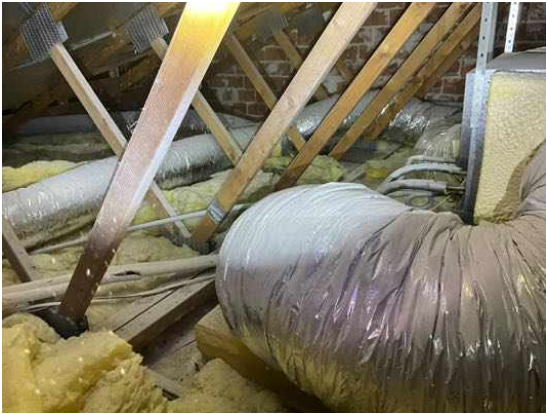
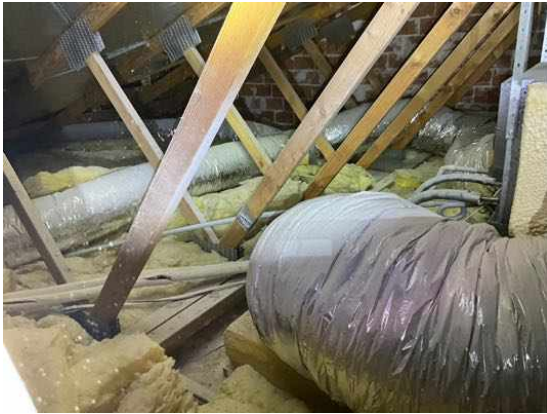
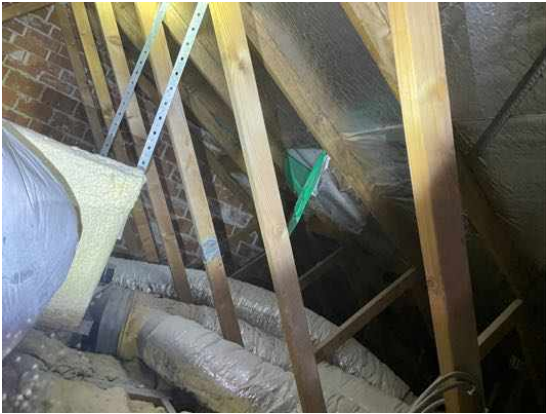
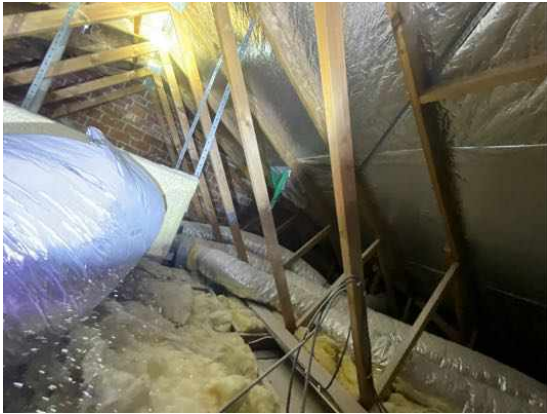
**Noted Item**

Building: Main Building  
Location: All Areas  
Finding: Additional Photos - Obstructions and Limitations  
Information: These photographs are an indication of the obstructions and limitations which impeded full inspection of the property at the time of inspection. These obstructions can hide an array of defects and should be removed to allow full inspection to be carried out. A re-inspection is recommended once the areas are made accessible.
