Building and Timber Pest Inspection Report

Inspection Date: Wed, 28 Jan 2026

Property Address: 2A Hancock Dr, Cherrybrook NSW 2126,
Australia

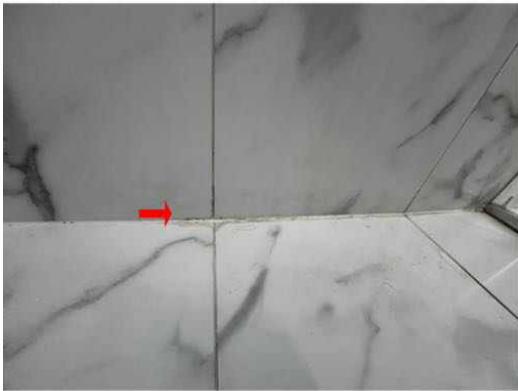
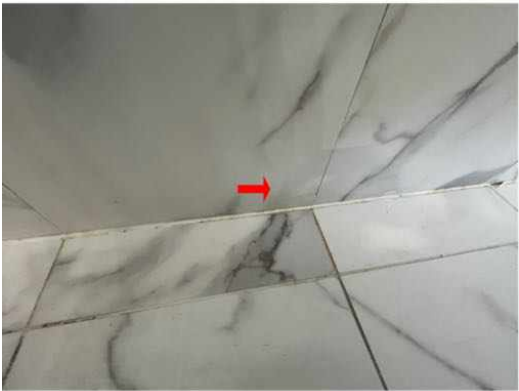
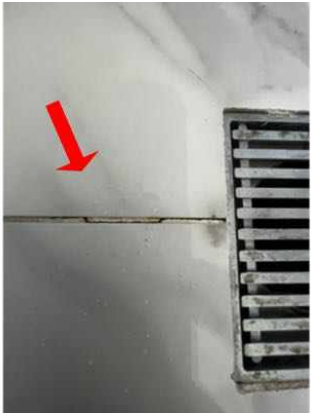
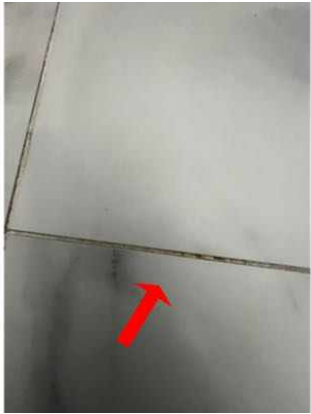
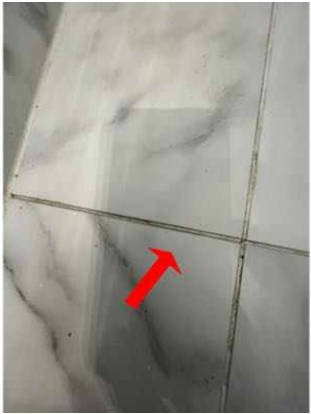
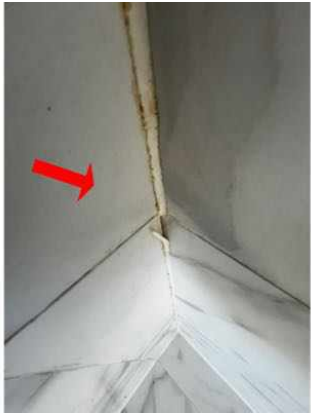
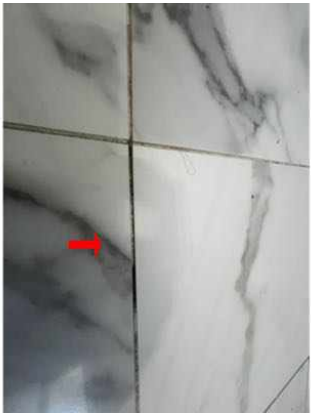
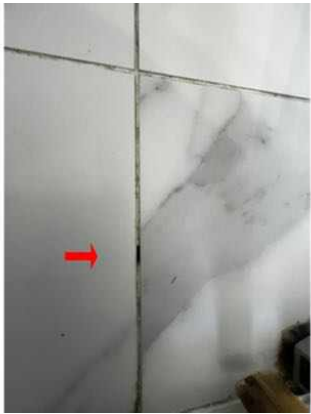
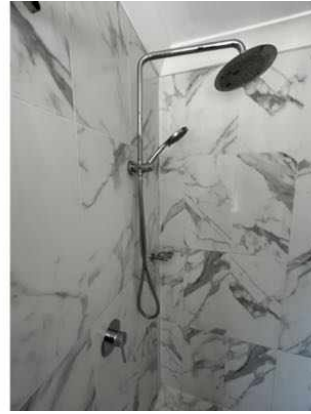
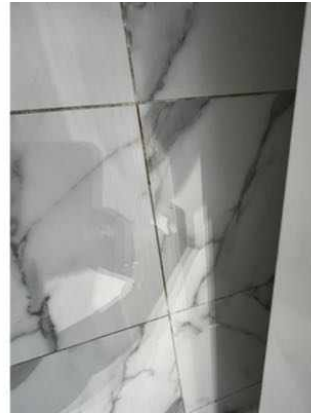
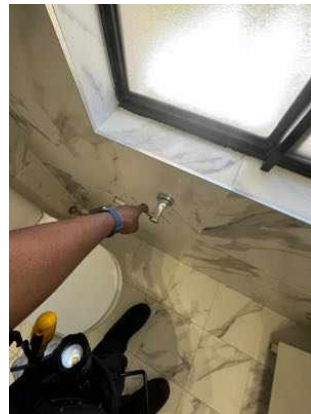
Building: Main Building
Location: Ensuite
Finding: Sealant and grouting - Missing or needs Cleaning
Information: It was noted on inspection that sealant or grout is to be cleaned and attended to before final handover in the tiled shower alcove and or other areas of the bathroom.

Different materials and floor areas move at different rates, generally causing cracking to grout or sealant at this point. A flexible sealant is required to allow for expected expansion and contraction, while keeping the joint water tight and protective of all associated building materials.

Flexible and mould resistant materials should be applied to affected areas to prevent any subsequent water damage that is likely to occur. Regular maintenance and replacement of damage or missing or damaged sealant and grout is highly recommended to the wet areas, as this is a regular wear and tear defect. Sealant and grouting in areas that come into regular contact with water should be maintained for the long term care of your property.

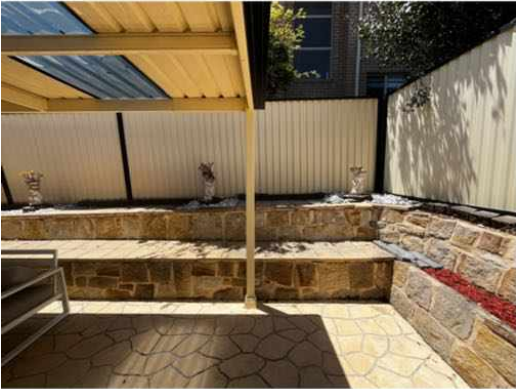
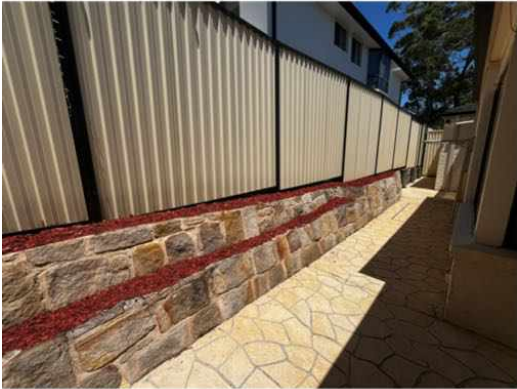
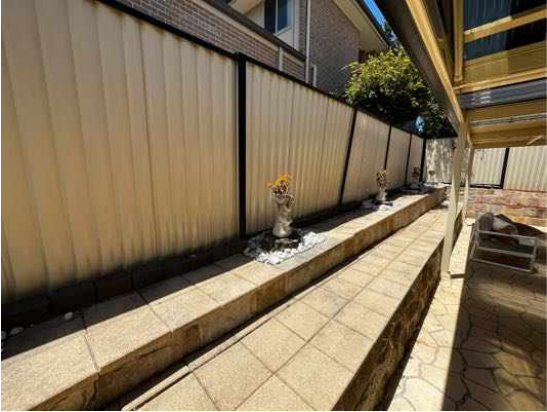
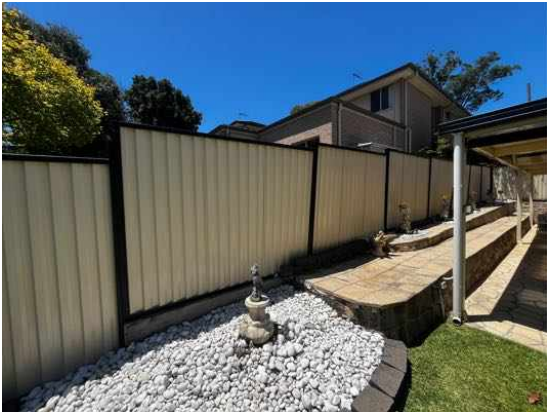
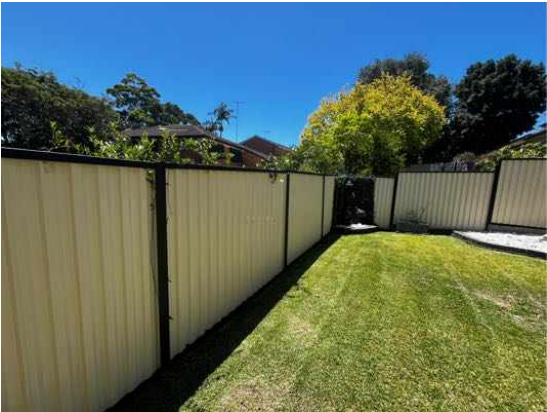
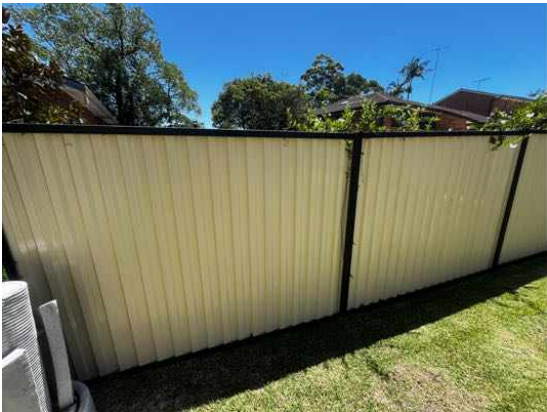
Building: Main Building
 Location: Yard
 Finding: Perimeter Fencing -
 Information: For your information photos taken at the time of inspection.

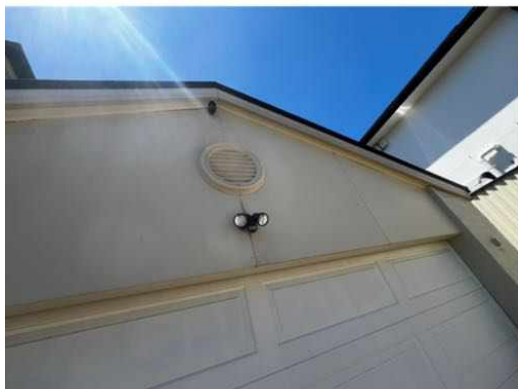
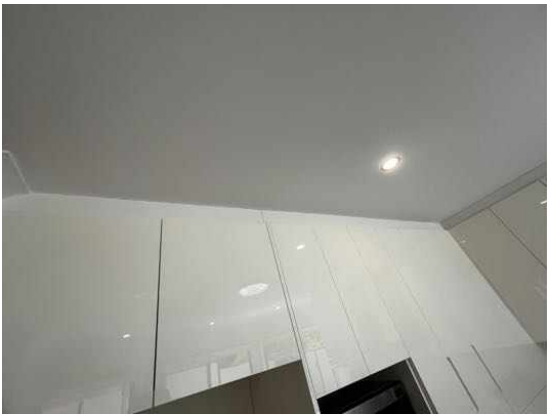
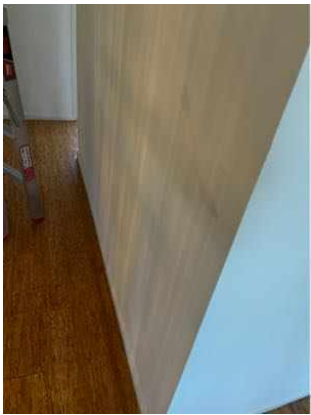
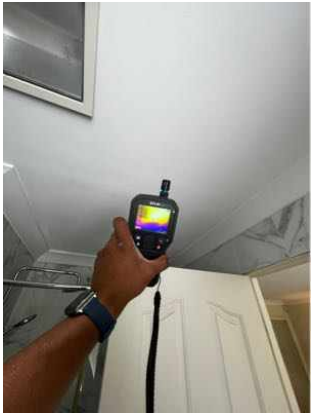
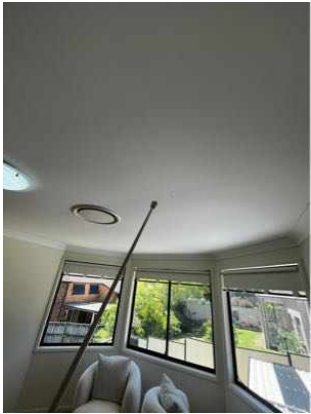
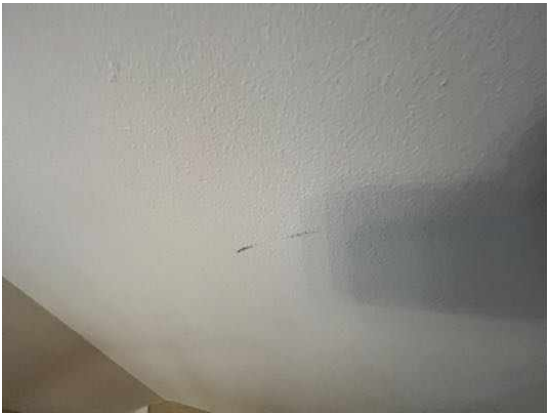
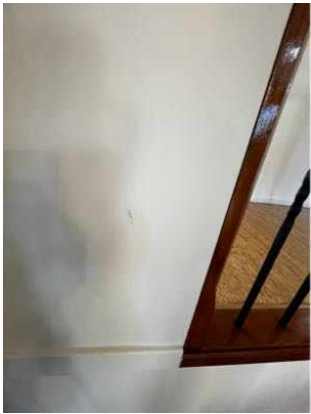
Finding 3.05

Whilst incomplete or missing paint finish is generally an appearance defect, it can also lead to the development of secondary building defects over time. Incomplete areas of paint finish expose the area to moisture, potentially accelerating the deterioration of underlying building materials.

Incomplete paint finishes should be sanded back, filled, leveled and painted, as applicable. Where inadequate or missing paint protection has led to the deterioration of the associated building element, repair and/or replacement of this building element may be required.

A painting contractor should be appointed as soon as possible to perform necessary works to aid the appearance of the affected area and to ensure the area is protected against further deterioration. Alternatively, the homeowner following manufacturer instructions may perform these works.

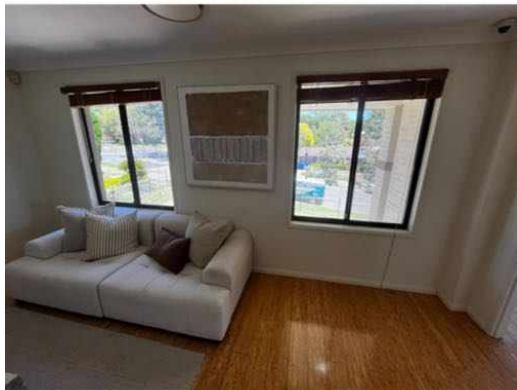
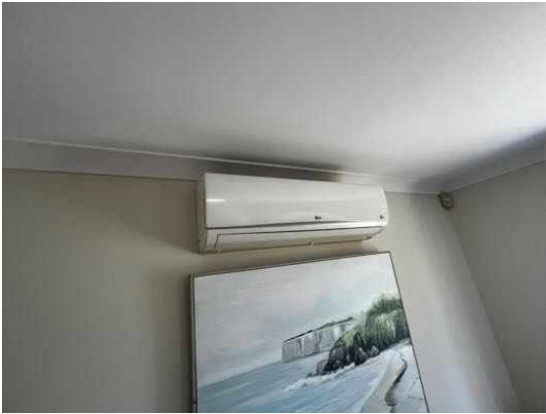
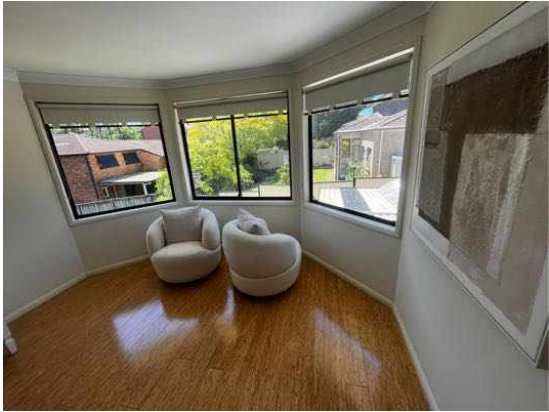
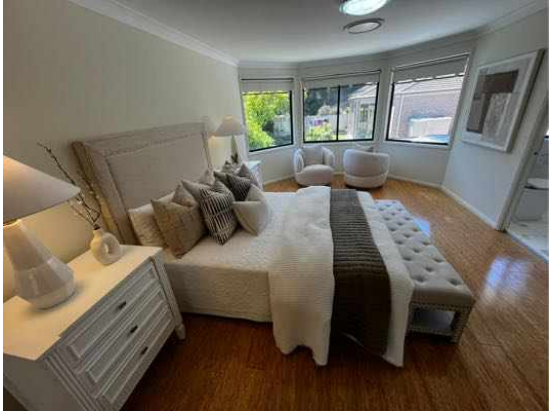
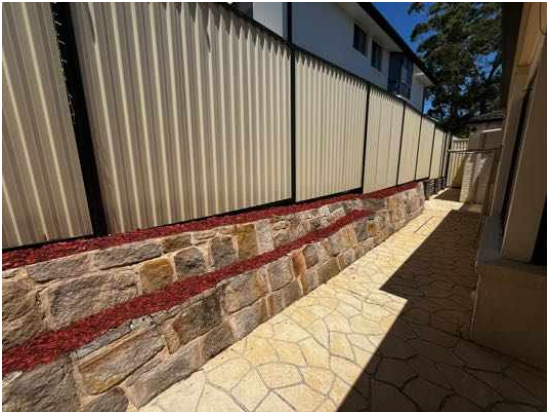
Finding: Additional Photos - Obstructions and Limitations

Information: These photographs are an indication of the obstructions and limitations which impeded full inspection of the property at the time of inspection. These obstructions can hide an array of defects and should be removed to allow full inspection to be carried out. A re-inspection is recommended once the areas are made accessible.

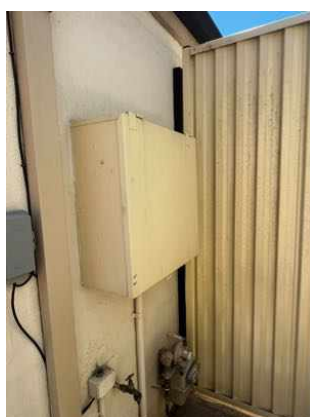
Finding 6.02

Building:	Main Building
Location:	Electrical Switchboard
Finding:	Evidence of a previous termite management system was identified
Information:	Upon Inspection There was a Durable Notice of Termite treatment identified but the date and the information in the notice was not readable/ identifiable - So It is highly recommended to have a termite treatment organised and to follow a termite treatment proposal and keep note of the system every 12 months in duration.

Where a Termite Management System has been identified you should refer to the type of barrier date of installation warranty conditions and any documentation provided by a builder or past owner. Consult the company who installed the barrier to confirm whether the system is still under warranty.

Most chemical termite management systems expire and require replenishment and all physical systems are primarily designed to prevent concealed entry.

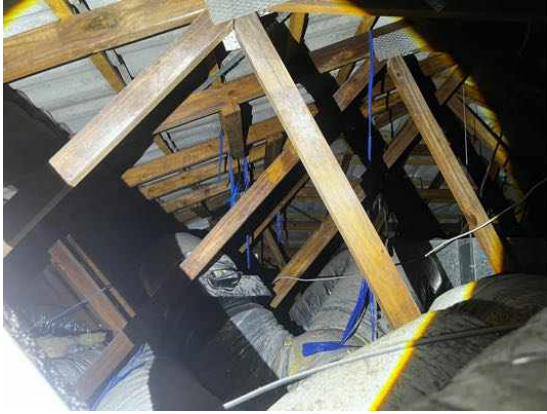
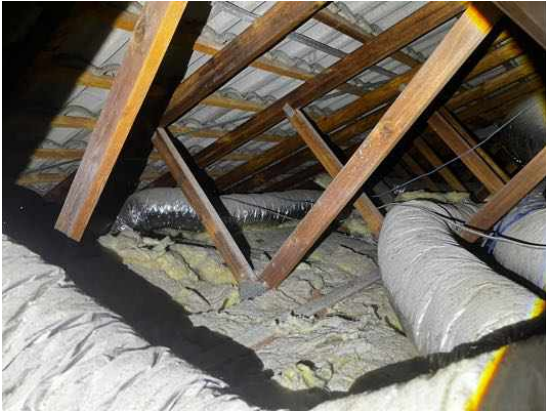
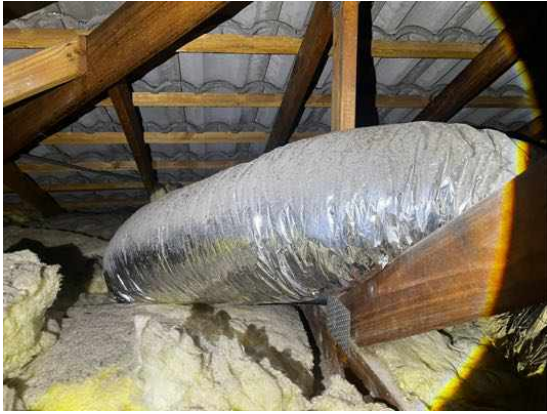
Finding 6.03

Building: Main Building
Location: Roof Void
Finding: Obstructions and Limitations - Roof space
Information: The Roof Void was inspected up to the safe point of access possible -

These obstructions can hide an array of defects and should be removed to allow full inspection to be carried out.

A re-inspection is recommended once the areas are made accessible.

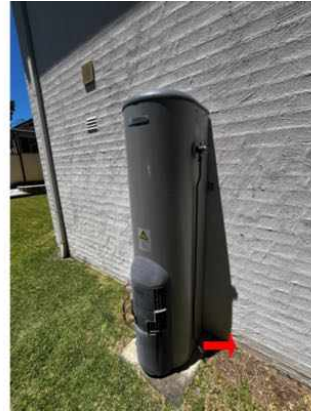
Finding 6.05

Building:	Main Building
Location:	All External Areas
Finding:	Slab Edge - Exposure (No Access)
Information:	An inspection zone of at least 75mm in relation to the exposed slab edge, between the bottom brick and the perimeter pavement, is required. This inspection zone should be maintained in order to force termites into the open where they can be detected more readily during regular inspections. The slab edge should not be concealed by anything that may prevent inspection of the area, including render, landscaping, soil, turf, paving, concrete cladding or other structures.

If the slab edge is not properly exposed there is a high risk of termite attack. Sometimes, in order to determine the type of slab, a suitably qualified person such as an architect or builder may be required to consult the construction plans.

Where the slab edge cannot be properly inspected, it is highly recommended that termite or timber pest inspections be carried out every 6-12 months to aid protection of the property against infestation.

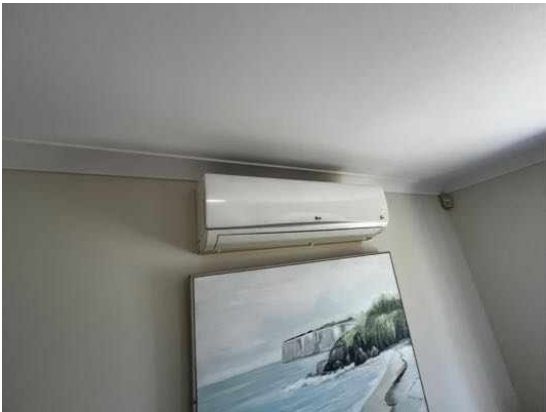
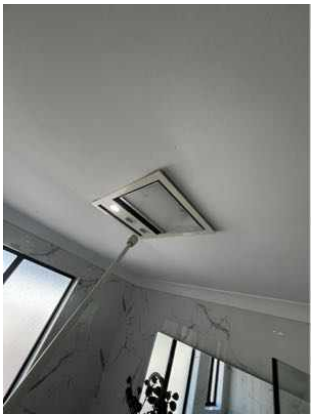
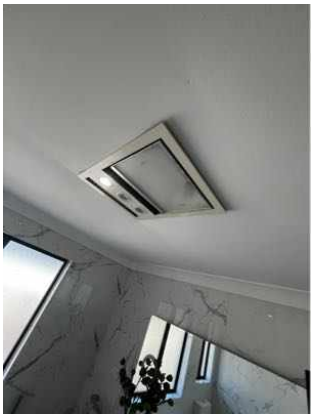
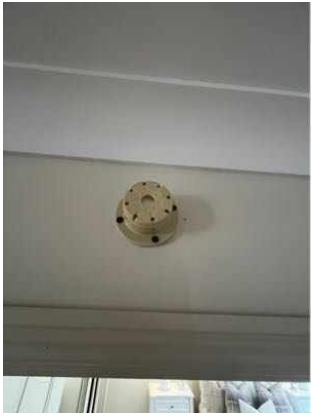
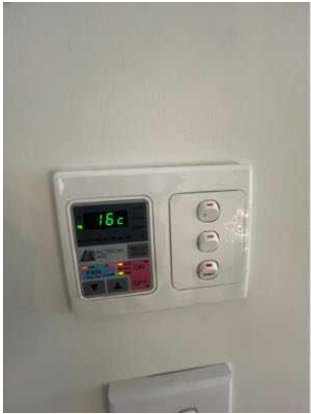
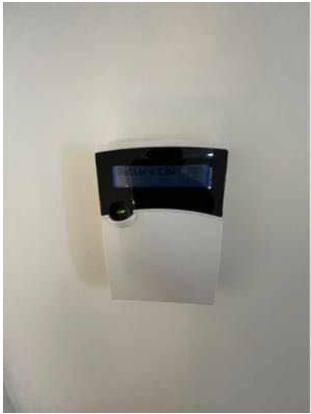
Building: Main Building
Location: All Areas
Finding: Plumbing/electrical/gas/aircon/appliances/pool equipment/fire safety etc
Information: Plumbing and electrical inspections are outside the scope of the building inspection and must be conducted by a Licensed and registered Trades person.

It was noted that the Appliances in the kitchen had to be installed yet during inspection.

It is highly recommended that the client makes immediate arrangements to have the gas appliances checked by a licensed gas plumber to ensure that the appliances are working safely and efficiently.

We recommend all other installations be checked also.

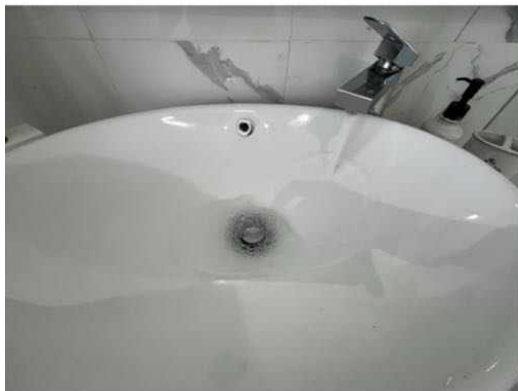
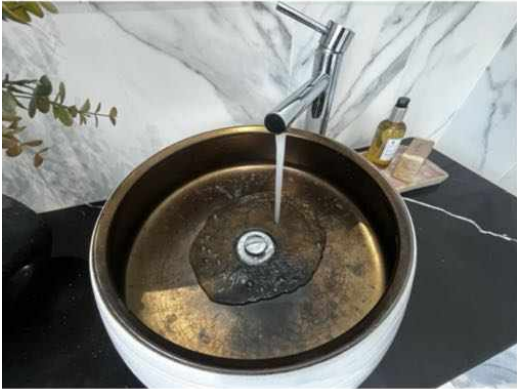
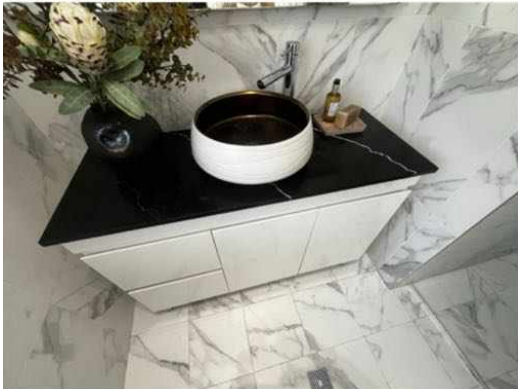
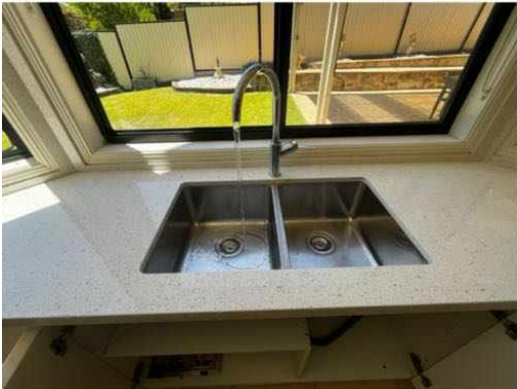
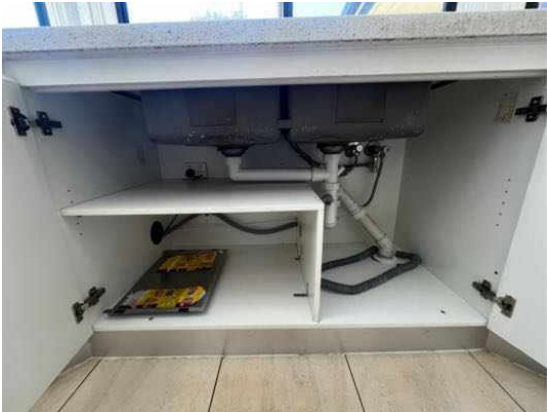
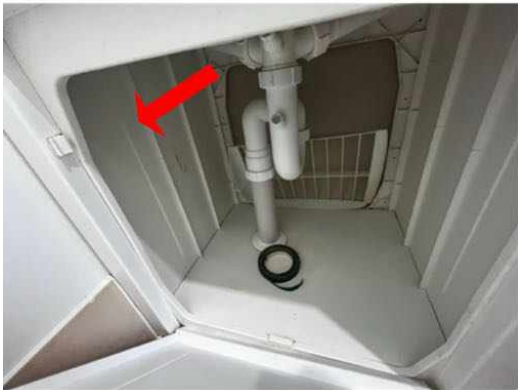
Information: All cupboards where sinks and basins with drainage plumbing were inspected and the ensuite vanity had evidence of leaks were present at the time of inspection.

The Laundry tub door was damaged noted during inspection.

The shower rail and head in the ensuite had signs of rust during inspection.

If damp or wet conditions do occur there are many consequences including the development of fungal decay and/or wood rot, swelling or water damage to building materials.

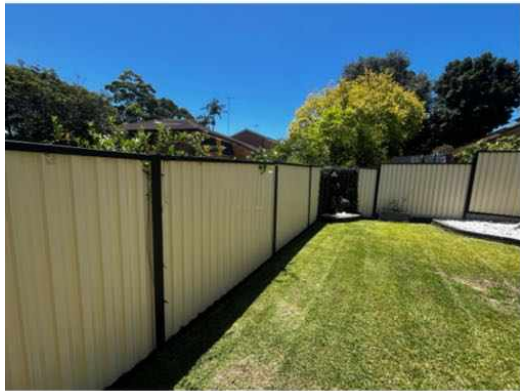
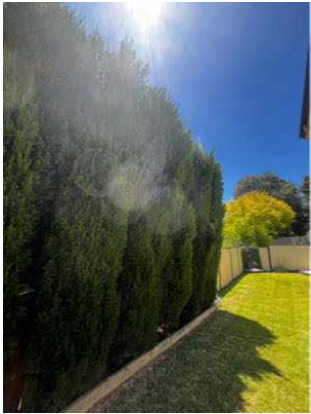
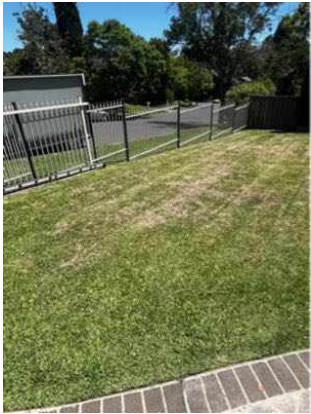
The general adequacy of site drainage is not included in the standard property inspection report. Comments on surface water drainage are limited as where there may have been either little or no rainfall for the period of time, Surface water drainage may appear to be adequate during the inspection but then during periods of heavy rain, may be found to be inadequate.

Any comments made in the section are relevant only in light of the conditions present at the time of inspection. It is recommended that a smoke test be obtained to determine any illegal connections, blocked or broken drains.
