Building and Timber Pest Inspection Report

Inspection Date: Wed, 28 Jan 2026

Property Address: 7/11 Lisson Grove, Hawthorn VIC 3122,
Australia

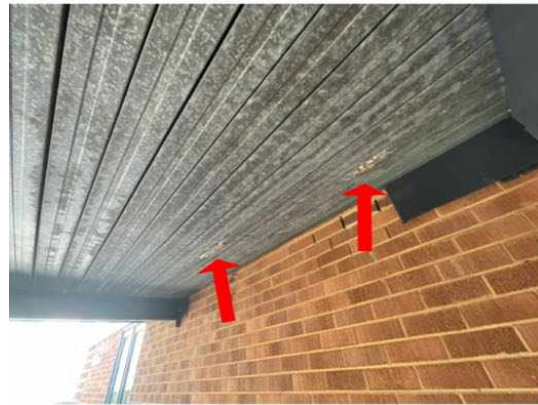
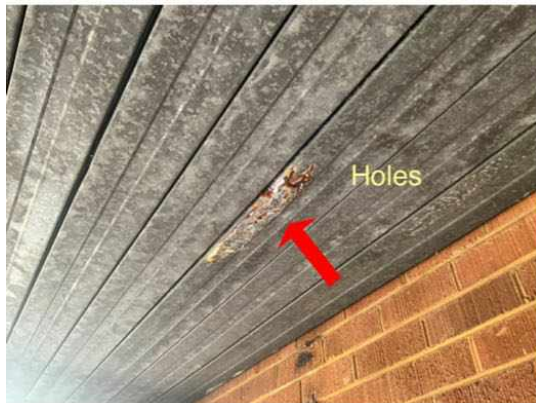
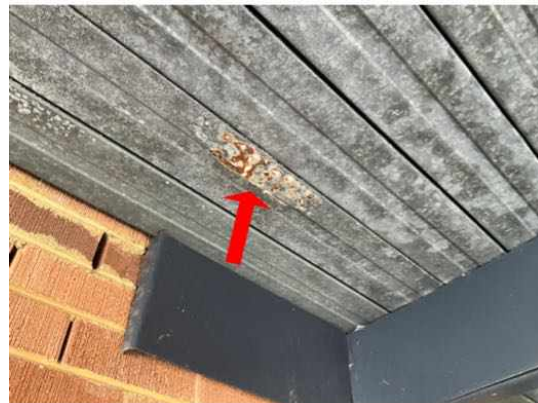
Finding: Metal Roof - Deteriorated and rusting (possible owners corporation issue)

Information: Upon inspection of the exterior roofing of the carport, it was found that the metal roof shows signs of deterioration due to rust, with holes noted within the surface.

Rusted, deteriorated and damaged metal roofing is susceptible to water penetration, exposing the surrounding associated area to internal roof leaks and potential water damage.

Rusting was noted to the flat metal roof above the carport. Holes were evident in some of these rusted areas. It is suspected sections of this roof sheeting will need to be replaced. This is listed as a major defect as value to rectify will cause further deterioration of the property.

A roofing contractor should be appointed immediately to assess the damage to the metal roofing and to perform remedial works as necessary. Works may include replacement of severely affected roofing or minor works such as the application of rust-retardant surface protectors.

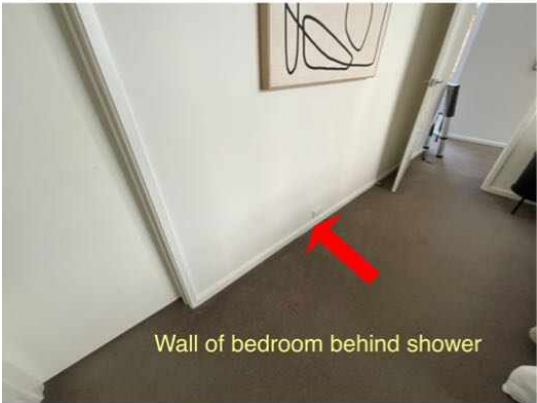
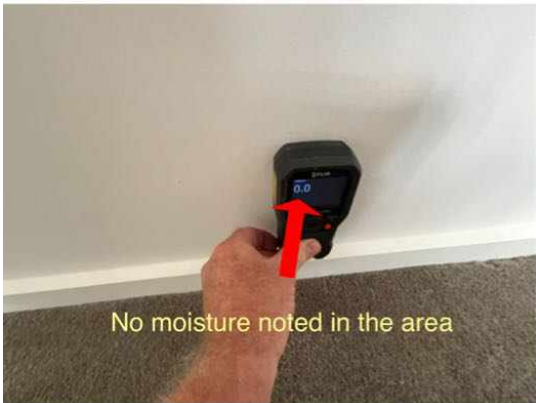
Building:	
Location:	Bathroom
Finding:	Shower - Damp noted within wall of shower
Information:	Damp was evident to the lower part of the tiled walls within the shower alcove when tested with a moisture meter. This defect is quite common, and is suspected to have been caused by moisture permeating through the grouting in this area, which shows evidence of deterioration. Leaking pipes within the adjoining wall is also a possible cause although there was no moisture noted higher up the wall nor to the wall in the bedroom or living area behind the shower.)

Damp (or structural damp) refers to the presence of unwanted moisture in the structure of a building, either as the result of intrusion from outside, or condensation from within the structure. In the shower area, internal water leaks or other sources of excessive moisture are generally the cause of damp.

Unmanaged damp in the shower recess can facilitate the formation and development of mould and fungi growth. It is important to address damp conditions, as the World Health Organisation notes that excess moisture leads - on almost all indoor materials - to growth of microbes such as moulds, fungi and bacteria, which subsequently emit spores and other matter into the indoor air. Exposure to these contaminants is associated with a wide range of respiratory and other health-related problems.

Moisture was noted within the lower walls of the shower and also in the architraves and skirting immediately next to the shower area. It is suspected this has been caused by internal spills from the shower. No moisture was noted to the wall behind the shower in the bedroom and the living area.

Should the damp continue and/or staining to the walls behind the bathroom occurs, consultation with a qualified plumber or bathroom specialist would be advised

immediately to identify the cause of damp and to perform remedial works as required.

Always ensure that sealant and grout is in good condition to prevent any moisture issues occurring in the future.

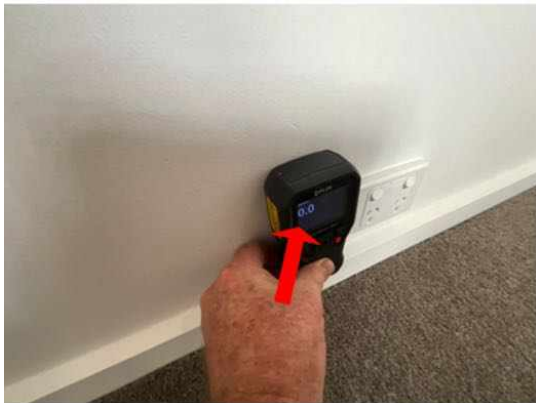
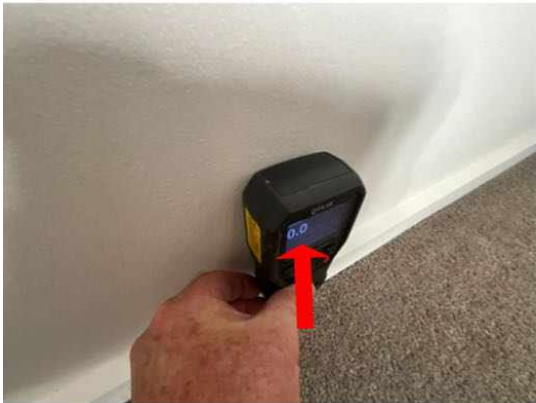
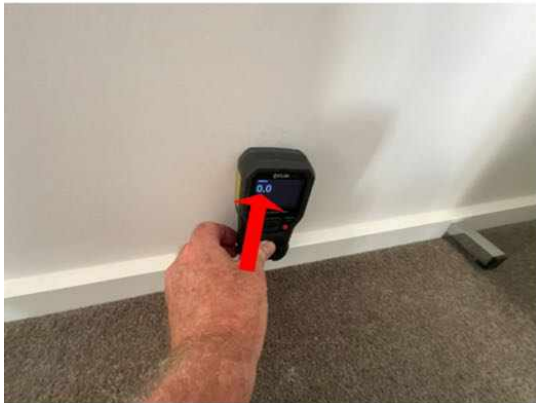
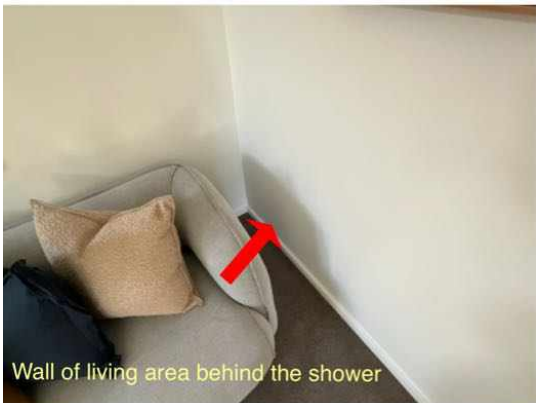
No moisture noted in the area

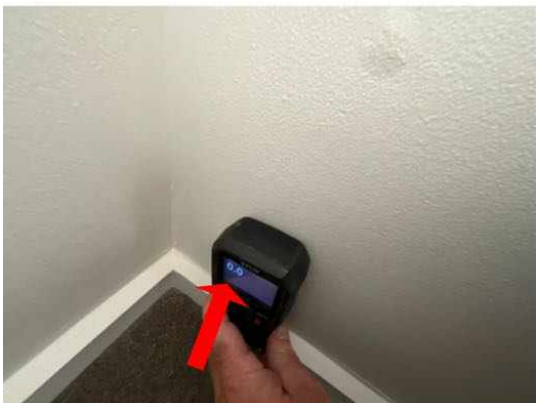
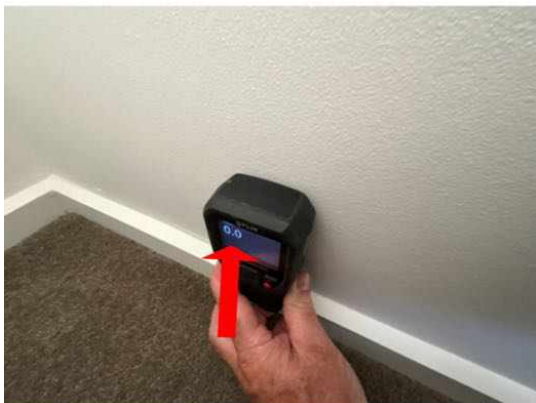
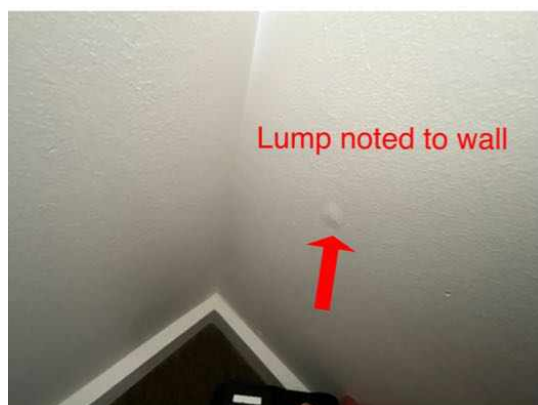
No moisture noted within the area

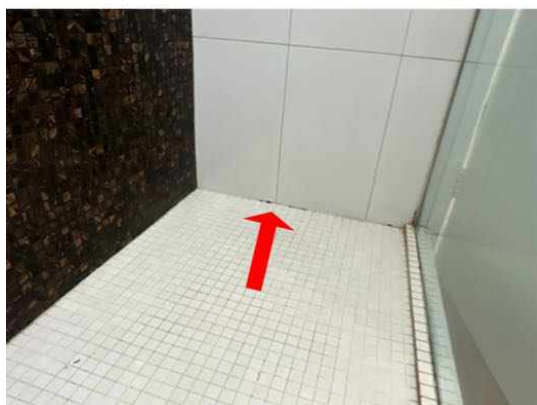
Finding 3.05

Finding: Grout and sealant - Missing or degraded within the bathroom area

Information: It was noted on inspection that grout or sealant is degraded to the shower and other areas within the bathroom.

Different materials move at different rates, generally causing cracking to grout at this point. Build up of moisture in the bathroom can also cause grout and sealants to degrade and become mouldy.

Any damaged or degraded materials should be scraped out and flexible and mould resistant materials should be applied to affected areas to prevent any subsequent water damage that may occur. Regular maintenance and replacement of damaged or missing grout/ sealant is highly recommended to the wet areas, as this is a regular wear and tear defect. Both grout and sealant in areas that come into regular contact with water should be maintained for the long term care of your property.

A bathroom specialist or tiling contractor should be appointed to complete these works as a matter of urgency.

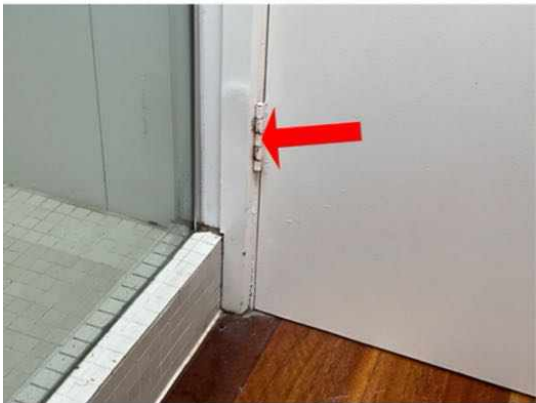
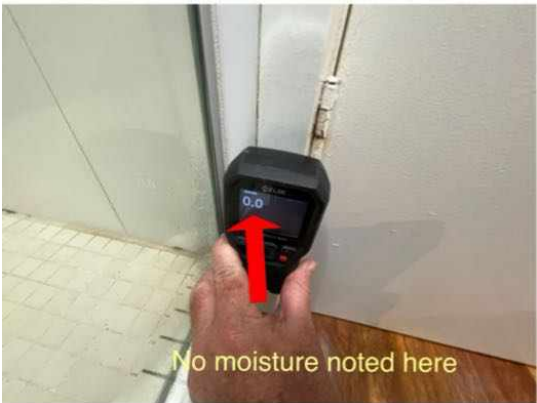
Finding 3.06

Finding: Moisture damage to architrave and door frame with current moisture noted in the area

Information: Evidence of moisture damage was identified to the architrave and door frame in the bathroom. Current Moisture was also noted within the area when tested with a moisture meter.

It is suspected that moisture has escaped the shower and soaked into the timber framing next to the shower.

It is highly recommended that a bathroom specialist be engaged to inspect the area to improve the water tightness of the bathroom and prevent moisture exiting. Where moisture damage is not severe, minor repairs and repainting may be carried out. Where damage becomes excessive, replacement of framing may be required.

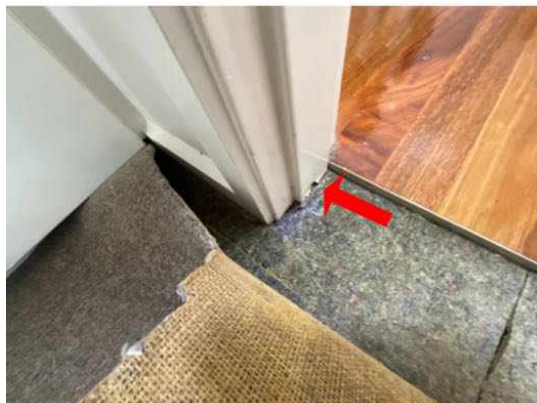
No moisture noted

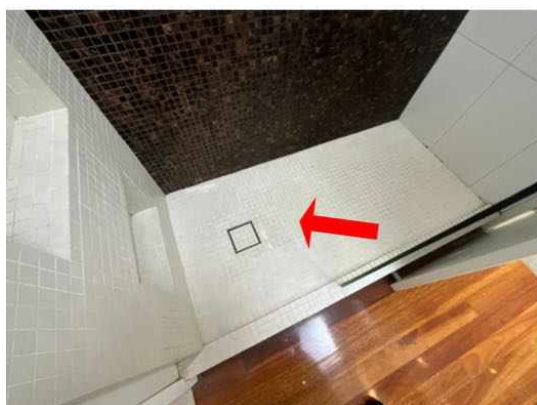
Finding 3.07

This pooling is minor overall but is still considered unsatisfactory, as correct tiling practices would not permit this situation to occur. Pooling water around floor tiles can create a slip hazard in extreme cases and also create conditions that are conducive to mould growth over time. Where left unmanaged, the degradation of sealant and grouting may also occur, possibly necessitating further repair works.

In severe cases (not noted in this instance) , works may involve repair and replacement of some sections of tiling and flooring . A tiling contractor or bathroom specialist can be appointed to provide further advice on repair options and to perform works as necessary.

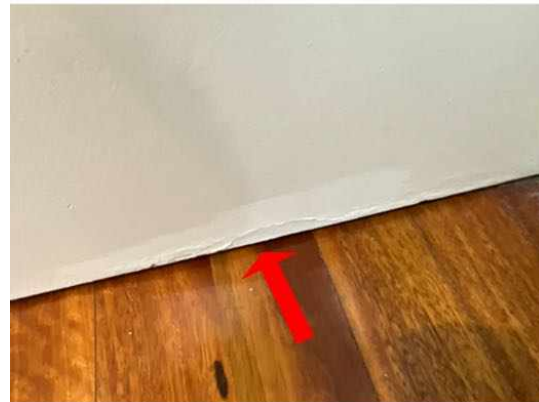
Finding 3.08

Finding: Door showing signs of damage to the base
 Information: At the time of inspection moisture damage was noted to the base of the door in the bathroom. It is suspected moisture may have entered the base of the door from internal spills.

Doors should be sealed on all faces including top and bottom to prevent moisture seeping into the door structure and potentially causing secondary damage.

A suitably qualified handyman should be engaged to inspect the door. The door should be removed, repaired and repainted to seal all exposed faces.

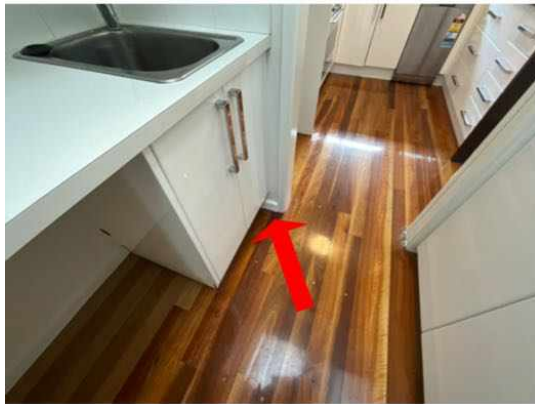
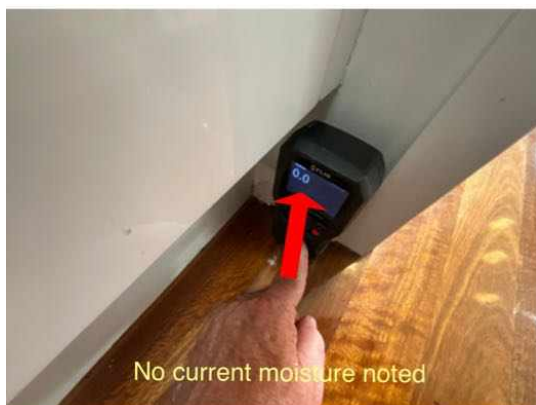
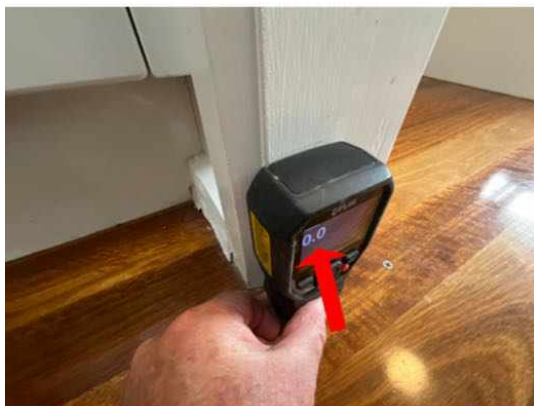
Finding 3.09

Building: Laundry
 Location: Laundry
 Finding: Moisture damage to architraves and door frame in the laundry area
 Information: Evidence of moisture damage was identified to the architraves and door frame in the laundry area.

It is suspected that this has occurred as a result of excess moisture from internal spills.

At the time of inspection no current moisture was noted when checked with a

moisture meter. As a result , no further damage is likely in this area.

A licenced carpenter or competent handyman should be engaged to inspect the moisture damaged areas and repair or replace any items where necessary.

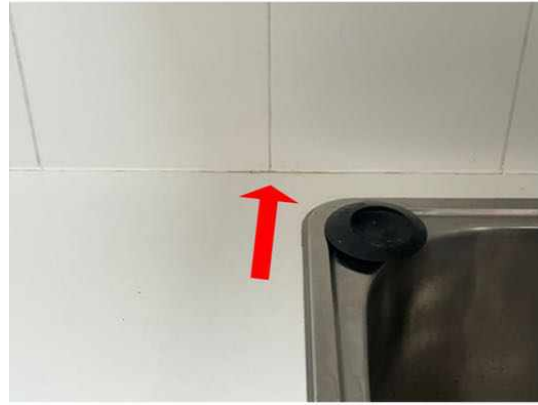
Finding 3.10

Building:	
Location:	Laundry
Finding:	Sealant - Damaged or Missing
Information:	Sealant is damaged in this area. Sealant is used to protect gaps and crevices in building materials to ensure that they are water-tight and prevent water penetration to the associated structures.

Failure to do so may lead to further deterioration of the sealant which in turn can lead to water damage to the surrounding area.

Where sealant is missing or damaged , a competent handyman may be appointed to scrape out and re-apply any silicone where necessary.

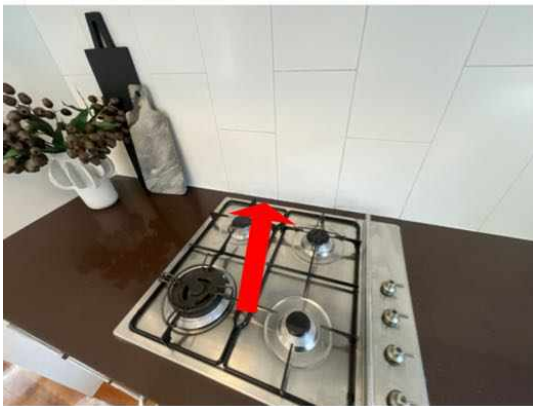
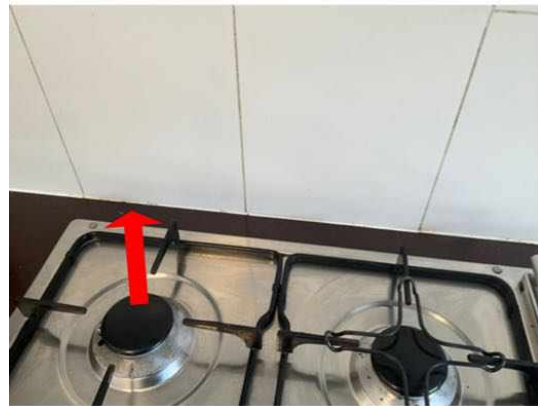
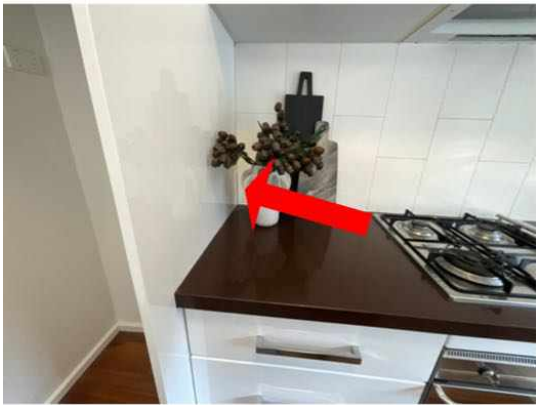
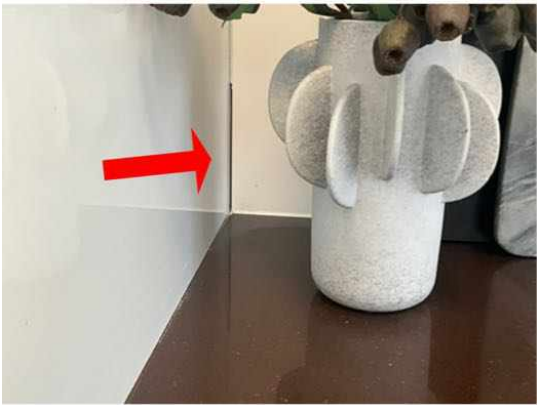
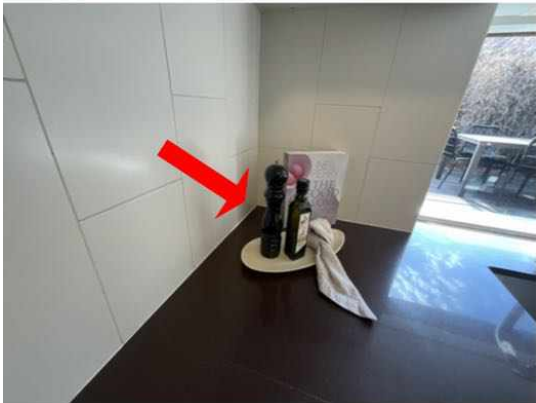
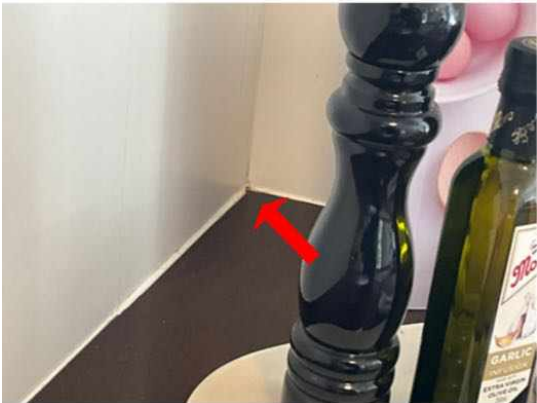
Finding 3.11

Finding: Grout/ sealant - Missing or degraded

Information: Grout/ sealant is missing or degraded in this area. Grout and sealant is used to protect gaps and crevices in building materials to ensure that they are water-tight and prevent water penetration to the associated structures.

Failure to do so may lead to further deterioration of the grout or sealant which in turn can lead to water damage to the surrounding area.

Where grout or sealant is missing, a tiling contractor should be appointed immediately to apply grout and re-apply any silicone where necessary.

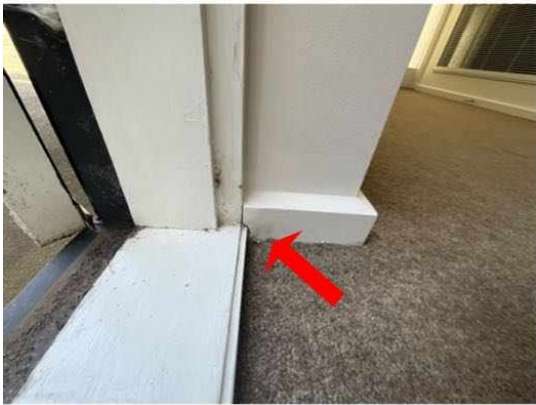
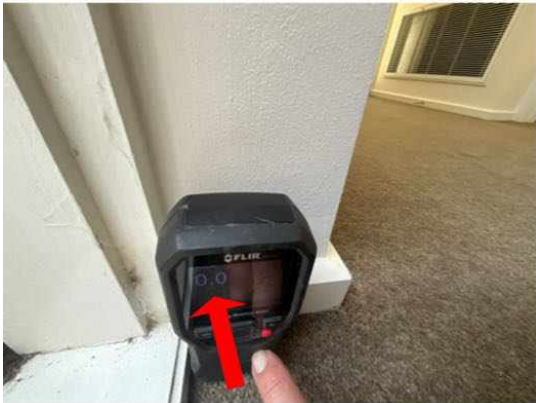
Finding 3.12

Building:
Location: Living Room
Finding: Moisture damage to the door frame of the French doors.
Information: Evidence of moisture damage was identified to the door frame of the French doors in the living area.

It is suspected that this has occurred as a result of excess moisture from external sources. No current moisture was noted in the area when tested with a moisture meter.

A licenced carpenter or competent handyman should be engaged to inspect the moisture damaged areas and repair or replace any items where necessary.

Should further damage occurred to the framing, further works may be required to prevent moisture ingress in this area.

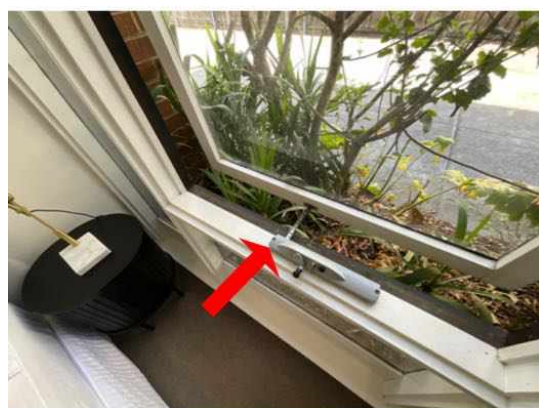
Finding: Window winder loose - window still operates

Information: At the time of inspection the window winder to the bedroom window appeared to be loose. It is suspected that this has occurred as a result of deterioration with age.

Even though the winder is loose, the window was still able to be operated.

It is recommended that the winder be tightened.

A competent handyman or window specialist can be engaged to perform this task.

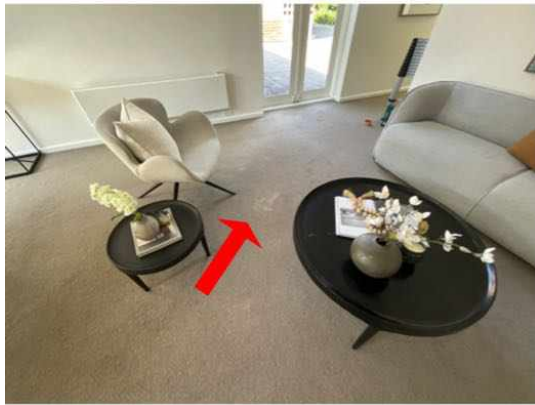
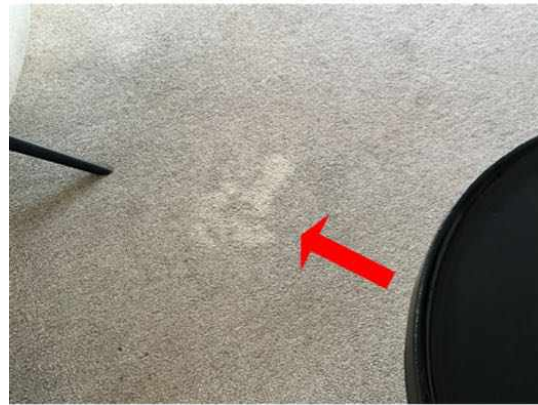
Finding 3.15

Finding: Carpet deteriorated in some areas

Information: At the time of inspection, some areas of the carpet throughout the property showed signs of wear. This is consistent with properties of this age.

Please note other areas of the property may have deteriorated carpet but not be shown here

The carpet may be replaced at the discretion of the homeowner.

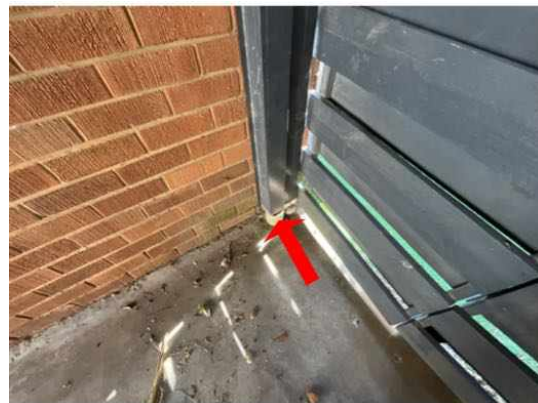
Finding: Building element - Rusted or corroded

Information: This building element shows evidence of slight rusting and corrosion, which is likely to have developed as a result of excessive exposure to moisture and or inadequate coatings.

As surface rust provides no protection to the underlying iron, the deteriorating condition is likely to worsen if not addressed in the short-term future.

Where possible, the use of galvanized (treated) metals or aluminium coated metals aid in rust prevention, as does regular general maintenance. Rusting and corrosion should be managed by ideally removing or limiting the affected surface from exposure to moisture. Rust formation can be controlled with coatings, such as paint, that isolate the iron from the environment.

Where sealing with a specialised coating is not effective, a registered builder may be appointed to replace any building elements that have been severely affected by rust or water damage.

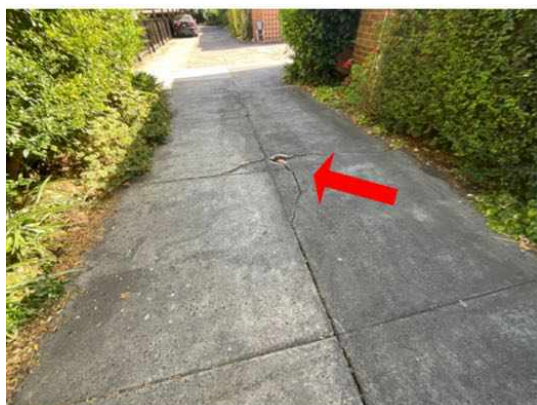
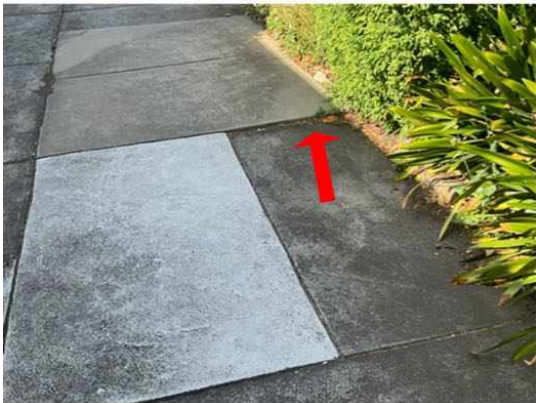
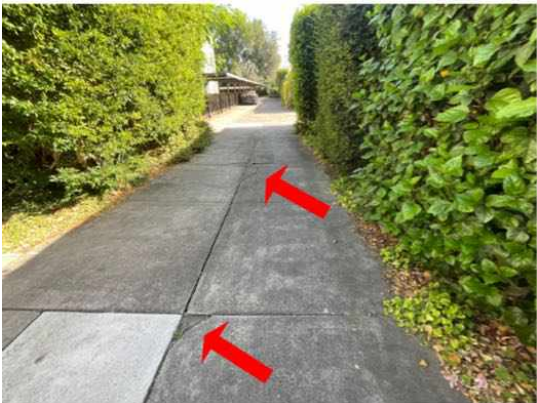
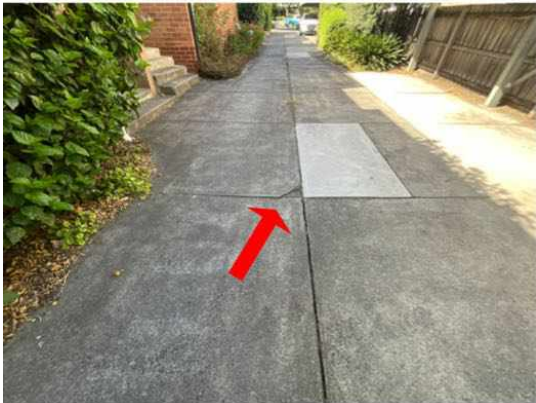
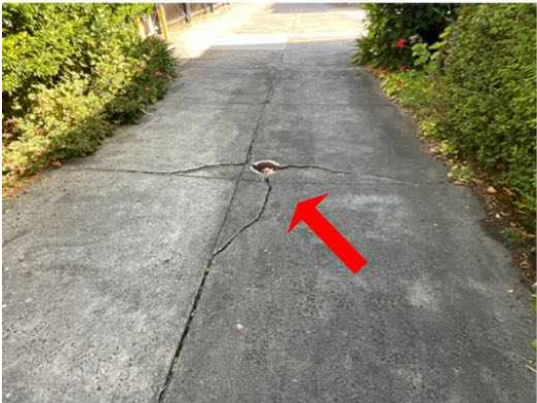
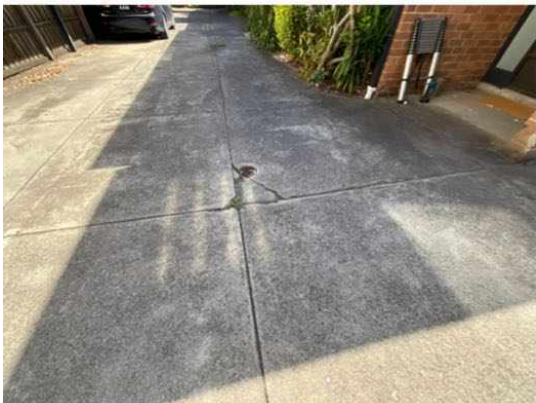
Finding 3.19

Building:
Location: Driveway
Finding: Cracking - Noticeable cracking to driveway paving (probable owners corporation issue)
Information: Noticeable cracks were identified in the concrete paving of the driveway. These noticeable cracks may lead to the development of tripping hazards and secondary defects if they develop further.

General age and expected deterioration of the paved areas is a common cause of this type of cracking. However, expansion and contraction of the driveway may also have occurred due to environmental factors. Such factors include variable moisture and weather conditions, the presence of trees and their roots having a settling or lifting affect on the soil, or the effect of load bearing, e.g. heavy vehicles over a sustained period of time.

Cracking to this degree may also be due to poor original installation of the driveway. Factors such as poor compaction of the sub surface and/or inadequate reinforcing of the slab may create cracking and other secondary defects. Noticeable cracks may also be due to subsidence of soils.

The area should be monitored for any changes that may occur and potentially cause tripping hazards. Should this occur, repair or replacement of the concrete paving may be necessary.

Please note: it is suspected this would be covered by the owners corporation. Your own enquiry should be made to determine whether this is the case.

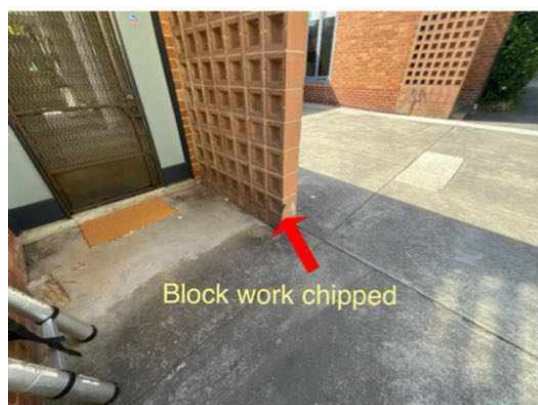
Finding 3.20

Building:
Location: All Areas
Finding: Additional Photos - minor defects
Information: Additional photos are provided for your general reference. Arrows have been included where necessary to highlight areas of importance.

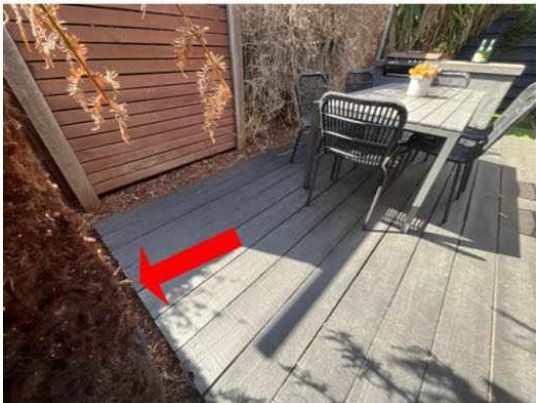
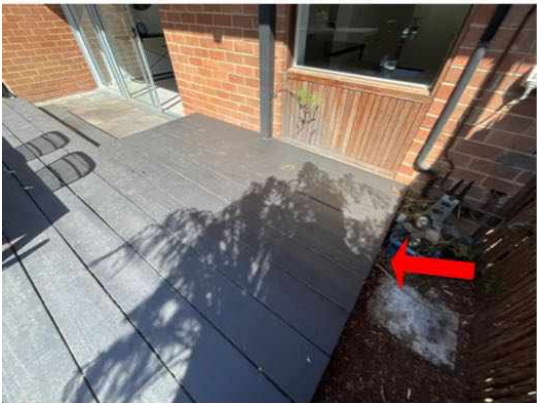
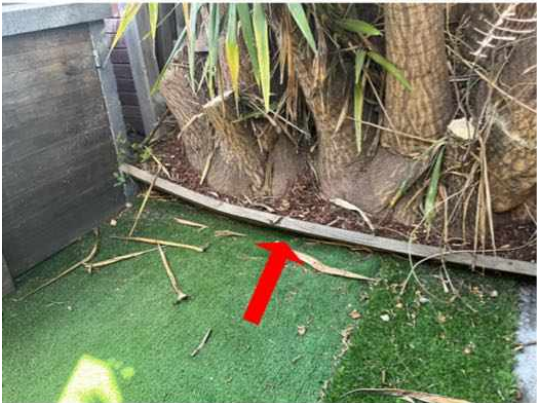
Information: Where timber elements are in direct contact with the ground and consequently moisture or dampness, they become conducive to termite activity. Whether timber is used as a building element, part of a fencing structure or stored as an unused item, they can provide an environment that is attractive to termite infestation.

When met with excessive moisture, timber begins to decay and develop wood rot. Any timbers that are in direct contact with external grounds especially if left untreated or non-durable also provide ingress for subterranean termites into that particular element.

Where possible, the removal of any such materials that may be conducive to termite activity should be carried out as soon as possible to minimise the risk of termite attack. Where not possible or practical, regular monitoring of timber elements is recommended. Replacement of any damaged materials should be carried out where necessary.

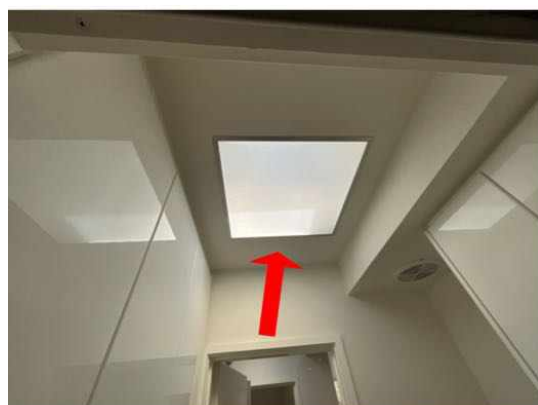
The ceilings around the skylights should be regularly monitored for any evidence of moisture leaking eg staining or bubbling of paint.

Where moisture damage is evident, a plumber should be appointed as soon as possible to identify the leak and perform rectification works as necessary, ensuring the moisture damage is restricted.

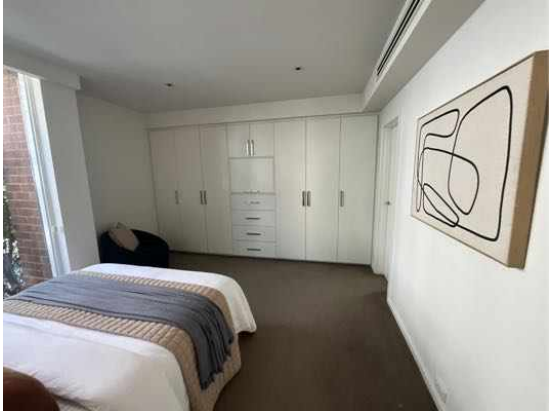
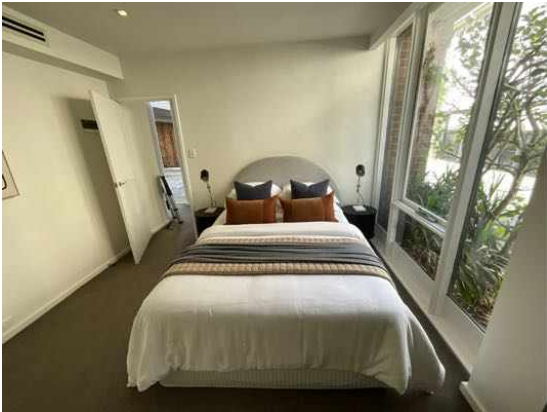
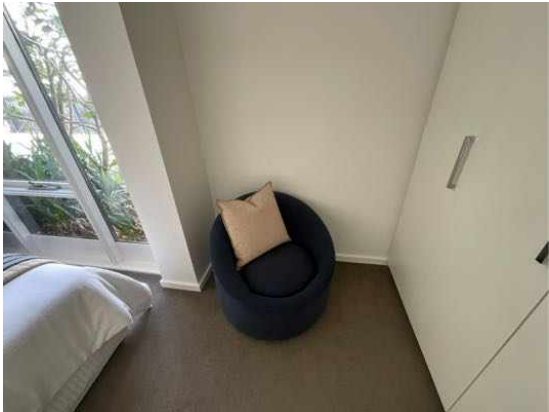
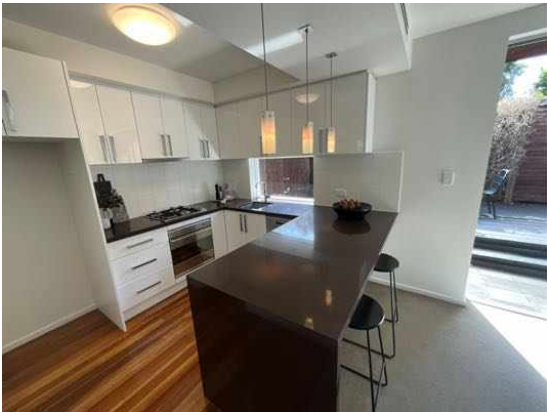
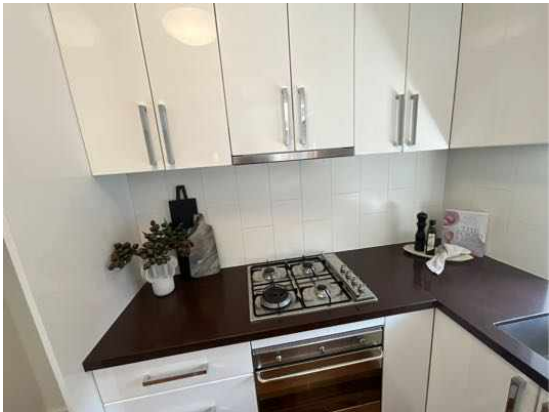
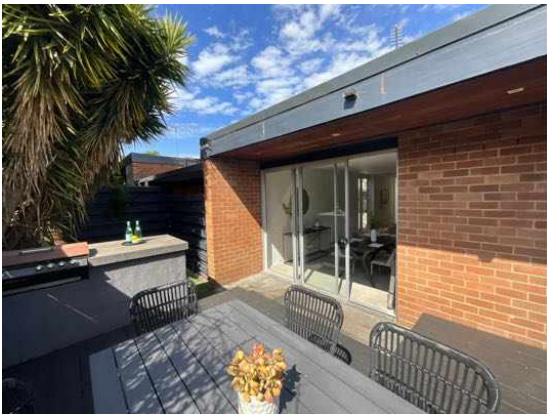
These photographs are an indication of the obstructions and limitations which impeded full inspection of the property at the time of inspection. These obstructions can hide an array of defects and should be removed to allow full inspection to be carried out. A re-inspection is recommended once the areas are made accessible.
