# Building and Timber Pest Inspection Report

Inspection Date: Wed, 21 Jan 2026

Property Address: 1/86 Lincoln Rd, Croydon VIC 3136,  
Australia

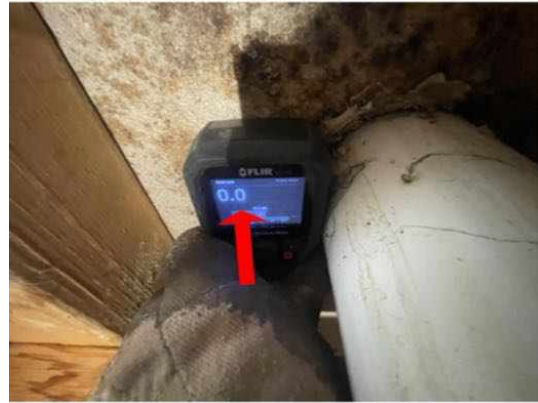
Finding: Moisture staining to flooring underneath ensuite bathroom

Information: At the time of inspection, the flooring underneath the ensuite bathroom area had evidence of moisture staining when viewed from within the subfloor. No current moisture was noted in the area when tested with a moisture meter.

It is suspected that there may have been a moisture leak from the shower or the vanity within the ensuite bathroom previously, causing the staining to occur.

As there is no current moisture within the flooring, the defect is classified as a minor defect at this stage.

The purchaser should be aware that there is a risk the bathroom may leak if it is used on a daily basis. This would then become a major defect which may require a significant spend to be carried out to rectify any leaks.

The area should be monitored for any new signs of leaks . Should leaking occur, consultation with a licensed plumber should be carried out immediately.

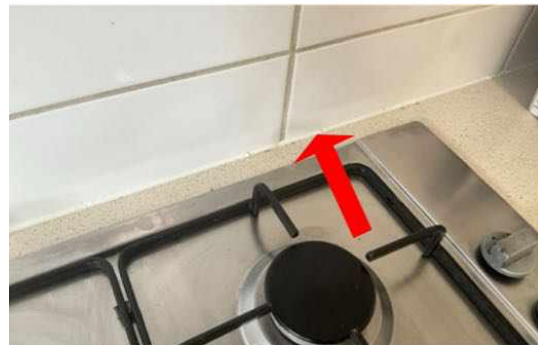
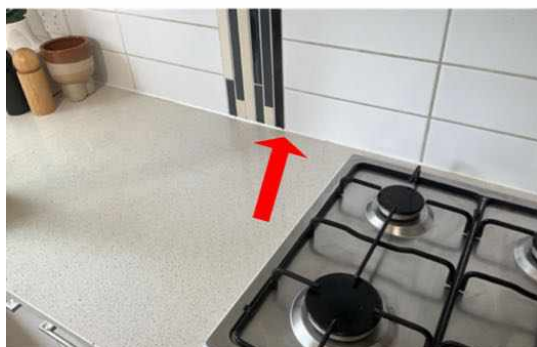
### Finding 3.02

Finding: Sealant - Damaged or Missing

Information: Sealant is damaged in this area. Sealant is used to protect gaps and crevices in building materials to ensure that they are water-tight and prevent water penetration to the associated structures.

Failure to do so may lead to further deterioration of the sealant which in turn can lead to water damage to the surrounding area.

Where sealant is missing or damaged , a competent handyman may be appointed to scrape out and re-apply any silicone where necessary.

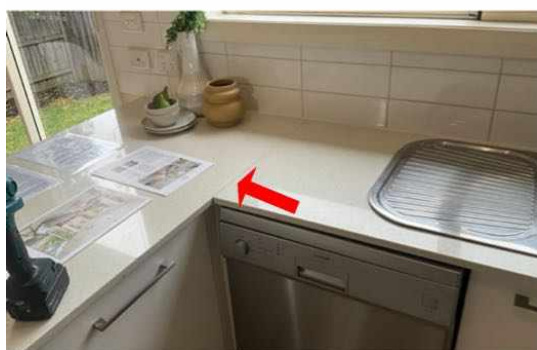
### Finding 3.03

Information: At the time of inspection, the join within the bench top surface was slightly open and not sealed effectively. This has the potential to allow water ingress into the gap and cause secondary damage to the cabinets underneath.

It is highly recommended that the benchtop be sealed to prevent water ingress.

A competent handyman or kitchen benchtop specialist may be engaged to perform this task.

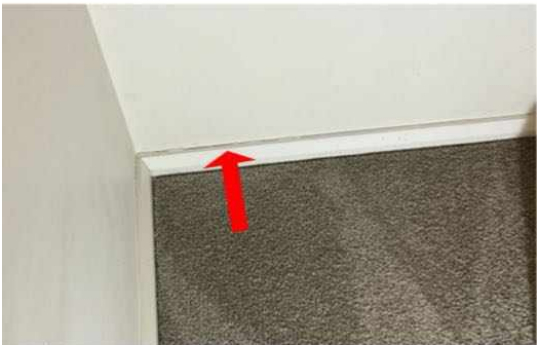
### Finding 3.04

Finding: Cracking - fine

Information: Some fine cracking was noted throughout the property.

Although fine cracks are quite noticeable, they are often only considered to be an appearance defect, and usually do not indicate any structural damage. Generally, the cause of a fine crack is indicative of a separation between building materials and

Cracking of this nature can generally be repaired with minor sanding, filling and/or repainting. Such works should be performed by a qualified painter or a general handyman.

Monitoring of all cracking should be conducted frequently. Always contact a building inspector should cracks widen, lengthen, or become more numerous.

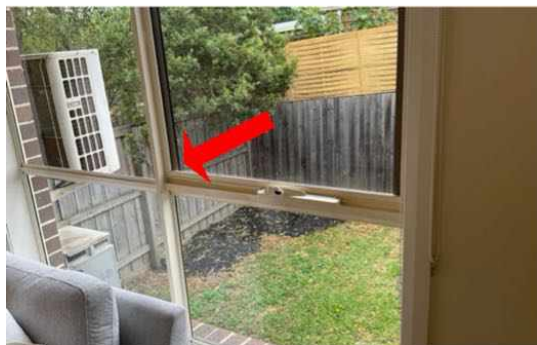
### Finding 3.06

Information: At the time of the inspection, the window in this area was sticking slightly when opened. Windows provide ventilation to the adjoining area and should be at a fully operational level to ensure user comfort. Restricted function of the window may also create potential for secondary defects to the associated building elements, such as damage to the window frames as well as a potential safety hazard if required for emergency egress from the building.

The most usual causes of sticking with aluminium windows is slight misalignment of window within frame, buckling of the frame, or stiffness from lack of use. Easement may be required, which may involve slight adjustment to the window frames. It will almost always include ensuring the areas are cleaned and free of any debris that may be detrimental to their operational state.

A competent handyman can be engaged where necessary to address this issue.

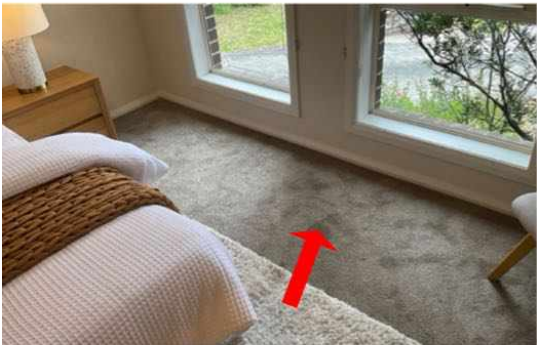
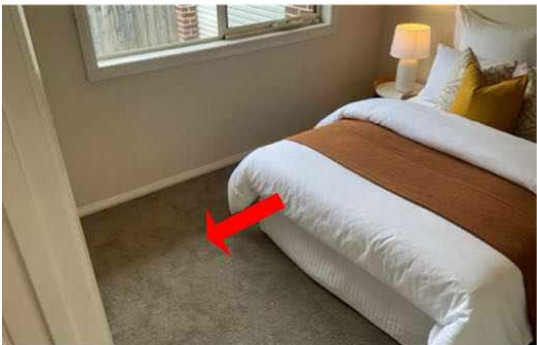
Creaking floors generally indicate that the fixings for the flooring may be coming loose slightly.

The area should be monitored for any changes or unevenness. Should this occur, consultation with a registered builder should be undertaken to determine the cause. The potential resolution may involve regluing and screwing the floor down through to replacement of subfloor support structures.

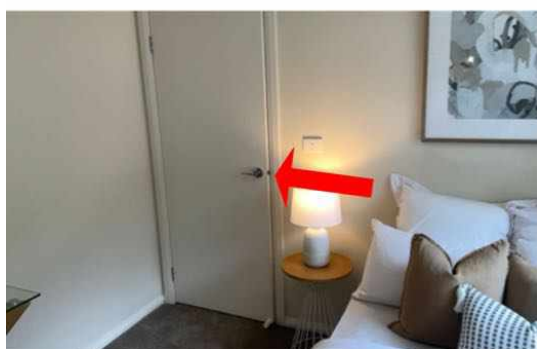
This is a common defect and is expected in a property of this age, whether being due to substandard installation or general deterioration of the door hardware.

Readjustment of the striker plate is recommended at client discretion. Works such as these can be completed by a general handyman or qualified carpenter.

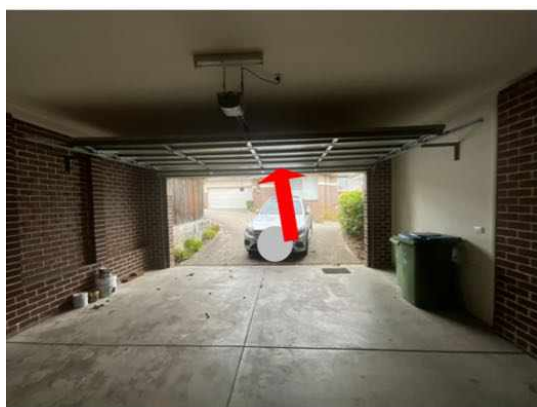
### Finding 3.13

He did say that this would be addressed prior to settlement.

Your own enquiries should be made to ensure the correct working of the garage door.

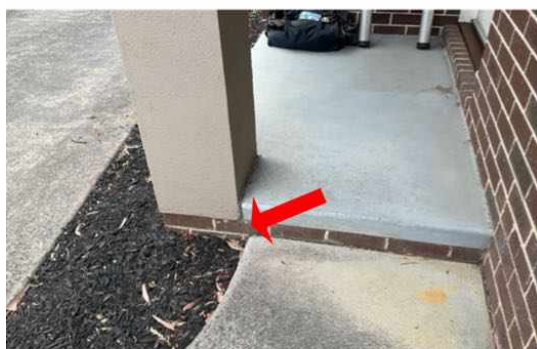
Building:  
 Location: All External Areas  
 Finding: Brickwork - Cracking [Fine]  
 Information: Although fine cracks are quite noticeable, they are often only considered to be an appearance defect and usually do not indicate any structural damage. Generally, the cause of a fine crack is indicative of a separation between brickwork and mortar throughout the structure, but single bricks may also show cracks of this nature.

Cracking of this nature can generally be repaired with minor filling and should be conducted by a qualified bricklayer.

Always contact a building inspector should cracks widen lengthen or become more numerous.

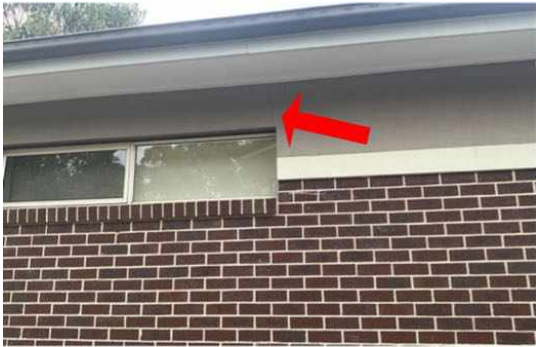
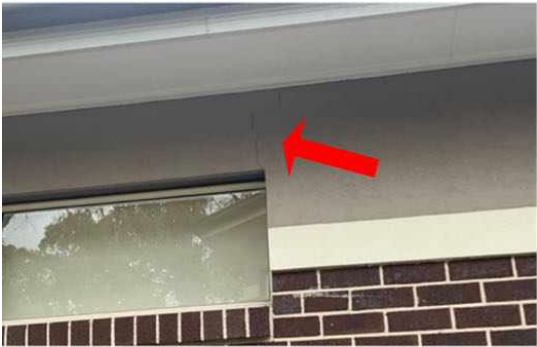
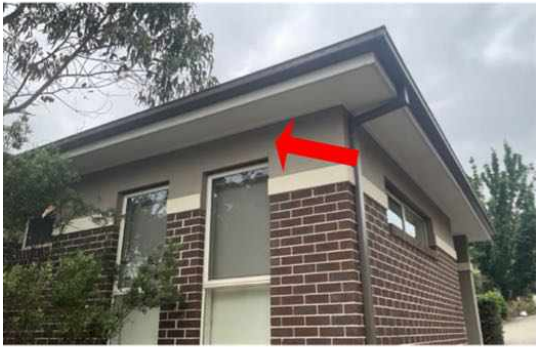
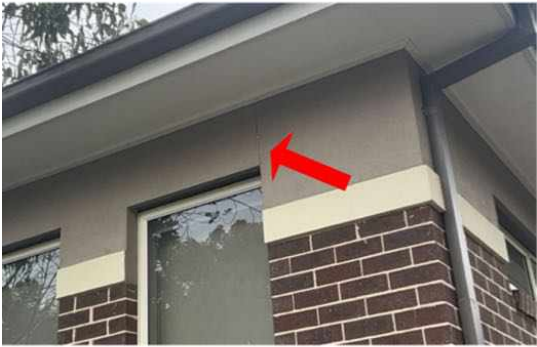
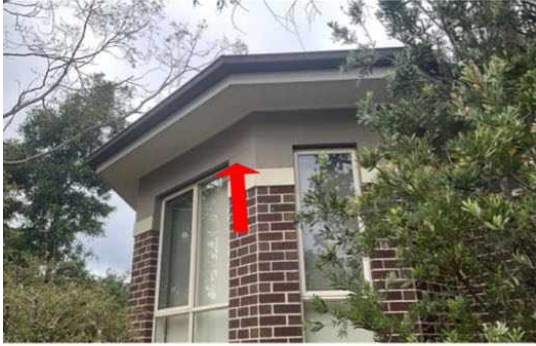
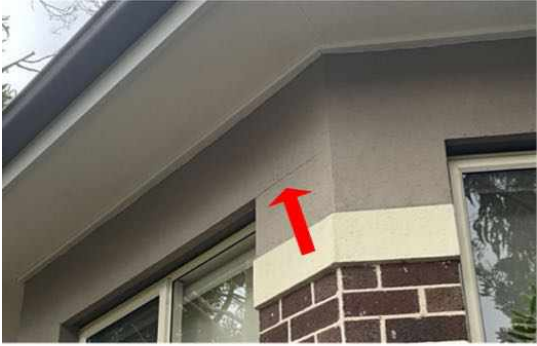
### Finding 3.16

Building:  
 Location: All External Areas  
 Finding: Rendered wall - minor but noticeable cracking  
 Information: Minor but noticeable cracking was noted to the expansion joints within the rendered wall at the time of inspection.

This type of defect is often consistent with general movement of the foundations of the property and is not considered a major structural defect.

Whilst it is more of an appearance issue, repairs may be required as failure to act may allow moisture to enter any cracks and cause secondary damage to other building elements.

Consultation with a suitably qualified renderer should be sought to determine costs involved with any repairs necessary.

The areas should be monitored for any further changes. Should cracks increase in size or number, or the joints become further exposed, speak with your building inspector for further advice.

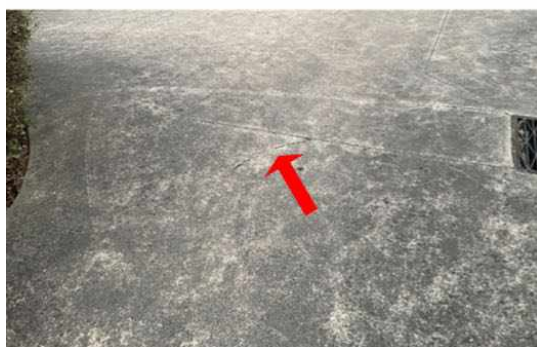
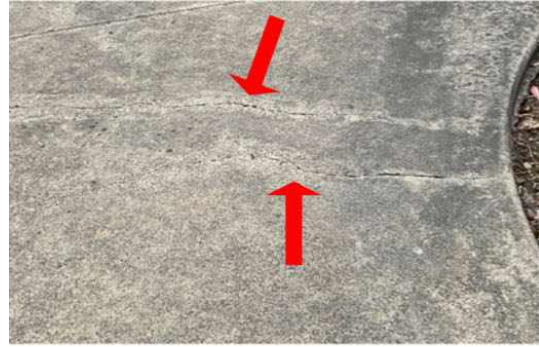
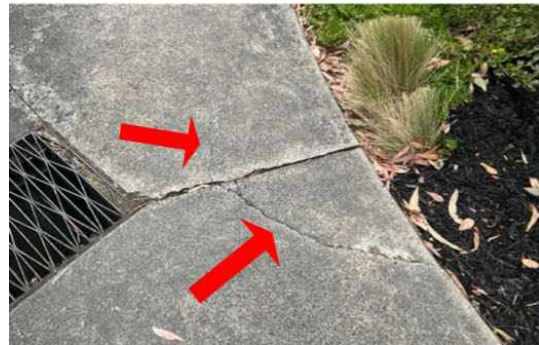
### Finding 3.17

Building:  
Location: Driveway  
Finding: Noticeable Cracking - Concrete driveway ( suspected owners corporation responsibility)  
Information: Noticeable cracks were identified in the concrete driveway.

General age and expected deterioration of the concreted areas is a common cause of this type of cracking. However, expansion and contraction of the driveway may also have occurred due to environmental factors. Such factors include variable moisture and weather conditions, the presence of trees and their roots having a settling or lifting affect on the soil, or the effect of load bearing, e.g. heavy vehicles over a sustained period of time.

Cracking to this degree may also be due to poor original installation of the driveway. Factors such as poor compaction of the sub surface and/or inadequate reinforcing of the slab may create cracking and other secondary defects. Noticeable cracks may also be due to subsidence of soils.

The area should be monitored for any changes that may occur and potentially cause tripping hazards. Should this occur, repair and likely replacement of the concrete section may be necessary.

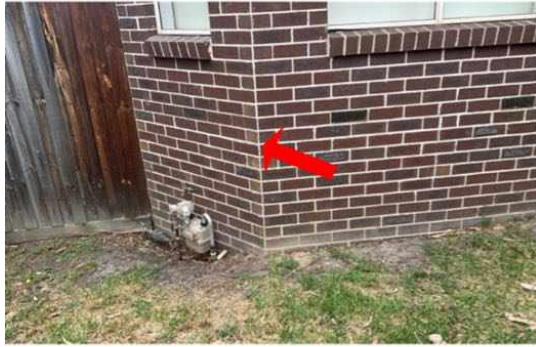
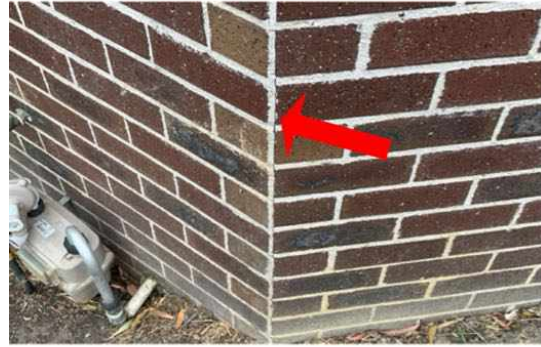
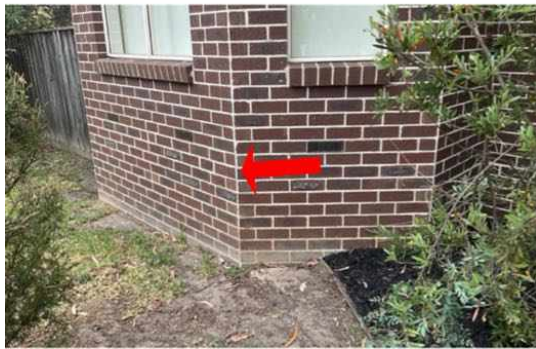
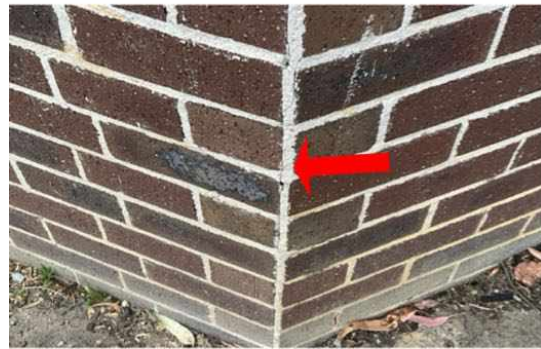
### Finding 3.18

Finding: Brickwork - Deteriorated mortar

Information: Fine cracking within the mortar between brickwork was noted in this area.

Mortar may deteriorate as a result of age of building materials, minor movement of bricks, or frequent exposure to weathering. Mortar is used to ensure that bricks remain in their intended location and to prevent gaps, which would allow water or moisture ingress and secondary damage as a result.

Should mortar deteriorate further creating gaps, this can be addressed by a bricklayer where necessary.

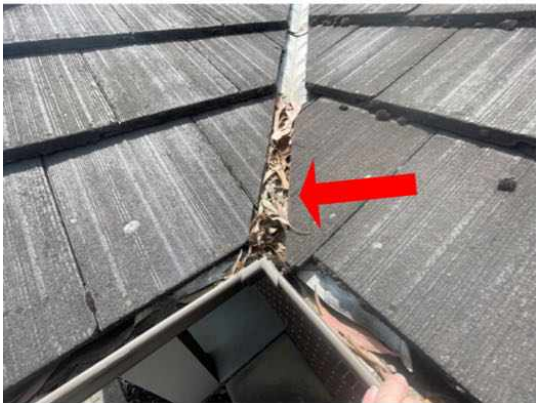
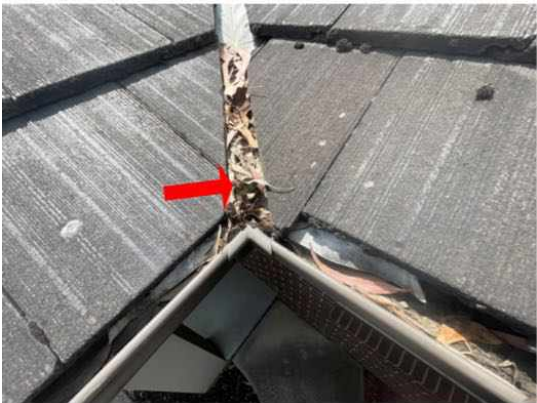
### Finding 3.19

Information: At the time of inspection it was noted that the gutter in this area was full of leaves .

Blocked gutters are likely to lead to high levels of moisture in the affected areas. Such moisture will not only cause rust and decay of the associated building materials, but can also provide conditions that are conducive to termite and timber pest activity. Blockages in gutters should therefore be removed immediately to ensure dry conditions are maintained.

It is highly advised that blocked gutters be cleared by the homeowner or a general handyperson as a matter of urgency. Failure to do so may result in moisture entering the property causing more significant damage.

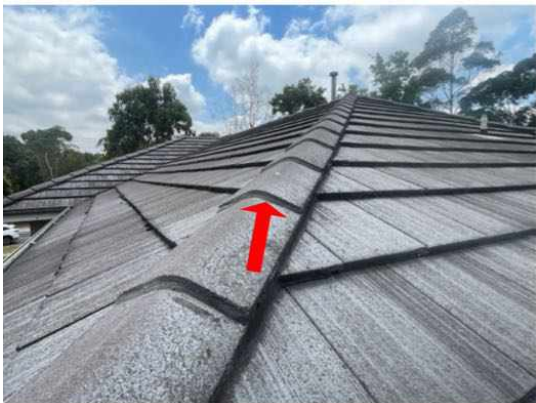
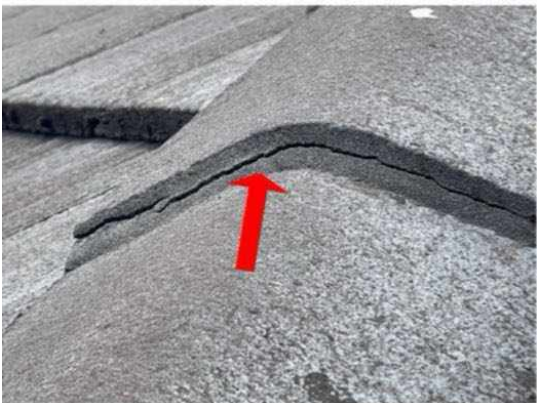
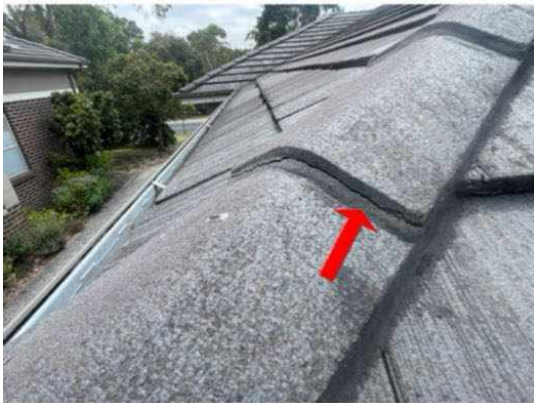
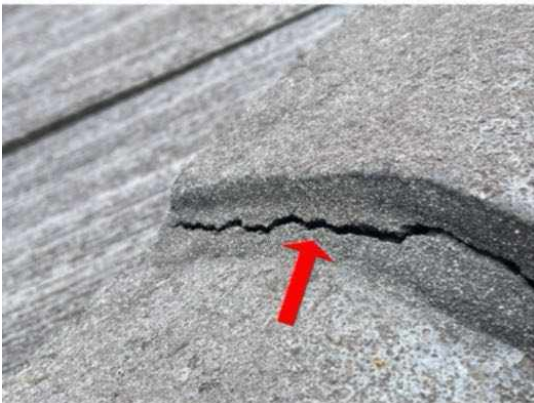
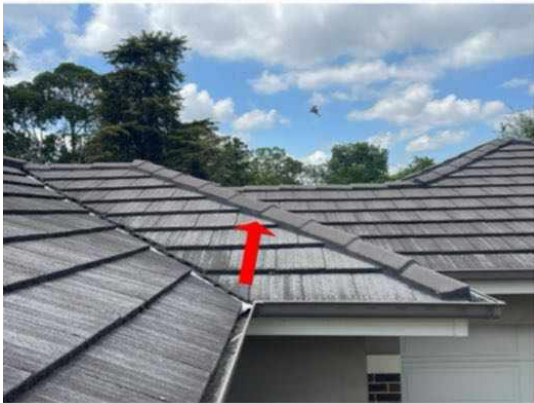
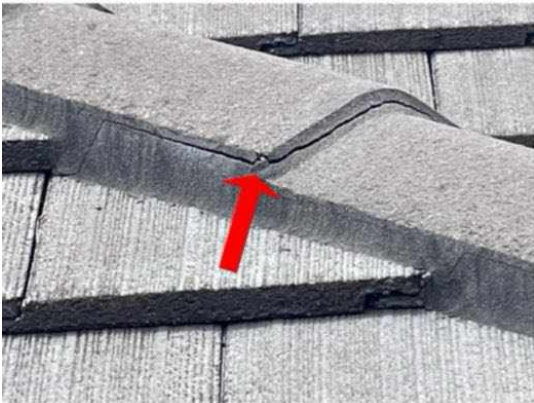
**Finding 3.20**

Building:  
Location: Roof Exterior  
Finding: Roof tiles - generally good condition but with some minor maintenance required  
Information: Upon inspection of the exterior roofing, the majority of roof tiles were considered to be in a good condition. While weathering of the tiles is consistent with the age of the property, some minor maintenance works are required.

Fine cracking of the mortar around the ridge and hip capping was noted.

Repairs cracked mortar is required.

Consultation with a roofing contractor is advised to gain advice on remedial works that will be required . Where left unmanaged, damage can lead to a number of secondary defects, including water leaks and weather exposure to internal roofing structures.

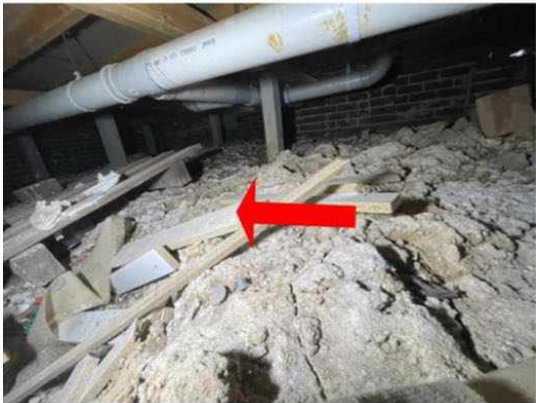
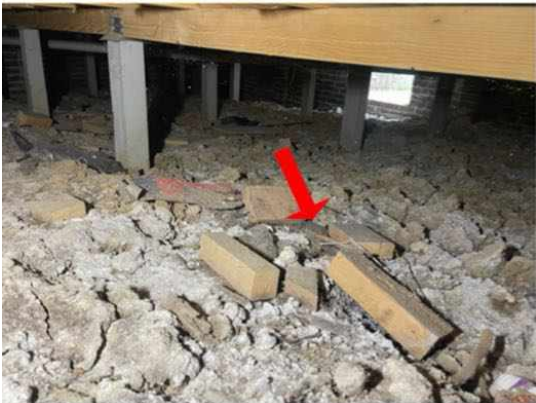
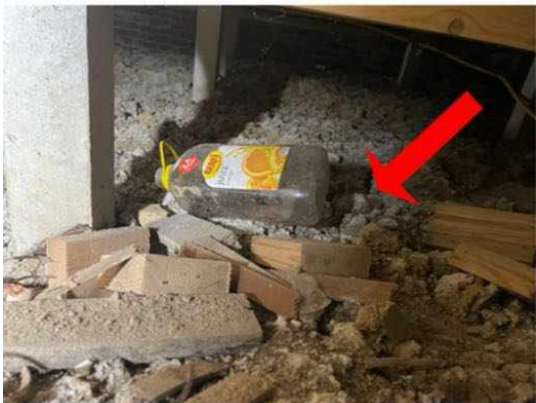
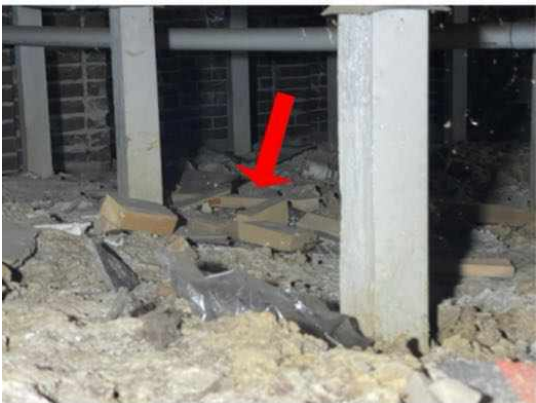
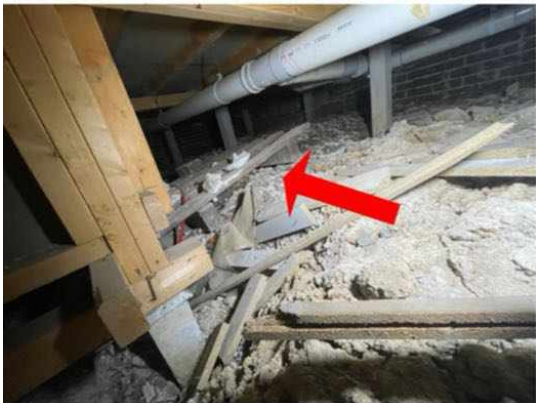
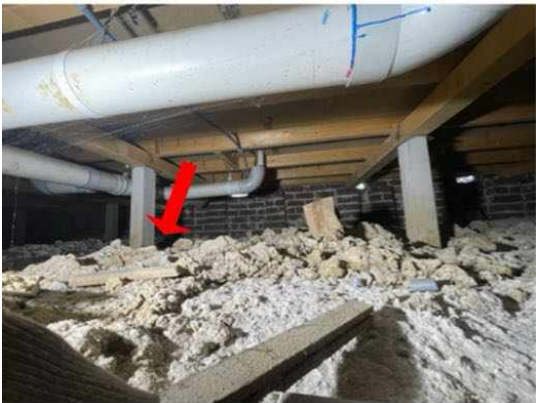
Information: An array of debris was found in the subfloor area at the time of inspection. Debris in this area restricts subfloor ventilation and creates potential for concealed pest entry. Stored timbers and other materials may also make the area susceptible to termite activity and wood rot.

A clear and empty subfloor will be better ventilated and easier to maintain in a dry condition. The removal of any timber debris is vital in minimising the risk of termite or wood borer activity.

Debris in the subfloor should be removed as soon as possible. Depending on the location and amount of debris and stored items, the homeowner may elect to undertake this task. Alternatively there are a large number of rubbish removal subcontractors that could undertake these works.

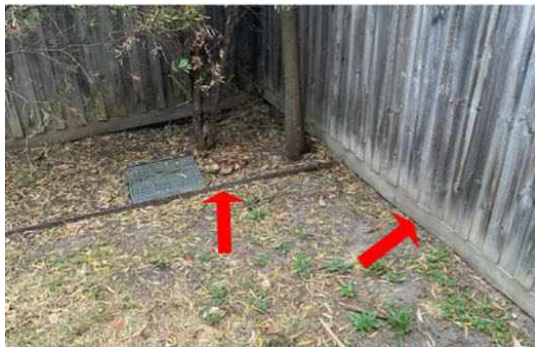
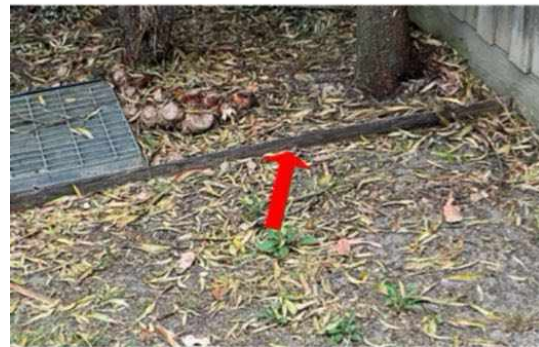
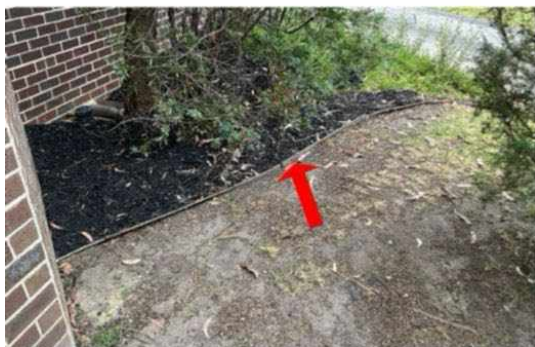
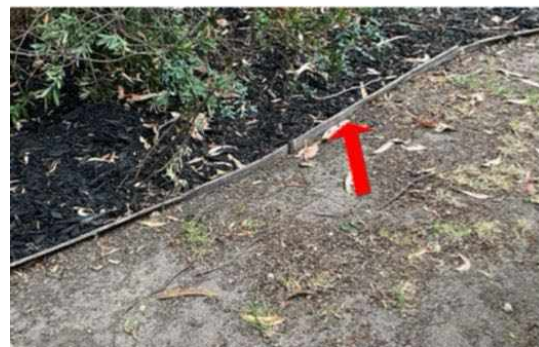
Finding 6.02

Building:	
Location:	All External Areas
Finding:	Building materials in direct ground contact - conducive to termites
Information:	Where timber elements are in direct contact with the ground and consequently moisture or dampness, they become conducive to termite activity. Whether timber is used as a building element, part of a fencing structure or stored as an unused item, they can provide an environment that is attractive to termite infestation.

When met with excessive moisture, timber begins to decay and develop wood rot. Any timbers that are in direct contact with external grounds especially if left untreated or non-durable also provide ingress for subterranean termites into that particular element.

Where possible, the removal of any such materials that may be conducive to termite activity should be carried out as soon as possible to minimise the risk of termite attack. Where not possible or practical, regular monitoring of timber elements is recommended. Replacement of any damaged materials should be carried out where necessary.

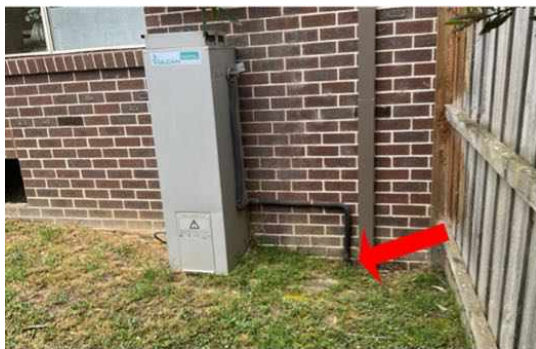
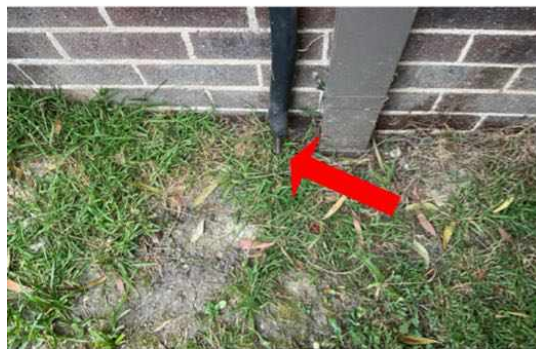
These damp conditions can lead to secondary defects such as rot, rust or corrosion of associated building elements or the formation of fungal decay. When coupled with poor site drainage, pooling of water may also attract termite activity to this area.

It is recommended that a qualified plumber be appointed to install adequate drainage to the overflow or that it be diverted away from the edge of the building. These works will ensure that the area remains dry and free of any secondary defects.
