## Building Inspection Report

Inspection Date: Thu, 26 Feb 2026

Property Address: 18/22 Cohen Ct, Clovelly Park SA 5042,  
Australia

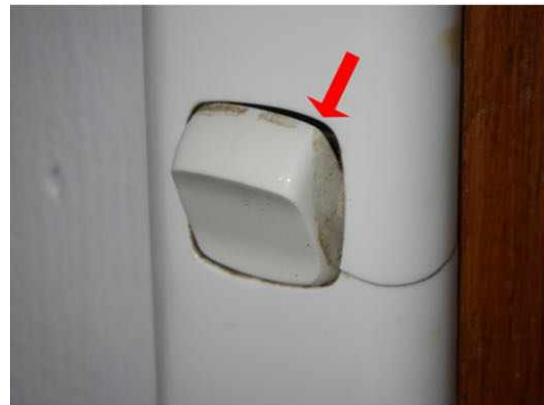
#### Defects 1.01

Building:	Building 1
Location:	All Internal Areas
Finding:	Electrical fitting - Broken
Information:	The electrical fitting in this bedroom -3 area was found to be broken at the time of inspection. Breakage occurs generally when the building materials have aged and decayed, but may also be indicative of impact damage to the building element (accidental or deliberate).

Left unmanaged, the fitting is unlikely to cause further damage to surrounding building elements. However, the broken fitting does expose electrical works, and may create a safety hazard if there is potential contact with persons in the area.

Repair and/or replacement of the broken fitting is advised. A Licensed electrician should be appointed to repair/replace the fitting immediately.

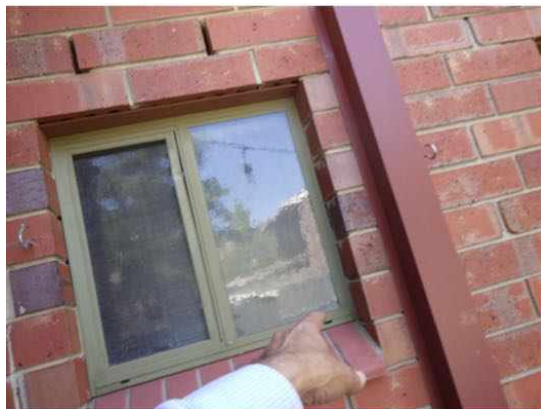
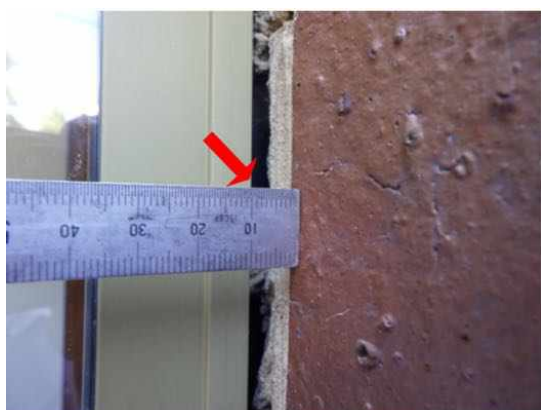
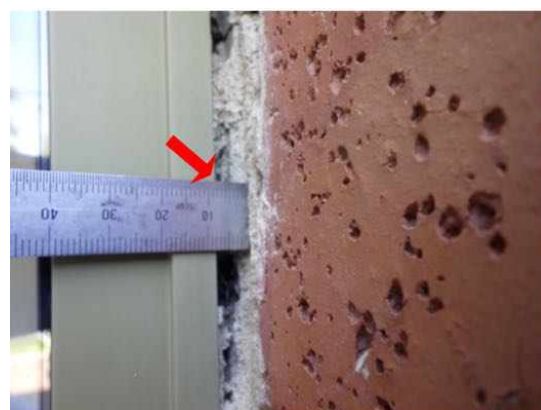
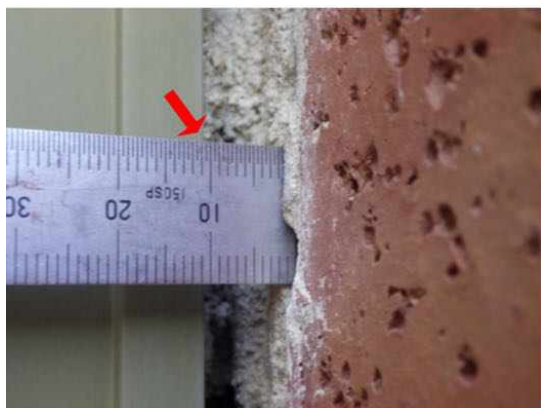
## Defects 2.01

Breakage occurs generally when the building materials have either aged and decayed, or as a result of damage (accidental or deliberate).

Repair and/or replacement of broken elements is advised to ensure that additional secondary defects do not arise as a consequence. Such works are necessary, as all building elements play a key role in the operation and function of the overall structure and its performance.

A relevant tradesperson should be appointed as soon as possible to repair or replace the affected building element prior to any subsequent damage being caused.

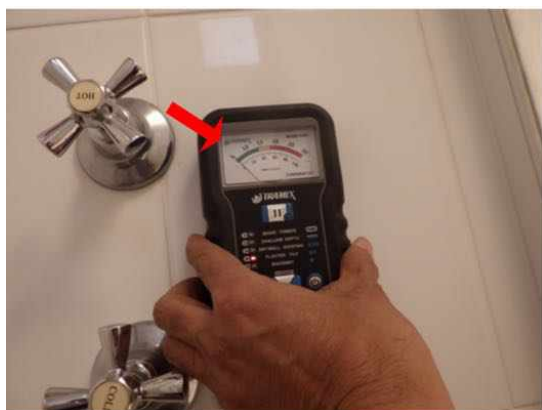
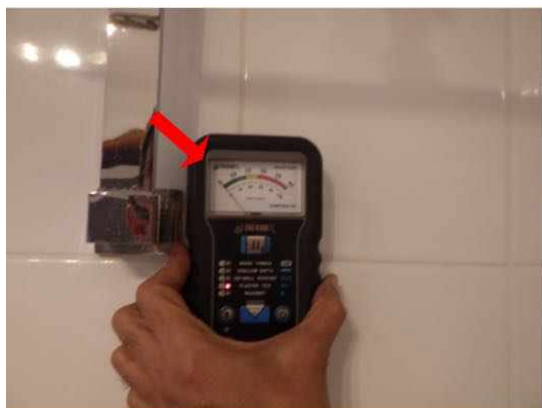
## Defects 2.02

Building:	Building 1
Location:	Bathroom
Finding:	Shower Alcove - Damp
Information:	Damp is evident to the lower 400mm approximately of wall to the shower alcove. This defect is quite common, and is suspected to have been caused by moisture permeating through the grouting in this area, which shows evidence of deterioration. Leaking pipes within the adjoining wall is also a possible cause.

Damp (or structural damp) refers to the presence of unwanted moisture in the structure of a building, either as the result of intrusion from outside, or condensation from within the structure. In the shower area, internal water leaks or other sources of excessive moisture are generally the cause of damp.

Unmanaged damp in the shower recess is likely to facilitate the formation and development of mould and fungi growth, decaying associated building materials and compromising their structural integrity. Exposure to these contaminants is associated with a wide range of respiratory and other health-related problems.

Consultation with a qualified plumber or bathroom specialist is advised immediately to identify the cause of damp and to perform remedial works as required. Where excessive mould growth is present, further inspection by a specialist environmental health inspector should also be considered.

Always ensure that sealant and grout is in good condition to prevent any moisture issues occurring in the future.

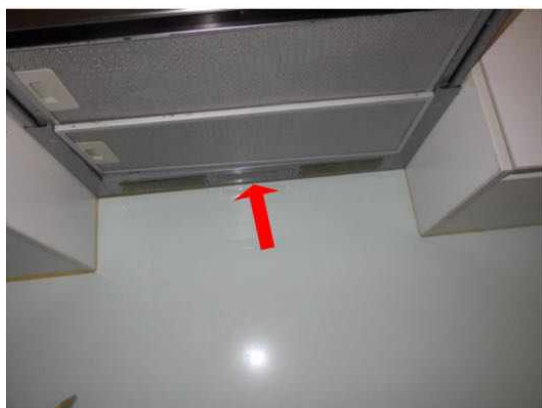
### Defects 2.03

Building:	Building 1
Location:	Kitchen
Finding:	Range hood assembly - Not operating
Information:	At the time of inspection it was noticed that range hood assembly is not operational in this kitchen area.

Non-operational items should be addressed to ensure that the full function of the building structure is available. Where some building elements are not operating as intended, it is possible that secondary building defects could arise due to their non-operation.

Repair and/or replacement of the faulty building element is recommended. It is highly recommended that the relevant tradesperson be engaged to as soon as possible perform any necessary works.

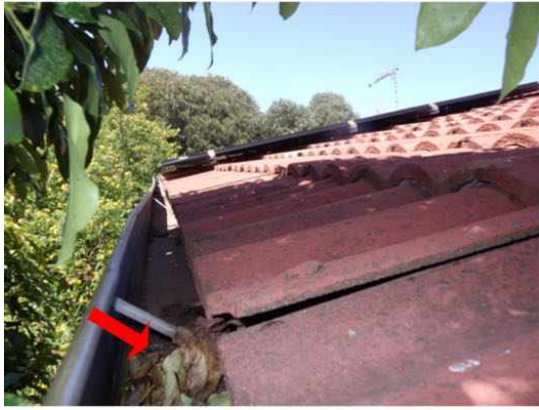
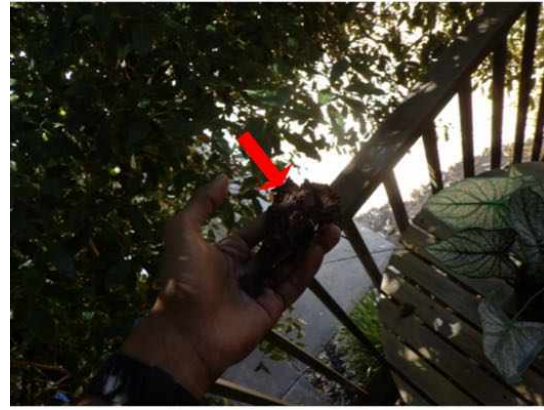
### Defects 3.01

Blocked gutters are likely to lead to high levels of moisture in the affected areas. Such moisture will not only cause rust and decay of the associated building materials, but can also provide conditions that are conducive to termite and timber pest activity. Blockages in gutters should therefore be removed immediately to ensure dry conditions are maintained.

Consult a Licensed Plumber for further specific advice on remedial works that may be required. In the interim, it is highly advised that blocked gutters be removed by the homeowner or a general handyperson as a matter of urgency.

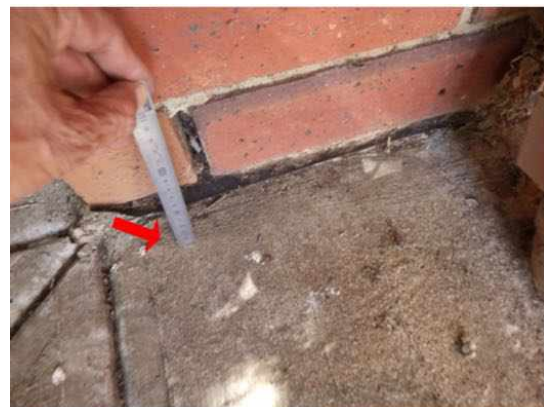
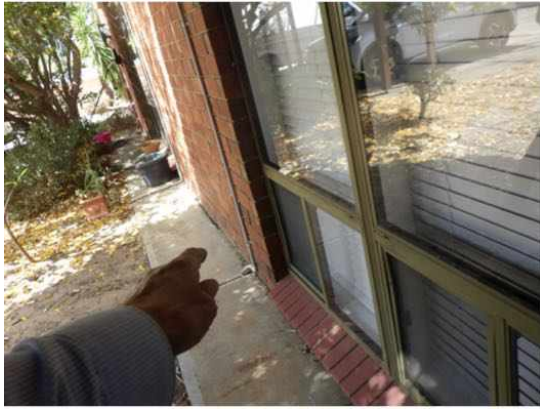
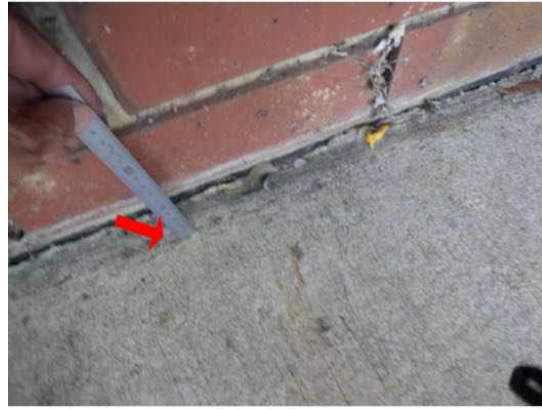
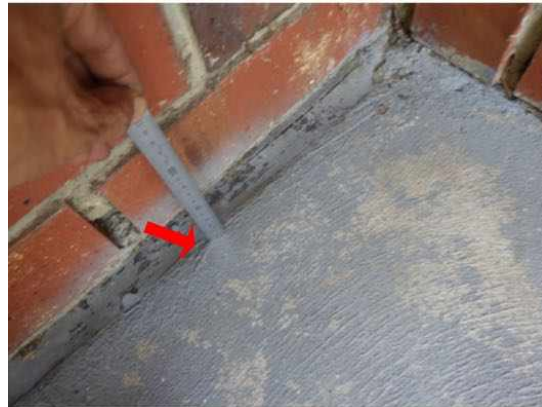
### Defects 3.02

Building:	Building 1
Location:	All External Areas
Finding:	Slab Edge - Exposure compromised
Information:	At the time of inspection it was noticed that slab edge exposure has been compromised in few sections around the property.

If the slab edge is not properly exposed there is a high risk of termite attack. Sometimes, in order to determine the type of slab, a suitably qualified person such as an architect or builder may be required to consult the construction plans.

Where the slab edge cannot be properly inspected, it is highly recommended that termite or timber pest inspections be carried out every 6-12 months to aid protection of the property against infestation.

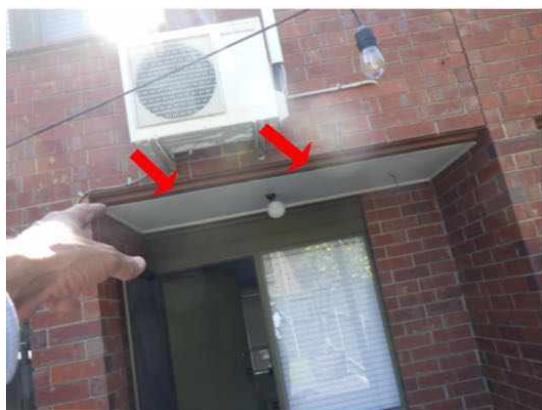
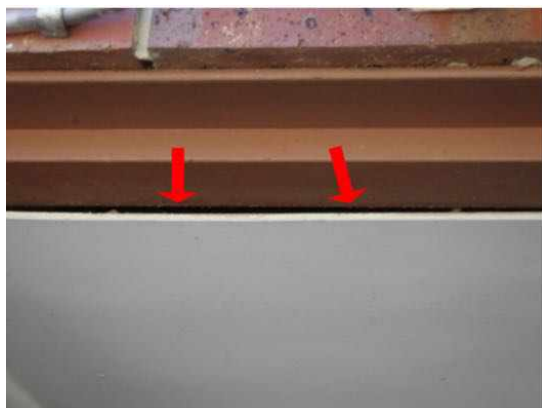
### Defects 3.03

Building:	Building 1
Location:	All External Areas
Finding:	Building element - Damaged/ Loose from its original fixing
Information:	At the time of inspection it was noticed that ceiling in this rear area is loose from its original fixing.

Breakage occurs generally when the building materials have either aged and decayed, or as a result of damage (accidental or deliberate).

Repair and/or replacement of broken elements is advised to ensure that additional secondary defects do not arise as a consequence. Such works are necessary, as all building elements play a key role in the operation and function of the overall structure and its performance.

A relevant tradesperson should be appointed to repair or replace the affected building element prior to any subsequent damage being caused.

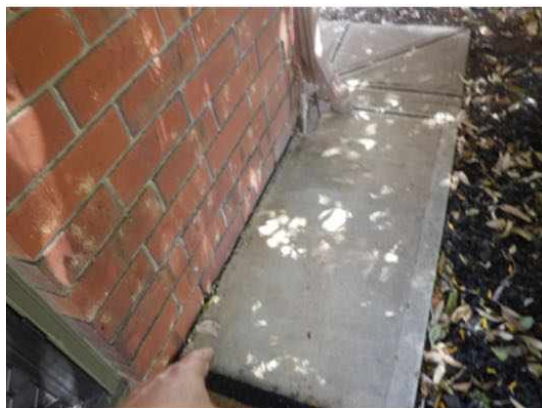
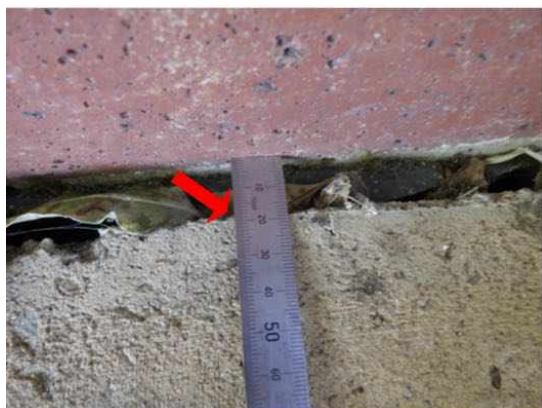
### Defects 3.04

Building:	Building 1
Location:	All External Areas
Finding:	Gaps in perimeter pavement
Information:	Gaps in the external concrete paving were identified at the time of inspection. Gaps in the slab are significant and are likely to lead to the development of secondary defects if left unmanaged, such as the creation of a trip hazard and water entry points.

With reactive clay soils, it is extremely important to ensure that all stormwater flows including roof and ground flows, contained and continually maintained. High moisture also creates an environment that is conducive to termite attack.

A licensed Plumber should be appointed immediately to ensure that the stormwater pipework is intact and adequate, and all gaps to concrete, driveways and paths should be sealed by a licensed builder or a general handy person to keep moisture from entering.

A licensed concretor may be required to replace pavements that are beyond repair.

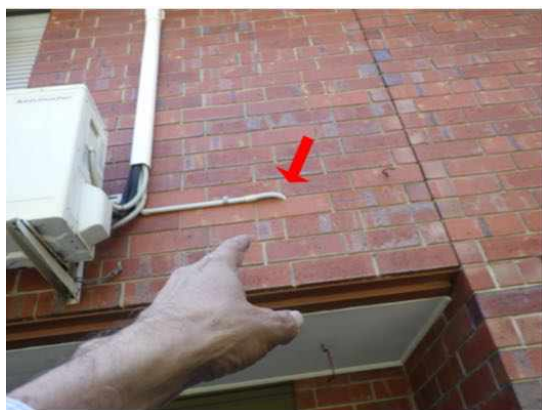
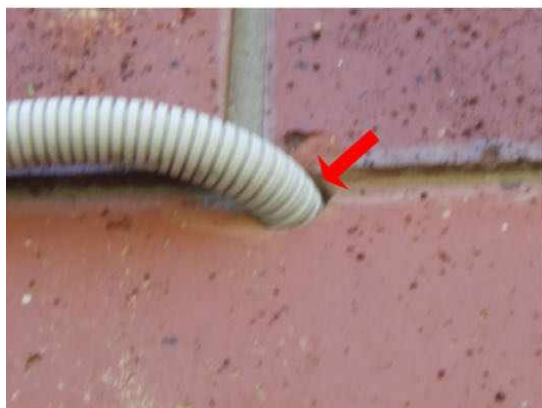
### Defects 3.05

Building:	Building 1
Location:	All External Areas
Finding:	External walls - Holes
Information:	Significant holes were identified around pipe penetrations in this wall section. It is suspected that the installation of this pipework was completed to a substandard level of workmanship or is incomplete.

Gaps and holes around pipework makes the area susceptible to insect and vermin ingress, as well as allowing water penetration to the cavity wall. As such, associated building elements are likely to deteriorate at an accelerated rate, and major implications are expected if holes around the pipework are left unmanaged.

All excessive holes, gaps or cracks should be adequately filled by a suitable sealant or trimmings as soon as possible to prevent any further damage. Such works may be conducted by a general handyperson or licensed plumber.

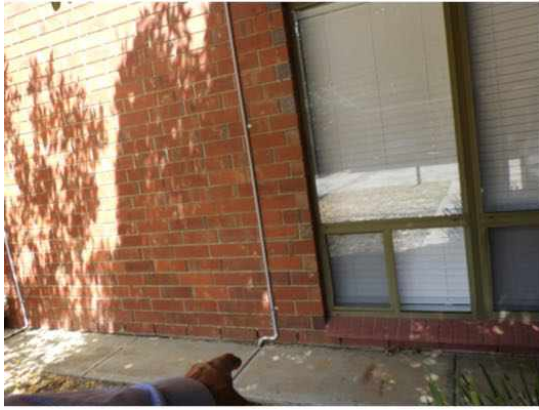
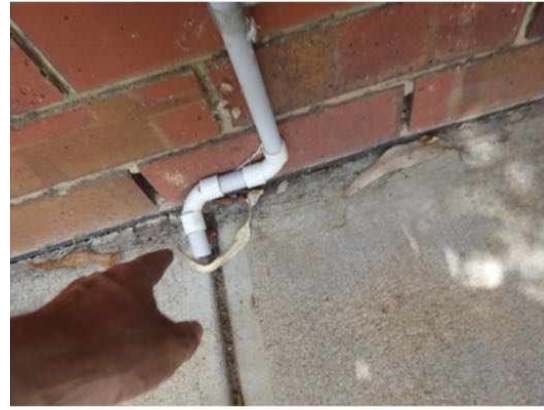
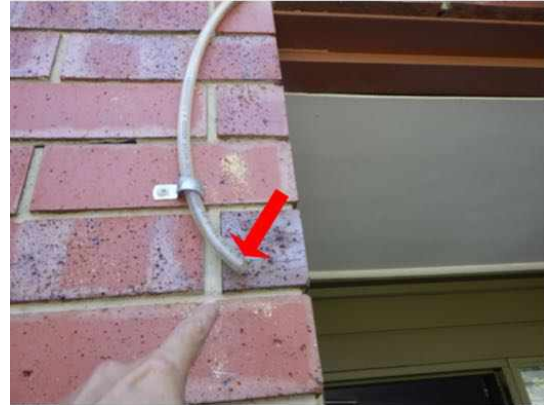
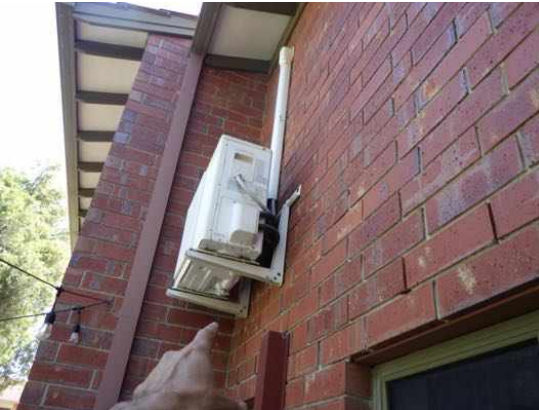
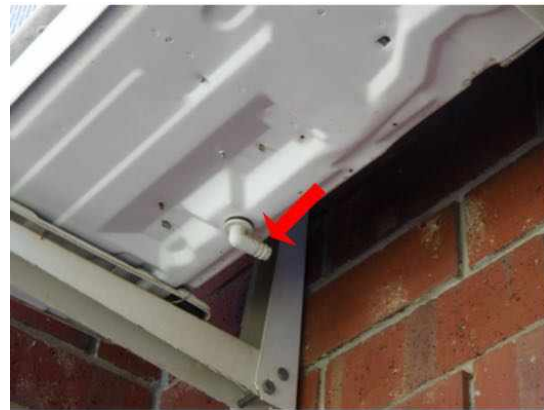
### Defects 3.06

Building:	Building 1
Location:	All External Areas
Finding:	Air conditioner - Disconnected overflow
Information:	The Air Conditioner (A/C) overflow was found to be disconnected from storm water drainage and is creating excessive moisture in the surrounding area.

Such leaking creates an environment which is conducive to an array of defects, including water damage to associated building elements and the attraction of termite or timber pest infestation.

It is highly recommended that a licensed plumber be appointed to connect the A/C overflow in order to prevent such an environment from being created. These minor works should be carried out as soon as possible.

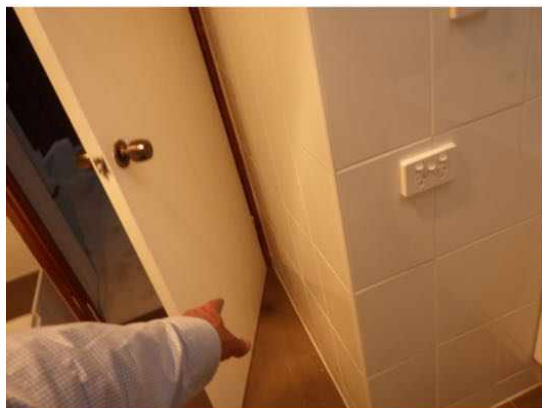
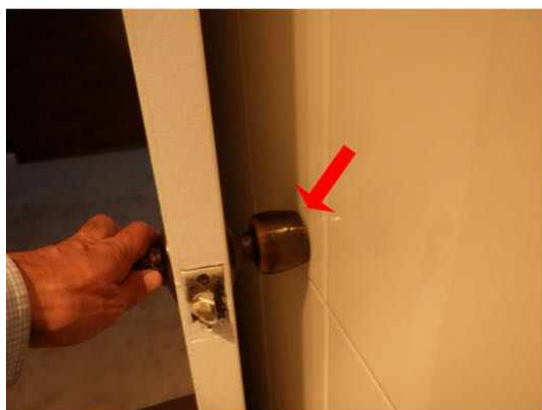
### Defects 3.07

Building:	Building 1
Location:	Bathroom
Finding:	Door stop - Missing
Information:	The door stop is missing or is inadequate to stop the door handle from damaging the wall. Although some building elements may seem irrelevant or unnecessary, all building elements play a key role in the operation and function of the overall structure and its performance.

Re-installation or replacement of the door stop is advised as soon as possible to prevent any subsequent damage to the door or associated structures. A general handyman may be appointed to perform these works at client discretion.

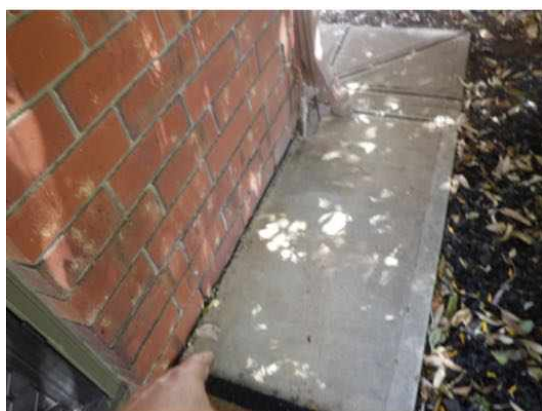
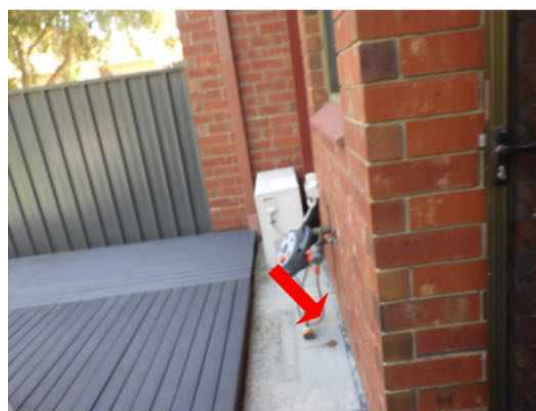
Building: Building 1  
 Location: All External Areas >  
 Finding: Termite Management System - No evidence of a chemical installation  
 Information: The application of a post-construction chemical termite barrier is highly recommended for all properties, particularly if live termite activity has been found on the site previously. Such barriers are highly effective in preventing termite attack on any timber building elements throughout the property.

A durable notice should be placed in the switchboard unit to indicate current termite barriers. At the time of inspection, it appeared as though no termite management system has been installed, with no evidence to suggest preventative works taking place.

The client may consider gaining further advice from a pest controller as to the costs and procedures involved with this application. It is recommended that obtaining such advice be a short-term priority.

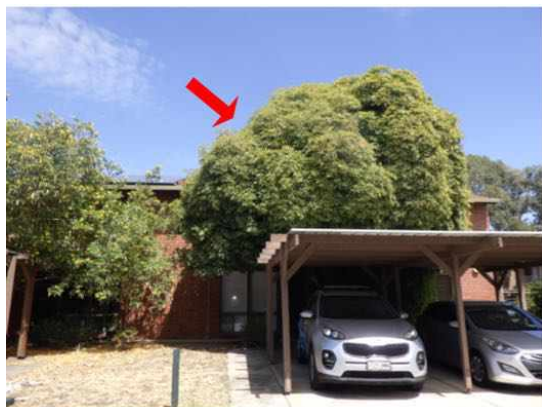
Building: Building 1  
 Location: All External Areas  
 Finding: Trees - Overhanging and filling gutters  
 Information: Overhanging trees often result in excessive amounts of leaf debris accumulating in gutters.

Gutters are a critical part of the building's management of storm water and rain. It is therefore important that they be kept clear to prevent secondary damage to associated building elements, including exterior and interior walls, ceiling linings and

any adjoining building elements. Where gutters are blocked, pooling of rainwater is likely to occur, fast-tracking rust and corrosion of the roof plumbing elements.

It is highly advised that all overhanging tree branches be removed as soon as possible to prevent any further damage. Repair and/or replacement of sections of damaged guttering may also be required where the extent of the damage necessitates.

Such works should be performed by the homeowner; however, appointment of a landscape contractor or an arborist may be required. Consultation with a licensed roof plumber is required where guttering has been damaged.

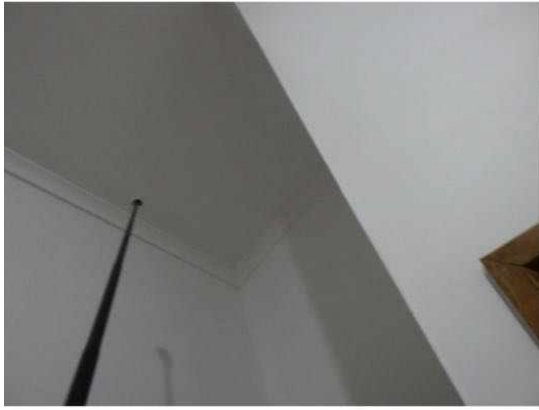
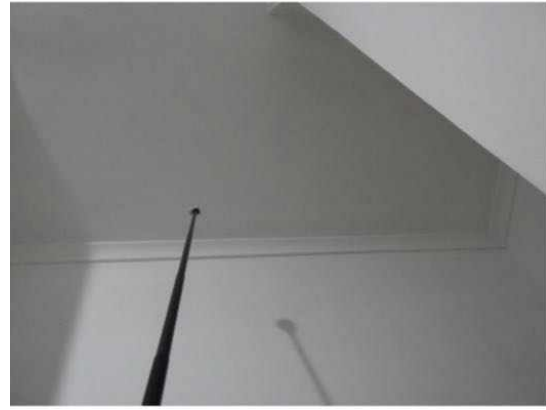
Building:	Building 1
Location:	All Internal Areas
Finding:	Roof Space – No Access
Information:	At the time of inspection, access to the roof space was not available, and therefore this area could not be inspected. The lack of access appears to be due to the design and construction of the property.

As a result, the condition of the roof structure, insulation, services, and any concealed defects within the roof space could not be assessed.

For further clarification regarding roof space access provisions, approvals, or any associated documentation, it is recommended that you consult your real estate agent or the relevant parties.

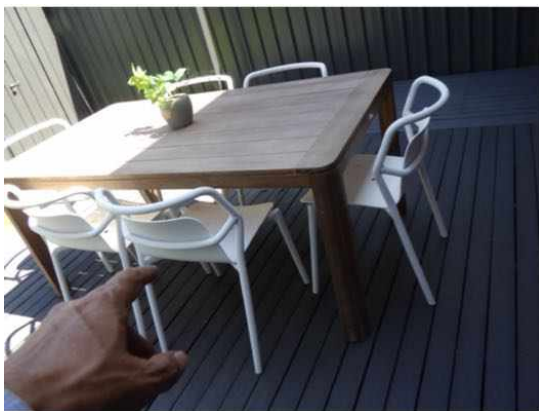
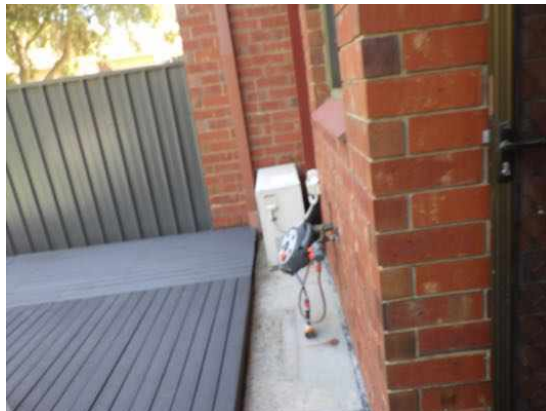
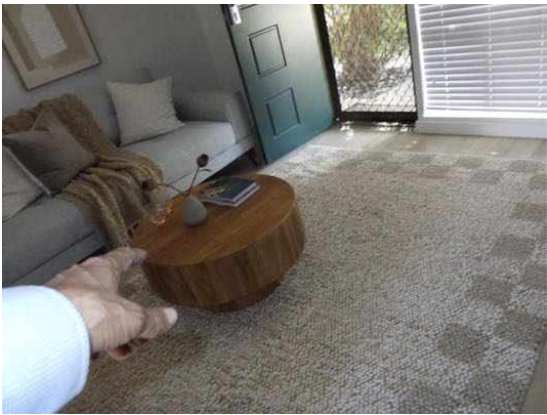
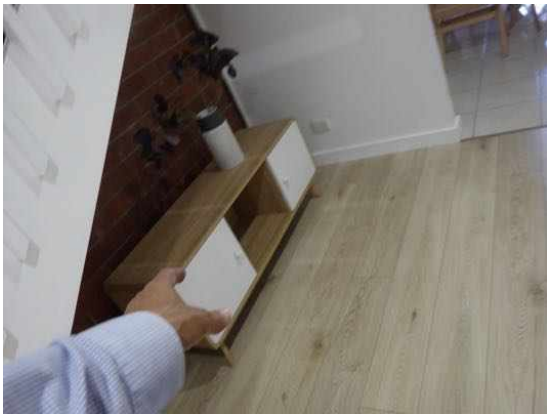
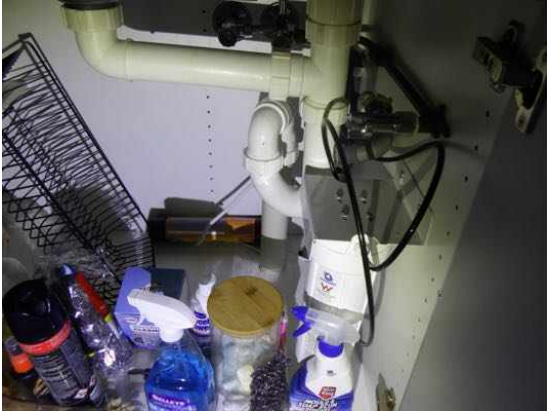
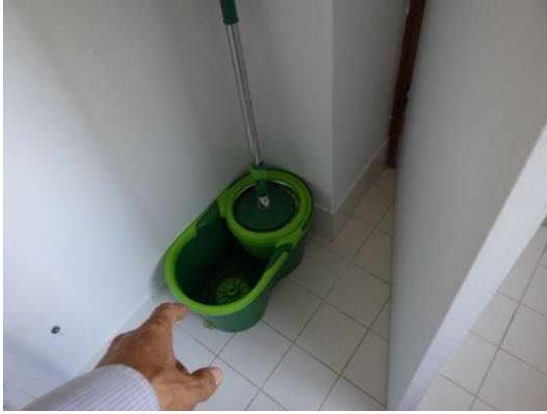
Building:	Building 1
Location:	All Areas
Finding:	Additional Photos - Obstructions and Limitations
Information:	These photographs are an indication of the obstructions and limitations which impeded full inspection of the property at the time of inspection. These obstructions can hide an array of defects and should be removed to allow full inspection to be carried out. A re-inspection is recommended once the areas are made accessible.
