# Building and Timber Pest Inspection Report

Inspection Date: Thu, 29 Jan 2026

Property Address: U2/68 Flora St, Kirrawee NSW 2232,  
Australia

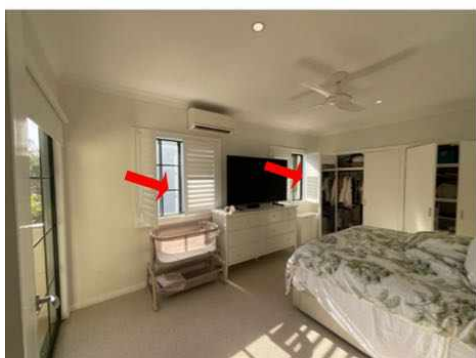
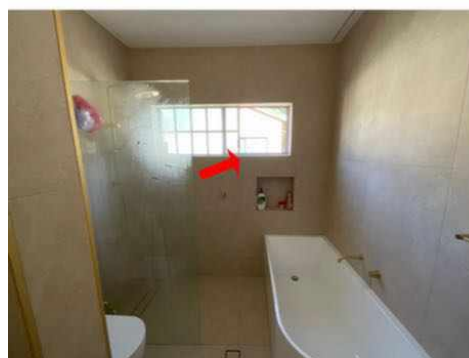
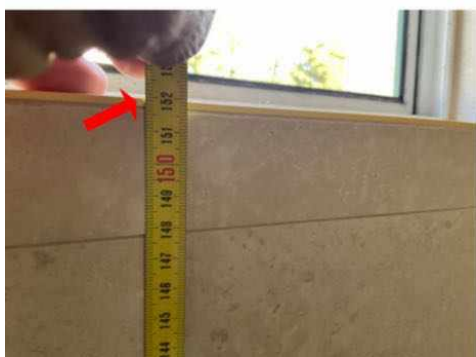
Building: Building 1  
Location: Pictured upstairs windows  
Finding: Window opening restrictors missing.  
Information: The Building Code of Australia rules require all openable windows (where the internal floor is more than 2m above the ground outside) in residential rooms to be fitted with a suitable screen or restrictor. Windows located 1.7m above the floor level do not require protection.

Window restrictors are required where people who are vulnerable to the risk of falling have access to windows. This means all windows above ground level which do not have another fall prevention safety measure in place, such as a balcony or balustrade should have a restrictor.

These need to be added urgently for the safety of all persons.

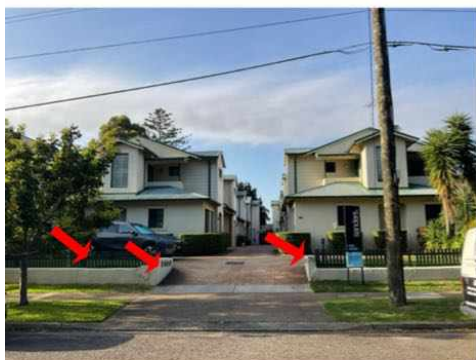
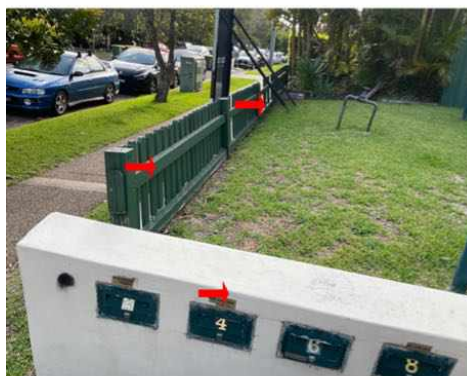
### Finding 3.01

Building:	Building 1
Location:	Pictured fences
Finding:	Fences damaged - leaning
Information:	Evidence of damage to some common area fencing was identified at the time of the inspection. The likely cause of these fences leaning is not enough concrete used in the post footings and vehicle impact damage. A licensed builder can repair these common areas when convenient.

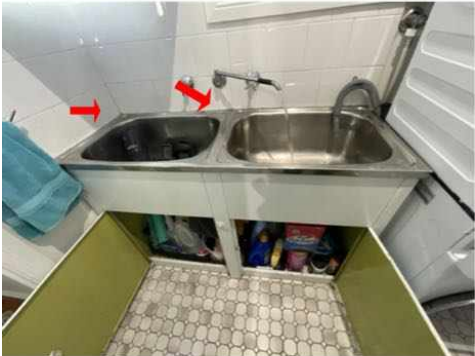
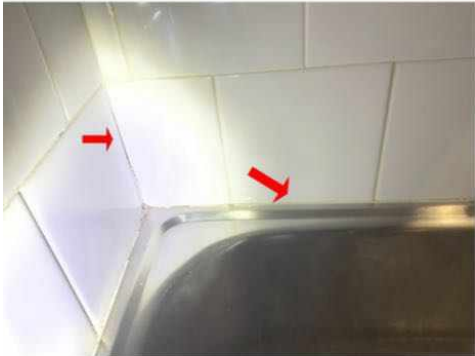
### Finding 3.02

Building:	Building 1
Location:	Laundry
Finding:	Sealant and grouting - Missing or damaged
Information:	It was noted on inspection that sealant or grout is degraded to these pictured areas.

Different materials and floor areas move at different rates, generally causing cracking to grout or sealant at this point. A flexible sealant is required to allow for expected expansion and contraction, while keeping the joint water tight and protective of all associated building materials.

Flexible and mould resistant materials should be applied to affected areas to prevent any subsequent water damage that is likely to occur. Regular maintenance and replacement of damage or missing or damaged sealant and grout is highly recommended to the wet areas, as this is a regular wear and tear defect. Sealant and grouting in areas that come into regular contact with water should be maintained for the long term care of your property.

A sealant specialist or tiling contractor should be appointed to complete these works

as soon as possible

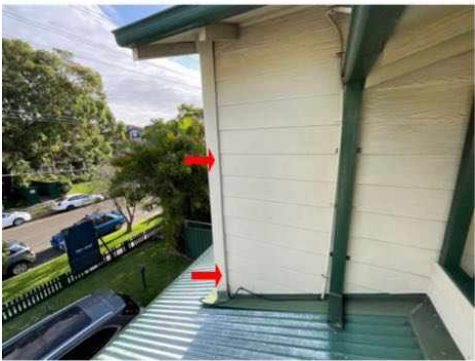
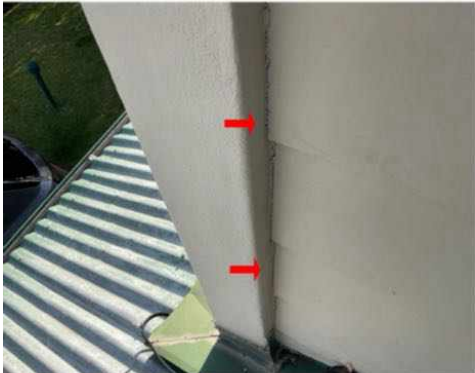
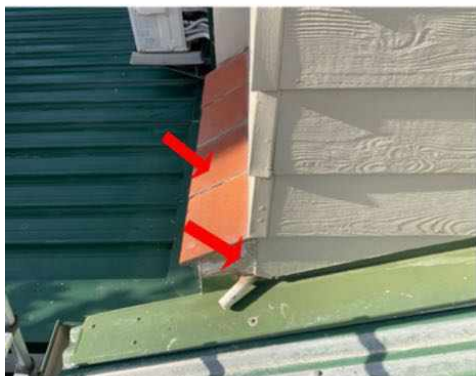
**Finding 3.03**

Building: Building 1  
Location: Exterior front walls  
Finding: Sealant (external) - missing in 2 areas  
Information: It was noted on inspection that small areas of external sealant was missing some of the external walls.

Flexible sealants should be applied to these affected areas to prevent any subsequent water damage that is likely to occur.

A sealant specialist or skilled handy person should be appointed to complete these works as soon as possible. This may be a body corporate responsibility.

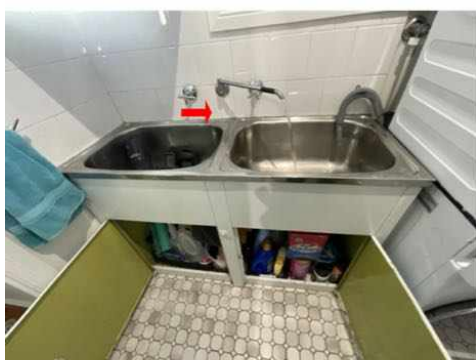
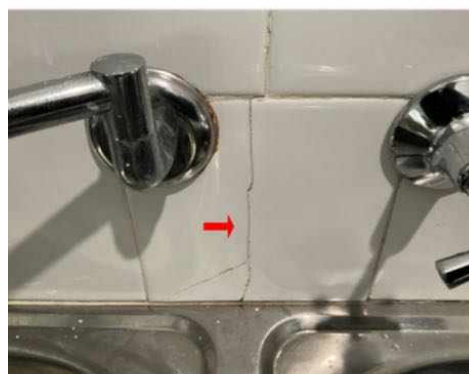
### Finding 3.04

Building:	Building 1
Location:	Laundry
Finding:	Tiles cracked
Information:	Cracked tiles were evident in these pictured areas at the time of inspection. It is suspected that this cracking has occurred as a result of minor settlement or impact damage.

Cracked tiles throughout the household detract from the overall appearance of the affected areas. In wet areas of kitchens and bathrooms, it can lead to water damage of adjoining walls and floors.

Replacement of cracked tiles is recommended as soon as possible. A tiling contractor may be appointed to perform these works. Where cracks become more numerous, contact a licensed building inspector for further investigation.

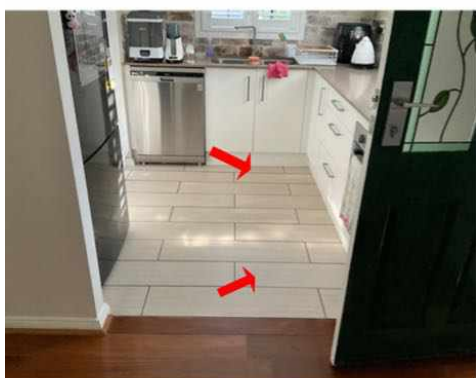
### Finding 3.05

Building:	Building 1
Location:	Kitchen
Finding:	Tiles - Drummy
Information:	Drummy tiled areas were identified in the kitchen at the time of inspection. The term

'drummy' refers to tiles that have become detached from their fixing, despite otherwise being in relatively good condition. Such defects are generally caused by physical or moisture damage to the area. Drummy tiled areas may also be a direct result of poor workmanship during the construction process.

Tiled areas may swell and shrink with changes in air humidity if the area has sustained moisture damage. Any exposure to moisture is capable of causing tiled areas to become drummy and/or cracked over a prolonged period of time. Specialist trades are available for these types of services.

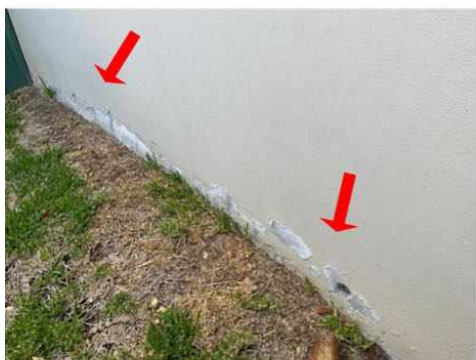
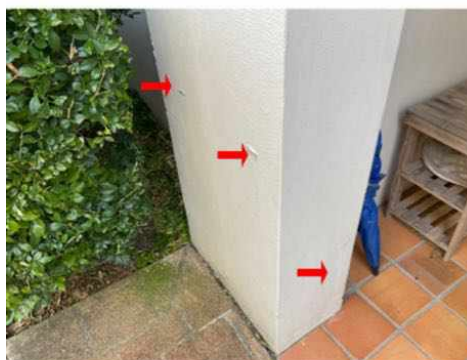
### Finding 3.06

Building:	Building 1
Location:	Front walls
Finding:	External painting deteriorated
Information:	Some areas of the lower external paintwork has been neglected and require attention to prepare and re-paint.

Whilst incomplete or missing paint finish is generally an appearance defect, it can also lead to the development of secondary building defects over time. Incomplete areas of paint finish expose the area to moisture, potentially accelerating the deterioration of underlying building materials.

Degraded paint finishes should be sanded back, filled, leveled and painted, as applicable. Where inadequate or missing paint protection has led to the deterioration of the associated building element, repair and/or replacement of this building element may be required.

A painting contractor should be appointed as soon as possible to perform necessary works to aid the appearance of the affected area and to ensure the area is protected against further deterioration. Alternatively, the homeowner following manufacturer instructions may perform these works.

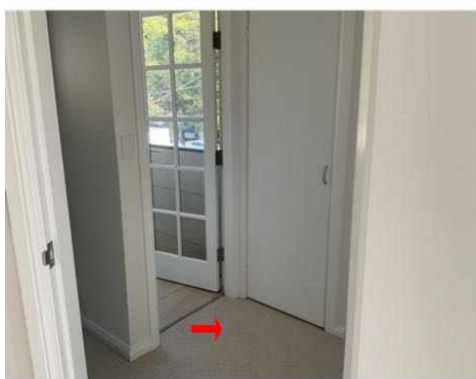
### Finding 3.07

Building:	Building 1
Location:	Stair Landing
Finding:	Squeaking flooring areas
Information:	A squeaking floor is a common issue in homes, especially timber-framed ones, and it can be caused by several factors.

Common causes of squeaking floors are loose floorboards, movement between floorboards or between the boards and joists, fasteners that are slightly loose, wood shrinkage or seasonal changes in humidity can also cause timber to expand or contract, leading to gaps and movement.

A carpenter can be consulted for repairs if required.

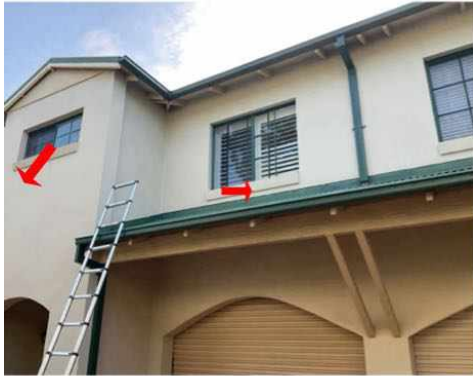
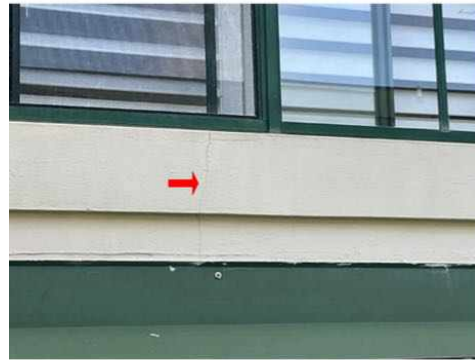
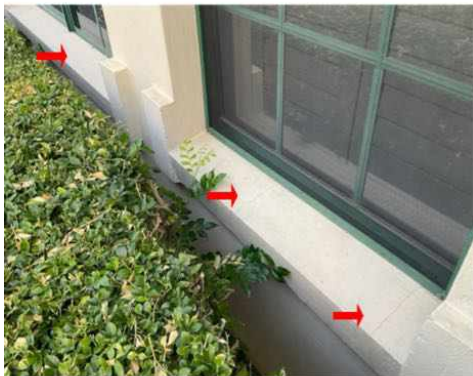
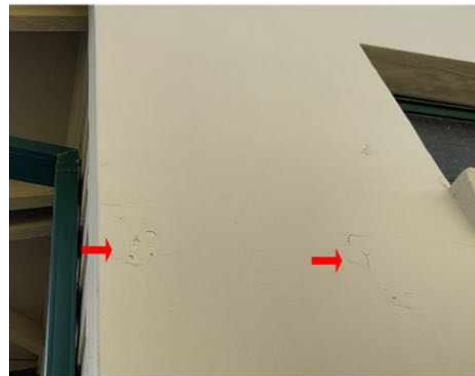
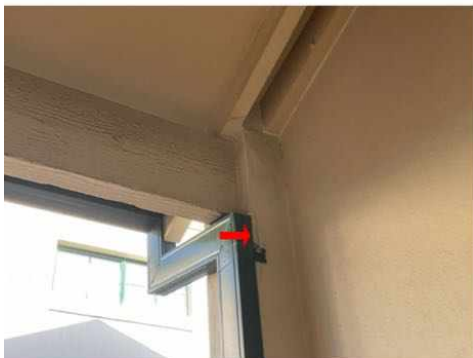
### Finding 3.08

Building:	Building 1
Location:	Pictured areas
Finding:	Render cracking (minor)
Information:	It has been observed that minor cracking to some external rendered surfaces. The degree of damage is described as "slight" noticeable cracks which are easily filled. Cracking of this size are generally less than 5mm in width.

Always contact your building inspector should cracks widen, lengthen, or become more numerous.

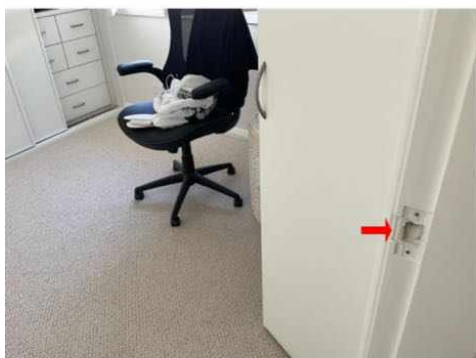
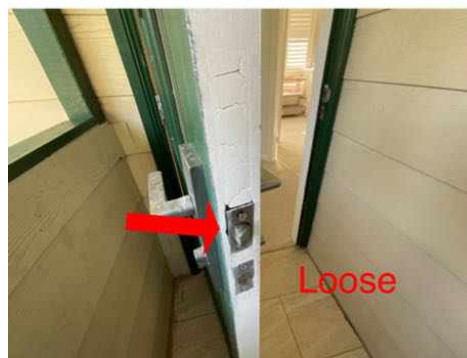
### Finding 3.09

Building: Building 1  
 Location: Stair Landing  
 Finding: Door plates missing and loose  
 Information: The striker plate to this bedroom door is missing and the verandah barrel is loose requiring tightening.

This is a common defect and is expected in a property of this age, whether being due

to substandard installation or general deterioration of the door hardware.

Works such as these can be completed by a general handyman or qualified carpenter.

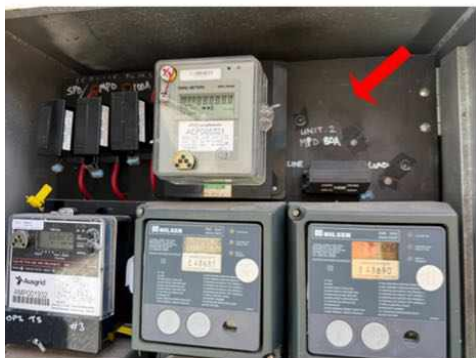
Building:	Building 1
Location:	Meter Box
Finding:	Termite Management System - no evidence of a chemical installation
Information:	The application of a post-construction chemical termite barrier is highly recommended for all properties. Such barriers are highly effective in preventing termite attack on any timber building elements throughout the property.

A durable notice should be placed in the switchboard unit to indicate current termite barriers. At the time of inspection, no durable notice was evident and it appeared as though no chemical termite management system has been installed, with no evidence to suggest preventative works taking place since the property was built.

The client may consider gaining further advice from a pest controller and the body corporate as to the costs and procedures involved with a 'chemical' application.

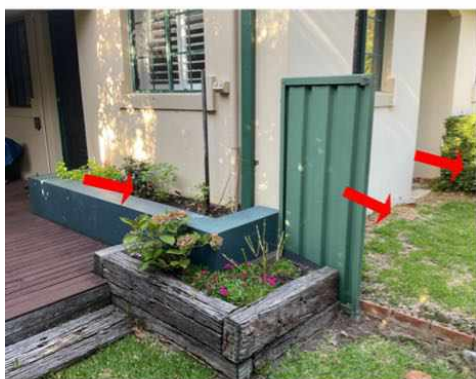
If the slab edge is not properly exposed there is a high risk of termite attack. Sometimes, in order to determine the type of slab, a suitably qualified person such as an architect or builder may be required to consult the construction plans.

Where the slab edge cannot be properly inspected, it is highly recommended that termite or timber pest inspections be carried out every 6-12 months to aid protection of the property against infestation.

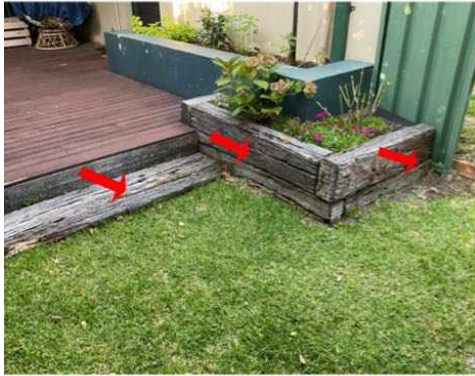
### Finding 6.04

**Building:** Building 1  
**Location:** Rear deck  
**Finding:** Timber in contact with the ground  
**Information:** Any timbers in direct ground contact provide opportunity for concealed termite entry and are likely to be subject to premature rot and decay as the soil retains moisture or damp conditions against the timbers.

Removal of all waste timber that is in direct contact with ground is highly advised. This timber is promoting mould and wood rot and is very attractive to termites.

Frequent pest inspections are advised to readily identify any termite activity in these areas.

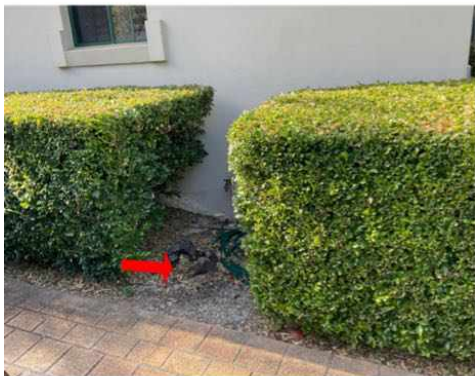
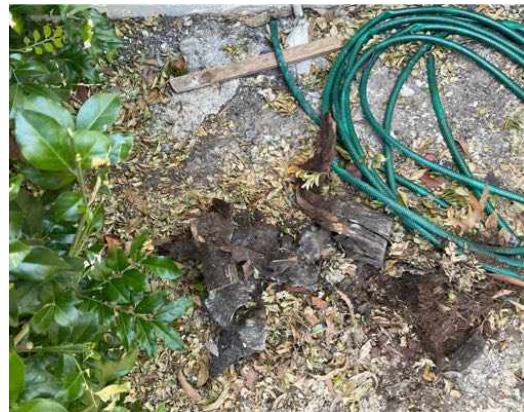
### Finding 6.05

Building:	Building 1
Location:	Pictured yard area
Finding:	Tree stumps - left in ground
Information:	Tree stumps left in ground provide opportunity for termite attack as they are likely to be subject to rot and decay providing an attractive food source. Treatment and/or Removal of the stump is highly recommended. A pest controller and tree removalist should be engaged to perform such works.

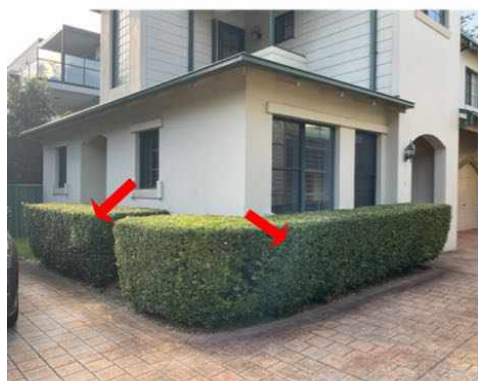
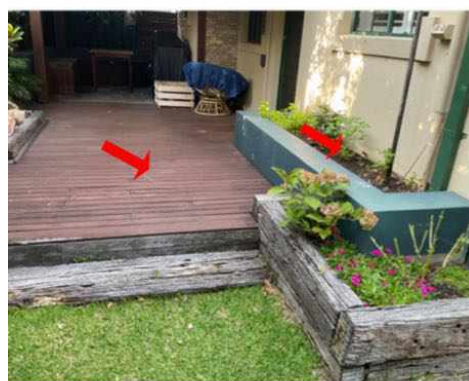
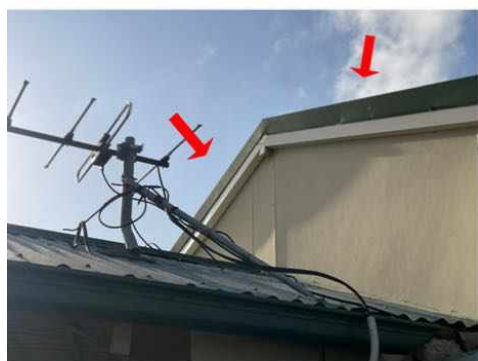
Building: Building 1  
 Location: All External Areas  
 Finding: Additional Photos - Obstructions and Limitations of EXTERNAL AREAS  
 Information: These photographs are an indication of the obstructions and limitations which impeded full inspection of external areas at the time of inspection. These obstructions can hide an array of defects and should be removed to allow full inspection to be carried out. A re-inspection is recommended once the areas are made accessible.

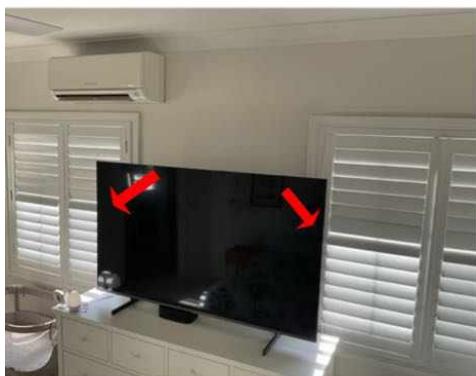
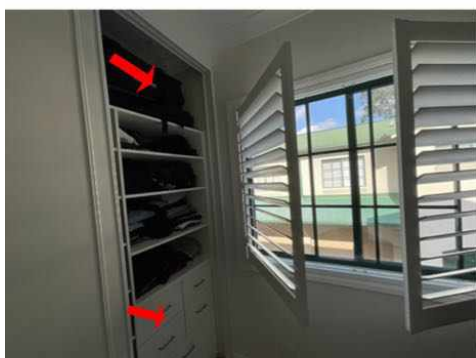
Building: Building 1  
 Location: All Internal Areas  
 Finding: Additional Photos - Obstructions and Limitations of INTERNAL AREAS  
 Information: These photographs are an indication of the obstructions and limitations which impeded full inspection of Internal areas at the time of inspection. These obstructions can hide an array of defects and should be removed to allow full inspection to be

carried out. A re-inspection is recommended once the areas are made accessible.

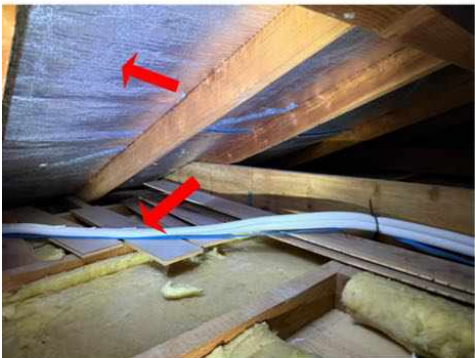
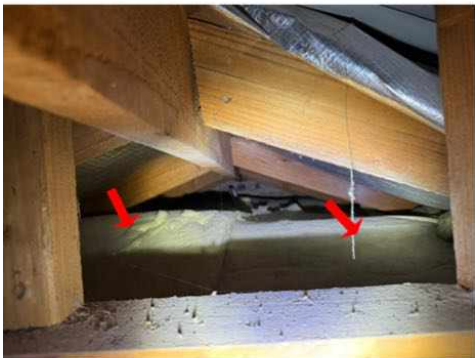
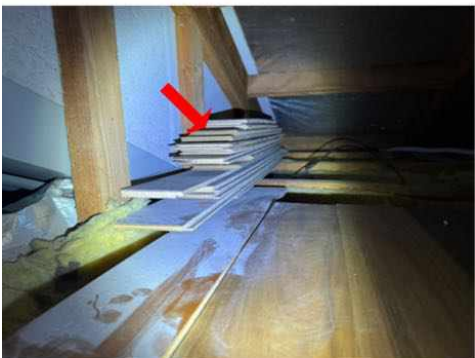
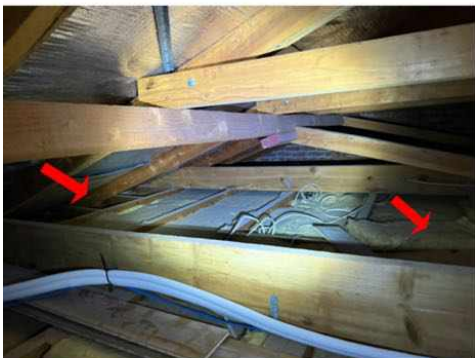
Building: Building 1  
 Location: All Roof cavity areas  
 Finding: Additional Photos - Obstructions and Limitations of the ROOF CAVITY  
 Information: These photographs are an indication of the obstructions and limitations which impeded full inspection of roof cavity areas at the time of inspection. These obstructions can hide an array of defects and should be removed to allow full inspection to be carried out if applicable. A re-inspection is recommended once the areas are made accessible.

The inspection was also limited to areas with an allowable crawl space of 600mm x 600mm, in particular towards the external walls where the roof line diminishes, these areas were not accessible.
