Building and Timber Pest Inspection Report

Inspection Date: Thu, 2 Apr 2026

Property Address: 27A Hollis St, Constitution Hill NSW 2145, Australia

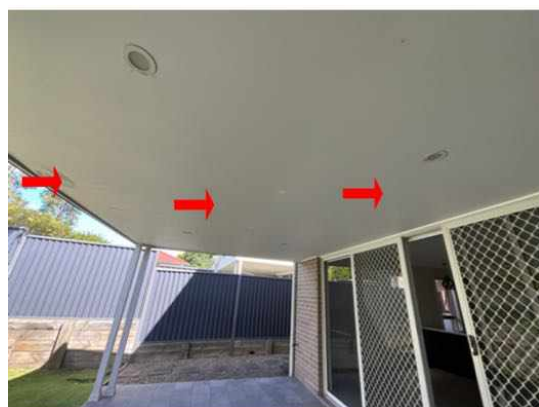
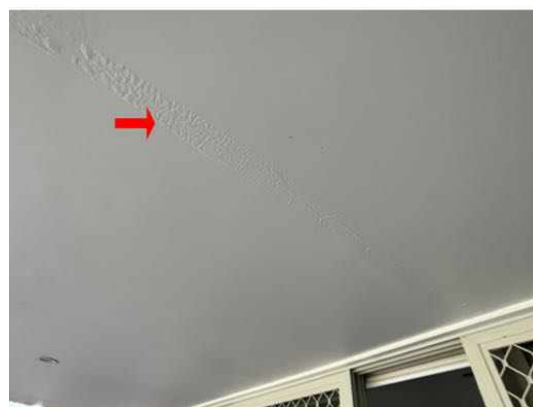
Building: Main Building
 Location: Alfresco
 Finding: Ceiling - Water damaged
 Information: Water damage to the ceiling lining is generally an indication of excessive moisture being present in the roof void, usually via a leak to the roof covering.

Roof flashing to the lower roof above the alfresco was found to be defective and suspected to be the source of water leak to the alfresco ceiling. Water damages were identified, however it is not suspected to be active due to the patch repair silicone work on the roof flashing in this area. A licensed roof plumber must be appointed urgently to rectify flashings, followed by licensed carpenters, plasterers and painters to repair surface damage.

Where water damage is evident to the ceiling, the primary requirement is to identify and rectify the source of the leak. A roofing plumber should be appointed as soon as possible to identify the leak and perform rectification works as necessary, ensuring the water damage is restricted.

Once the leak is repaired, consultation with relevant tradespeople, including plasterers and painters, is advised. Rectification works may include replacement of ceiling lining or minor repainting, depending on the extent of the damage.

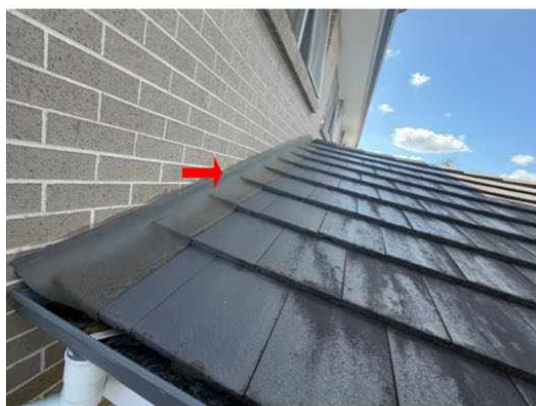
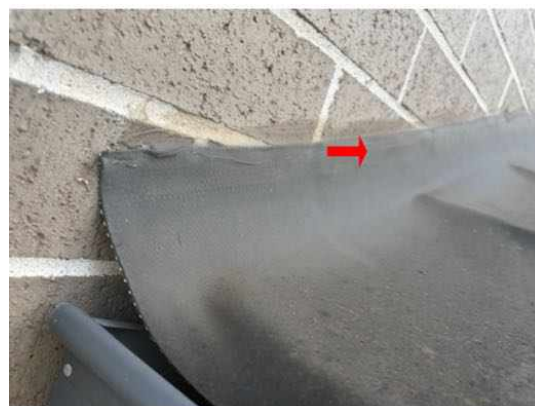
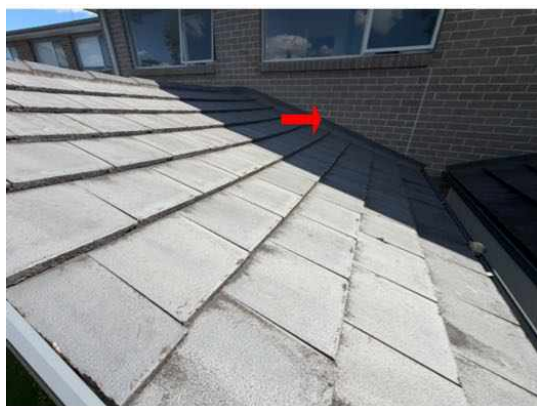
Finding 2.02

Building: Main Building
 Location: Alfresco
 Finding: Flashing - Defective
 Information: Instances where flashings are defective were noted. It is expected the silicon to wear out causing water leaks in this area.

Flashings that are not installed adequately or are missing are likely to result in water penetration to the interior of the property, as well as creating excessively damp conditions against the exterior surfaces and around the base perimeter of the building.

Premature ageing and secondary building defects are imminent where roof plumbing is missing or inadequately installed. Additionally, water pooling also creates an environment that is susceptible to termite and pest infestation.

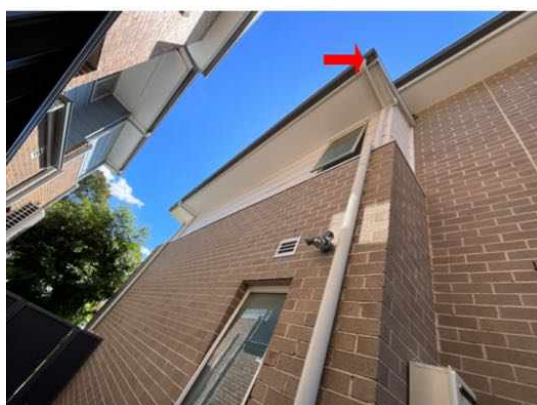
Finding 3.01

Building:	Main Building
Location:	Downpipe LHS
Finding:	Water leak - External
Information:	Water leaks were found to be present to exterior plumbing work. Leaks are generally caused by deterioration of the plumbing elements over time, due to exposure to weather conditions, but may have also been caused by minor impact damage.

Such leaking creates damp conditions in the affected area, causing potential for water pooling and subsequent water damage if left unattended. These conditions may also attract termite attack, particularly if the area is subject to minimal levels of sun throughout daylight hours.

It is highly advised that a licensed plumber be appointed to rectify any water leaks that may be present. Areas of repair and replacement of plumbing fittings and fixtures may be required and, as such, a quotation should be sought.

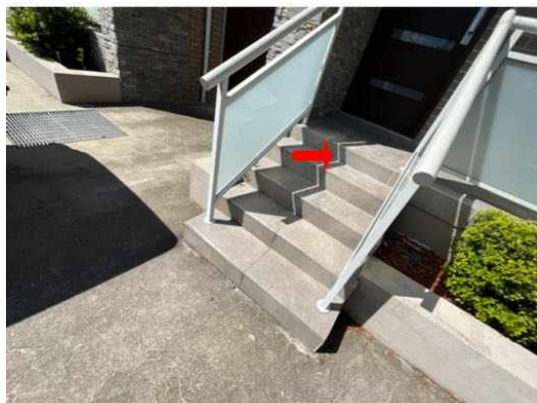
Finding 3.02

Location: Entry
 Finding: Grout — Missing/deteriorated
 Information: Grout is missing or deteriorated in this area. Grout is used to protect gaps and crevices in building materials to ensure that they are water-tight and prevent water penetration to the associated structures.

Where grout is missing, a licensed tiling contractor should be appointed immediately to apply grout and re-apply any silicone where necessary. Failure to do so is likely to lead to water damage to the surrounding area.

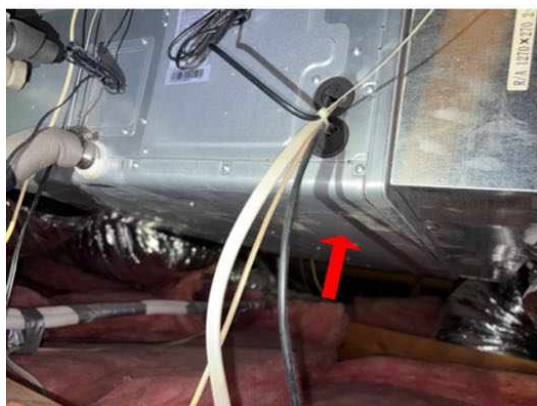
Finding 3.03

Building: Main Building
 Location: Roof Void
 Finding: Internal air conditioning unit - Missing condensation tray
 Information: The internal air conditioning unit in the roof was found to be missing the condensation tray at the time of inspection.

An internal air conditioning unit inside the roof must have a secondary drip tray with a separate drain line to ensure any condensation is dealt with accordingly to avoid water leaks.

A HVAC specialist must be appointed urgently for consultation and rectification, ensuring the manufacturer guidelines are closely followed.

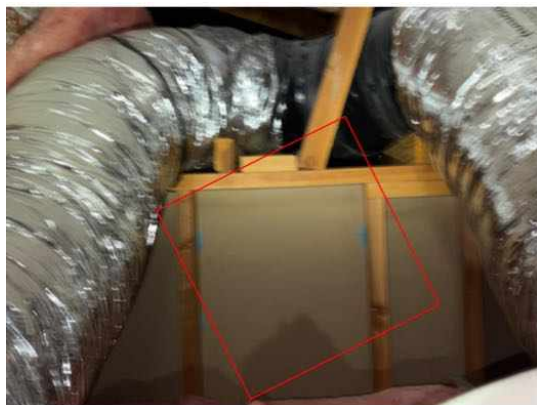
Finding 3.04

Building:	Main Building
Location:	Roof Void
Finding:	Insulation - Inadequate
Information:	Upon inspection of the roof void it was noted that there is a lack of adequate insulation.

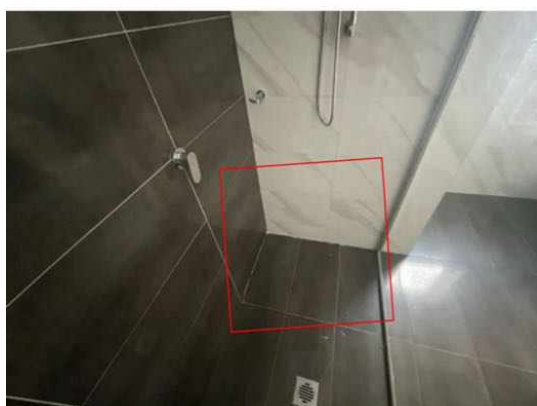
Finding 3.05

Building: Main Building
 Location: All Wet Areas
 Finding: Sealant and grouting - Missing or damaged
 Information:

It was noted on inspection that sealant or grout is degraded to this area.

Different materials and floor areas move at different rates, generally causing cracking to grout or sealant at this point. A flexible sealant is required to allow for expected expansion and contraction, while keeping the joint water tight and protective of all associated building materials.

Flexible and mould resistant materials should be applied to affected areas to prevent any subsequent water damage that is likely to occur. Regular maintenance and replacement of damage or missing or damaged sealant and grout is highly recommended to the wet areas, as this is a regular wear and tear defect. Sealant and grouting in areas that come into regular contact with water should be maintained for the long term care of your property.

A sealant specialist should be appointed to complete these works as soon as possible.

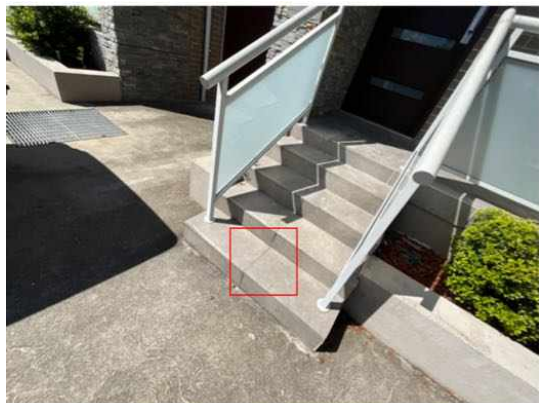
Finding 3.06

Building: Main Building
 Location: Porch
 Finding: Cracked floor tiles
 Information:

Cracking in the floor tiles was evident in this area at the time of inspection. It is suspected that this cracking has occurred as a result of minor settlement or shrinkage.

Cracked tiles throughout the household detract from the overall appearance of the affected areas however it is unlikely to create or lead to any secondary defects.

While not considered a matter of urgency, replacement of cracked floor tiles is recommended at the clients discretion. A licensed tiling contractor may be appointed to perform these works. Where cracks become more numerous, contact a licensed building inspector for further investigation.

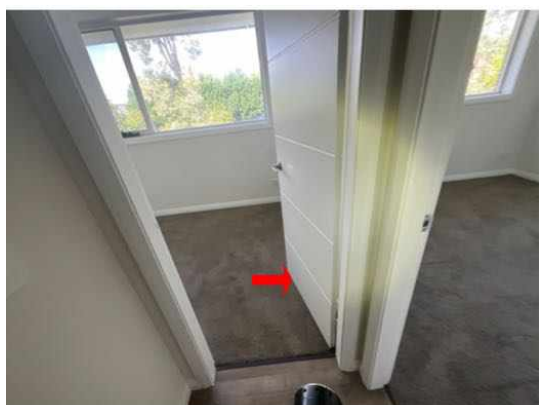
Finding 3.07

Building: Main Building
 Location: Bedroom 4
 Finding: Door - Binding/jamming
 Information:

Binding and/or jamming of this door is evident during standard operation. This defect inhibits the functionality of the affected door as well as creating potential for secondary defects to associated building elements, such as damage to the floor covering or adjacent frame.

A door that binds to flooring or to the associated door frame may have several causes, ranging from minor defects, such as poor installation of the door or deteriorated hinges.

A licensed carpenter should be appointed to perform minor rectification works at client discretion.

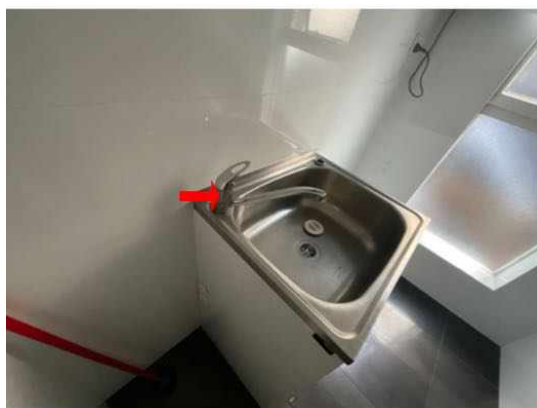
Finding 3.08

Building: Main Building
Location: Laundry, bathroom
Finding: Plumbing fitting or fixture - Loose
Information:

The fitting in this area is loose and requires adjustment to tighten.

If left unmanaged, the fitting may further deteriorate, causing potential for the development of other minor secondary defects.

A licensed plumber should be appointed to perform these rectification works at discretion of the client.

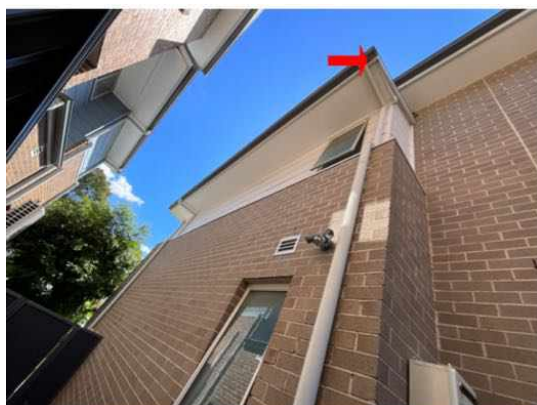
Building:	Main Building
Location:	Downpipe LHS
Finding:	Water leak - External
Information:	Water leaks were found to be present to exterior plumbing work. Leaks are generally

caused by deterioration of the plumbing elements over time, due to exposure to weather conditions, but may have also been caused by minor impact damage.

Such leaking creates damp conditions in the affected area, causing potential for water pooling and subsequent water damage if left unattended. These conditions may also attract termite attack, particularly if the area is subject to minimal levels of sun throughout daylight hours.

It is highly advised that a licensed plumber be appointed to rectify any water leaks that may be present. Areas of repair and replacement of plumbing fittings and fixtures may be required and, as such, a quotation should be sought.

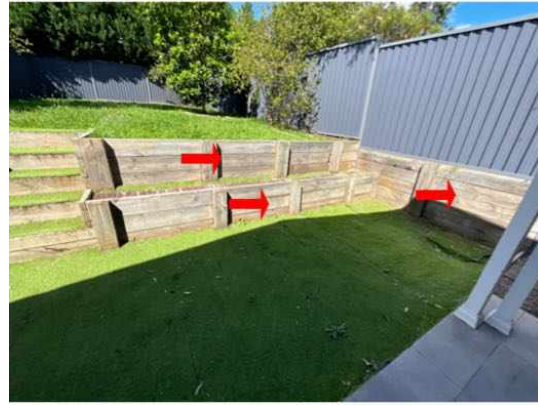
Finding 6.04

Building:	Main Building
Location:	Fencing & Landscaping
Finding:	Building materials in direct ground contact - conducive to termites
Information:	Where timber elements are in direct contact with the ground and consequently moisture or dampness they become conducive to termite activity. Whether timber is used as a building element part of a fencing structure or stored as an unused item they can provide an environment that is attractive to termite infestation.

When met with excessive moisture timber begins to decay and develop wood rot. Any timbers that are in direct contact with external grounds especially if left untreated or non-durable also provide ingress for subterranean termites into that particular element.

The removal of any such materials that may be conducive to termite activity should be removed as soon as possible to minimise the risk of termite attack.

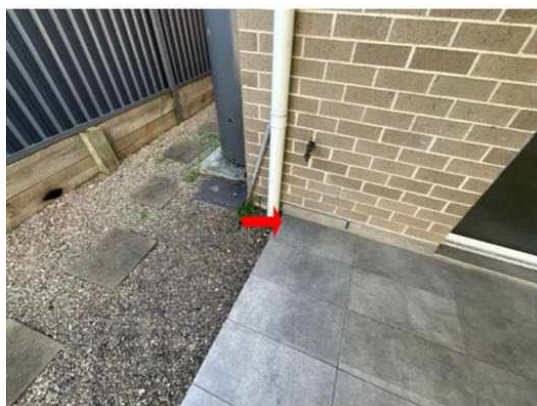
Finding 6.06

Building:	Main Building
Location:	External tap
Finding:	Tap - No drain
Information:	The external tap in this area was noted to have no drain at the time of inspection. This keeps the surrounding surfaces damp while using the tap, which becomes conducive to termite activity. A licensed plumber must be appointed to ensure an appropriate drain is installed.

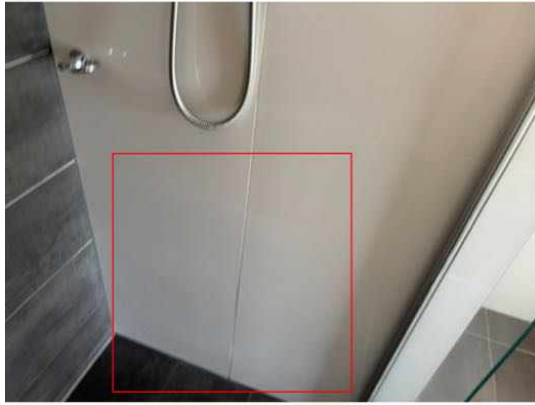
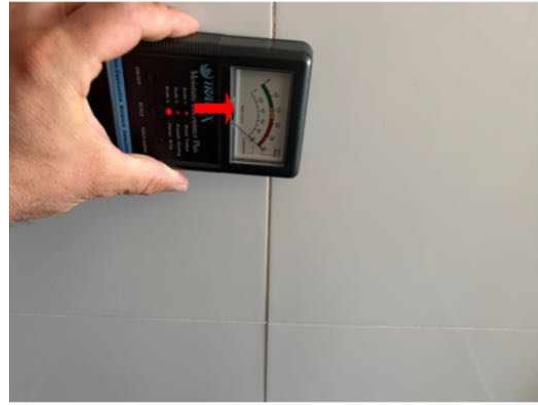
Finding 6.07

Building:	Main Building
Location:	Bathroom
Finding:	Shower damp - Sealant and grout
Information:	Damp is evident to the lower 400mm of wall to the shower alcove. This defect is quite common, and is suspected to have been caused by moisture permeating or leaching through the grouting and sealant in this area, which shows evidence of deterioration. Leaking pipes within the wall is also a possible cause however this seems unlikely in this instance as there is no moisture build up around the taps or transferring to the other side of the wall. There appears to be no sealant around the tap spindles which may be a small contributing factor.

Damp (or structural damp) refers to the presence of unwanted moisture in the structure of a building, either as the result of intrusion from outside, or condensation from within the structure. In the shower area, internal water leaks, degraded materials or other sources of excessive moisture are generally the cause of damp.

Unmanaged damp in the shower recess is likely to facilitate the formation and development of mould and fungi growth, decaying associated building materials and compromising their structural integrity of associated elements. It is important to address damp conditions, as the World Health Organisation notes that excess moisture leads - on almost all indoor materials - to growth of microbes such as moulds, fungi and bacteria, which subsequently emit spores and other matter into the indoor air. Exposure to these contaminants is associated with a wide range of respiratory and other health-related problems. Damp conditions also create a conducive environment for termite infestation.

Consultation with a bathroom sealant specialist is advised immediately to identify the cause of damp and to perform remedial works as required.

Always ensure that sealant and grout is in good condition to prevent any moisture issues occurring in the future.

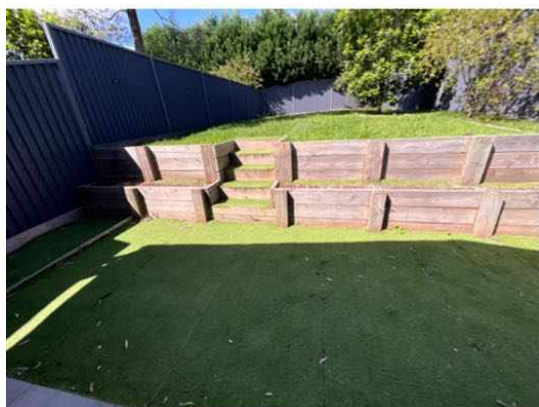
Building: Main Building
 Location: Retaining walls
 Finding: Retaining walls
 Information: At the time of inspection the retaining walls were checked and no defects were observed other than those which May have been mentioned earlier in this report.

AS4349.1-2007 requires all retaining walls in excess of 700mm to be inspected by a licensed and practicing structural engineer.

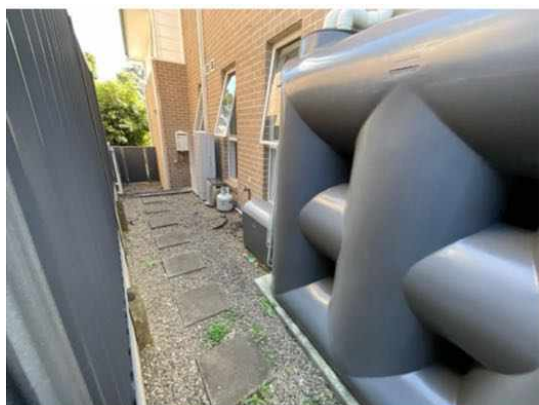
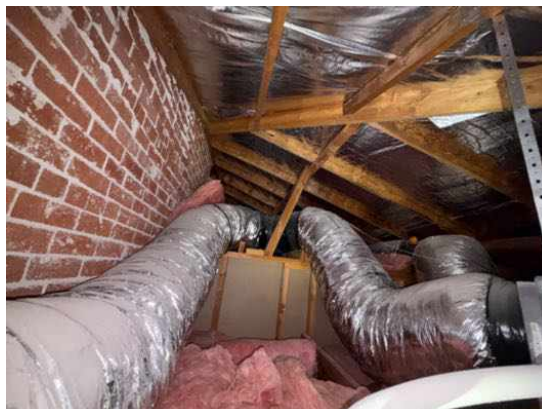
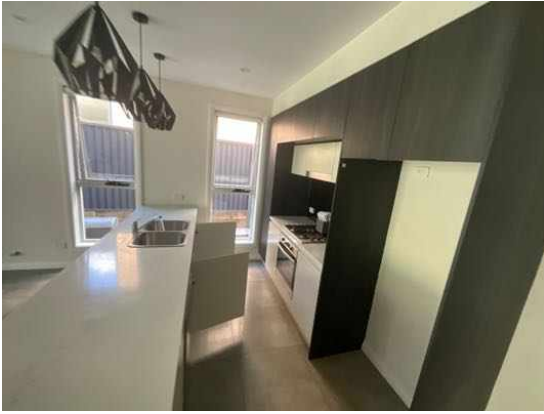
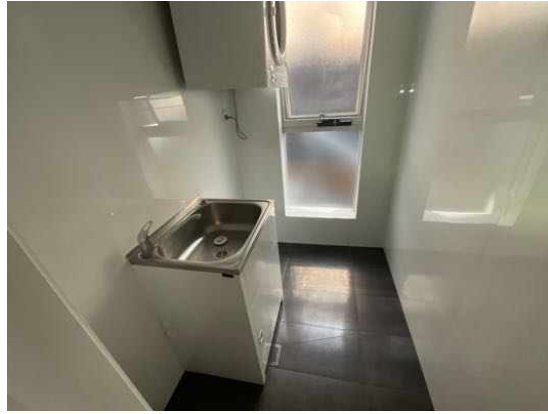
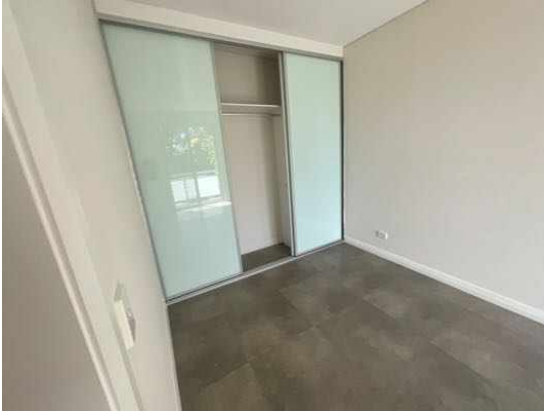
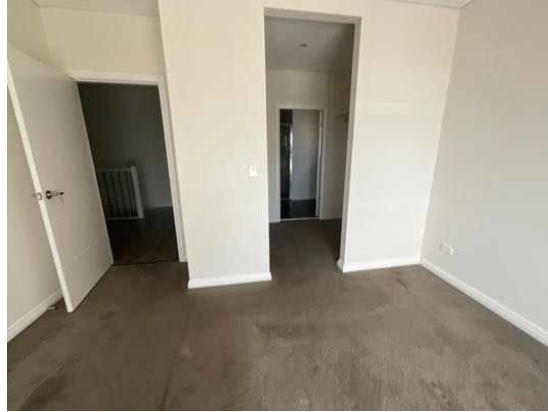
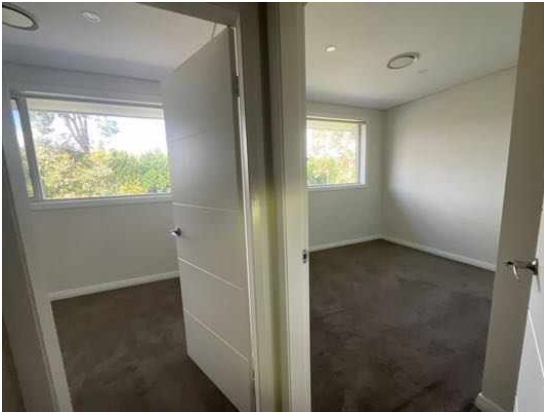
These photographs are an indication of the obstructions and limitations which impeded full inspection of the property at the time of inspection. These obstructions can hide an array of defects and should be removed to allow full inspection to be carried out. A re-inspection is recommended once the areas are made accessible.
