Building and Timber Pest Inspection Report

Inspection Date: Fri, 13 Mar 2026

Property Address: 22 Withers St, West Wallsend NSW 2286,
Australia

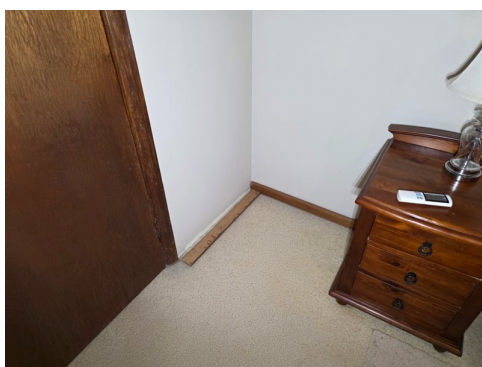
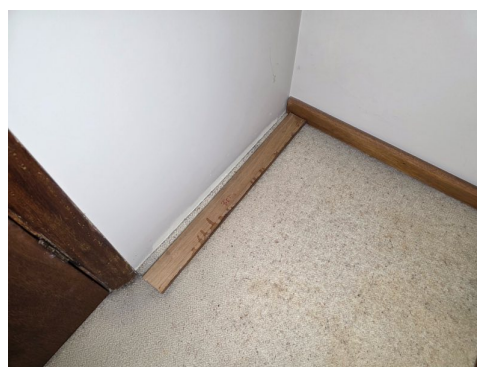
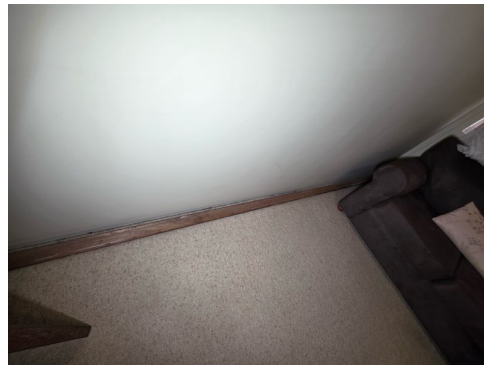
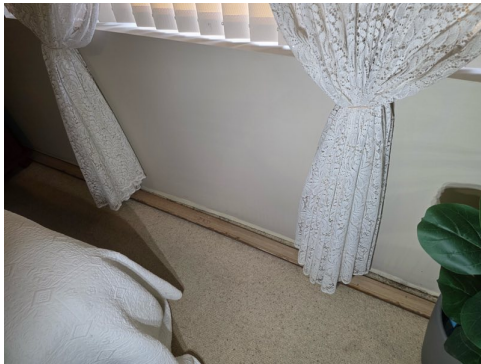
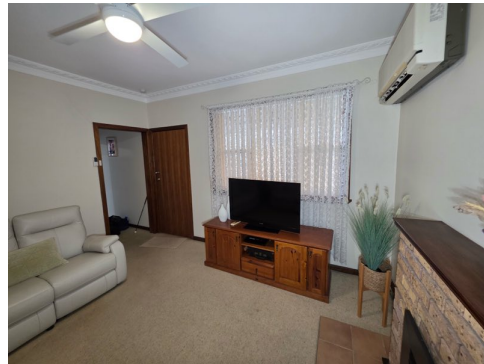
Finding 3.01

Building:	Main Building
Location:	All Internal Areas
Finding:	Loose and Incomplete Skirting and Architrave Installation (Multiple Rooms)
Information:	<p>Skirting and architrave boards were observed loose in multiple rooms throughout the property. The boards appear to have been cut and positioned against the wall but not fixed in place, and corner joints do not appear to have been mitred or scribed. Unsecured skirting boards can become dislodged with normal use and may leave wall-floor junctions exposed to impact damage, gaps and debris accumulation.</p> <p>A licensed carpenter should be engaged to assess and rectify as required. This should be done at the owner's discretion. Photos are indicative of defect throughout.</p>

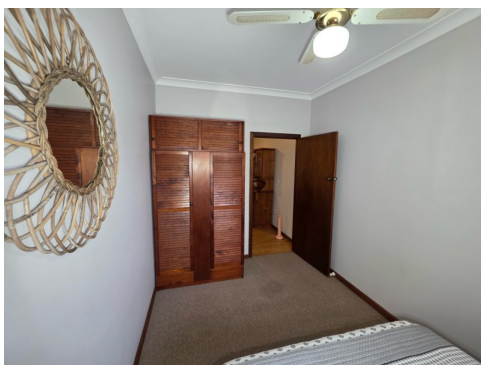
Finding 3.02

Finding: Delaminated and Damaged Door (Bedroom 2)

Information: The door to Bedroom 2 was observed to be delaminated and damaged. The door surface layers have separated and the door panel appears broken, resulting in a loss of rigidity. Where delamination progresses, the door may continue to weaken, affecting normal operation and its ability to function as intended.

A licensed carpenter should be engaged to assess and rectify as required. This should be done as soon as practicable.

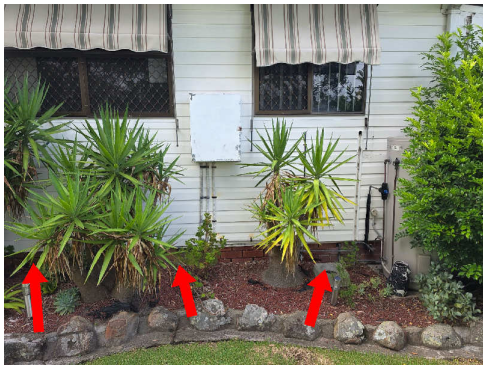
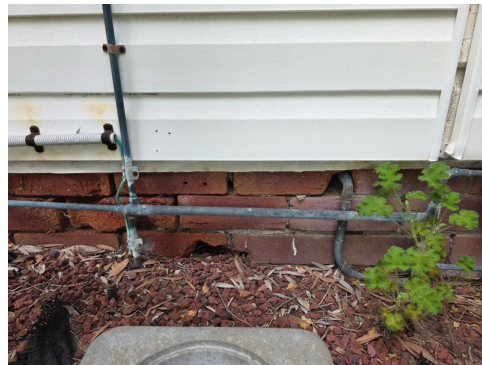
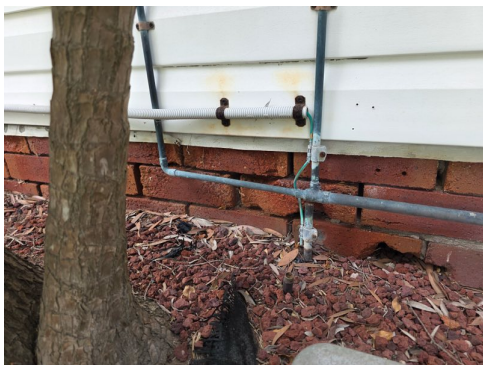
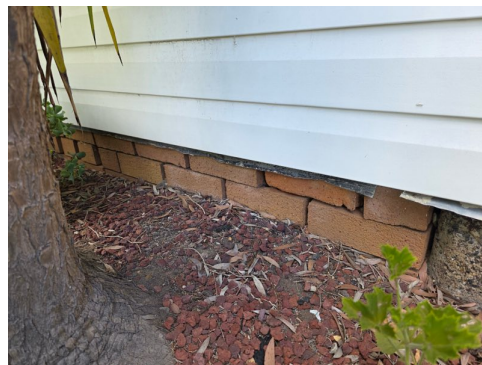
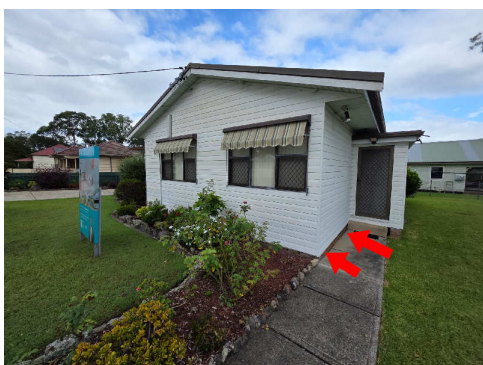
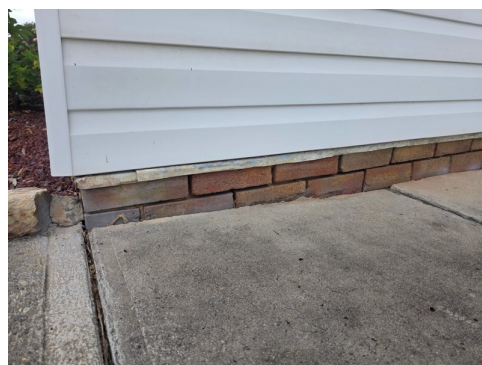
Information: Erosion and weathering of mortar joints were observed in sections of the external brickwork wall along the side of the house. This condition is commonly seen in properties of this age due to long-term exposure to weather and natural deterioration of the mortar. Loss of mortar can allow moisture to penetrate the wall assembly and may progressively reduce the bond between bricks if deterioration continues.

A licensed builder should be engaged to assess the condition of the affected brickwork and carry out repointing or repairs as required. This should be done at the owner's discretion.

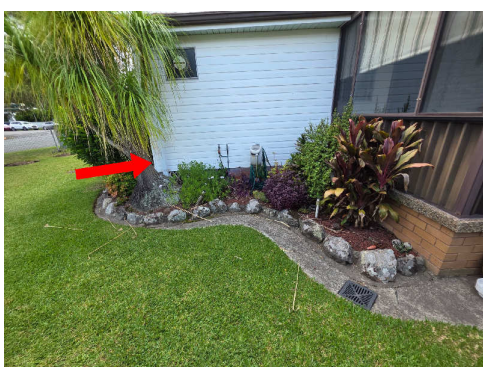
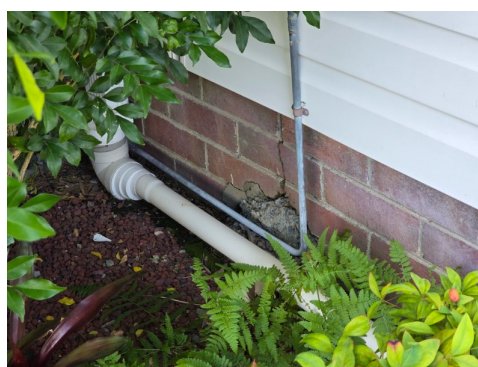
Finding: Cracking to Subfloor Brickwork Near Sewer Penetration

Information: A crack was observed through a brick within the subfloor brickwork behind the toilet location, extending upward from the area surrounding a sewer pipe penetration. Cracking through masonry units may allow moisture ingress and may indicate localised movement.

A qualified bricklayer should be engaged to assess and rectify as required. This should be done as soon as practicable.

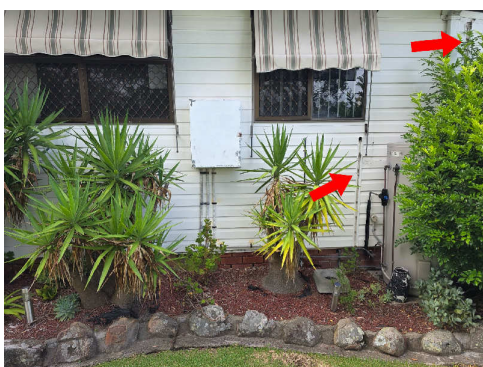
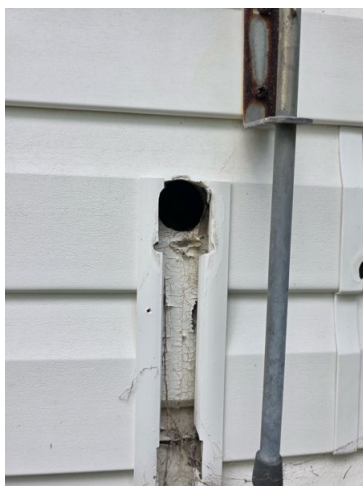
Finding 3.10

Information: The external walls have been clad with PVC weatherboard strips installed over the original timber weatherboards. In two locations along the side of the house, gaps were observed in the PVC cladding where the original timber weatherboards behind are exposed. These openings appear consistent with cladding being installed around a previous fixture that has since been removed, leaving unfinished openings. Exposed gaps may allow water entry behind the cladding and expose concealed materials to moisture.

A licensed builder should be engaged to assess and rectify as required. This should be done as soon as practicable.

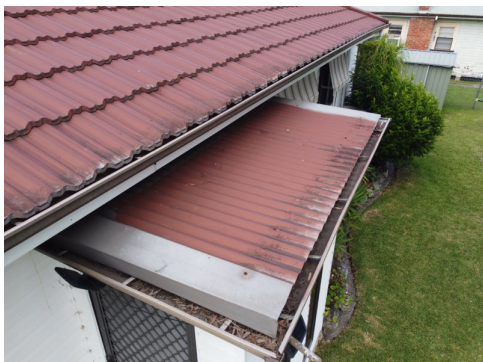
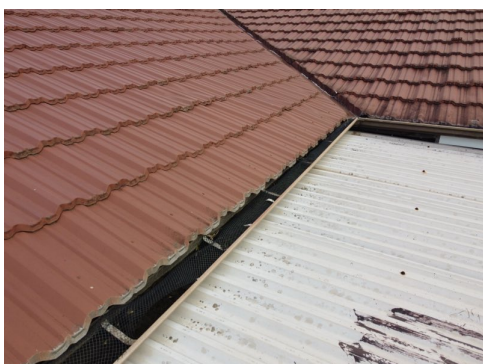
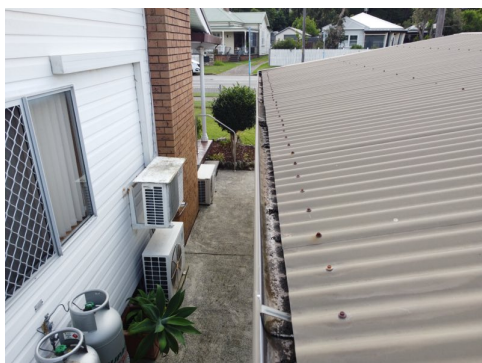
Finding 3.11

Leaf litter was observed within sections of the gutters and minor standing water was present in one gutter to the garage roof. Accumulated debris can obstruct water flow and may lead to overflow or increased moisture exposure to roof edge components if not maintained.

A licensed builder should be engaged to assess and rectify as required. This should be done at the owner's discretion.

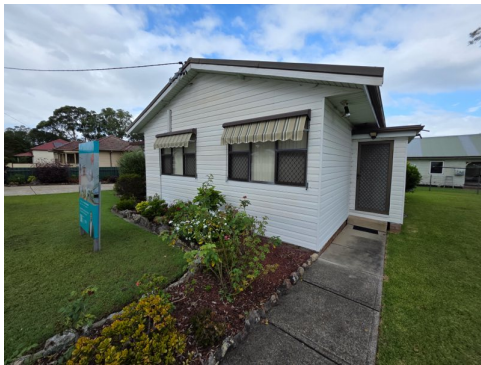
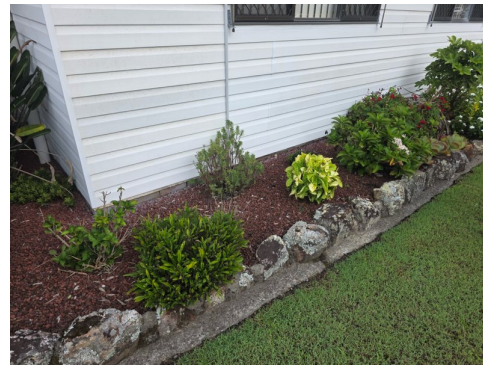
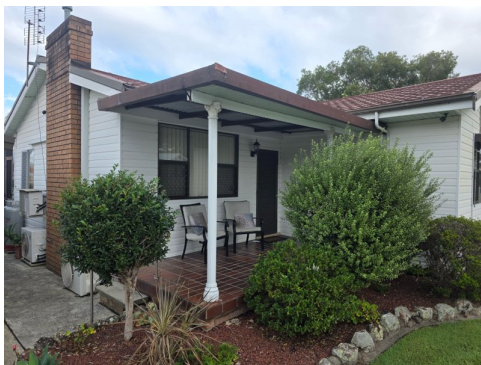
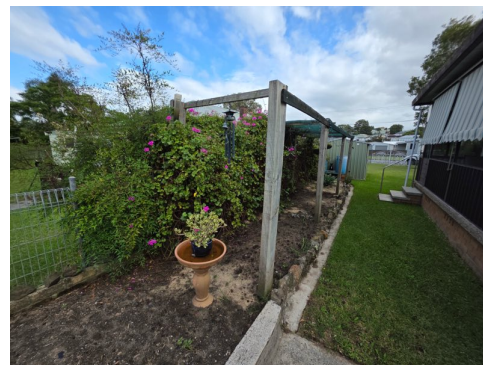
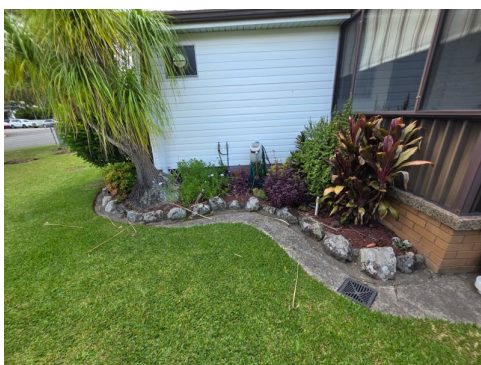
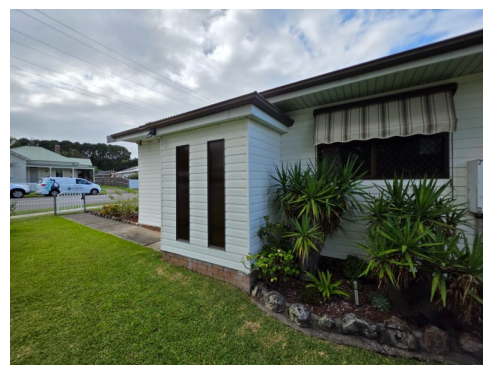
Finding: Garden Beds - Conditions Conducive to Termites

Information: Garden beds, particularly those constructed from untreated timber, were noted adjacent to the dwelling. These create a highly conducive environment for termite activity due to the combination of retained soil moisture from watering, direct soil contact, and the organic material in the soil and timber edging. Such conditions increase the risk of concealed termite ingress into the property, as termites can travel through the garden beds and enter the structure undetected.

Where practical, garden beds should be removed, relocated, or modified so that they do not abut the dwelling. Where this is impractical or undesirable, the risk of concealed termite activity remains. In these cases, a licensed pest controller should establish an ongoing termite management plan, and regular timber pest inspections should be carried out every 6–12 months to assist in protecting the property against infestation.

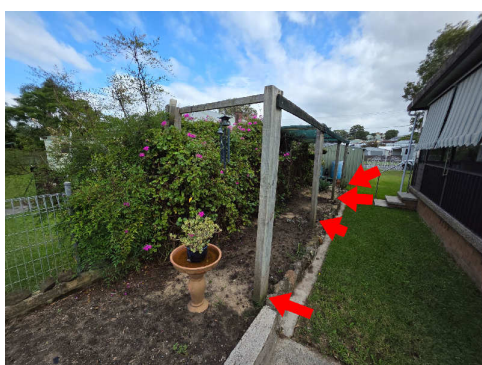
Finding 6.02

Information: Timber elements in direct contact with the ground, and consequently exposed to moisture or dampness, create conditions conducive to termite activity. Whether timber is used as part of a building structure, such as a fence or retaining wall, or stored as unused material, it can attract termite infestations.

When exposed to excessive moisture, timber begins to decay and develop wood rot. Any timber in direct contact with the ground - especially untreated or non-durable timber - provides an easy entry point for subterranean termites into the material.

To minimize the risk of termite attack, it is recommended to remove any materials that could foster termite activity. If removal is impractical or undesirable, it is strongly advised that termite or timber pest inspections be conducted every 6 to 12 months to protect the property from potential infestation.

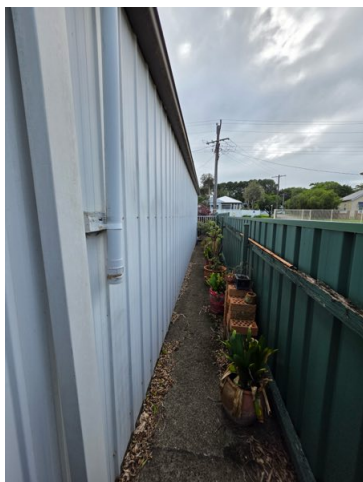
Finding 7.01

Finding: Fungal Decay to Boundary Fence

Fungal decay was observed to sections of the boundary fence shared with the neighbouring property. Timber affected by decay progressively loses strength and durability and may deteriorate further when exposed to ongoing moisture.

A licensed carpenter should be engaged to assess and rectify as required. This should be done at the owner's discretion.

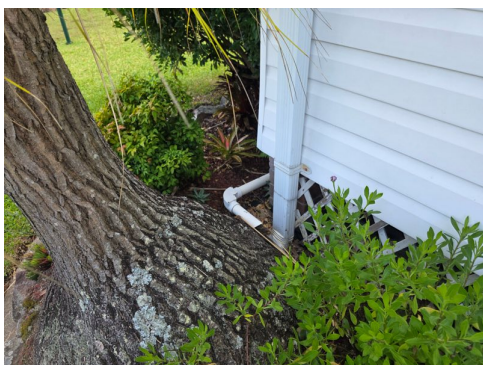
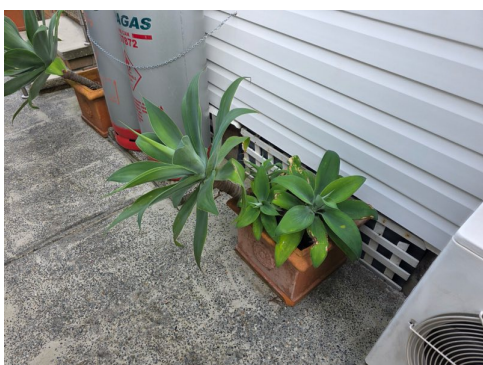
Information: The subfloor area could not be accessed or inspected due to restricted access at the time of inspection. Where areas cannot be entered, elements within the subfloor space cannot be fully assessed and concealed defects, moisture issues or timber pest activity may remain undetected.

Improving access to the subfloor area is recommended to allow proper inspection during future assessments.

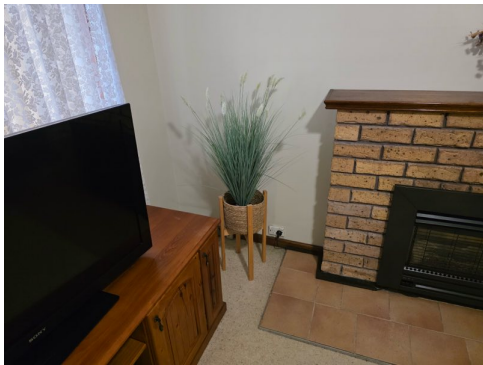
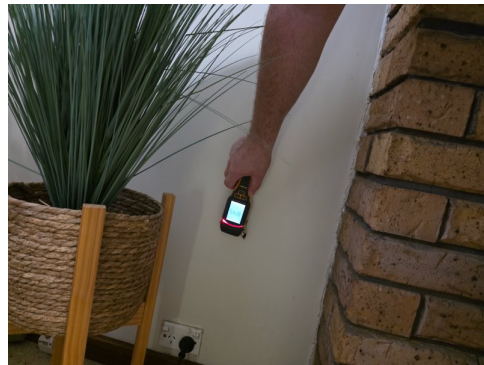
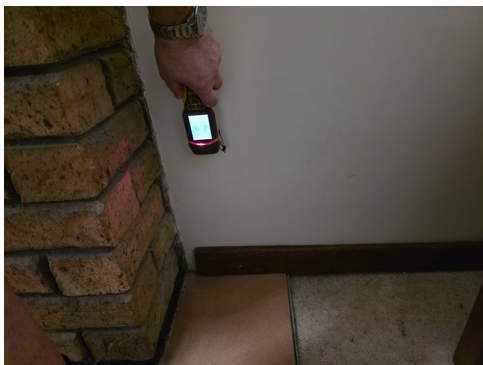
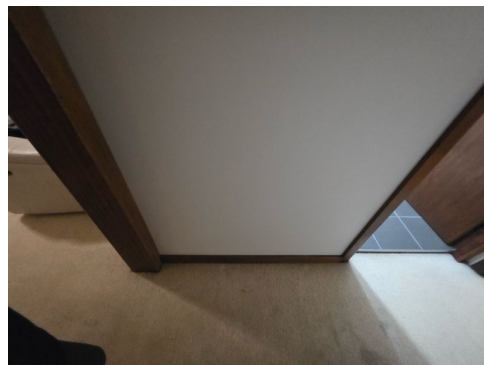
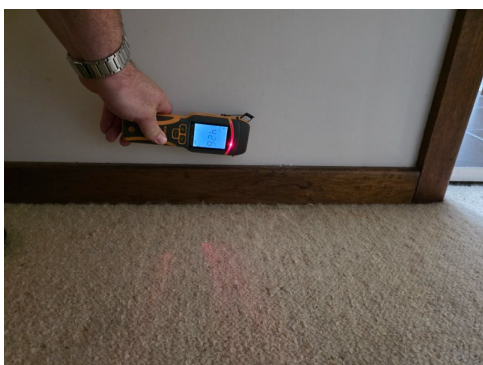
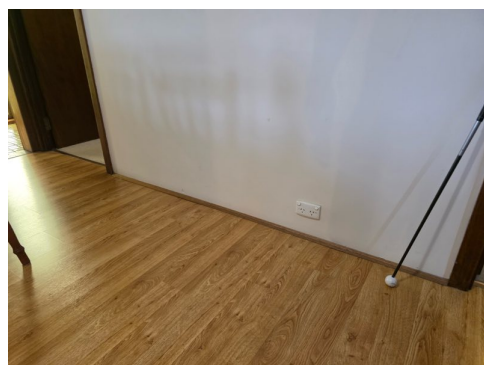
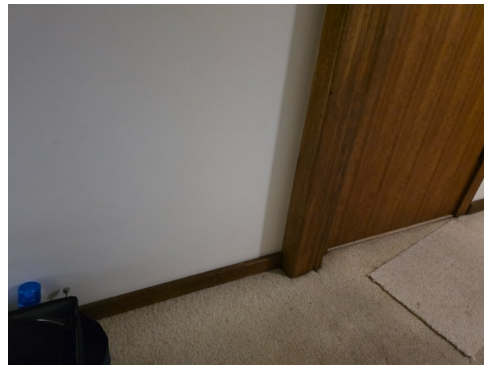
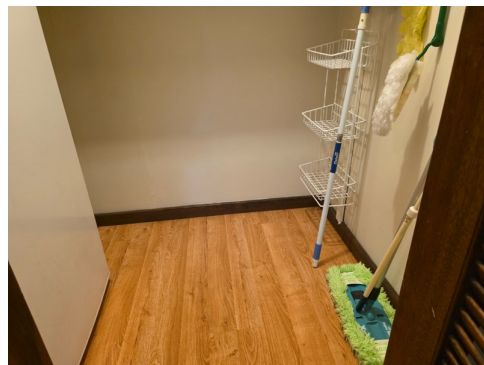
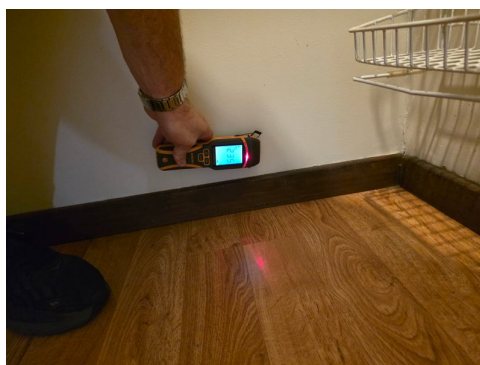
Finding: Low-Level Elevated Moisture

Information: Low-level elevated moisture readings were recorded to some internal walls throughout the property. No visible mould, deterioration or discolouration was observed at the time of inspection. The readings may not necessarily indicate active moisture ingress and could be influenced by environmental conditions; however, the source cannot be confirmed during a visual, non-invasive inspection. The area should be monitored, and if deterioration, discolouration or mould growth develops, further investigation may be required.

A licensed builder should be engaged to assess and provide further investigation if required. This should be done at the owner's discretion.

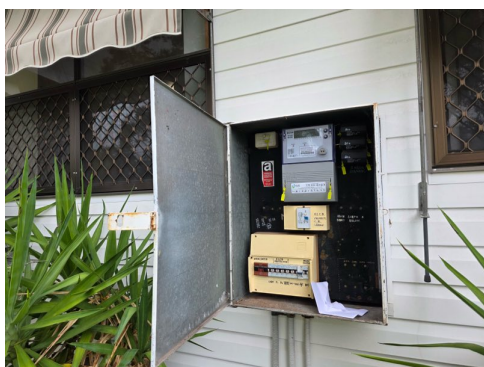
Information: Reporting on asbestos is outside the scope of this inspection. Suspected asbestos-containing material (ACM) was observed in the meter box. Based on our experience in the building industry, there is a higher risk that the identified building elements contain asbestos, particularly given that any home constructed prior to 1990 may contain asbestos in various forms.

No sample testing has been undertaken to confirm the presence of asbestos. We strongly recommend a separate Asbestos Inspection and Condition Audit be carried out by a licensed assessor, which may include laboratory testing for definitive confirmation.

In the meantime, the client is advised to act with caution, especially when considering any disturbance of the material through wear and tear, renovations, extensions, demolition, or maintenance activities.

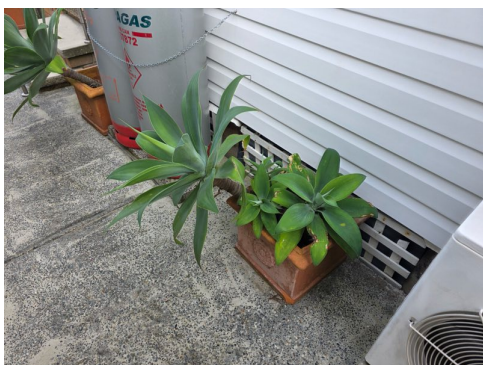
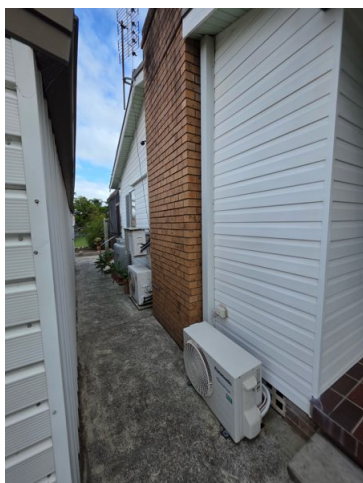
Information: The subfloor area could not be accessed at the time of inspection due to restricted access. Where areas cannot be entered or viewed, their condition cannot be confirmed and defects may be present but not visible during a visual, non-invasive inspection.

Access should be improved to allow inspection during future building and timber pest inspections.
