Building Inspection Report

Inspection Date: Fri, 6 Mar 2026

Property Address: 25 Highfielde Ave, Berwick VIC 3806,
Australia

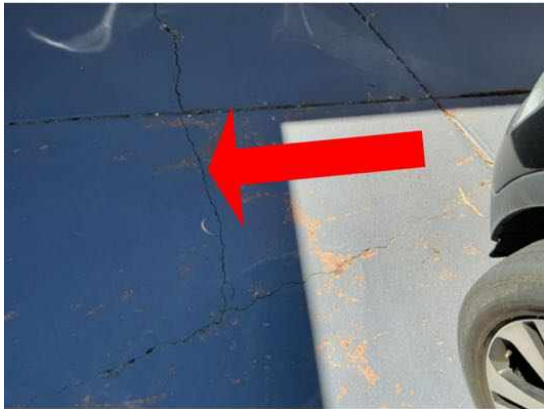
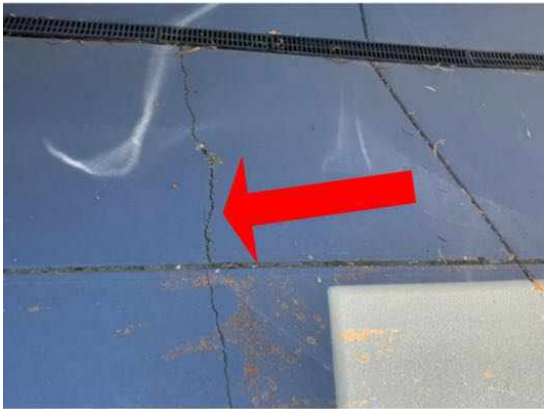
Defects 3.01

Building:	Main Building
Location:	All External Areas
Finding:	Cracking - External Concrete Paving and Driveway Damage Category 2 - Distinct (less than 3mm)
Information:	Distinct cracks were identified in external concrete paving and driveway. Distinct cracks are generally found in older concrete paving, and may also present as a trip hazard as consequence of an uneven or curved surface.

General age and expected deterioration of the paved areas is a common cause of this type of cracking. However, expansion and contraction of the slab may also have occurred due to environmental factors. Such factors include variable moisture and weather conditions, the presence of trees and their roots having a settling or lifting affect on the soil, or the effect of load bearing, e.g. heavy vehicles over a sustained period of time.

Cracking to this degree may also be due to poor original installation of the concrete. Factors such as poor compaction of the sub surface and/or inadequate reinforcing of the slab may create cracking and other secondary defects.

Repairs are likely to be required to prevent further cracking and to reduce hazards associated with cracking, such as tripping. Monitoring of all cracking should be conducted frequently. Always contact a building inspector should cracks widen, lengthen, or become more numerous.

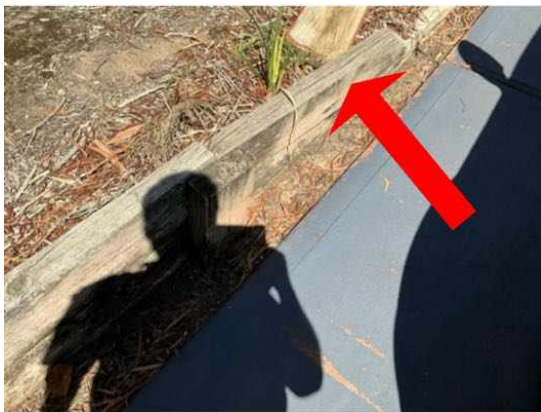
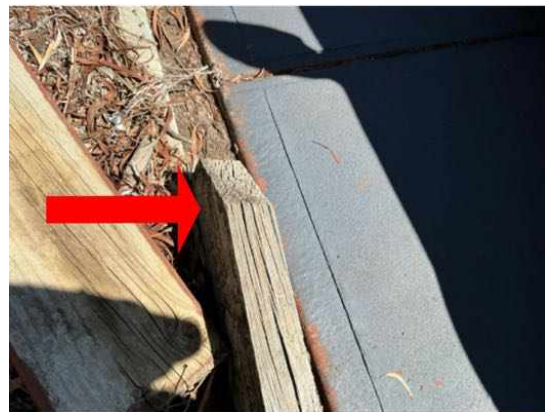
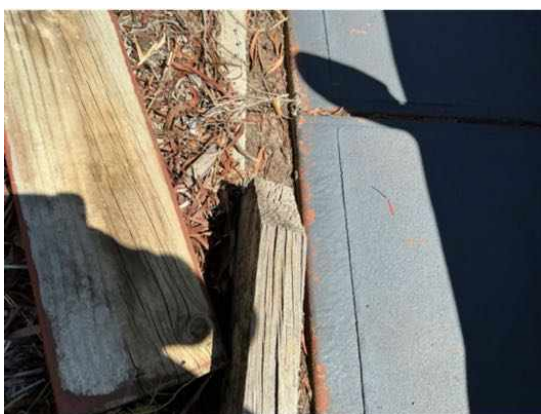
Defects 3.02

Building: Main Building
 Location: Driveway
 Finding: Minor Misalignment to Retaining Wall Timber Sleeper at Driveway Entrance
 Information:

At the time of the inspection, one section of the timber retaining wall sleeper located at the driveway entrance was observed to be slightly misaligned. The sleeper appears to have shifted from its original position, resulting in a small offset along the retaining wall line.

Minor movement of retaining wall sleepers can occur over time due to ground movement, vehicle loads, or deterioration of the fixings. If left unattended, the misalignment may worsen and could affect the stability and appearance of the retaining wall section.

It is recommended that a qualified carpenter or fencing contractor be engaged to inspect the affected sleeper and carry out the necessary rectification works, which may include realigning the sleeper and securing it properly to restore the structural integrity of the retaining wall.

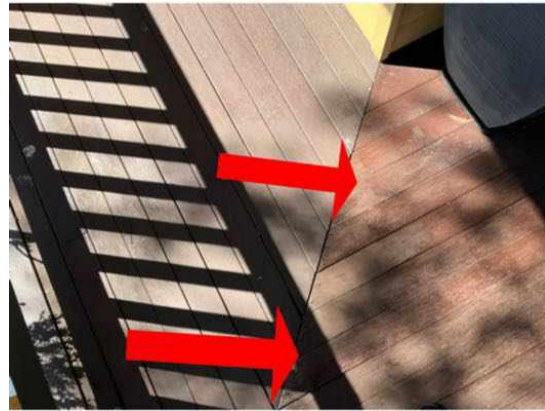
Defects 3.03

During the inspection, several sections of the timber decking at the front veranda were observed to exhibit noticeable movement or bounce underfoot when walked upon.

Movement of this nature may indicate that the decking boards or the supporting structural members beneath, such as joists or bearers, may be inadequately supported, loose, or potentially deteriorated. In some cases, this condition may also be associated with timber decay or failure of the supporting elements beneath the decking.

It is recommended that a licensed carpenter be engaged to further investigate the affected areas. This may involve lifting selected decking boards to inspect the underlying structural members and confirm whether adequate support is present. Any deteriorated timber, loose fixings, or insufficient structural support should be repaired, reinforced, or replaced as required to restore the stability of the veranda decking.

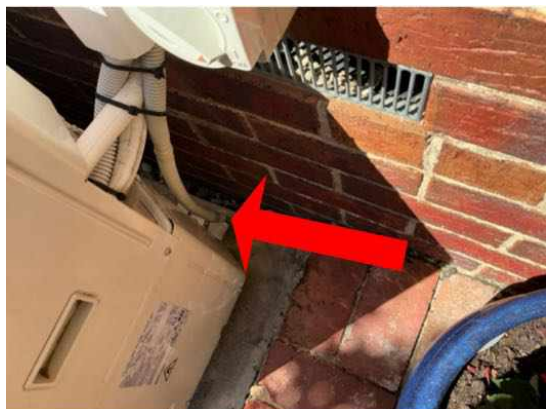
Defects 3.04

Information: Upon inspection, it was found that the AC overflow is not plumbed or connected to

suitable drainage. This could lead to the surrounding area becoming excessively damp, which in turn may cause secondary defects such as rot, rust, corrosion of associated building elements, and the formation of fungal decay. In addition, prolonged damp conditions could create potential slip hazards. Poor site drainage may exacerbate the issue, potentially attracting termite activity to the area.

We recommend that a licensed plumber be appointed to properly plumb the AC overflow and connect it to suitable drainage. This will help ensure that the area remains dry and free from secondary defects.

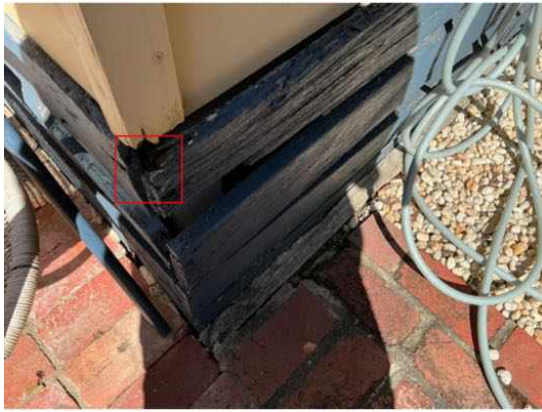
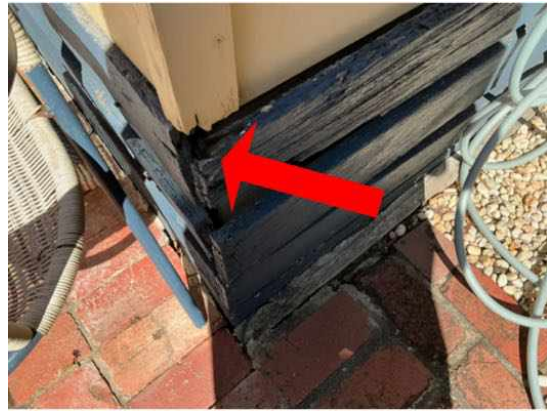
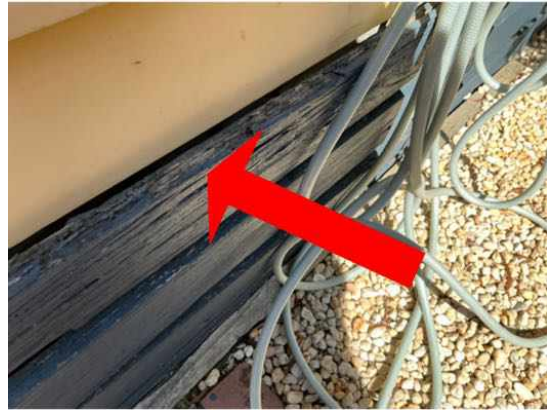
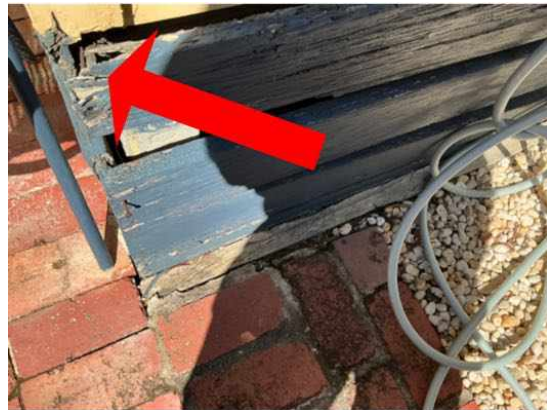
Defects 3.05

Building: Main Building
 Location: All External Areas
 Finding: Timber Rot to Plinth Boards Around the Dwelling
 Information:

Sections of the timber plinth boards around the perimeter of the dwelling were observed to be showing signs of timber rot and deterioration at the time of inspection.

Timber rot typically occurs when timber elements are exposed to prolonged moisture or weathering, which can lead to loss of structural integrity and progressive deterioration if left untreated. Decayed plinth boards may also create conducive conditions for timber pest activity.

It is recommended that a licensed carpenter be engaged to assess the condition of the affected plinth boards and replace any deteriorated sections as necessary. Any new timber installed should be appropriately treated and protected to minimise future moisture exposure and deterioration.

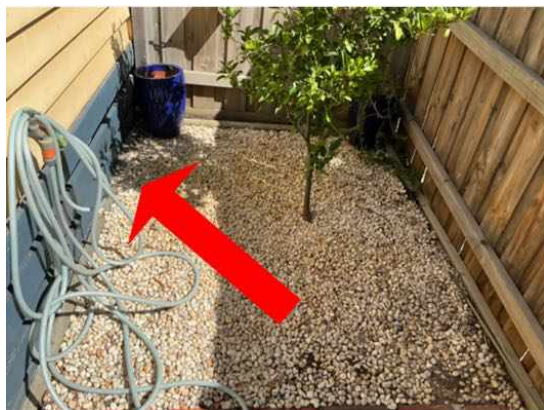
Defects 3.06

Building:	Main Building
Location:	All External Areas
Finding:	Site drainage - Inadequate
Information:	The site drainage in the yards was found to be inadequate at the time of inspection, creating potential for subsequent water damage to associated building elements.

It is important that water does not lie against the base of walls; surrounding paths and ground levels should be sloped to drain water away from walls. Downpipes should not discharge stormwater onto lower walls or plinths. Stormwater should be carried away by large, regularly cleaned drains. Ground levels may need to be lowered to expose a buried DPC.

Where site drainage is inadequate, installation of an Agricultural (Aggie) Drain may be required. A qualified plumber should be appointed to further inspect the property and perform any remedial works as necessary. Water damage and secondary defects are likely to occur if left unmanaged.

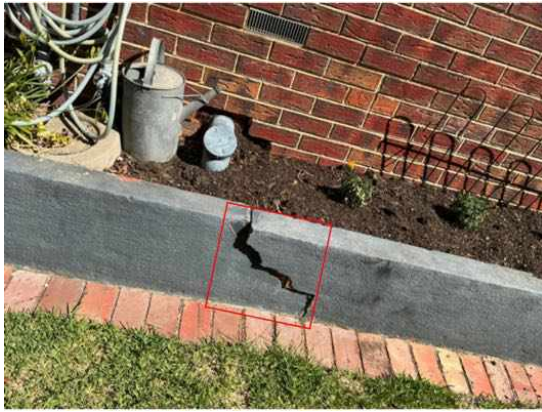
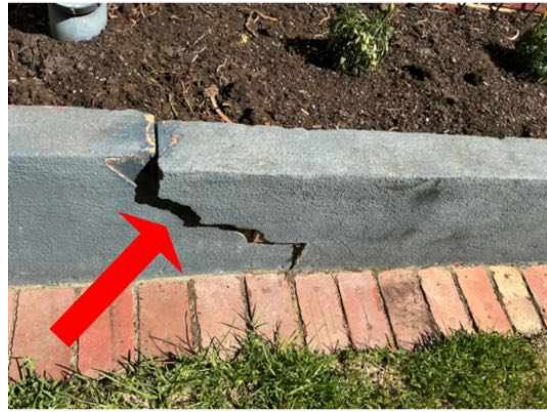
Defects 3.07

Building: Main Building
 Location: Yard - Back
 Finding: Structural Cracking and Damage to Garden Retaining Wall
 Information:

Significant cracking and physical damage were observed to the rendered masonry retaining wall located in the backyard. A section of the wall has fractured and partially broken away, resulting in a visible separation and loss of structural continuity within the wall element.

Damage of this nature may indicate movement, impact damage, or structural distress within the retaining wall. If left unrectified, the affected section may continue to deteriorate and could compromise the ability of the wall to adequately retain the soil behind it.

It is recommended that a qualified landscaper, concreter, or builder experienced in retaining wall construction be engaged to assess the extent of the damage and undertake the necessary repairs. Rectification will likely involve removal and reconstruction or reinforcement of the affected section to restore the structural integrity of the retaining wall.

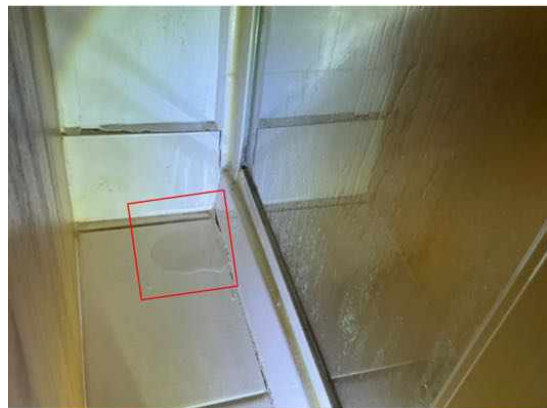
Defects 3.08

Building:	Main Building
Location:	Ensuite - Master
Finding:	Shower screen - Leaking
Information:	Leaking was evident to the ensuite's shower screen at the time of inspection. It is suspected that the leaking has occurred as a result of deteriorated or missing caulking to the shower or general ageing of the building elements.

Leaking from the shower where left unattended, is likely to lead to water damage to adjoining flooring and walls. Such damage can lead to water damage and necessitate extensive remedial works being required. Active water leaks may also create an environment that is susceptible to the formation and development of mould.

Appointment of a caulking contractor is required to repair or replace the caulking to the shower area. Such works should be performed as soon as possible to ensure that no further damage occurs.

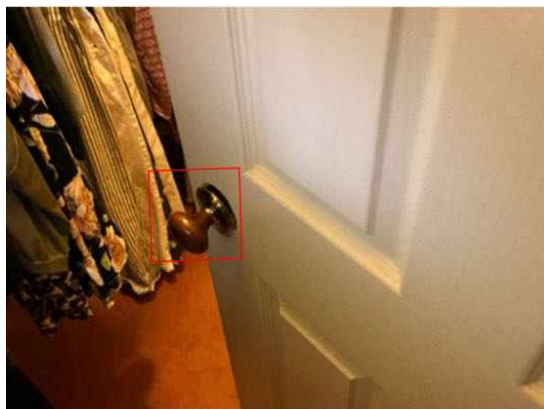
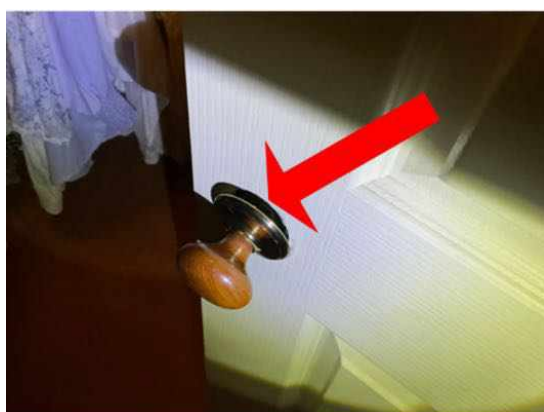
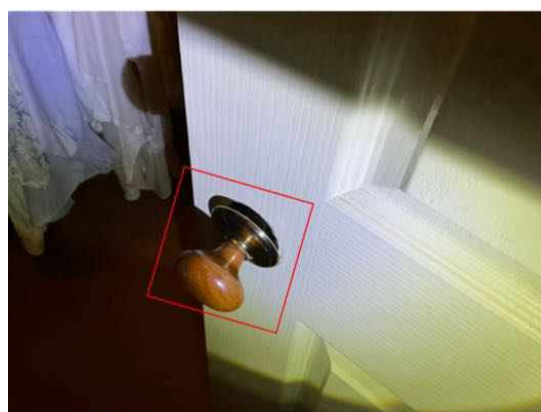
Defects 3.09

Building:	Main Building
Location:	Walk-In Robe - Master
Finding:	Loose Door Handle

Information: Upon visual inspection, we found that the WIR door handle was slightly loose and exhibited some movement when operated from both the interior and exterior sides. This condition may worsen over time with continued use, potentially leading to difficulty in operating the door or further mechanical failure. We recommend that a licensed carpenter or handyman be engaged to tighten or adjust the door handle to ensure secure and reliable operation.

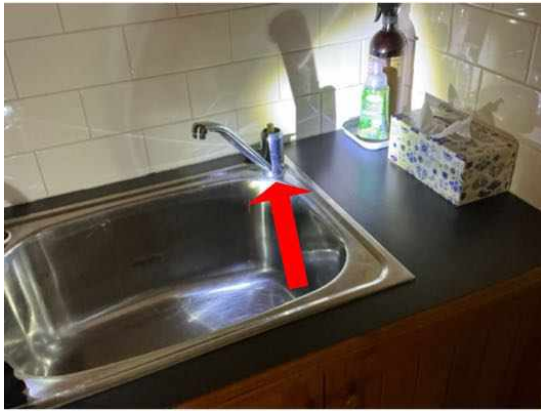
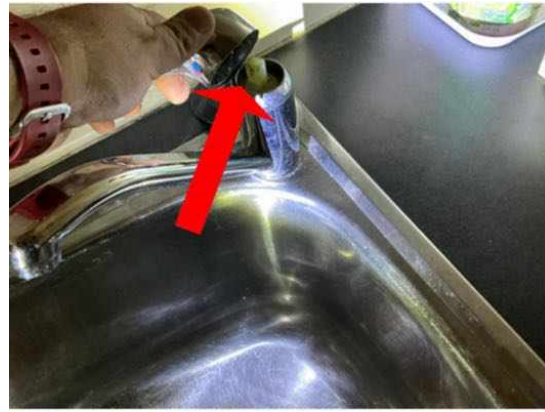
Defects 3.10

Building: Main Building
 Location: Laundry
 Finding: Laundry Tap Head Loose and Detaching
 Information:

At the time of the inspection, the tap head to the laundry tap was observed to be loose and prone to coming off during normal operation.

A loose or detached tap head may indicate worn or damaged internal components, including the retaining mechanism or threading.

It is recommended that a licensed plumber be engaged to inspect the laundry tap assembly and repair or replace the tap head as necessary to ensure the fixture operates properly and remains securely attached.

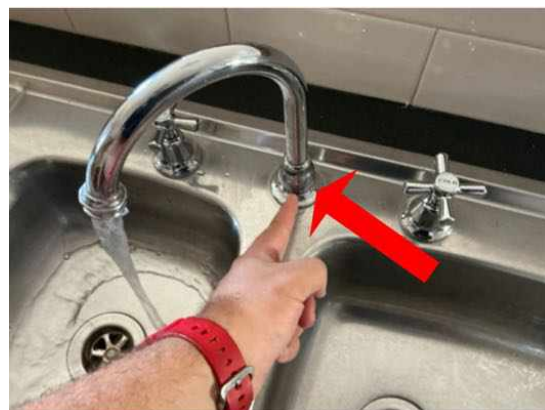
Defects 3.11

Information: The kitchen tap shows evidence of water hammer being present. Water hammer, a pressure surge resulting when a fluid is forced to suddenly change direction, is a common defect in plumbing fittings, particularly those that are aged and not frequently maintained. Water hammer is generally caused by factors that create high water pressure in the affected plumbing fixture, usually evidenced by a faint banging noise during operation of the affected tap.

Although water hammer is generally considered to be a minor defect, subsequent damage such as erosion of tap hardware and/or water damage to associated building elements is likely to occur if left unmanaged.

A licensed plumber should be appointed as soon as possible to replace any affected tap hardware and perform any remedial works as necessary. Please be advised that the appointment of a cabinet maker or qualified carpenter may be necessary if water damage to associated building elements has occurred.

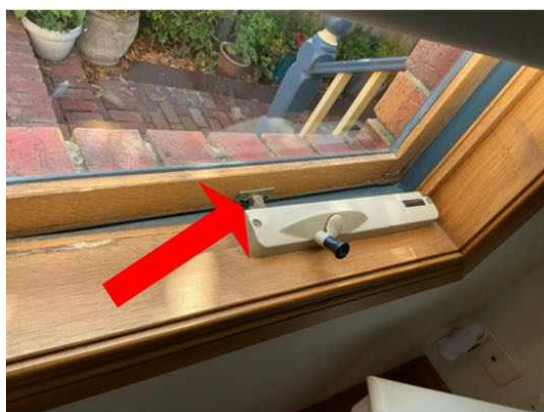
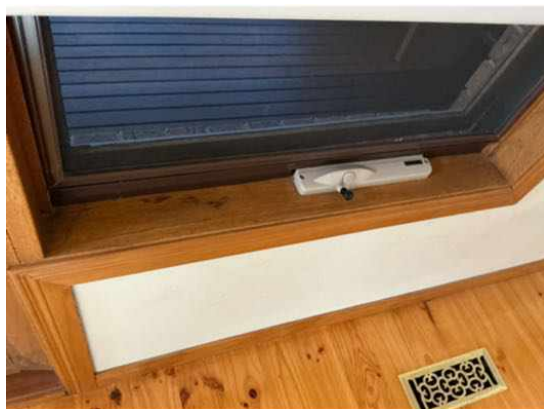
Defects 3.12

Location: All Internal Areas
 Finding: Windows - Stiff to slide
 Information: Several windows throughout the property were jammed and difficult to operate at the time of the inspection. Windows provide ventilation to the adjoining area and should be at a fully operational level to ensure user comfort. Restricted function of the window may also pose as a potential safety hazard if required for emergency egress from the building.

Generally, factors such as general age of the building element and a lack of maintenance are the usual causes for this type of defect.

Replacement of window hardware or frame may be required, as well as minor repairs and cleaning. A registered builder or general handy person will be required to repair the affected windows.

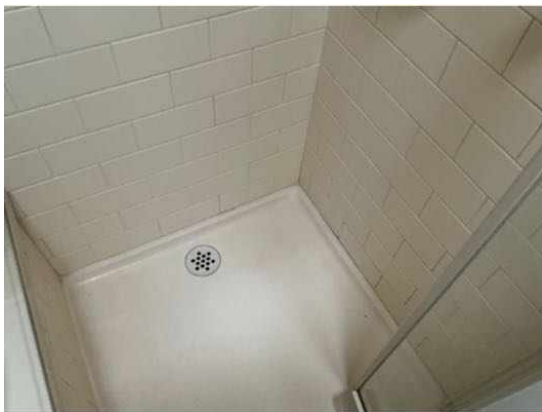
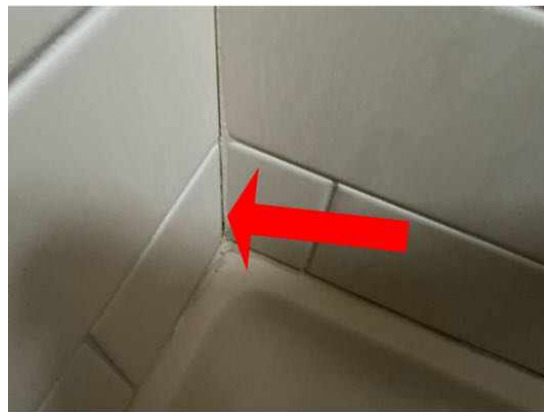
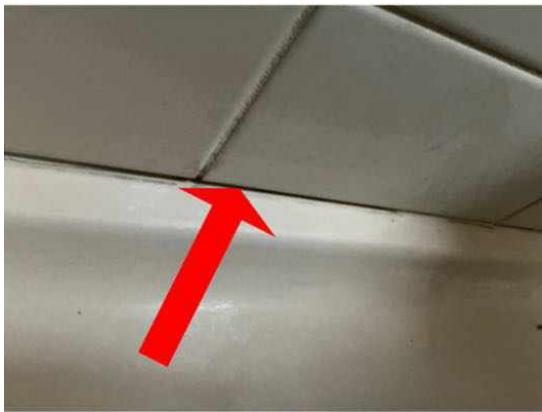
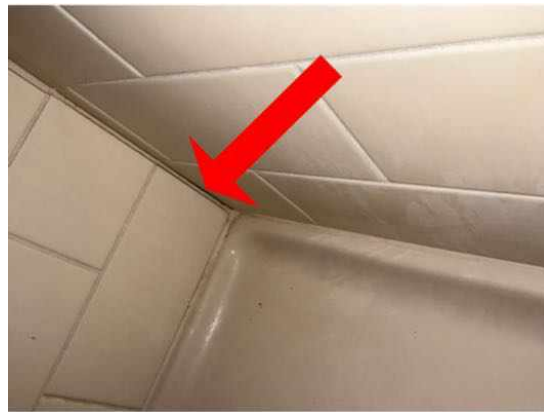
Defects 3.13

Building: Main Building
 Location: Bathroom 2
 Finding: Sealant and grouting - Deteriorated
 Information: It was noted on inspection that sealant or grout is degraded to the tiled shower alcove and or other areas of the bathroom.

Different materials and floor areas move at different rates, generally causing cracking to grout or sealant at this point. A flexible sealant is required to allow for expected expansion and contraction, while keeping the joint water tight and protective of all associated building materials.

Flexible and mould resistant materials should be applied to affected areas to prevent any subsequent water damage that is likely to occur. Regular maintenance and replacement of damage or missing or damaged sealant and grout is highly recommended to the wet areas, as this is a regular wear and tear defect. Sealant and grouting in areas that come into regular contact with water should be maintained for the long term care of your property.

A sealant specialist or tiling contractor should be appointed to complete these works as soon as possible

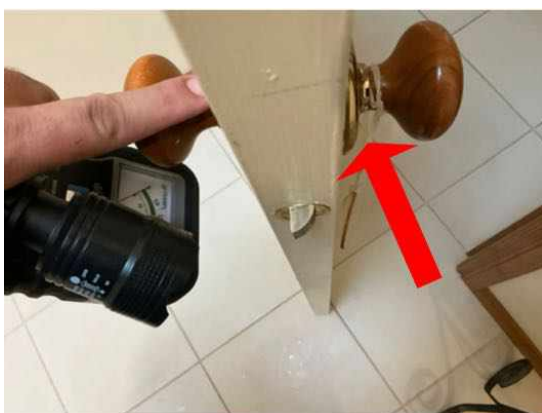
Defects 3.14

Building:	Main Building
Location:	Bathroom 2
Finding:	Loose Door Handle
Information:	Upon visual inspection, we found that the 2nd bathroom's door handle was slightly loose and exhibited some movement when operated from both the interior and exterior sides. This condition may worsen over time with continued use, potentially leading to difficulty in operating the door or further mechanical failure. We recommend that a licensed carpenter or handyman be engaged to tighten or adjust the door handle to ensure secure and reliable operation.

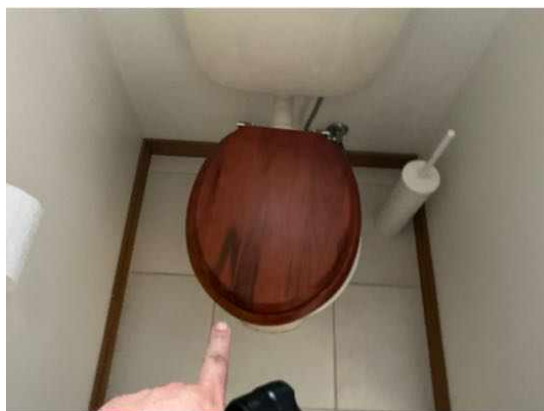
Defects 3.15

Building:	Main Building
Location:	Toilet (WC)
Finding:	Toilet seat - loose
Information:	The toilet seat was found to be loose and shifting during use at the time of inspection. This defect likely developed due to wear and tear of the seat's fixing hardware. However, it may also be the result of improper installation or accidental impact.

If left unaddressed, the loose toilet seat could worsen, leading to potential damage to the mounting points or discomfort for users. In some cases, further instability may lead

to minor injuries or increased wear on the toilet bowl.

It is recommended that the toilet seat be properly refastened or replaced by a licensed plumber to ensure safe and stable use.

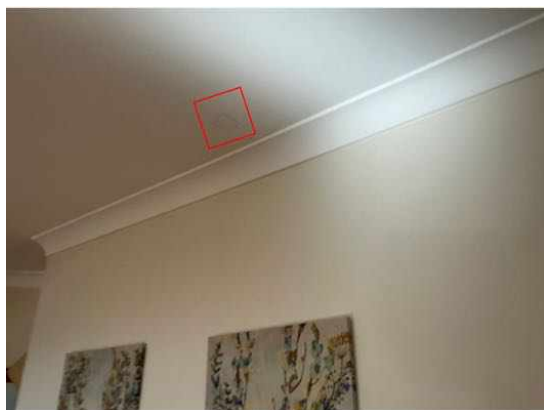
Defects 3.16

Building:	Main Building
Location:	Family Room
Finding:	Ceiling - Water stained
Information:	Water staining to ceiling linings in the family room was evident at the time of inspection. Water staining indicates that surfaces have been exposed to excessive moisture over time. The minerals and other elements in the water lead to staining, which may graduate to corrosion and deterioration if left unmanaged.

While mostly an appearance defect, water staining can be indicative of more serious defects, which may be currently concealed by interior ceilings.

Where water staining is active, a licensed plumber must be consulted to identify the cause of the staining and to provide advice on any reparation works that may be required. Replacement of any damaged structures is advised.

Conversely, where water staining is old and inactive, affected building materials may be repaired or replaced at client discretion.

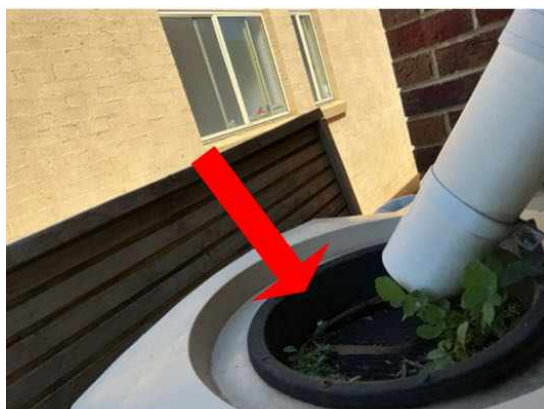
Defects 3.17

Building:	Main Building
Location:	Water tank
Finding:	Partially Blocked water tank inlet
Information:	The water tank inlet is currently partially blocked by an accumulation of grass, weeds, and rubbish. This obstruction hinders the proper flow of water into the tank, which can lead to reduced water capacity, contamination, and potential damage to the tank system. Immediate removal of the debris and regular maintenance are required to restore the water tank's functionality and prevent further issues.

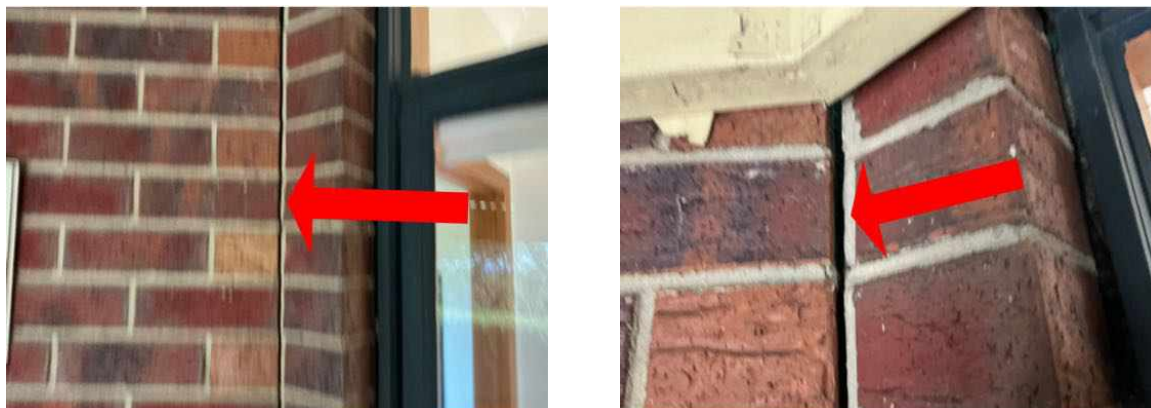
Defects 3.18

Building:	Main Building
Location:	Pergola
Finding:	Brickwork expansion joint - Seal missing.
Information:	During the inspection, it was noted that the seal for the brickwork expansion joint is missing on pergola exterior walls. Expansion joints in brickwork are critical as they accommodate the natural movement of building materials caused by thermal expansion, contraction, and other environmental factors. The absence of a proper seal in these joints can lead to several issues: <ul style="list-style-type: none"> - Water Penetration: Without a seal, water can penetrate the expansion joint,

potentially leading to water damage within the wall cavity and interior spaces. This can result in dampness, mold growth, and deterioration of building materials.

To address this issue, it is recommended that a qualified handyman, caulking specialist, or bricklayer be engaged to inspect and reseal the expansion joint. This will help maintain the integrity, durability, and appearance of the brickwork, as well as prevent potential water ingress and structural problems.

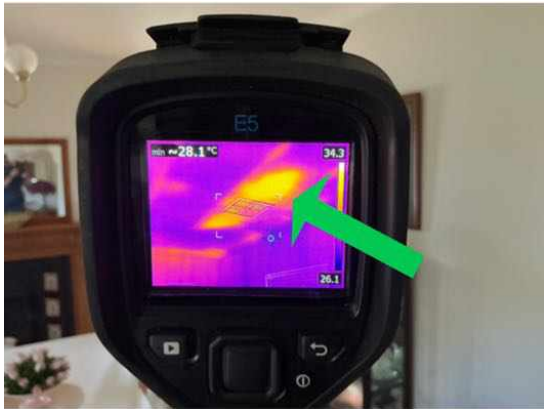
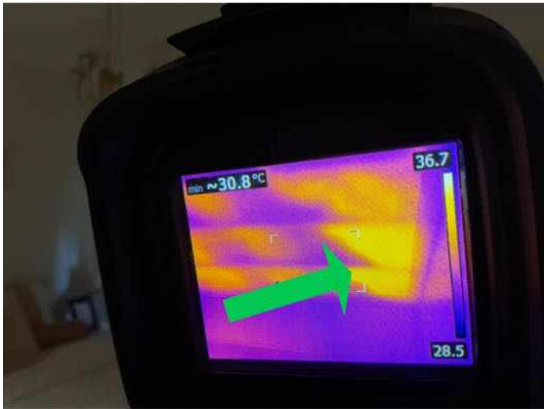
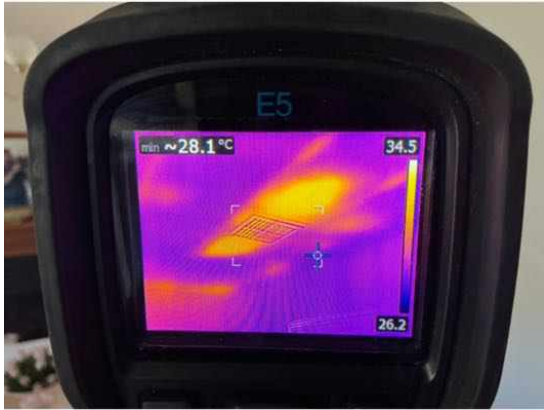
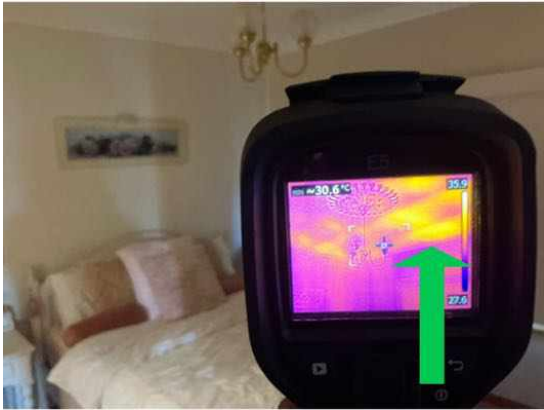
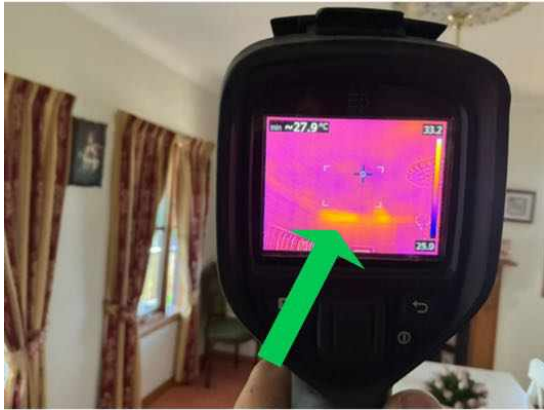
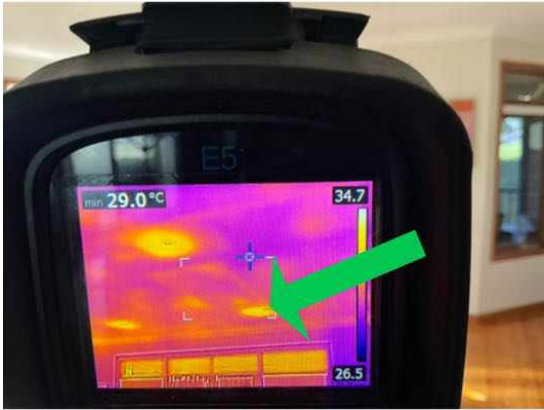
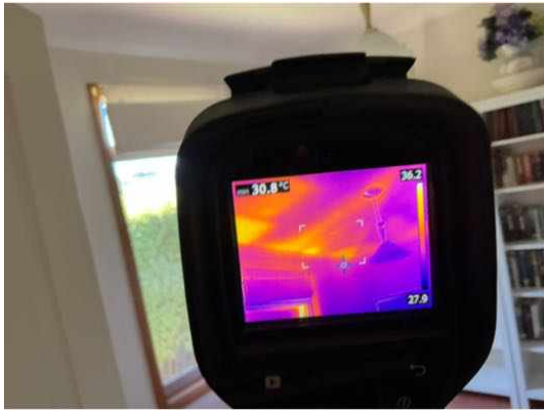
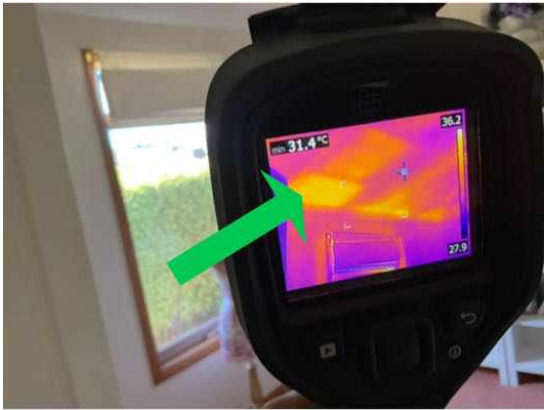
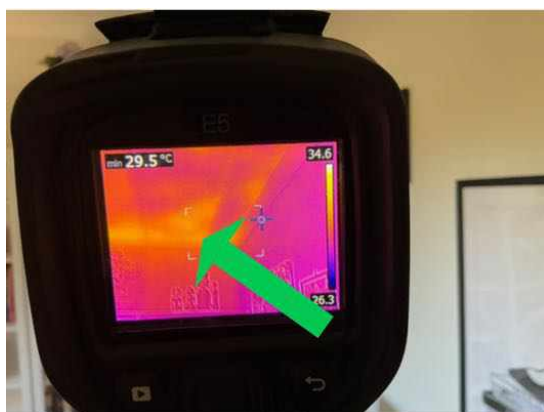
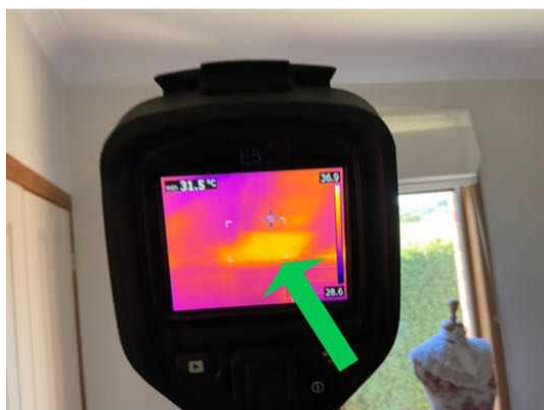
Defects 3.19

Building:	Main Building
Location:	All Internal Areas
Finding:	Inconsistent Thermal Performance to Ceiling Areas – Suspected Insulation Deficiencies
Information:	Thermal imaging conducted to internal ceiling areas at the time of inspection identified inconsistent heat patterns, which are indicative of variations in thermal performance across the roof space. These patterns are commonly associated with areas of missing, displaced, or insufficient insulation above the ceiling linings.

Inadequate or uneven insulation coverage can reduce the energy efficiency of the dwelling, contribute to heat loss in cooler periods and heat gain in warmer conditions, and may result in reduced occupant comfort and increased heating and cooling costs. Due to the non-invasive nature of the inspection, the exact extent and condition of insulation could not be confirmed visually in all affected areas.

It is recommended that a qualified insulation contractor inspect the roof space, assess insulation coverage and condition, and top up or reinstate insulation where required to achieve consistent thermal performance throughout the property.

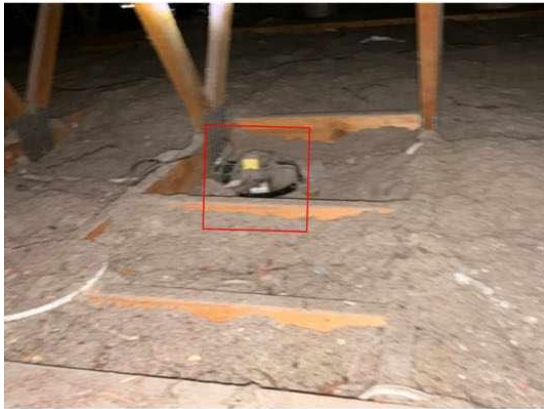
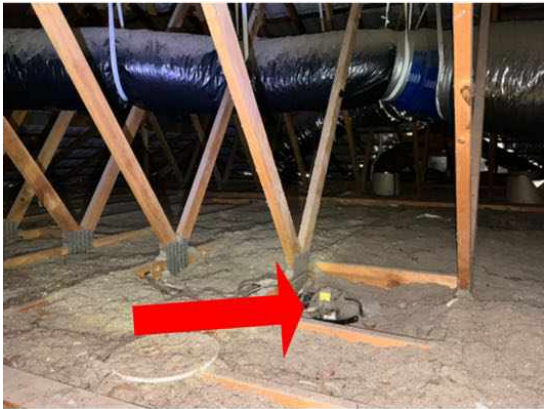
Defects 3.21

Building:	Main Building
Location:	Roof Void
Finding:	Bathroom Exhaust Fans Not Ducted to External Atmosphere
Information:	The exhaust fans installed in the bathrooms were observed to be discharging directly into the roof cavity rather than being ducted to the external atmosphere. This configuration does not comply with best practice ventilation standards, as it allows moist air to accumulate within the roof space.

Prolonged moisture build-up in the roof cavity can lead to elevated humidity levels, which may contribute to mould growth, timber decay, and potential damage to insulation or other roof components over time.

It is recommended that a licensed ventilation specialist or electrician be engaged to install compliant ducting that vents the exhaust air to the outside of the building, in accordance with current building regulations and ventilation standards.

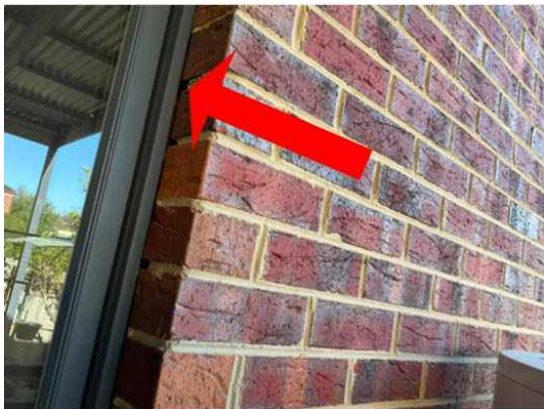
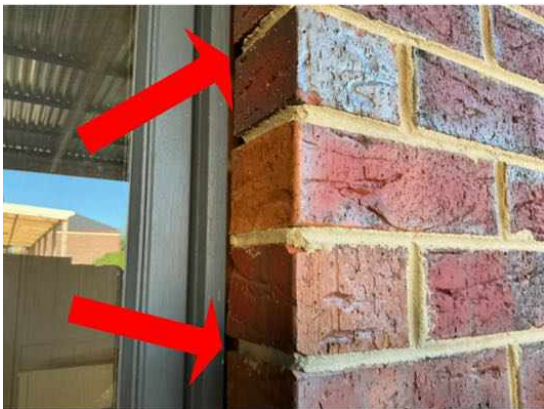
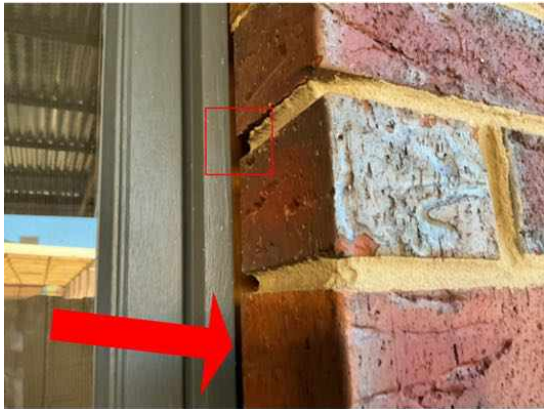
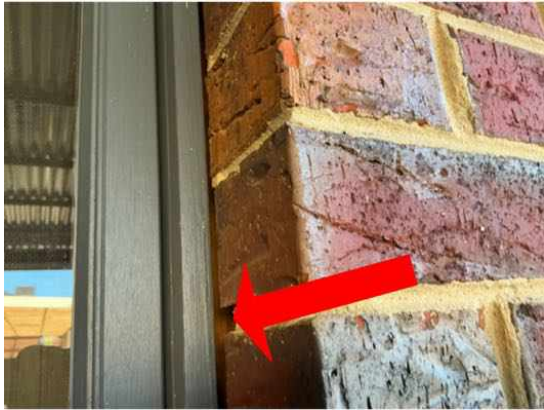
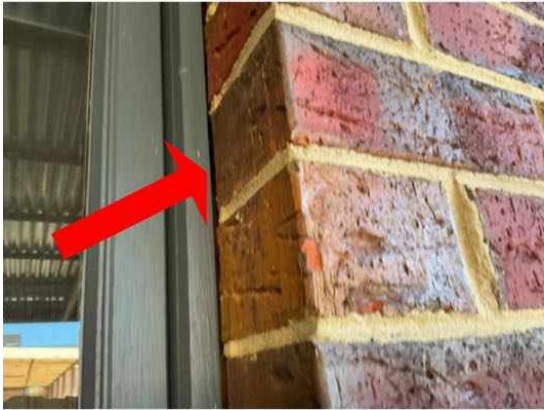
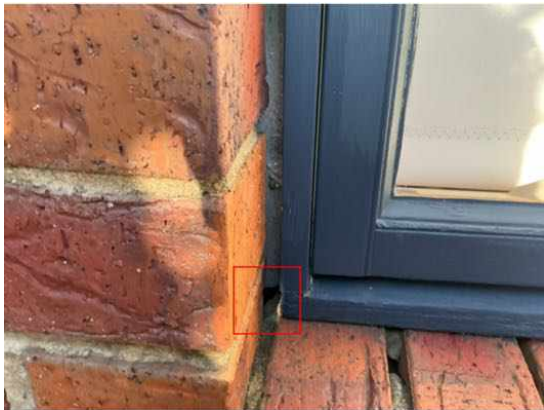
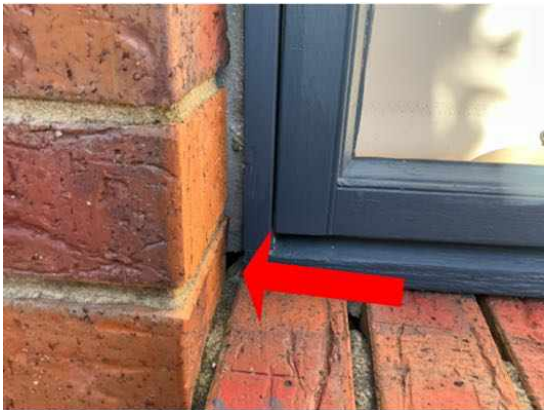
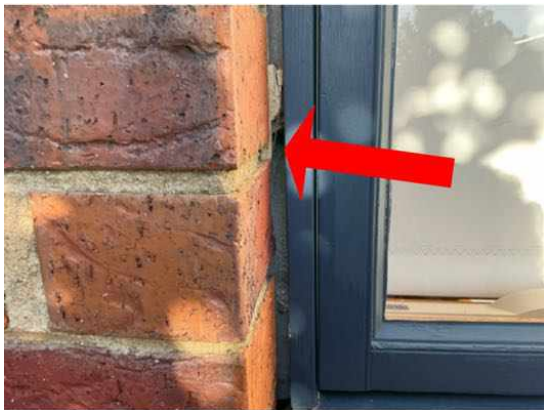
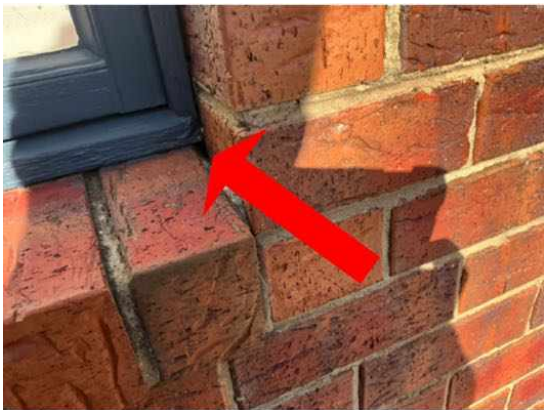
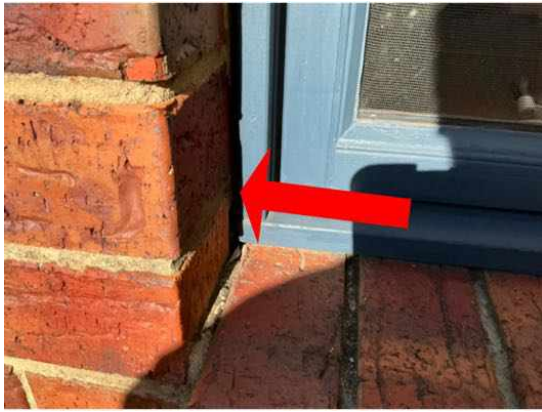
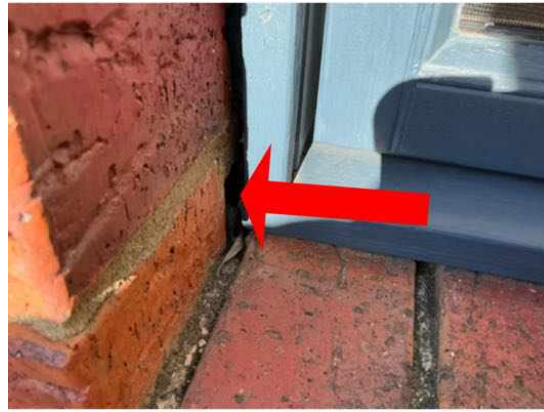
Defects 3.22

Building: Main Building
Location: All External Areas
Finding: Window seals - deteriorated
Information: The window seals have deteriorated and are in a generally poor condition. Due to frequent exposure to weather conditions and subsequent moisture, deterioration of window seals is expected in a property of this condition and age.

Where window seals have deteriorated, the window is no longer weather-tight; rain penetration and subsequent water damage is therefore likely to ensue. Insulation of the area against external weather conditions will also be compromised.

It is recommended that all deteriorated window seals be replaced by a general handyman or sealant expert to prevent any further damage and to restore the window to a fully functional level.

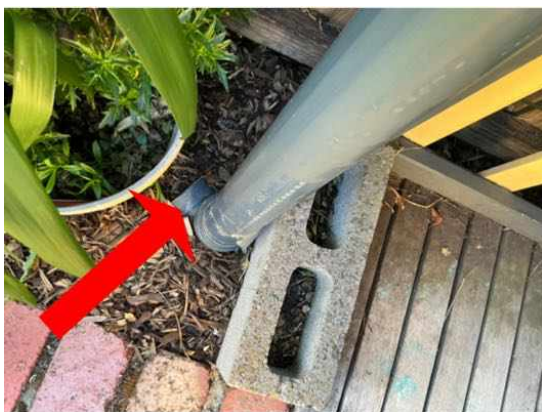
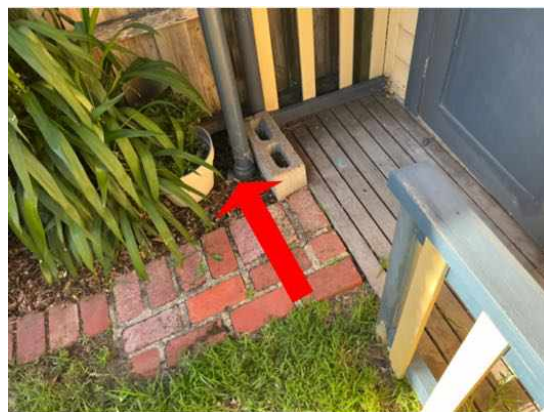
Defects 3.23

Building: Main Building
 Location: Cubby house
 Finding: Downpipe Discharging Directly onto Ground at Rear Cubby House
 Information:

The downpipe servicing the roof of the rear cubby house was observed to be discharging directly onto the surrounding soil and is not connected to an appropriate stormwater drainage point.

Downpipes should discharge into an approved stormwater drainage system to ensure that roof water is properly collected and directed away from the structure. Discharging stormwater directly onto the ground may lead to localized soil saturation, erosion, and potential moisture-related issues around the structure over time.

It is recommended that a licensed plumber be engaged to connect the downpipe to a suitable stormwater drainage point to ensure that rainwater is effectively collected and discharged away from the structure in accordance with standard drainage practices.

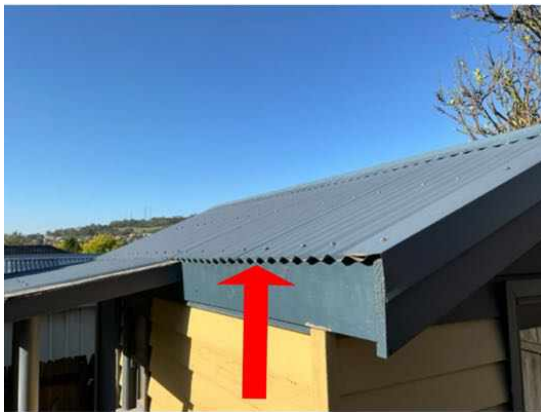
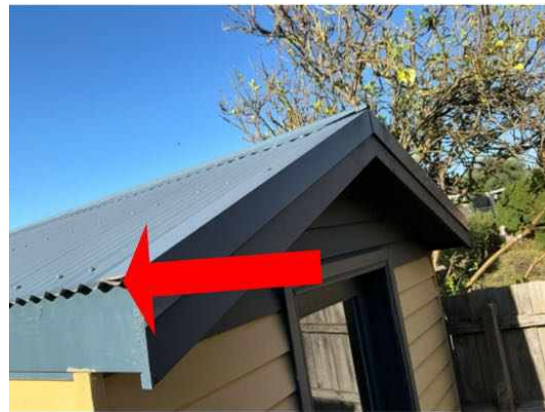
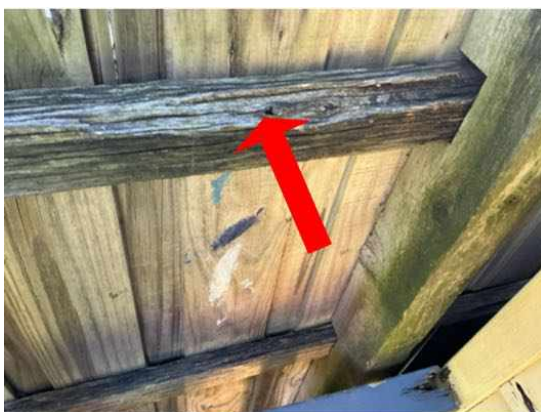
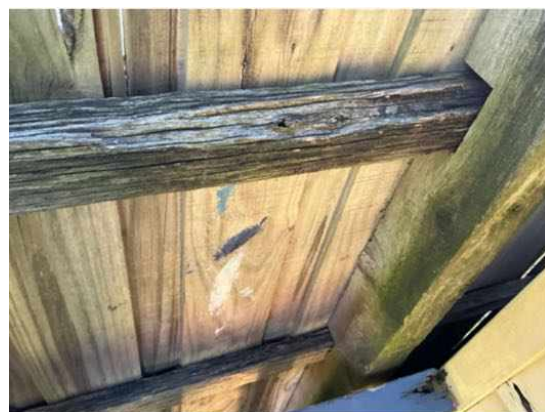
Defects 3.24

Building: Main Building
 Location: Cubby house
 Finding: Non-Compliant Construction and Timber Deterioration to Rear Cubby House

The rear cubby house structure was observed to be non-compliant in several respects at the time of inspection. Sections of the roof were noted to be lacking guttering, and the installed downpipe was not connected to an appropriate stormwater drainage point, instead discharging directly onto the surrounding ground. In addition, areas of timber rot were observed within parts of the internal timber framing.

Inadequate roof drainage and timber deterioration can contribute to accelerated weathering and ongoing structural deterioration of the structure over time. However, it is noted that the cubby house appears to be used primarily for storage purposes and should not be considered a habitable structure.

It is recommended that the owner consider engaging a qualified carpenter or handyman to assess the condition of the cubby house and undertake any necessary repairs or maintenance as required. This may include replacing deteriorated timber members and improving roof drainage provisions to help reduce further deterioration of the structure.

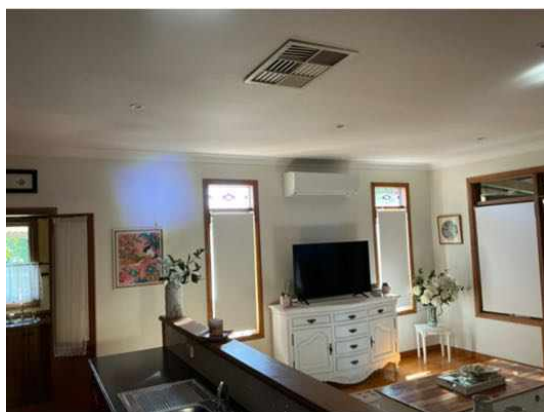
Noted Item

Building: Main Building
Location: All Internal Areas
Finding: Obstructions and Limitations - Interior
Information: These photographs are an indication of the obstructions and limitations which impeded the inspection of the internal areas of the property at the time of inspection. These obstructions can hide an array of defects and should be removed to allow full inspection to be carried out. A re-inspection is recommended once the areas are made accessible.

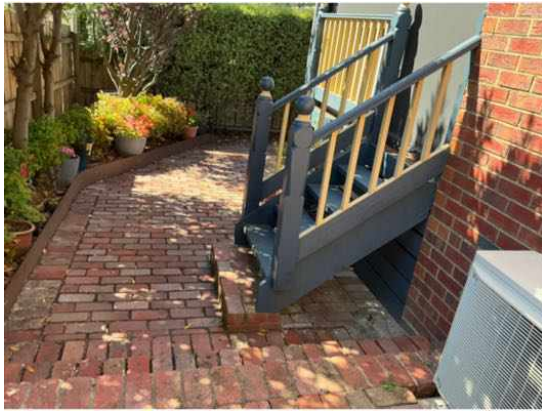
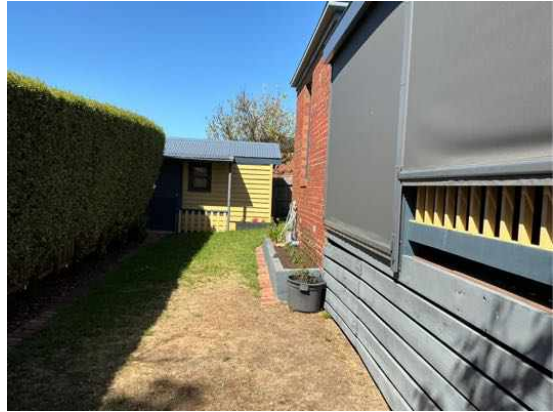
Noted Item

Building: Main Building
Location: All External Areas
Finding: Obstructions and Limitations - Exterior
Information: These photographs are an indication of the obstructions and limitations which impeded the inspection of the external areas of the property at the time of inspection. These obstructions can hide an array of defects and should be removed to allow full inspection to be carried out. A re-inspection is recommended once the areas are made accessible.

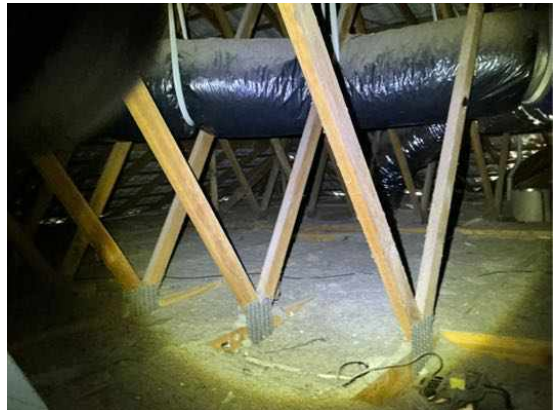
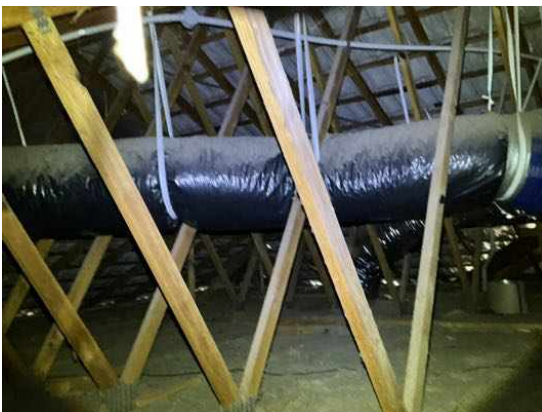
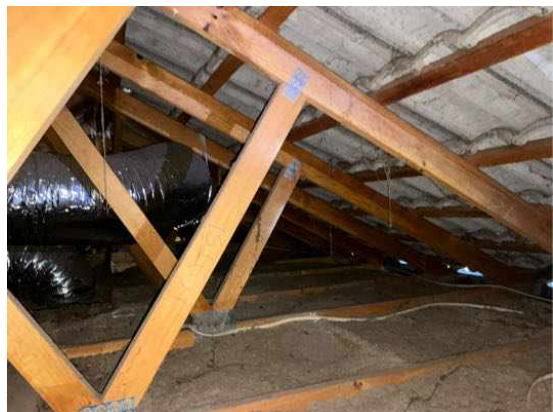
Noted Item

Information: These photographs are an indication of the obstructions and limitations which impeded the inspection of the roof cavity area of the property at the time of inspection. These obstructions can hide an array of defects and should be removed to allow full inspection to be carried out. A re-inspection is recommended once the areas are made accessible.

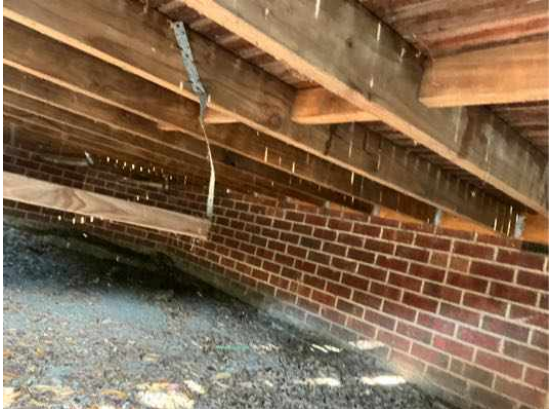
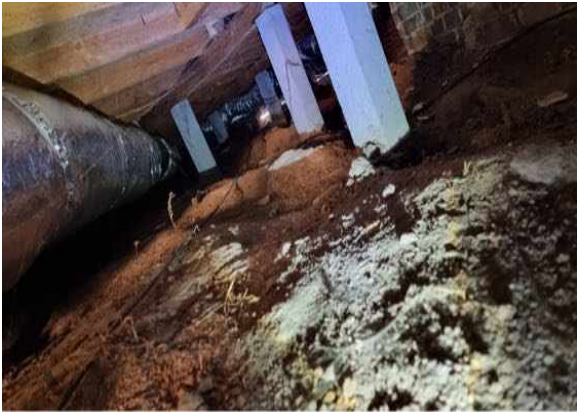
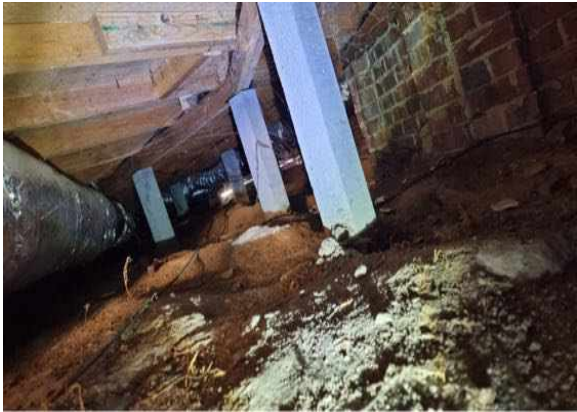
Noted Item

Building: Main Building
Location: Subfloor
Finding: Obstructions and Limitations - subfloor
Information: These photographs are an indication of the obstructions and limitations which impeded the inspection of the subfloor area of the property at the time of inspection. These obstructions can hide an array of defects and should be removed to allow full inspection to be carried out. A re-inspection is recommended once the areas are made accessible.
