Building and Timber Pest Inspection Report

Inspection Date: Wed, 11 Mar 2026

Property Address: 15 Melville Ct, Mount Coolum QLD 4573,
Australia

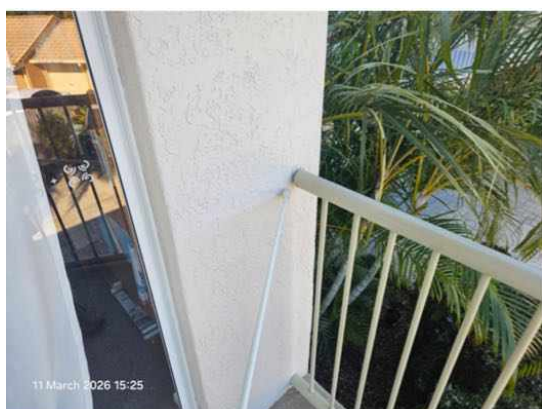
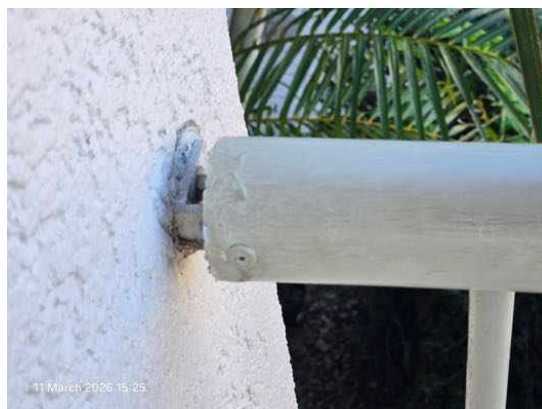
Finding 1.01

Building:	Main Building
Location:	Balcony
Finding:	Balustrade - damaged
Information:	The upper floor balcony balustrade is damaged and loose at the wall connection. This should be repaired without delay to prevent a fall risk.

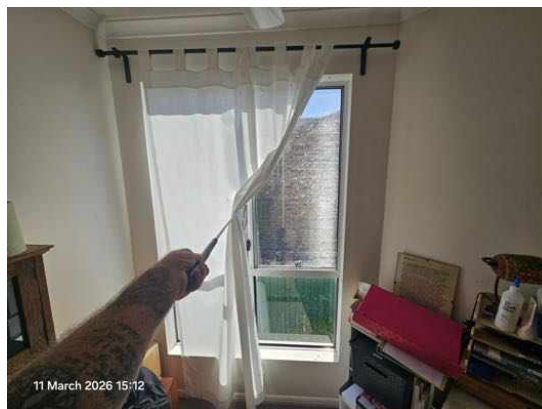
Finding 1.02

Building:	Main Building
Location:	Bedroom 3
Finding:	Window barriers - for information only
Information:	It appears that the windows shown in the bedrooms are suspected of not complying with current provisions of the Building Code of Australia (BCA), the National Construction Code (NCC), Part 3.9.2; Barriers and Handrails or the Australian Standards.

Windows to be protected Windows are defective if they do not comply with provision 3.9.2.6 of Volume 2 of the BCA that requires that a window opening must have protection if the floor below the window in a bedroom is 2m or more above the ground surface beneath.

Type of protection Windows requiring protection are defective if they are not fitted with a device to restrict the window opening or a screen, with secure fittings. The device or screen, where required, is defective if it permits a 125mm sphere to pass through the window or screen or is unable to resist an outward horizontal action of 250 N.

In cases where the screen or device can be removed, unlocked or over ridden, the installations are defective if they are not fitted with a child resistant release mechanism. Barrier In addition to window protection, windows are defective if a barrier is also not installed below the window whenever a child resistant release mechanism is required to be installed in a bedroom; or for all openable windows, in any room, that has a floor level located 4m or more above the ground surface beneath, if the window is not protected. The barrier is defective if it permits a 125mm sphere to pass through it or if it has any horizontal or near horizontal elements between 150mm and 760mm above the floor that can facilitate climbing.

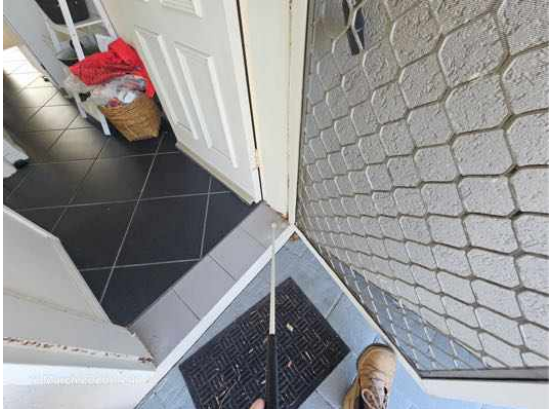
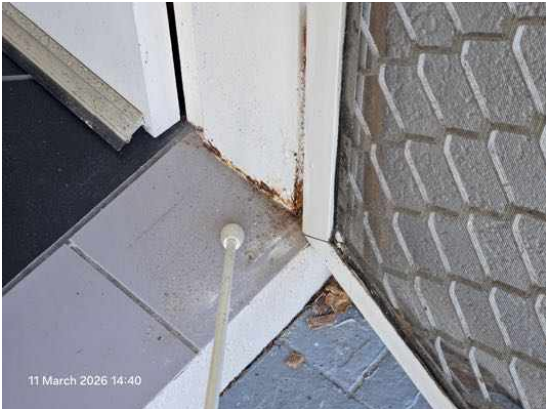
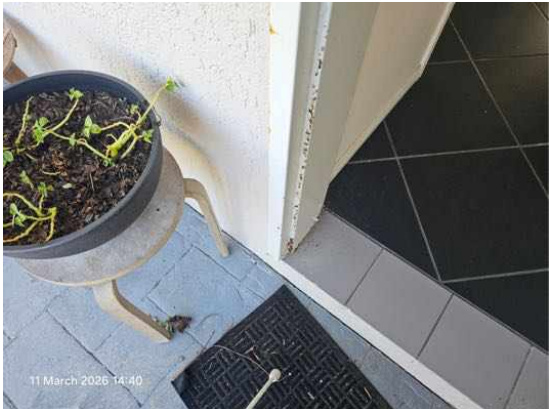
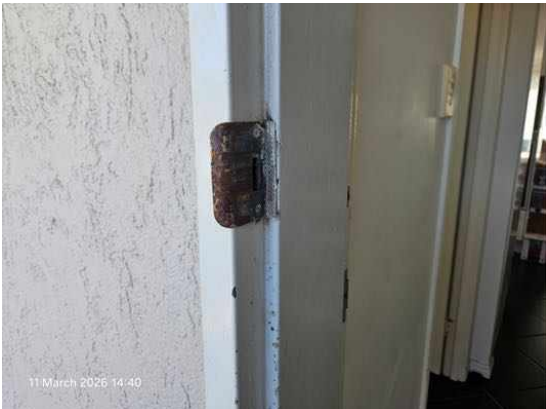
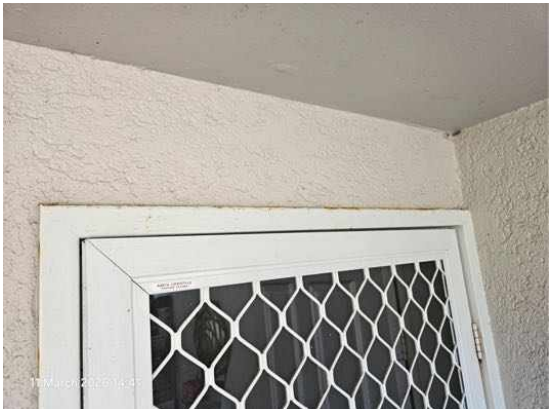
Finding 3.01

Building: Main Building
Location: Front entry
Finding: Entry door - rusted frame
Information: During the inspection it was noted that the metal entry door frame is rusting. This should be treated and re-painted to prevent further damage.

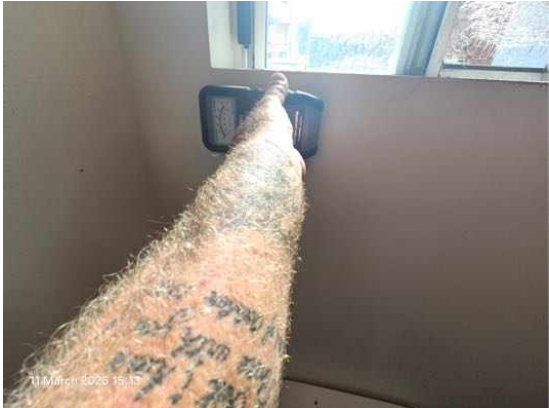
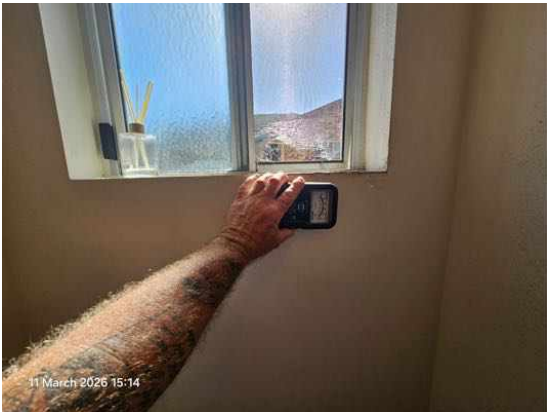
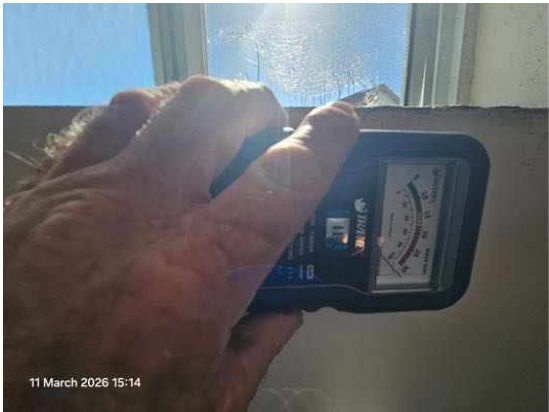
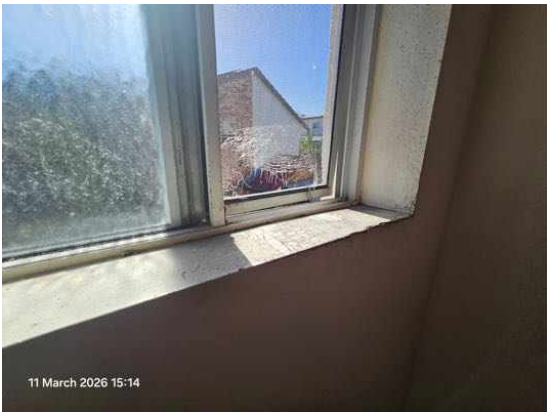
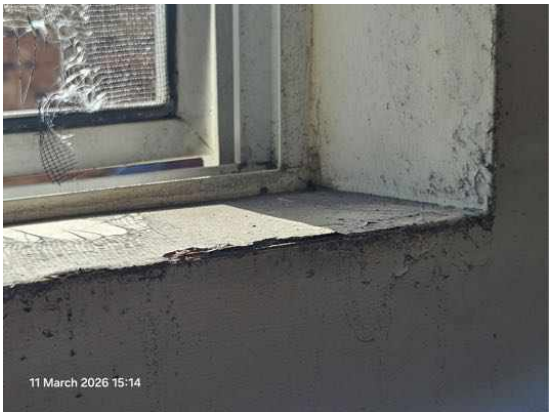
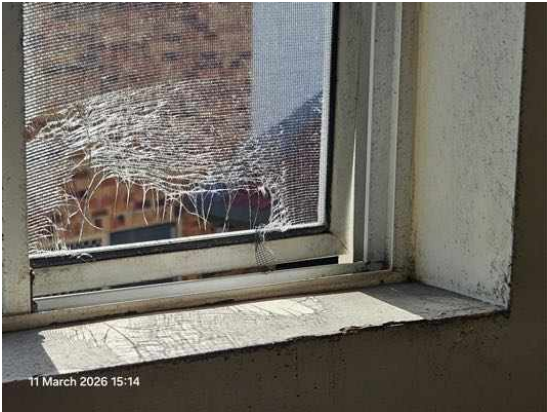
Finding 3.02

Building: Main Building
Location: As shown
Finding: Window sill / reveal damage

Information: During the inspection moisture damage was noted in the plastered reveals of the windows shown.

Damage is mostly isolated to the bottom sill and internal corners, which would indicate that moisture may be entering through the joint between the bottom aluminium profile and the rendered sill. Alternatively, it may be due to the windows being left open for extended periods and sea air and rain moisture having an effect. Some cracking and separation was noted in the render finish and the intersection of the render and the aluminium profiles.

It is not uncommon for this type of finish to be affected in building close to the coast. It was also noticeable that the moisture is affecting the metal external plaster angle.

The moisture affected window sills and reveals will require assessment by a qualified tradesperson for a repair proposal.

This should be monitored and there is no change in the reveal appearance, a licensed plasterer or painter should be engaged to carry out the necessary repairs.

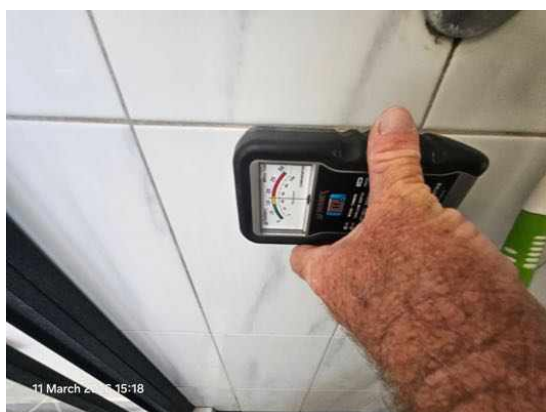
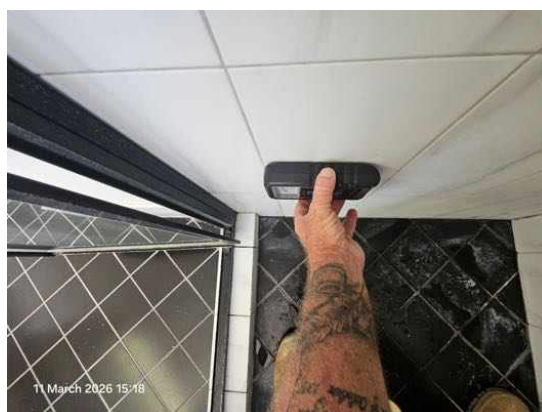
Finding 3.03

Building: Main Building
Location: Bathroom
Finding: Elevated moisture present at the time of inspection - bathroom
Information: Elevated moisture was noted in the lower tiled wall surfaces of the bathroom shower.

The levels varied at differing points throughout the recess. This could possibly be due to deteriorated grout and silicone sealants. These can break down over time and become porous, allowing moisture to enter the wall sheet surface behind the tiles. Some deterioration of the grout and sealant was noted. The opposite side of the showers wall could not be measured on the day due to obstructions.

Elevated moisture can attract timber pests and vermin, and produce conditions that promote timber pest attack, fungal growth and wood decay.

The moisture readings in the shower recess are limited to the lower courses of tiles, which can usually indicate grout and silicone degradation.

It is recommended that the moisture levels in these areas be monitored over time and the grout and silicone could be renewed to possibly eliminate any further moisture penetration.

A licensed tiler and / or sealant specialist could be engaged to renew these elements.

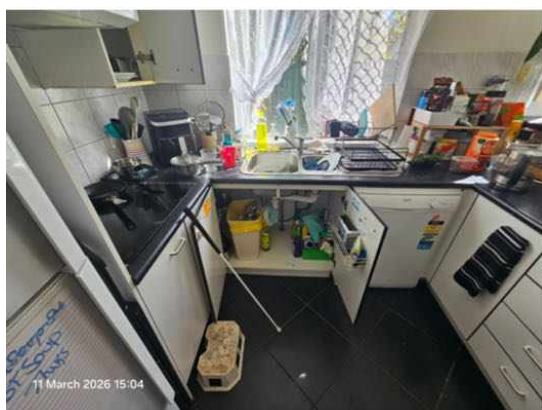
Building: Main Building
 Location: Kitchen cupboard
 Finding: Durable pest inspection notice
 Information: On the day of inspection it was noted that the durable pest inspection / treatment notice was in place and the most current inspection was notated and in date. These notices / stickers are to verify the timber pest inspection dates, the inspector, and, at times, the currency and type of timber pest system / barrier in place or being used in and around the property.

The client is advised to maintain annual inspections with the company listed or a company of their choosing.
