Building and Timber Pest Inspection Report

Inspection Date: Wed, 25 Feb 2026

Property Address: 119A Cottenham Ave, Kingsford NSW
2032, Australia

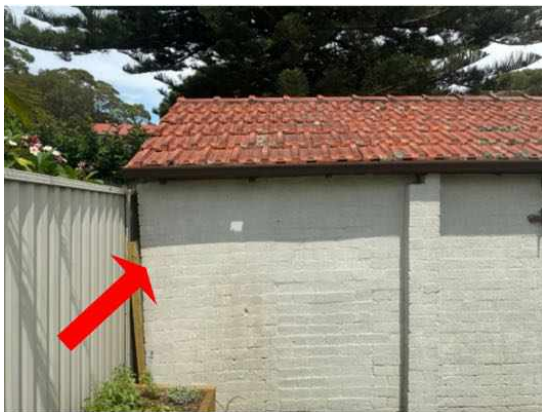
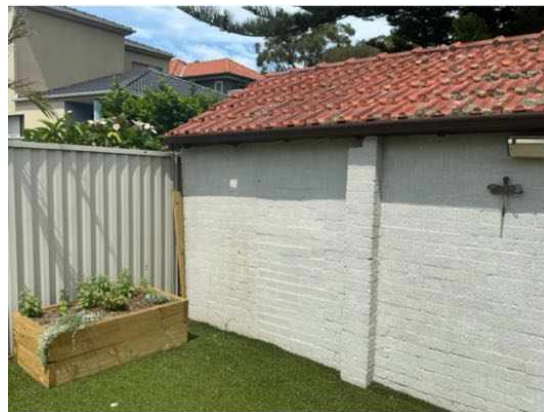
Finding 2.01

Building: Garage
 Location: Garage
 Finding: Garage Subsidence – Rear Section
 Information: The rear section of the garage appears to have subsided, evidenced by noticeable dropping to the structure at the back. This movement is reflected in the alignment of the ceiling, roofline, guttering, and associated brickwork.

The internal area of the garage could not be inspected at the time of inspection as it was locked. Accordingly, the full extent of structural movement and any internal cracking or damage could not be determined.

The structure may remain serviceable in the short to medium term; however, ongoing settlement is likely to further compromise its stability. It is anticipated that substantial structural repairs or eventual demolition and replacement of the garage will be required. Further assessment by a qualified builder or structural engineer is recommended.

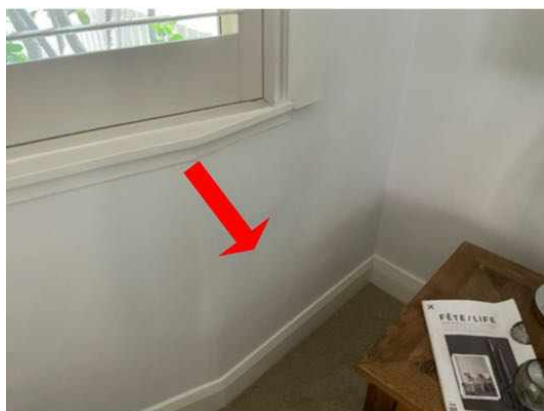
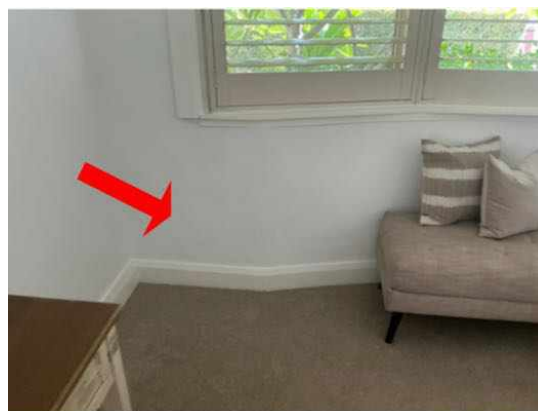
Finding 3.01

Building: Main Building
 Location: Bedroom

Finding: Damp Walls (front bedroom) or Former Balcony

Information: Rain penetration (also known as penetrating damp) is a common form of dampness that can occur through walls. The walls in the front bedroom (which was likely formerly a balcony that has been enclosed) is only likely a double layer of bricks and not cavity construction. Walls with no cavity can allow moisture to be absorbed into the interior of the property. Masonry is an absorbent material, and therefore will slowly draw rainwater or even humidity into the wall. Measures can be taken to prevent the moisture-absorbing from the interior of the wall such as waterproofing barriers or waterproof paint. A damp specialist or builder can be appointed to carry out these works

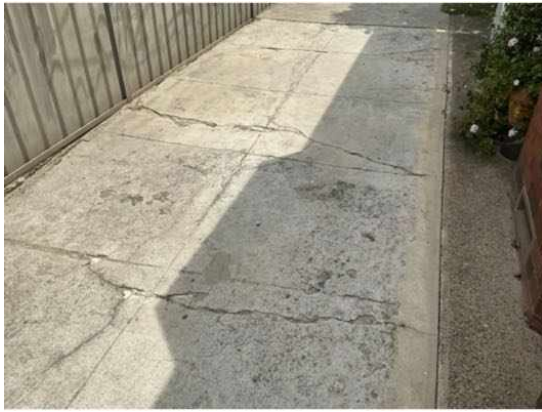
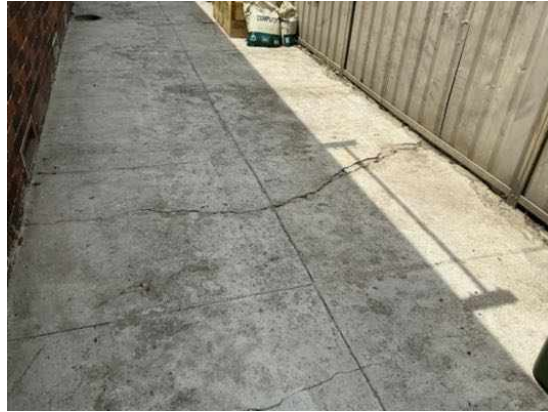
Finding 3.02

Building: Main Building

Location: Driveway

Finding: Cracking - External Concrete Paving

Information: Distinct cracks were identified in external concrete paving. Distinct cracks are generally found in older concrete paving, and may also present as a trip hazard as consequence of an uneven or curved surface.

General age and expected deterioration of the paved areas is a common cause of this type of cracking. However, expansion and contraction of the slab may also have occurred due to environmental factors. Such factors include variable moisture and weather conditions. Cracking to this degree may also be due to poor original installation of the concrete.

Factors such as poor compaction of the sub surface and/or inadequate reinforcing of the slab may create cracking and other secondary defects.

Repairs are likely to be required to prevent further cracking and to reduce hazards associated with cracking, such as tripping. Monitoring of all cracking should be conducted frequently. Always contact a building inspector should cracks widen, lengthen, or become more numerous.

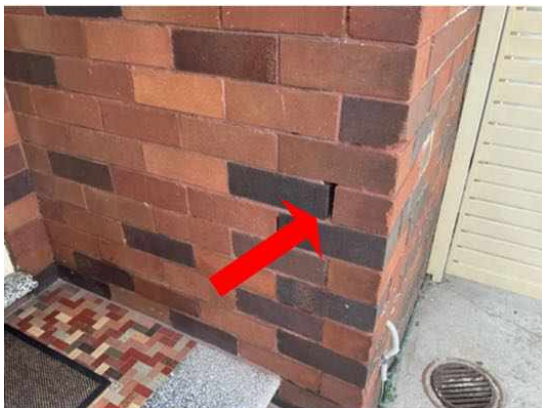
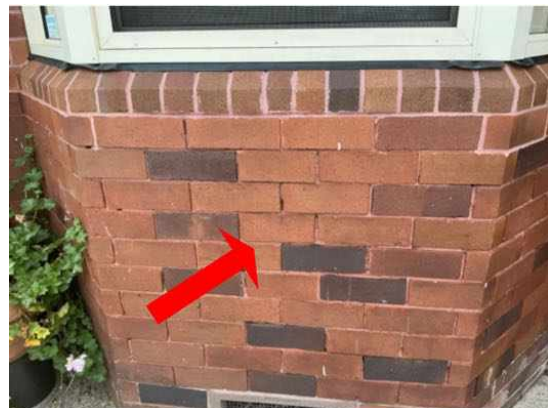
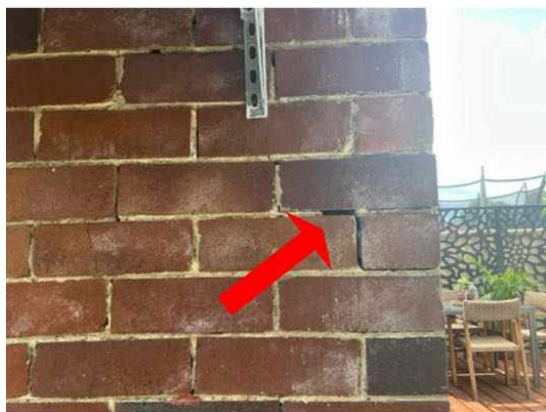
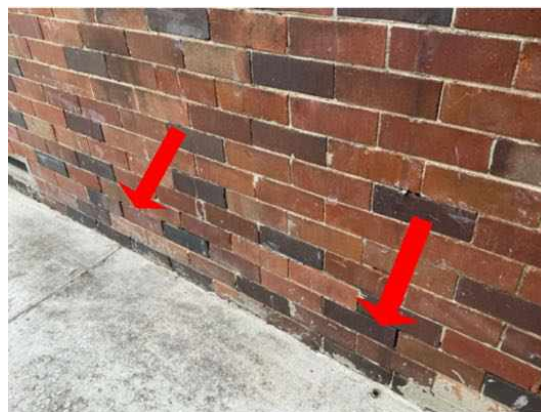
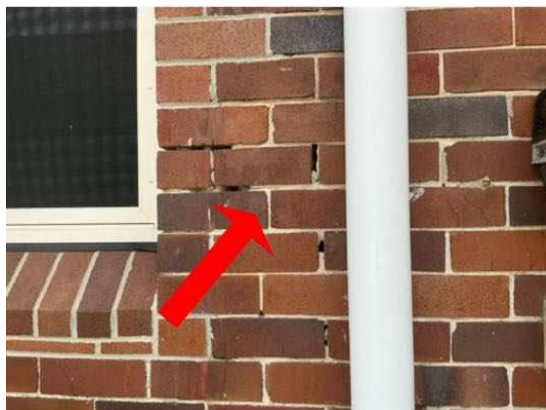
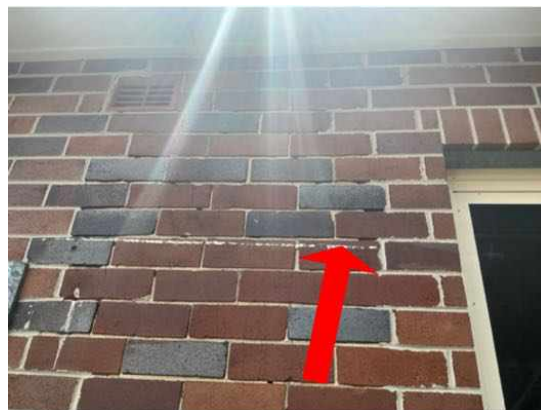
Finding 3.03

Building:	Main Building
Location:	Exterior walls - left side
Finding:	Brickwork - Deteriorated mortar
Information:	Mortar, or 'bedding', is the material which fills joins and intersections between bricks in masonry walls and structures. Sections of mortar in this brickwork were identified as having deteriorated, which is generally expected for a property of this age and condition.

Mortar may deteriorate as a result of age of building materials, minor movement of bricks, or frequent exposure to weathering. Mortar should be replaced to ensure that bricks remain in their intended location and to prevent gaps, which would allow water or moisture ingress and secondary damage as a result.

Mortar deterioration can be addressed by a bricklayer where areas of deterioration are localised and easily accessible.

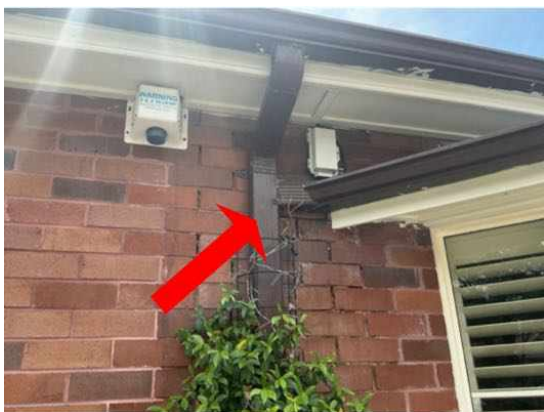
Finding 3.04

Building:	Main Building
Location:	Exterior walls - left side
Finding:	Gutter - Leaking
Information:	Evidence of a leak was showing in the guttering at the time of inspection. Leaks can have a number of causes, including deterioration of plumbing fixtures and fittings, or substandard original installation or blockage or damage to gutter.

Where water leaks are active, moisture is likely to cause water damage to associated structures and building elements in this area, which can have a range of implications.

A roof plumber should be appointed as soon as possible to primarily identify the cause of the leak, and to provide subsequent repair works if necessary.

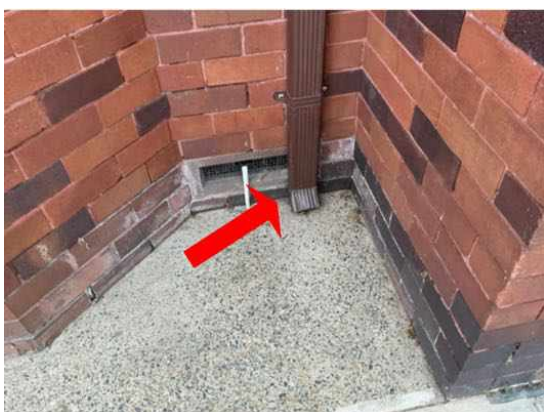
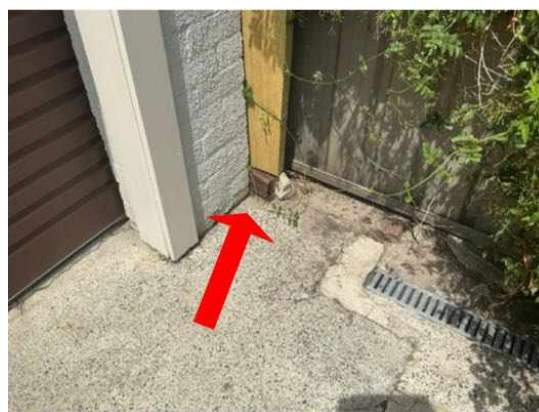
Finding 3.05

Building:	Main Building
Location:	Exterior walls - left side
Finding:	Stormwater drain - Not connected
Information:	The roof plumbing is not adequately connected to stormwater drainage on the site. This disconnection negatively impacts the functional capacity of the roof plumbing.

Where roof plumbing doesn't drain adequately, the area at the base perimeter can become excessively damp, potentially creating an environment that is susceptible to rust and corrosion of surrounding building elements, as well as attracting termites and other pests. The excess water may even undermine footings of walls and lead to structural issues.

It is highly recommended that a plumber be appointed to further inspect the area and to install adequate drainage equipment where necessary.

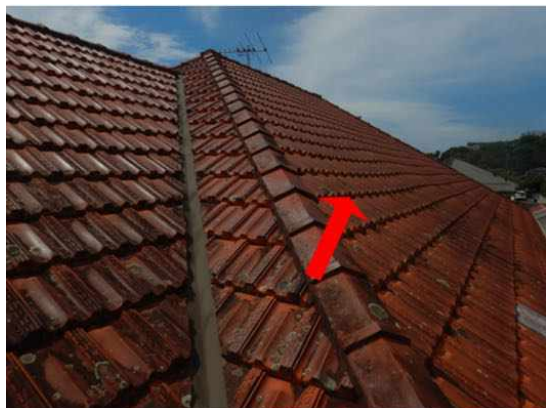
Finding 3.06

Building:	Main Building
Location:	Roof Exterior
Finding:	Sagging Roof Line
Information:	The roofing structure was found to be sagging in a sections at the time of inspection.

Sagging roof structures are likely to create strain on associated building elements, creating potential for secondary damage including the deterioration of roof coverings.

Although it does not appear to be causing any structural issues, and there is no indications of cracking or movement on the interior side of the roof, it is recommend appointing a builder to further inspect the area and determine if repairs are required.

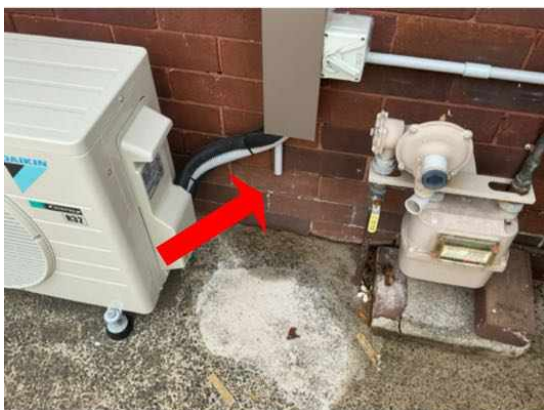
Finding 6.01

Building:	Main Building
Location:	Exterior walls - left side
Finding:	Air conditioner - Disconnected overflow
Information:	The Air Conditioner (A/C) overflow was found to be disconnected from storm water drainage and is creating excessive moisture in the surrounding area.

Such leaking creates an environment which is conducive to an array of defects, including water damage to associated building elements and the attraction of termites.

It is recommended that a licensed plumber be appointed to connect the A/C overflow in order to prevent such an environment from being created. These minor works should be carried out as soon as possible.

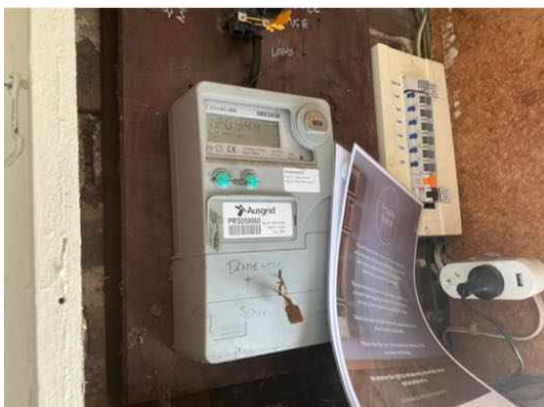
Finding 6.02

Building:	Main Building
Location:	Electrical circuit box
Finding:	Termite Management System No Evidence of Installation
Information:	The application of a post-construction termite barrier is highly recommended for all properties. Such barriers are highly effective in preventing termite attack on any timber building elements throughout the property.

A durable notice should be placed in the switchboard unit to indicate current termite barriers. At the time of inspection, it appeared as though no termite management system has been installed, with no evidence to suggest preventative works taking place.

The client may consider gaining further advice from a pest controller as to the costs and procedures involved with this application. It is recommended that obtaining such advice be a short-term priority.
