# Building and Timber Pest Inspection Report

Inspection Date: Fri, 27 Mar 2026

Property Address: 43/59-61 Good St, Westmead NSW 2145,  
Australia

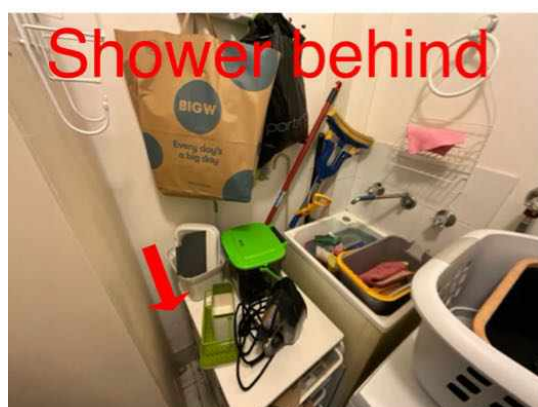
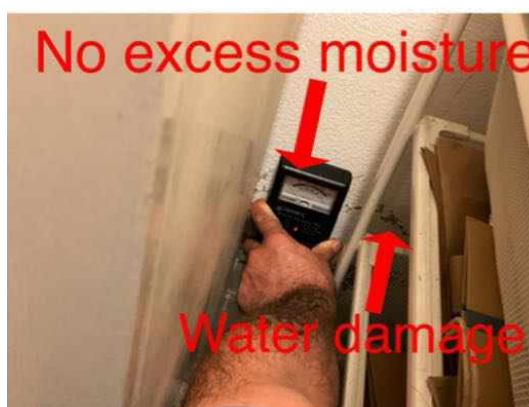
| Finding: | Water leak - Inactive |
| Information: | Water leaks generally occur when a particular area of the property is not weather- or water-tight. While the damage in this area appears to be from an old inactive water leak, the area should be monitored frequently for the recurrence of any dampness. |

Repair and / or replacement of previously affected building elements is at client discretion. Consider a further invasive inspection: removal of obstructions around the damaged area may reveal further damage which has been concealed. A more significant or major defect may be identified at this time.

Where recurrence of an active water leak is identified, a bathroom specialist should be appointed immediately to rectify the leak and advise on any further preventative works as necessary.

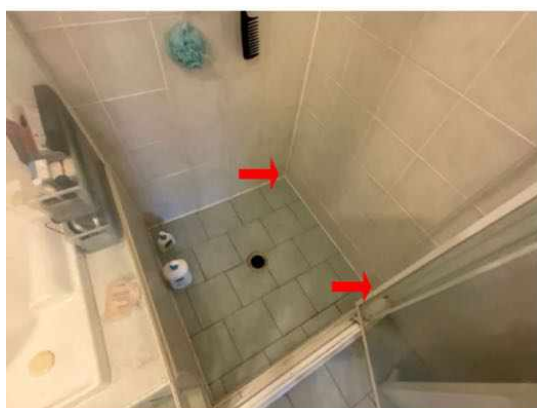
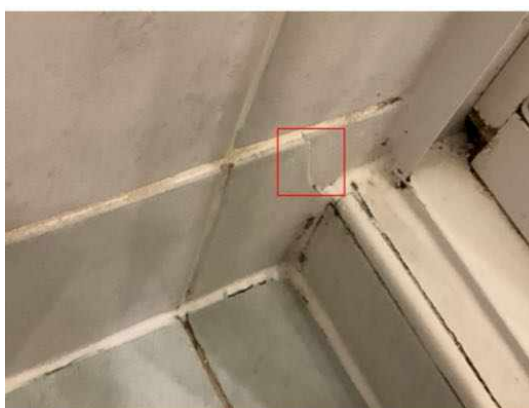
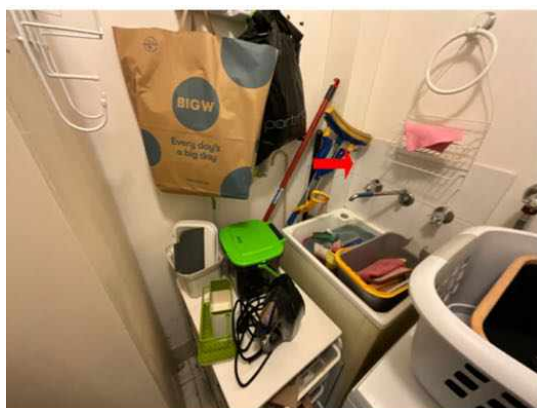
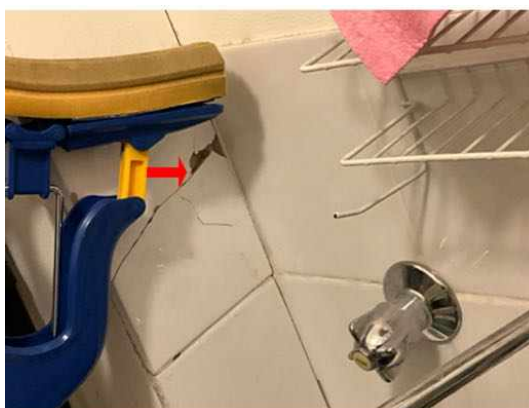
#### Finding 3.02

Finding: Wet area tiles - Cracked or damaged

Information: Cracking was evident to the tiling in this area at the time of inspection. While the cracking appears to be minor, this area is frequently exposed to water, allowing potential for water penetration into adjoining sections of walls or flooring.

If left unmanaged, water penetration to these areas may lead to subsequent water damage, which is likely necessitate repair work to affected building elements.

A bathroom specialist should be appointed to determine the integrity of the bathroom waterproofing membrane. If the membrane was found to be intact then relatively minor works to replace the cracked tiles should be carried out to ensure no further damage occurs. The re-application of silicone and grouting throughout remaining tile work is also advised, to further protect the area against water penetration.

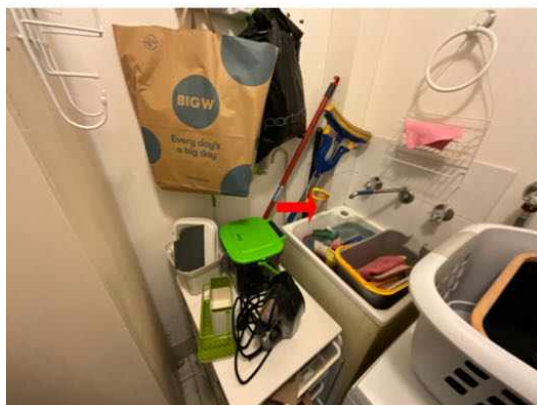
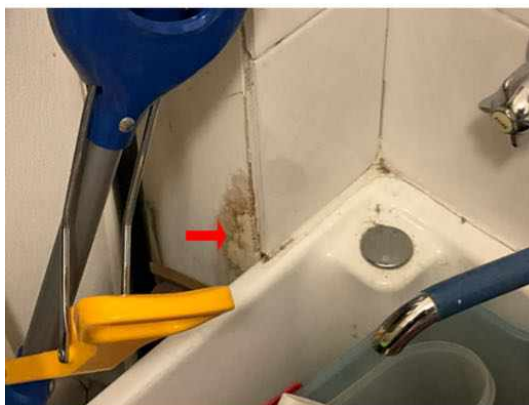
### Finding 3.03

Finding: Water staining

Information: Water staining was evident in this area at the time of inspection. Water staining indicates that surfaces have been exposed to excessive moisture over time. The minerals and other elements in the water lead to staining, which may graduate to corrosion and deterioration if left unmanaged.

While mostly an appearance defect, water staining can be indicative of more serious defects, which may be currently concealed by other building elements.

It is suspected the staining to have been caused by moisture in the vicinity due to the regular laundry sink use.

A licensed painter maybe appointed for cosmetic repair.

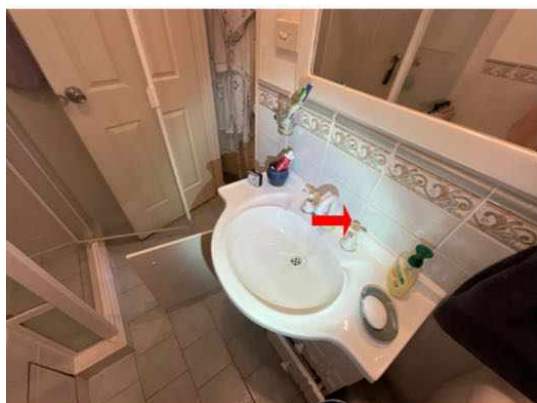
### Finding 3.04

| Finding: | Washers - Degraded |
| Information: | The washers on the taps in this area appear to have degraded as a result of general ageing. Degraded washers generally result in slow, persistent leakage from taps and plumbing hardware. |

Replacement of washers will ensure that water wastage does not occur and that the persistent water leak does not result in secondary damage to surrounding structures. Such damage may range from rust and corrosion to damage of surfaces, e.g. bench tops, etc.

A qualified plumber should be appointed to replace degraded washers and to further inspect associated plumbing fixtures and fittings. Where water damage has occurred, a carpenter or cabinet maker may be appointed to replace affected building elements.

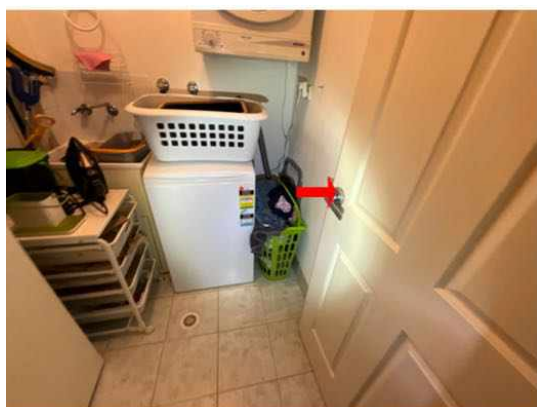
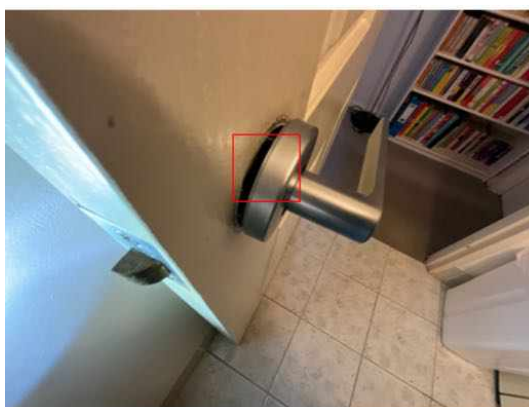
### Finding 3.05

| Finding: | Fitting or fixture - Loose |
| Information: | The fitting in this area is loose and requires adjustment to tighten. |

If left unmanaged, the fitting may further deteriorate, causing potential for the development of other minor secondary defects.

A relevant tradesperson should be appointed to perform these rectification works at discretion of the client.

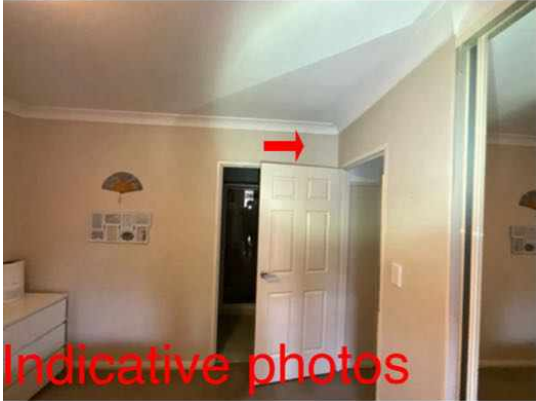
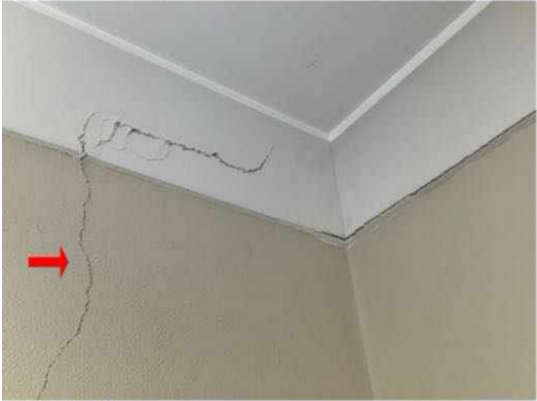
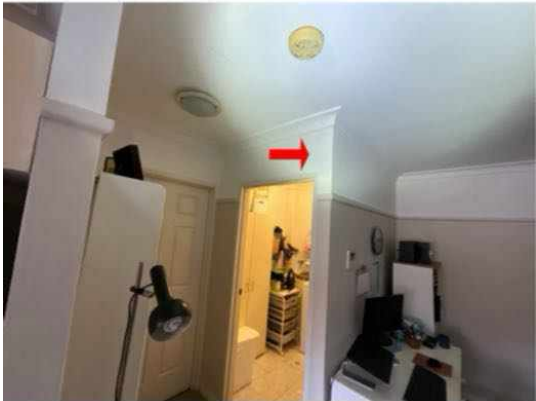
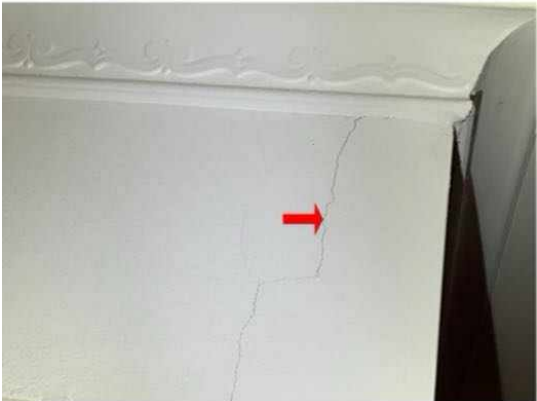
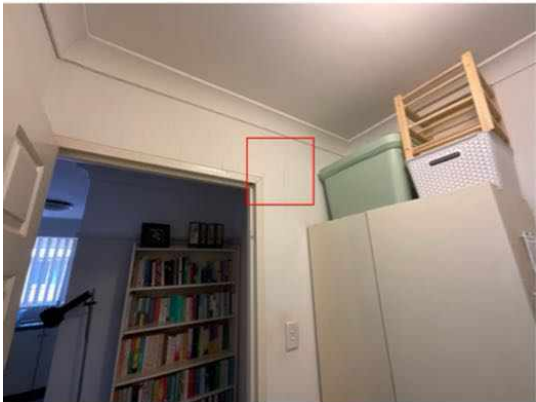
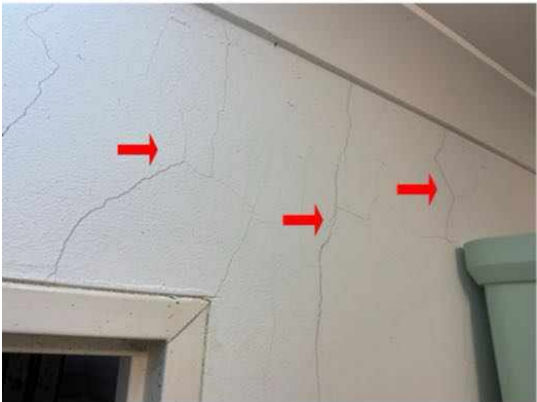
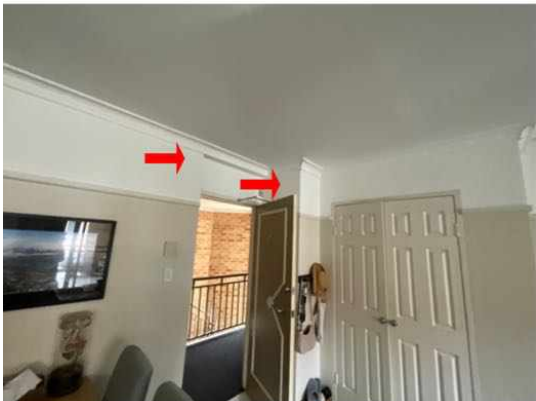
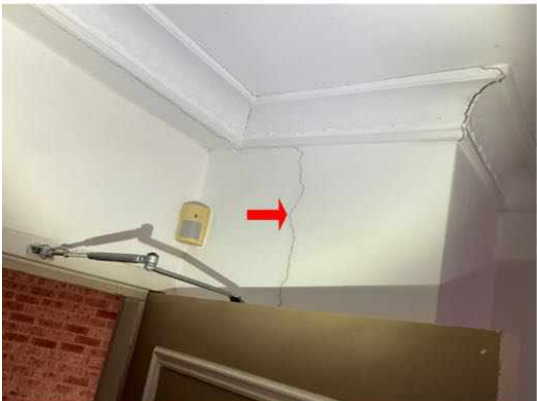
### Finding 3.06

| Finding: | Cracks to internal render - Category 1 |
| Information: | It has been observed that cracking to internal rendered surfaces has occurred. The degree of damage falls within Category 1, described as fine cracks that do not need repair and which are less than 1.0mm in width limit. |

Damage of this category is not considered a defect for rectification. Always contact your building inspector should cracks widen, lengthen, or become more numerous.

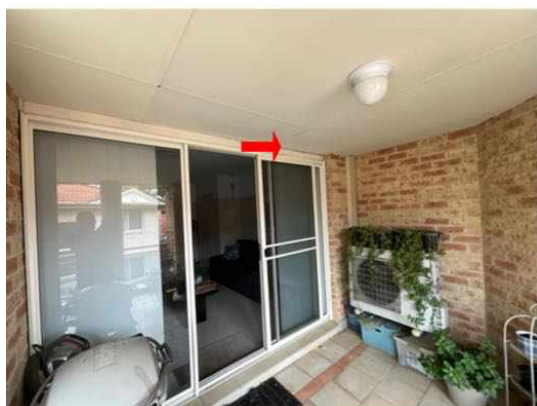
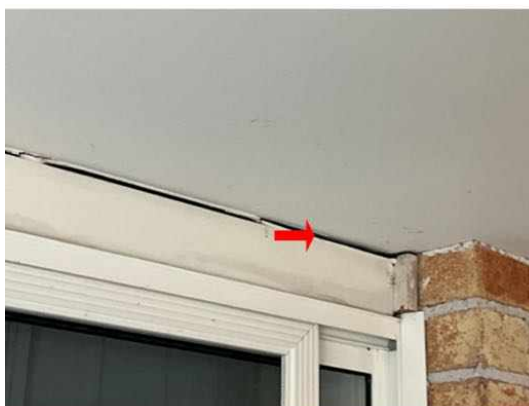
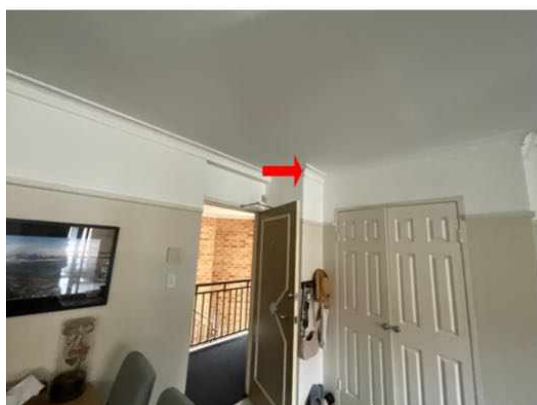
### Finding 3.07

Building: Main Building  
 Location: Multiple areas  
 Finding: Cracking - Damage Category 2 - Noticeable (up to 5mm)  
 Information: Noticeable cracks are a common occurrence as a result of many primary defects. Such causes may include age, general wear and tear, expected building movement, general expansion/contraction of building materials in different weather conditions, and/or minor failings in the installation or application of building materials.

Noticeable cracks may result in minor sticking or jamming of associated doors and windows, which require easement. However, noticeable cracks are easily filled and repaired. A plasterer can be consulted to install an expansion joint at this point to allow for this movement during different weather conditions.

Monitoring of all cracking should be conducted frequently. Always contact a building inspector should cracks widen, lengthen, or become more numerous. Additionally, your building inspector should also be contacted if associated building elements such as doors and windows become more difficult to operate over time.

Relevant tradespeople, such as carpenters, painters and plasterers, should be appointed to perform remedial works, as deemed necessary.

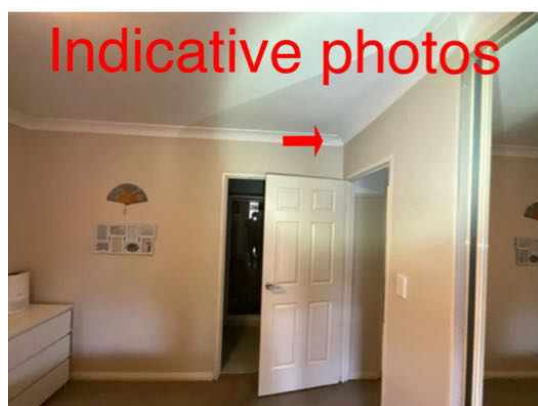
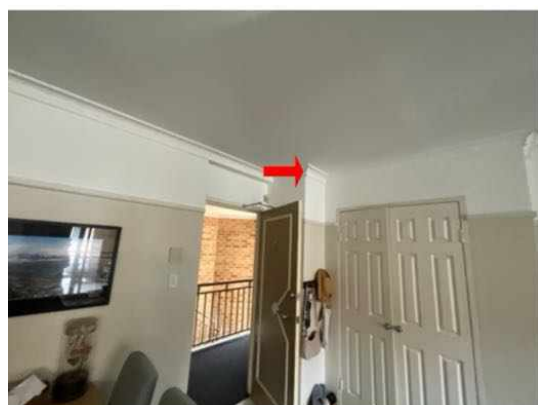
### Finding 3.08

| Finding: | Cracking - Damage Category 1 - Fine (up to 1mm) |
| Information: | Although fine cracks are quite noticeable, they are often only considered to be an appearance defect, and usually do not indicate any structural damage. Generally, the cause of a fine crack is indicative of a separation between building materials and finishes (e.g. paint, plaster, etc.) along joins. |

Cracking of this nature can generally be repaired with minor sanding, filling and/or repainting. Such works should be performed by a qualified painter or a general handyman.

Monitoring of all cracking should be conducted frequently. Always contact a building inspector should cracks widen, lengthen, or become more numerous.

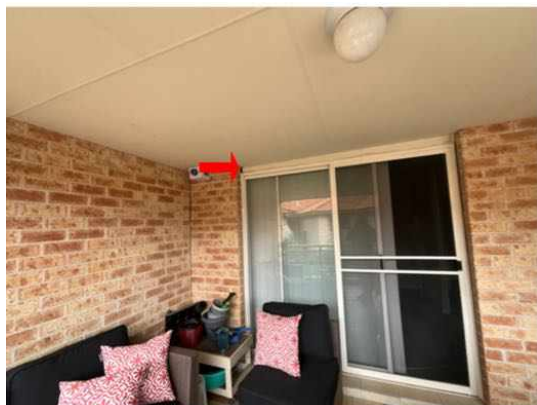
### Finding 3.09

| Finding: | Beads - Missing |

materials. It was noted at the time of inspection that beading in this area is missing.

Beading is important in weatherproofing the surrounding building elements and preventing pest ingress. Furthermore, beading works to protect the joins of building materials, which are more susceptible to deterioration and decay.

Replacement of the beading is advised to ensure the protection and longevity of any associated building elements. Such works may be performed by a general handyperson or qualified carpenter.

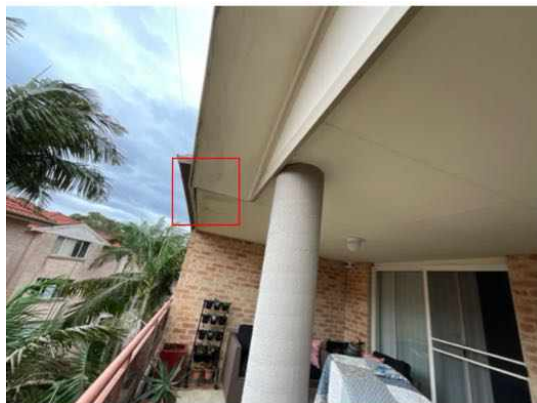
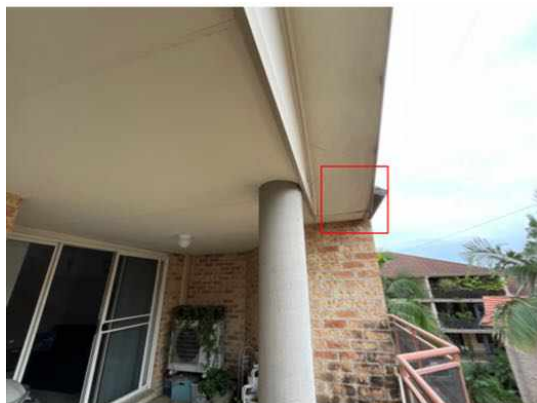
### Finding 3.10

| Finding: | Eaves/Roof plumbing -- water damages |
| Information: | Water damage is generally an indication of excessive moisture being present, usually via a leak. It is suspected that gutter blockages causing stormwater to backflow into the eaves causing water damages. This is additionally conducive to termite activity due to the damp conditions. |

Where water damage is evident, the primary requirement is to identify and rectify the source of the leak. Gutters must be kept clear of any blockages moving forward. A roofing plumber should be appointed for further assessment if the problem persists.

Once the leak is repaired, consultation with relevant tradespeople, including carpenters, plasterers and painters, is advised.

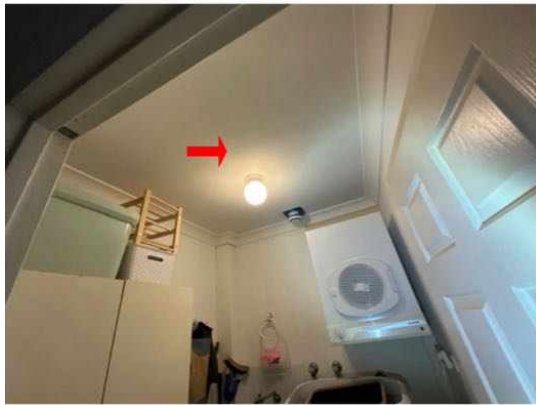
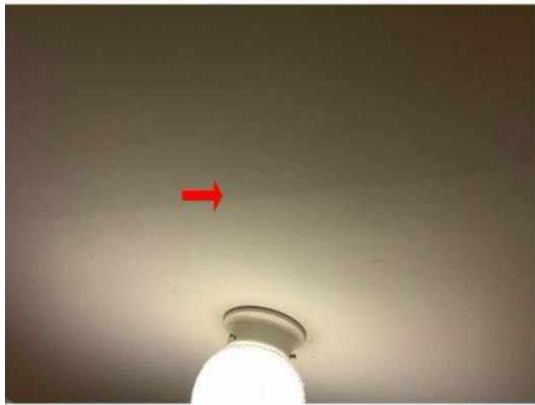
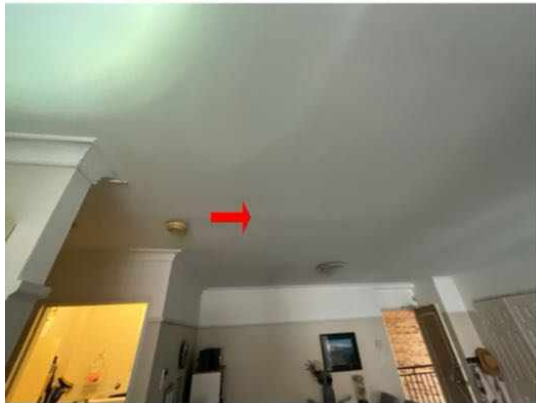
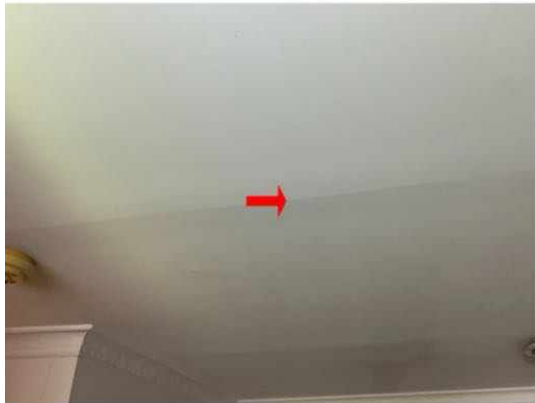
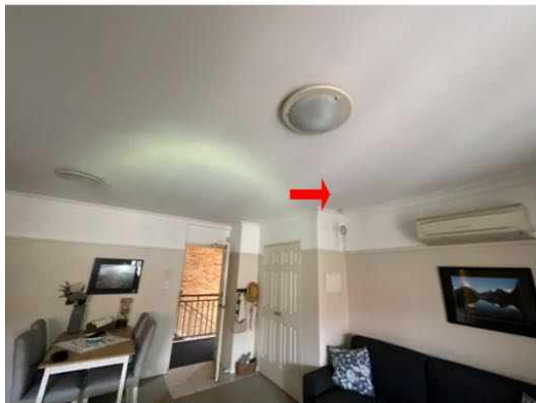
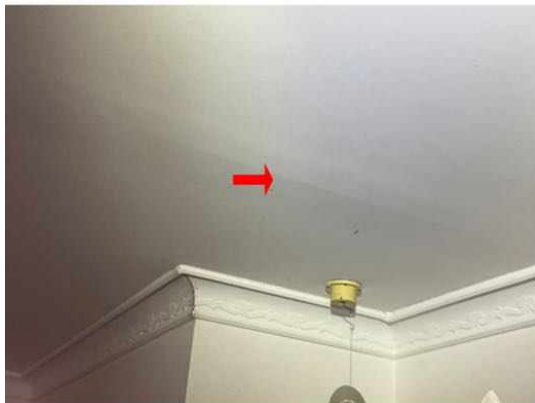
### Finding 3.11

Information: Sections of the ceiling were found to be sagging at the time of inspection. Sagging to the fixed ceiling structure generally indicates that the building materials have swollen, due to contact with water, or that fixings (e.g. nails or glue) have become loose and require reattachment.

Where minor sagging is evident, comparatively minor works, such as re-gluing of ceiling sheets, may be required. Such works may be performed by relevant tradespeople, such as plasterers and painters. Where excessive moisture has caused the roofing structure to swell and sag, the source of the water leak should primarily be identified prior to any remedial works being performed.

The appropriate action should be taken by the client as soon as possible to ensure that any potential further damage is limited.

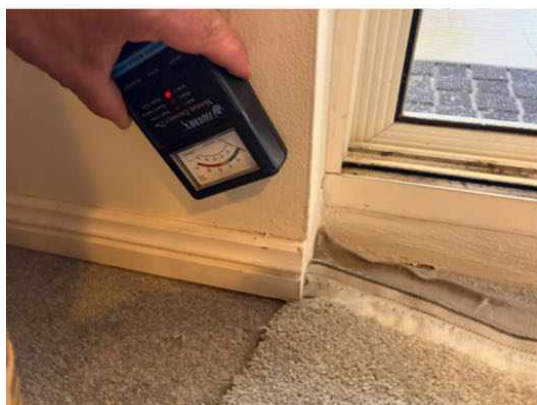
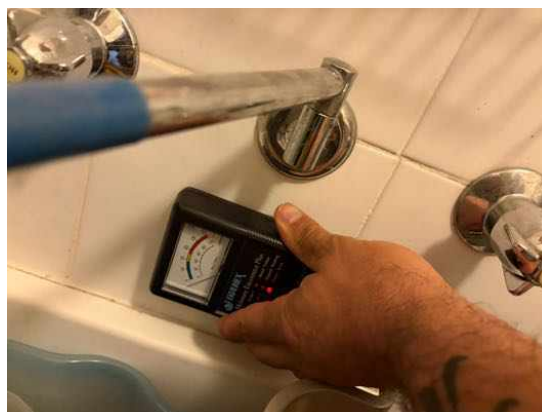
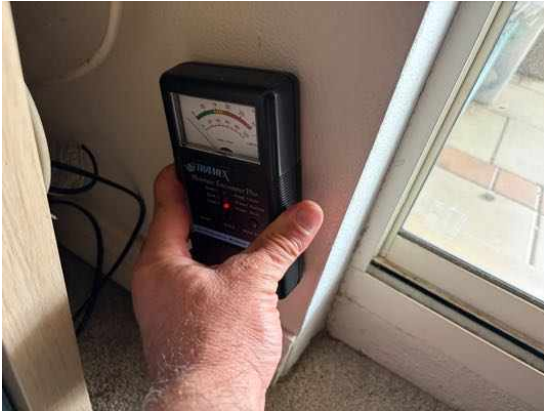
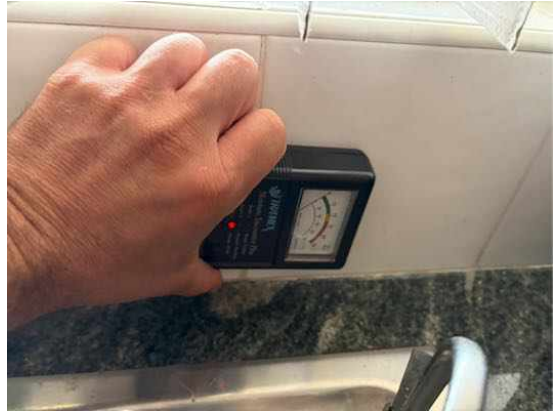
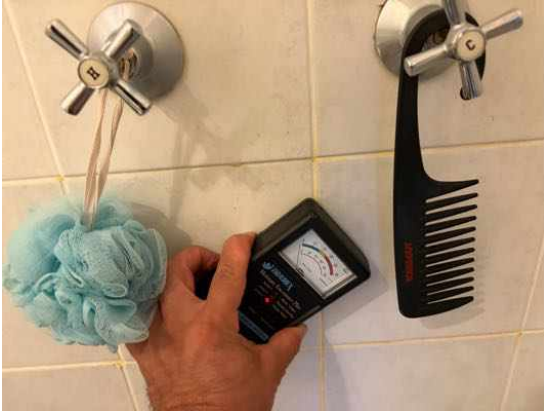
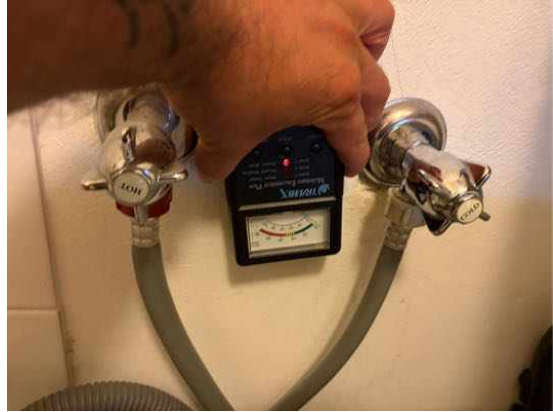
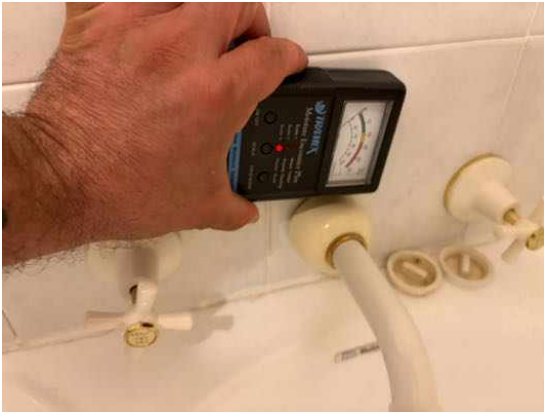
Building: Main Building  
 Location: All Areas  
 Finding: Moisture metre  
 Information: During the inspection the property was checked for moisture using a moisture metre.

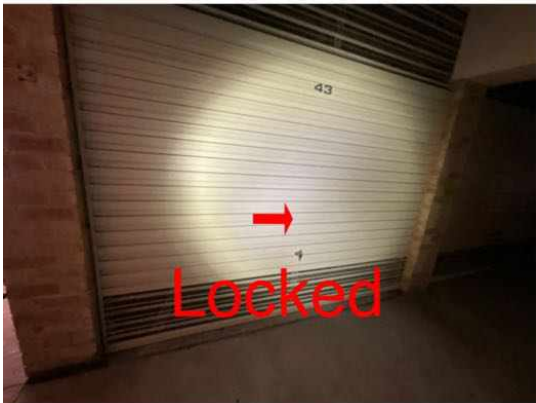
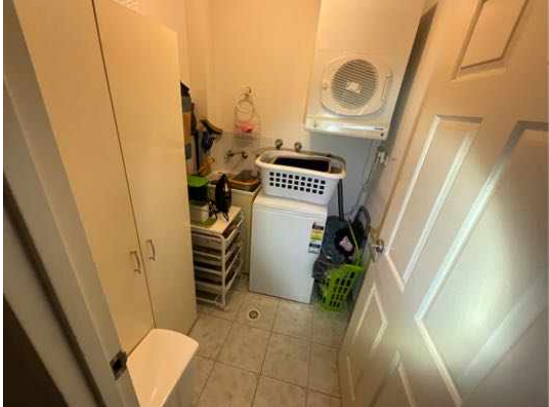
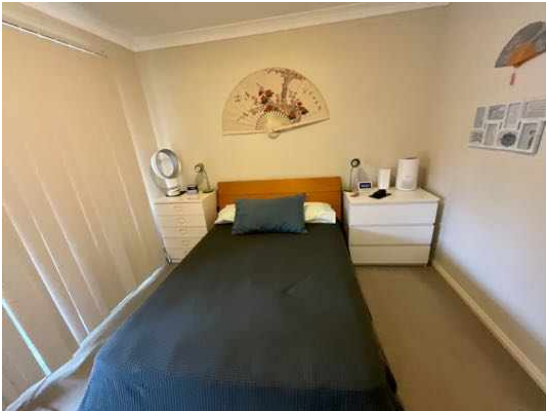
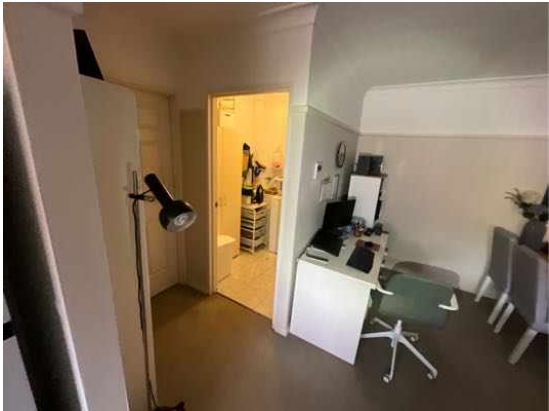
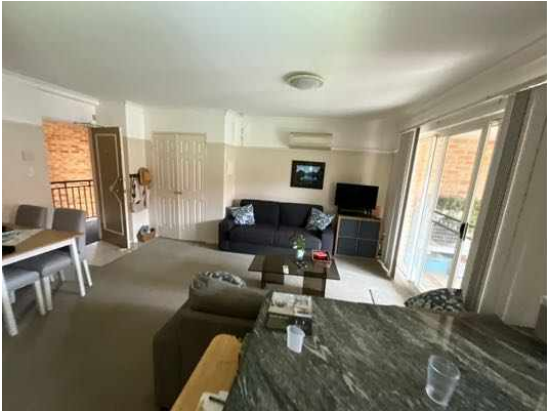
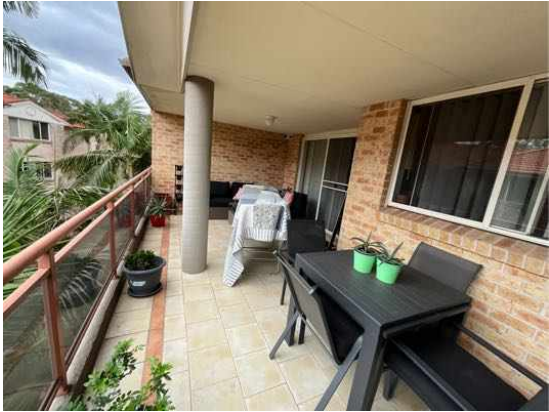
Building: Main Building  
Location: All Areas  
Finding: Additional Photos - Obstructions and Limitations  
Information:

These photographs are an indication of the obstructions and limitations which impeded full inspection of the property at the time of inspection. These obstructions can hide an array of defects and should be removed to allow full inspection to be carried out. A re-inspection is recommended once the areas are made accessible.
