# Building and Timber Pest Inspection Report

Inspection Date: Thu, 12 Feb 2026

Property Address: 38/12 Yeates Cres, Meadowbrook QLD  
4131, Australia

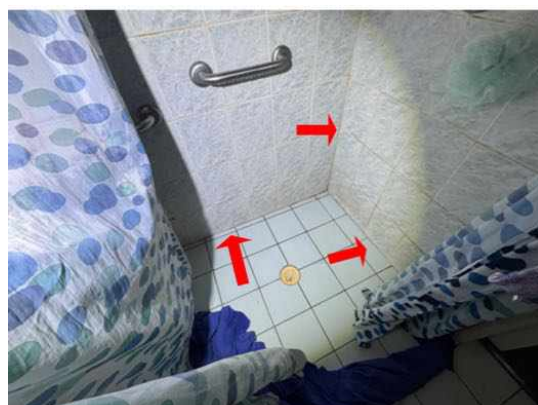
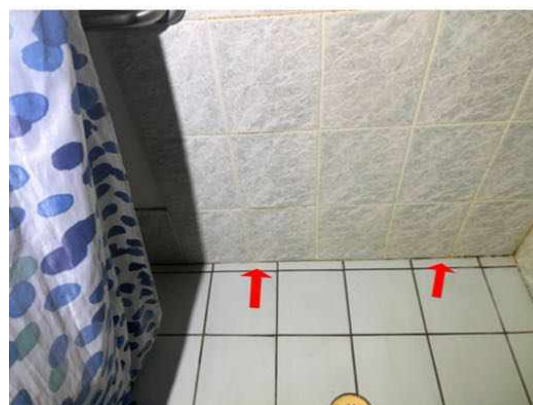
#### Finding 3.01

Building: Main Building  
Location: Bathroom  
Finding: Sealant deteriorating  
Information: At the time of the inspection it was noticed that the sealant in the bathroom was deteriorating.

Sealant is used in tiled areas to prevent moisture from entering the wall cavity and causing damage to the building elements. A moist environment in the wall cavity may also be a conducive condition for termite activity.

If it is not addressed, damage to building elements will occur and would require invasive works to rectify any damage.

A building maintenance professional or sealant applicator should be appointed to replace all sealant as a matter of urgency.

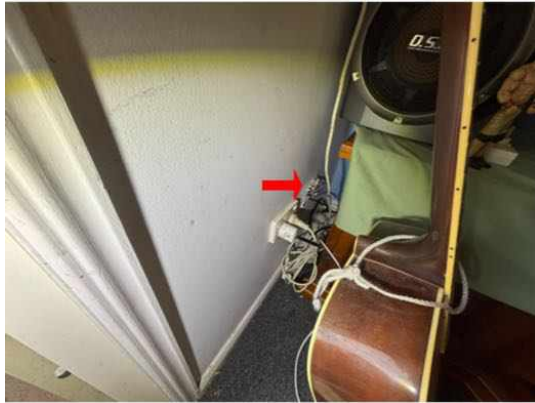
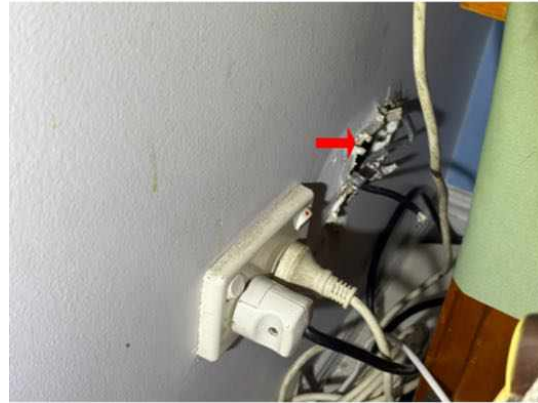
#### Finding 3.02

Building: Main Building  
Location: Living/dining

Finding: Living/dining - wall lining damaged  
 Information: At the time of the inspection, it was noted that there was some damage to a section of the wall lining in the living/dining area. This appears to be where a hole has been cut to bring cables into the dwelling.

A building maintenance professional or painting contractor could be engaged to carry out this minor repair. This can be done at the clients discretion.

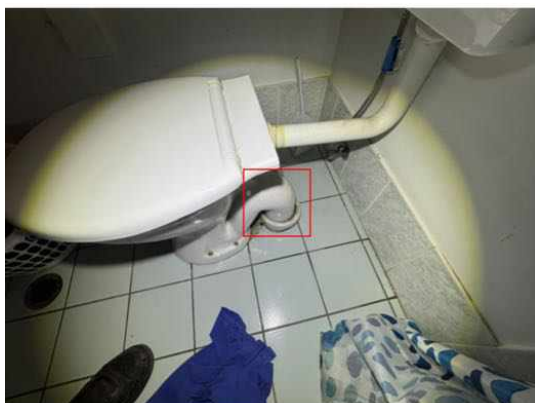
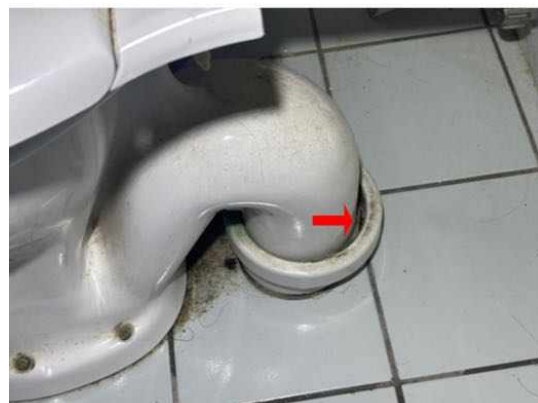
### Finding 3.03

Building: Main Building  
 Location: Bathroom  
 Finding: Bathroom - toilet gasket torn  
 Information: At the time of the inspection, it was noted that the rubber gasket for the toilet outlet had a small tear in it. This is due to the age of the materials and general wear and tear. If left unaddressed, further deterioration will occur which may result in toilet waste escaping. The rubber seal also prevents smells from escaping from the sewerage drain.

A licensed plumber should be engaged to replace the rubber seal. This should be done as a short term priority.

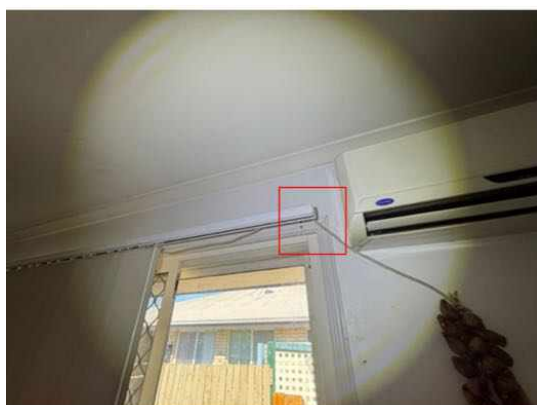
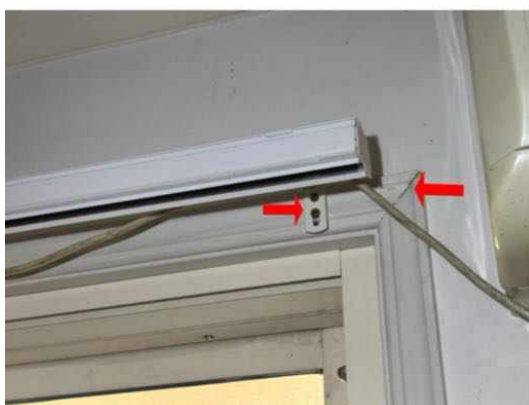
### Finding 3.04

Building:	Main Building
Location:	Lounge
Finding:	Lounge - curtain rail loose
Information:	At the time of the inspection, it was noted that the curtain rail in the lounge was pulling away from the wall. The curtain rail is only attached to the architrave which is not strong enough to support it. Longer screws are required to ensure that the curtain rail is securely attached to the wall.

A building maintenance professional could be engaged to re-install the curtain rail. This can be done at the clients discretion.

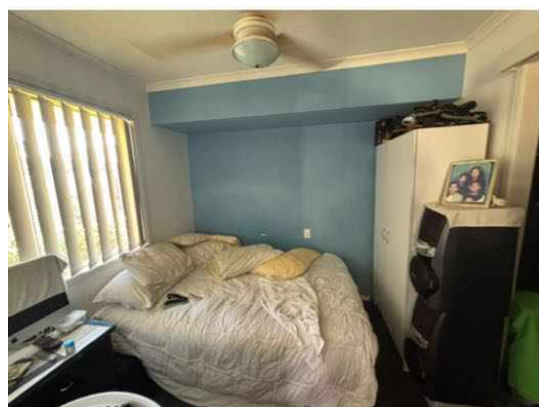
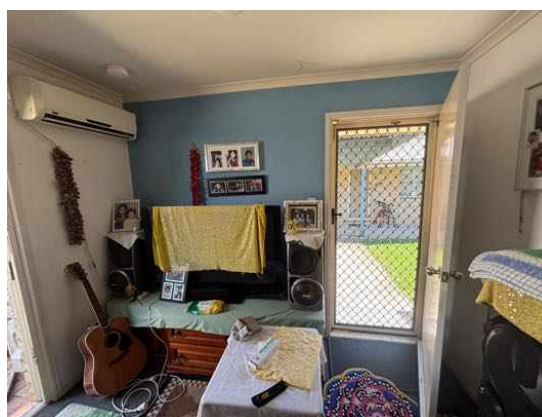
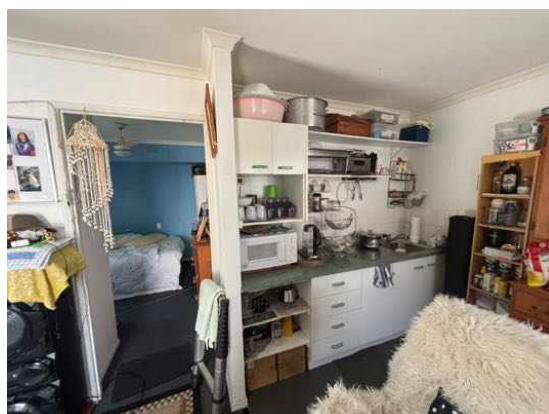
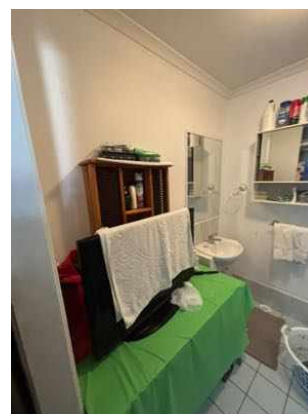
Building: Main Building  
 Location: All Internal Areas  
 Finding: Obstructions and Limitations - Internal areas  
 Information: These photographs are an indication of the obstructions and limitations which impeded full inspection of the property of the internal areas at the time of inspection. These obstructions can hide an array of defects and should be removed to allow full inspection to be carried out. A re-inspection is recommended once the areas are made accessible.

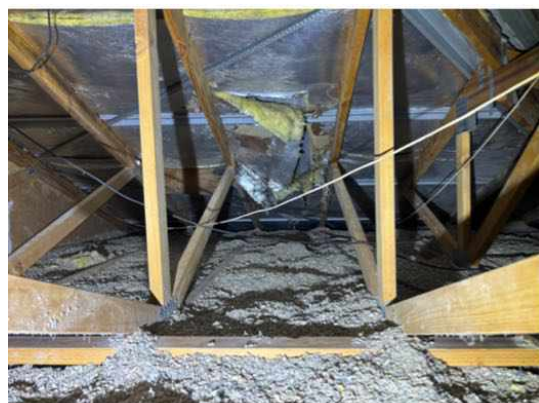
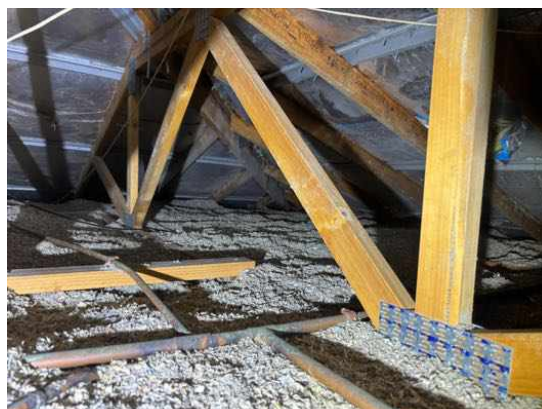
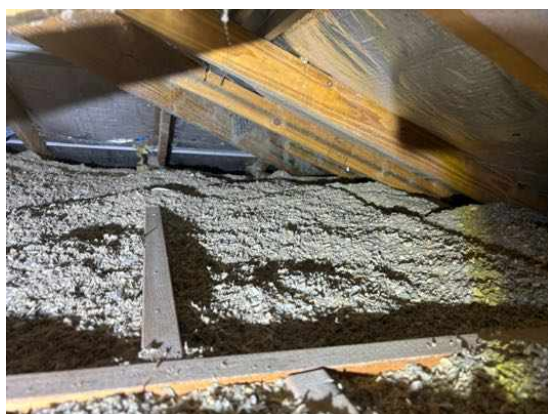
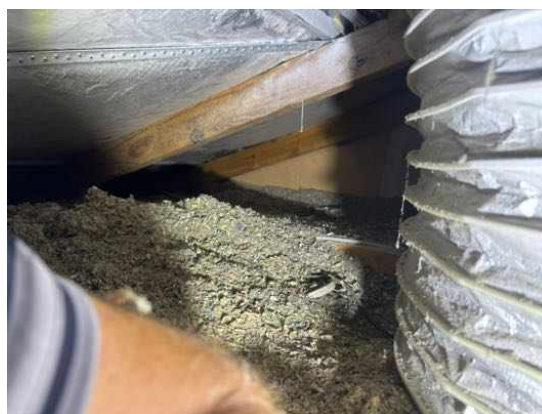
Building: Main Building  
 Location: Roof Void  
 Finding: Obstructions and Limitations - Roof cavity  
 Information: These photographs are an indication of the obstructions and limitations which impeded full inspection of the property of the roof cavity

at the time of inspection. These obstructions can hide an array of defects and should be removed to allow full inspection to be carried out. A re-inspection is recommended once the areas are made accessible.

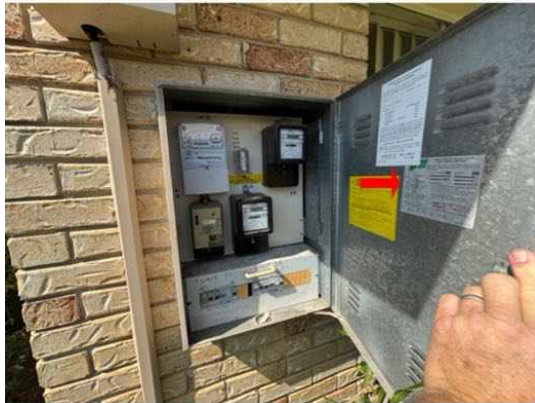
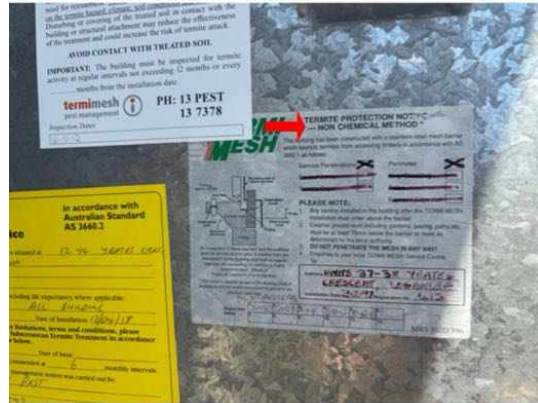
Building:	Main Building
Location:	All External Areas
Finding:	Evidence of a physical termite management system was identified.
Information:	At the time of the inspection, evidence of a physical termite management system was found by way of a durable notice in the electricity meter box on the wall of unit 38.

A physical termite barrier was installed to the slab penetrations and perimeter during construction. The product used was Termimesh. The durable notice is dated the 21/02/1997. Physical termite barriers do not stop or eliminate termites. Physical termite barriers are designed to expose concealed termite activity.

The client should enquire of the body corporate as to the nature of the termite management plan for the complex and the individual units. Also, are annual termite

inspections being carried out and up to date.

A termite and timber pest technician should be engaged to carry out annual termite inspections as per AS 3660 in order to further protect the dwelling. Annual termite inspections must be carried out in partnership with any termite treatment system, physical or chemical, as no termite treatment system can be expected to be 100% effective.
