Building and Timber Pest Inspection Report

Inspection Date: Thu, 26 Feb 2026

Property Address: 231 A Sydney St, Grantham Farm NSW 2765, Australia

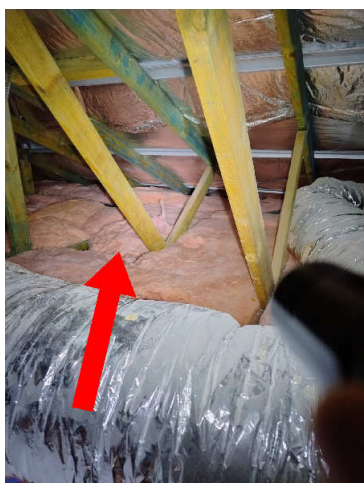
Information: Sections of insulation in the roof void have been poorly installed or moved from their original position and are covering down light fittings at the time of inspection. While the down lights have been fitted with appropriate protective covers, the presence of this insulation creates a potential fire hazard.

Any insulation within the vicinity of down light fixtures should be moved and re-applied to more appropriate sections of the roof void, thus ensuring the area is fire-safe. An insulation contractor should be appointed as soon as possible to perform any necessary works as required.

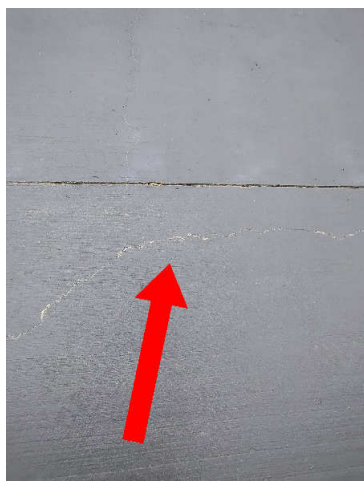
Finding: Cracks in concrete slab - Category 2

Information: A crack coded as Category 2 was identified in the driveway slab at the time of inspection. A Category 2 crack is described as a distinct crack, with the slab being noticeably curved or changed in level.

To be considered Category 2, the approximate width of the crack is less than 2.0mm, or a change in offset of less than 15mm when a 3m straight edge is placed over the defect.

Category 2 cracks to slabs should be monitored for a period of 12 months. At the end of the monitoring period, cracks rated greater than Category 2 are considered defects that require rectification.

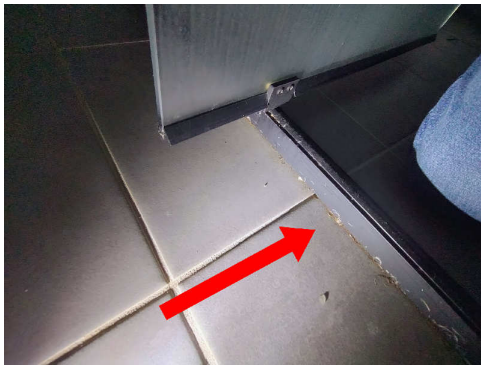
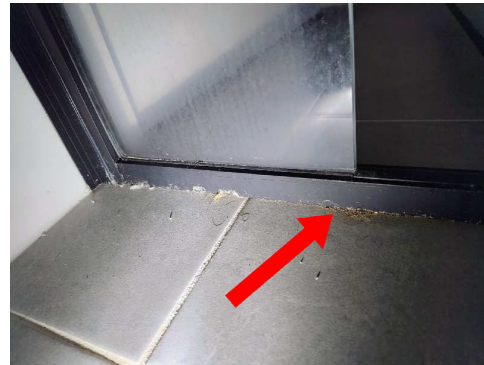
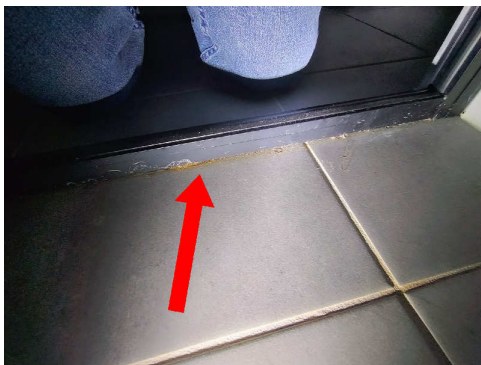
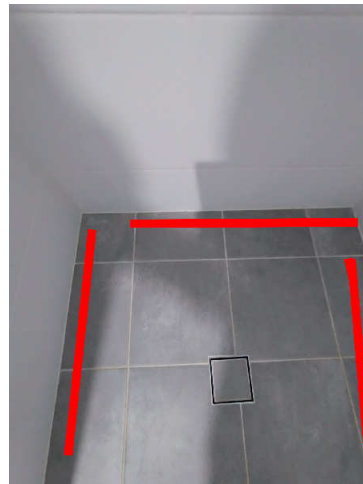
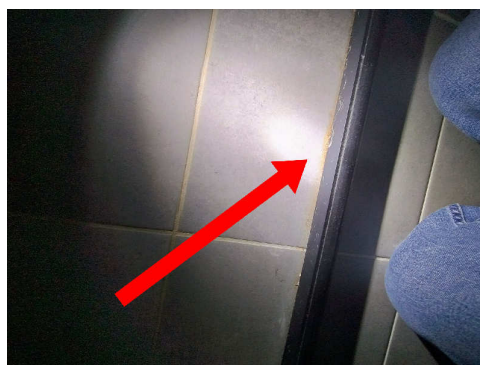
Finding 3.04

Finding: Sealant and Grouting - Damaged or Detoriorated

Information: It was noted on inspection that sealant or grout is degraded to the tiled shower alcove and or other areas of the bathroom.

There mould to the sealant and grout which will likely require scraping out and replacement.

This can lead to water ingress into the shower base and creates conducive condition to termite activity. If left unmanaged can cause further deterioration to building elements.

Flexible and mould resistant materials should be applied to affected areas to prevent any subsequent water damage that is likely to occur. Regular maintenance and replacement of damage or missing or damaged sealant and grout is highly recommended to the wet areas, as this is a regular wear and tear defect. Sealant and grouting in areas that come into regular contact with water should be maintained for the long term care of your property.

Qualified trade person or plumber must be appointed for rectification on priority.

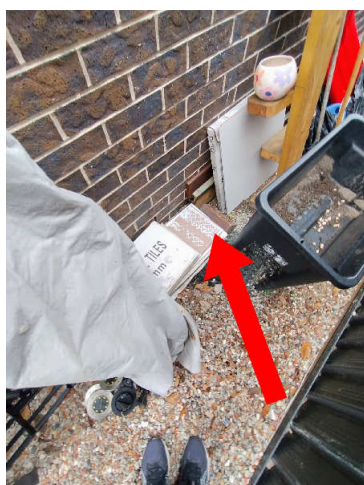
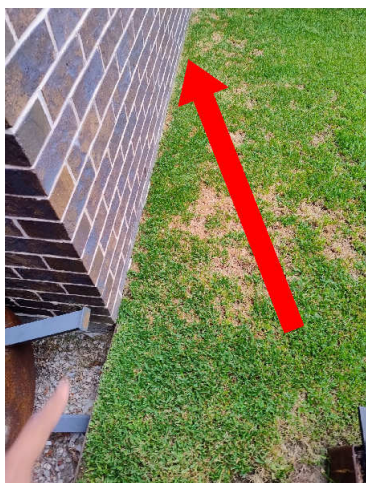
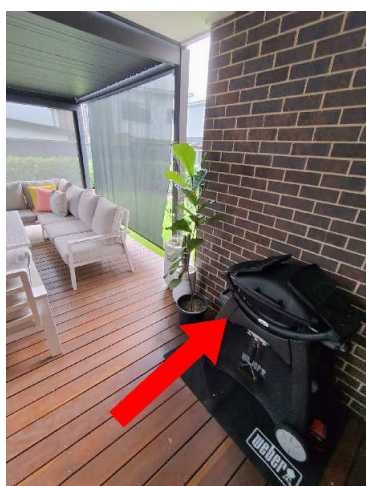
Finding 3.05

Information: Weep holes were observed to be covered in some location at the time of inspection.

Additionally build-up of moisture is likely to occur if weep holes are covered further attracting termite activity to these areas.

It is highly recommended that weep holes are left exposed in all areas throughout the external property. Therefore if any termite activity leading into weep holes becomes easily detectable during frequent pest inspections.

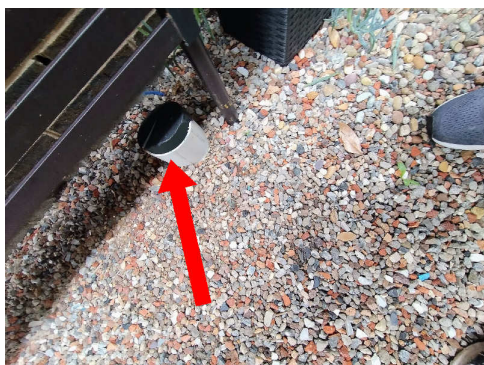
Finding 3.06

Finding: Plumbing work - appears defective

Information: An instance of potentially defective plumbing work was identified in left side yard. Whilst we are not licensed plumbers it appears that work which is not compliant with the relevant plumbing regulations and or the contract documents has occurred. The area of suspected non-compliance or poor workmanship should be referred to the builder and or the Building Surveyor or Certifier. The builder is required to provide a Certificate of Compliance when required by the relevant regulations.

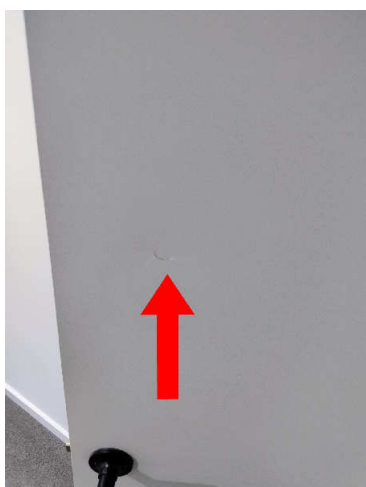
Finding 3.07

Finding: Door - small dent or Damage

Information: Small dent or damage was observed on the inside face of master bedroom door.
Breakage occurs generally when the building materials have either aged and decayed, or as a result of damage (accidental or deliberate).

Repair and/or replacement of broken elements is advised to ensure that additional secondary defects do not arise as a consequence. Such works are necessary, as all building elements play a key role in the operation and function of the overall structure and its performance.

A relevant tradesperson should be appointed to repair or replace the affected building element prior to any subsequent damage being caused.

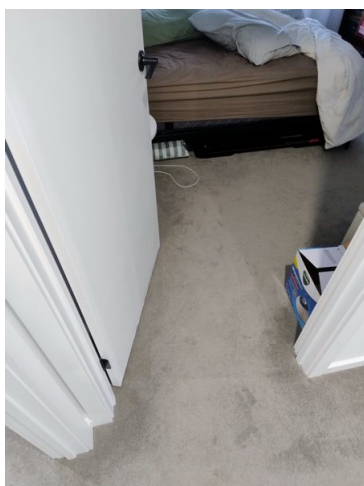
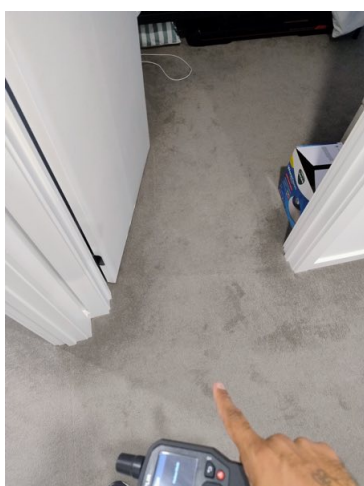
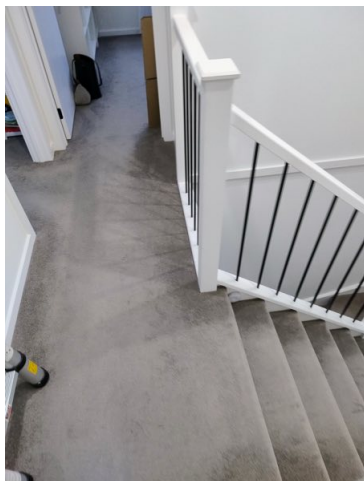
Finding 3.08

Finding: Carpet - Deteriorated

Information: All area of the carpet floor covering in upper floor area appeared to be deteriorated and used. Deteriorated carpet pose health hazards by trapping allergens like dust mites and pet dander, which can trigger asthma and allergies. They can also hold bacteria, mould and fungi, especially if damp, leading to respiratory problems and infections,

Replacement of the carpet is suggested as a matter to ensure the safety of the area at client discretion. Where required, remedial works should be undertaken to any associated walls and flooring showing evidence of mould.

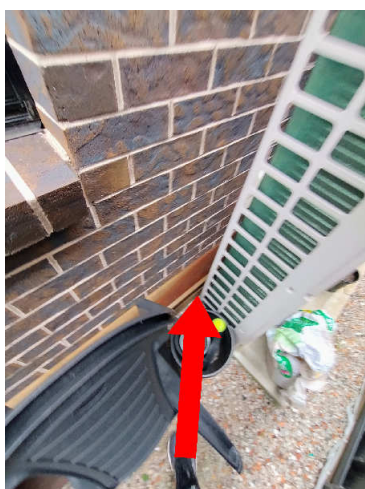
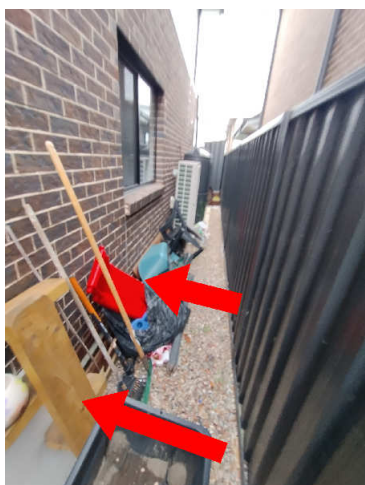
Finding 6.03

Information: The storing of timbers and other material around the external property increases the risk of termite activity being present at the time of inspection. As they are likely to come into contact with weather conditions or excessive moisture wood rot is likely to develop on timbers that are not treated.

It is highly recommended that any stored timbers be immediately removed from areas in which they may attract any termite / timber pest attack. Minimisation of risk / prevention of termite attack is far more adequate than dealing with the presence of termite activity.

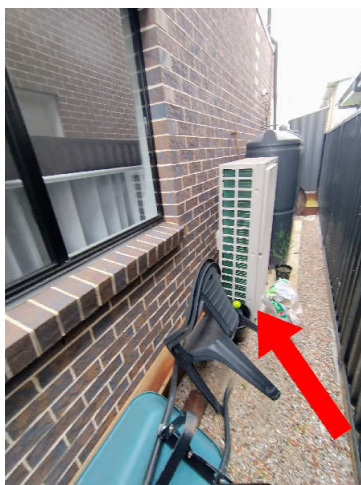
Finding 6.04

Finding: Air conditioner - Not Connected overflow

Information: The Air Conditioner (A/C) overflow was found to be Not connected from storm water drainage and is creating excessive moisture in the surrounding area.

Such leaking creates an environment which is conducive to an array of defects, including water damage to associated building elements and the attraction of termite or timber pest infestation.

It is highly recommended that a licensed plumber be appointed to connect the A/C overflow in order to prevent such an environment from being created. These minor works should be carried out as soon as possible.

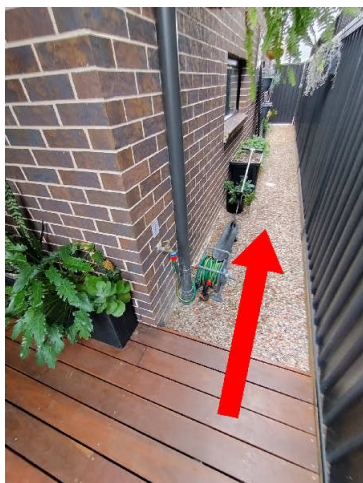
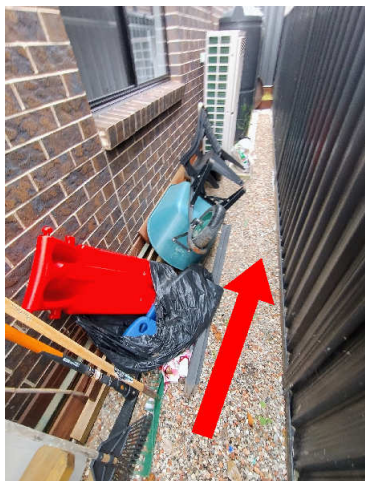
Finding 6.05

Finding: Site drainage - Inadequate

Information: The site drainage in left side area was found to be inadequate at the time of inspection, creating potential for subsequent water damage to associated building elements.

It is important that water does not lie against the base of walls; surrounding paths and ground levels should be sloped to drain water away from walls. Downpipes should not discharge stormwater onto lower walls or plinths. Stormwater should be carried away by large, regularly cleaned drains. Ground levels may need to be lowered to expose a buried DPC.

Where site drainage is inadequate, installation of an Agricultural (Aggie) Drain may be required. A qualified plumber should be appointed to further inspect the property and perform any remedial works as necessary. Water damage and secondary defects are likely to occur if left unmanaged.

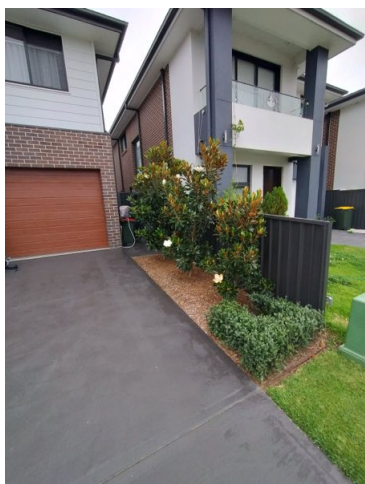
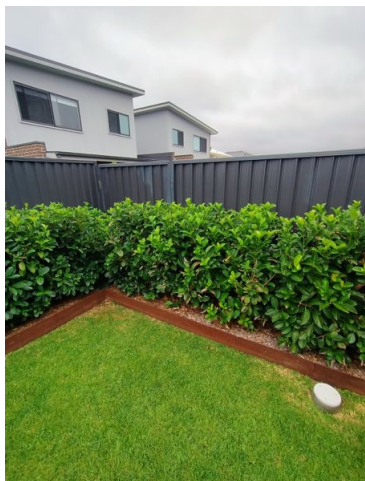
Finding 6.06

Finding: Garden Beds - Conditions Conducive to Termites

Information: Garden beds were found to be evident in the garden area. These garden beds can include untreated timber, and with a combination of moisture from watering hosing can make conditions conducive to termite activity and termite ingress.

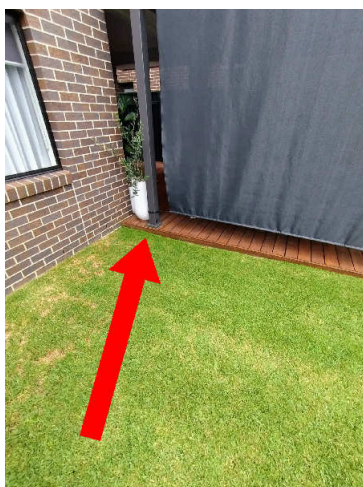
Information: External decking was found hard up against the building and it is observed to be providing bridging condition at the time of inspection at rear end of the yard.

Where bridging has occurred full inspection is prevented and termites may enter a property in a concealed or undetectable manner.

The client should consider obtaining further advice from a timber pest technician regarding treatments required in this area. It is recommended that obtaining such advice be a short-term priority.

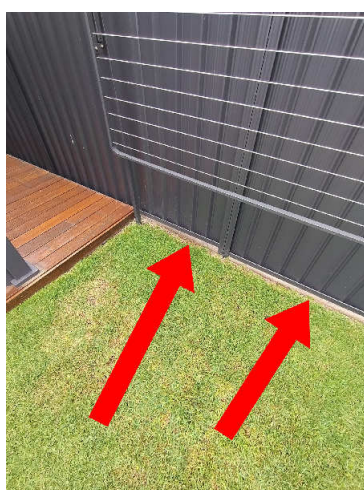
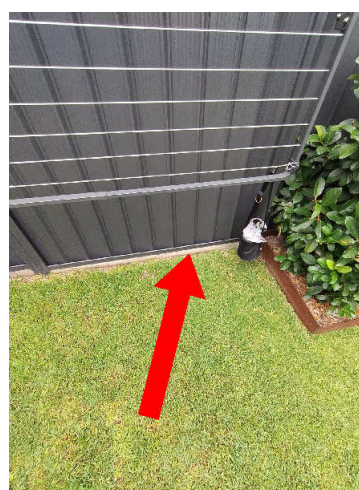
Finding 6.09

Timber was found in direct contact with ground in rear area of building at the time of inspection. Where timber elements are in direct contact with the ground and consequently moisture or dampness they become conducive to termite activity. Whether timber is used as a building element part of a fencing structure or stored as an unused item they can provide an environment that is attractive to termite infestation.

When met with excessive moisture timber begins to decay and develop wood rot. Any timbers that are in direct contact with external grounds especially if left untreated or non-durable also provide ingress for subterranean termites into that particular element.

The removal of any such materials that may be conducive to termite activity should be removed as soon as possible to minimise the risk of termite attack.

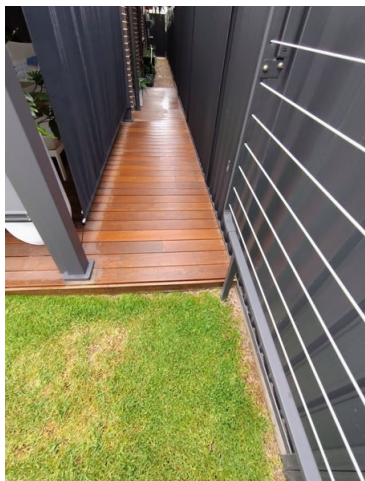
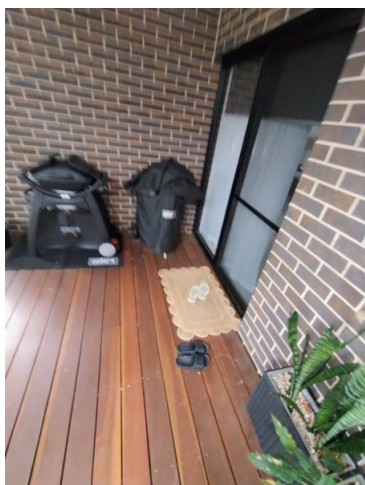
Information: The additional wooden decking structure that has been affixed to rear area of the dwelling does not appear to comply with contemporary building practices and current Australian Standards. While the structure does not currently appear to be unsafe, compliance with such standards ensures the structural integrity of the main dwelling and abutting addition.

As building standards have not been followed, this area provides a heightened risk of the development of building defects. The structural integrity of the area may have been compromised, which creates potential for the development or presence of major safety issues.

It is highly recommended that any planned repair, remodeling or demolition works be carried out by registered builders.

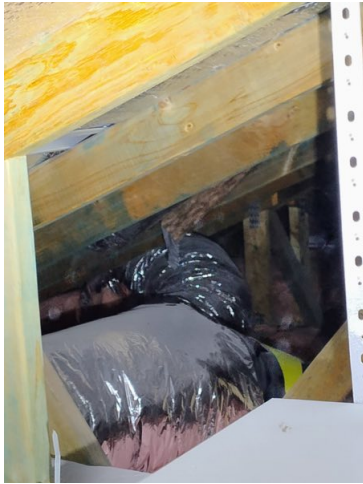
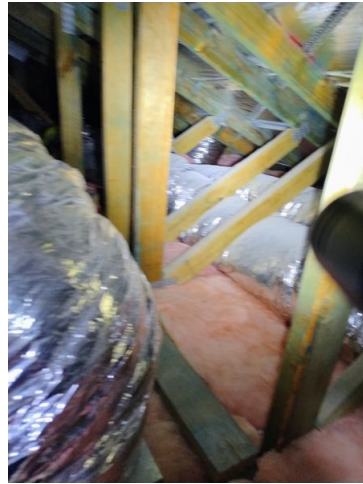
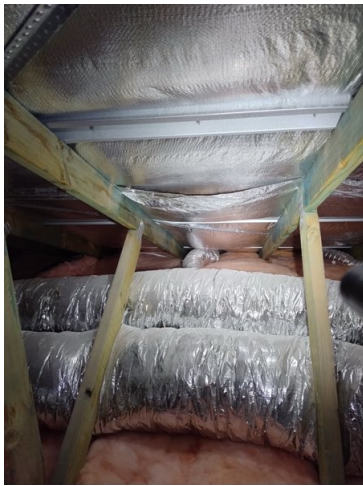
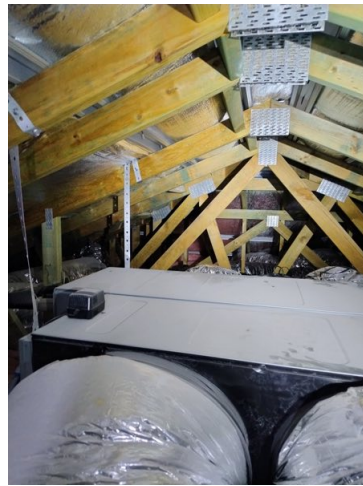
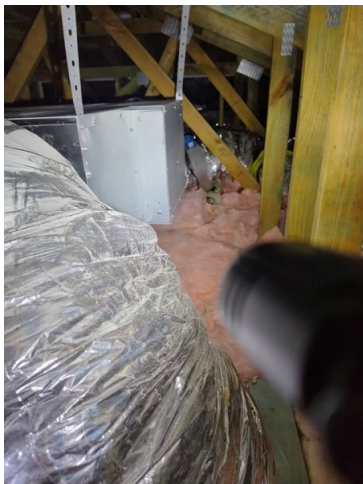
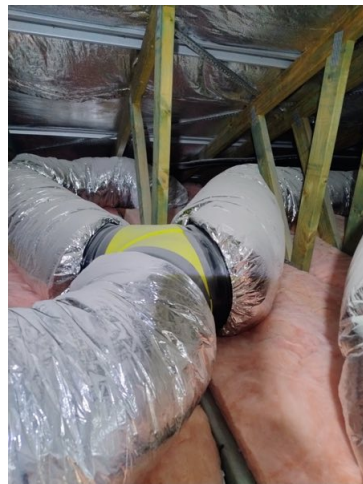
Finding: Roof void access limitations

Information: Limited access to the roof void was present due to facts including but not limited to access hatch size or placement, low pitch, timber framing in roof, for this reason access to the roof void was minimal.

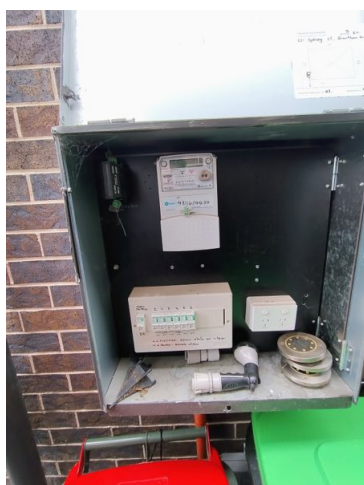
Building:	Main Building
Location:	Meter Box
Finding:	Termite Management System - no evidence of a Termite Management system or Durable notice
Information:	At the time of inspection, it was noted that there is no visible durable notice indicating the installation of a termite management treatment system, as required by current building regulations.

The absence of such a notice may compromise the effectiveness of termite control measures and could lead to potential risks related to termite infestations and damage. It is noted that without further information from the current owner or real estate agent regarding the installation of a termite management treatment system, it is then assumed that there is no termite treatment system installed to the property.

It is strongly recommended that a licensed pest control contractor be engaged to assess the property and to install an appropriate termite management system as a matter of urgency.
