# Building and Timber Pest Inspection Report

Inspection Date: Wed, 1 Apr 2026

Property Address: 10 Lockwood St, Asquith NSW 2077,  
Australia

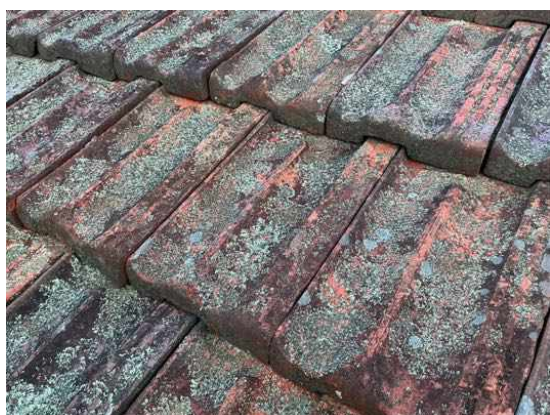
Building:	Main Building
Location:	All Areas
Finding:	Roof Tiles Weathered - Lichen Build Up
Information:	Upon inspection of the exterior roofing, the majority of roof tiles were considered to be in a fair condition with mortar deterioration. While weathering of the tiles is consistent with the age of the property, maintenance works are required.

Concrete roof tiles are typically cleaned to have the visible moss and lichen removed. Concrete tiles are made from a product which is a naturally moist material. Moss and lichen is attracted to the roof tiles surface, and if left will continue to grow and most likely restrict the flow of rain water over the tiles surface, into the roofs gutters. An application of an environmentally friendly anti-fungal solution should be applied to all moss and lichen, prior to undertaking the roof cleaning process.

A roof restoration company can be contacted for further advice at the clients

discretion.

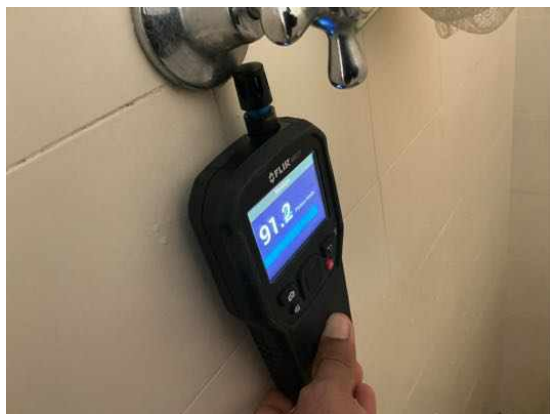
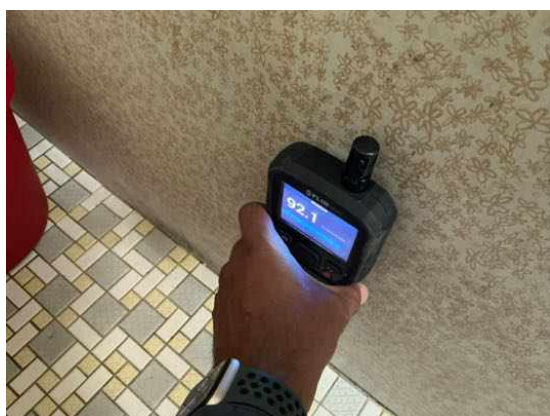
Building:	Main Building
Location:	Both Bathrooms
Finding:	Excessive Moisture - Shower Damp
Information:	At the time of inspection, excessive moisture was noted within the shower area, which is a common issue in wet areas due to the continual exposure to water. This condition is typically caused by moisture seeping through grout lines and settling behind tiles, resulting in localised high-moisture zones. Provided there is no evidence of water staining or elevated moisture readings on the opposite side of the wall, this is considered a minor defect.

However, persistently damp conditions may act as conducive conditions for termite activity, as termites are strongly attracted to moisture-rich environments. It is recommended that the client ensures regular use of the exhaust fan and maintains adequate ventilation after shower use to promote drying and reduce long-term moisture build-up, thereby also reducing the risk of attracting termites.

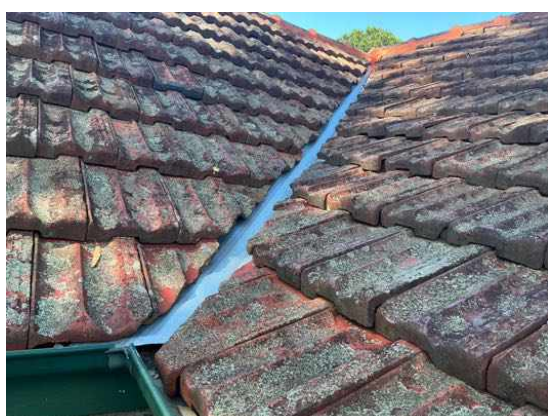
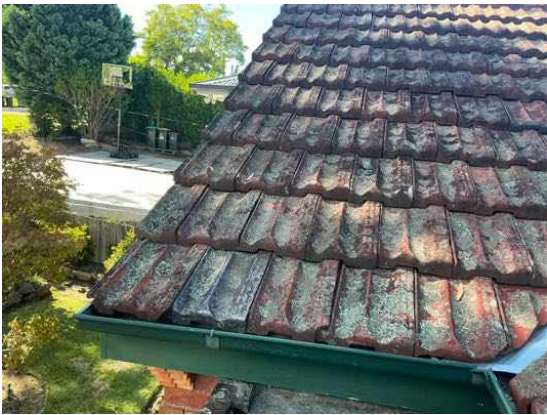
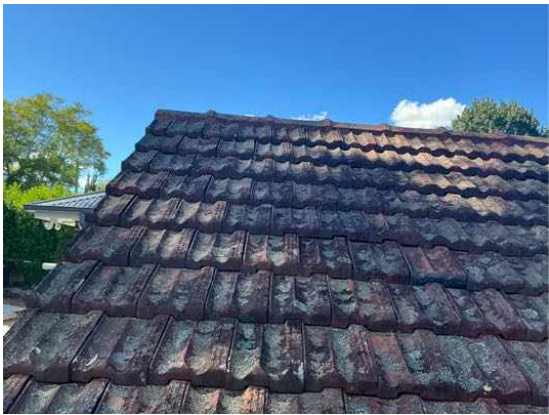
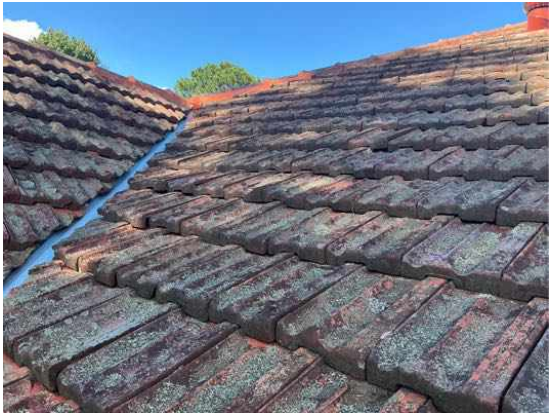
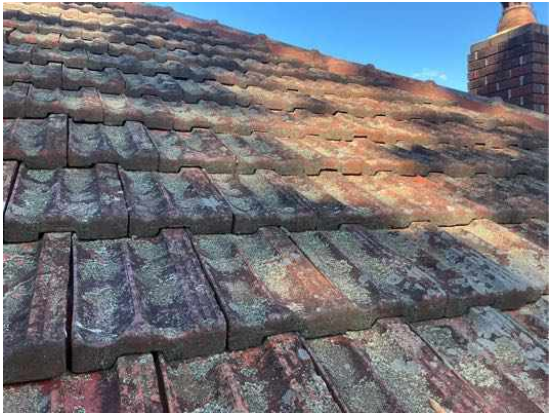
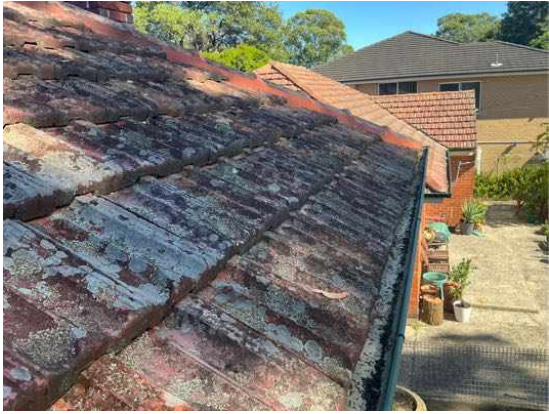
Noted Item

Building: Main Building  
Location: Roof Exterior  
Finding: Additional Roof Photos  
Information:

As part of the information provided, please note that the attached roof photos represent the condition of the roof at the time of inspection. These photos are for visual reference only and do not constitute a detailed roofing assessment. Any defects or issues identified with the roof are mentioned separately in the defect statements. It is strongly recommended that the client engage a qualified roofer to conduct a thorough inspection of the roof, ensuring that any potential issues, such as leaks, structural integrity, or wear and tear, are properly identified and addressed.
