Building and Timber Pest Inspection Report

Inspection Date: Tue, 3 Feb 2026

Property Address: 15 Kurama Cres, Whalan NSW 2770,
Australia

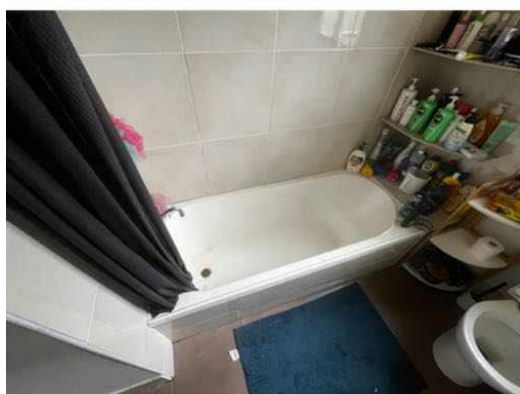
Building: Main Building
Location: Main Bathroom >
Finding: Sealant and grouting - Missing or damaged -
Information: It was noted on inspection that sealant or grout is degraded to the tiled shower alcove and or other areas of the bathroom.

Different materials and floor areas move at different rates, generally causing cracking to grout or sealant at this point. A flexible sealant is required to allow for expected expansion and contraction, while keeping the joint water tight and protective of all associated building materials.

There appears to be excessive mould to the sealant and grout which will likely require scraping out and replacement.

Flexible and mould resistant materials should be applied to affected areas to prevent any subsequent water damage that is likely to occur. Regular maintenance and replacement of damage or missing or damaged sealant and grout is highly recommended to the wet areas, as this is a regular wear and tear defect. Sealant and grouting in areas that come into regular contact with water should be maintained for the long term care of your property.

A sealant specialist or tiling contractor should be appointed to complete these works as soon as possible to prevent water ingress

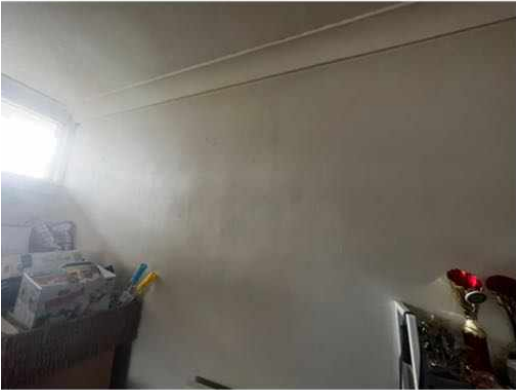
Finding: Cracking - Damage Category 2 - Noticeable (up to 5mm)

Information: Noticeable cracks are a common occurrence as a result of many primary defects. Such causes may include age, general wear and tear, expected building movement, general expansion/contraction of building materials in different weather conditions, and/or minor failings in the installation or application of building materials.

Noticeable cracks may result in minor sticking or jamming of associated doors and windows, which require easement. However, noticeable cracks are easily filled and repaired. A plasterer can be consulted to install an expansion joint at this point to allow

for this movement during different weather conditions.

Monitoring of all cracking should be conducted frequently. Always contact a building inspector should cracks widen, lengthen, or become more numerous. Additionally, your building inspector should also be contacted if associated building elements such as doors and windows become more difficult to operate over time.

Relevant tradespeople, such as carpenters, painters and plasterers, should be appointed to perform remedial works, as deemed necessary.

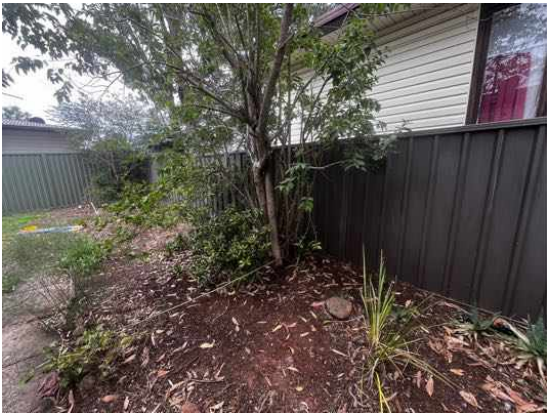
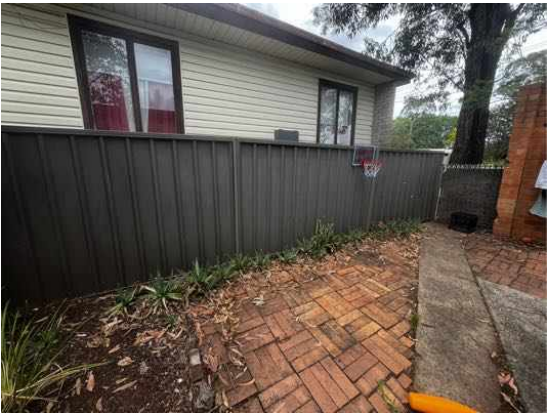
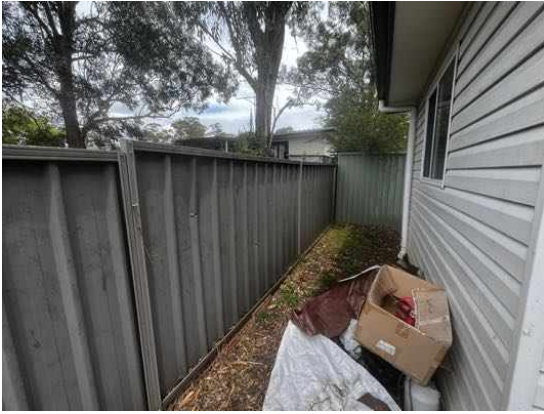
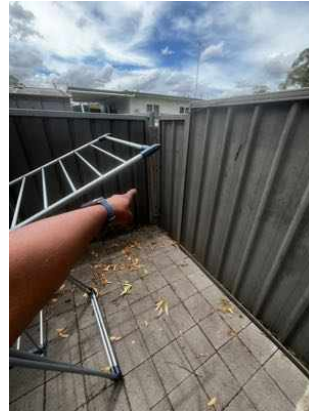
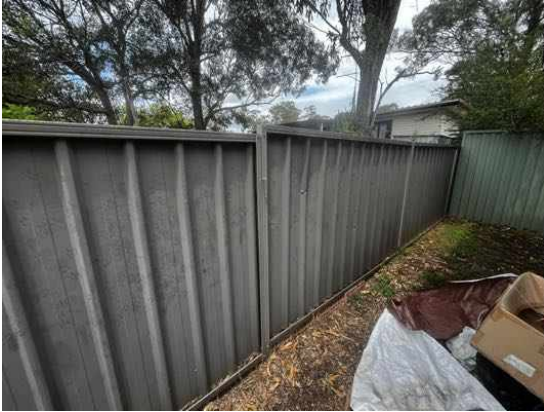
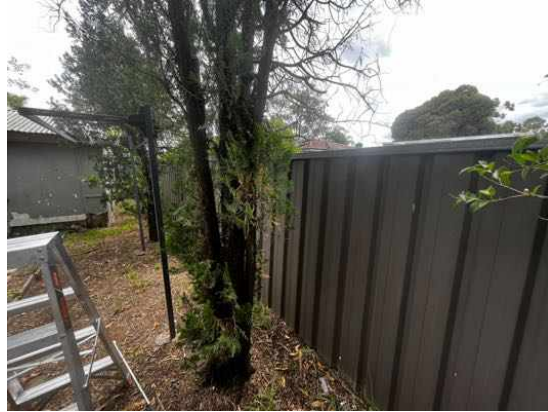
Finding 3.02

Finding: Fencing - Deteriorated

Information: It was noted at the time of inspection that sections of the fencing throughout the property have deteriorated. Typically fencing deteriorates due to age and or wear, rot and or rust which is generally expected for a structure of this age, due to prolonged exposure to weather conditions. Sometimes inadequate installation or maintenance can be to blame.

If left unattended, it is likely that further damage will occur. It is suspected that repair of several elements of the fencing may be required however replacement may be a consideration of the client also.

A licensed fencing contractor should be appointed to provide further advice and perform rectification works as necessary.

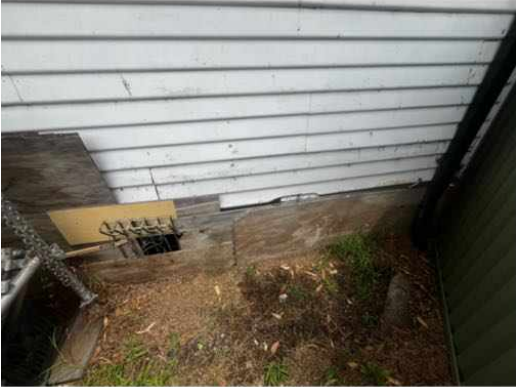
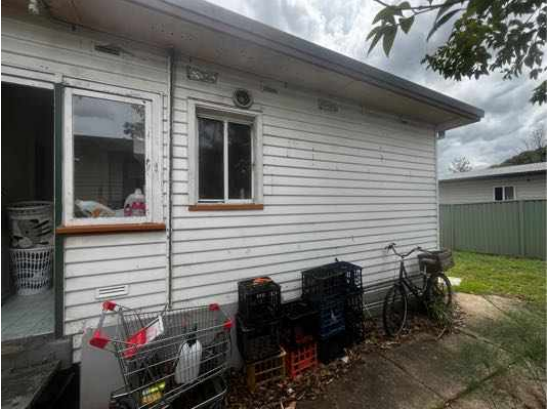
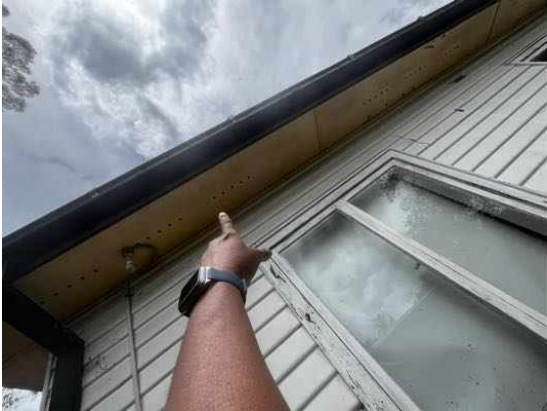
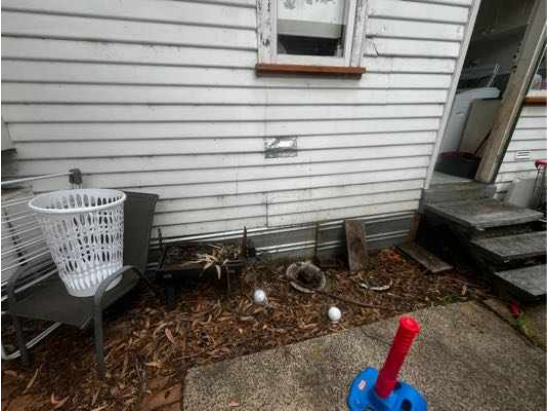
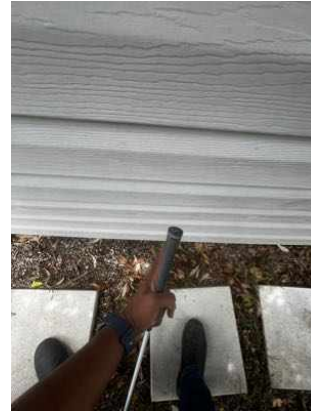
Finding 3.03

Building:	Main Building
Location:	Main House
Finding:	Weatherboards - Rotting
Information:	The external weatherboards show signs of fungal decay (wood rot) in several sections. This wood rot is suspected to have developed over a prolonged period of time due to frequent weather exposure, which is expected in a property of this age and condition

Weatherboards are sealed and protected by paint and other sealants. When these sealants deteriorate over time, they allow water penetration to the weatherboards, causing wood rot. If left unmanaged, the wood rot is likely to develop further, possibly necessitating major repair or replacement works in the long-term future.

To maintain the condition of the external wall cladding, any severely affected weatherboards should be substituted as soon as possible with pre-treated replacements. Where weatherboards have rotted due to excessive moisture other than rain penetration, the cause of the moisture should be identified immediately by a licensed plumber. A qualified carpenter should be appointed to repair and replace rotting weatherboards.

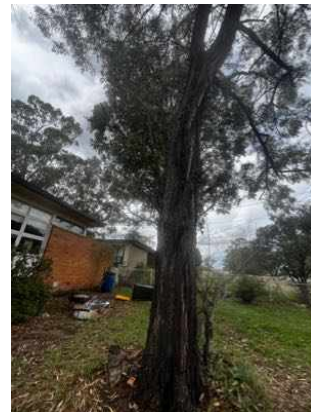
Finding 3.04

Building:	Main Building
Location:	Roof Exterior
Finding:	Trees - Overhanging and filling gutters
Information:	Upon Inspection The gutters in the property were filled with leaves and rubbish, Overhanging trees often result in excessive amounts of leaf debris accumulating in gutters.

Gutters are a critical part of the building's management of storm water and rain. It is therefore important that they be kept clear to prevent secondary damage to associated building elements, including exterior and interior walls, ceiling linings and any adjoining building elements. Where gutters are blocked, pooling of rainwater is likely to occur, fast-tracking rust and corrosion of the roof plumbing elements.

It is highly advised that all overhanging tree branches be removed as soon as possible to prevent any further damage. Repair and/or replacement of sections of damaged guttering may also be required where the extent of the damage necessitates.

Such works should be performed by the homeowner; however, appointment of a landscape contractor or an arborist may be required. Consultation with a licensed roof plumber is required where guttering has been damaged.

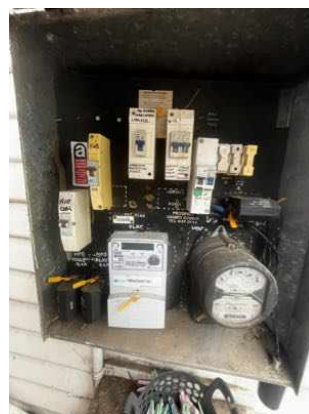
Building:	Main Building
Location:	Electrical Switchboard
Finding:	Termite Management System - no evidence of a chemical installation no Durable Notice
Information:	The application of a post-construction chemical termite barrier is highly recommended for all properties, particularly if live termite activity has been found on the site previously. Such barriers are highly effective in preventing termite attack on any timber building elements throughout the property.

A durable notice should be placed in the switchboard unit to indicate current termite barriers. At the time of inspection, it appeared as though no termite management system has been installed, with no evidence to suggest preventative works taking place.

The client may consider gaining further advice from a pest controller as to the costs and procedures involved with this application. It is recommended that obtaining such advice be a short-term priority.

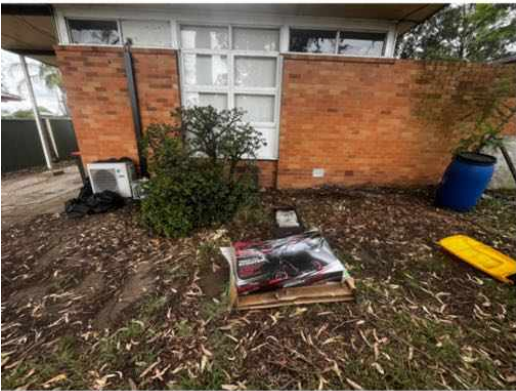
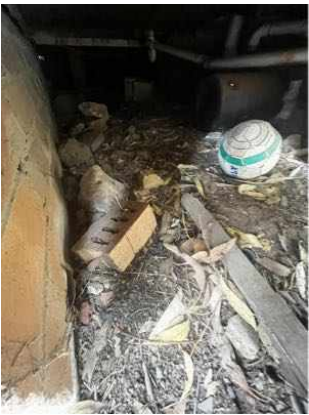
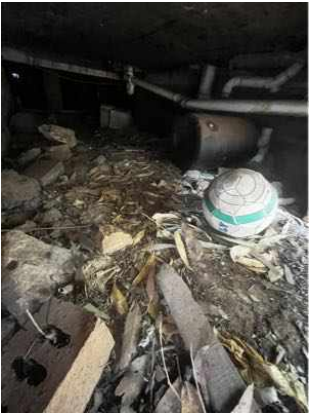
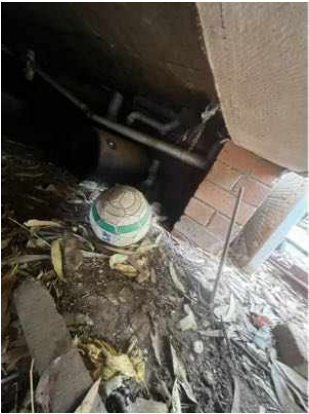
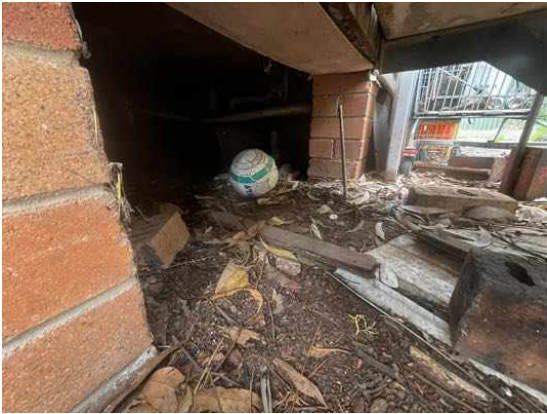
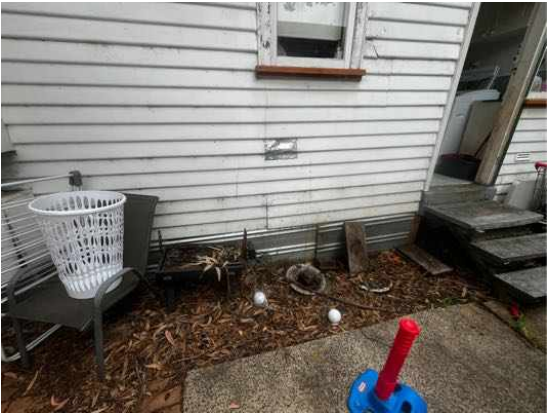
Finding 6.02

Information: Any timbers in direct ground contact provide opportunity for concealed termite entry and are likely to be subject to premature rot and decay as the soil retains moisture or damp conditions against the timbers.

Remove untreated timber that is in direct contact with external grounds. Consider replacement with more durable materials i.e. treated timber or non timber elements. Frequent pest inspections are advised to readily identify any termite activity in these areas.

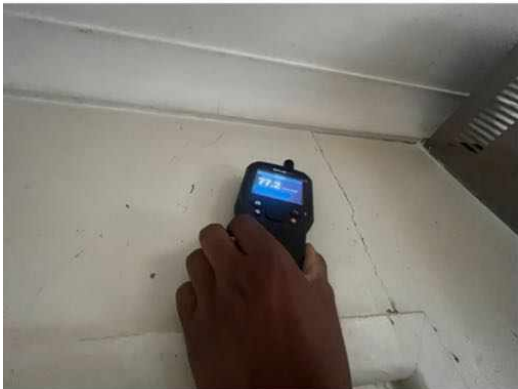
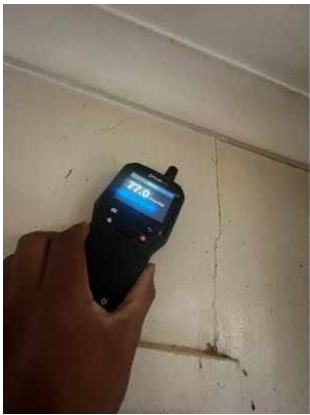
Finding 6.03

Building:	Main Building
Location:	Laundry
Finding:	High Moisture Readings
Information:	All areas of dwellings are checked with particular attention paid to wet areas which were closely assessed to check for moisture levels of moisture and temperature anomalies.

Some readings for moisture were found in the walls adjacent the showers at the time of inspection.

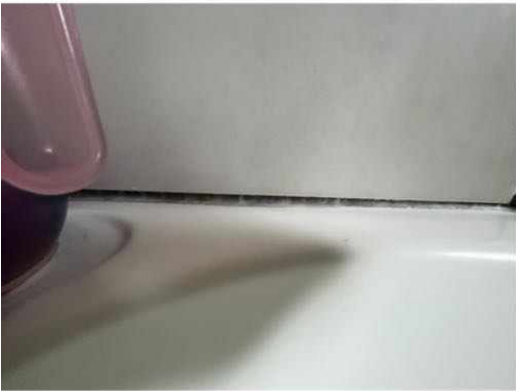
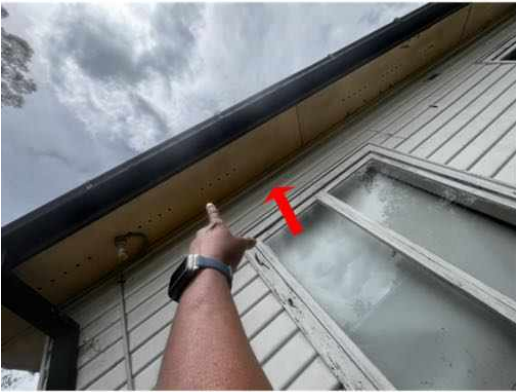
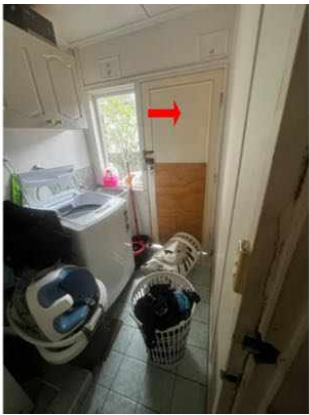
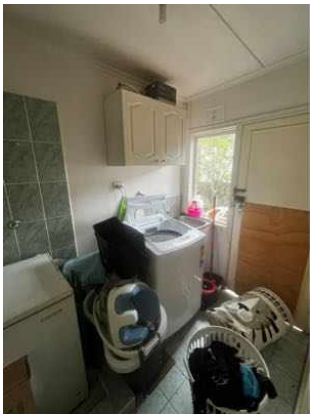
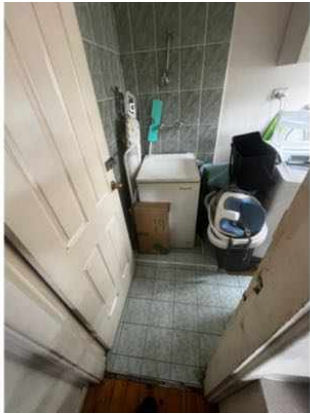
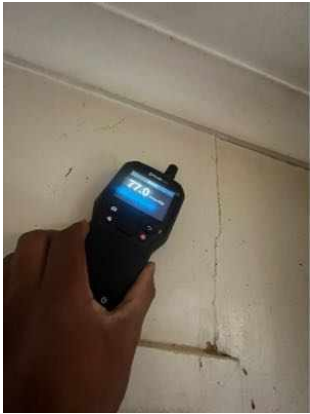
Building: Main Building
Location: All Areas
Finding: Asbestos - Suspected ACM Identified on Site
Information: Reporting on Asbestos is outside the Scope of this Report. This suspected defect is highlighted as a caution only. We suspect, based on our experience in the building industry, that there is a higher risk of the identified building element containing asbestos.

As Asbestos Reporting is outside the scope of this report, we advise that you consider a separate Asbestos Inspection and Condition Audit, which can include the taking of samples for definitive confirmation of the presence of Asbestos.

In the interim, the client is advised to act with caution, especially when considering any damage to building materials general wear and tear renovations extensions demolition and general maintenance activities due to the suspected presence of Asbestos.
