Building and Timber Pest Inspection Report

Inspection Date: Fri, 6 Mar 2026

Property Address: 306 Sutherland St, Lavington NSW 2641,
Australia

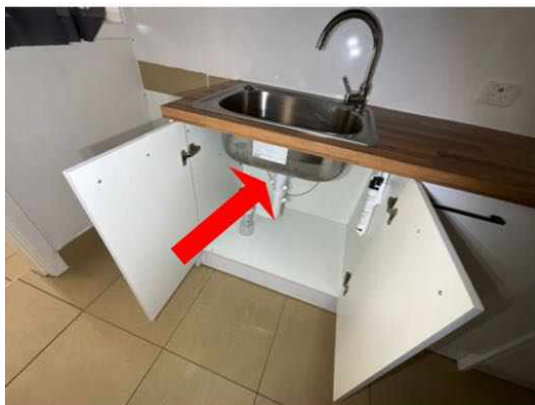
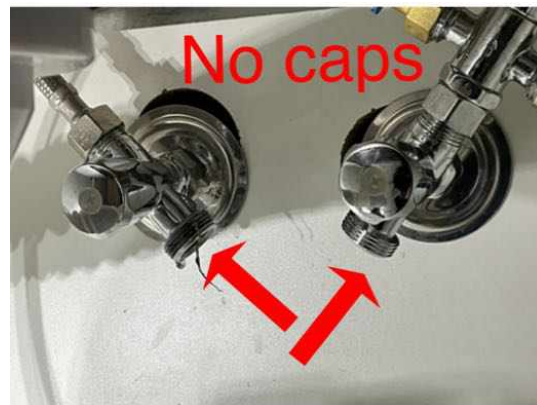
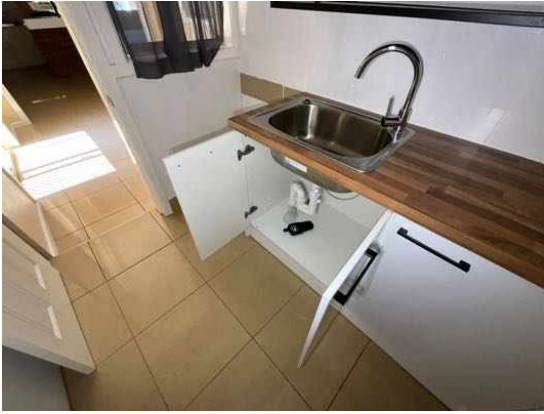
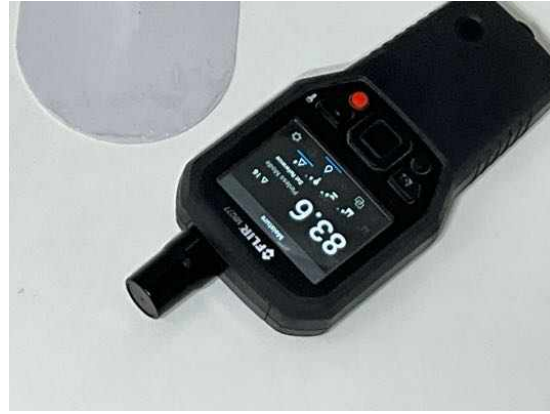
Building: Building 1
Location: Laundry
Finding: Water leak - Active
Information: Generally, water leaks occur when a particular area of the property is not weather or water tight. As the surrounding area was found to be damp at the time of inspection, the leak is considered ongoing and hence requires urgent action.

Regardless of the location, even minor leaks that are left unmanaged can lead to serious damage of associated building elements and result in the need for replacement of building materials. Mould and other hazards such as electrical hazards may also arise if the leak is left to develop.

It is highly advised that the cause of the leak be identified and resolved immediately by a licensed plumber to prevent any further damage. Depending on the extent of the damage previously sustained, repair and/or replacement of any affected building materials may be required.

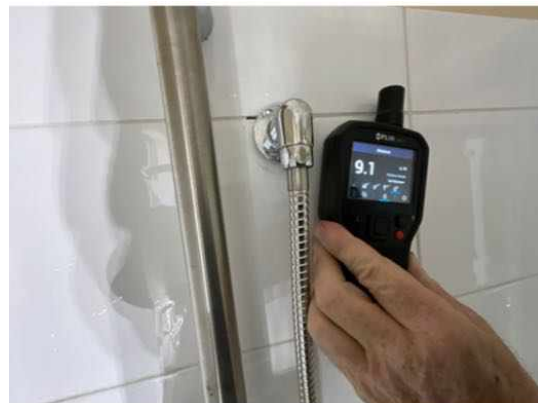
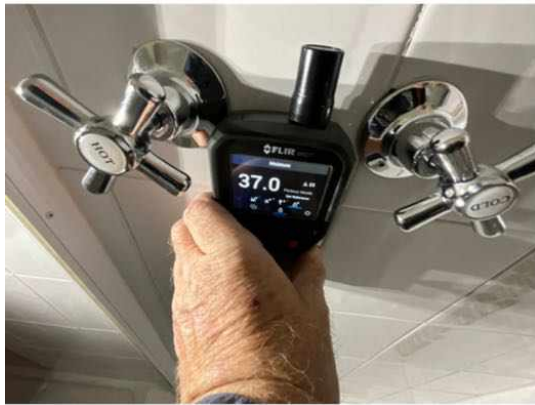
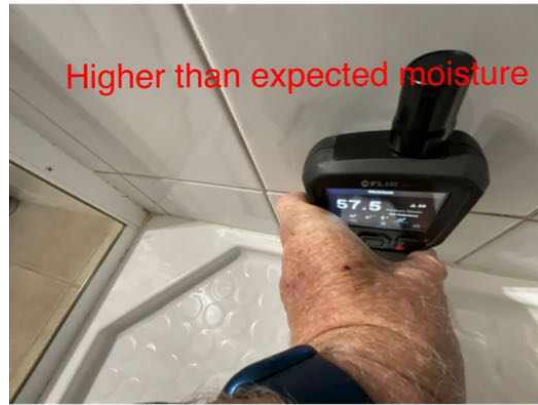
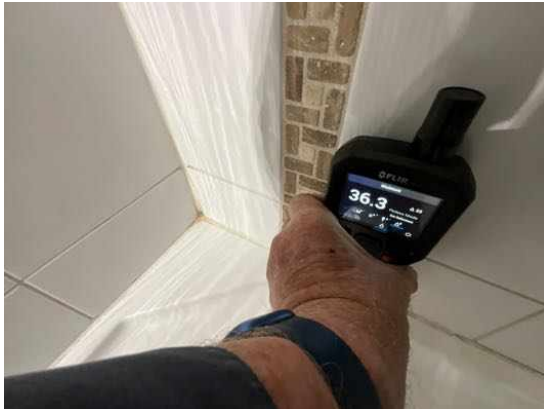
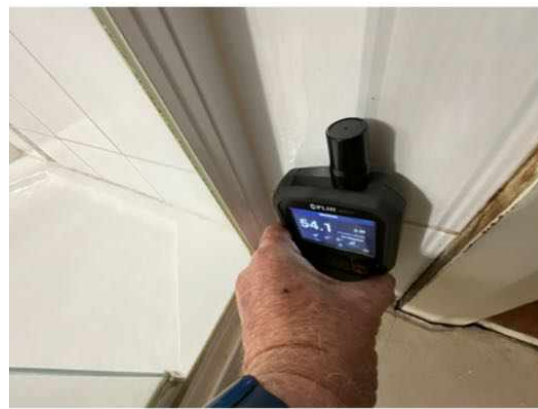
Finding 2.02

Building:	Building 1
Location:	Bathroom 2
Finding:	Shower Damp- Major
Information:	Damp is evident to the lower 300mm of wall to the Shower Alcove. This is suspected to have been caused by moisture permeating through the grouting in this area, which shows evidence of deterioration.

High levels of moisture were observed on the outside of the shower walls in the opposite wall.

Damp (or structural damp) refers to the presence of unwanted moisture in the structure of the building, either as a result of intrusion from outside, or condensation from within the structure. In the Shower area, internal water leaks or other sources of excessive moisture are generally the cause of damp.

Consultation with a qualified Plumber or Bathroom Specialist is advised immediately to identify the cause of damp and to perform remedial works as required.

Always ensure that sealant and grout is in good condition to prevent any moisture issues occurring in the future.

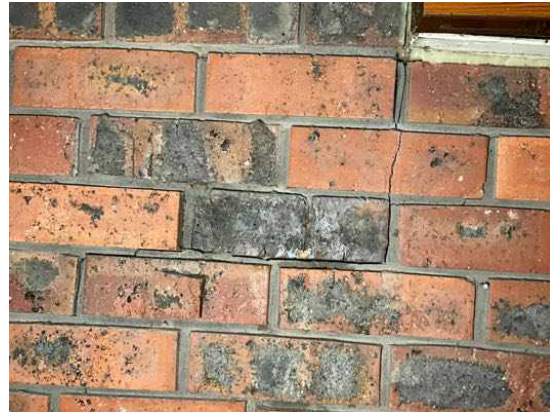
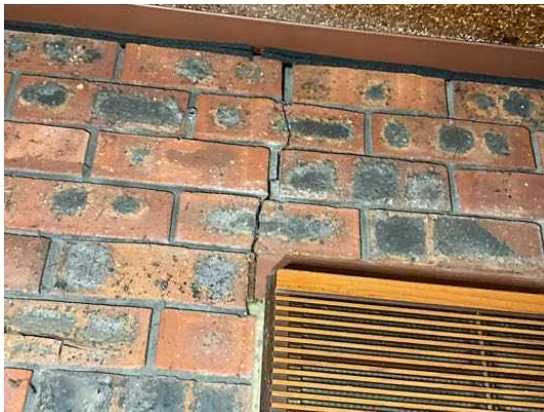
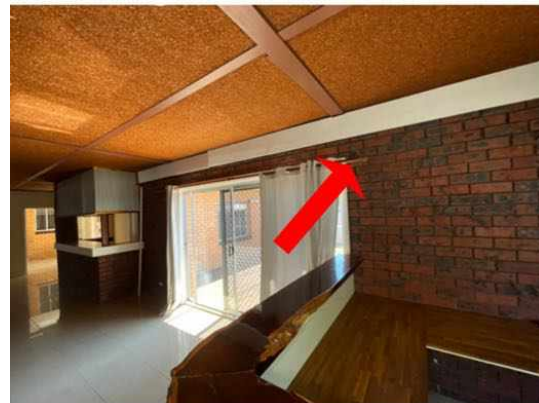
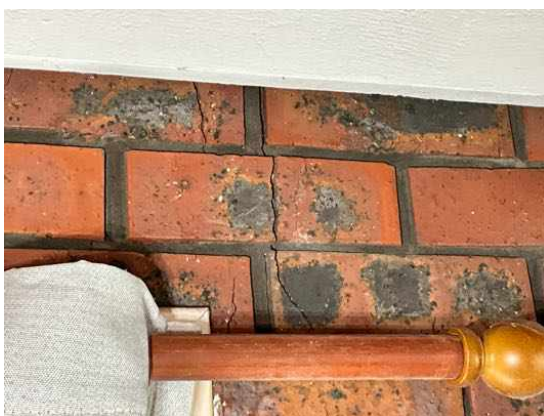
Finding 3.01

Building: Building 1
Location: Family Room
Finding: Brickwork - Cracking noticeable
Information: There were several cracks and or crack repairs evident to external brickwork.

Noticeable cracks are a common occurrence in external brickwork and are a likely result of age expected building movement, general expansion, and/or contraction of

building materials in different weather conditions. Noticeable cracks in brickwork may develop if left unattended, with potential for necessitating major remedial works or replacement of the brickwork.

It is highly advised that a qualified bricklayer be appointed to provide necessary works to cracked brickwork to prevent any further damage. Such works should be conducted as soon as possible.

Always monitor these cracks and contact a building inspector should cracks widen, lengthen, or become more numerous.

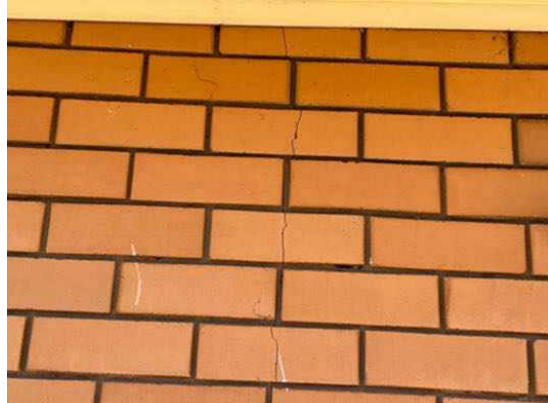
Building:	Building 1
Location:	Yard - Side
Finding:	Brickwork - Cracking [Fine]
Information:	Although fine cracks are quite noticeable, they are often only considered to be an appearance defect and usually do not indicate any structural damage. Generally, the cause of a fine crack is indicative of a separation between brickwork and mortar throughout the structure, but single bricks may also show cracks of this nature.

Cracking of this nature can generally be repaired with minor filling and should be conducted by a qualified bricklayer.

Always contact a building inspector should cracks widen lengthen or become more numerous.

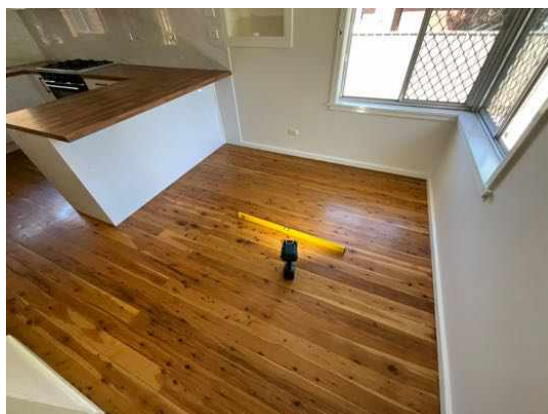
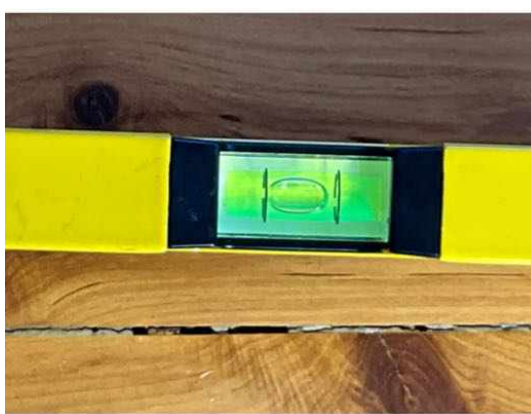
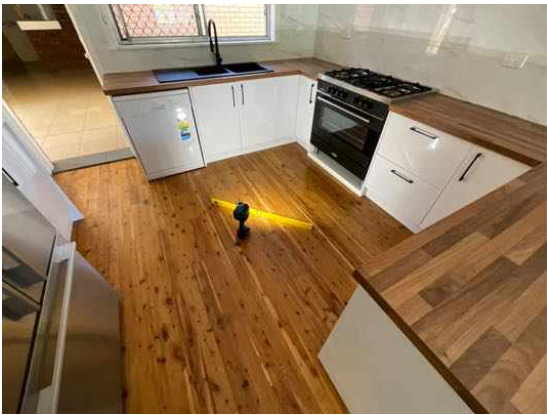
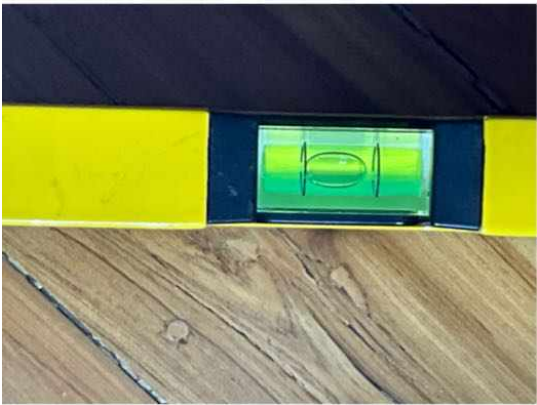
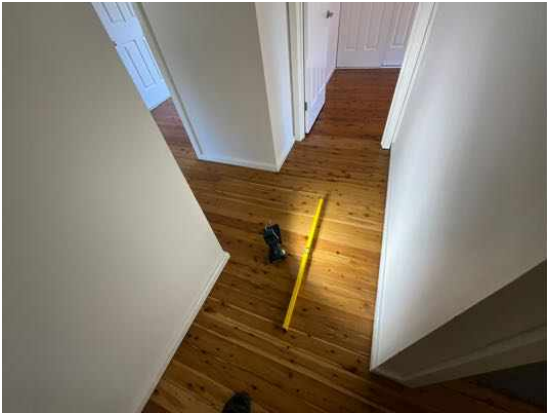
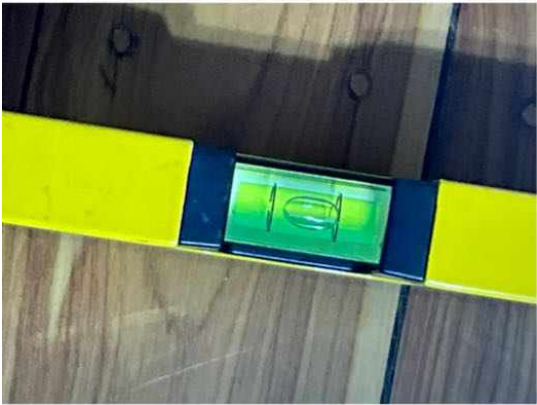
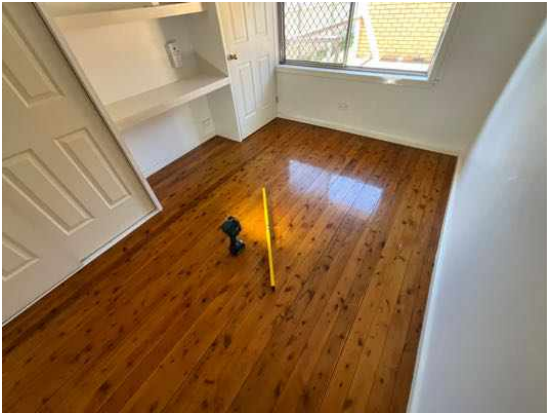
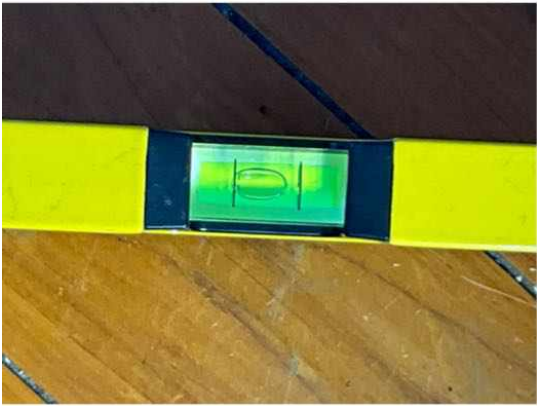
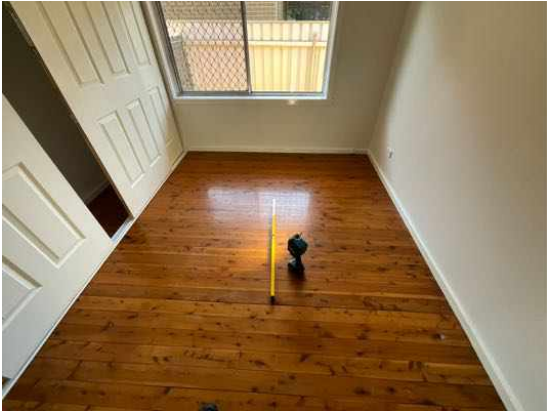
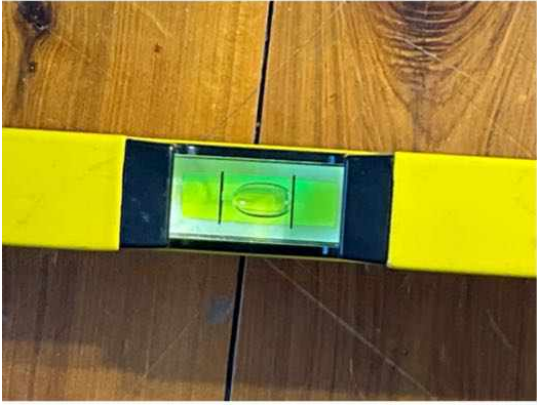
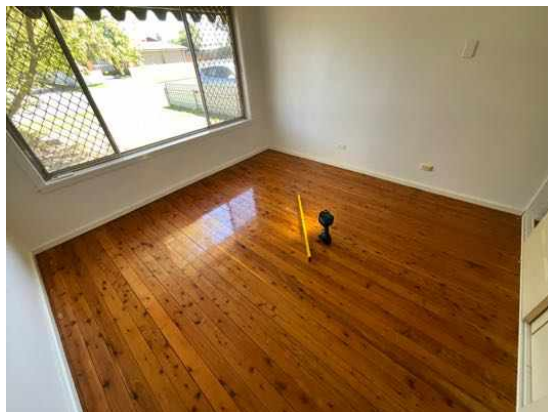
Finding 3.04

Building: Building 1
Location: All Internal Areas
Finding: Flooring - Uneven
Information: The internal flooring in this area is out of level and uneven. Uneven flooring is likely to indicate minor defects such as expected movement of the foundations of the property, but may also indicate subsidence of the associated subfloor stumps.

It is advised that the flooring be closely monitored to identify any further movement. Where flooring remains relatively unchanged for an extended period of time (i.e. several months), it is likely that this defect has been caused by expected movement of the foundations of the property.

However, where flooring is uneven further, potentially invasive inspection of the subfloor structures and stumps in this area is required. In this case, works to repair are likely to be required, and would be carried out by a registered builder specialising in re-stumping.

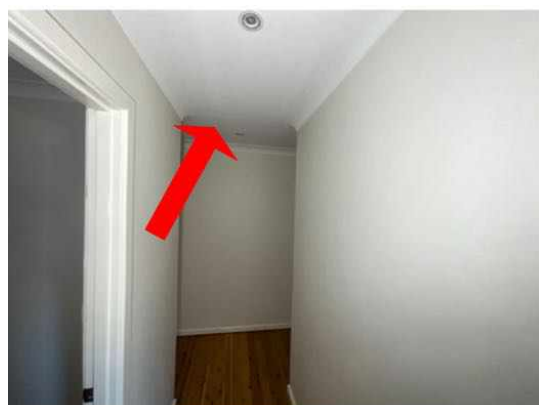
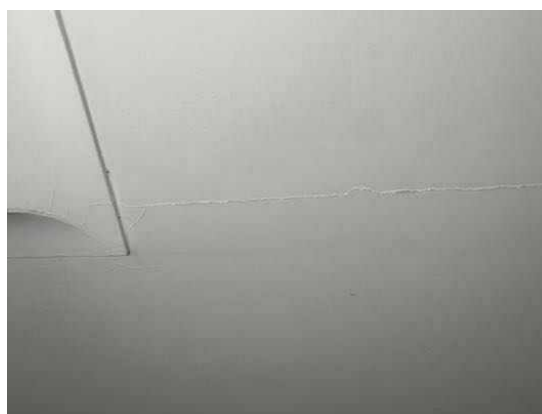
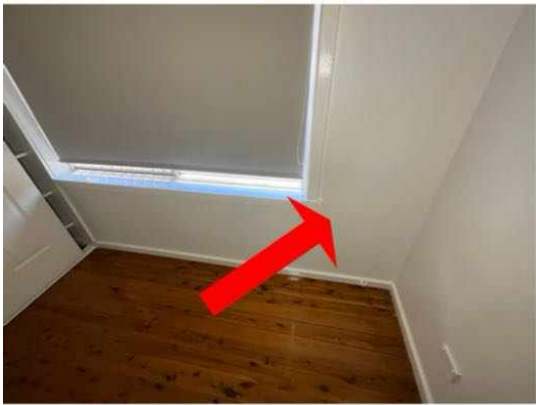
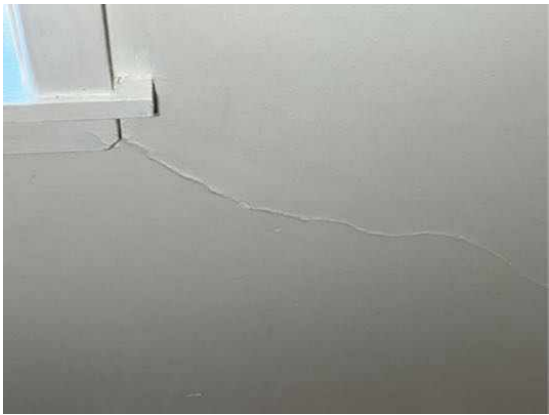
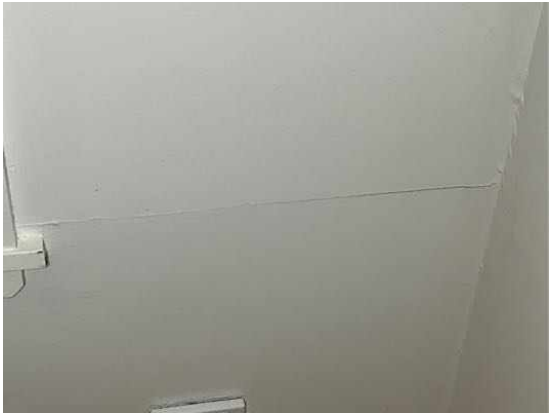
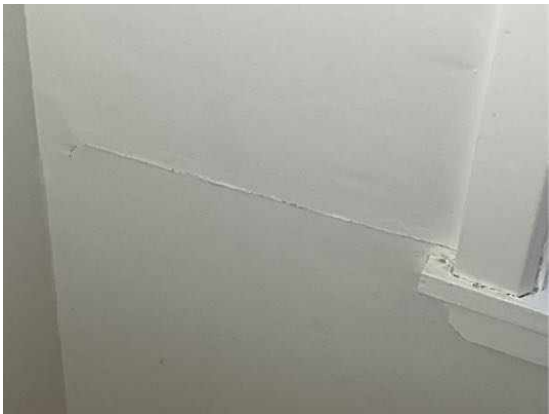
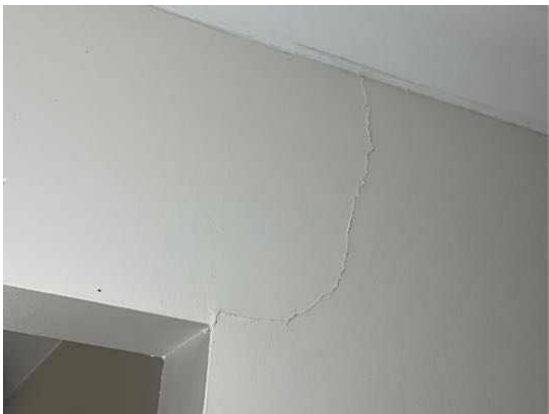
Finding 3.05

Building:	Building 1
Location:	Hall, bed 2, living
Finding:	Cracking - Damage Category 1 - Fine (up to 1mm)
Information:	Although fine cracks are quite noticeable, they are often only considered to be an appearance defect, and usually do not indicate any structural damage. Generally, the cause of a fine crack is indicative of a separation between building materials and finishes (e.g. paint, plaster, etc.) along joints.

Cracking of this nature can generally be repaired with minor sanding, filling and/or repainting. Such works should be performed by a qualified painter or a general handyman.

Monitoring of all cracking should be conducted frequently. Always contact a building inspector should cracks widen, lengthen, or become more numerous.

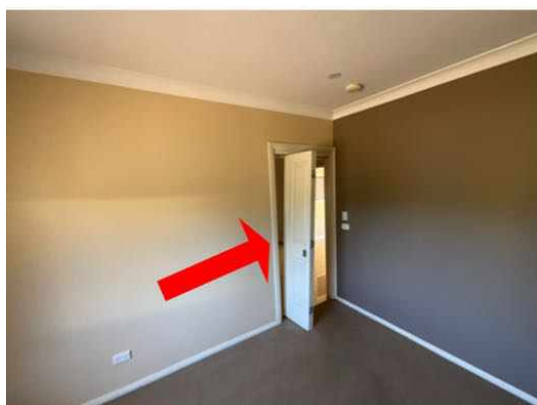
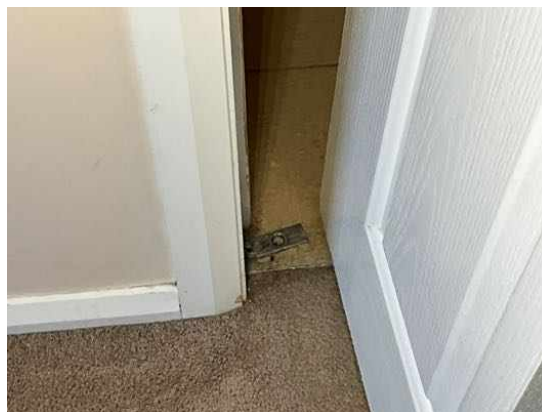
Finding 3.06

Building: Building 1
 Location: Bedroom 4
 Finding: Door- Poor condition
 Information: The door in this area was found to be in poor condition at the time of inspection. Breakage occurs generally when the building materials have aged and decayed, but may be indicative of impact damage (accidental or deliberate).

Repair and/or replacement of the broken door is advised to improve the operational state of the associated door.

A general handyman should be appointed to repair/replace the door at the client's discretion.

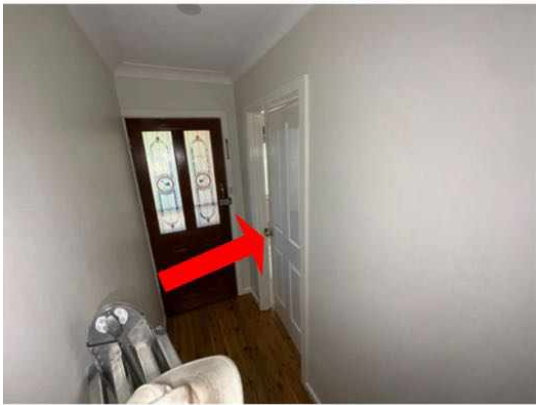
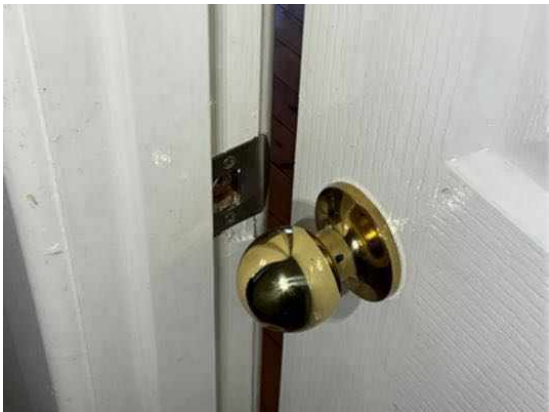
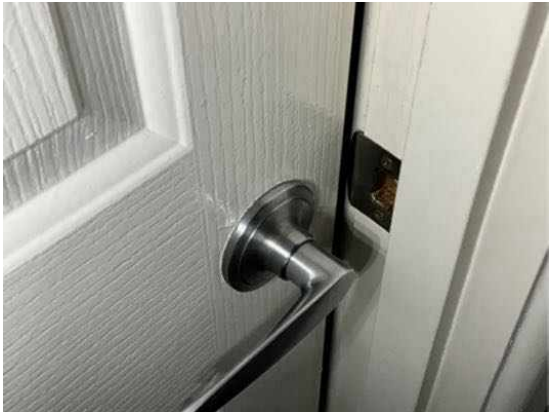
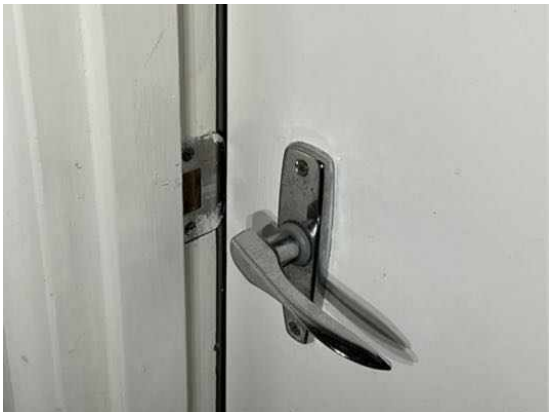
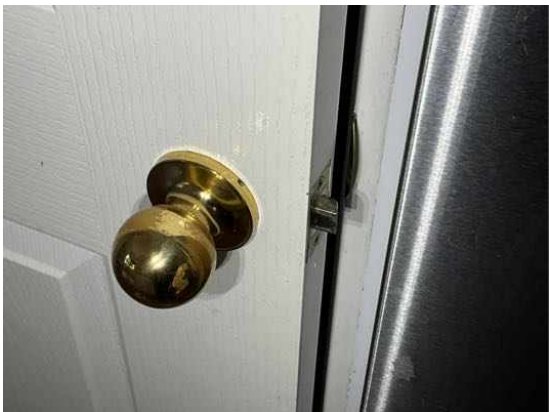
Finding 3.07

Building: Building 1
 Location: Bedroom 1, 3, laundry, pantry
 Finding: Door - Striker plate misaligned
 Information: The striker plate to this door appears to have become misaligned and has consequently resulted in the door's operation being compromised.

This is a common defect and is expected in a property of this age, whether being due to substandard installation or general deterioration of the door hardware.

Readjustment of the striker plate is recommended at client discretion. Works such as these can be completed by a general handyman or qualified carpenter.

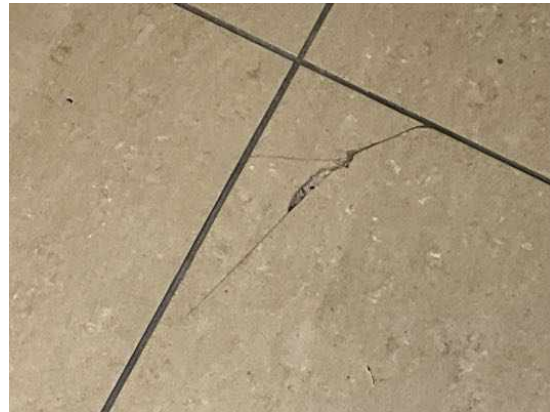
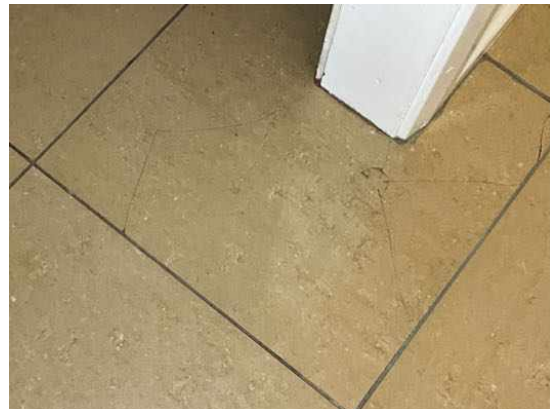
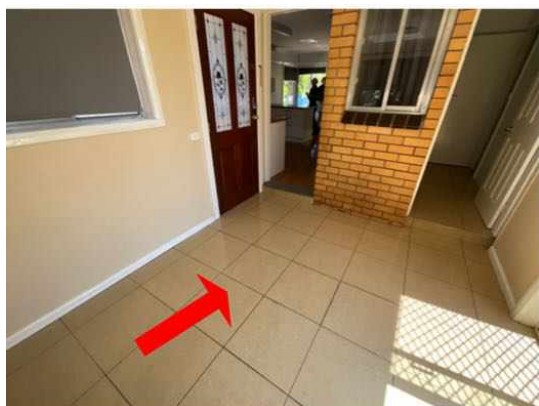
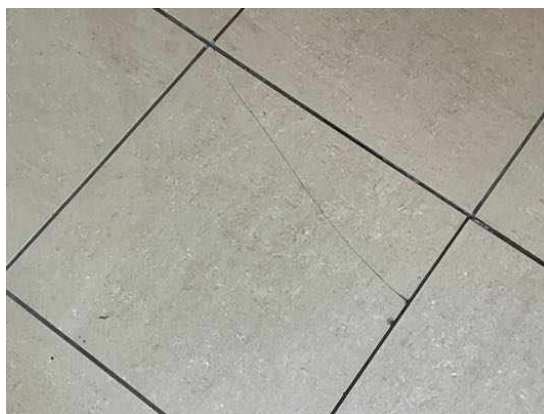
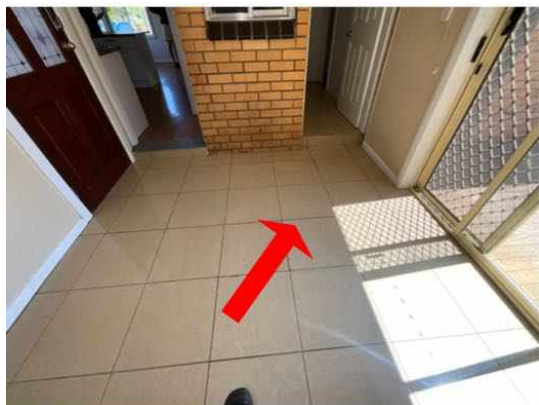
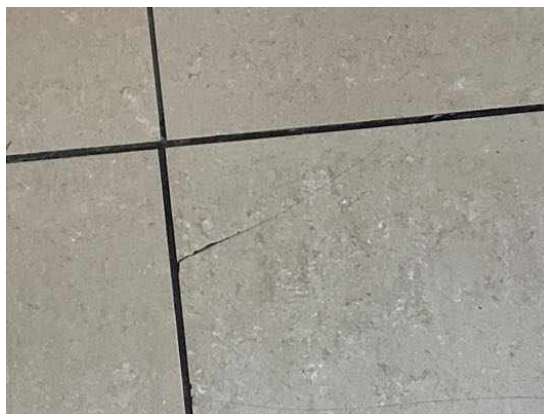
Finding 3.08

Building: Building 1
Location: Transition
Finding: Cracked floor tiles
Information: Cracking in the floor tiles was evident in this area at the time of inspection. It is suspected that this cracking has occurred as a result of minor settlement or impact damage.

Cracked tiles throughout the household detract from the overall appearance of the affected areas however it is unlikely to create or lead to any secondary defects.

While not considered a matter of urgency, replacement of cracked floor tiles is recommended at the clients discretion. A tiling contractor may be appointed to perform these works. Where cracks become more numerous, contact a licensed building inspector for further investigation.

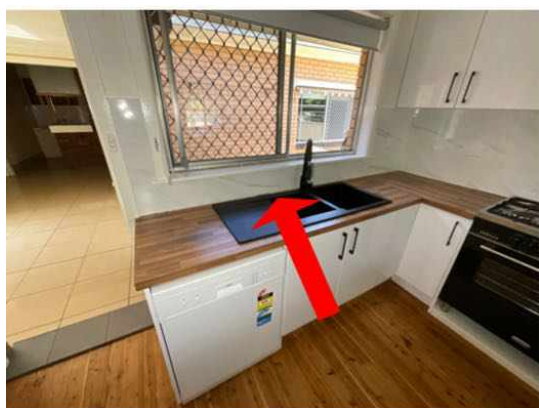
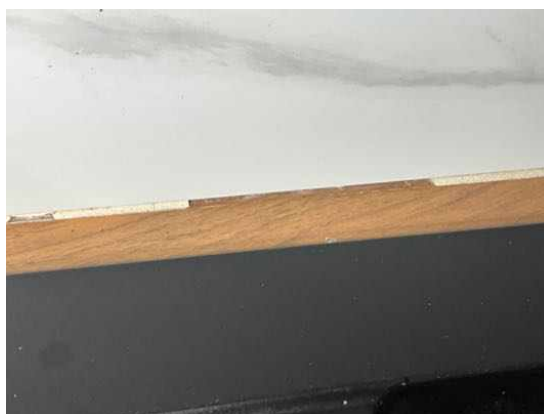
Finding 3.09

Building: Building 1
Location: Kitchen
Finding: Inadequate sealant or Grout
Information: This area has a lack of effective Sealant or Grout. This is allowing the ingress of water to the structure inside the wall.

The presence of water encourages Termite attack, Mould and Fungal Decay.

A Tiler or General Handy person must be contacted as soon as possible to effect repairs and prevent further deterioration.

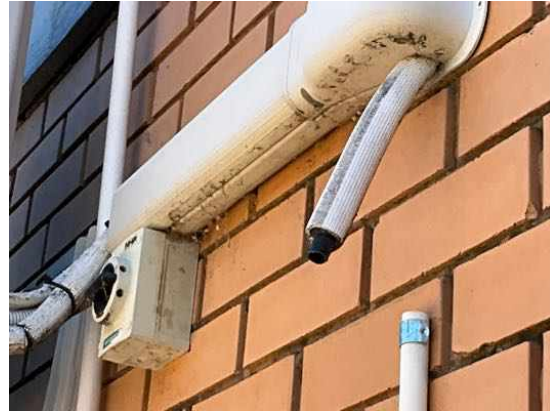
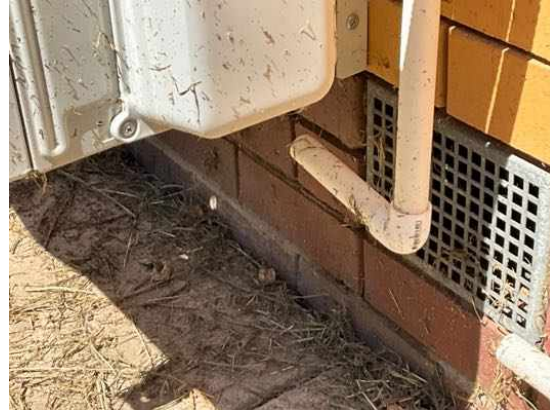
Building:	Building 1
Location:	Yard - Back,side
Finding:	Air conditioner - Disconnected overflow
Information:	The Air Conditioner (A/C) overflow was found to be disconnected from storm water drainage and is creating excessive moisture in the surrounding area.

Such leaking creates an environment which is conducive to an array of defects, including water damage to associated building elements and the attraction of termite or timber pest infestation.

It is highly recommended that a licensed plumber be appointed to connect the A/C overflow in order to prevent such an environment from being created. These minor works should be carried out as soon as possible.

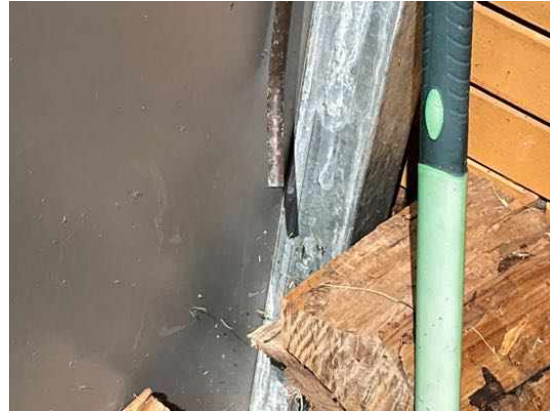
Finding 6.02

Building:	Building 1
Location:	Yard - Side
Finding:	HWS Overflow - Not Connected
Information:	The Hot Water System (HWS) overflow was found to be disconnected from storm water drainage and is creating excessive moisture in the surrounding area.

These damp conditions can lead to secondary defects such as rot, rust or corrosion of associated building elements, the formation of fungal decay, or even the creation of potential slip hazards. When coupled with poor site drainage, pooling of water may also attract termite activity to this area.

It is highly recommended that a licensed plumber be appointed to connect the HWS overflow in order to prevent such an environment from being created. These minor works should be carried out as soon as possible.

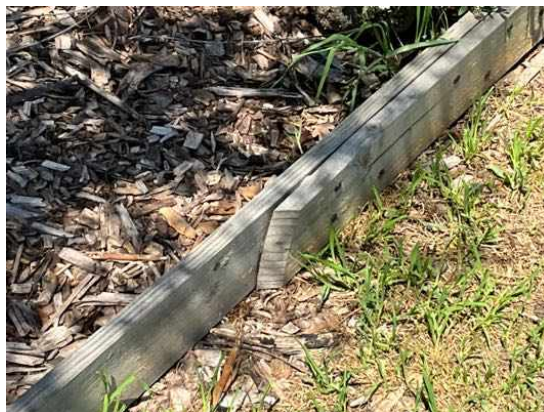
Finding 6.03

Building:	Building 1
Location:	Yard - front, back
Finding:	Untreated or non-durable timbers in a hazardous environment
Information:	To reduce the risk of timber pest attack it is essential that timber used in a hazardous environment (e.g. in direct contact with the ground or frequently exposed to damp conditions) is of sufficient durability and/or is adequately preservative treated.

Untreated timbers in direct contact with the ground are likely to develop severe wood rot and/or fungal decay if left unattended creating attraction for subterranean termites to infest the timbers from surrounding areas.

If untreated or non-durable timbers are found to be in a hazardous environment it is highly advised that replacement of these building elements be performed as soon as possible to aid the protection of the property against termite / timber pest attack.

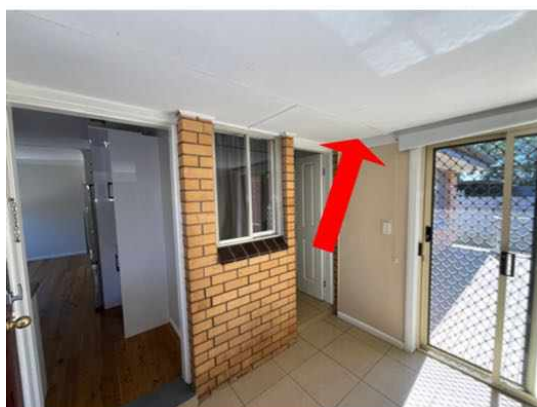
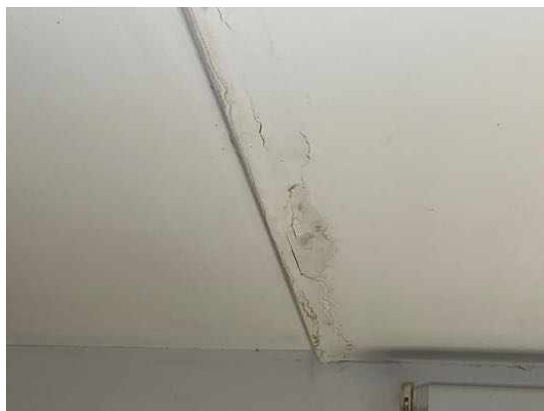
Finding 6.04

Building: Building 1
 Location: Transition
 Finding: Ceiling - Water stained
 Information: Water staining to ceiling linings in this area was evident at the time of inspection. Water staining indicates that surfaces have been exposed to excessive moisture over time. The minerals and other elements in the water lead to staining, which may graduate to corrosion and deterioration if left unmanaged.

While mostly an appearance defect, water staining can be indicative of more serious defects, which may be currently concealed by interior ceilings.

Where water staining is active, a licensed plumber must be consulted to identify the cause of the staining and to provide advice on any reparation works that may be required. Replacement of any damaged structures is advised.

Conversely, where water staining is old and inactive, affected building materials may be repaired or replaced at client discretion.

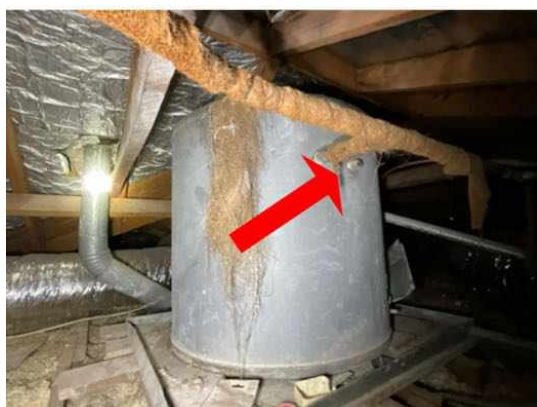
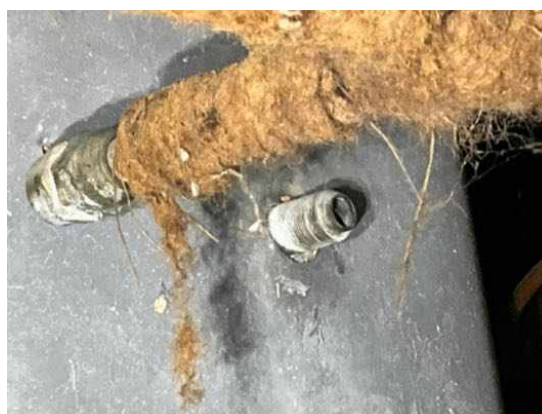
Finding 6.05

Building: Building 1
 Location: Roof Void

Finding: Gravity-Fed HWS - Disconnected
 Information: It was noted at the time of inspection that a disconnected gravity-fed hot water system (HWS) remains in this area.

Despite this plumbing structure being unused, it is likely to be storing residual water, and is therefore susceptible to rust and corrosion. If allowed to continue, rust and corrosion is likely to lead to damage to adjoining building elements, and may also make the area susceptible to termite or timber pest activity.

While it is a costly exercise to remove the disused gravity-fed HWS, it is advisable in the short-term future to prevent any further damage to the area. Further consultation with a licensed plumber is required to gain further advice on removal of the structure.

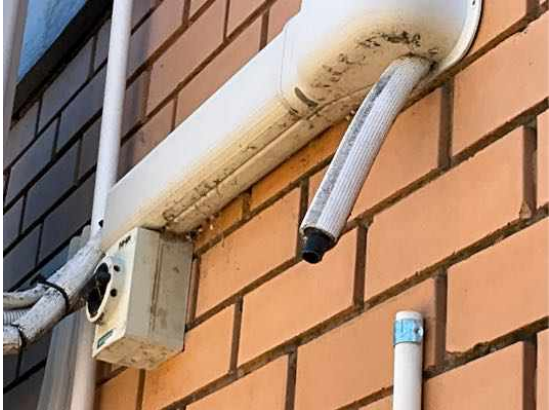
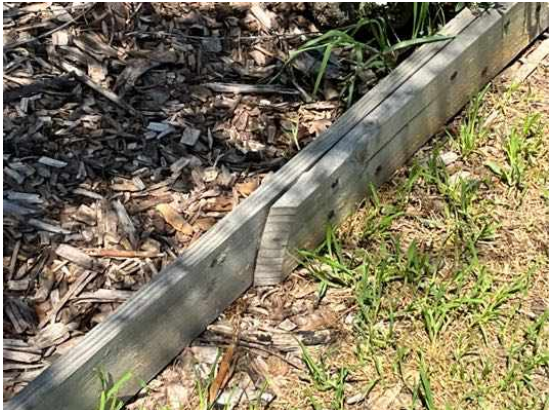
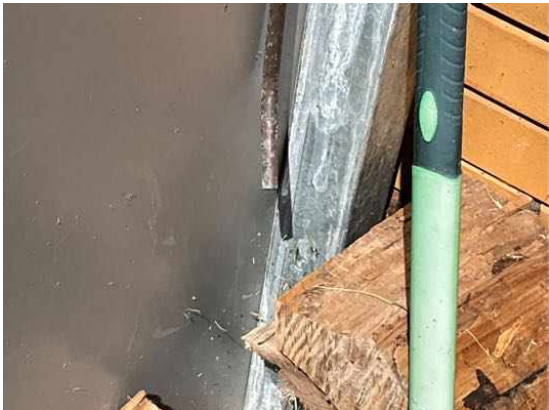
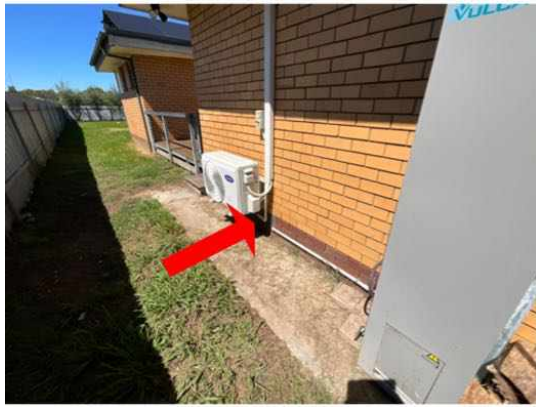
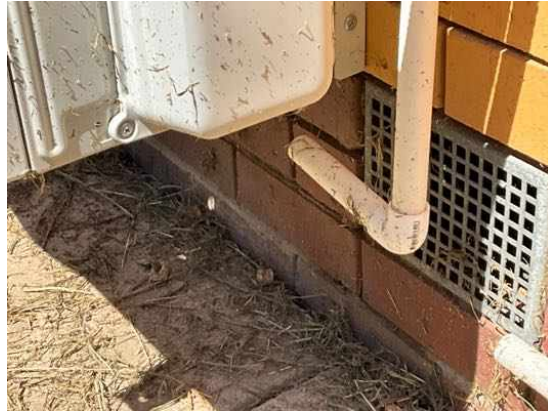
Finding 6.06

Building: Building 1
 Location: All External Areas
 Finding: Termite Management System - no evidence of a chemical installation
 Information: The application of a post-construction chemical termite barrier is highly recommended for all properties, particularly if live termite activity has been found on the site previously. Such barriers are highly effective in preventing termite attack on any timber building elements throughout the property.

A durable notice should be placed in the switchboard unit to indicate current termite barriers. At the time of inspection, it appeared as though no termite management system has been installed, with no evidence to suggest preventative works taking place.

The client may consider gaining further advice from a pest controller as to the costs and procedures involved with this application. It is recommended that obtaining such advice be a short-term priority.

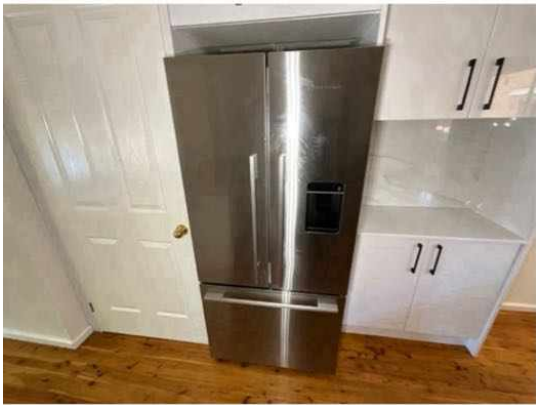
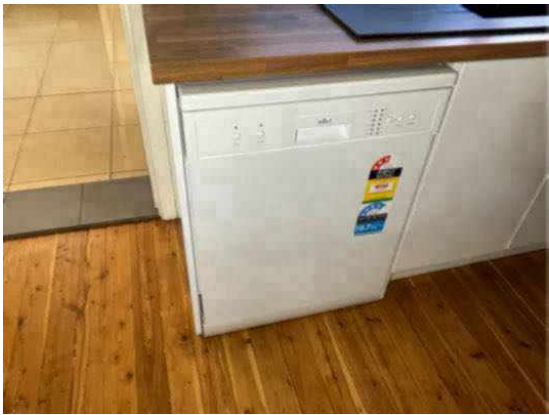
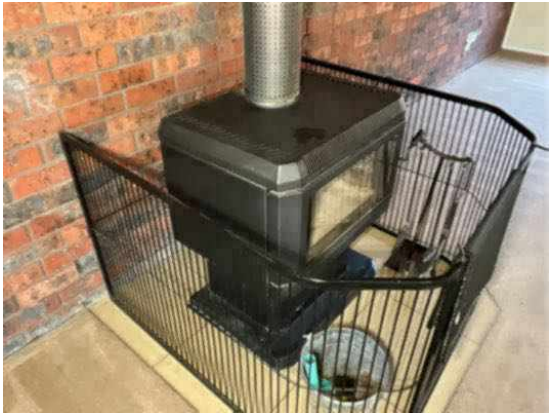
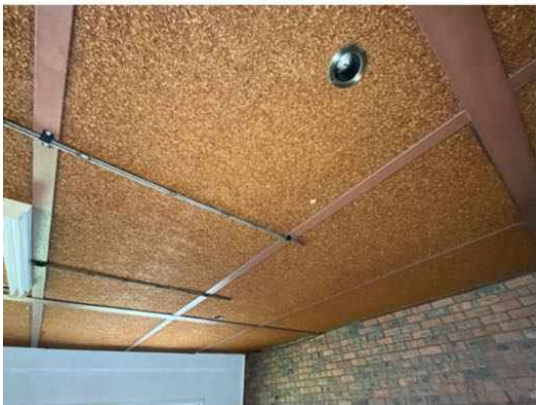
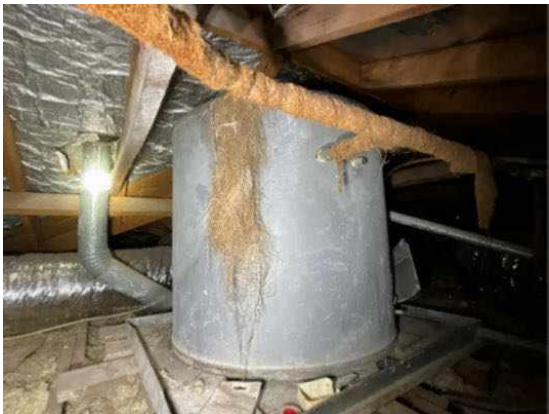
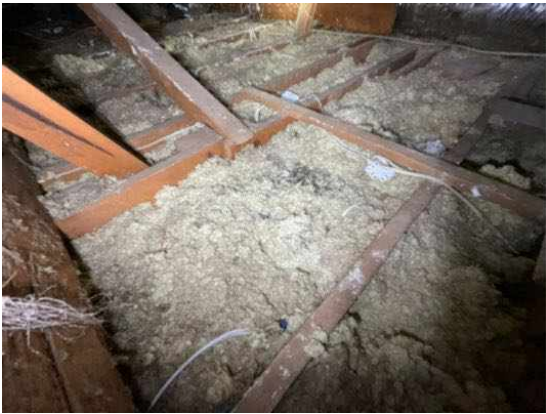
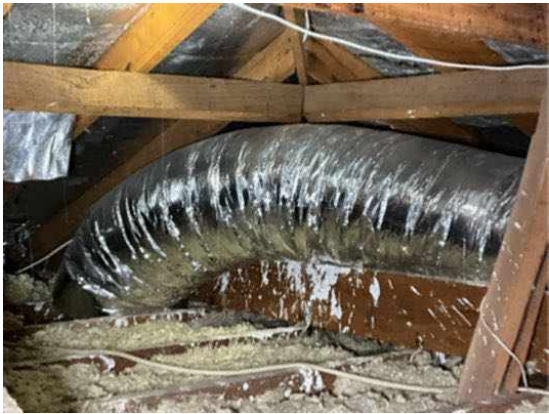
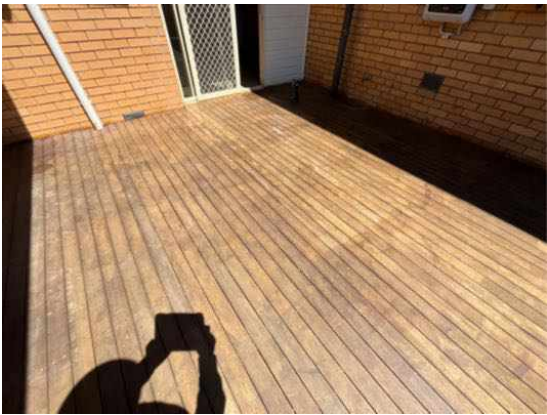
Building: Building 1
 Location: All Areas
 Finding: Additional Photos - Obstructions and Limitations
 Information: These photographs are an indication of the obstructions and limitations which impeded full inspection of the property at the time of inspection. These obstructions can hide an array of defects and should be removed to allow full inspection to be carried out. A re-inspection is recommended once the areas are made accessible.
