Building Inspection Report

Inspection Date: Tue, 7 Apr 2026

Property Address: 4/51 Spring St, Thomastown VIC 3074,
Australia

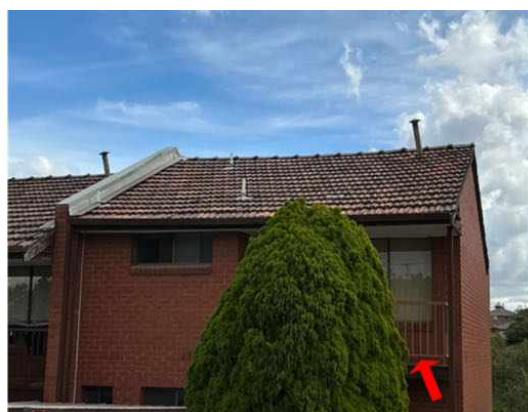
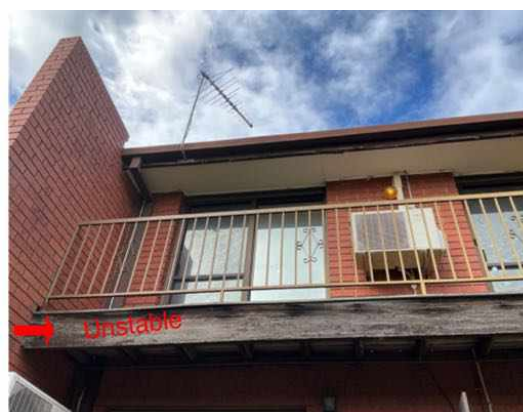
Defects 1.01

External timber structures are also constantly exposed to weather elements and can deteriorate in an accelerated manner, ongoing assessments are required.

It is highly recommended that a Structural Engineer further assess the external timber balcony or deck to inform the client of its load capacity. Regular maintenance inspections by competent practitioners is needed.

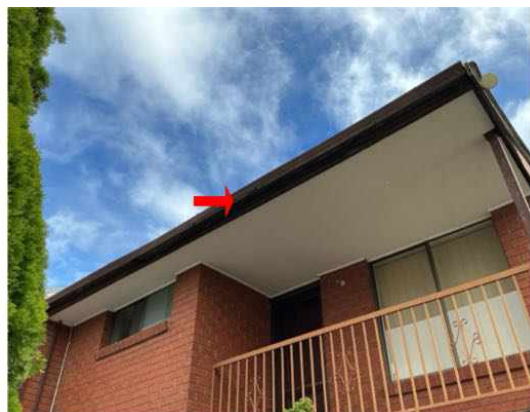
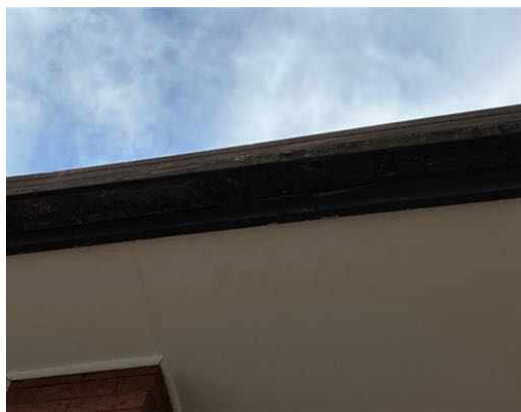
Defects 2.01

Building:	Main Building
Location:	All Areas
Finding:	Roof plumbing - Rusted or corroded
Information:	The roof plumbing has areas of rust and corrosion. It is suspected that this has been caused by blockages, resulting in pooling or standing water, that have prematurely rusted elements of the roof plumbing.

Rusted roof plumbing will generally develop holes and leaks that can affect other building elements with poor drainage of storm water. Poorly drained roof areas will also lead to damp conditions surrounding the base perimeter of the building which, if

left unmanaged, can lead to a range of secondary building defects.

Repair and/or replacement of rusted roof plumbing is highly required in order to reinstate the roof drainage system to a fully operational level. To further maintain these areas, gutters should be cleaned frequently, allowing the avoidance of any partial blockages.

A licensed plumber or specialist roof restoration company should be appointed to undertake these works. It is advised that such works be completed as soon as possible to prevent any further damage and deterioration.

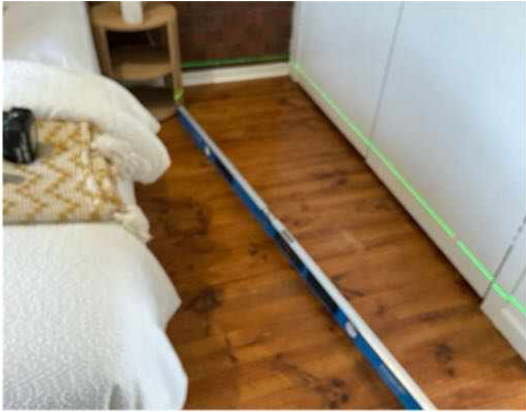
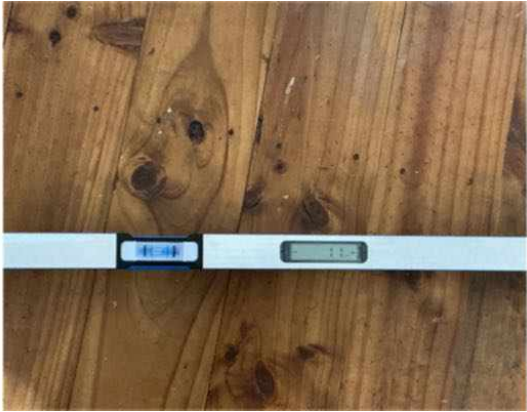
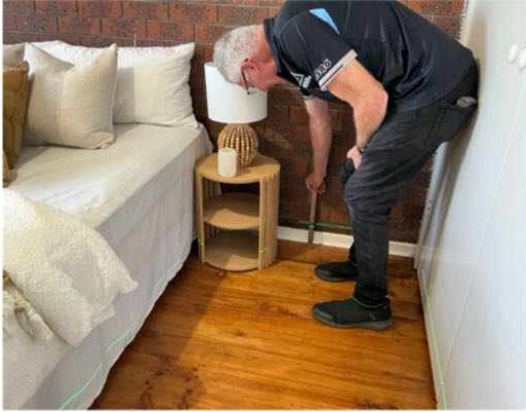
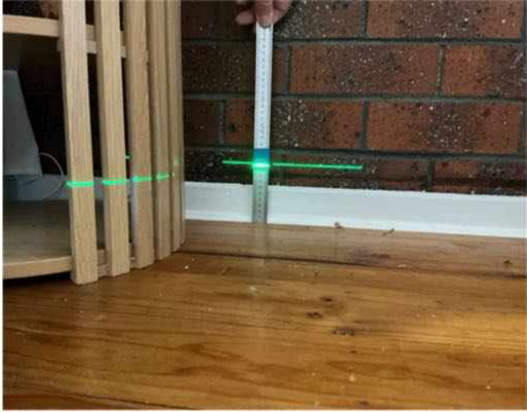
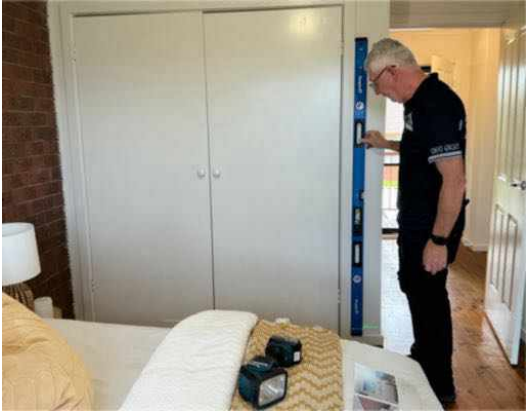
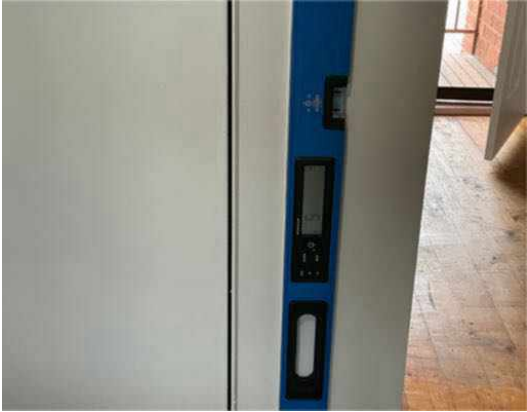
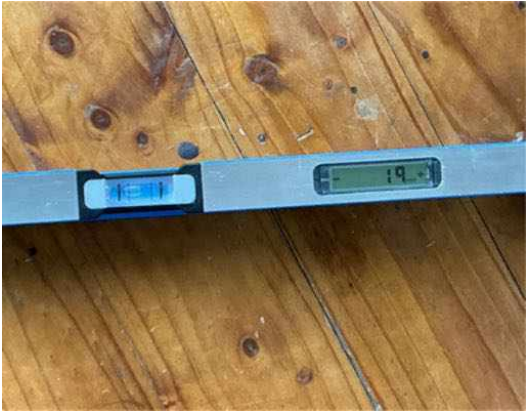
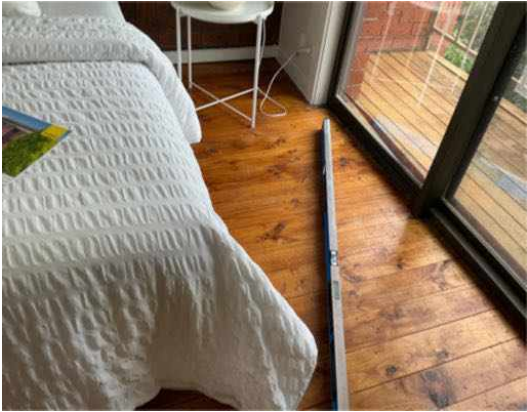
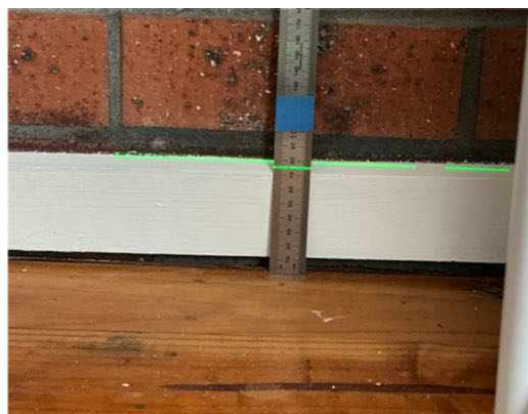
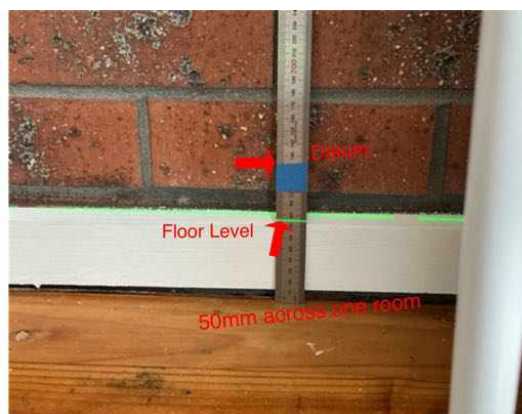
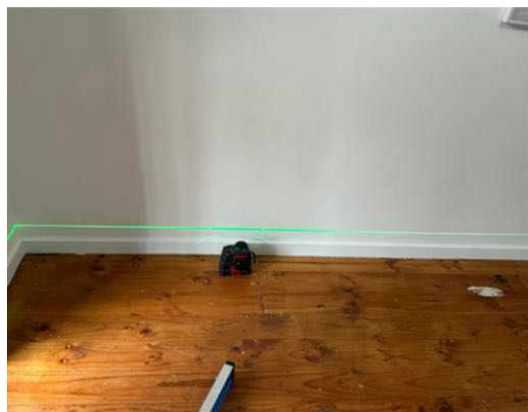
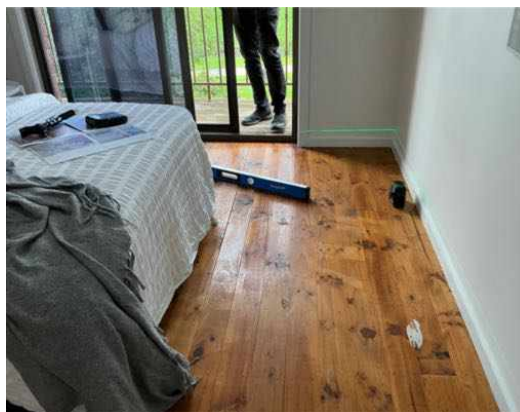
Defects 2.02

Building:	Main Building
Location:	All Areas upstairs
Finding:	Flooring - Uneven
Information:	The internal flooring in this area is out of level and uneven. Uneven flooring is likely to indicate minor defects such as expected movement of the foundations of the property, but may also indicate subsidence of the associated subfloor stumps.

A major defect was found in the form of uneven flooring with a difference of up to 50 mm in one room alone, this is well beyond acceptable tolerance. It is suspected that some subsidence is occurring. Together with brickwork cracking, cracked floor tiles and uneven door gaps. This signifies significant movement which will require stabilisation in the short term.. a specialist restumper and geotechnical engineer should be contacted in order to conduct a more invasive inspection of the subfloor structures and soil and suggest rectifications in order to stabilise this property. There was no subfloor access available at the time of inspection.

It is advised that the flooring be closely monitored to identify any further movement. Where flooring remains relatively unchanged for an extended period of time (i.e. several months), it is likely that this defect has been caused by expected movement of the foundations of the property.

However, where flooring is uneven further, potentially invasive inspection of the subfloor structures and stumps in this area is required. In this case, works to repair are likely to be required, and would be carried out by a registered builder specialising in re-stumping.

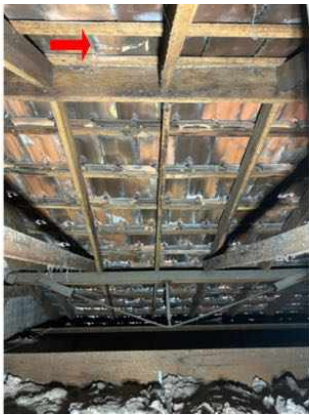
Defects 2.03

Building:	Main Building
Location:	Roof Void
Finding:	Roof tiles - Broken
Information:	Upon inspection of the exterior roof covering, broken roofing tiles were identified. Broken and friable roof tiles are generally the result of ageing and weathering of what is essentially a porous material.

If left to further deteriorate, broken and brittle roof tiles are likely to lead to water penetration via the roof into the ceiling space, causing secondary damage to ceiling linings, insulation and roof structures. Broken roof tiles are also likely to detract from the effectiveness of the roof drainage system, creating potential for secondary damage to the exterior roof covering and roof plumbing.

Replacement of broken tiles is required and should be performed by a roofing contractor as soon as possible.

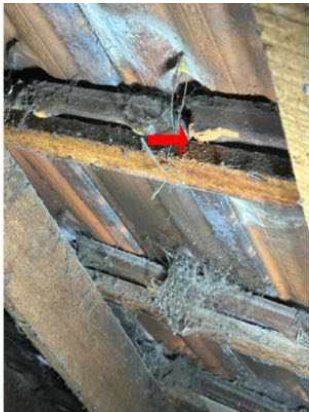
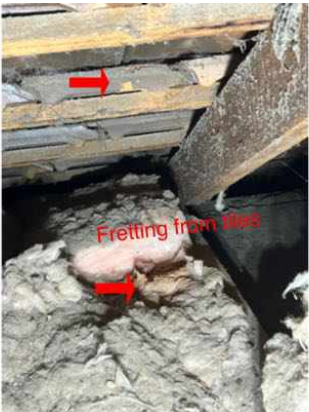
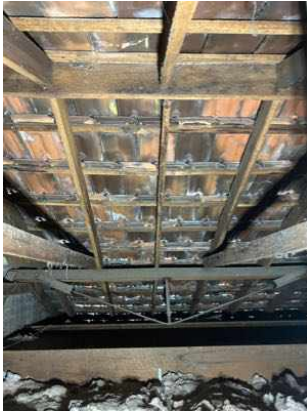
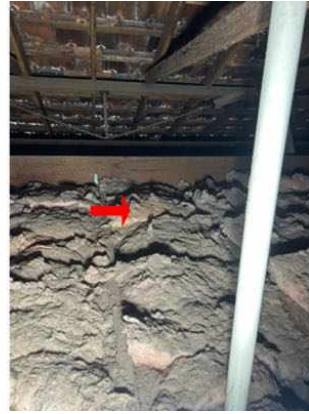
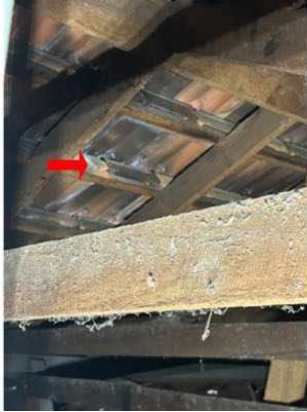
Defects 2.04

Building: Main Building
 Location: All Areas
 Finding: Terracotta Roof Tile Cancer
 Information: Upon inspection of the exterior roof covering, it was noted that numerous tiles have roof tile cancer, although not leaking at the time of inspection.

This is considered a major defect because if not rectified the affected tiles will continue to deteriorate and eventually lead to leaking.

Roof tile cancer is when the original tiles start to degrade and crumble and can slip from the battens supporting them.

Roof tiles that have moved from their original position are very likely to allow water penetration into the roof void, exposing roofing structures to excessive moisture. This creates an environment that is conducive to water damage and accelerated deterioration of all associated building elements.

Replacement of loose or crumbling roofing tiles is recommended immediately to prevent the development of any secondary defects. A roofing restoration specialist should be appointed to complete such works as necessary.

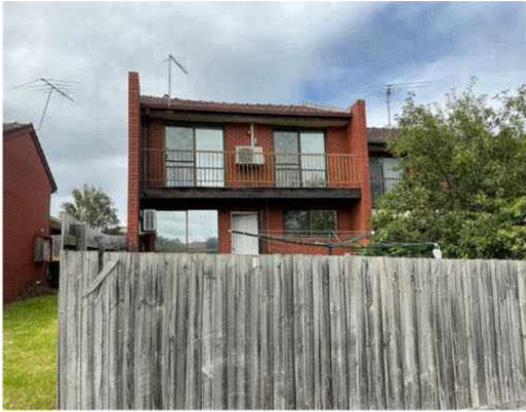
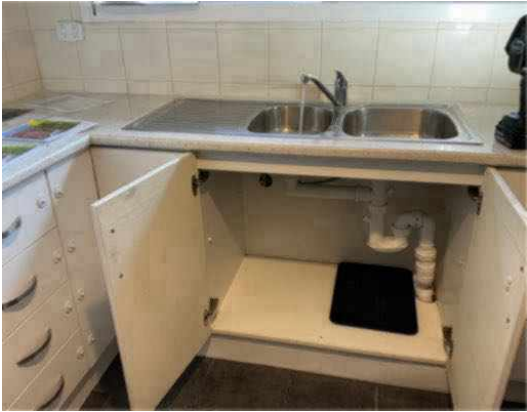
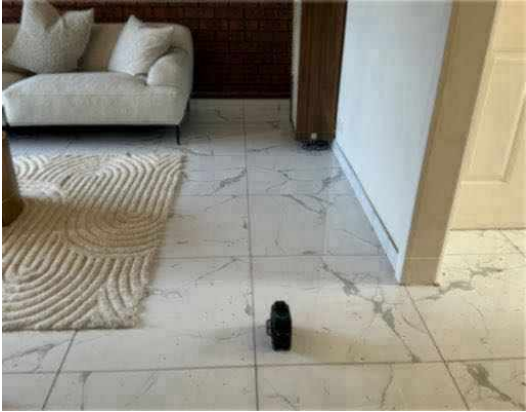
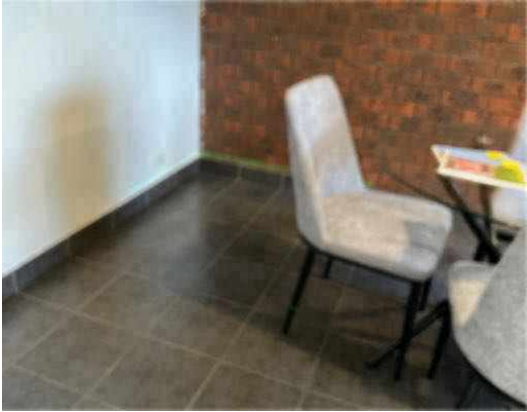
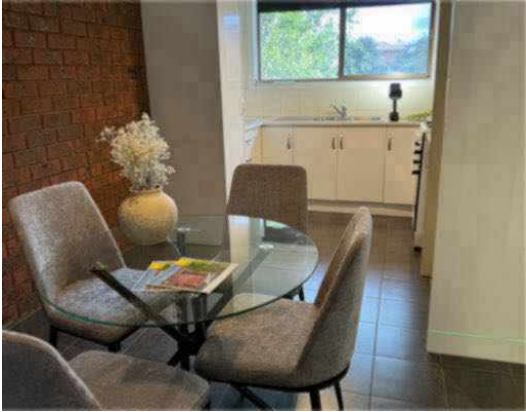
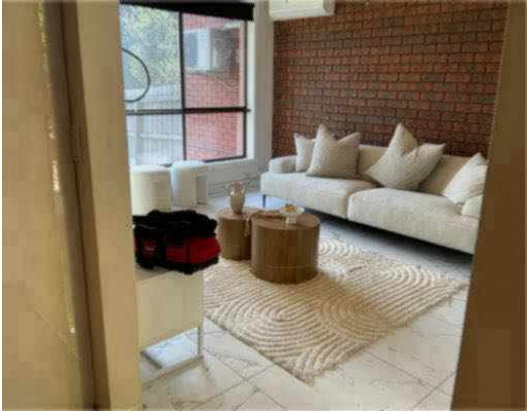
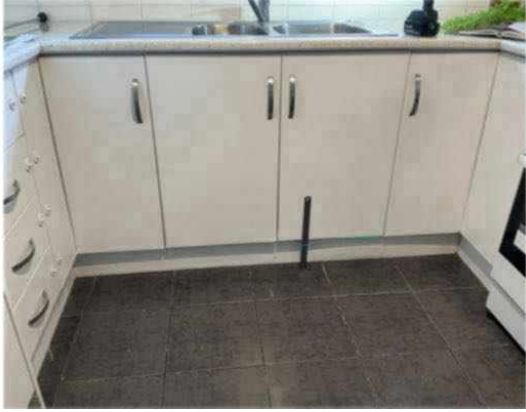
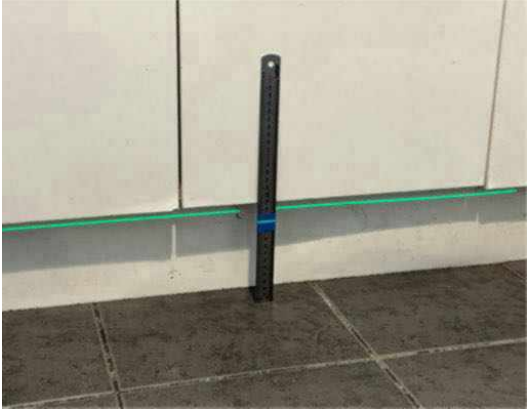
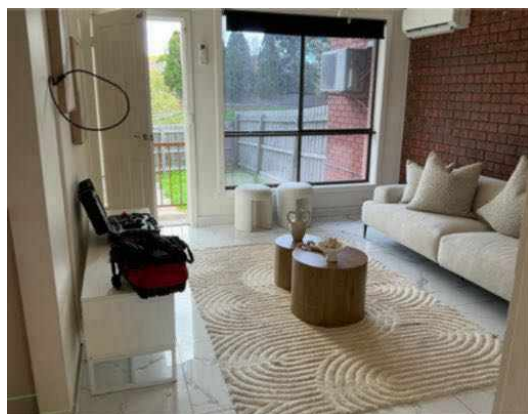
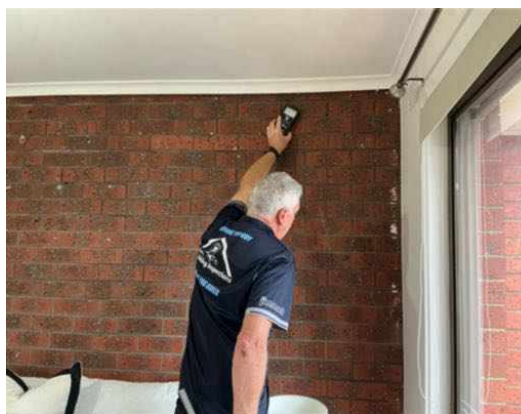
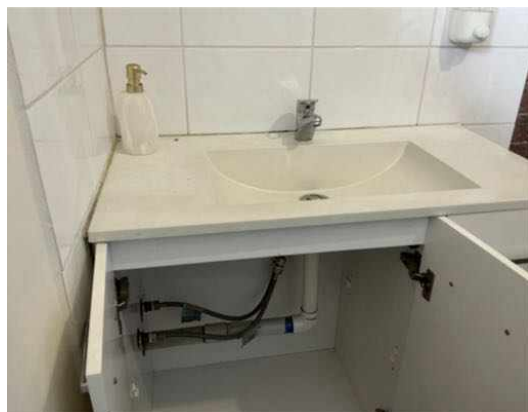
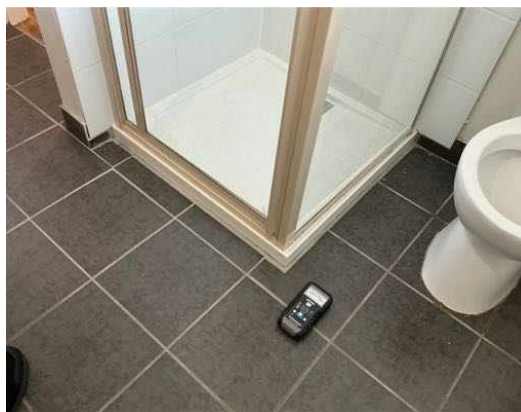
Defects 3.01

Building:	Main Building
Location:	All Areas
Finding:	Additional Photos and Obstructions and Limitations
Information:	These are additional photographs and photographs of the obstructions and limitations inside and outside (furniture, landscaping etc) which may impede full inspection of the property at the time of inspection. These obstructions can hide an array of defects and may be removed to allow full inspection to be carried out. A re-inspection may be made if clients require once the areas are made accessible.

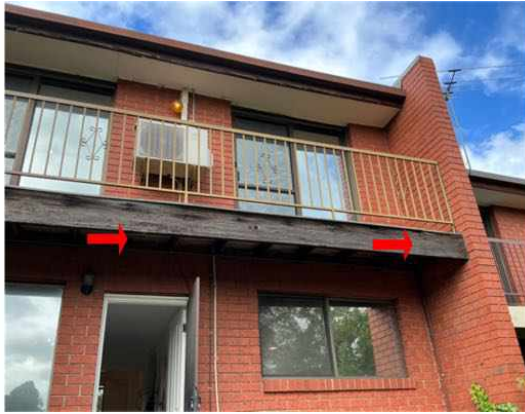
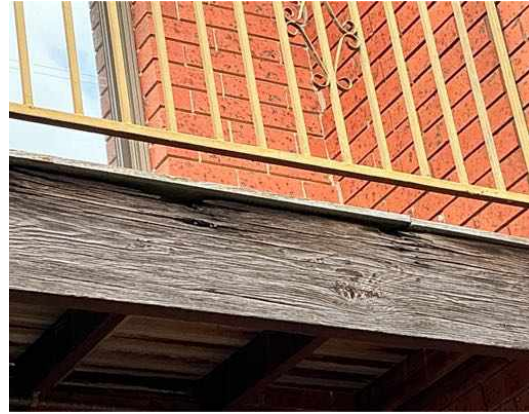
Defects 3.02

Finding: Wood rot

Information: This building element shows evidence of wood rot. Wood rot, also known as Fungal Decay, occurs when timbers and other cellulose building materials are exposed to damp conditions on an ongoing basis. This could be the result of exposure to weathering over a prolonged period of time, or the attraction of excessive moisture from other abutting building materials. Contributing factors also include poor air ventilation in the area.

Wood rot is often associated with general damp problems and is evidenced by a 'musty' smell or mould and mildew occurring on surfaces. If left unmanaged, damp conditions can lead to further health problems and the decay of timbers will continue.

Early intervention and regular maintenance, particularly of exterior timbers, will prolong the useful life of these building elements. Prior to any works being performed, the cause of the moisture that has created the visible wood rot should be identified and addressed in a suitable manner. Replacement of affected timbers may then be a necessary step in protecting surrounding building elements from such deterioration.

A qualified plumber may be appointed to assess the cause of excessive moisture and to provide advice on any remedial works as required. A qualified carpenter or

registered builder may also be required to replace affected building materials.

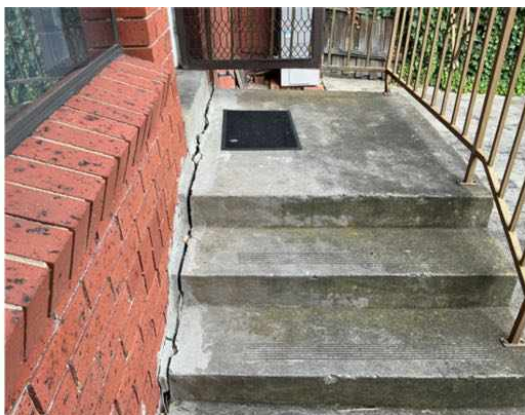
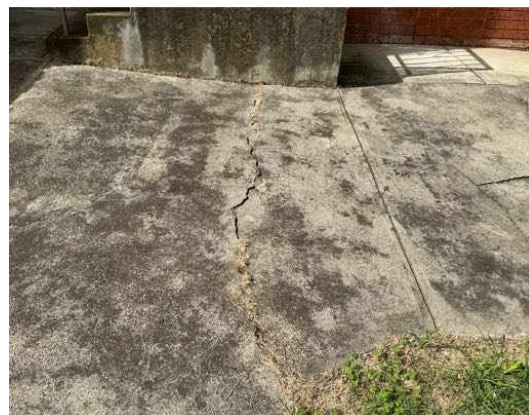
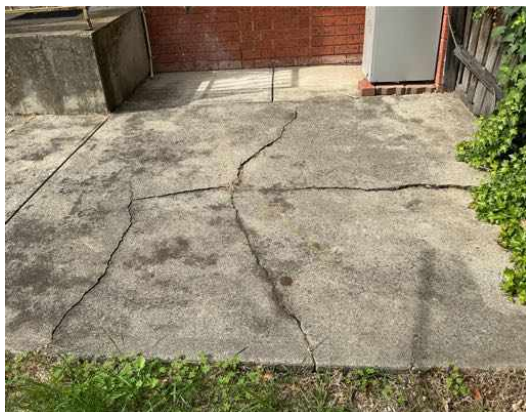
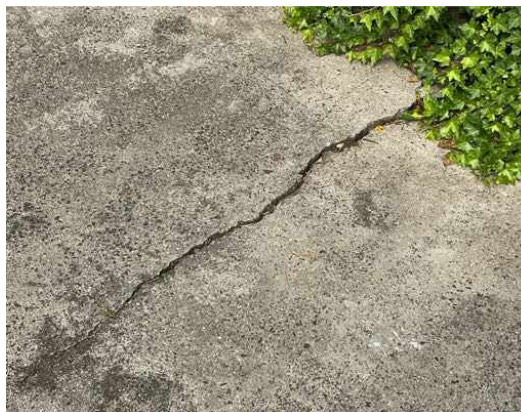
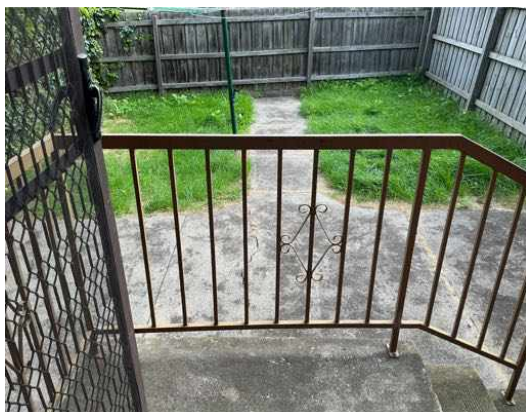
Defects 3.03

Information: It appears that the rear paving and stairs have been affected by movement of the foundations, often referred to as sinking or subsidence. Whilst a degree of movement is expected over time, especially as environmental conditions change and buildings 'settle' after construction, this degree of movement requires attention.

General subsidence is usually initiated by changes in soil moisture content. The most critical factor is identifying the specific causes, and identifying if this is a recurring or ongoing problem, or one that has been resolved by previous works in the past.

Subsidence can have complex and varying causes, which will influence the required remedial works. It is advised to begin by consulting a structural engineer to determine the required scope of works.

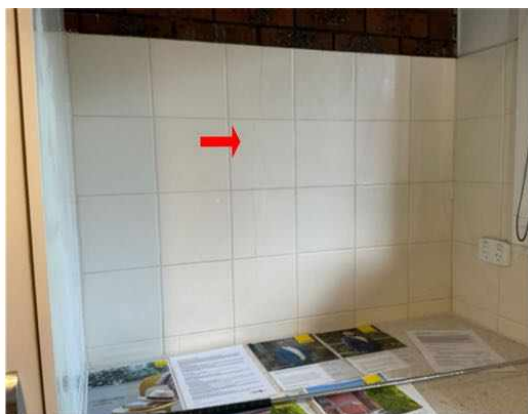
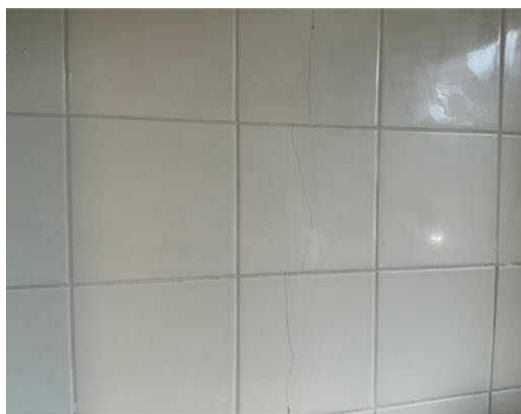
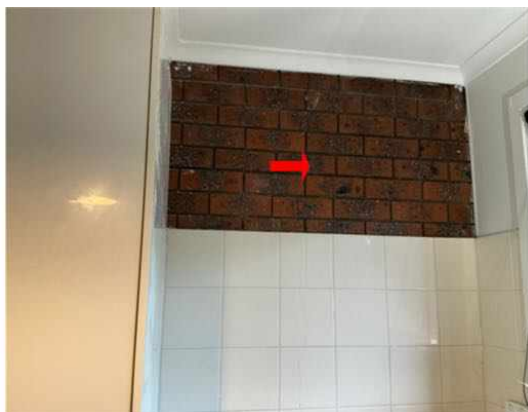
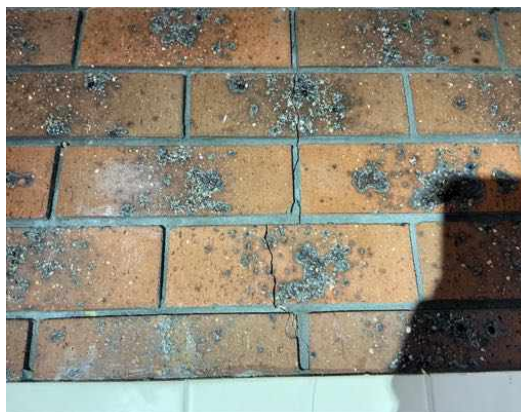
Defects 3.04

Building:	Main Building
Location:	Kitchen
Finding:	Brickwork - Cracking noticeable
Information:	There were several cracks and or crack repairs evident to external brickwork.

Noticeable cracks are a common occurrence in external brickwork and are a likely result of age expected building movement, general expansion, and/or contraction of building materials in different weather conditions. Noticeable cracks in brickwork may develop if left unattended, with potential for necessitating major remedial works or replacement of the brickwork.

It is highly advised that a qualified bricklayer be appointed to provide necessary works to cracked brickwork to prevent any further damage. Such works should be conducted as soon as possible.

Always monitor these cracks and contact a building inspector should cracks widen, lengthen, or become more numerous.

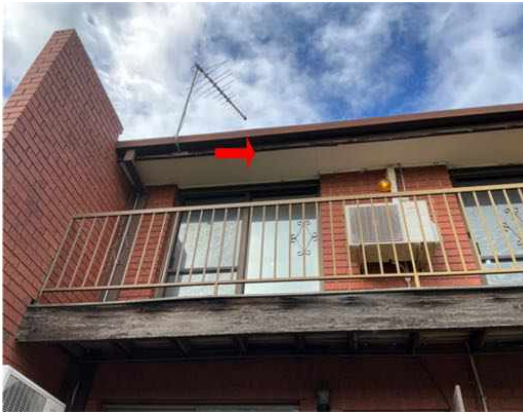
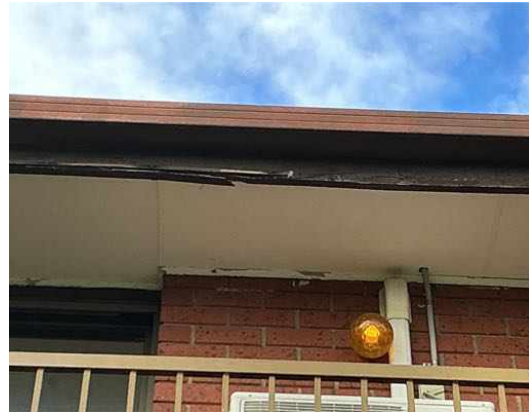
Defects 3.05

Building:	Main Building
Location:	Fascias
Finding:	Fascias - Wood rot
Information:	Wood rot was found to be affecting fascias and barges in this area, evidenced by the presence of mould on the surface in some areas. Wood rot, also known as Fungal Decay, occurs when timbers and other cellulose building materials are exposed to damp conditions on an ongoing basis.

It is likely that this wood rot has developed as a result of faults in the roof plumbing, creating excessive moisture in this areas. Frequent exposure to rain and other weather conditions also make fascias and barges susceptible to accelerated deterioration.

Early intervention and regular maintenance will prolong the useful life of these building elements. Prior to any works being performed, the cause of the moisture that has created the visible wood rot should be identified and addressed in a suitable manner.

It is advised that a roof plumber be appointed to inspect all roof plumbing and subsequently identify the cause of the wood rot. Replacement of affected fascias and barges may then be a necessary step in protecting surrounding building elements from such deterioration.

A qualified plumber may be appointed to assess the cause of excessive moisture and

to provide advice on any remedial works as required. A qualified carpenter or registered builder may also be required to replace affected building materials.

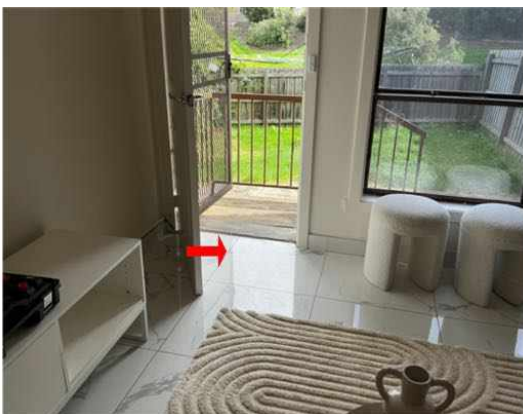
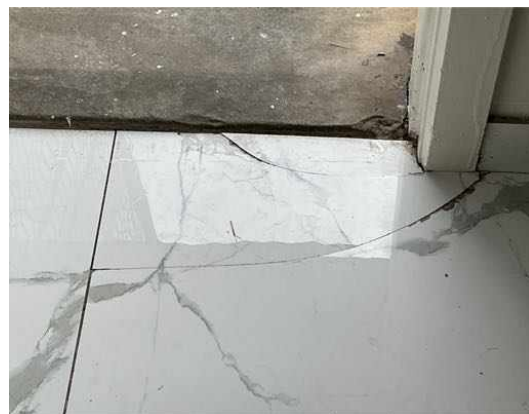
Defects 3.06

Building: Main Building
 Location: Lounge Room
 Finding: Floor tiles - Cracked
 Information: Cracking in the floor tiles was evident in this area at the time of inspection. It is suspected that this cracking has occurred as a result of the floor being uneven and lacking a solid or suitable foundation for the tiles to be laid on. Settlement in the floor foundations may also have caused movement and resulted in the cracking of tiles in this area.

Cracked tiles throughout the household detract from the overall appearance of the affected areas, as well as creating potential for water penetration to adjoining building elements. If left unmanaged, water damage may occur as a result of constant water penetration over a prolonged period of time.

While not considered a matter of urgency, replacement of cracked floor tiles is advised as a solution. A tiling contractor or general handyperson may be appointed to perform these works at client discretion. Where cracks become more numerous, consultation with a registered builder specialising in re-stumping may be required.

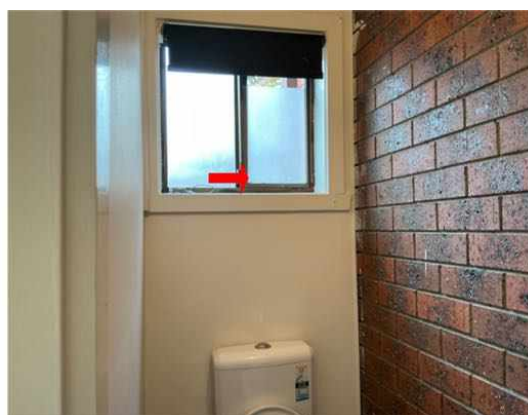
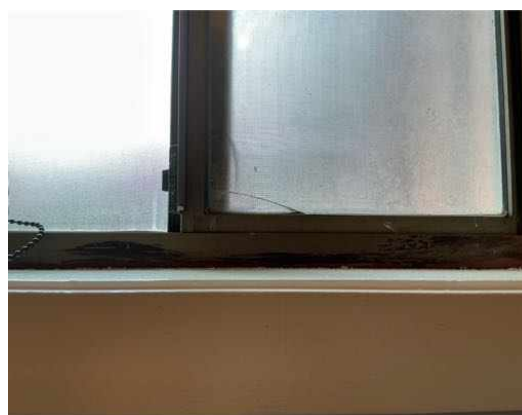
Defects 3.07

Building:	Main Building
Location:	Toilet (WC)
Finding:	Window - Cracked
Information:	Cracks were identified in the window in this area. Cracking in windows is generally the result of impact damage, and is likely to develop further when left unmanaged.

The likelihood of this windowpane further cracking and shattering is increased exponentially, providing a safety hazard in the area. The cracked window also impairs the weather tightness of the building, creating potential for minor water leaks.

A qualified glazier is required to repair the window as soon as possible. Depending on the extent of the cracking, replacement of the window may be required. Please be advised that any persons coming into contact with the cracked window should do so with due caution to avoid any personal injury that may ensue.

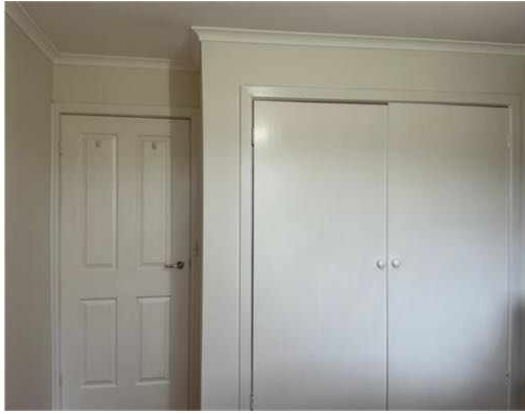
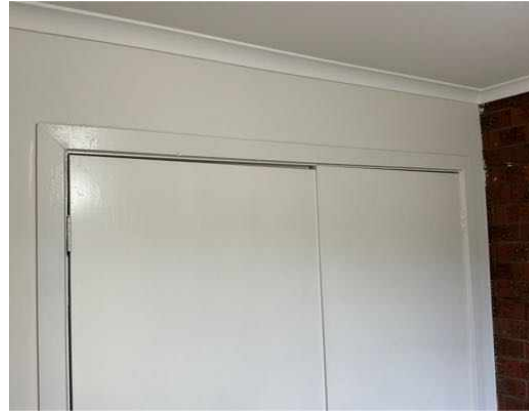
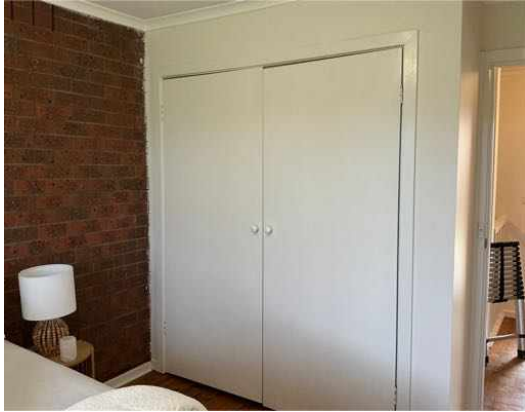
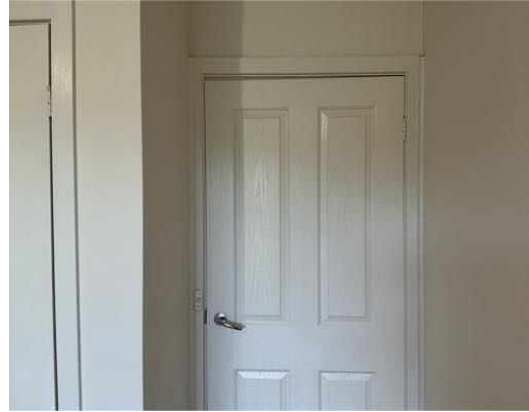
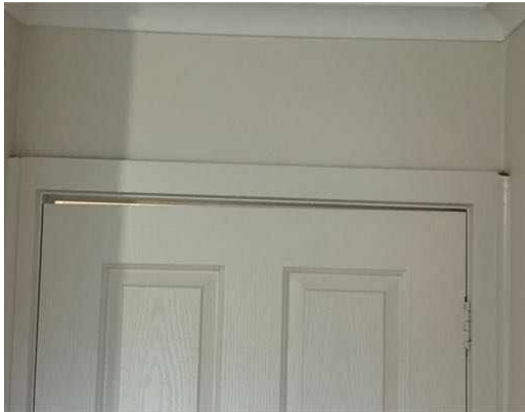
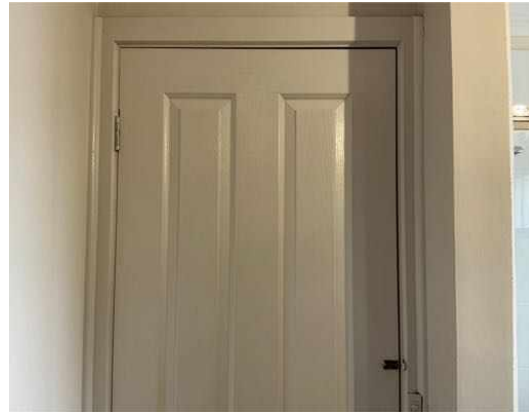
Defects 3.08

Building:	Main Building
Location:	All Areas
Finding:	Door - Gap
Information:	A significant gap was identified between the door and door frame in this area. Where large gaps to the head or foot of door frames appear, it may indicative of a variety of defects, ranging from uneven framework, sagging hinges or uneven flooring.

A gap to the head of the door may also indicate movement of the foundation of the property, which is a common occurrence and does not indicate structural damage.

A qualified carpenter should be appointed to perform remedial works to restore the door to a fully operational level.

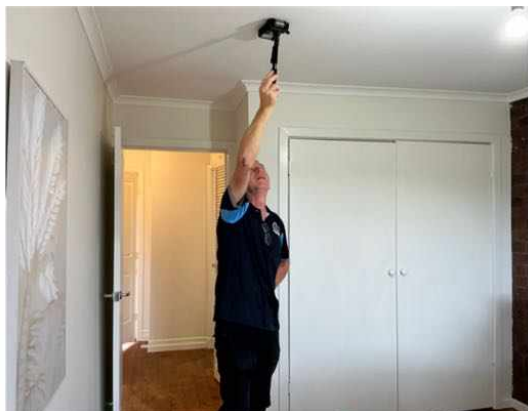
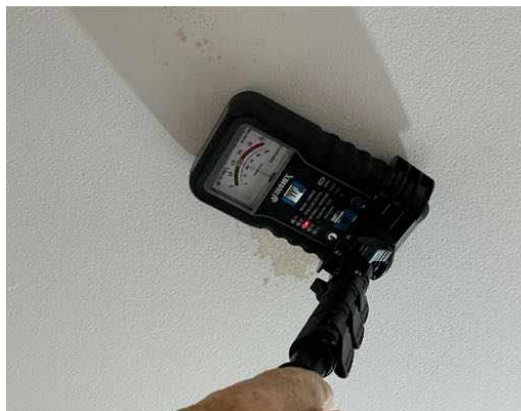
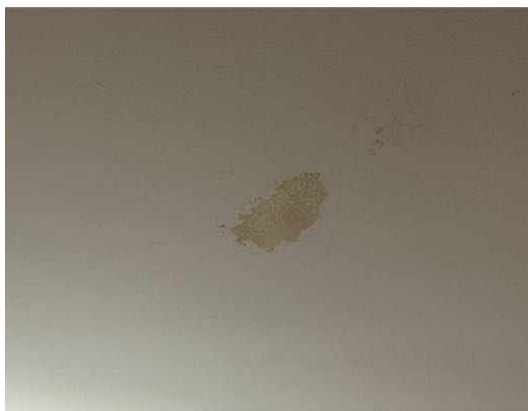
Defects 3.09

Finding: Ceiling - Water stained

Information: Water staining to ceiling linings in this area was evident at the time of inspection. Water staining indicates that surfaces have been exposed to excessive moisture over time. The minerals and other elements in the water lead to staining, which may graduate to corrosion and deterioration if left unmanaged.

While mostly an appearance defect, water staining can be indicative of more serious defects, which may be currently concealed by interior ceilings.

Where water staining is active, a licensed plumber must be consulted to identify the cause of the staining and to provide advice on any reparation works that may be required. Replacement of any damaged structures is advised.

Conversely, where water staining is old and inactive, affected building materials may be repaired or replaced at client discretion.

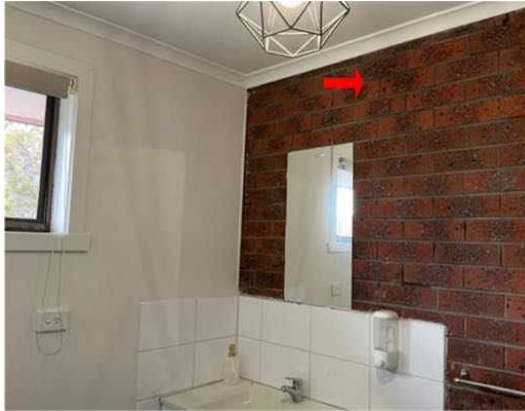
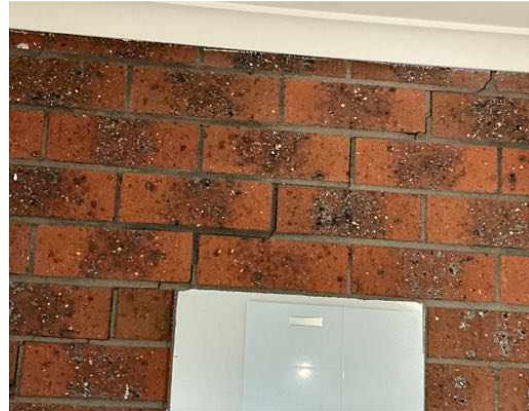
Defects 3.10

Building:	Main Building
Location:	Bathroom
Finding:	Brickwork - Step cracking
Information:	Step cracking was identified to the brickwork in this area at the time of inspection. Step cracking, which is similar to other forms of cracking, has a variety of possible causes. However, the most common is the subsidence of adjacent footings.

Step cracking is a relatively common defect, and is most likely to occur adjacent to windows, doors and other openings. Mortar failure in the gaps between affected bricks indicates the stresses and tensions affecting the wall.

Where step cracking is extensive or severe, the client is advised to consult a structural engineer. Minor step cracking can be used as a warning sign to address factors causing stress to the wall, which can include the effect of surrounding trees, water leaks, soil erosion, or even the presence of reactive soils in the surrounding area.

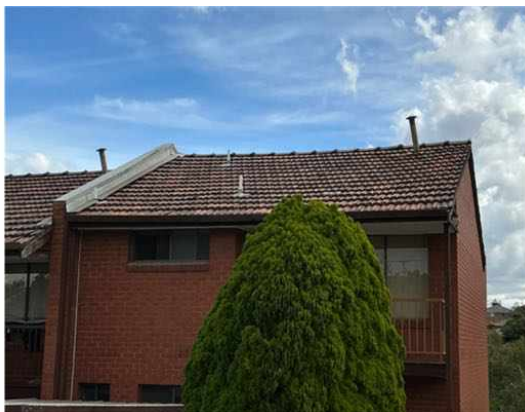
Defects 3.11

Building:	Main Building
Location:	Roof Exterior
Finding:	Roof tiles - Weathered
Information:	Upon inspection of the exterior roofing, the majority of roof tiles were considered to be in a fair condition. While weathering of the tiles is consistent with the age of the property, maintenance works are required.

Isolated areas of mortar have come loose in the valleys and minor cracking is also present. Re-pointing and re-sealing the may be considered as an interim solution by the client to help preserve and extend the life span of the tiles.

Where left unmanaged, deteriorating roof tiles are likely to lead to a number of secondary defects, including minor water leaks and weather exposure to internal roofing structures.

Consultation with a roofing contractor is highly advised to gain advice on cost of remedial works that may be required in the short to medium term. Remedial works are likely to increase the longevity of the exterior roofing structure.

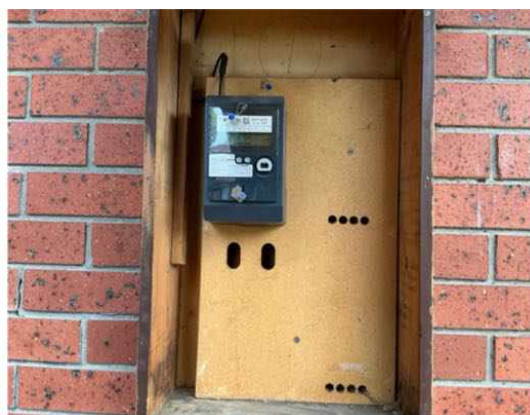
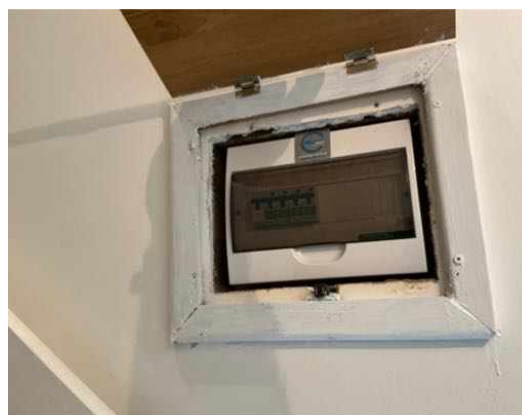
Noted Item

Building:	Main Building
Location:	Electrical Switchboard
Finding:	Termite Management System - no evidence of a chemical installation
Information:	The application of a post-construction chemical termite barrier is highly recommended for all properties, particularly if live termite activity has been found on the site previously. Such barriers are highly effective in preventing termite attack on any timber building elements throughout the property.

A durable notice should be placed in the switchboard unit to indicate current termite barriers. At the time of inspection, it appeared as though no termite management system has been installed, with no evidence to suggest preventative works taking place.

The client may consider gaining further advice from a pest controller as to the costs and procedures involved with this application. It is recommended that obtaining such advice be a short-term priority.

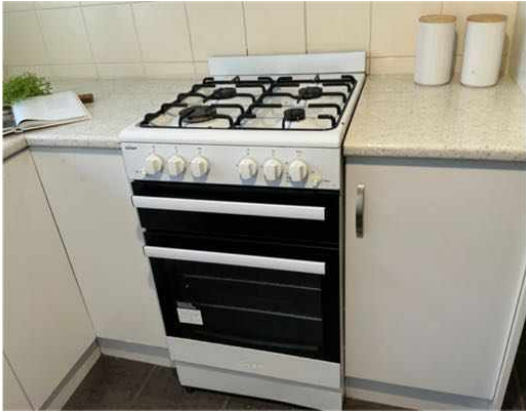
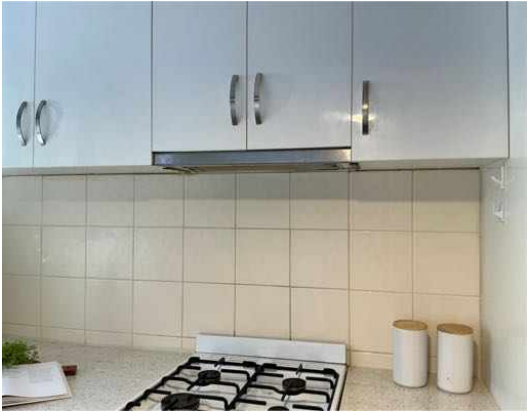
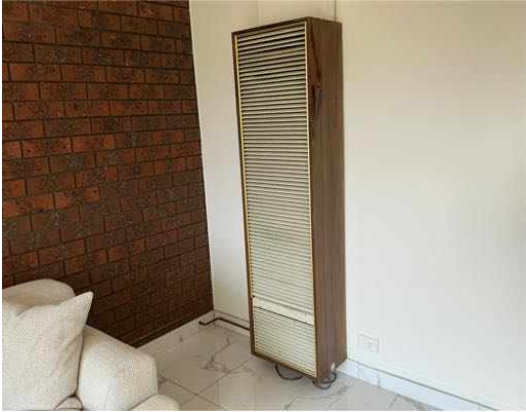
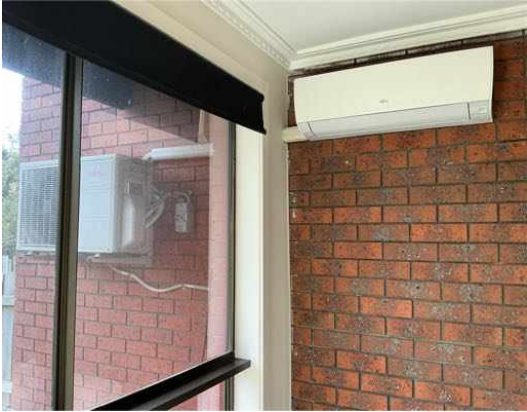
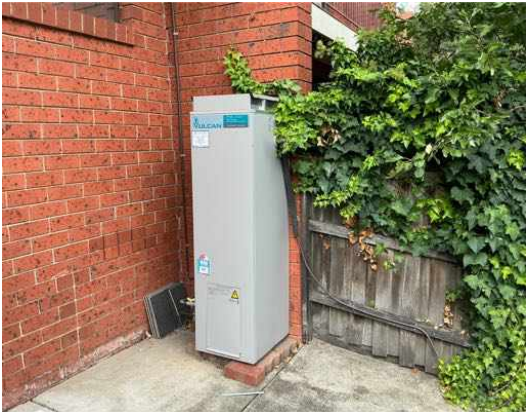
Noted Item

Building:	Main Building
Location:	All appliances
Finding:	Warranty - Expired
Information:	Where appliances are beyond their warranty period, the owner should be prepared to meet the cost of replacement or repair of the item at any time. The operation of the appliance can not be guaranteed and further inspection by an appropriately qualified tradesperson may be required.
