Building and Timber Pest Inspection Report

Inspection Date: Wed, 18 Feb 2026

Property Address: 34 Mann St, Wodonga VIC 3690, Australia

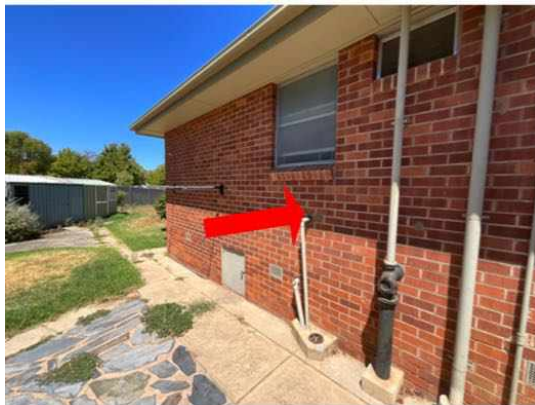
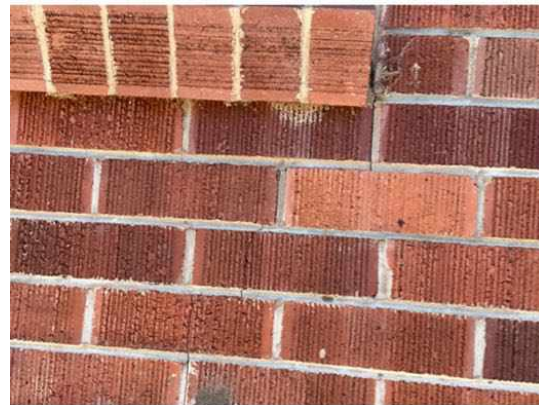
Finding 3.01

Building: Building 1
 Location: Bathroom
 Finding: Brickwork - Cracking [Fine]
 Information: Although fine cracks are quite noticeable, they are often only considered to be an appearance defect and usually do not indicate any structural damage. Generally, the cause of a fine crack is indicative of a separation between brickwork and mortar throughout the structure, but single bricks may also show cracks of this nature.

Cracking of this nature can generally be repaired with minor filling and should be conducted by a qualified bricklayer.

Always contact a building inspector should cracks widen lengthen or become more numerous.

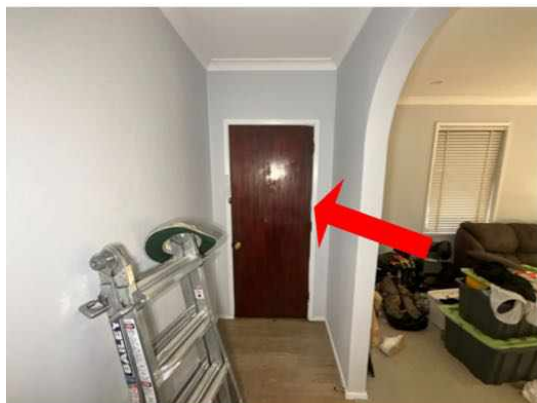
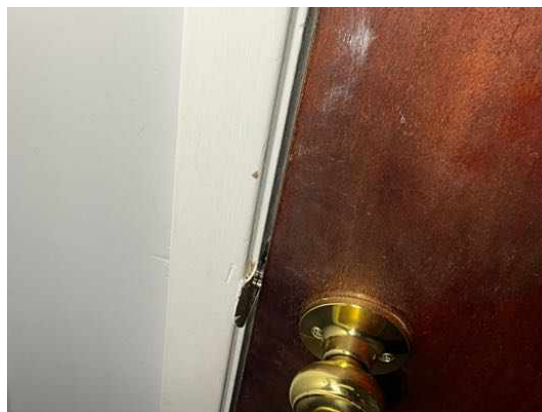
Finding 3.02

Building: Building 1
 Location: Entry
 Finding: Door- Binding/jamming
 Information: Binding and/or jamming of this door is evident during standard operation. This defect

inhibits the functionality of the affected door as well as creating potential for secondary defects to associated building elements, such as damage to the floor covering.

A door that binds to flooring or to the associated door frame may have several causes, ranging from minor defects, such as poor installation of the door or deteriorated hinges, through to major structural issues, such as damage to subfloor structures.

A qualified carpenter or general handyperson should be appointed to perform minor rectification works at client discretion.

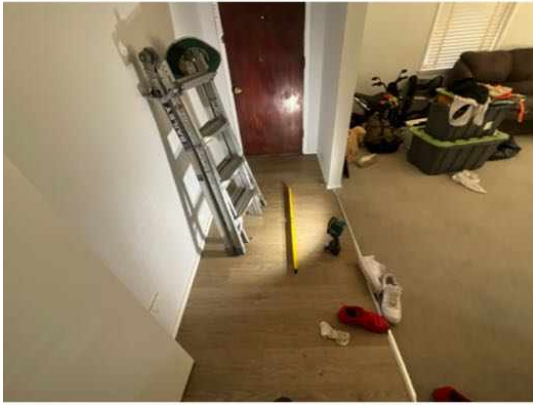
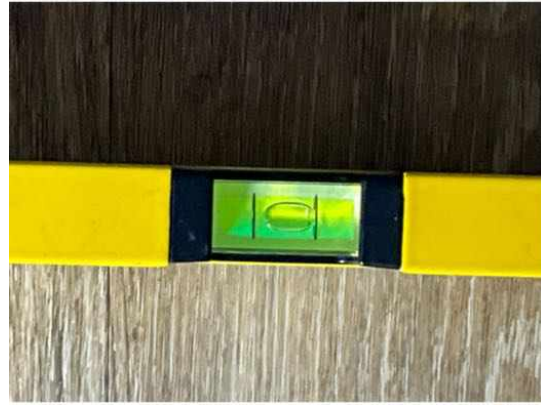
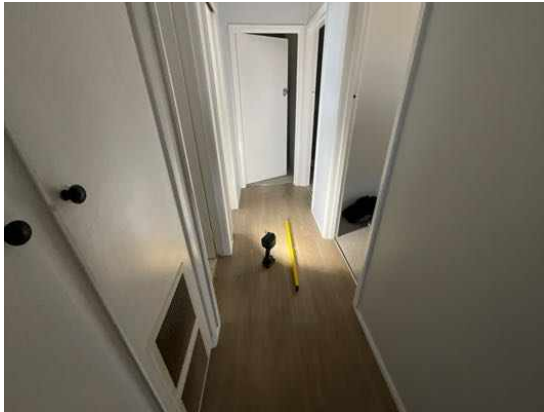
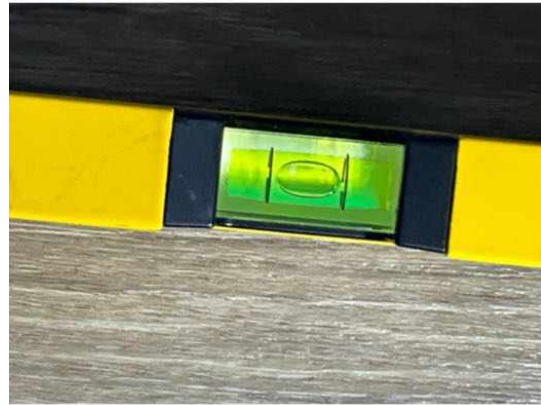
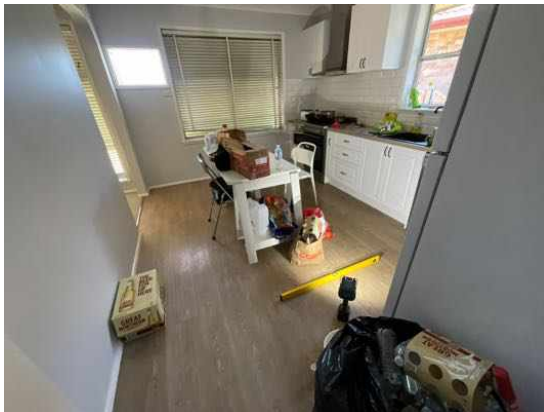
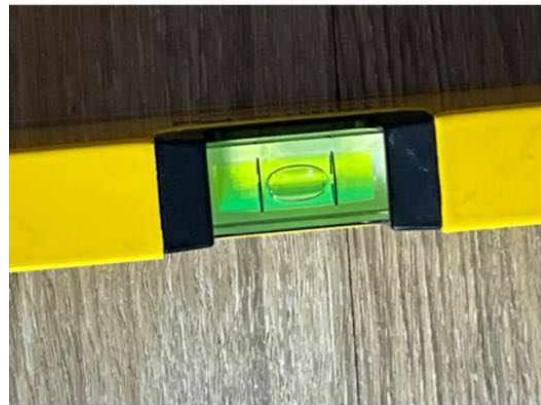
Finding 3.03

Building:	Building 1
Location:	All Internal Areas
Finding:	Flooring - slightly uneven
Information:	The internal flooring in this area is out of level and uneven. Uneven flooring is likely to indicate minor defects such as expected movement of the foundations of the property, but may also indicate subsidence of the associated subfloor stumps.

It is advised that the flooring be closely monitored to identify any further movement. Where flooring remains relatively unchanged for an extended period of time (i.e. several months), it is likely that this defect has been caused by expected movement of the foundations of the property.

However, where flooring is increasingly uneven, potentially invasive inspection of the subfloor structures and stumps in this area is required. In this case, works to repair are likely to be required, and would be carried out by a registered builder specialising in re-stumping.

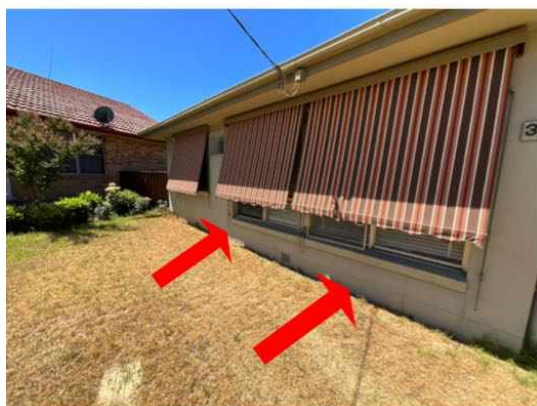
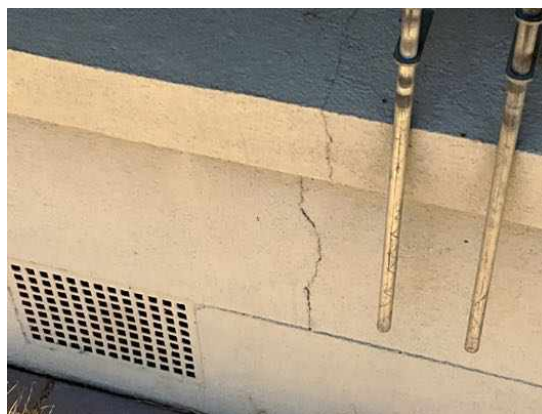
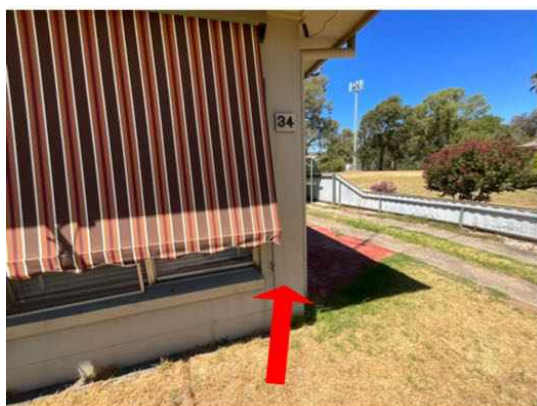
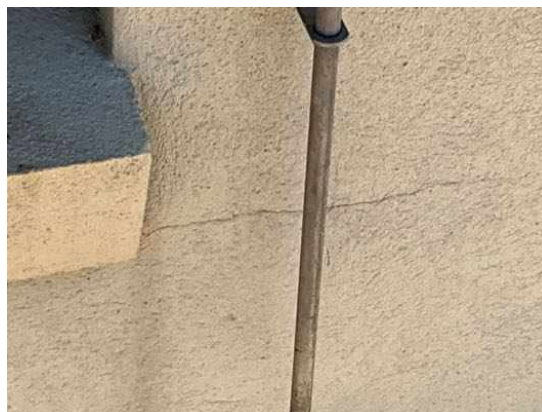
Finding 3.04

Building: Building 1
 Location: Front wall
 Finding: Render- Cracking
 Information: Cracking to the render in this area was identified at the time of inspection.

This type of cracking is often consistent with general dilapidation of the property, and may continue to develop if left unmaintained.

Frequent monitoring should be carried out to identify any further damage.

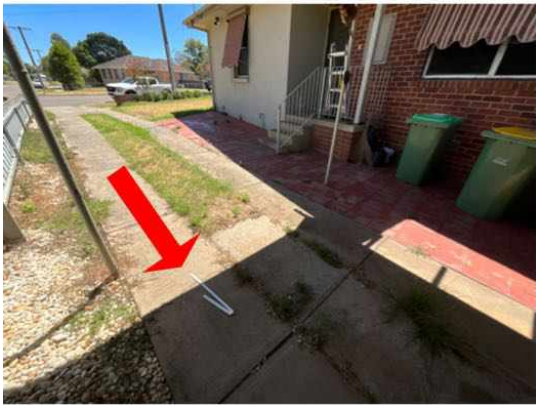
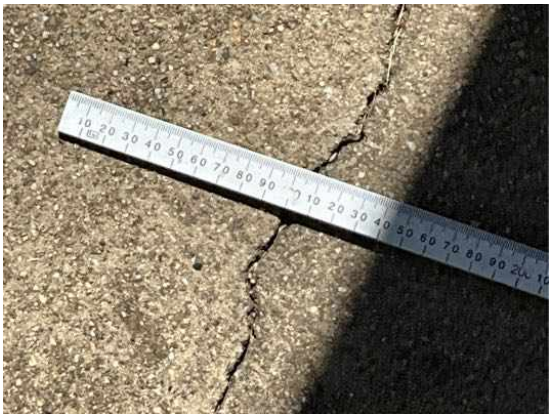
Finding 3.05

Building:	Building 1
Location:	Driveway
Finding:	Cracking - External Concrete Paving Damage Category 1 - Fine (less than 2mm)
Information:	Fine cracks were identified in external concrete paving. Although fine cracks are quite noticeable, they are often only considered to be an appearance defect, and usually do not indicate any structural damage. To be considered a Category 1 or fine crack, the crack is found to be less than 2mm in width.

Generally the cause of a hairline crack in existing concrete paving such as driveways and pathways is indicative of the expansion and contraction of the concrete. Such causes are generally due to environmental factors, such as moisture levels, weather conditions, root systems of nearby trees or the soil types on which they are laid.

Fine cracks may also be due to poor original installation of the concrete. Factors such as poor compaction of the sub surface and/or inadequate reinforcing of the slab may create cracking and other secondary defects.

Monitoring of all cracking should be conducted frequently. Always contact a building inspector should cracks widen, lengthen, or become more numerous.

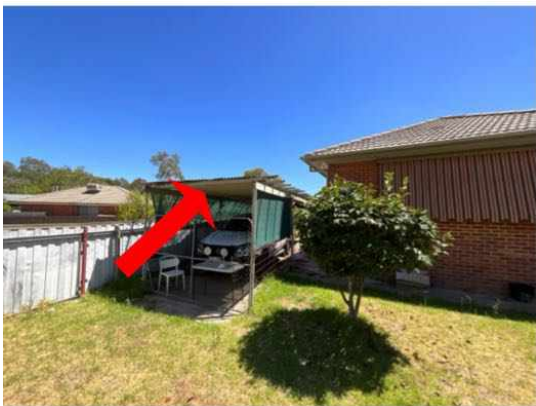
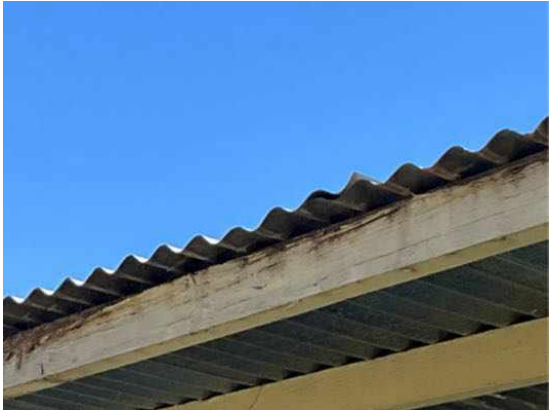
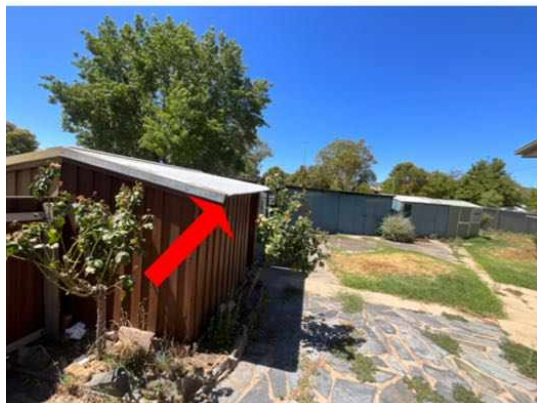
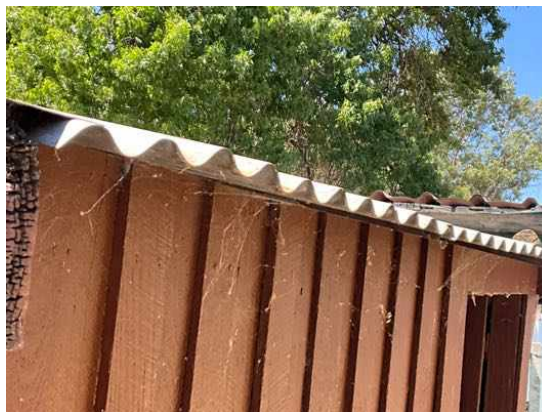
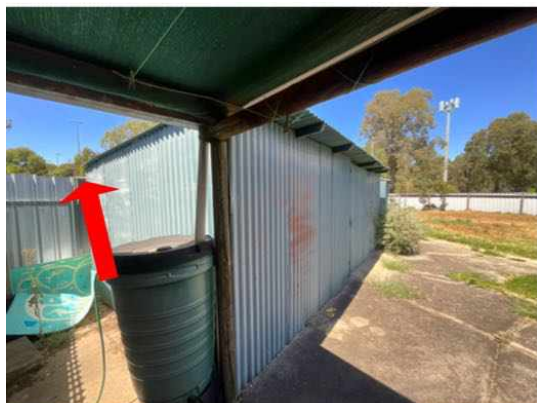
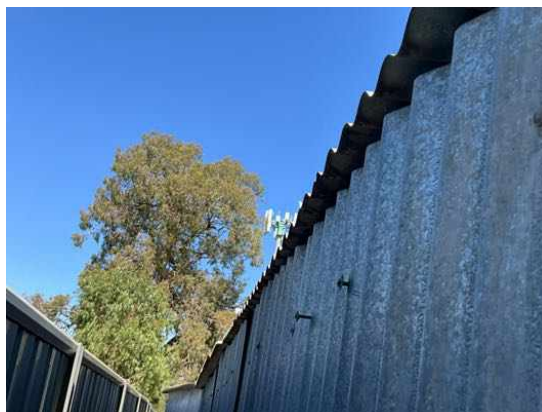
Finding 6.01

Building: Building 1
 Location: Carport, sheds
 Finding: Guttering Missing
 Information: The Guttering in this area was missing at the time of inspection. Guttering, Downpipes and Stormwater drainage are vital to protect the integrity of the structure and to prevent an environment conducive to Timber Pest attack.

A Plumber should be contacted as soon as possible to replace and connect to drainage the missing Guttering.

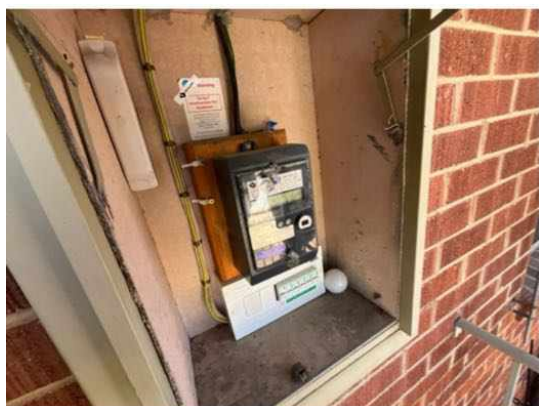
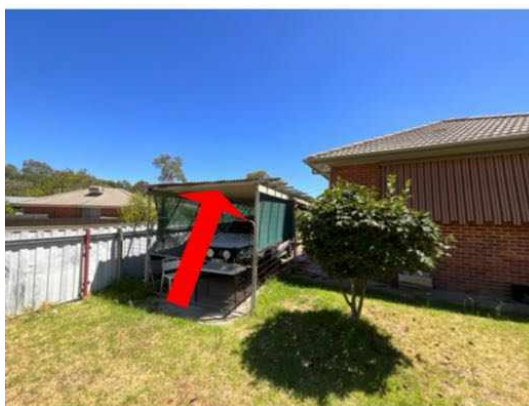
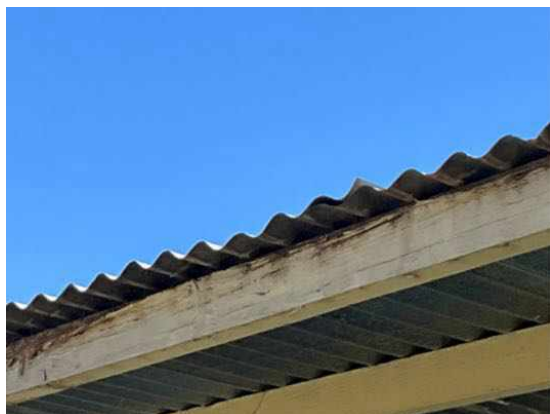
Finding 6.02

Building:	Building 1
Location:	All External Areas
Finding:	Termite Management System - no evidence of a chemical installation
Information:	The application of a post-construction chemical termite barrier is highly recommended for all properties, particularly if live termite activity has been found on the site previously. Such barriers are highly effective in preventing termite attack on any timber building elements throughout the property.

A durable notice should be placed in the switchboard unit to indicate current termite barriers. At the time of inspection, it appeared as though no termite management system has been installed, with no evidence to suggest preventative works taking place.

The client may consider gaining further advice from a pest controller as to the costs and procedures involved with this application. It is recommended that obtaining such advice be a short-term priority.

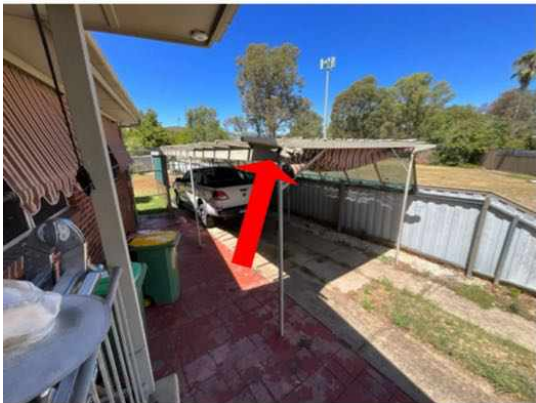
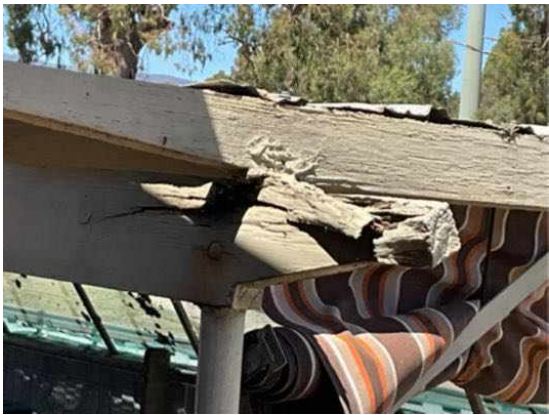
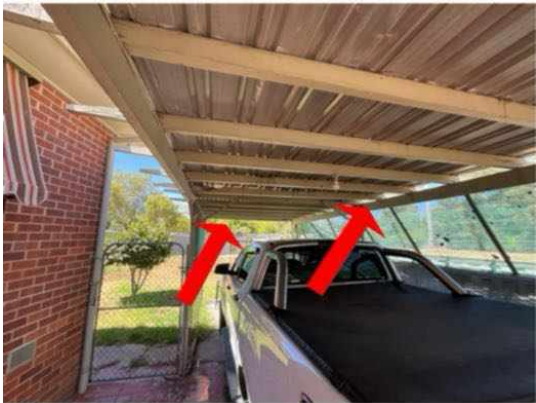
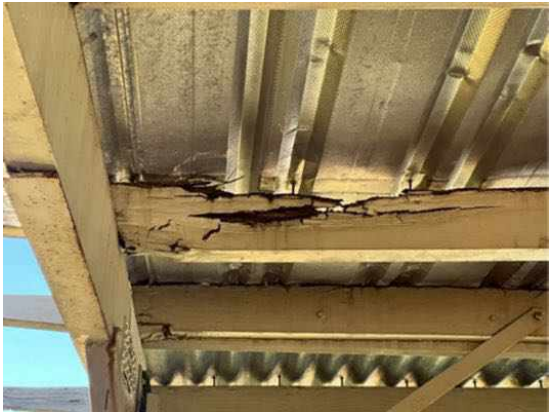
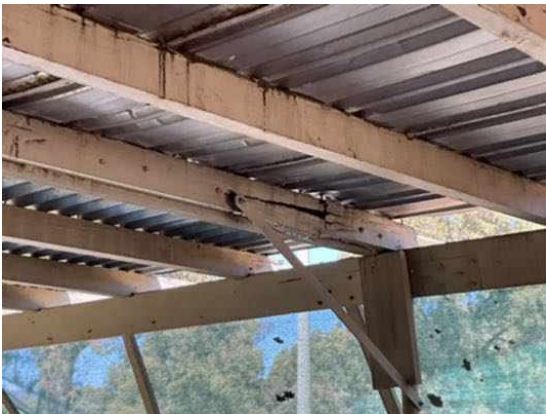
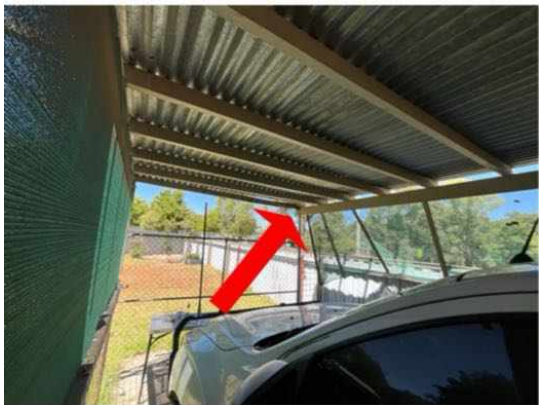
Finding 7.01

Building:	Building 1
Location:	Carport, eaves
Finding:	Fungal decay - present (localised)
Information:	Fungal decay also known as wood decay or wood rot generally refers to the deterioration of timber elements when in contact with excessive levels of moisture for a prolonged period of time.

The development of fungal decay is accelerated by temperatures in the range of 5degreeC to 40degreeC as well as the presence of oxygen. Generally fungal decay develops on timber elements that are in use in an external environment which are exposed to rain penetration.

In this case although the affected timber element is in a decaying state the extent of any visible damage appears to be localised to a specific area and is yet to spread to other parts of the building element or affect adjoining structures. The fungal decay is therefore likely to be of a relatively superficial nature with minimal impact on the structural integrity or tensile strength of the timber element.

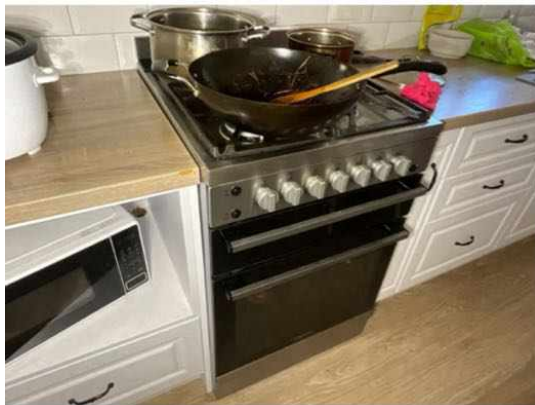
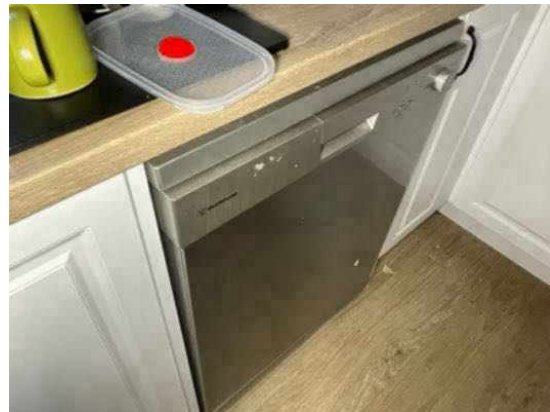
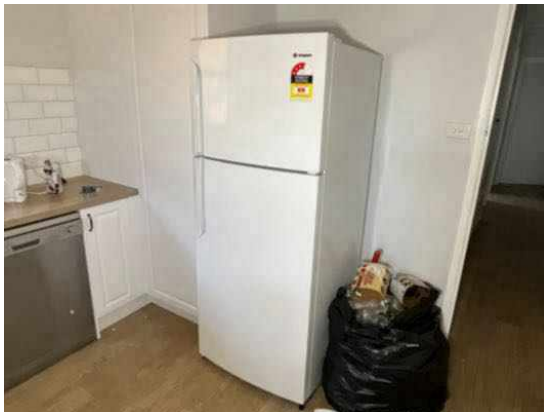
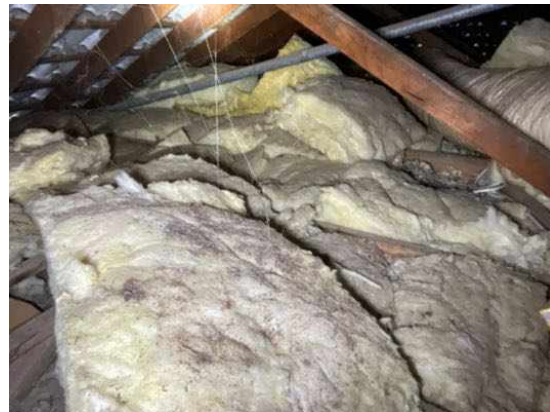
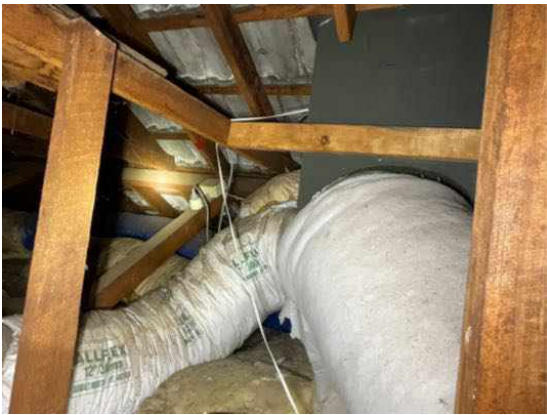
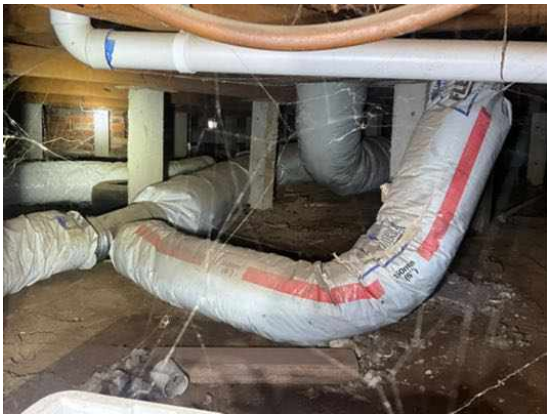
Noted Item

Building: Building 1
Location: All Areas
Finding: Additional Photos - Obstructions and Limitations
Information: These photographs are an indication of the obstructions and limitations which impeded full inspection of the property at the time of inspection. These obstructions can hide an array of defects and should be removed to allow full inspection to be carried out. A re-inspection is recommended once the areas are made accessible.
