Building and Timber Pest Inspection Report

Inspection Date: Tue, 7 Apr 2026

Property Address: 4/276 Woodward Rd, Golden Square VIC
3555, Australia

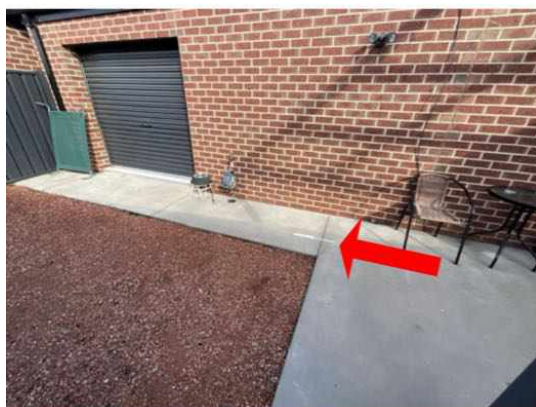
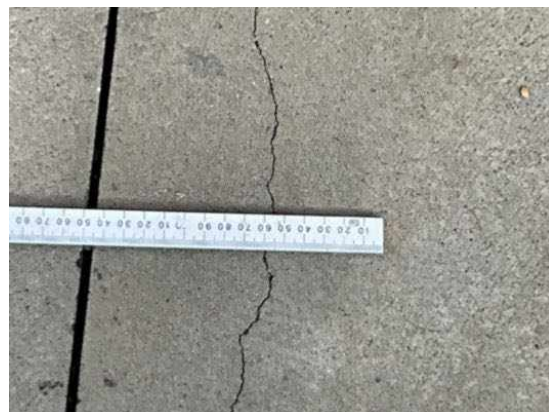
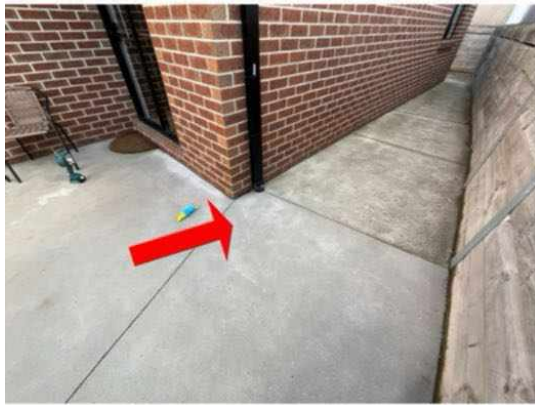
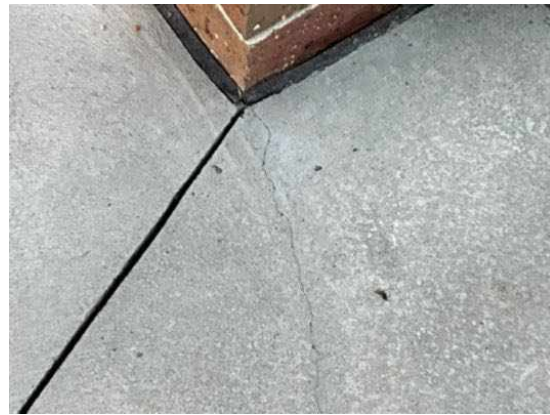
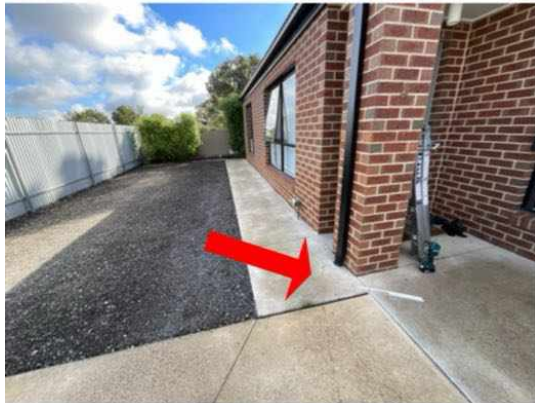
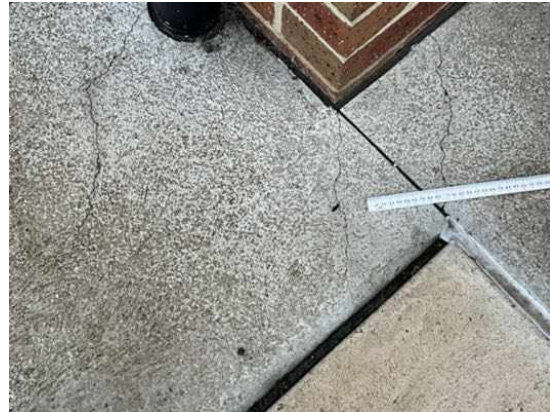
Finding 3.01

Building: Building 1
 Location: Yard - Back, front
 Finding: Cracking - External Concrete Paving Damage Category 1 - Fine (less than 2mm)
 Information: Fine cracks were identified in external concrete paving. Although fine cracks are quite noticeable, they are often only considered to be an appearance defect, and usually do not indicate any structural damage. To be considered a Category 1 or fine crack, the crack is found to be less than 2mm in width.

Generally the cause of a hairline crack in existing concrete paving such as driveways and pathways is indicative of the expansion and contraction of the concrete. Such causes are generally due to environmental factors, such as moisture levels, weather conditions, root systems of nearby trees or the soil types on which they are laid.

Fine cracks may also be due to poor original installation of the concrete. Factors such as poor compaction of the sub surface and/or inadequate reinforcing of the slab may create cracking and other secondary defects.

Monitoring of all cracking should be conducted frequently. Always contact a building inspector should cracks widen, lengthen, or become more numerous.

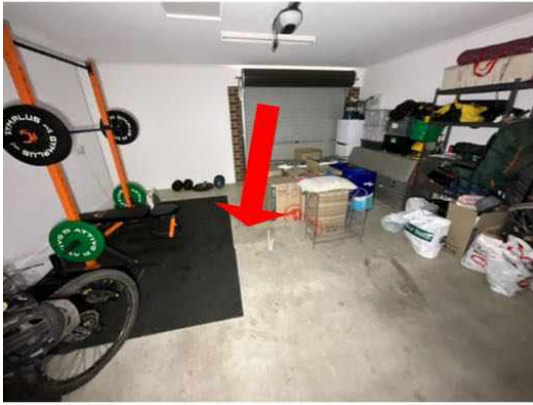
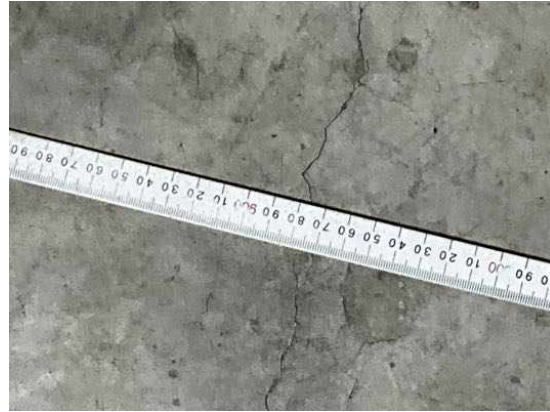
Finding 3.02

Building:	Building 1
Location:	Garage
Finding:	Crack in concrete slab - Category 1
Information:	A crack coded as Category 1 was identified in the slab. A Category 1 crack is described as a fine but noticeable crack, with the slab at an otherwise reasonable level.

To be considered Category 1, the approximate width of the crack is less than 1.0mm, or a less than 10mm change in offset when a 3m straight edge is placed over the defect.

Category 1 cracks should be monitored for a period of 12 months. At the end of the monitoring period, identified cracks that are rated greater than Category 2 are considered defects, and require rectification.

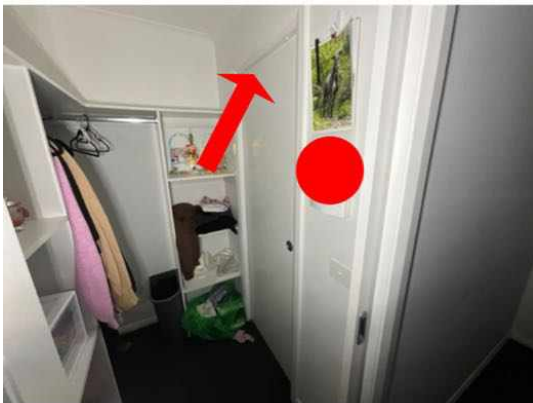
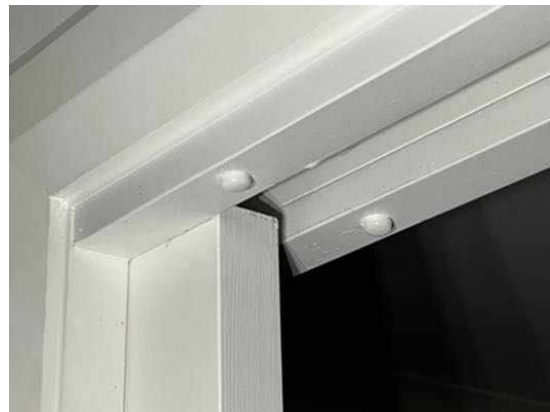
Finding 3.03

Building:	Building 1
Location:	Ensuite
Finding:	Door- Stiff to slide
Information:	The door in this area was jammed and difficult to slide along the associated tracks at the time of the inspection. Restricted function of the affected door may pose as a potential safety hazard if required for emergency egress from the building.

Generally, factors such as general age of the building element and a lack of maintenance are the usual causes for this type of defect.

Replacement of door hardware or tracks may be required, as well as minor repairs and cleaning. A registered builder or general handy person will be required to repair the affected doors.

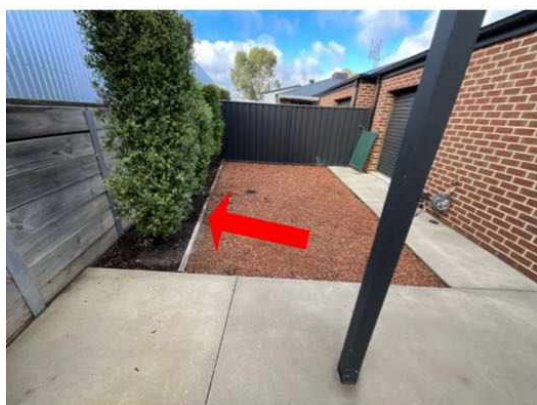
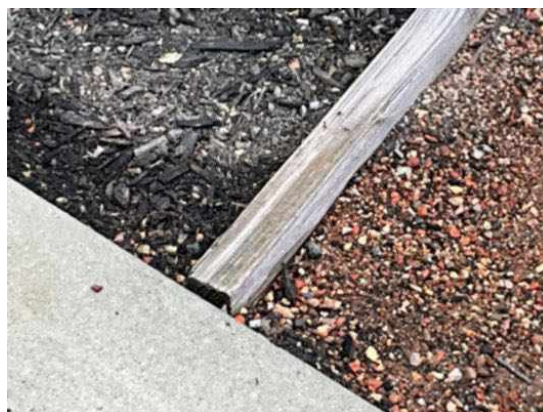
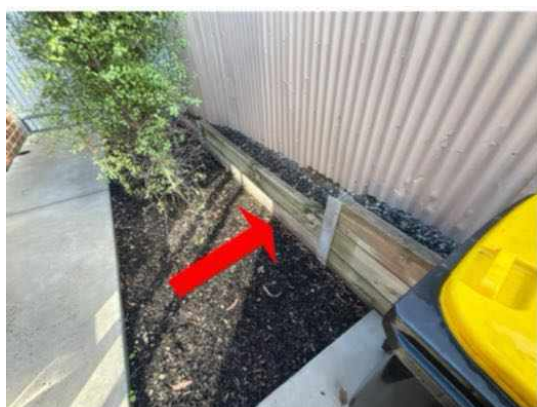
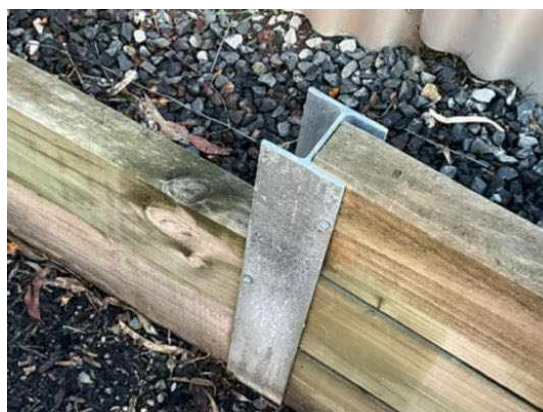
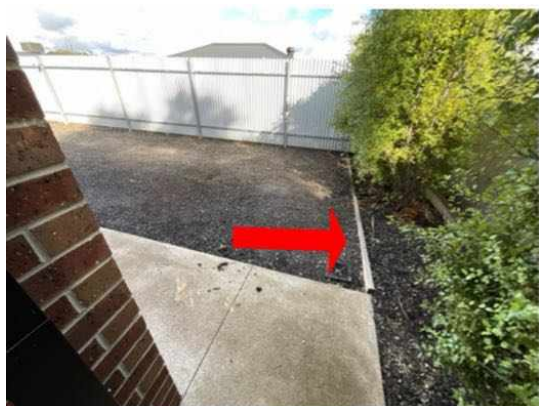
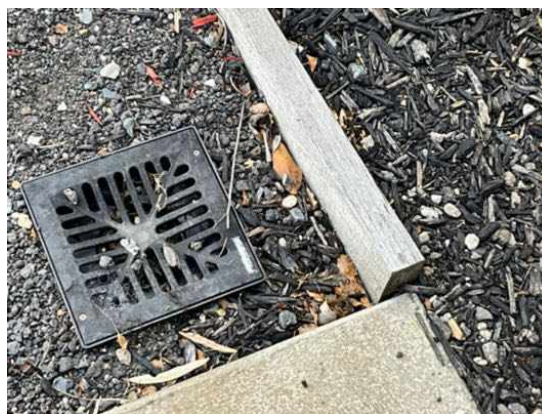
Finding 6.01

Building:	Building 1
Location:	Yard - Back, front
Finding:	Untreated or non-durable timbers in a hazardous environment
Information:	To reduce the risk of timber pest attack it is essential that timber used in a hazardous environment (e.g. in direct contact with the ground or frequently exposed to damp conditions) is of sufficient durability and/or is adequately preservative treated.

Untreated timbers in direct contact with the ground are likely to develop severe wood rot and/or fungal decay if left unattended creating attraction for subterranean termites to infest the timbers from surrounding areas.

If untreated or non-durable timbers are found to be in a hazardous environment it is highly advised that replacement of these building elements be performed as soon as possible to aid the protection of the property against termite / timber pest attack.

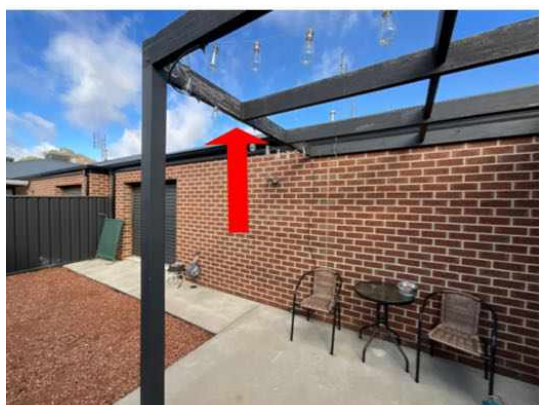
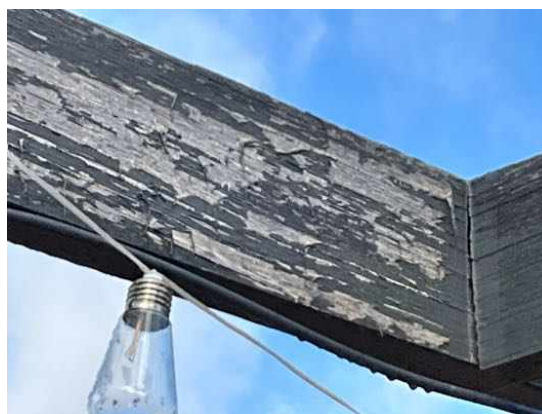
Finding 6.02

Building:	Building 1
Location:	Yard - Back
Finding:	Timber - exposed to weather
Information:	External timbers that are frequently exposed to harsh weather conditions require adequate protection in order to maintain their condition. Where timbers have not been painted or treated adequately, general deterioration is likely to occur at an accelerated rate.

If left unattended, replacement of these timbers is likely to be necessary in the short-term future. Adequate treatment of these timbers is required as soon as possible by a painting contractor or general handyman.

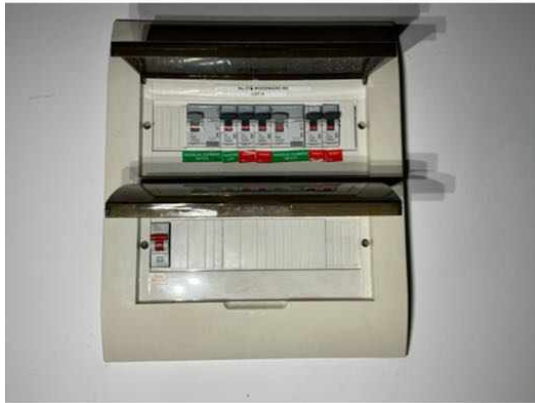
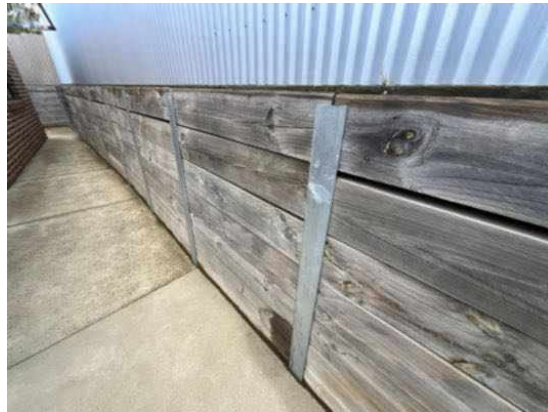
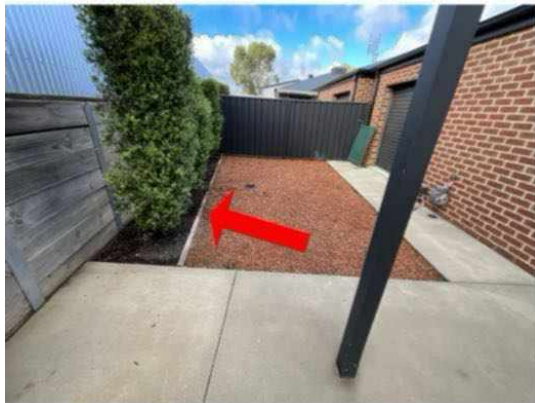
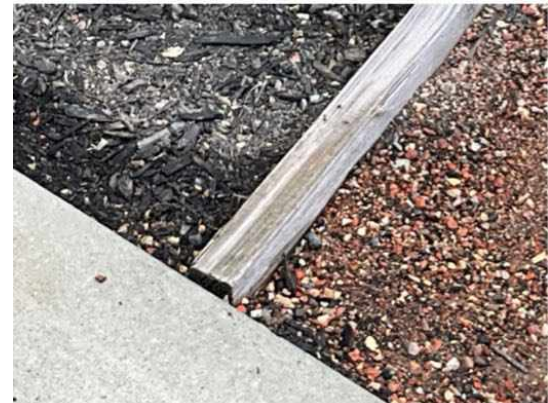
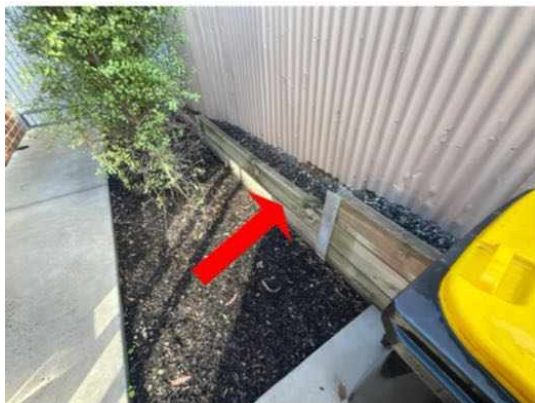
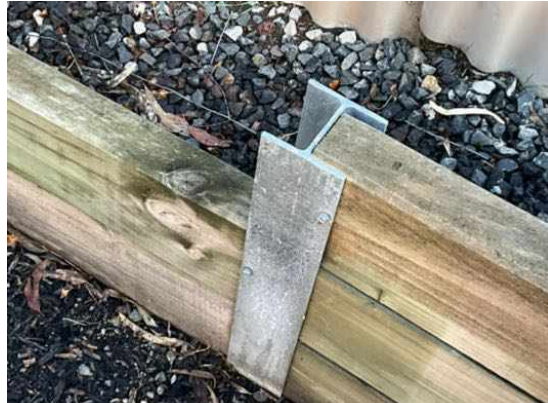
Finding 6.03

Building:	Building 1
Location:	All External Areas
Finding:	Termite Management System - no evidence of a chemical installation
Information:	The application of a post-construction chemical termite barrier is highly recommended for all properties, particularly if live termite activity has been found on the site previously. Such barriers are highly effective in preventing termite attack on any timber building elements throughout the property.

A durable notice should be placed in the switchboard unit to indicate current termite barriers. At the time of inspection, it appeared as though no termite management system has been installed, with no evidence to suggest preventative works taking place.

The client may consider gaining further advice from a pest controller as to the costs and procedures involved with this application. It is recommended that obtaining such advice be a short-term priority.

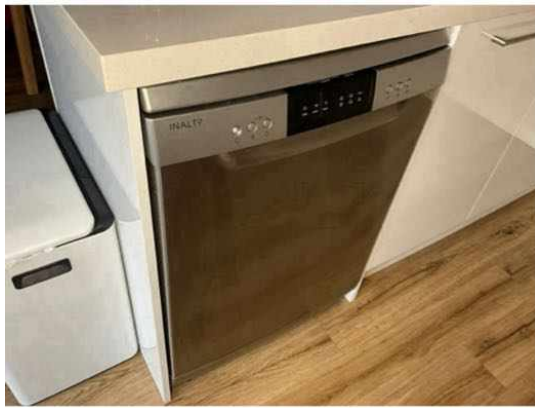
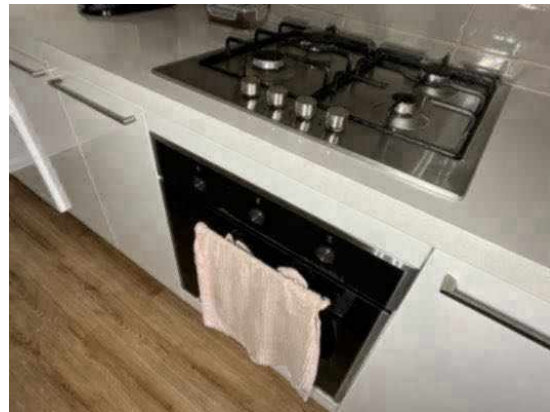
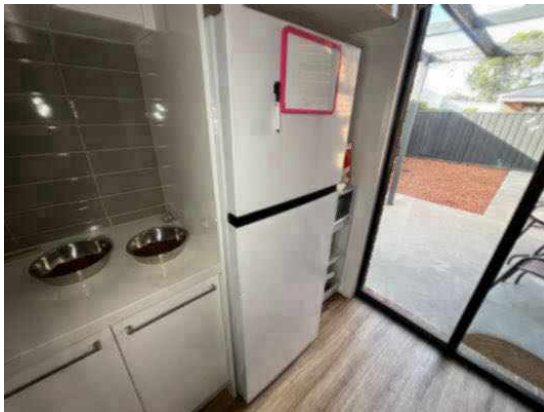
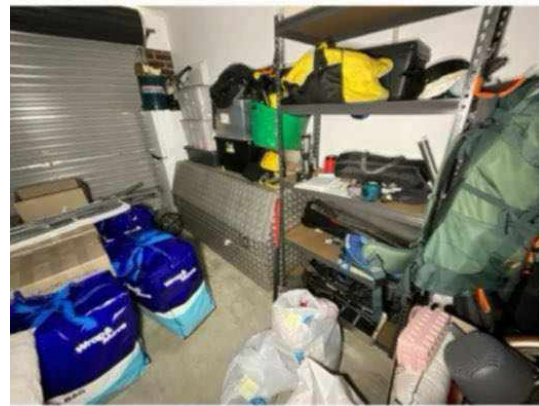
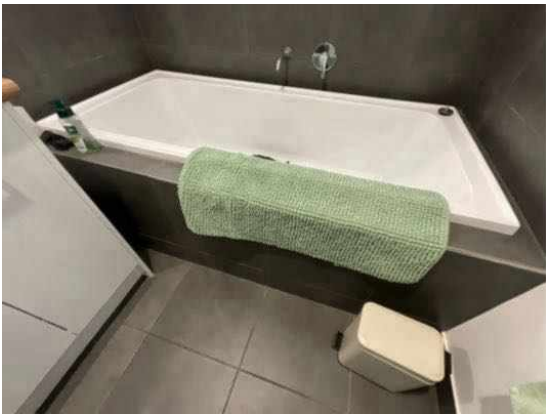
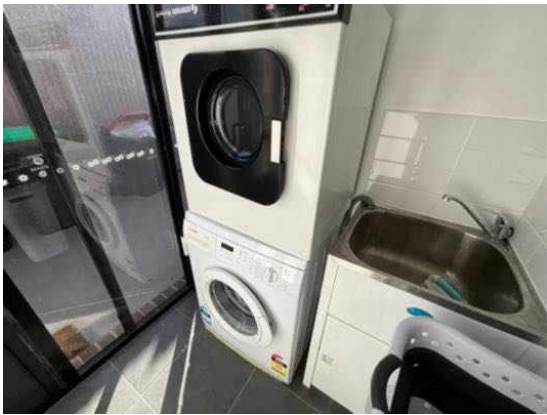
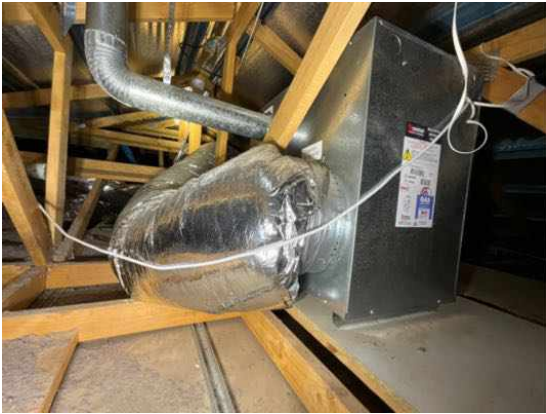
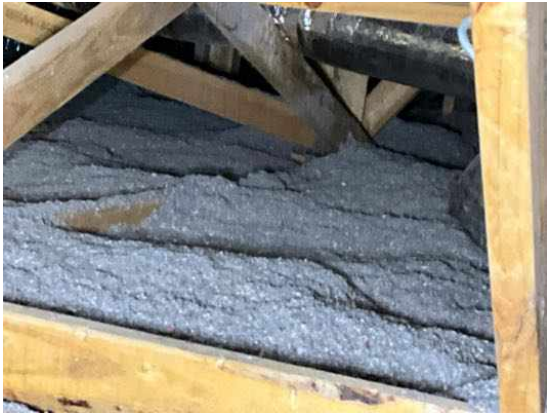
Building: Building 1
Location: All Areas
Finding: Additional Photos - Obstructions and Limitations
Information: These photographs are an indication of the obstructions and limitations which impeded full inspection of the property at the time of inspection. These obstructions can hide an array of defects and should be removed to allow full inspection to be carried out. A re-inspection is recommended once the areas are made accessible.
