Building and Timber Pest Inspection Report

Inspection Date: Mon, 16 Feb 2026

Property Address: 12 Disraeli St, Kew VIC 3101, Australia

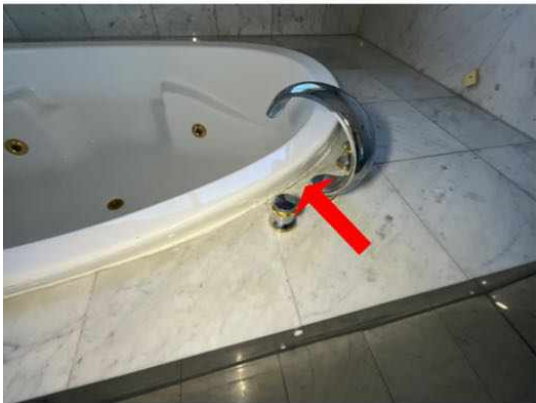
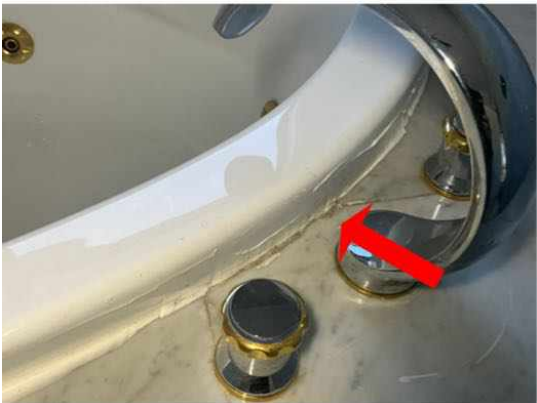
Finding: Grout and sealant - Missing or degraded within the bathroom area

Information: It was noted on inspection that grout or sealant is degraded to areas within the bathroom.

Different materials move at different rates, generally causing cracking to grout at this point. Build up of moisture in the bathroom can also cause grout and sealants to degrade and become mouldy.

Any damaged or degraded materials should be scraped out and flexible and mould resistant materials should be applied to affected areas to prevent any subsequent water damage that may occur. Regular maintenance and replacement of damaged or missing grout/ sealant is highly recommended to the wet areas, as this is a regular wear and tear defect. Both grout and sealant in areas that come into regular contact with water should be maintained for the long term care of your property.

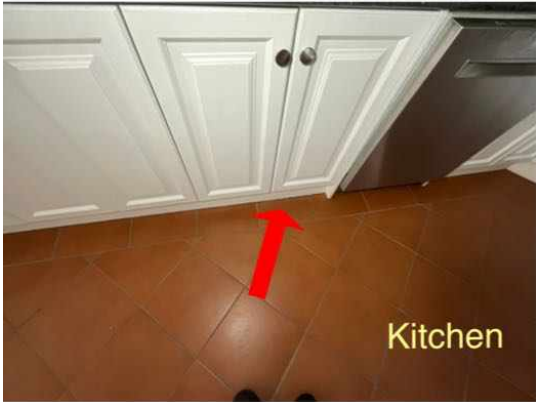
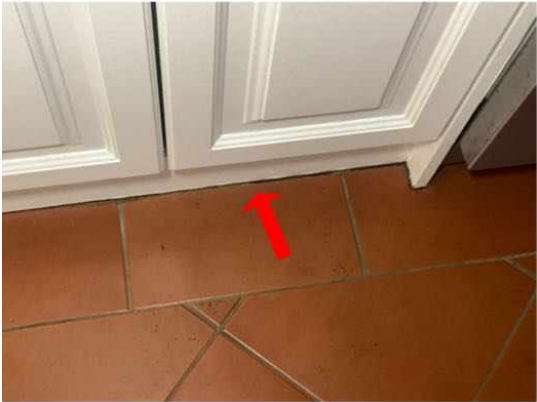
Finding 3.05

Building:
Location: All Areas
Finding: Grouting - Missing or damaged within floor tiles
Information: It was noted on inspection that grout is degraded around various areas of the floor tiles.

This can be the result of floor tiles moving at different rates generally causing cracking to grout at this point, or poor installation of the grout. A flexible sealant should be used around edges where movement is anticipated, to lessen the chance of cracking.

The deteriorated grout should be scraped out and new grouting or flexible sealant applied where necessary.

A competent handyman may be appointed to complete these works.

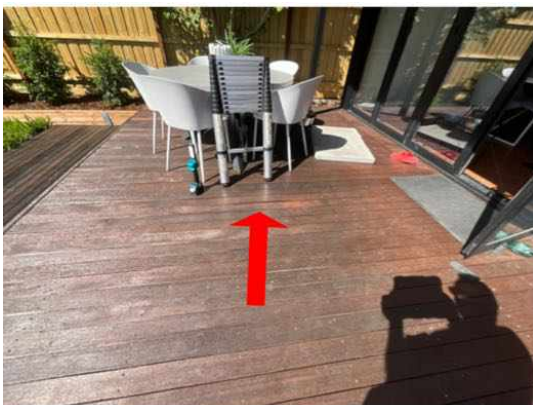
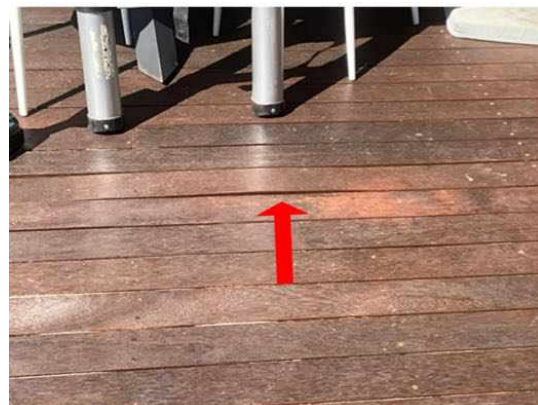
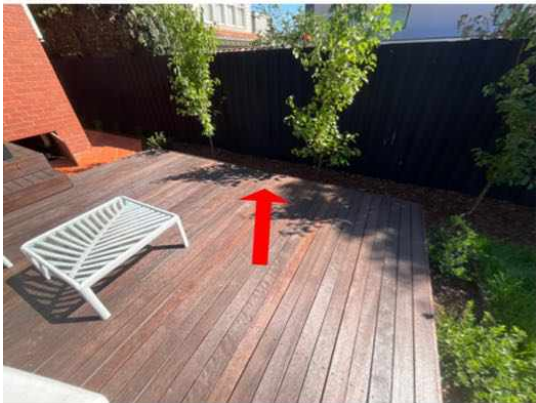
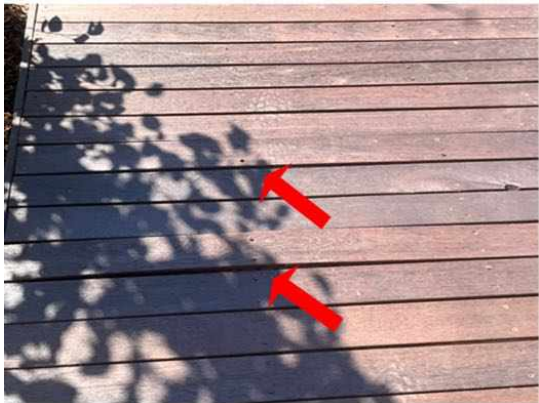
Information: At the time of inspection whilst the deck area at the rear of the house appeared in a good condition overall, there were a few sections where the boards were raised slightly and uneven. These raised areas may cause tripping hazards if not they lift further.

It is advised that a qualified carpenter or decking specialist be engaged to ascertain ways to rectify the defect. Re fixing, repair and / or replacement of the raised decking boards may be required.

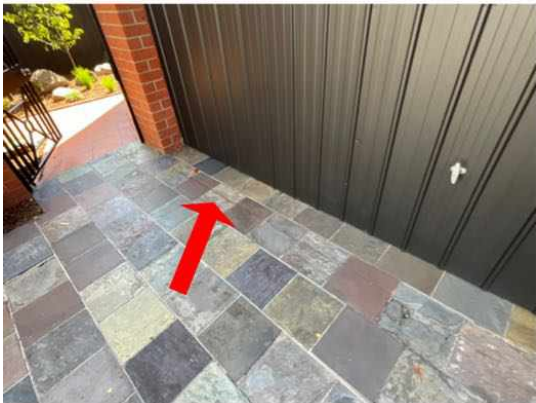
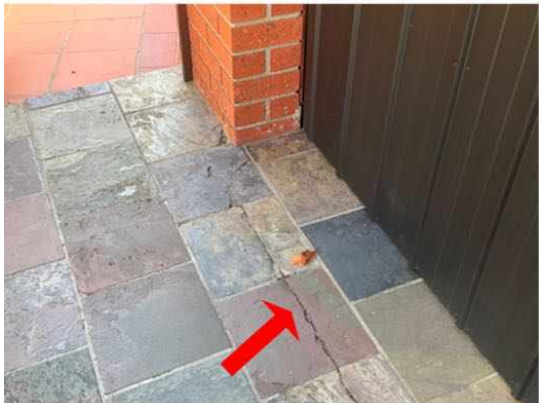
Finding 3.07

Building:
Location: Driveway
Finding: Paving - deterioration and cracking noted in some areas
Information: Sections of the external paved area on the driveway showed cracking, and missing pavers in some areas. It appears as though the area may have been subject to poor installation, or that paving sections have deteriorated over time.

Monitoring of the area is recommended . Should pavers deteriorate further, re-paving of the area may be required to remedy this situation.

Further consultation with a specialist landscaper would then be advised.

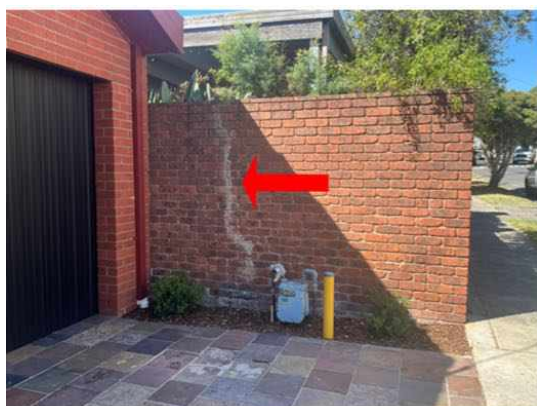
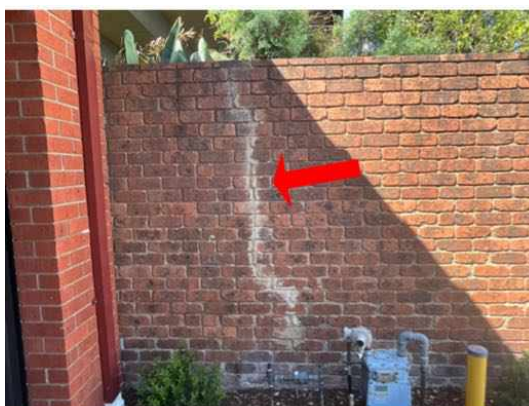
Finding 3.08

Building:	
Location:	Exterior walls - rear
Finding:	Brickwork - cracks and crack repairs noticeable
Information:	A crack and crack repairs was evident to boundary brick wall.

Noticeable cracks are a common occurrence in external brickwork and are a likely result of age, ground movement, or general expansion and/or contraction of brickwork in different weather conditions. Noticeable cracks in brickwork may develop if left unattended, with potential for necessitating remedial works or replacement of the brickwork.

It is highly advised that monitoring of these cracks and crack repairs be carried out to ensure no further cracking occurs in the area.

Always contact a building inspector should cracks widen, lengthen, or become more numerous.

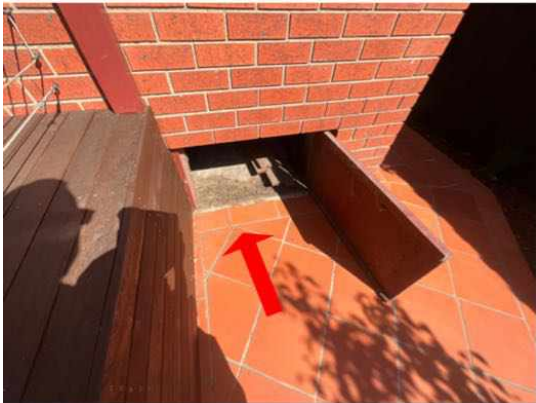
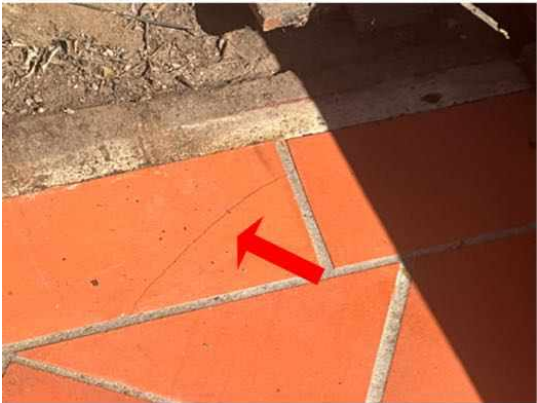
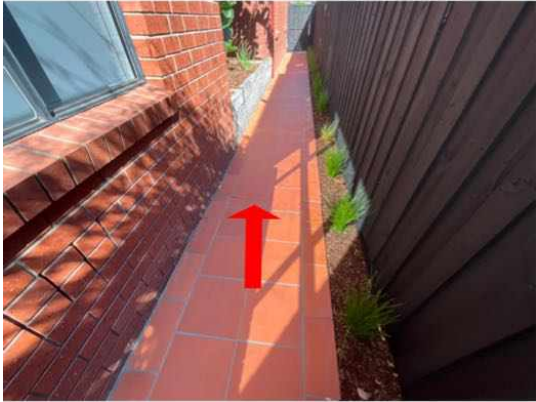
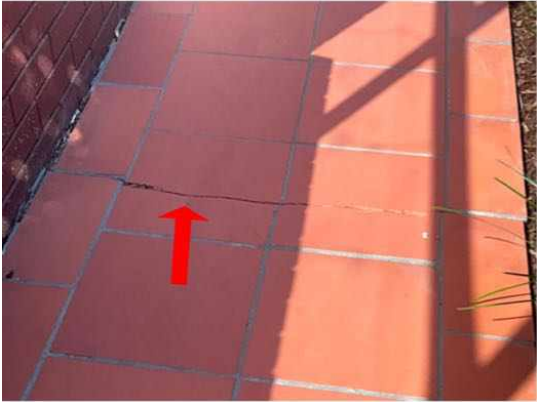
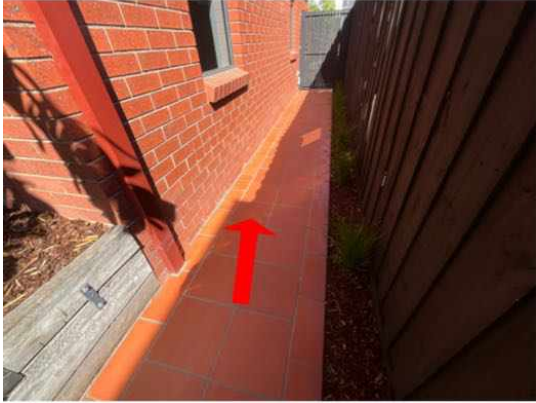
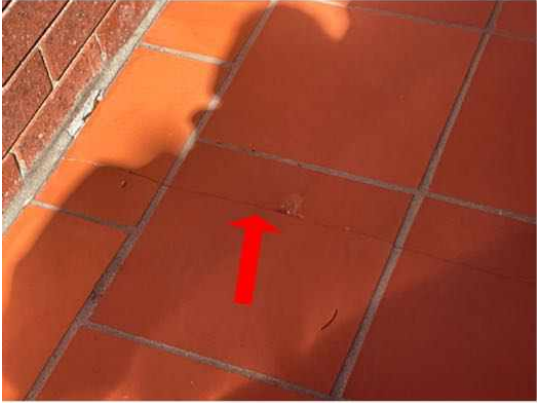
Finding 3.09

Building:	
Location:	All External Areas
Finding:	Fine but noticeable Cracking - External Concrete Paving
Information:	Fine but noticeable cracks were identified in the paved areas around the property.

General age and expected deterioration of the paved areas is a common cause of this type of cracking. However, expansion and contraction of the concrete may also have occurred due to environmental factors. Such factors include variable moisture and weather conditions, the presence of trees and their roots having a settling or lifting affect on the soil, or the effect of load bearing over a sustained period of time.

Cracking to this degree may also be due to poor original installation of the paving. Factors such as poor compaction of the sub surface and/or inadequate reinforcing of the paving may create cracking and other secondary defects. Noticeable cracks may also be due to subsidence of soils.

The area should be monitored for any changes that may occur and potentially cause tripping hazards. Should this occur, repair and likely replacement of the concrete paving may be necessary.

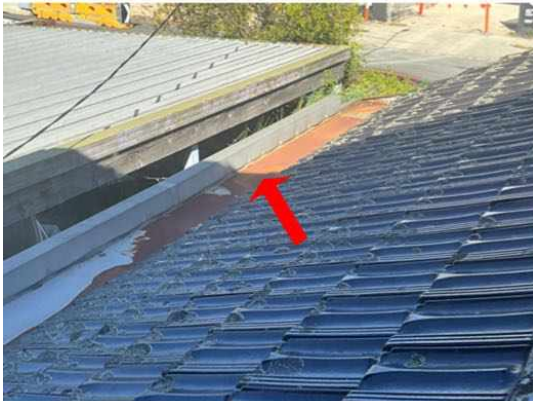
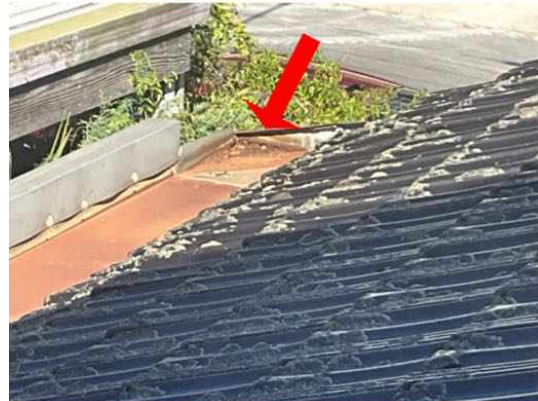
Finding: Guttering - Deterioration and rusting

Information: Upon inspection of the exterior roofing, it was found that the guttering above the garage shows signs of deterioration, with surface rust noted.

Rusted, deteriorated and damaged guttering is susceptible to water penetration, exposing the surrounding associated area to potential roof leaks and water damage.

A roofing contractor should be appointed immediately to assess the damage to the guttering and to perform remedial works as necessary. Works may include replacement of severely affected roofing or minor works such as the application of rust-retardant surface protectors.

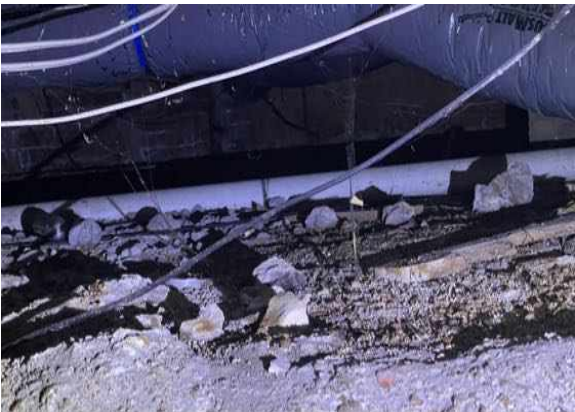
Finding: Surface mould found within the subfloor

Information: Upon inspection of the subfloor area, some surface mould was noted on the ground . It is suspected that the subfloor ventilation may be insufficient in these areas allowing the ground to remain slightly damp after rainfall. As a result, mould then forms on the surface. This is very common for properties such as this where ducting may prevent full cross flow ventilation .

Where ventilation is substandard it is usually caused by factors such as failure to install adequate vents during construction, subsequent building works or earth and vegetation covering over vents, low subfloor clearance, ducting, or stored items / debris within the subfloor restricting airflow.

Subfloor ventilation can be improved in some cases by addressing the causes such as exposing subfloor vents, installing additional new vents, installing mechanical (forced airflow) ventilation or removing debris from the subfloor.

A registered builder may be appointed to inspect the subfloor area and make any recommendations as necessary.

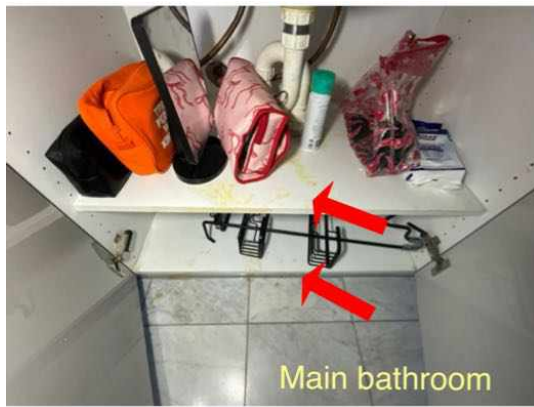
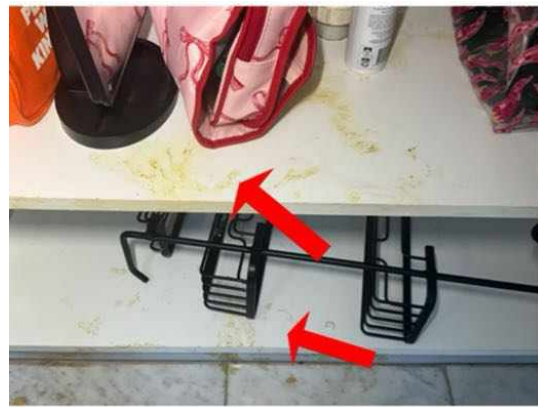
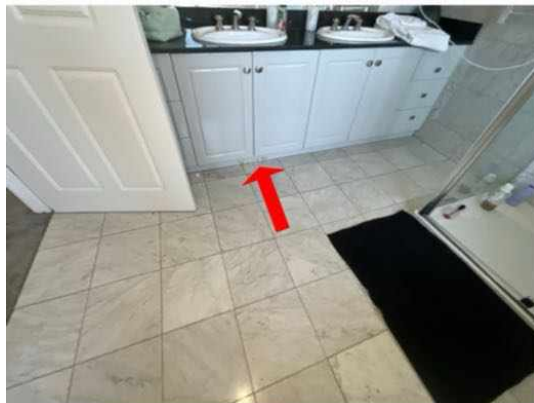
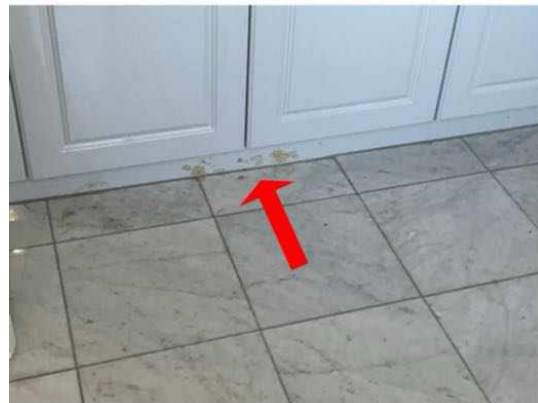
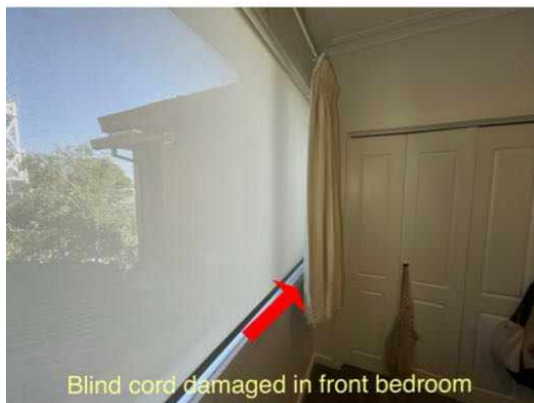
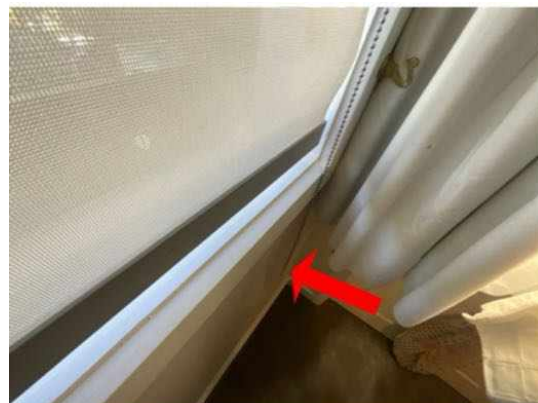
Finding 3.17

Building:
Location: All Areas
Finding: Additional Photos - minor defects
Information: Additional photos are provided for your general reference. Arrows have been included where necessary to highlight areas of importance.

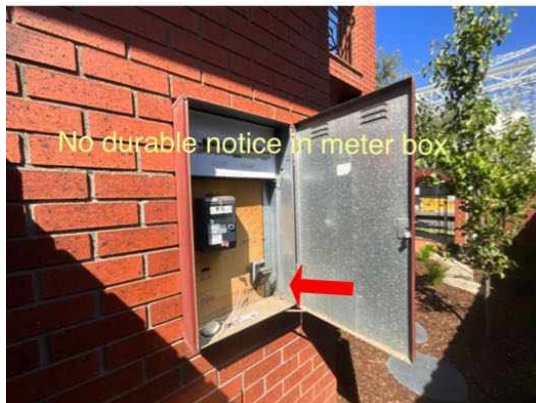
Information: The application of a post-construction chemical termite barrier is highly recommended for all properties, particularly if live termite activity has been found on the site previously. Such barriers are highly effective in preventing termite attack on any timber building elements throughout the property.

A durable notice should be placed in the switchboard unit to indicate current termite barriers. At the time of inspection, it appeared as though no termite management system has been installed, with no evidence to suggest preventative works taking place.

The client may consider gaining further advice from a pest controller as to the costs and procedures involved with this application. It is recommended that obtaining such advice be a short-term priority.

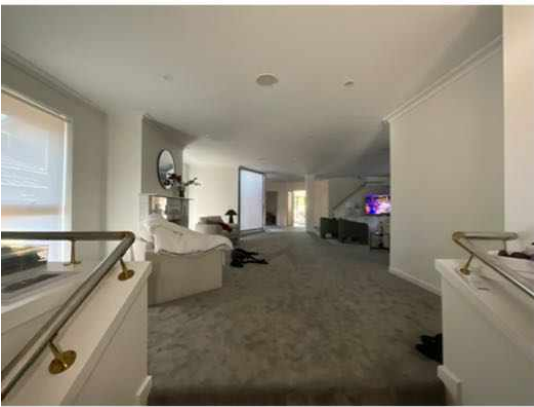
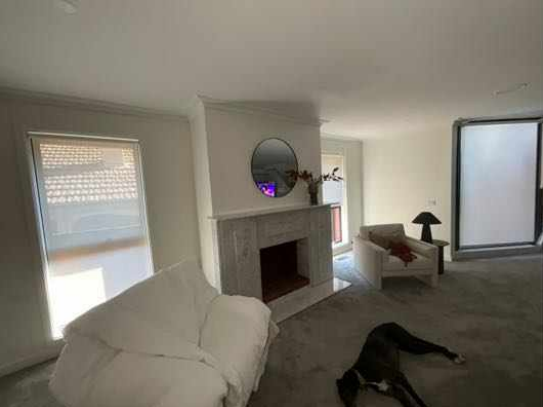
Noted Item

Building:
 Location: All Areas
 Finding: Additional Photos - Obstructions and Limitations
 Information: These photographs are an indication of the obstructions and limitations which impeded full inspection of the property at the time of inspection. These obstructions can hide an array of defects and should be removed to allow full inspection to be carried out. A re-inspection is recommended once the areas are made accessible.
